Semi-annual Environmental Monitoring Report

Project Number GEO 51257-001

Reporting period: January - June 2021

Georgia: North-South Corridors (Kvesheti – Kobi) Road Project

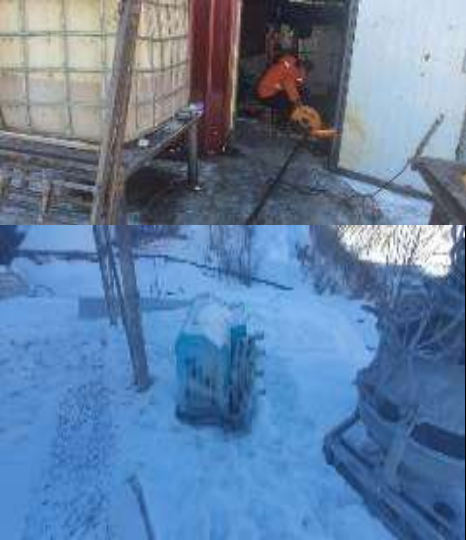
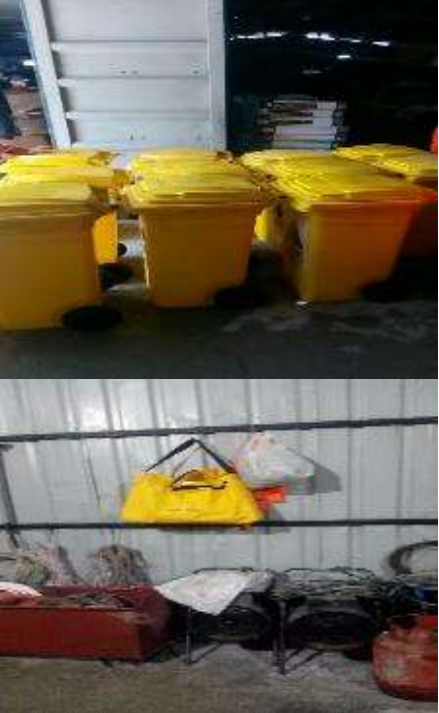
ID#	Affected Location	Date	Issue raised	Mitigation Required	Estimated time	Corrective Actions	Status of Action
1	North portal Kobi	Jan 2021	<ul style="list-style-type: none"> • Drip trays not provided under the oil drums and water reducing chemical containers • Hazardous waste containers are not provided at the site to store hazardous material. • Spill kits to be provided by the CC at the site

<p>CC for lot#1 should provide dip trays, under all oil drums, chemical containers</p> <p>CC to provide hazardous waste containers at site</p> <p>Cc to provide spill kits at the site</p>	Immediately	<p>CC provided the spill kit at the site and distributed these at the site near the oil contained facilities .</p> <p>Containers for hazardous waste are provided at the site</p>

<p>Open</p> <p>CC to complete requirements and provide the drip trays for the chemical containers which are in use.</p>

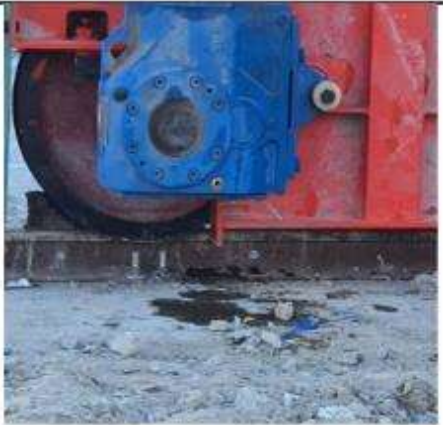
Closed
5	North portal Kobi side camp	Jan 2021	Oil spill observed at several locations of about 2 to 3 liters due to leakage from spare parts and dripping of oil during refilling of diesel in to trucks.	CC for lot#1 should collect the contaminated soil, store in the hazardous material storage area and hand over to the subcontractor for hazardous waste collection	immediately	Contaminated soil was removed and stored in hazardous storage area. It was taken by the sub-contractor Medical Technology LLC in June 2021 responsible for collection, transportation and treatment of the hazardous waste. License shown in the picture below	Closed

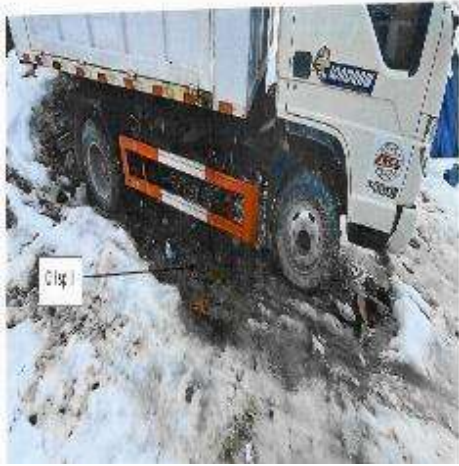
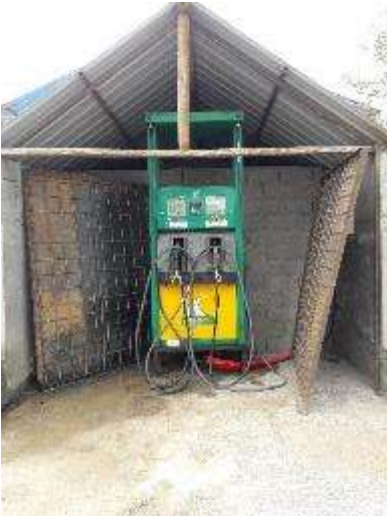
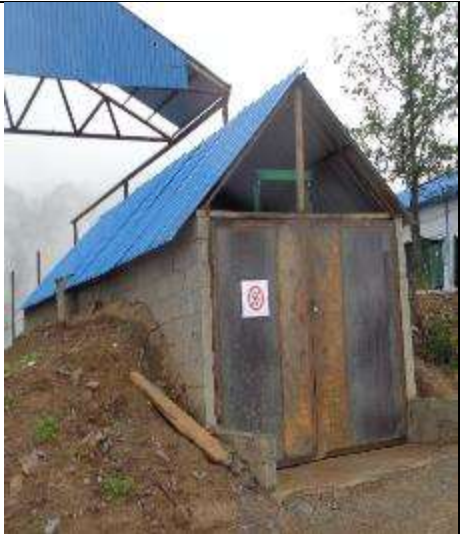
9	Lot#2	Feb 2021	Oil Spill due to improper refueling of Dumper Truck from the diesel tanker for lot #2.

CC to provide secondary containment for refueling and trucks should get the fuel from the nearest fuel station. CC to collect the contaminated soil, store in the hazardous material storage area and handover to subcontractor	One month	Currently CC for lot# 2 arranged drip trays for oil containing facilities and installed new refueling facility at Plateau near BP# 2

<p>CC collected the contaminated soil and handed over to the subcontractor hired for collecting hazardous waste.</p>	
10	Lot#1 TUN# 5 Kobi	Feb 2021	During winter workers were warning hands by burning wood near tunnel portal.	CC to provide heaters inside the cabin near tunnel portal	Two weeks	<p>Heating facility provided for the workers inside the Cabin close to tunnel 5.</p> <p>Training provided to the workers to restrict the open burning of wood.</p>	Closed

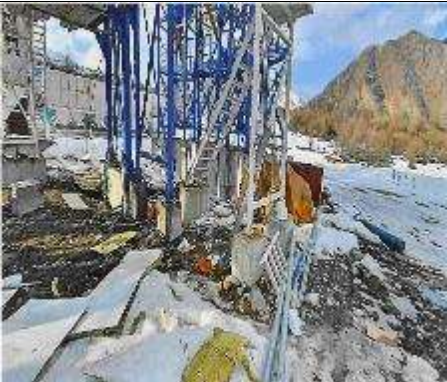
11	Lot#2 Camp 2	Feb 2021	<p>Waste scattered on site and there is no proper waste disposal area</p>  	<p>CC for Lot#2 to arrange the waste disposal area and scattered waste should be collected immediately</p>	<p>Collect and waste immediately and arrange waste disposal arrangement and bins in two weeks</p>	<p>Waste bins are provided on the Site. Toolbox trainings are conducted to the staff about waste management, its issues, etc.</p>  	Closed

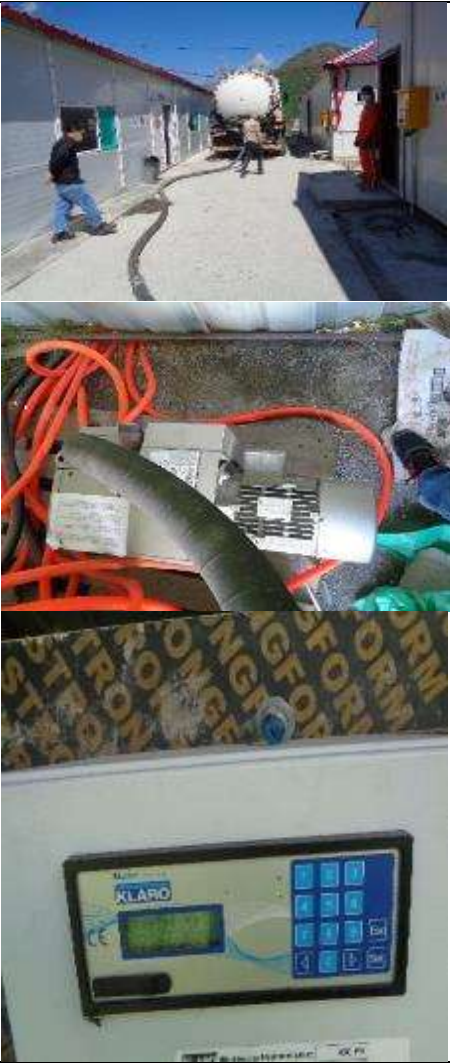
14	North portal Kobi side	Feb 2021	Sewage treatment plant (STP): The Contractor has prepared a Wastewater Management Plan. At the time of the site visit a sewage treatment plant (STP) consisting with two reservoirs with capacity 100m ³ applying biological treatment method was constructed and the sewage generated on the site comprising sanitary wastewater (sewage) and domestic wastewater (wastewater from kitchens, showers, washing facilities) conveyed to the STP for treatment). At this stage the STP is closed by concrete blocks but soon it will be closed with a roof. Fencing is also should be installed around the reservoir. In the future, the treated sanitary wastewater will be discharged into the Narovani River which flows adjacent to the Accommodation	Sewage to be treated to meet the National and IFC requirements. CC required to obtain the approval from MoEPA ASAP.	One month	<p>Treated water from the wastewater treatment plant is not discharged into the river, as there is still no MoEPA approval for the maximum permissible levels of pollutants discharged into the river from the WWTP. The contractor removes waste water from the tank by the subcontractor "Sanitary ltd". The documentation is available on the Site.</p> <p>Discussed in detail with CC in weekly progress meeting on 9-06-2021. CC replaced the old treatment plant with the new on at Septic tank which was not working properly. Cesspool truck is carrying out the sewage</p>	Open

Currently sewage truck also carrying the wastewater from the gutter for kitchen separately: however, CC is ready to build an oil grease trap near the kitchen

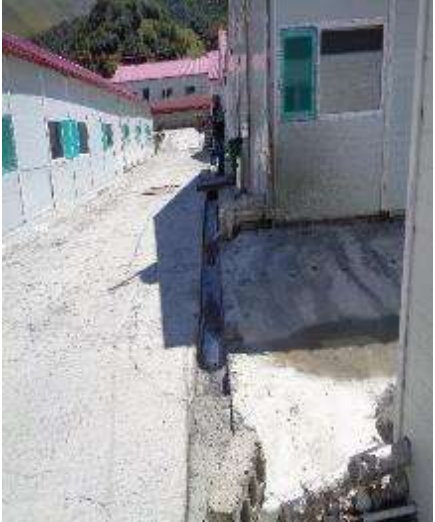
15	North portal Kobi side camp	Feb-April 2021	<p>Rainwater drainage was partially constructed at the time of the site visit. No progress has been observed for completing the planned works. The rainwater runoff will be collected and drained to a basin (not constructed yet). The network will be equipped with sand traps (though not installed yet). The basin will be equipped with a 3-stage oil-water separator, the collected rainwater after passing through the oil-water separator will be discharged to the river. The discharge point is currently unknown. Contractor plans to resume rainwater drainage construction as soon as weather conditions will be improved.</p>	CC to build the drainage system for the campsite	Two weeks	<p>. CC has built the hard floor by concreting the floor of the campsite and provided the drainage ditches to carry the stormwater . Even after heavy rain water is being absorbed by the soil very quickly. However, some water ponding was observed along the access road close to E117 Highway and CC is pumping that water, when required, and spraying this water on the access road.</p>

<p>Open Kitchen wastewater r is disposed through septic tank and wastewater r being collected by LTD Sanitary .</p> <p>Oil trap to be installed for kitchen wastewater r.</p>

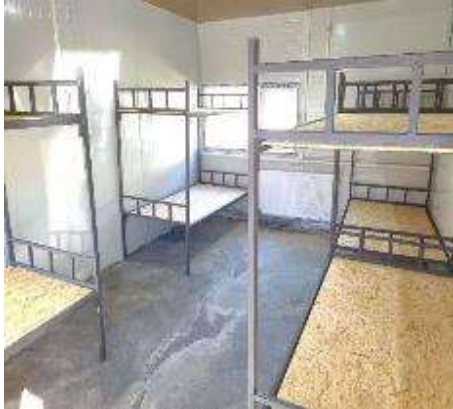
16	North portal Kobi side camp	Feb-April 2021	<p>Workers accommodation: Accommodation conditions of workers at the camp site of contractor is poor and not in line with the requirements of ADB and IFC. The following non-compliances with regard to hygiene were identified at the site:</p> <p>i) in some cases, there is not enough space for living,</p> <p>ii) rooms are equipped only with beds, no drawers and no closet;</p>	Workers and working conditions to be according to IFC and ADB requirements	One Month	<p>1) Contractor plans to provide some more dormitories for the Contractor's employees. Currently, each dormitory (about 20 m² room) is accommodated with 4 residents and is equipped with the double deck bunks (with enough clear space between the lower and upper bunk of the bed).</p>

<p><i>New Constructed Dormitory</i></p> <p>2) Contractor has provided the drawers and cabinets in some rooms. The same is required for all room.</p>	Open In progress

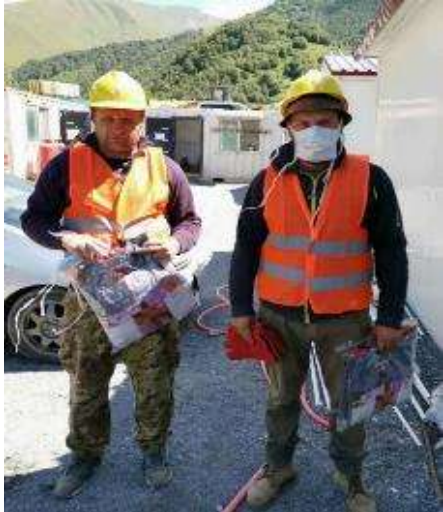
17	North portal Kobi site	Feb - April 2021	Besides some improvements regarding the H&S the following non-conformity issues related to occupational health and safety	CC to ensure the safe work practice , provision of First aid arrangements and ambulance service	One month		Open Ambulance to be at

<p>practice were observed during the site visit:</p> <p>i) Not all workers wearing PPE (some not wearing a helmet and/or safety boots);</p> <p>ii) Power cables are not installed according to safety requirements;</p>			<p>1) The appropriate PPE including fall arrest harness are distributed to all of workers, SHE department will supervise and enforce the workers to wear PPE on site at all time.</p>

<p>2) Power cable are installed properly on site</p>	<p>the site all the time;</p> <p>All sites to be fenced;</p>
--	--	---	--	--	--	--

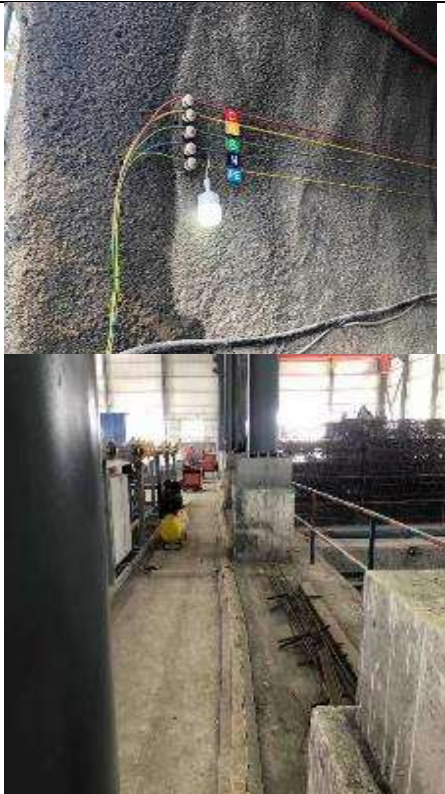
<p>iii) Construction camp and other facilities are not fenced and restricted from unauthorized entry, therefore there is a possibility that the local community may enter the project areas without wearing PPE;</p>

<p>3) Security guard hired and performing their duty to restrict the unauthorized entry and trespassing. Fence for the campsite has been completed, although fencing for difference sites still pending. .</p>
--	--	--	--	--	---	--

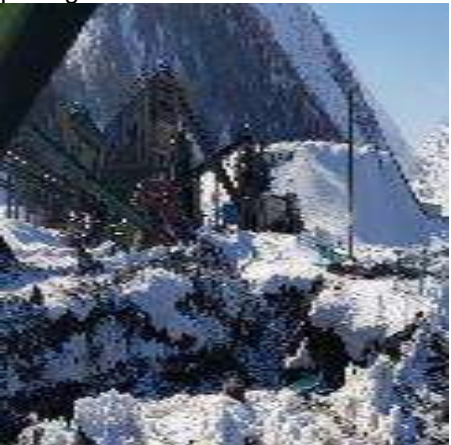
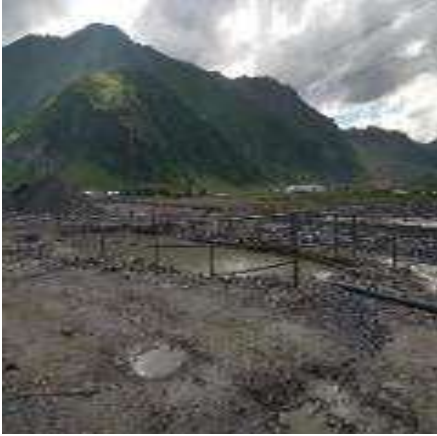
18	North portal Kobi Crushing plant	March 2021	The fence around the trench is damaged and covered by snow posing the hazard

CRTG has to repair and reinstall the fences	Immediately	The fencing is re-installed . No open trench seen at the site

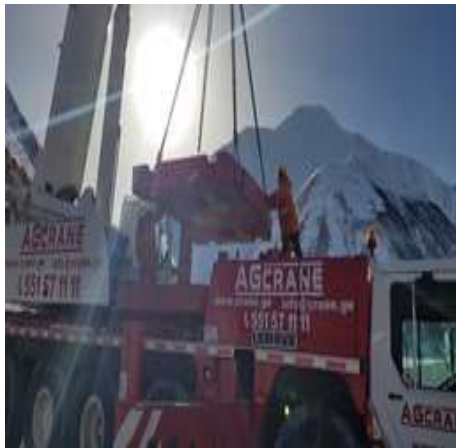
22	North portal Kobi side camp	March 2021	<p>The unsafe act was observed during the site inspection in the construction area, where preparation works for TBM is ongoing. Two persons were controlling the load by hand rather than using ropes as per good practice.</p>

<p>The contractor to stop the unsafe act and should instruct its personnel to control the load with ropes. CRTG has to improve HSE supervision on sites to Prevent similar disorders. The lifting activity must be performed according to safe lifting procedure</p>	immediately	<p>The unsafe activity was stopped immediately</p> <p>The safe lifting procedures were shared with the workers</p> <p>The OSHA company conducts rigger man training to lifting team</p> <p>The matter is being highlighted in daily Tool Box Talking</p>

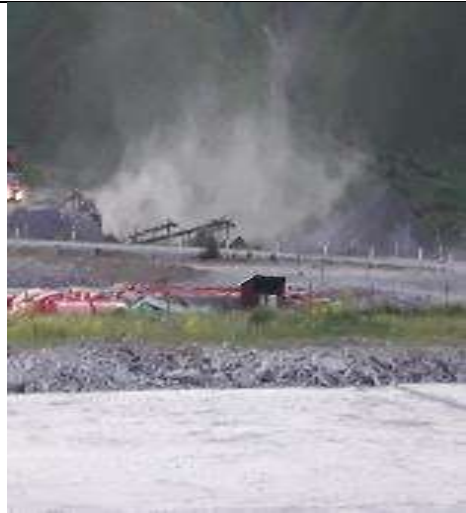
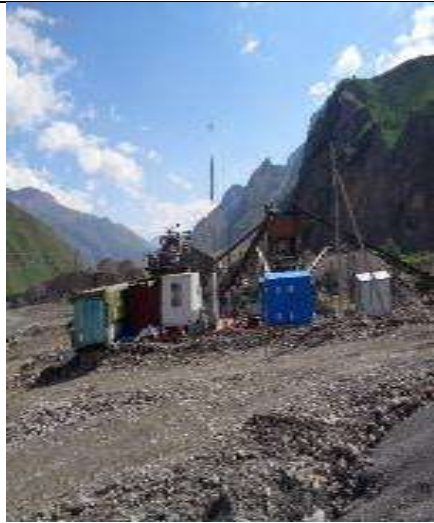
33	Crushing Plant Lot 1	June 2021	Fugitive dust emission due to accidental closure of water sprinkler system of crusher	Regular inspection for water sprinkler system is required	One week	Water sprinkler system restored in a minute to normal conditions	Closed

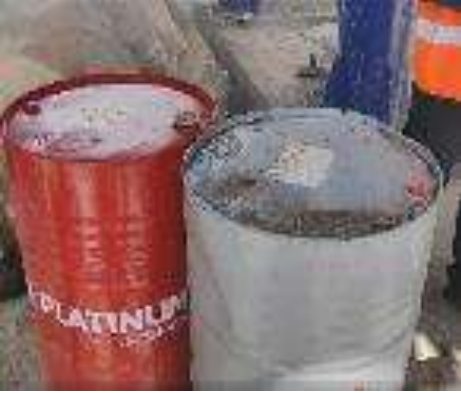
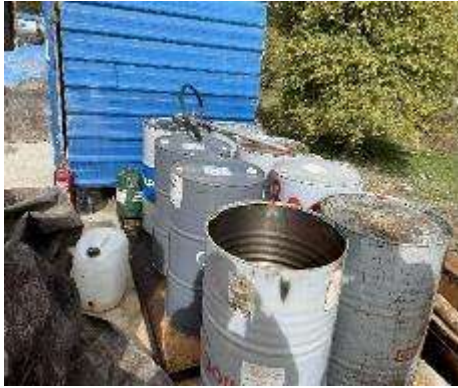
38	Lot 2 BP 2	June 2021	<p>Storage of hazardous Material</p>

<p>CC to store the drums at the hard floor and provide drip trays</p>	2 weeks	<p>Drums on Hard floor and covered by Tarpaulin, Advised CC to provide drip trays at site and provide under the drums while shifting oil. CC started providing drip trays for generators, machines.</p>

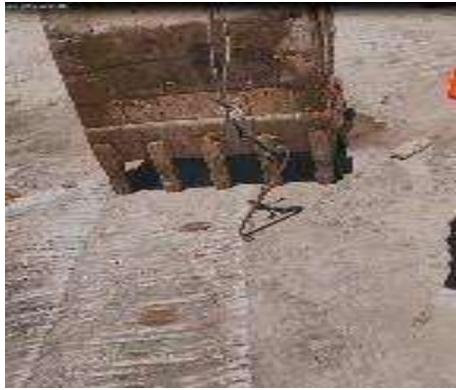
43	Lot 2	June 2021	<p>Unsafe lifting operation for concrete slab</p>

<p>Safe lifting procedures required with training of the workers involved</p>	One week	<p>Safe working procedures adopted at BP 1 Lifting training provided to the staff The mentioned equipment was removed from the site.</p>

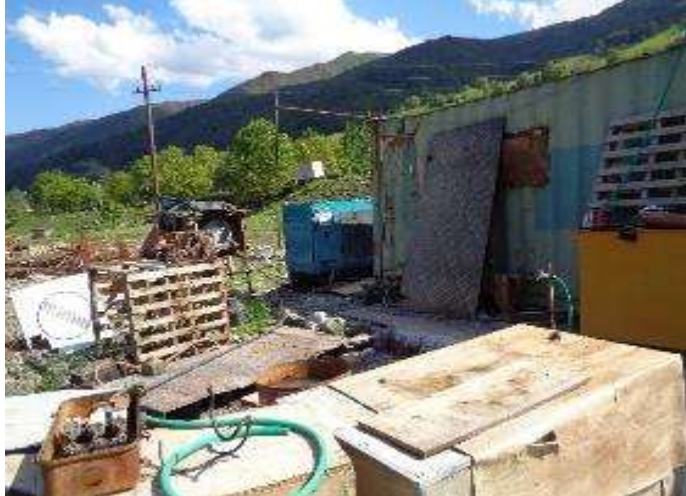
Parking area workshop needs to be rearranged
39	 	Rearranged after 2 days
40	 	Welding workshop need to be shifted at lot 2 BP 2

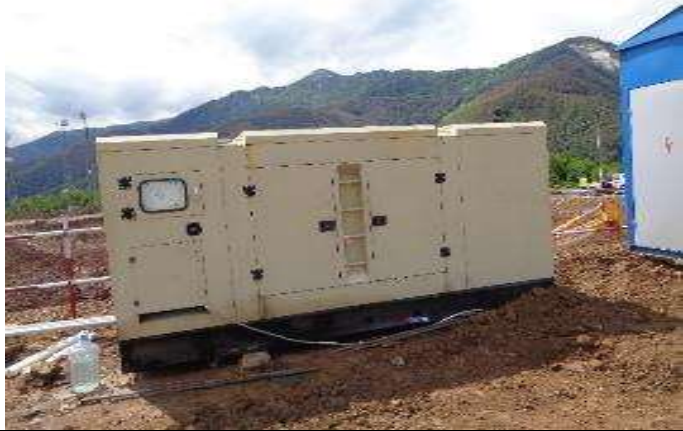
Generator requires drip tray and hard floor
45

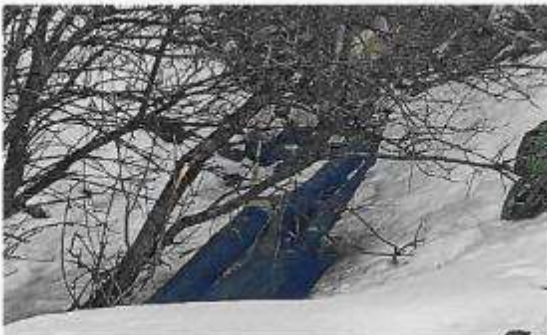
Damaged water collection pipe (approximate coordinates X459376 Y4711592)
