# Semi-annual Environmental Monitoring Report

January - June 2019

## **Georgia: East - West Highway (Khevi-Ubisa Section) Improvement Project**

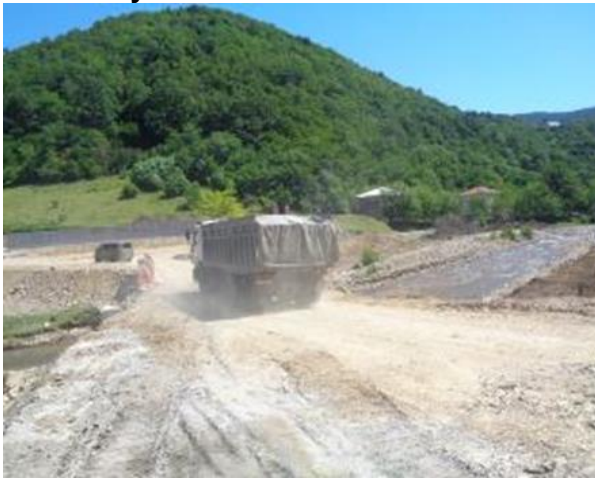
**Photo 11: Fugitive dust at batching plant 1 Khevi – Advised water sprinkling in dry and windy conditions**

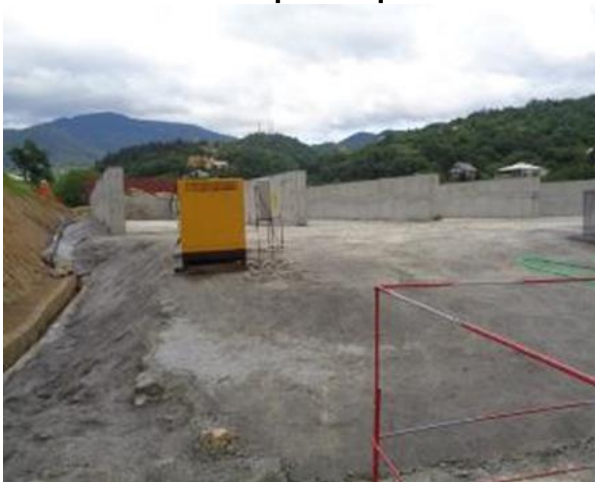
**Photo13:Hard floor for material yard with storm water drains- need to be covered - storm water interceptor required**

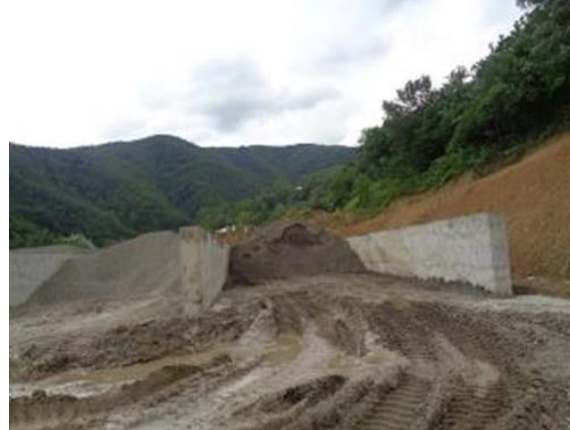
**Photo 18: Muddy floor – Mud is carried by the vehicle tires to E60 road.**

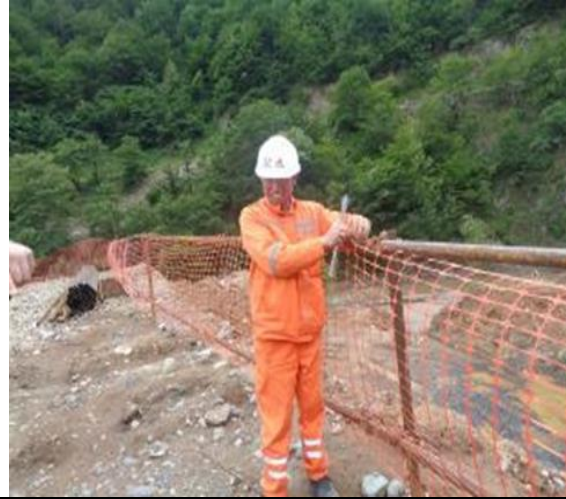
**Photo 22: Advised worker to strengthen the Fence at Rebar sites**

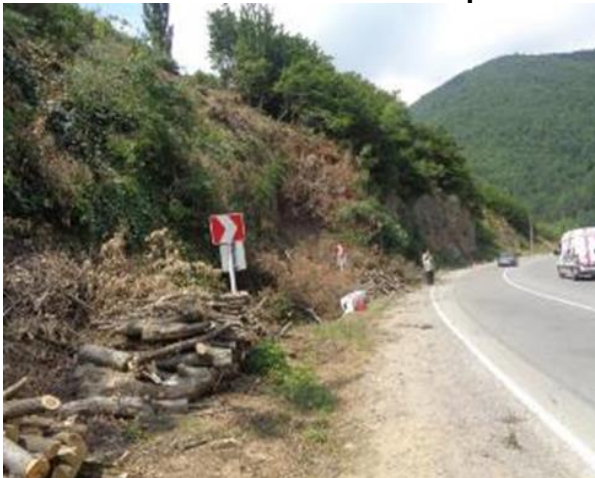
**Photo 25: Wood logs need to be removed by municipalities – advised the contractor to contact with municipalities**

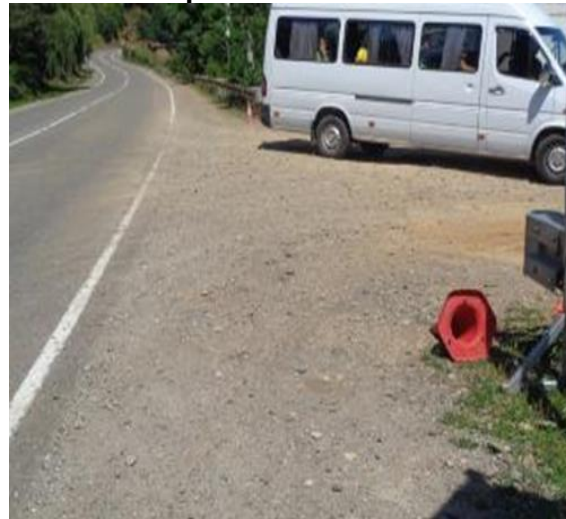
**Photo 28: Traffic bumps and line separation required along the road to control the speed**

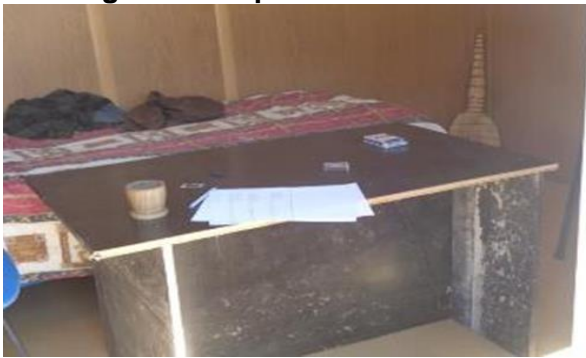
**Photo 29: Guard room need to be equipped with fire extinguisher, hangers, drinking water dispenser and PPEs**

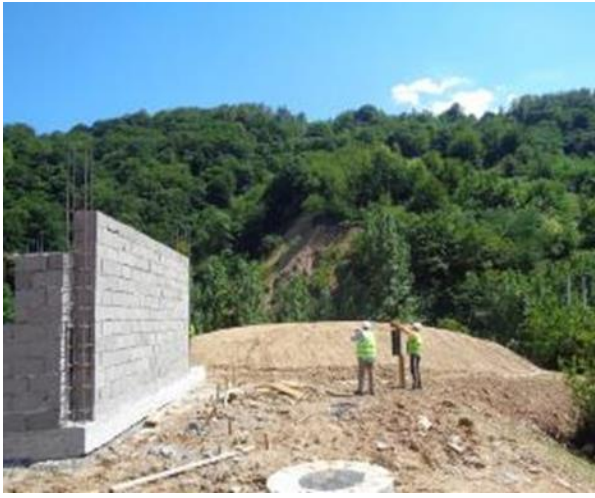
**Photo 33: Topsoil need to be reserved to control the flow of sediments**

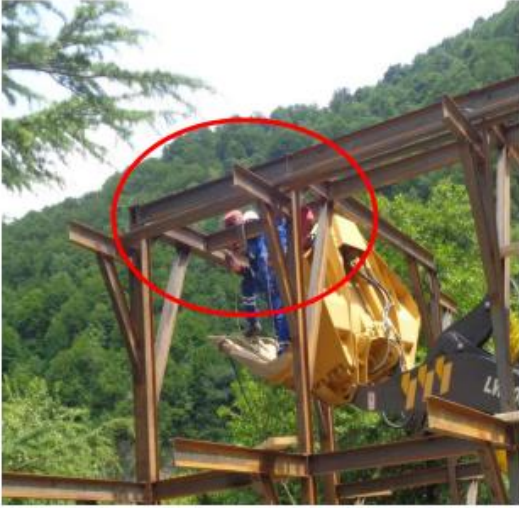
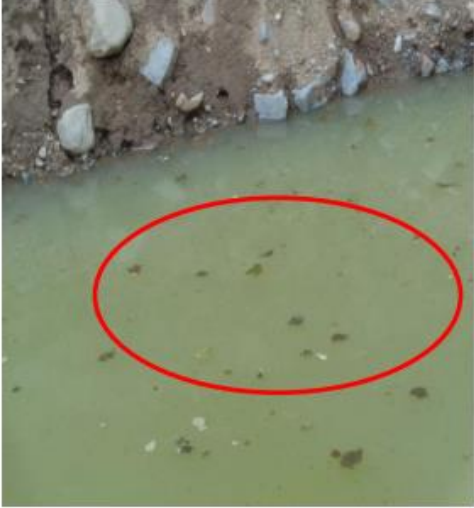
<p><b>1. Description of nonconformance:</b></p> <p>During the site inspection 28-6-2019, it was found that near tunnel portal 3 site worker was using loader for working at height which is extremely dangerous and at bridge 8 stagnant water is being polluted and acting as breeding habitat for insects</p> <p><b>Figure :</b> i Working at height by using loader,      ii Stagnant water in the excavation- breeding habitat</p> <div style="display: flex; justify-content: space-around;">

</div>		
<p><b>2. Action to be taken to prevent</b></p> <ul style="list-style-type: none"> <li>• Work stopped immediately and warning Given to the Worker</li> <li>• Stagnant water need to be extracted from the excavation within 2 days</li> </ul> <p>All these conditions need to be rectified within 2 days.</p>		
Environmental Engineer	Name: Kashif Bashir

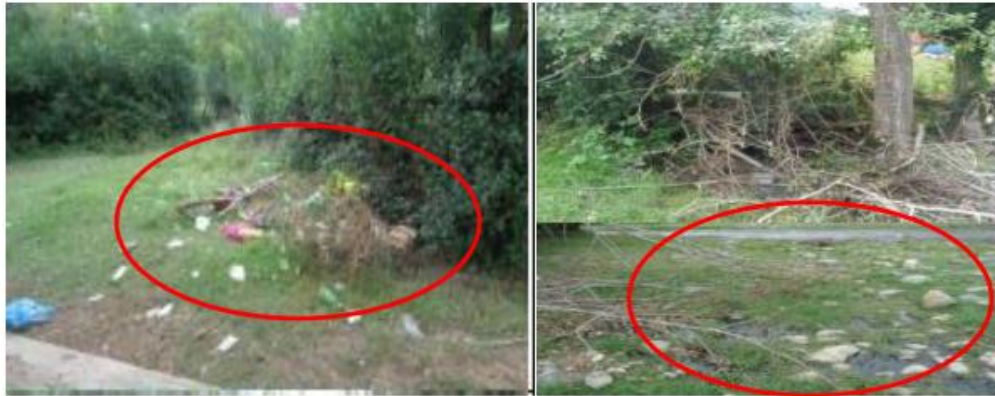
Immediate action required to clean out the River Bank contaminated by the garbage thrown by workers and sanitary wastewater being discharged from the septic tank. Sanitary wastewater disposal should be according to Georgian laws and IFC guidelines. This practice need to be stopped in future and you are required to take action immediately

**Figure :** waste thrown by local workers along the river Dzirula, stagnant water taking the way to River

- Sanitary wastewater need to be tested and must be within the MCL according to Georgian law
- Waste need to be removed immediately in one day

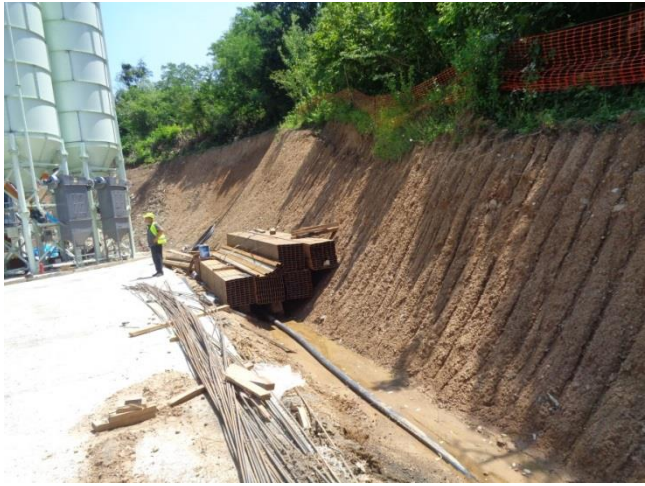
Potential chances of uncontrolled erosion due to de-vegetation. Replantation of fast-growing species is required to limit the flow of soil

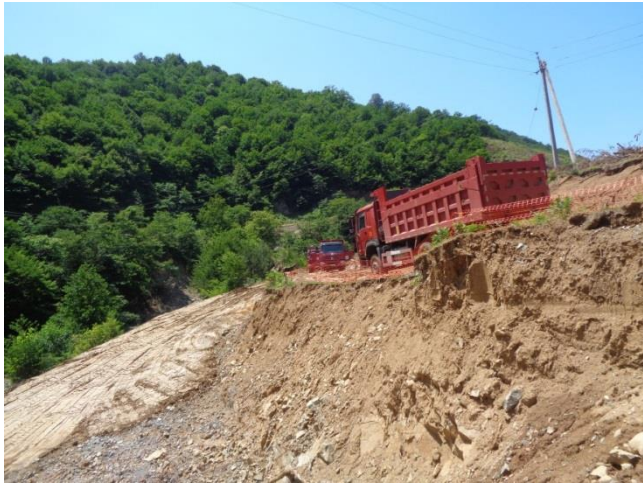
<p>Vehicles leaving the storage area of batching plant carrying the mud to the road by their tires. Surface needs to be hardened with proper drainage.</p> <p>Chances of muddy water coming on the road at batching plant 2.</p> <p>Material needs to covered by shades</p>

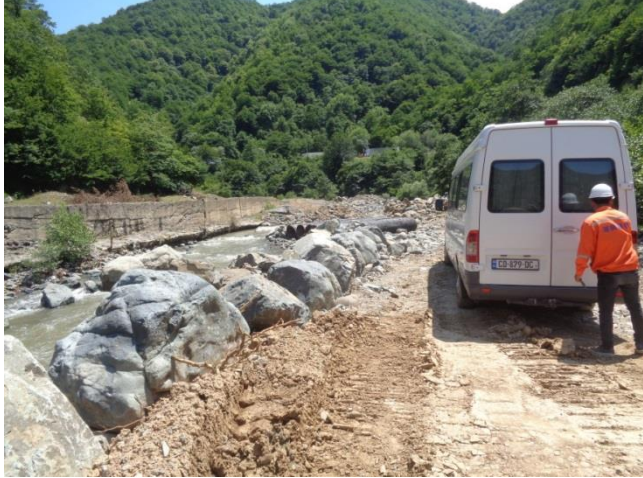
22	 	Dusty Conditions during the rock cutting at construction site
23	 	Erosion control measures required to avoid the contamination/ sedimentation loading of River Dzirula near Khunevi. Temporary measure required at this stage to limit the flow of eroded material in to water body
24
