## BI-ANNUAL ENVIRONMENTAL MONITORING REPORT

*Project Number: 41122-023*

*January – June 2015*

Georgia: Road Corridor Investment Program  
(Financed by the Asian Development Bank)

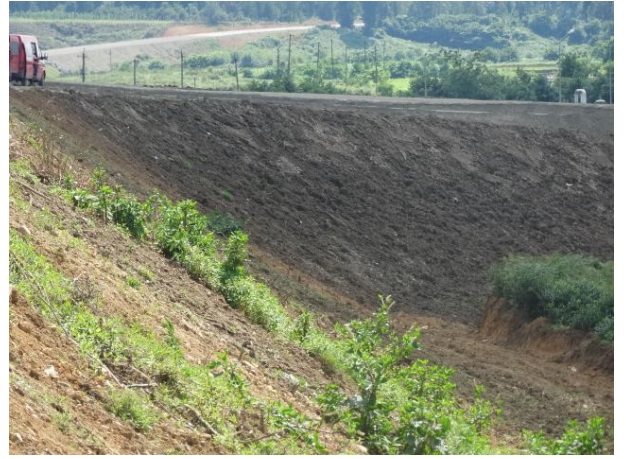
**Embankment reinforced by the topsoil**

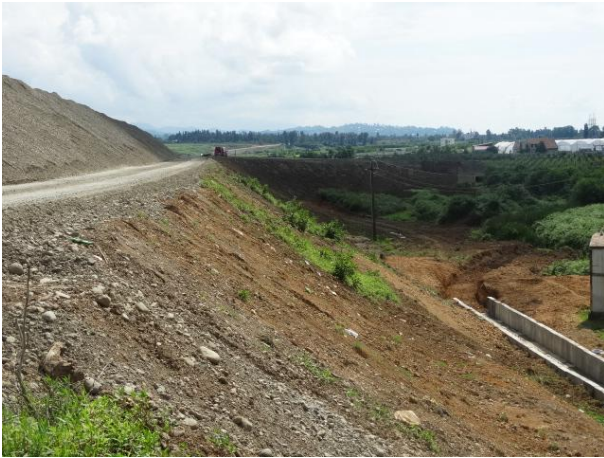
**Reinforced road embankment and concrete drainage**

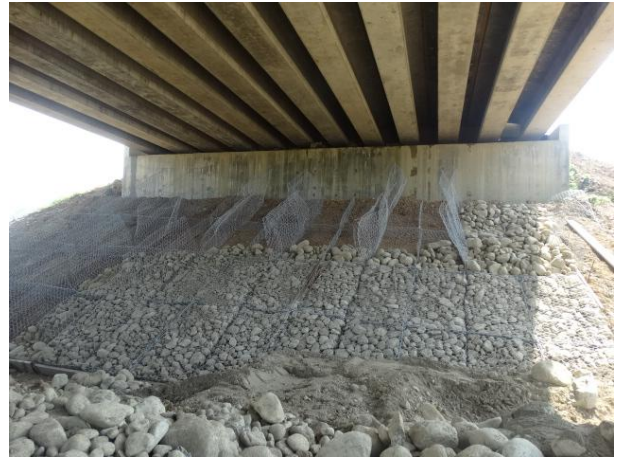
**Gabion constructed for stabilization of soil under bridge #1**

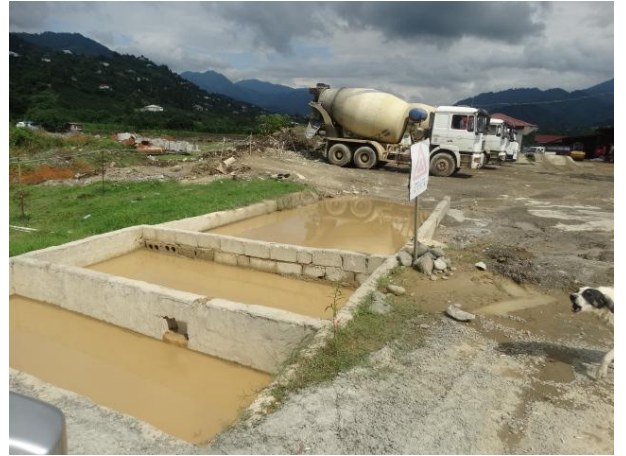
**Sedimentation filters for concrete factory**

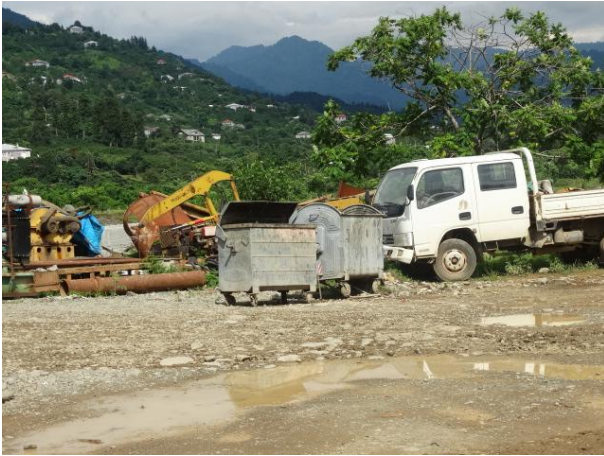
**Disposed household waste, empty waste containers**

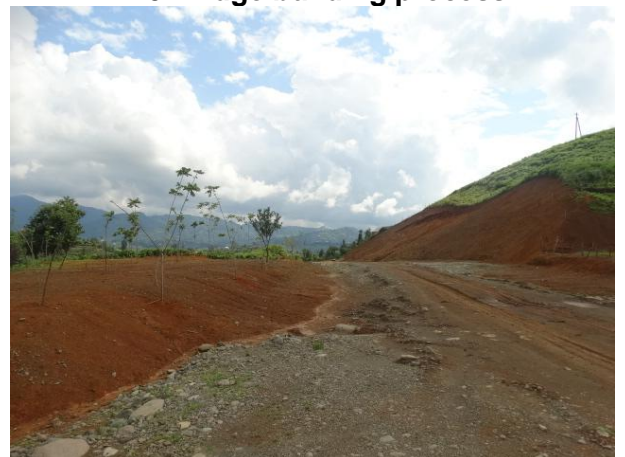
**Trees planted for stabilization of excavated slope**

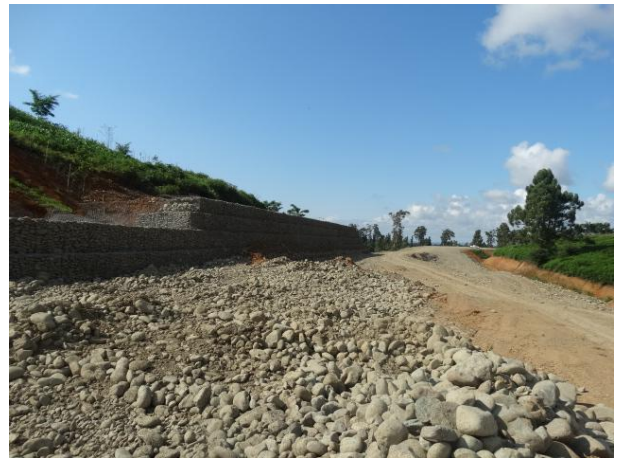
**Ongoing process of building gabion for reinforcement of the excavated slope**

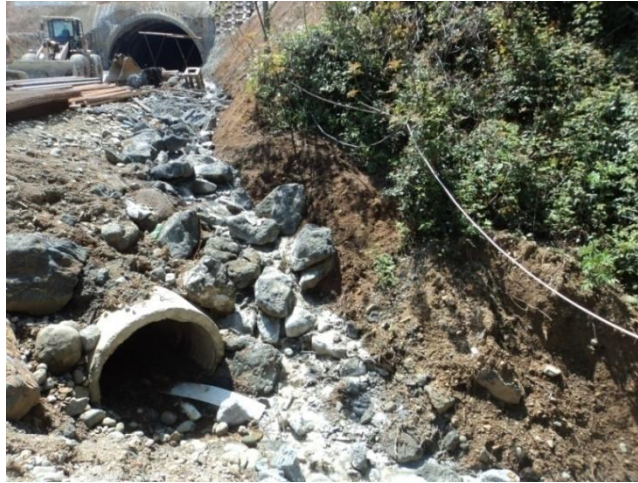
**Used water from tunnels draining in the ditch without proper filtration**

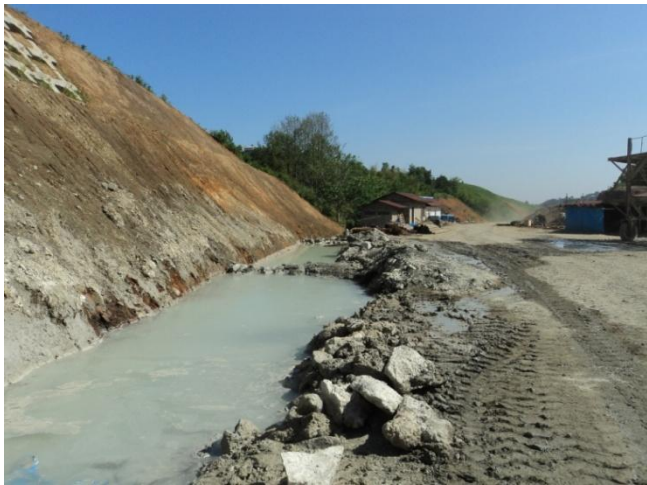
**Tunnel waters draining through 2-step sediment pond**

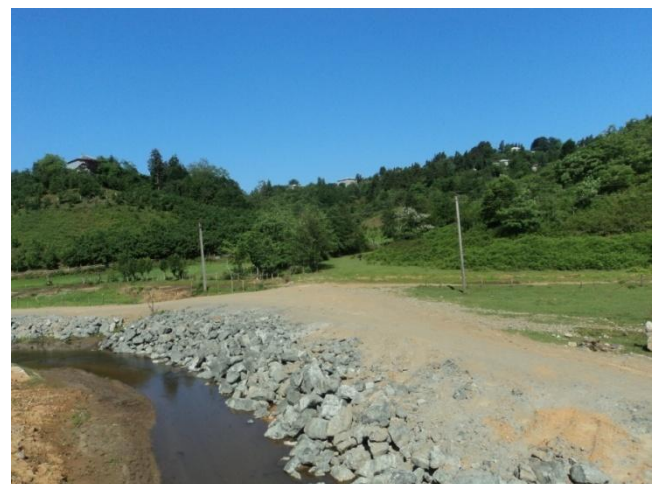
**Usage of rock boulders for reinforcement of the banks**

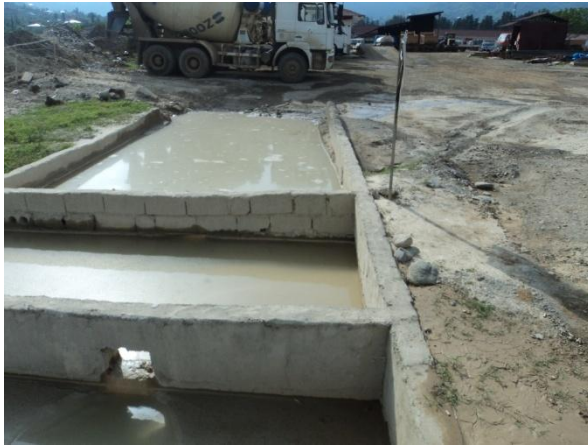
**Clean sediment pond**

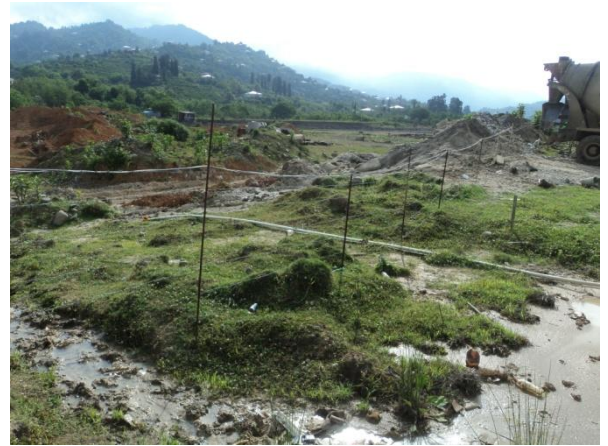
**Area clean from used oil filters and plastic bottles**
