Semi-annual Environmental Monitoring Report

Reporting time period January 2019-June 2019

Republic of Georgia: Rehabilitation of Dzirula –
Kharagauli –Moliti – Pona – Chumateleti Secondary Road
Section (50 Km)

SC Roads Rehabilitation and
Modernization Supervision Direction
Ltd,
ShalvaBosikashvili, Environmental
Specialist

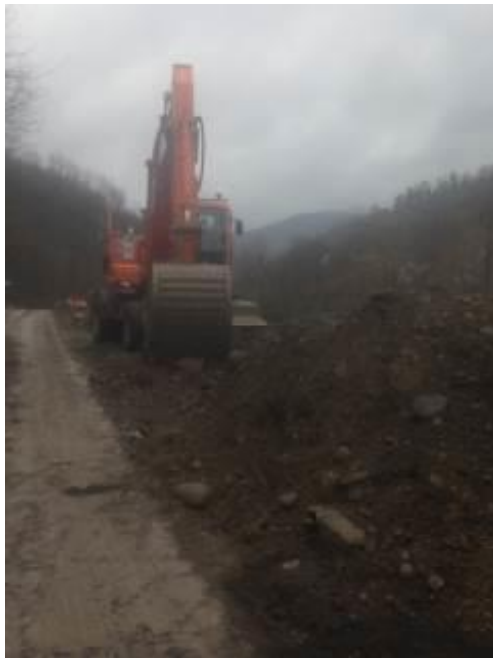
Backhoe works without banksman

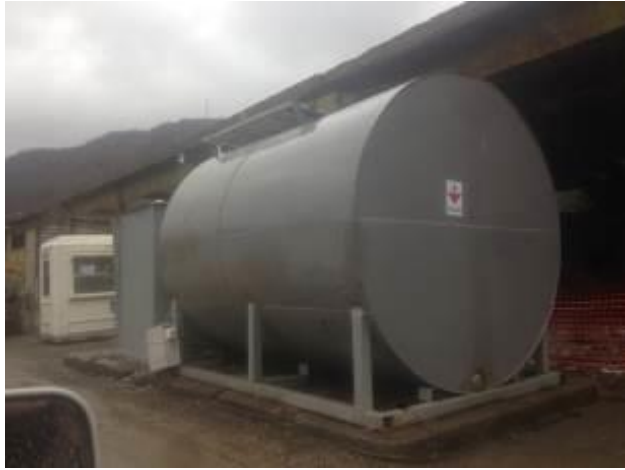
Fuel tank should be placed in the secondary containment structure and roofed

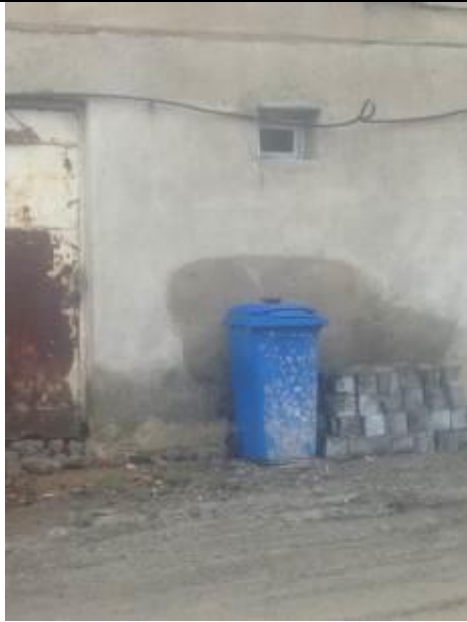
All waste containers should be clean and with appropriate label.

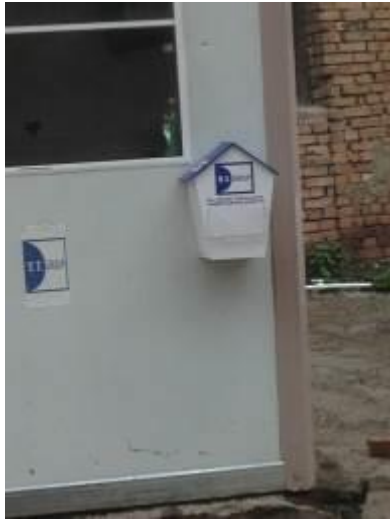
Grievance boxes are placed at the several locations

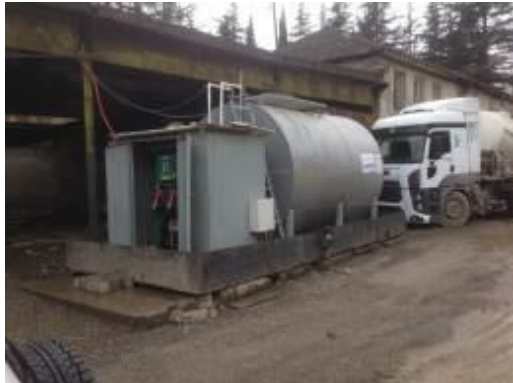
Fuel tank placed in the secondary containment structure, light roof should be constructed.

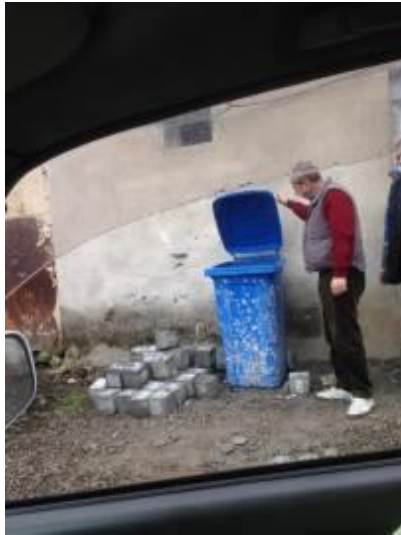
All waste containers should be clean and with appropriate label.

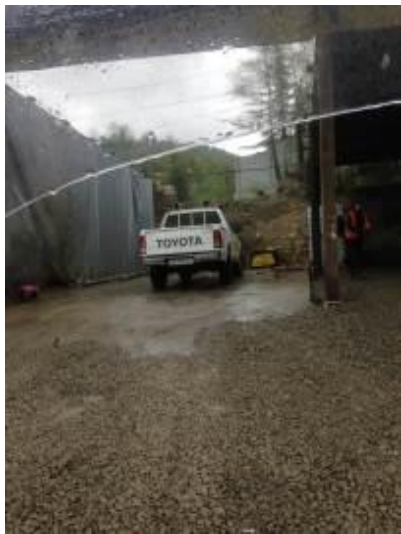
Car wash should be equipped with drainage system and oily water separator pit.

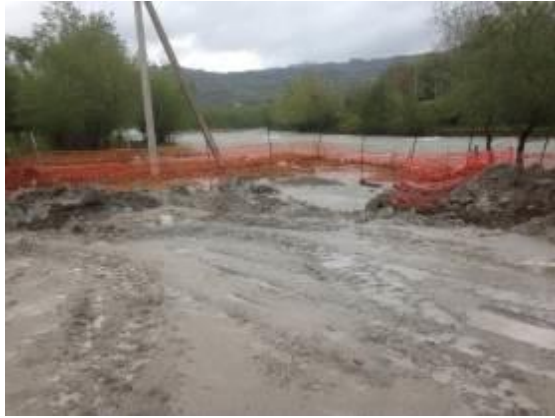
Area around the concrete washout pit is contaminated with concrete remains, relevant mitigation measures should be implemented ASAP to prevent nearby river contamination.

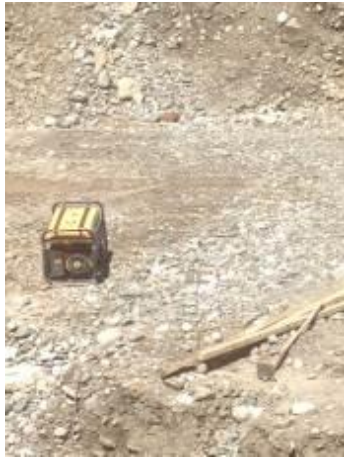
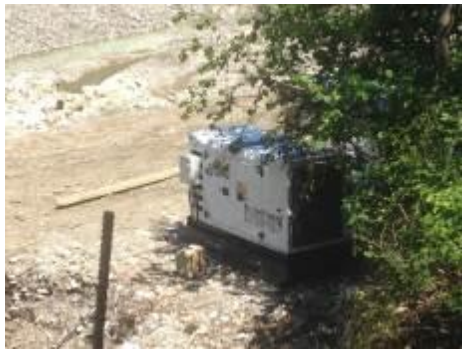
Power generators without drip trays, hand tools and timber scattered at the working area. KM 9+700

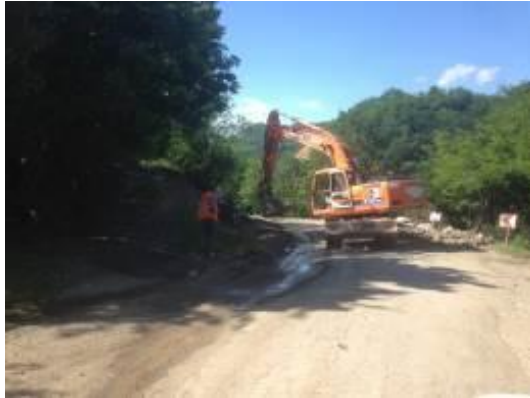
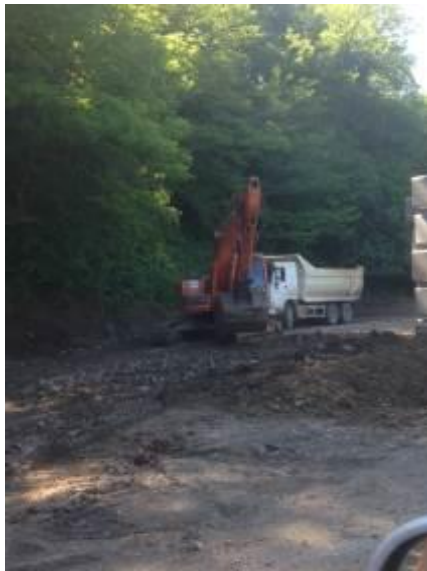
Backhoe worked without banksman .

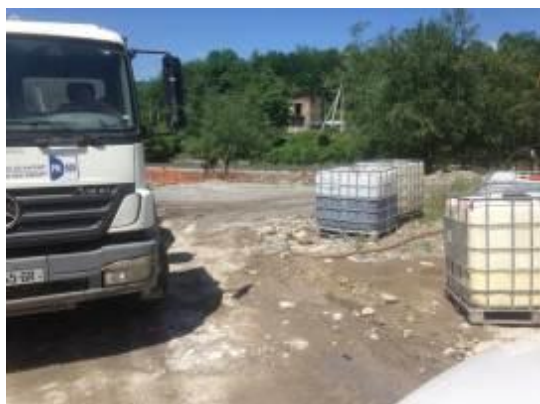
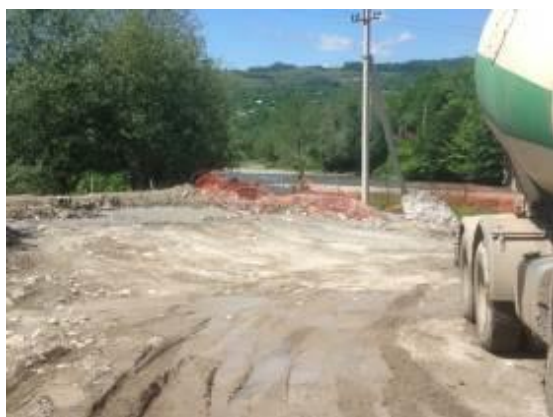
Ground surface down the batching plant contaminated with concrete. Relevant mitigation measures should be implemented ASAP to prevent nearby river contamination.

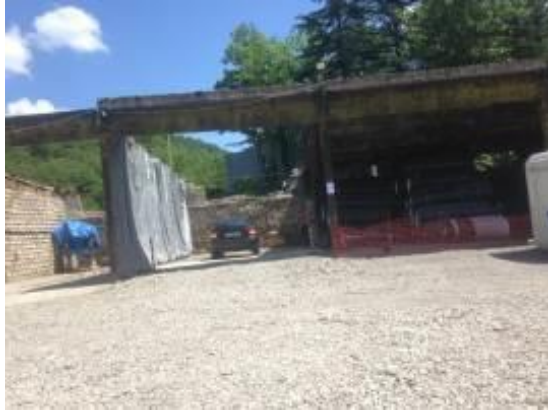
Car wash should be equipped with drainage system and oily water separator pit.

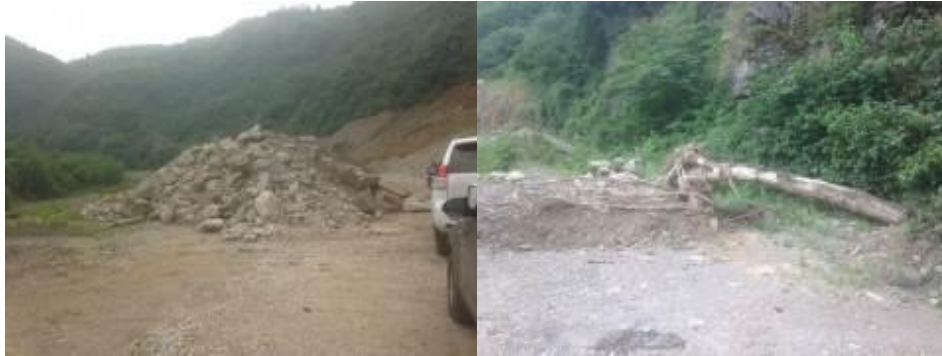
Spoil and other waste should be removed accordingly

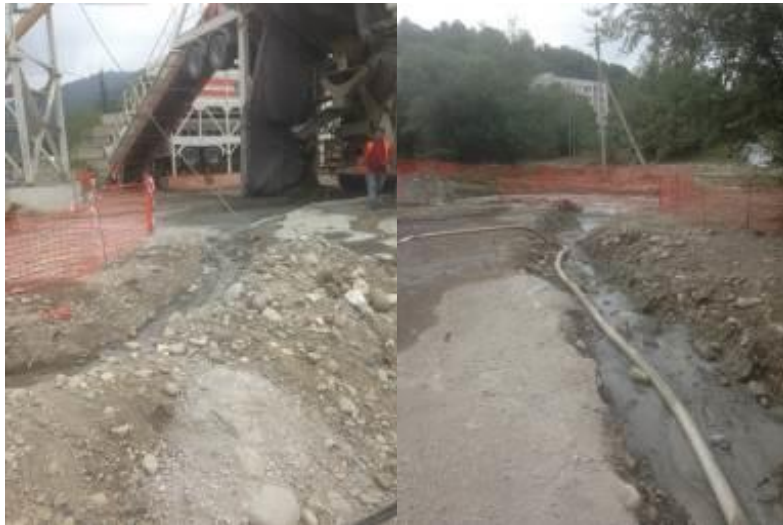
Drainage ditch arranged at the batching plant for the washout discharge to the pit.

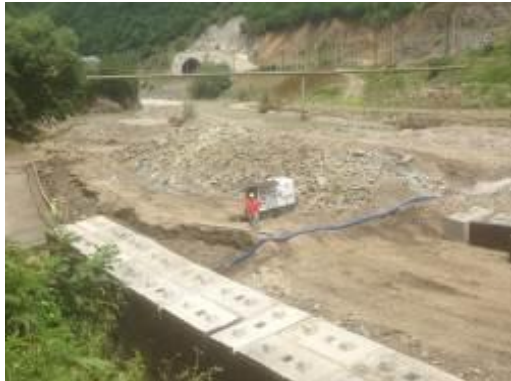
Outdoor power generator without drip tray and sufficient fire extinguisher.
