Semi-Annual Environmental Monitoring Report

Project Number: 53178-001

Semestral Report (January – June 2023)

Georgia: East-West Highway (Shorapani – Argveta Section) Improvement Project

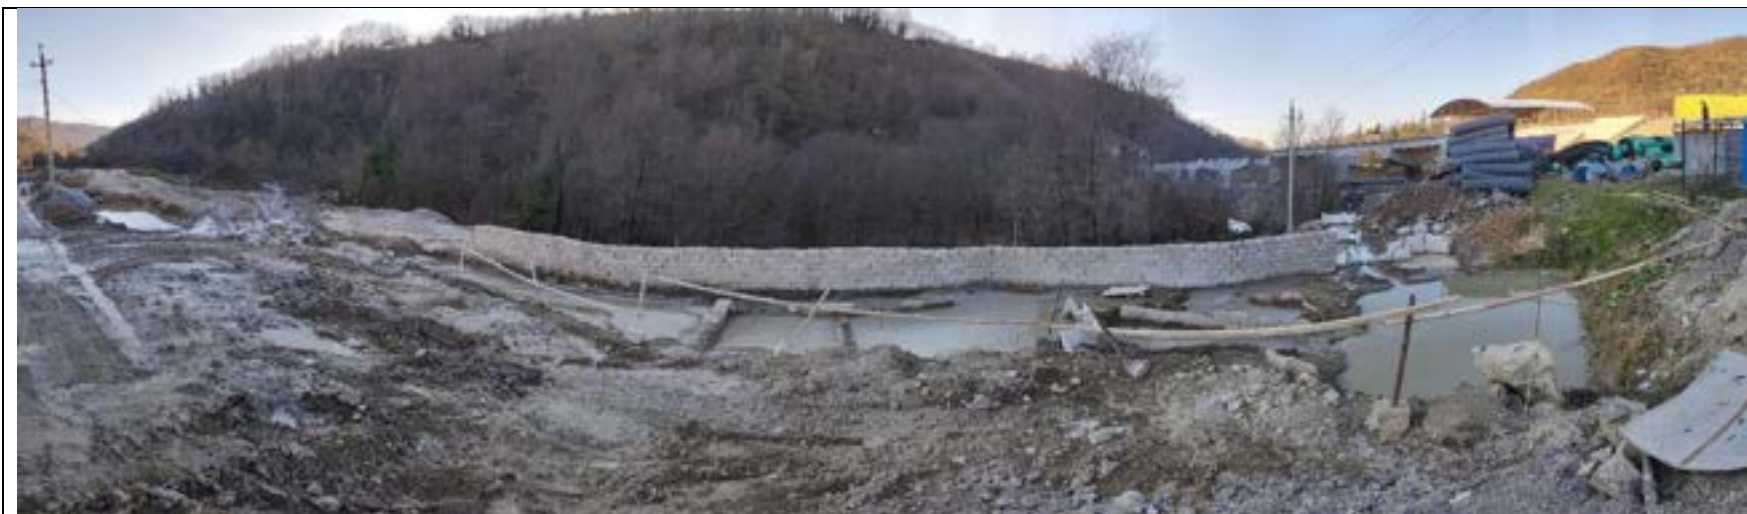
Batching Plant Discharge Water Settling Ponds (Batching Plant No 1 (January 2023))

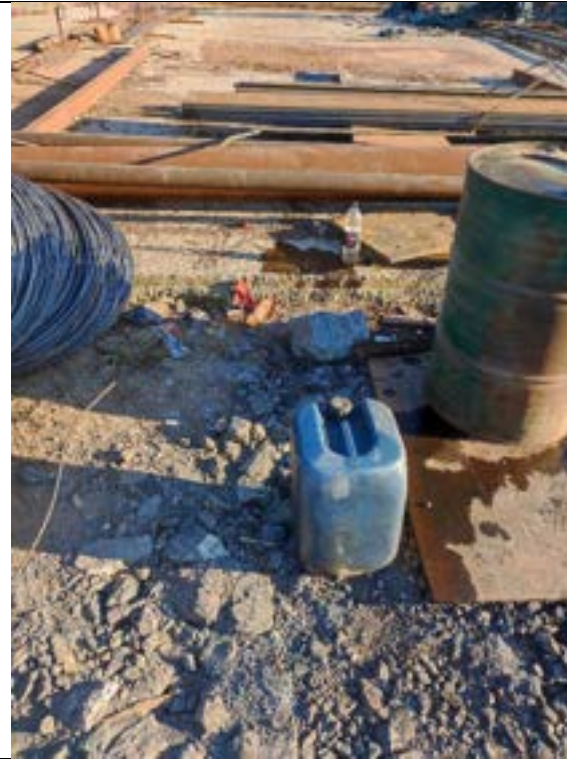
Improper Hazardous Material Storage (Steel Workshop at Interchange 2 ,
January 2023)

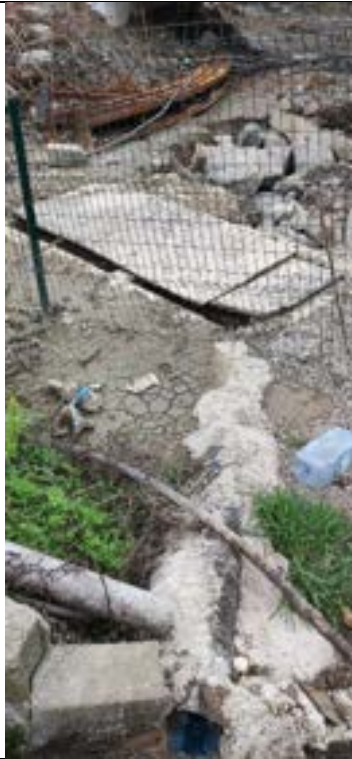
Leaking Sewage Tank (Worker's Camp No 2, March 2023)

53. There are occasional leaks observed in septic tanks on the sites, and the frequency of septic tank pumping should be increased to prevent such leaks. Leaks can cause environmental pollution by affecting the soil and water sources. Therefore, regular inspection and maintenance of septic systems are crucial steps to reduce their environmental impact.

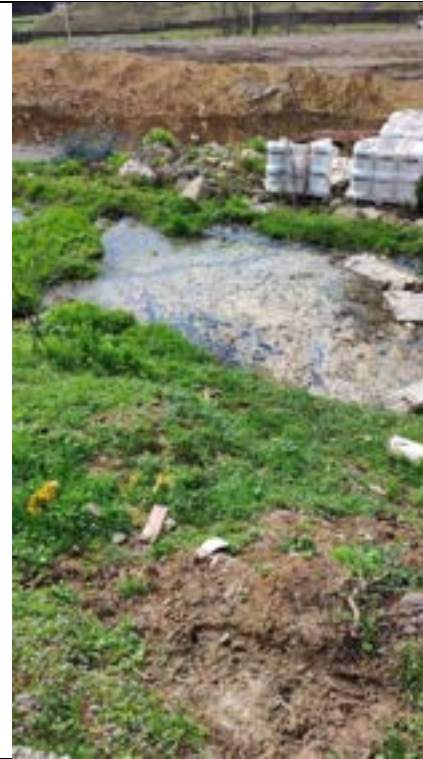
Full Sewage Tank (Worker's Camp No 6, March 2023)

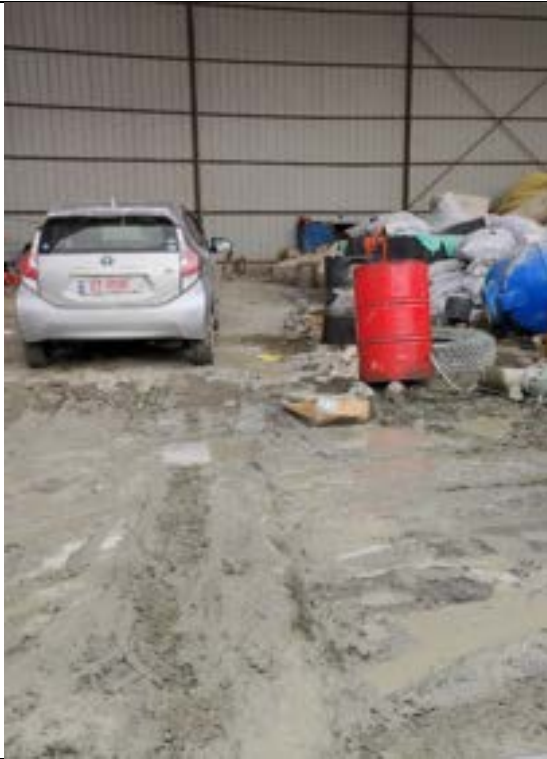
Improper Storage of Hazardous Material Container (Tunnel 5 Argveta Site Workshop, March 2023)

57. Adequate storage and proper placement of hazardous waste containers, such as fuel and other oils, should be ensured on the site, and regular collection of waste generated from these materials should be conducted. Hazardous wastes can have serious effects on ecosystems and human health. Therefore, proper management of hazardous wastes should be a priority to prevent leaks and pollution.

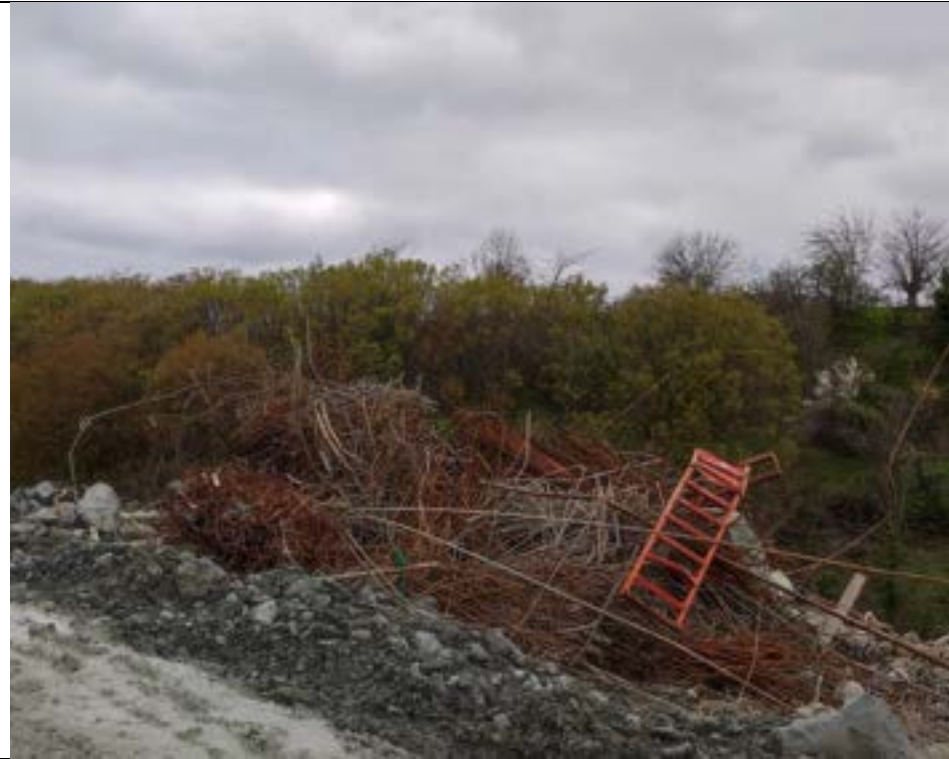
Improper Storage of Scrap Metal Waste (Tunnel 5 Argveta Site Workshop, March 2023)

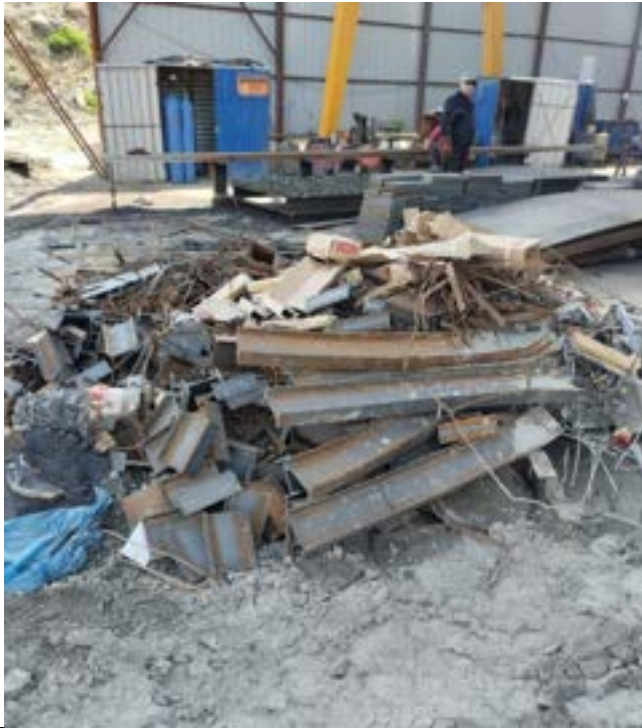
Poor Waste Management (Interchange 2, April 2023)

55. There are deficiencies in environmental organization and waste collection. Increasing waste collection and sorting efforts and assigning specific personnel to manage waste collection and segregation in the sites and camps are necessary. Since it is not feasible for the environmental team to manage all areas, it is important to designate specialized teams for waste collection and segregation. Additionally, the number and capacity of waste containers should be increased.

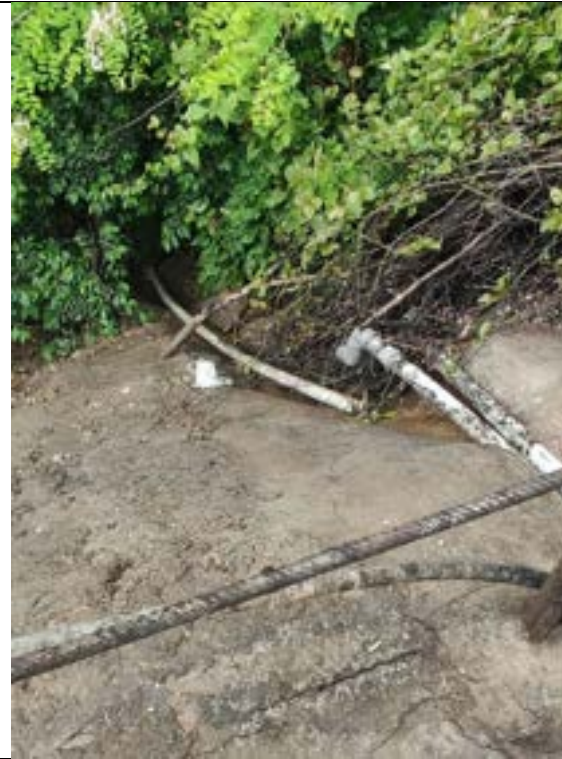
Broken Grey Water Pipes (Worker's Camp No 1, May 2023)

54. There are some repair issues in the greywater system that need to be addressed. Greywater is a system that treats and reuses wastewater. However, deficiencies and malfunctions can hinder the effective operation of the greywater system. Hence, regular inspection, identification, and repair of issues are important.

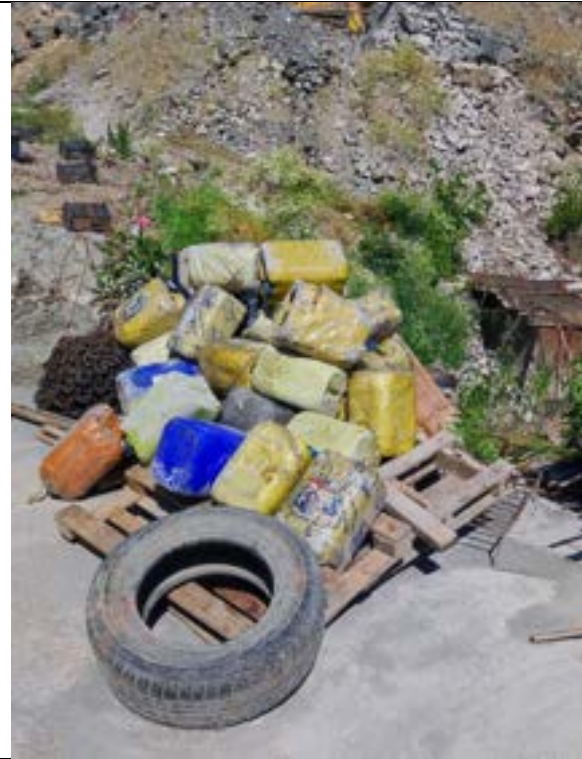
Poor Hazardous Waste Management (Tunnel 4 Portal, June 2023)

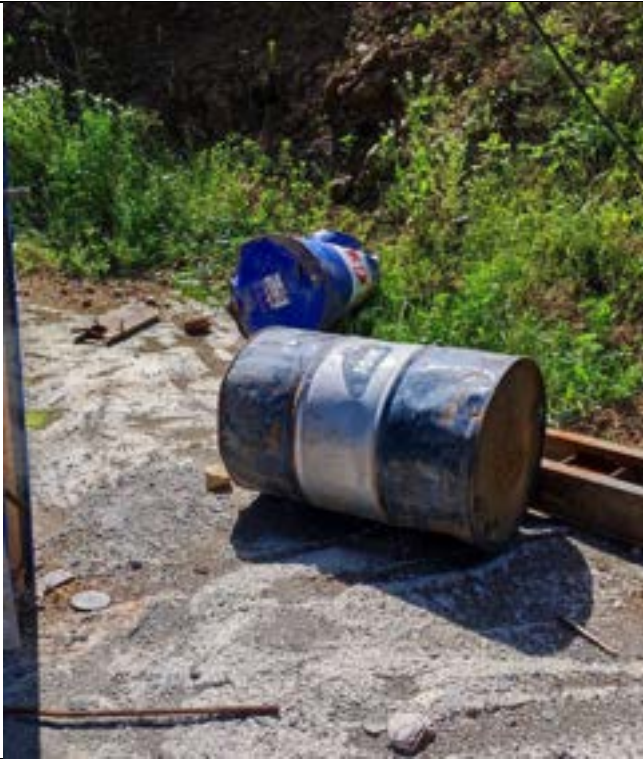
Poor Hazardous Waste Management (Tunnel 4 Portal, June 2023)

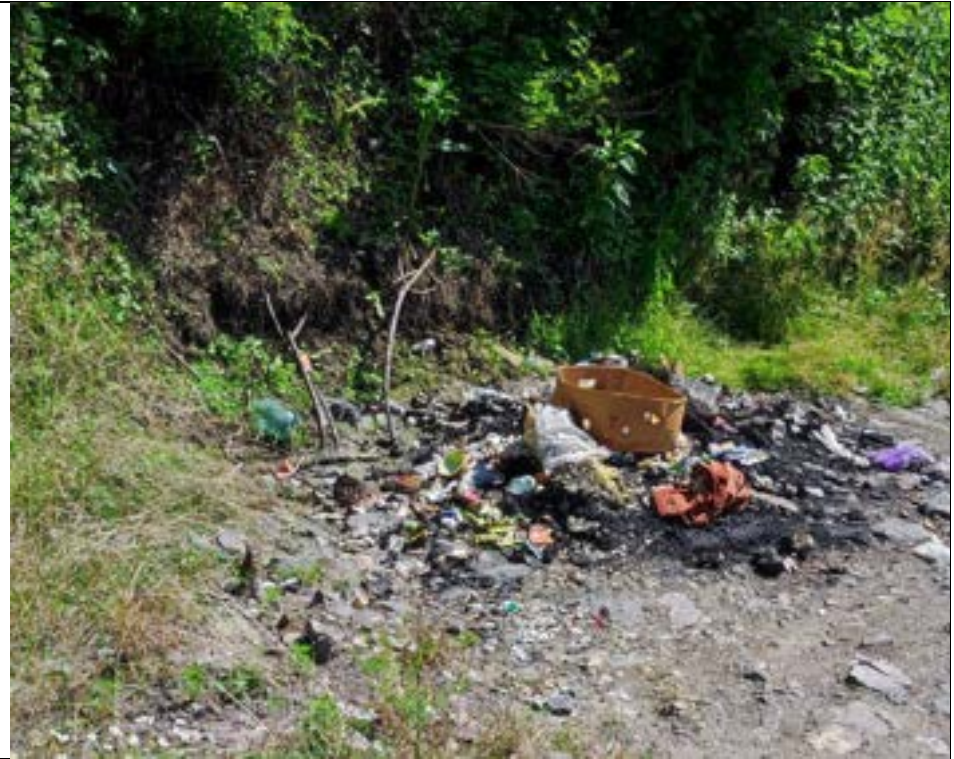
Poor Waste Management (Worker's Camp No 4, June 2023)

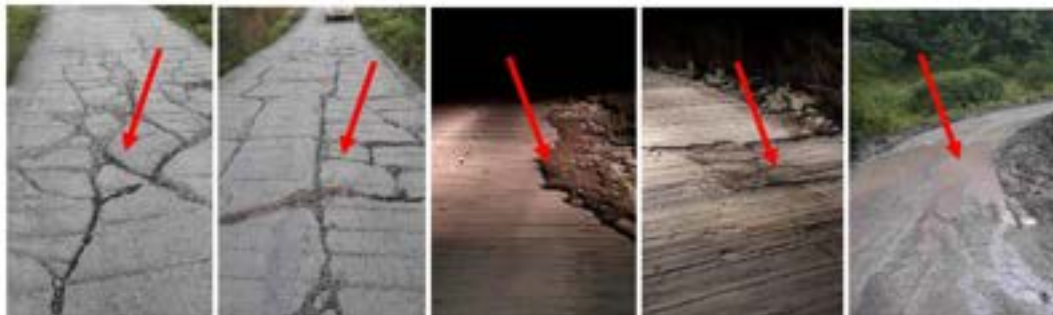
Picture 2: Driving safety (Road related incidents) (Access Road to Tunnels N4 and 5) - The non-compliance, related to road safety isn't solved yet. The Contractor has to react to this non-compliance as soon as possible, because the condition of the temporary access road surface is deteriorating day after day and it may cause the possible traffic related problem and possible delay in the working process. The existing cracks and holes are becoming more visible and wider than it was in the previous weeks. It is double danger, when driving in the night time (In some section of the access road, it becomes very narrow and there is a big risk to lose the concentration, drive out the road and turn over. In some section, road is partially damaged). The Engineers are highlighting this issue on the management weekly safety meetings with the Contractor's H&S team and asking the Contractor's site responsible persons many times to repair the road surface, arrange some jersey barriers or flashing safety poles and place it on most dangerous areas of mentioned access road to protect unsafe sections and safe people's life, but there are no positive changes in this regard. Plus, this road must be periodically be washed and cleaned from the mud. **Non-compliance is still open.**

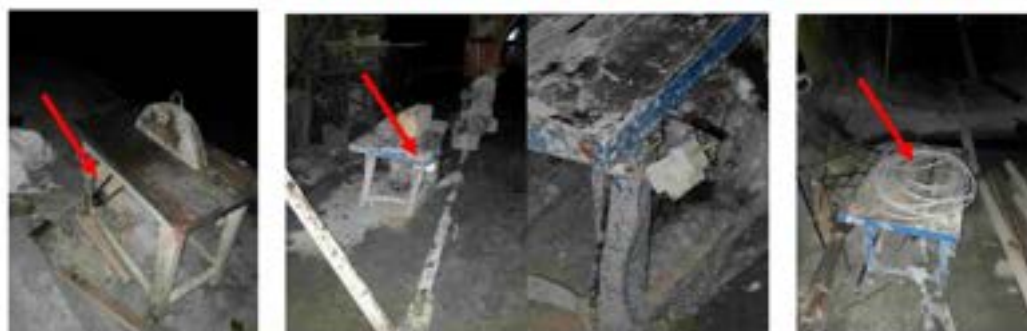
Tunnels N: 4TA-A and 5AT-T – The wood cutting machines in unsafe condition have been observed.

63. There are concerns regarding the use of inappropriate equipment and tools, such as hand-held cutters, ladders, etc. It is important to ensure that workers are provided with suitable and well-maintained equipment and trained on their correct usage. Regular checks and inspections should be conducted to identify and address any equipment-related hazards.

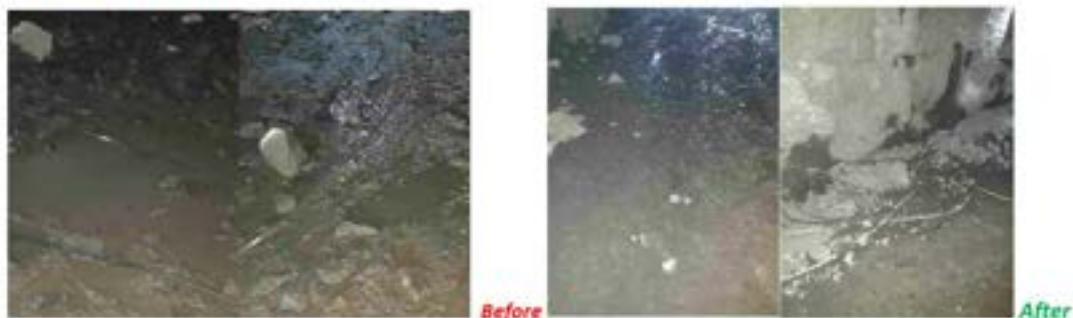
Thrown in mud and the water, electric cables have been observed. After verbal warning, given to the Contractor, all electric cables were removed from the mud, but they weren't hung on to the wall.

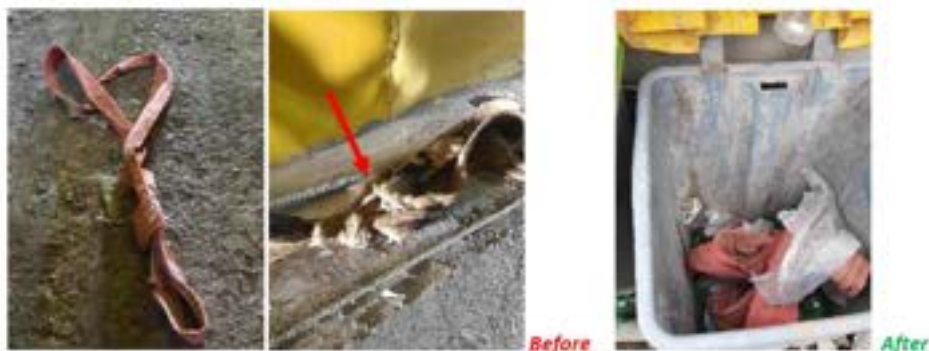
Tunnel N2TA-T – Damaged lifting devices in use have been observed. They were removed and sent to the trash bin.

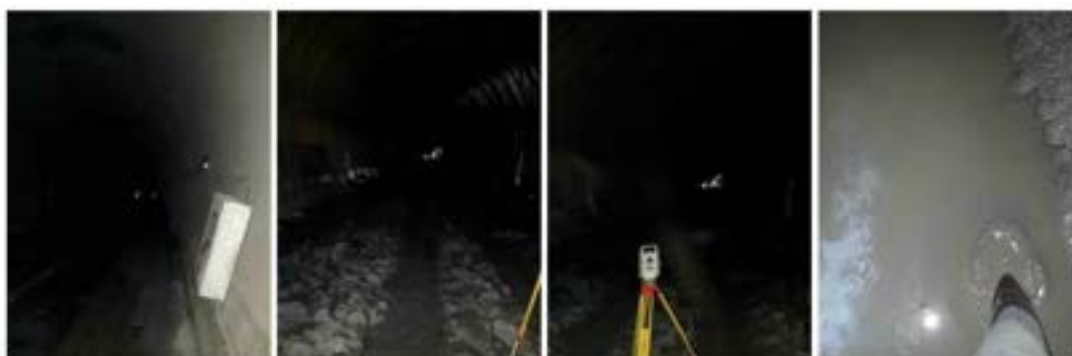
Picture 7: Bad observations – Electric Safety (Tunnel N5AT-T) – It has been observed that there is a section inside the tunnel, which isn't illuminated (About 100m in the middle of AT direction). It has also been observed that the walkway in the highlighted above section is in bad condition too. It is very dangerous, when visibility is "zero" and any wrong step in the mud may cause possible trip, slip and fall hazards. The electric bulbs must be fixed as soon as possible to avoid the trip, slip and fall hazards. Site responsible and H&S representatives from the Contractor Company were informed about this non-compliance. The Engineer has asked them to fix this non-compliance as soon as possible to avoid the possible incident from happening. **Non-compliance isn't solved.**

61. There are issues related to inadequate lighting inside tunnels. Sufficient and appropriate lighting should be installed to ensure clear visibility and prevent accidents or injuries caused by poor illumination.

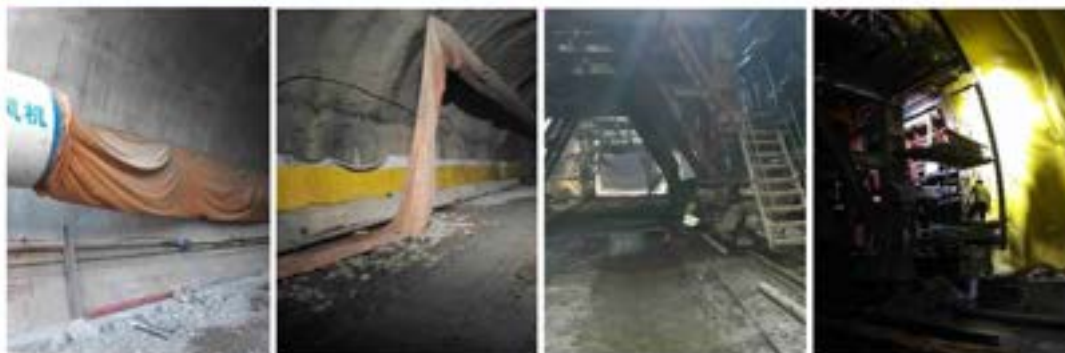
Tunnel N3AT-T – During site visit it has been observed that the ventilation system was turned off. After visual inspection, it has been observed that the workers were busy with some work activities inside the tunnel. The quality of oxygen was acceptable for that moment, but the Contractor has to pay additional attention to this issue and turn on the ventilation system, when somebody is performing the task inside the tunnel in order to avoid the possible personal injury.

62. Proper ventilation is crucial in tunnels to maintain air quality and prevent the accumulation of hazardous gases, dust, or fumes. Adequate ventilation systems should be in place and regularly maintained to create a safe working environment for the workers.

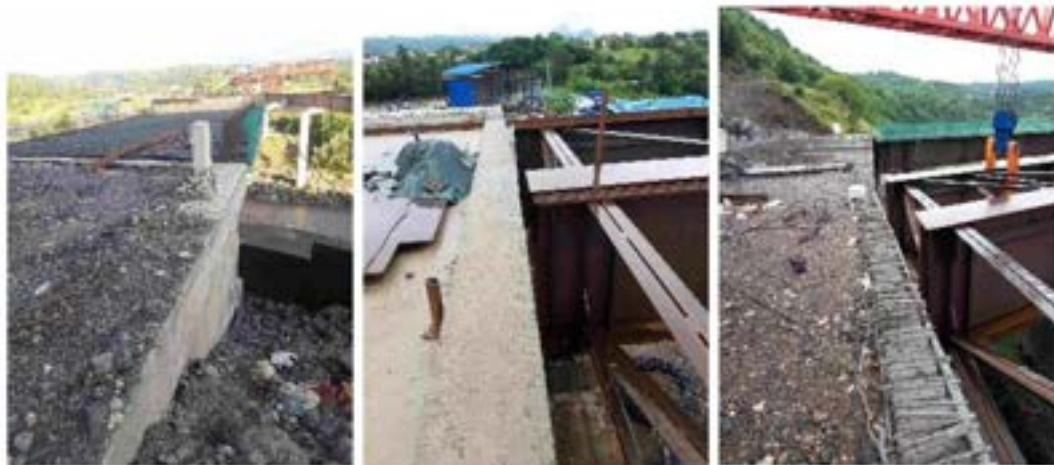
Interchange N2 (Bridge N4) – The trip, slip and falling related non-compliances that have been observed by the Engineer in the previous weeks, isn't solved (No hard barriers are placed nearby and no warning signs are fixed or hung to warn the workers about the possible hazards).

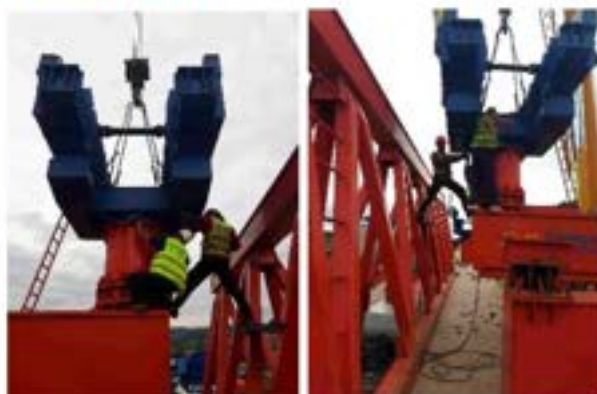
Picture 10: Non-compliances (Work at height Safety-Possible injury of working personnel) (Bridge 4 – Interchange 2) Violation of work at height safety standards has been observed by the Engineer, when inspecting the work process. The workers weren't equipped with personal safety harnesses, while platforming the task at height. The H&S and site responsible persons from the Contractor Company were informed about it. The Engineer has asked the Contractor to pay additional attention to this issue to avoid the possible incident and injury of working personnel. **Non-compliance isn't solved.**

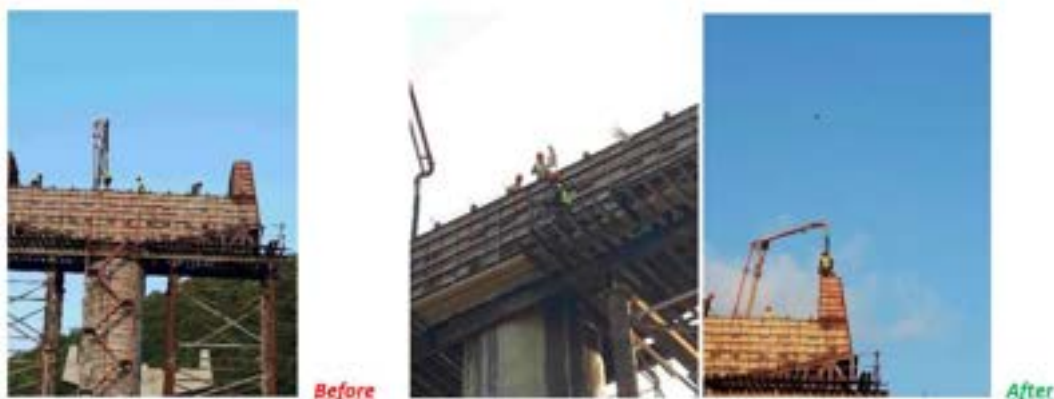
Picture 11: Non-compliances (Work at height Safety-Possible fall and injury of working personnel) (Bridge 1, Pier 2) - Violation of work at height safety standards has been observed by the Engineer, when inspecting the work process. The workers weren't equipped with personal safety harnesses, while platforming the task at height. The H&S and site responsible persons from the Contractor Company were informed about it. The Engineer has asked the Contractor to pay additional attention to this issue in order to avoid the possible incident and injury of working personnel. **Non-compliance isn't solved.**

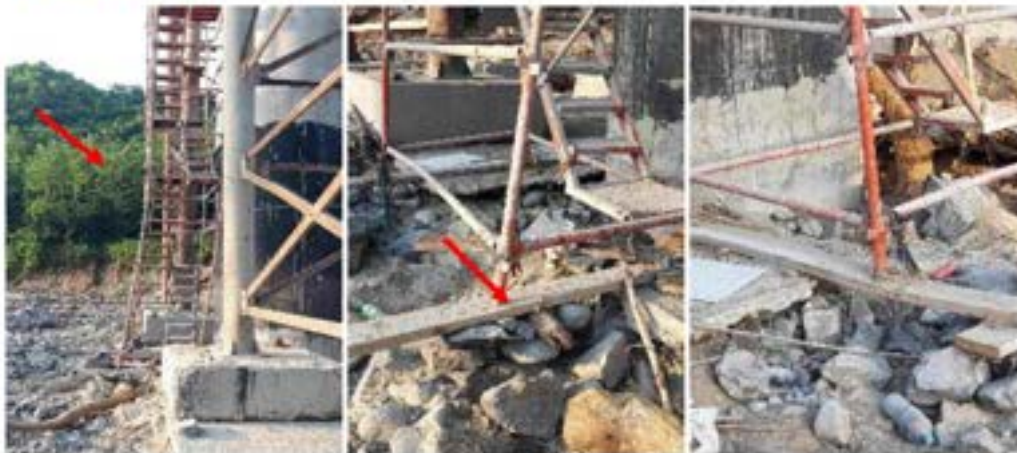
Picture 12: Negative observations (Safe work process) (Possible falls and injury of working personnel) – The temporary stair case in unsafe condition has been observed. It must be redesigned immediately, because the workers aren't fully protected from possible falls. The access onto the platform is not safe, because the stair case is bended and supports aren't fixed properly. The site responsible persons from the Contractor Company were informed about it and asked to solve all non-compliance before somebody from the working crew might get hurt there. **Non-compliance is still open.**

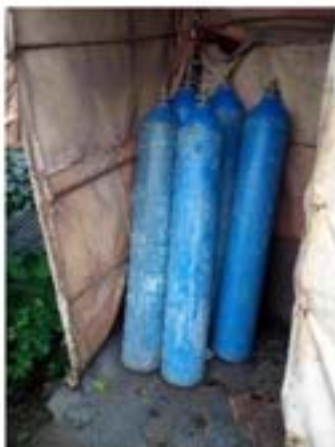
(Tunnel N4 (Tbilisi Portal)) – Not properly stored oxygen cylinders that had been observed by the Engineer in the previous week, weren't restored until now (They weren't well secured and the area wasn't well protected from the possible unacceptable and unauthorized contacts. The careless touch could cause the possible property damage and injury of working personnel. It has also been observed that no warning signs were hung at the shelter, to warn the people about the possible hazards). The responsible persons from the Contractor Company must react to this non-compliance as soon as possible to avoid the possible incident.

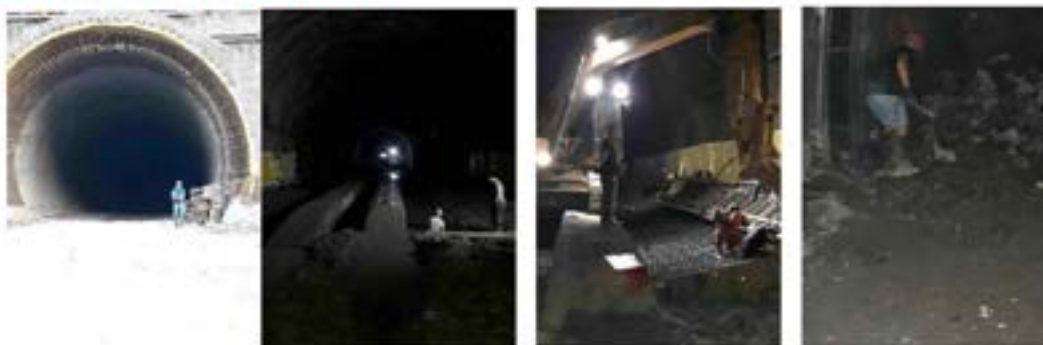
Tunnels: N4AT-A; N5AT-T; N1AT-A – *Improper use of PPE by the workers when performing the task.*

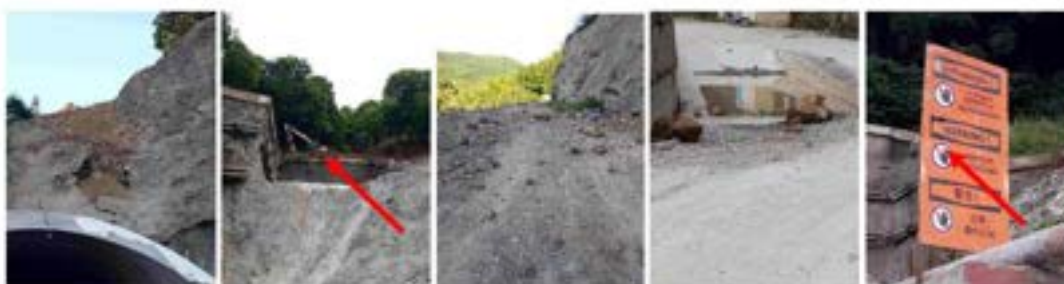
Tunnel N1AT-A – *Rolled down the hill loose rocks have been observed by the Engineer when inspecting the working territory. Wrong type warning signs were installed nearby. The Contractor has to pay additional attention to this issue and necessary safety precautions must be taken in order to avoid the possible incident and injury of working personnel. The access road to the tunnel portals must be well protected and correct type warning signs must be placed nearby to warn the working personnel about the hazards of getting possible injury.*

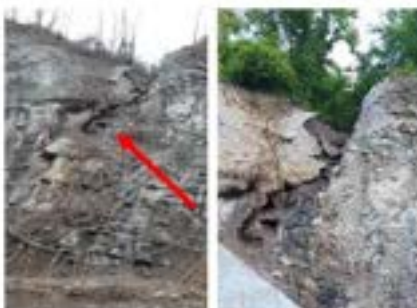
Tunnel N1AT-A – *Slope is partially washed and may collapse down.*

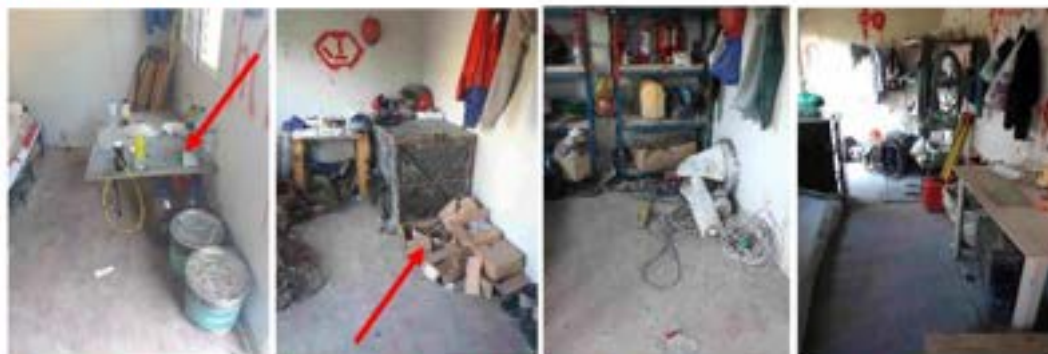
Picture 18: Non-compliance – Welfare facilities (Health and care) (Tunnels №2, 3 and 5) – No positive changes have been made seems last weeks. The dining room, rest room, room for to change the clothes and storage area for construction materials (Including hazardous materials). All these still are gathered in one space. Site responsible persons from the Contractor Company were informed about these non-compliances. The Engineer asked the Contractor to care about the worker's health and safety and split all these spaces. The Engineer is waiting for feedback from the Contractor. **Non-compliance isn't solved.**

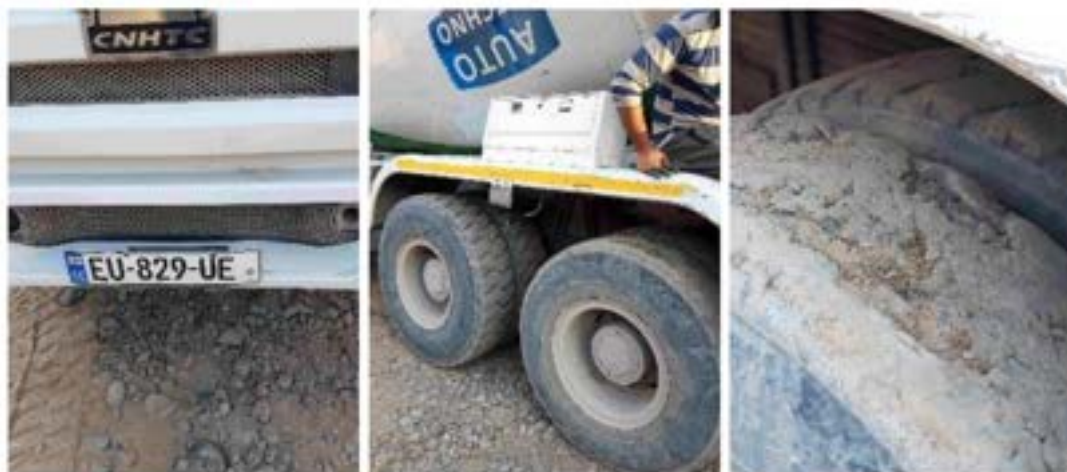
Picture 19: Driving safety (Possible accident (Company mixer and dump trucks)) – The driving safety related non-compliance has been observed by the Engineer when inspecting the working process at site. The mixer was equipped with worn (Partially damaged) tire. The Engineer has asked the Contractor's site responsible persons to take care of this issue and solve it as soon as possible in order to avoid the possible accidents and possible injury of working personnel. H&S representatives from the Contractor Company were also informed about it and the Engineer asked them to take this issue on their own control. The management of the Contractor Company gave promises to change all damaged and cut tires and close this issue as soon as possible. The Engineer is waiting for feedback from the Contractor. **Non-compliance is still open.**

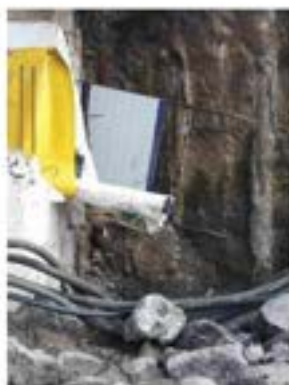
Picture 20: Non-compliance – Workplace safety (All tunnels) – Damaged and destroyed registration board has been observed by the Engineer during site visits. The registration boards are empty or not sufficient number of copies of ID cards are hung onto, because the workers are not using this boards as per requirements. They do not hang on their badges, before entering into the tunnels. Site responsible persons from the Contractor Company were informed about it. The Engineer asked H&S representatives from the Contractor Company to conduct additional safety training course for the Company employees and explain them why and what for they have to use these boards. **Non-compliance is still open.**

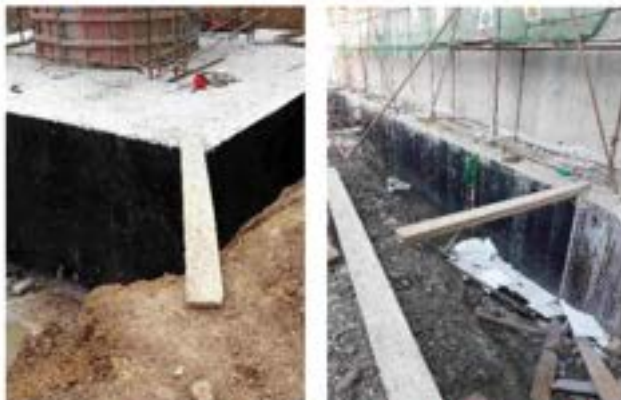
Picture 21: Non-compliance – Working at height safety Violations (Bridge N1, Pier 11 and Bridge N2 Abutment) – Unsafe accesses to the workplaces have been observed by the Engineer when inspecting the work process. The site responsible persons from the Contractor Company were informed about it. The Engineer has asked them to pay additional attention to this non-compliance in order to avoid the possible falls. **Non-compliance isn't solved.**

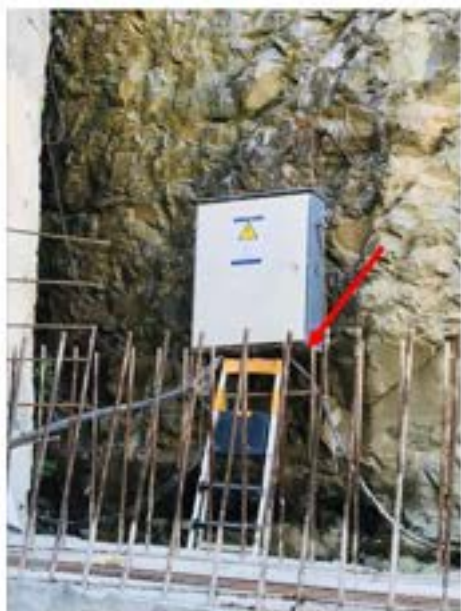
Picture 23: Non-compliance – Electrical Safety (Tunnel №5 TAA) –Violation of workplace safety, path leading to the electrical distribution box is very unsafe, there are armatures sticking out. Safe pathway must be ensured to get to the electrical distribution box.

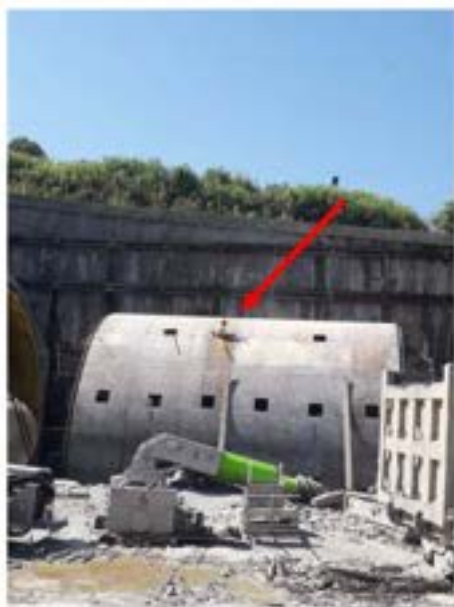
Picture 24: Non-compliance – Working at height safety Violations (Tunnel №4005 AT-TA Argveta Portal) – Violation of working at height safety requirements. Workers are not wearing safety harnesses, and personal protective equipment.

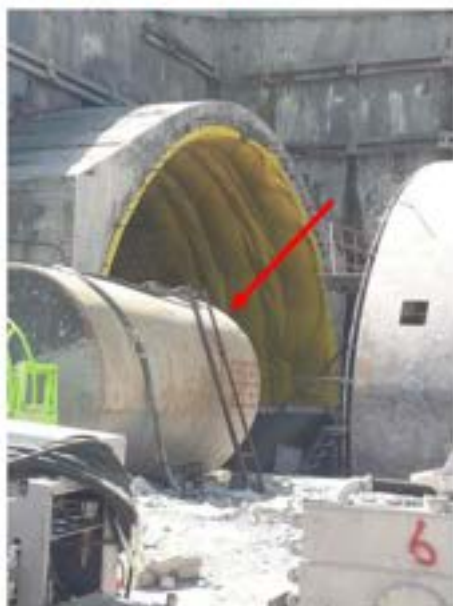
Picture 25: Non-compliance – Working at height safety Violations (Tunnel №4005 AT-TA Argveta Portal) – Violation of working at height safety requirements. Using homemade ladder, it is not allowed to use not industrially made tools and equipment.

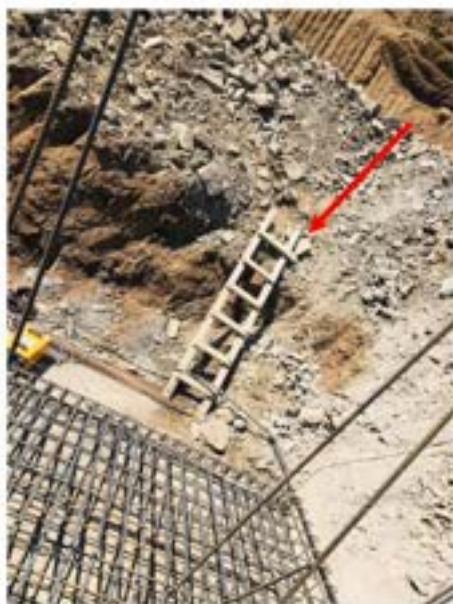
Picture 26: Non-compliance – Working at height safety Violations (Retaining wall 4501) –Homemade ladder is being used, it is not allowed to use not industrially made tools/equipment. Homemade ladder must be replaced.

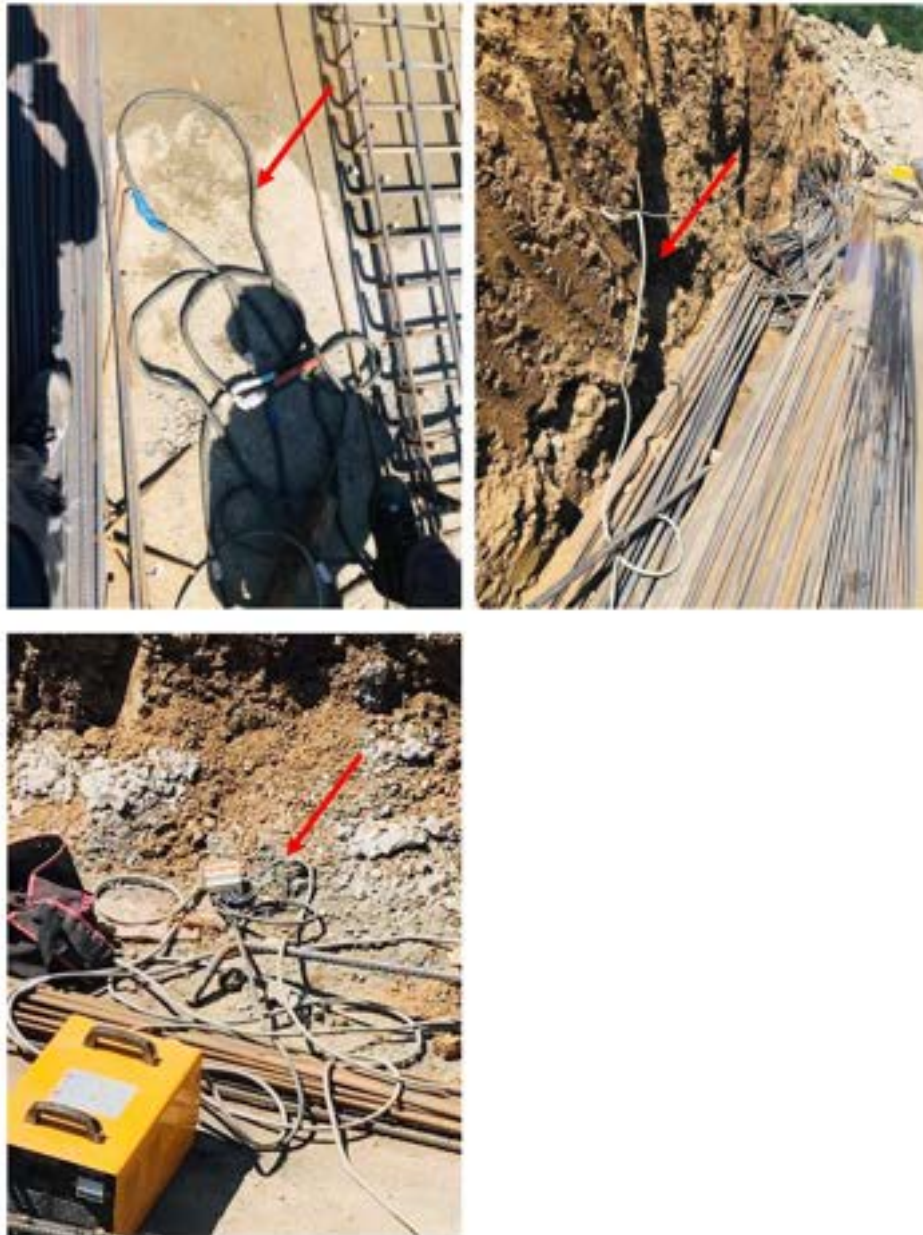
Picture 27: Non-compliance – Electrical Safety (Retaining wall 4501) –Electrical cables are scattered all around. Some of them are damaged. Damaged cables must be replaced and rest of the cables must be safely organized.

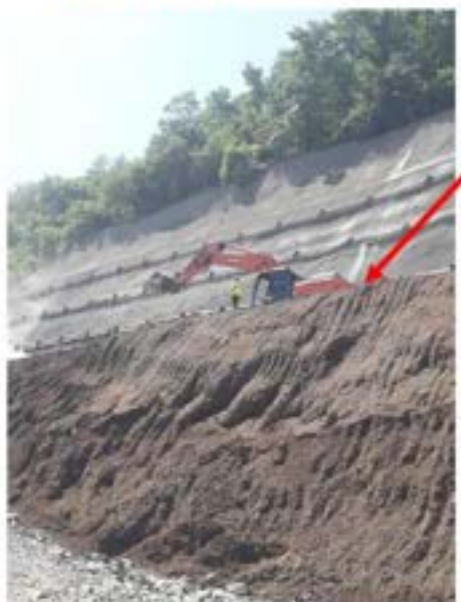
Picture 28: Non-compliance – Working at height safety Violations (Tunnel №4001 AT Tbilisi Portal) – Violation of working at height safety requirements. There are no guardrails, protective guardrails must be installed to avoid falling of people and equipment.

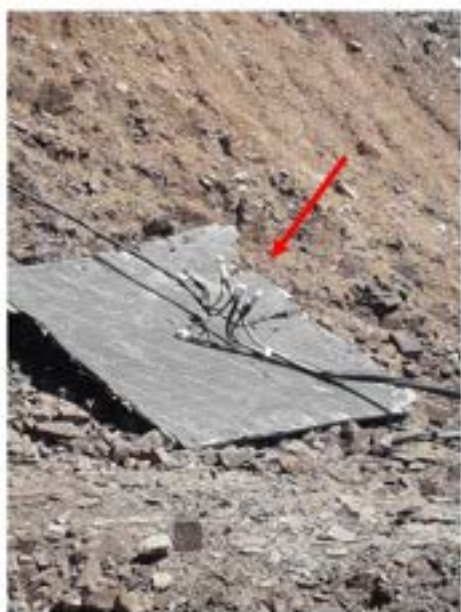
Picture 29: Non-compliance – Electrical Safety (Tunnel №4001 AT Tbilisi Portal) – Electrical wiring is not safe, cables must be checked and wiring must be safely organized.

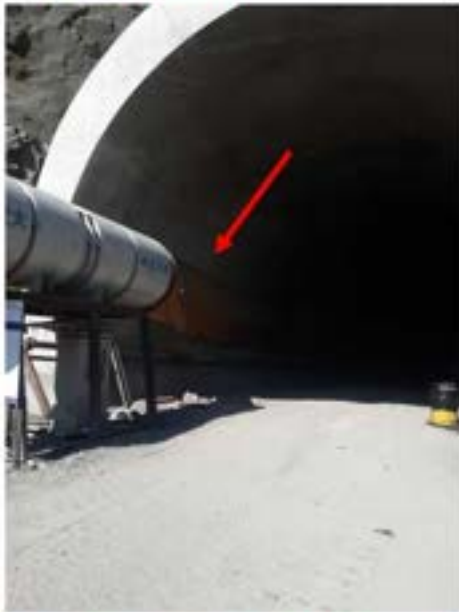
Picture 30: Non-compliance – Workplace safety Violations (Tunnel №4003 ATT) – Ventilation is turned off and there are people working inside. It is not allowed to work in the tunnel when there is not a safe environment.

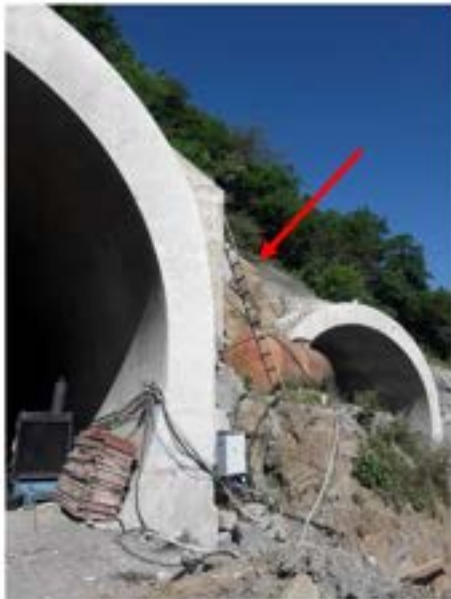
Picture 31: Non-compliance – Working at height safety Violations (Tunnel №4003 AT-T) –Homemade ladder is being used, it is not allowed to use not industrially made tools/equipment. Homemade ladder must be replaced.

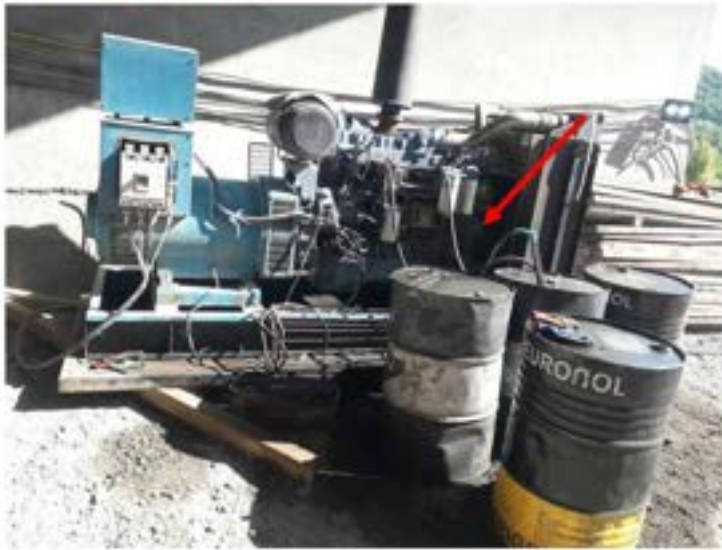
Picture 32: Non-compliance – Workplace safety Violations (Tunnel №4003 AT-T) – Generator is placed next to the fuel products, and there is no spill tray placed. Safe distance must be kept.

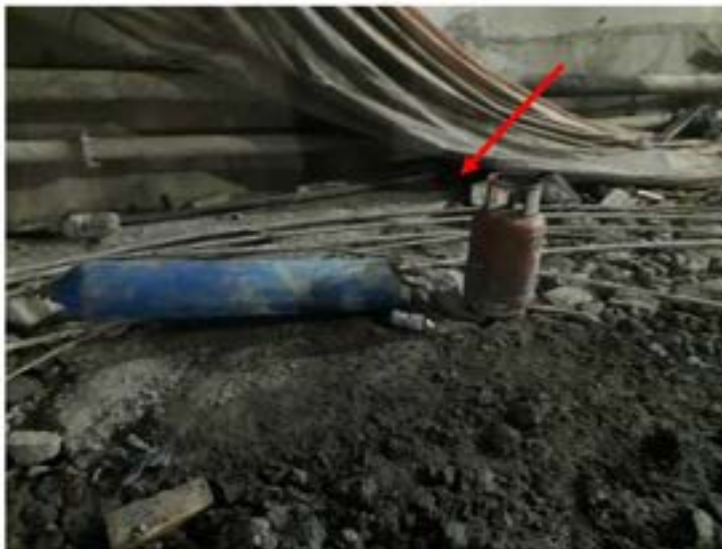
Picture 33: Non-compliance – Workplace safety Violations (Tunnel №3 AT-T) –Unsafe handling of cylinders. There is no safe distance kept between cylinders. Safe distance must be kept and special carts must be used to insert cylinders for safe handling.

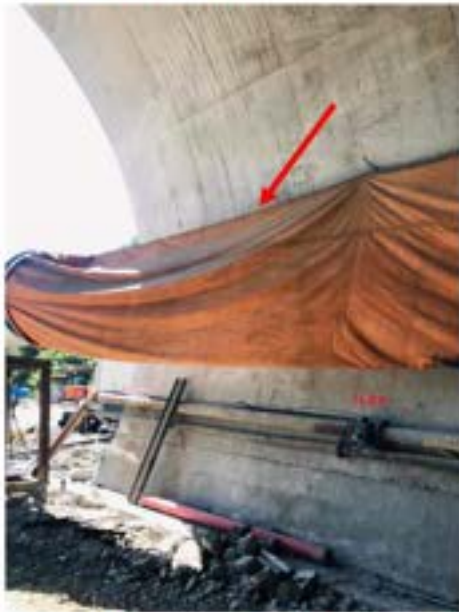
Picture 34: Non-compliance – Workplace safety Violations (Tunnel №3 ATT) – Ventilation system is turned off and there are people working inside. It is not allowed to work in the tunnel when there is not a safe environment.

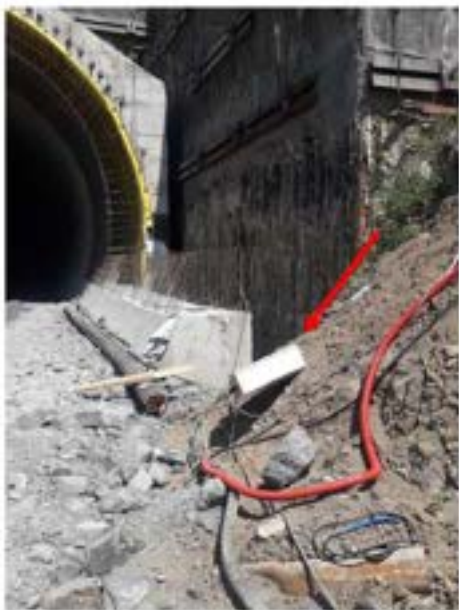
Picture 35: Non-compliance – Electrical Safety (Tunnel №4005 TA Tbilisi Portal) – Violation of electrical safety. Electrical distribution box is fallen on the ground.

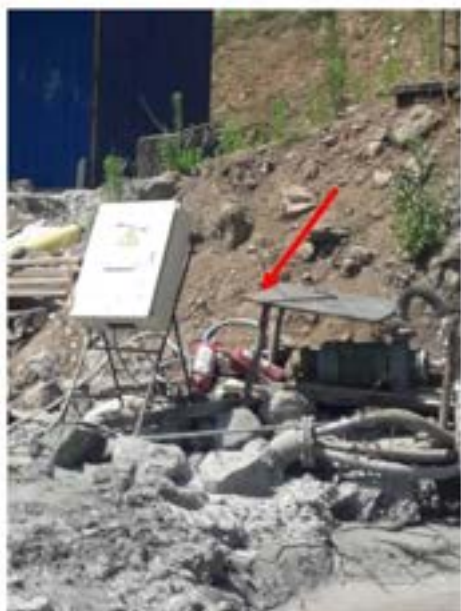
Picture 36: Non-compliance – Electrical Safety (Tunnel №4005 TA Tbilisi Portal) –Fire extinguishers are scattered around the electrical distribution box. Fire extinguishers must be placed at the proper places.

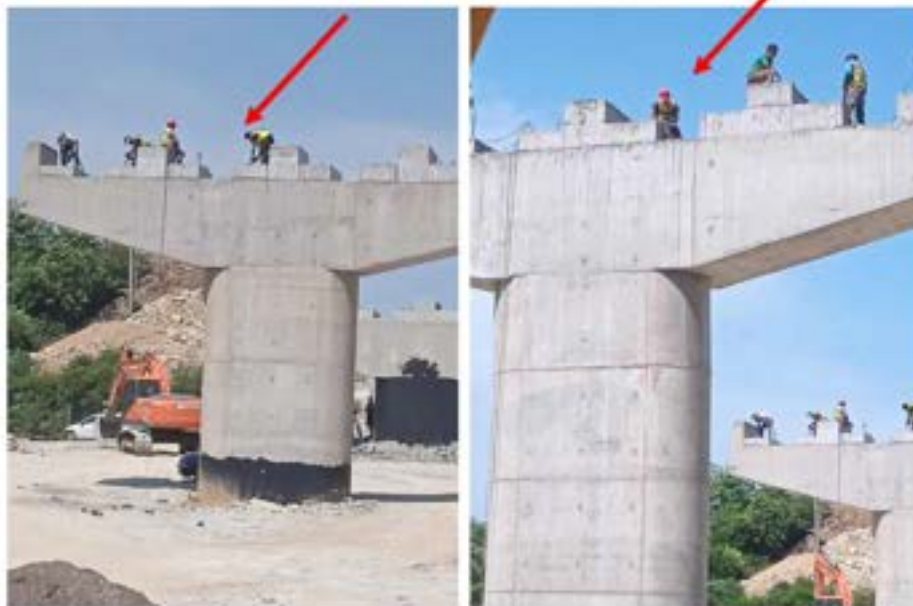
Picture 37: Non-compliance – Working at height safety Violations (Bridge №5 Pier №3 AT) –Violation of working at height safety requirements. Protective equipment is not being used when working at height, workers must wear safety harnesses.

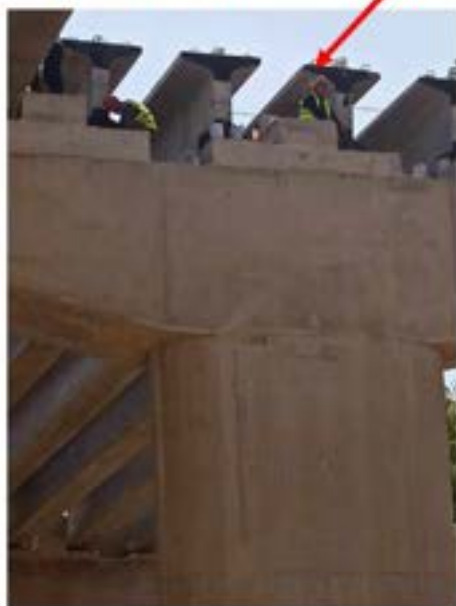
Picture 38: Non-compliance – Working at height safety Violations (Bridge №5 Pier №2 AT) –Workers are not wearing safety harnesses! Warnings regarding these violations have been given for two days and works still continued with several safety violations. These issues must be payed attention.
