# Semi-Annual Environmental Monitoring Report

Project Number: 53178-001

Semestral Report (July – December 2024)

## Georgia: East-West Highway (Shorapani – Argveta Section) Improvement Project

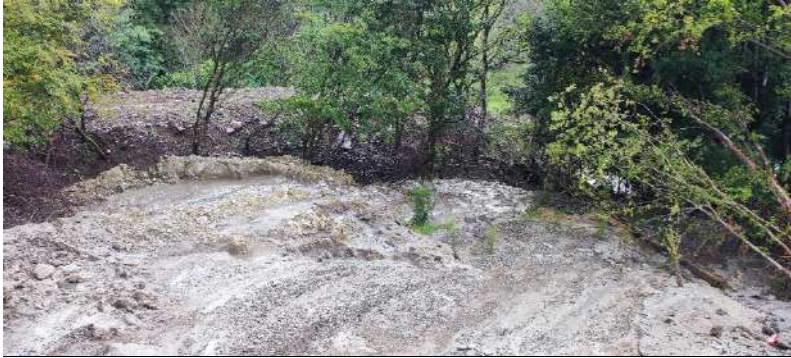
| Poor Management of Discharge Water (Batching Plant, July 2024) | Poor Riverbed Protection (Bridge 3, July2024) |

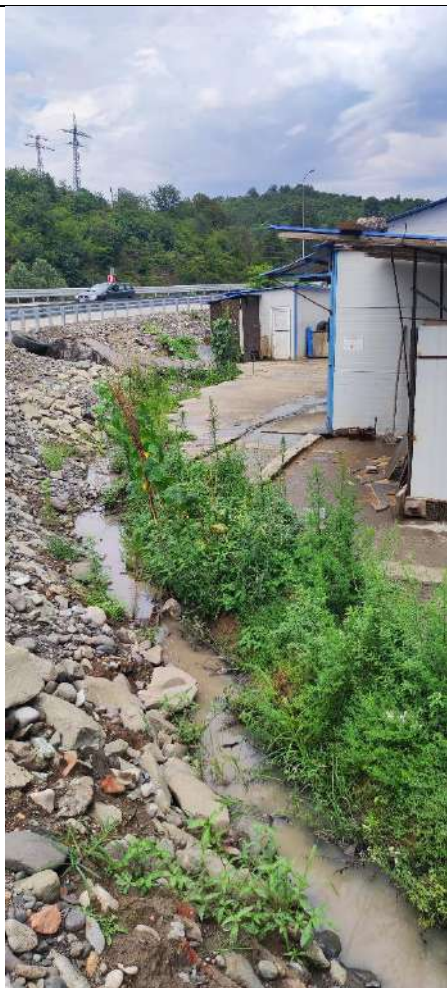
Leaking Sewage Tank (Worker's Camp No 3, July 2024)

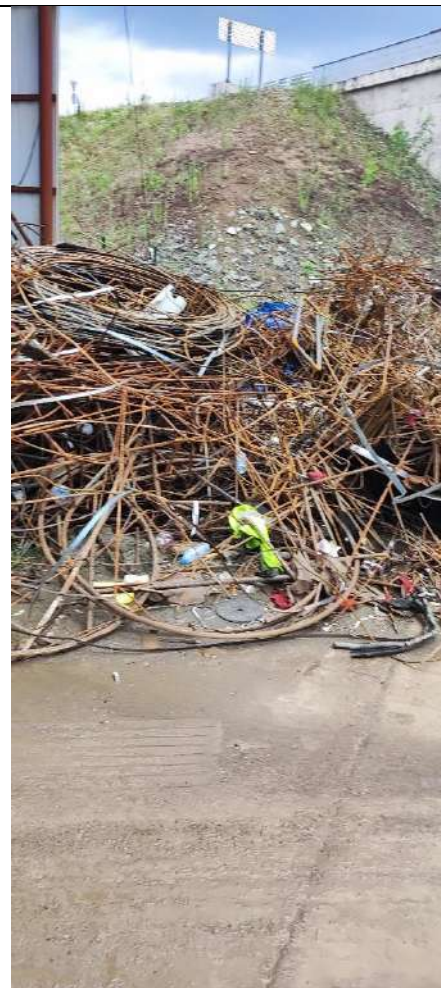
Metal Scraps (Near Workshop, July 2024)

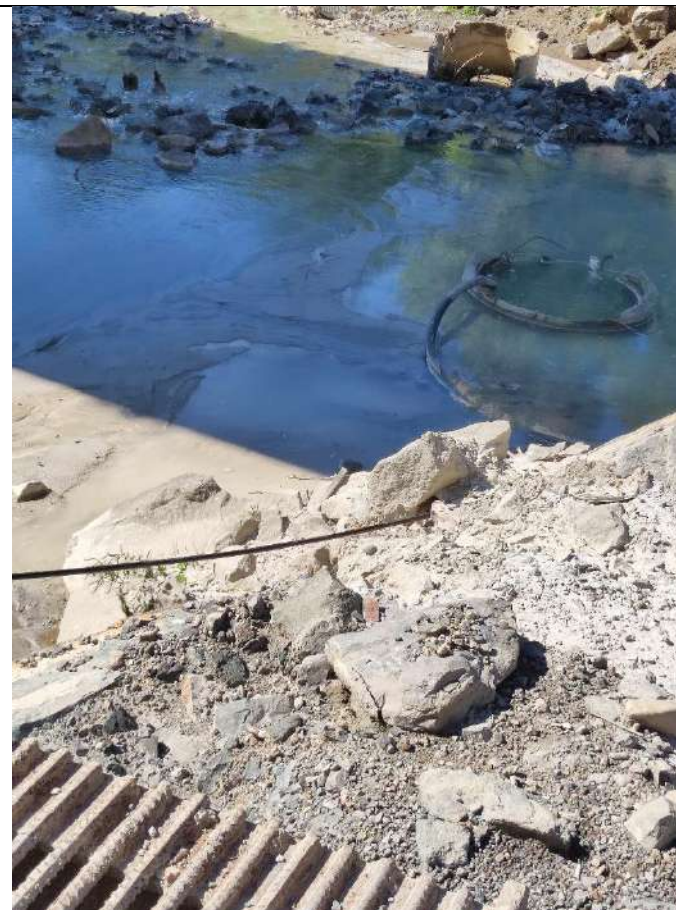
Poor Riverbed Protection and Improper water Usage (Bridge 3, August 2024)

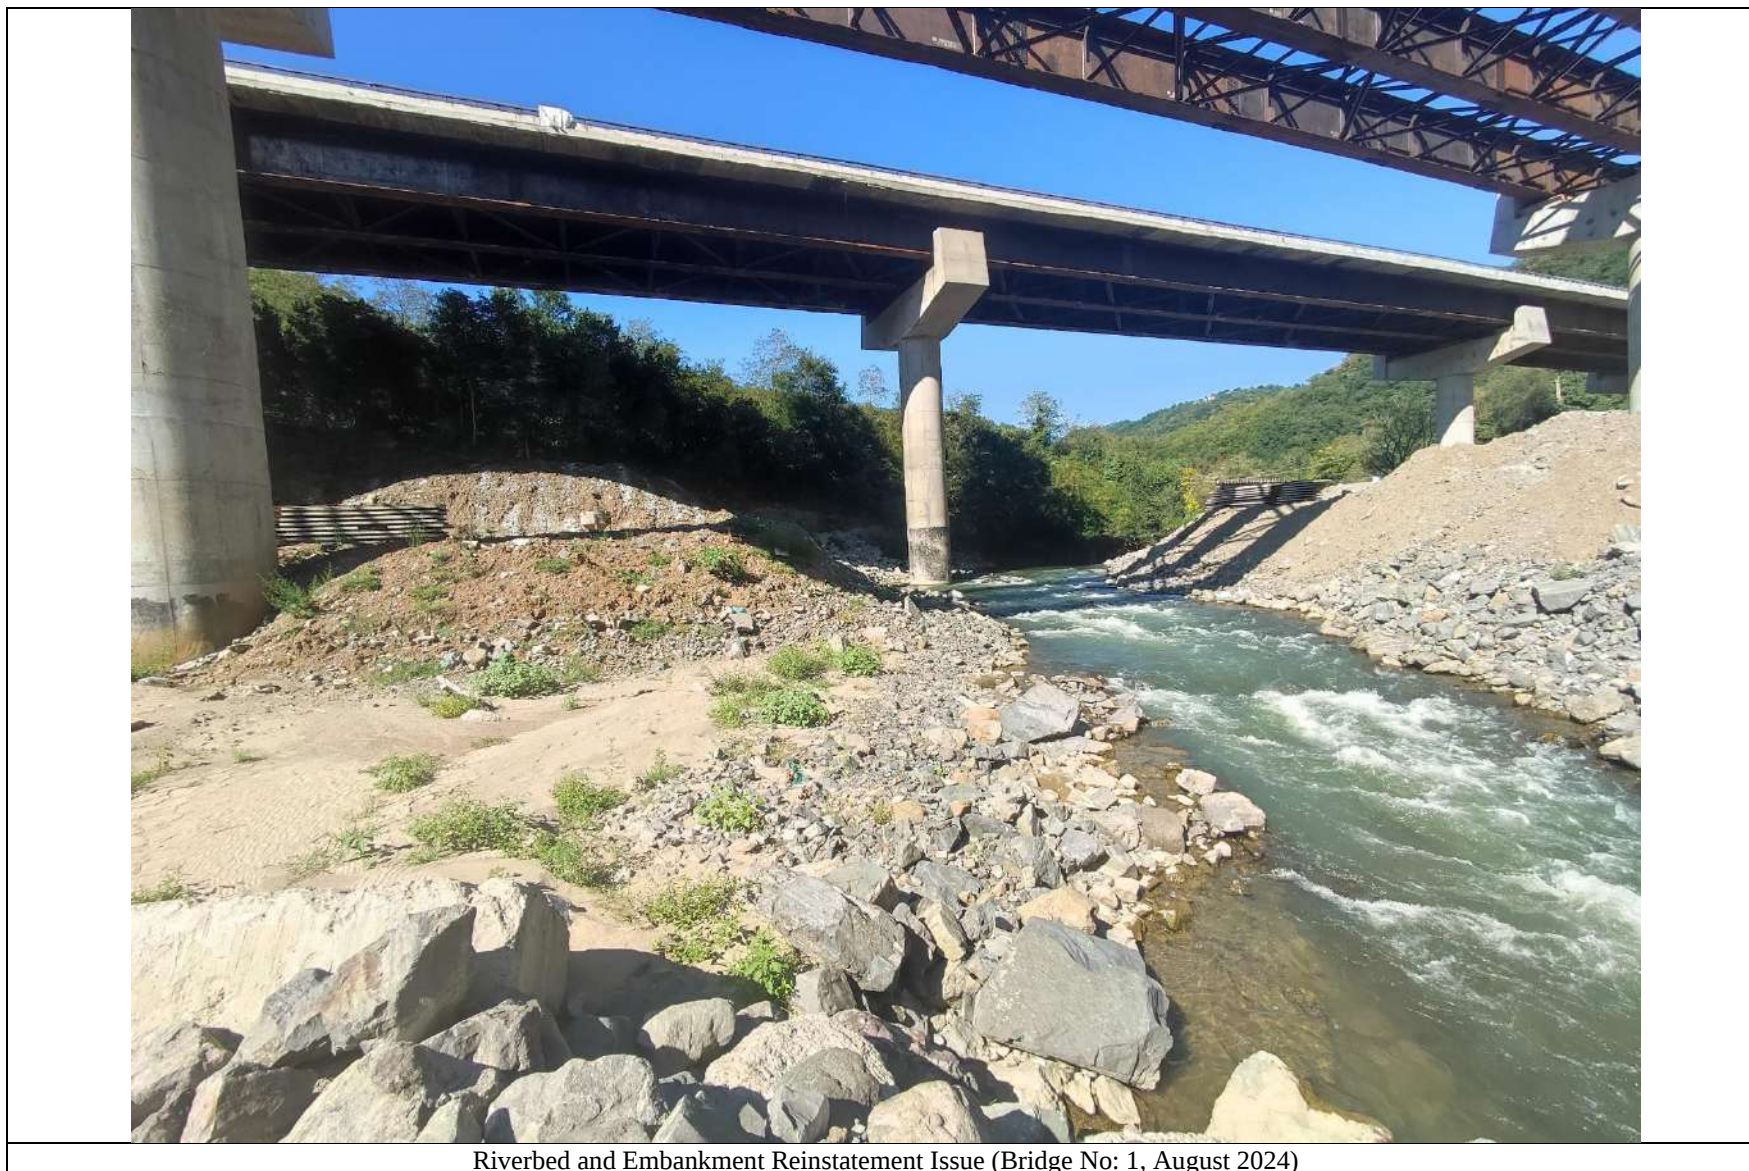
Riverbed and Embankment Reinstatement Issue (Bridge No: 1, August 2024)

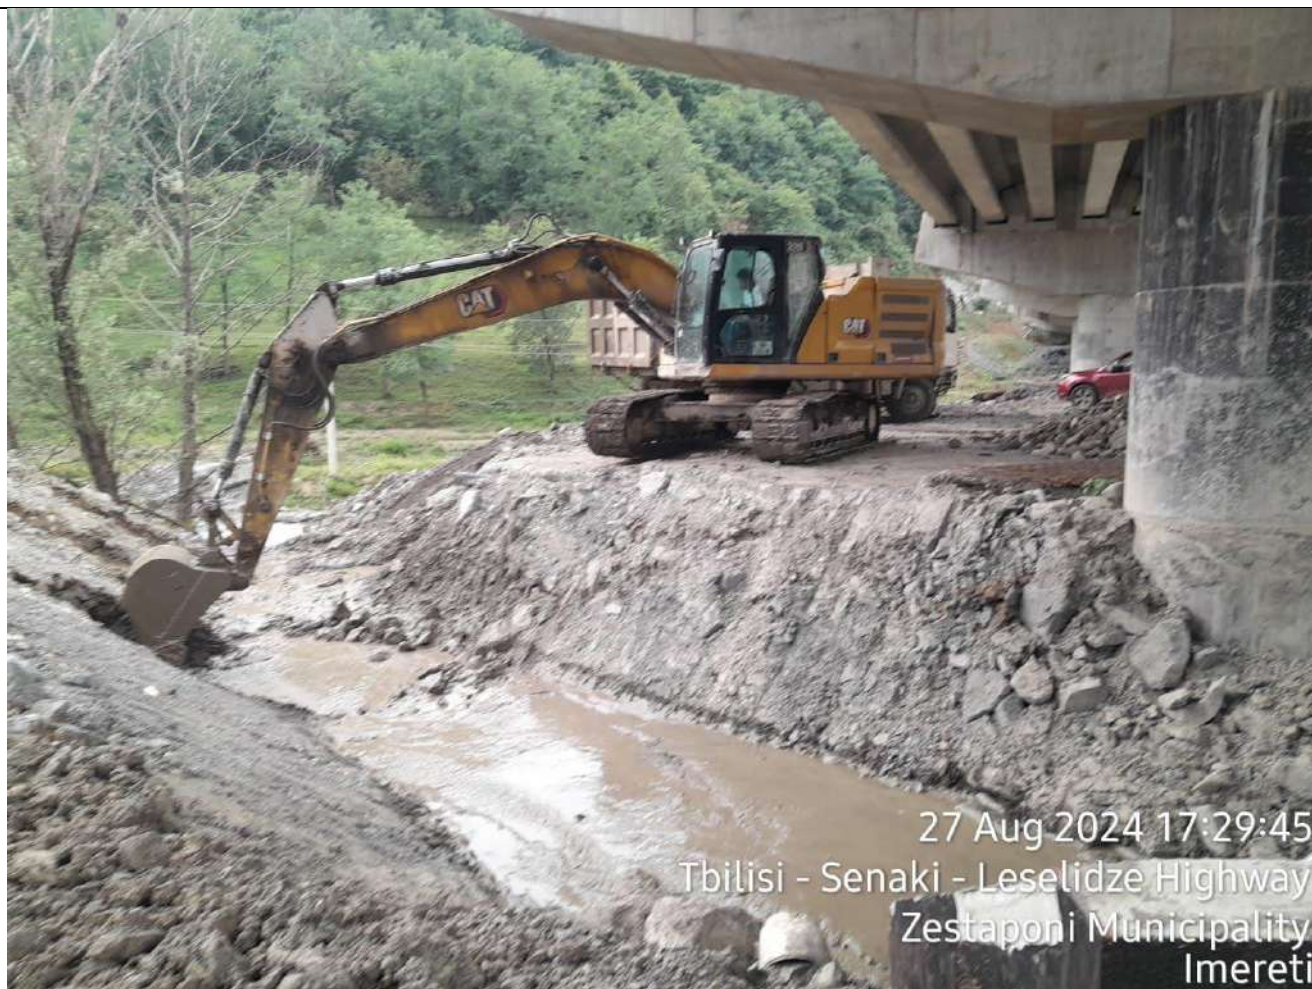
Batching Plant Temporary Sediment Trap Construction (August 2024)

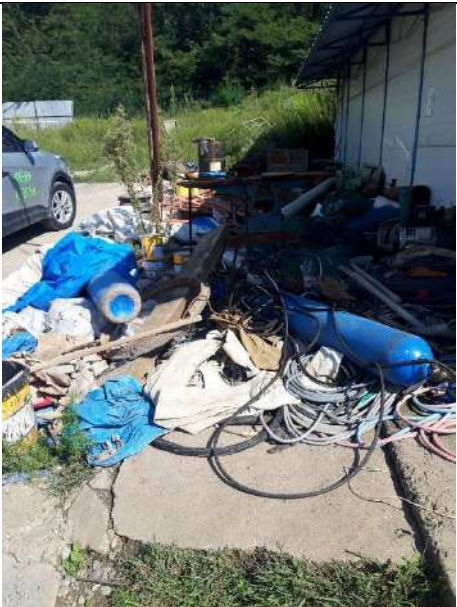
| <p>Poor Housekeeping (Worker's Camp No 4, September 2024)</p> | <p>Abandoned Worker's Camp No 1 (September 2024)</p> |

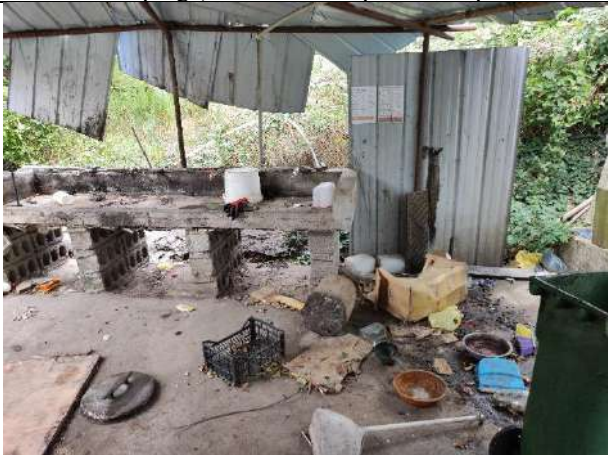
| <p>Abandoned Worker's Camp No 1 (September 2024)</p> | <p>Poor Housekeeping and waste management (Worker's Camp No 4, September 2024)</p> |

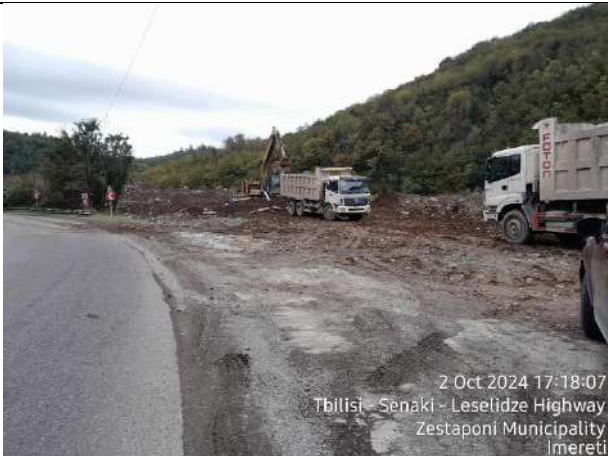
| <p>Spoil Removal from Spoil Disposal Area No:1 (October 2024)</p> | <p>Waste Collection (October 2024)</p> |
