Semi-Annual Environmental Monitoring Report

Project Number: 53178-001

Semestral Report (January - June 2022)

Georgia: East-West Highway (Shorapani – Argveta Section) Improvement Project

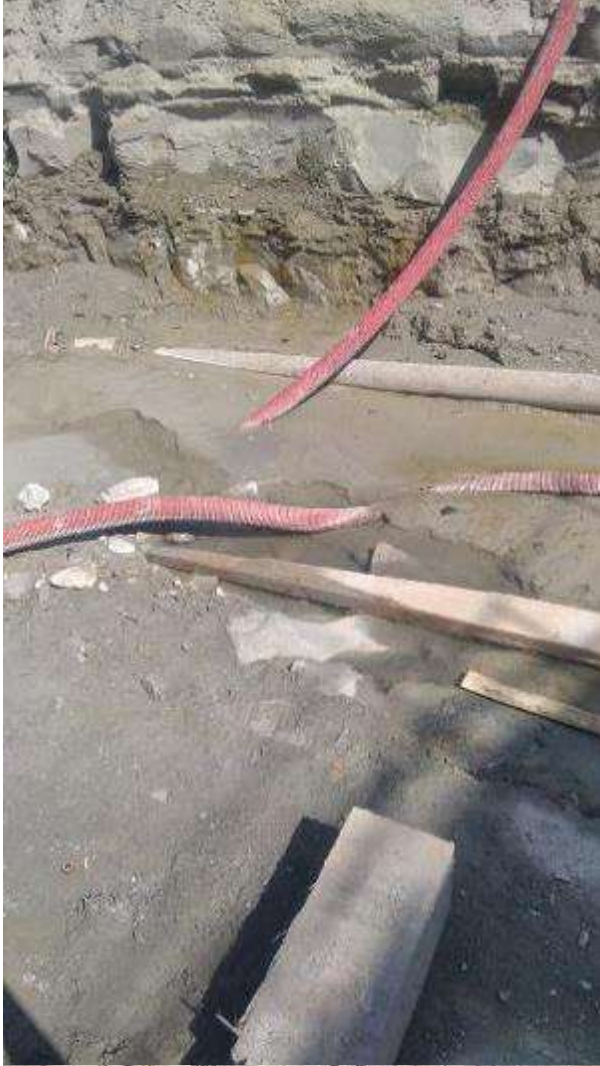
High voltage cables are scattered on the ground in the water

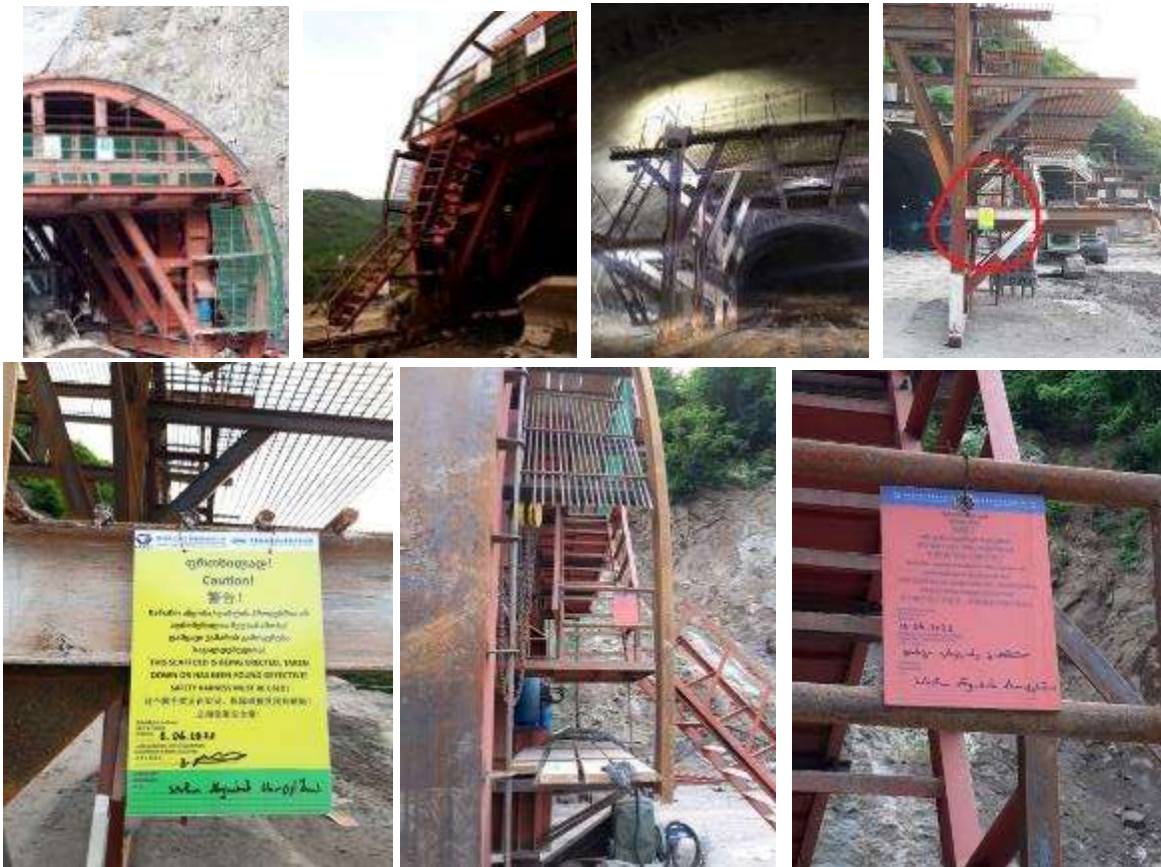
Picture 1: Non-Conformance (All tunnels): Visible changes have been made in the design of platforms and in the procedure of using steel structures. Appropriate guardrails and safety signs were fixed on some structures. Special color tags, warning workers about the procedure of how to use mentioned structures, were hung on. Systematical inspections of steel structures have to be done to ensure that the workers are following to instructions provided by the H&S team. **Issue closed.**

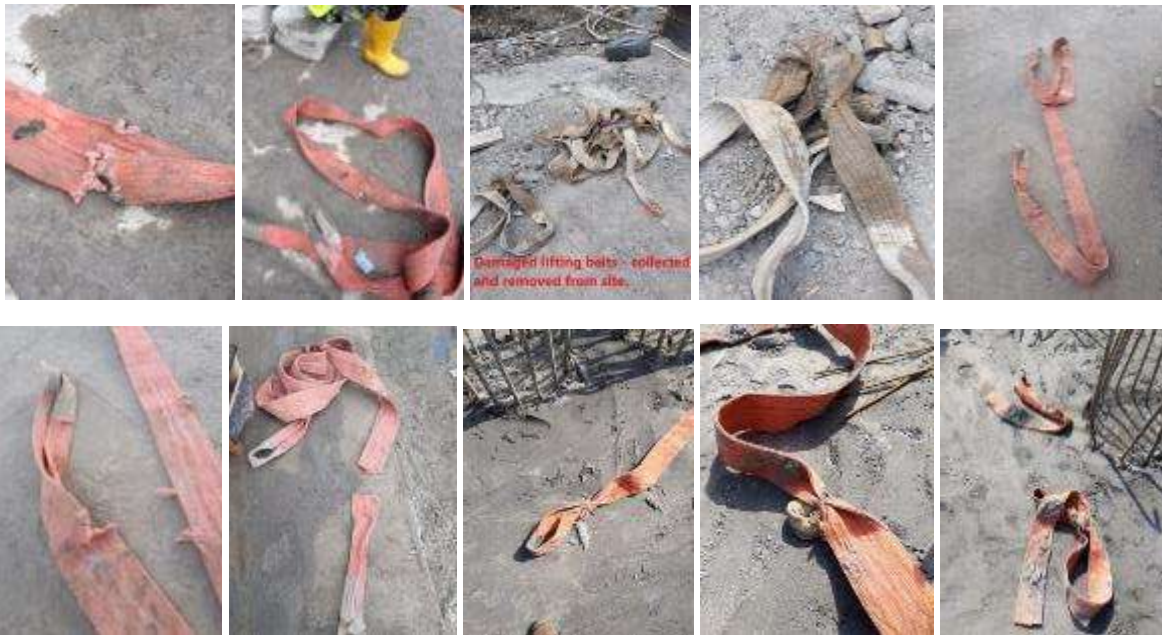
Picture 3: Non-compliance (Damaged lifting equipment) (All tunnels): - Damaged and cut lifting equipment has been found at workplaces during visiting the tunnels. Site responsible persons from the Contractor Company were informed about it by the Engineer. The Engineer has asked Contractor to pay additional attention to the workplace safety and do inspection of using tools and equipment (Including lifting equipment) very often for to find and remove from the site all damaged or cut equipment. Three of such damaged lifting belts has been found by the Engineer and cut it in pieces to avoid further usage and any type of possible incidents from happening. **Issue closed.**

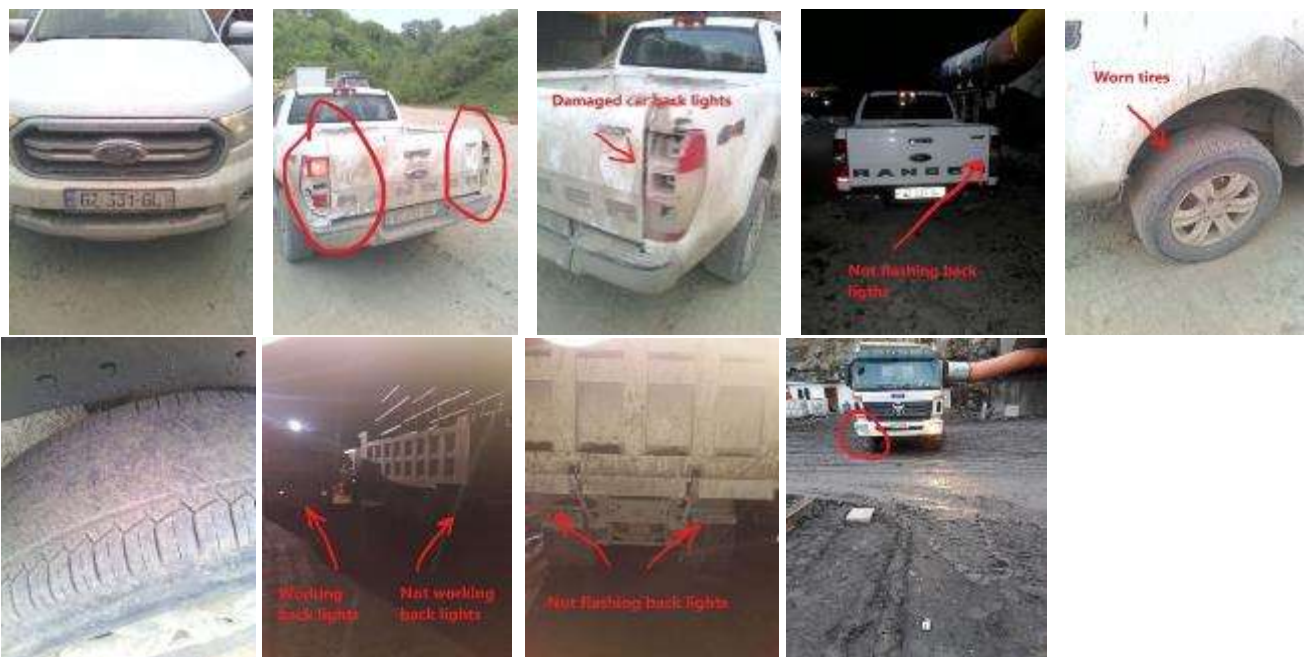
Picture 4: Non-compliance (Driving safety): Continue non-compliance to international H&S rules and requirement has been observed during site walk. More vehicles and trucks with damaged traffic lights and worn

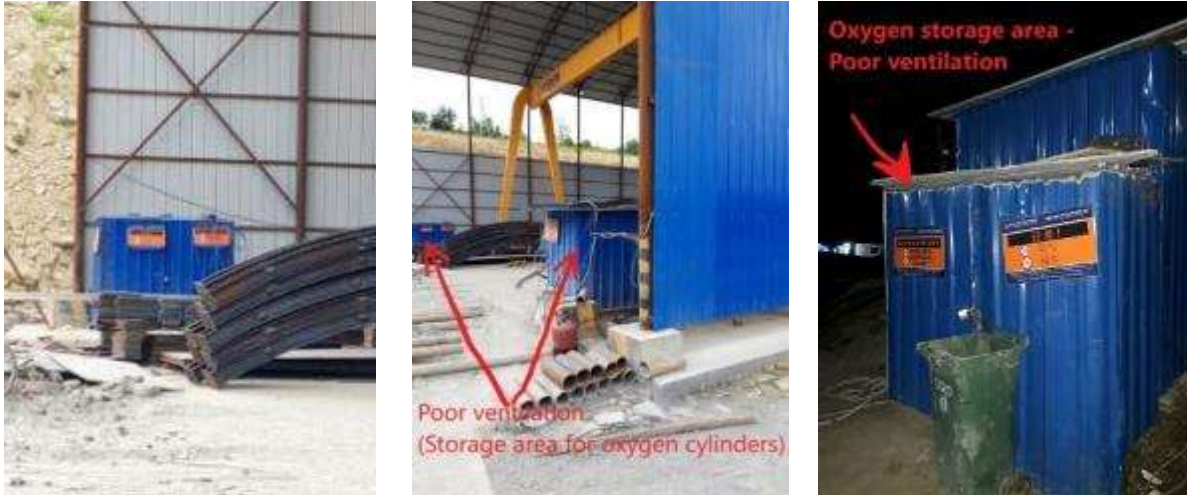
Picture 5: Non-compliance (Tools and equipment (Possible damage)) – (Tunnel N5) – Non-compliances to H&S regulations and requirements have been observed during site visit: Storage cages (To store the oxygen cylinders) aren’t equipped with proper ventilation system (Cages are fully closed). It may cause possible incidents. Engineer asked Contractor’s site responsible persons to react on mentioned above issue as soon as possible, to avoid possible injuries or property damage. **Issue still open.**

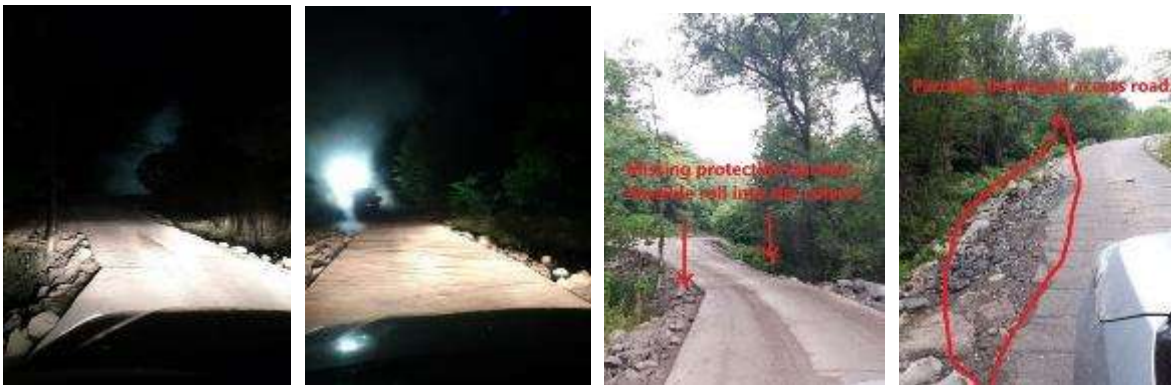
Picture 6: Driving safety (Road related incidents) – Access road to Tunnel N5 TA – It is unsafe to drive on access road to tunnel N5, because of poor road quality. It is double danger, when driving in the night time (In some section the road is becoming very narrow and there is a big risk to lose the concentration, drive out the road and turn over. In some section, road is partially damaged). Engineer asked Contractor’s site responsible persons to arrange some jersey barriers or flashing safety poles, place it on most dangerous areas of mentioned access road and protect unsafe sections and safe people’s life. Waiting for feedback, but there aren’t any updates until now. **Issue open.**

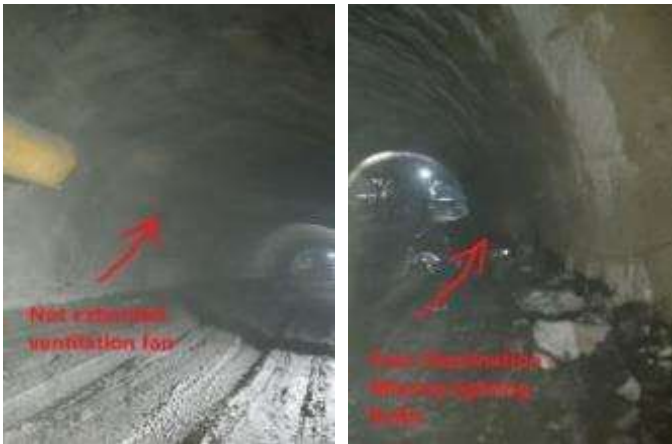
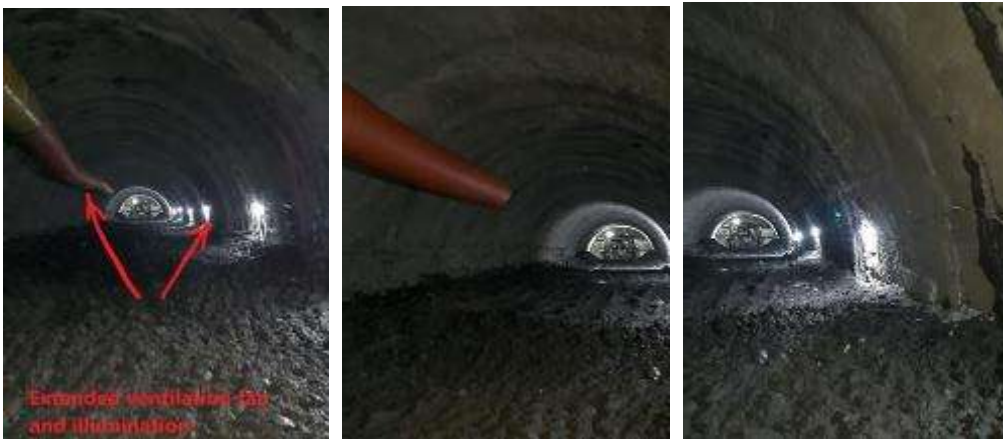
Picture 7: Non-compliance (Poor ventilation and lighting) (Tunnel N3) –During visiting the tunnel a few days ago, it was observed that the ventilation fan wasn't extended to sufficient length and lighting bulbs were missing too. Contractor's site responsible persons were informed by the Engineer. The Engineer asked to pay additional attention on such issues to avoid possible incidents at workplaces. After few days, the ventilation fan was extended and additional illumination bulbs have been installed **Issue closed.**

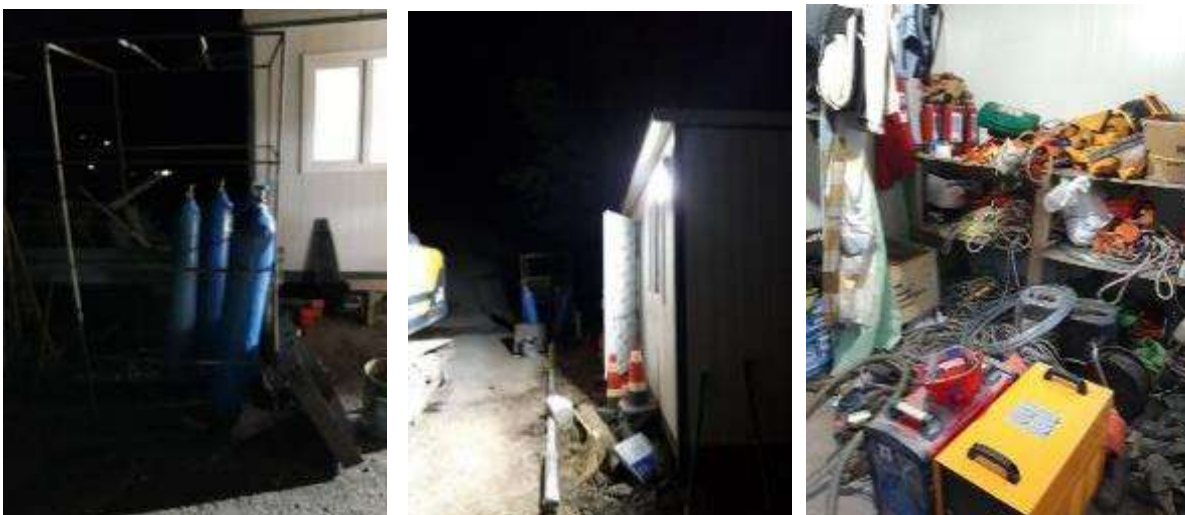
Picture 8: Non-compliance (Workplace safety) – Tunnel portal N 4004 TA - Mostly all health & safety related issues were solved on mentioned location, but there are some problems should be paid additional attention on. For example: Arrangement of bio toilet at workplace and improper storage of oxygen cylinders

and other construction materials (Including flammable liquids). The Engineer asked Contractor's site responsible persons to react on mentioned above issues as soon as possible. We are waiting for feedback from the Contractor. Issue still open.

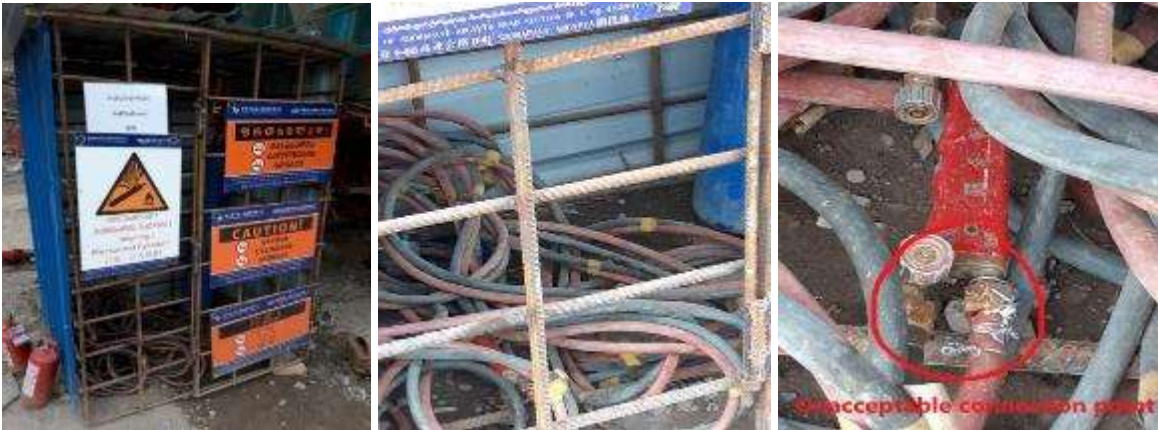
Picture 9: Material storage (Possible incident) Tunnel N2 – Engineers are still observing issue related to improper storage of materials at workplaces. Such case has been observed during visiting the tunnel N2. The rubber hoses, using for connecting the propane cylinder to heating torch has been found stored in the same cage with the oxygen cylinders. Also, handmade connections have been found during site inspections. Site responsible person from the Contractor Company was informed about it by the Engineer. The Engineer asked to keep all mentioned above materials separately, especially arranged for such materials designated places. Issue open.

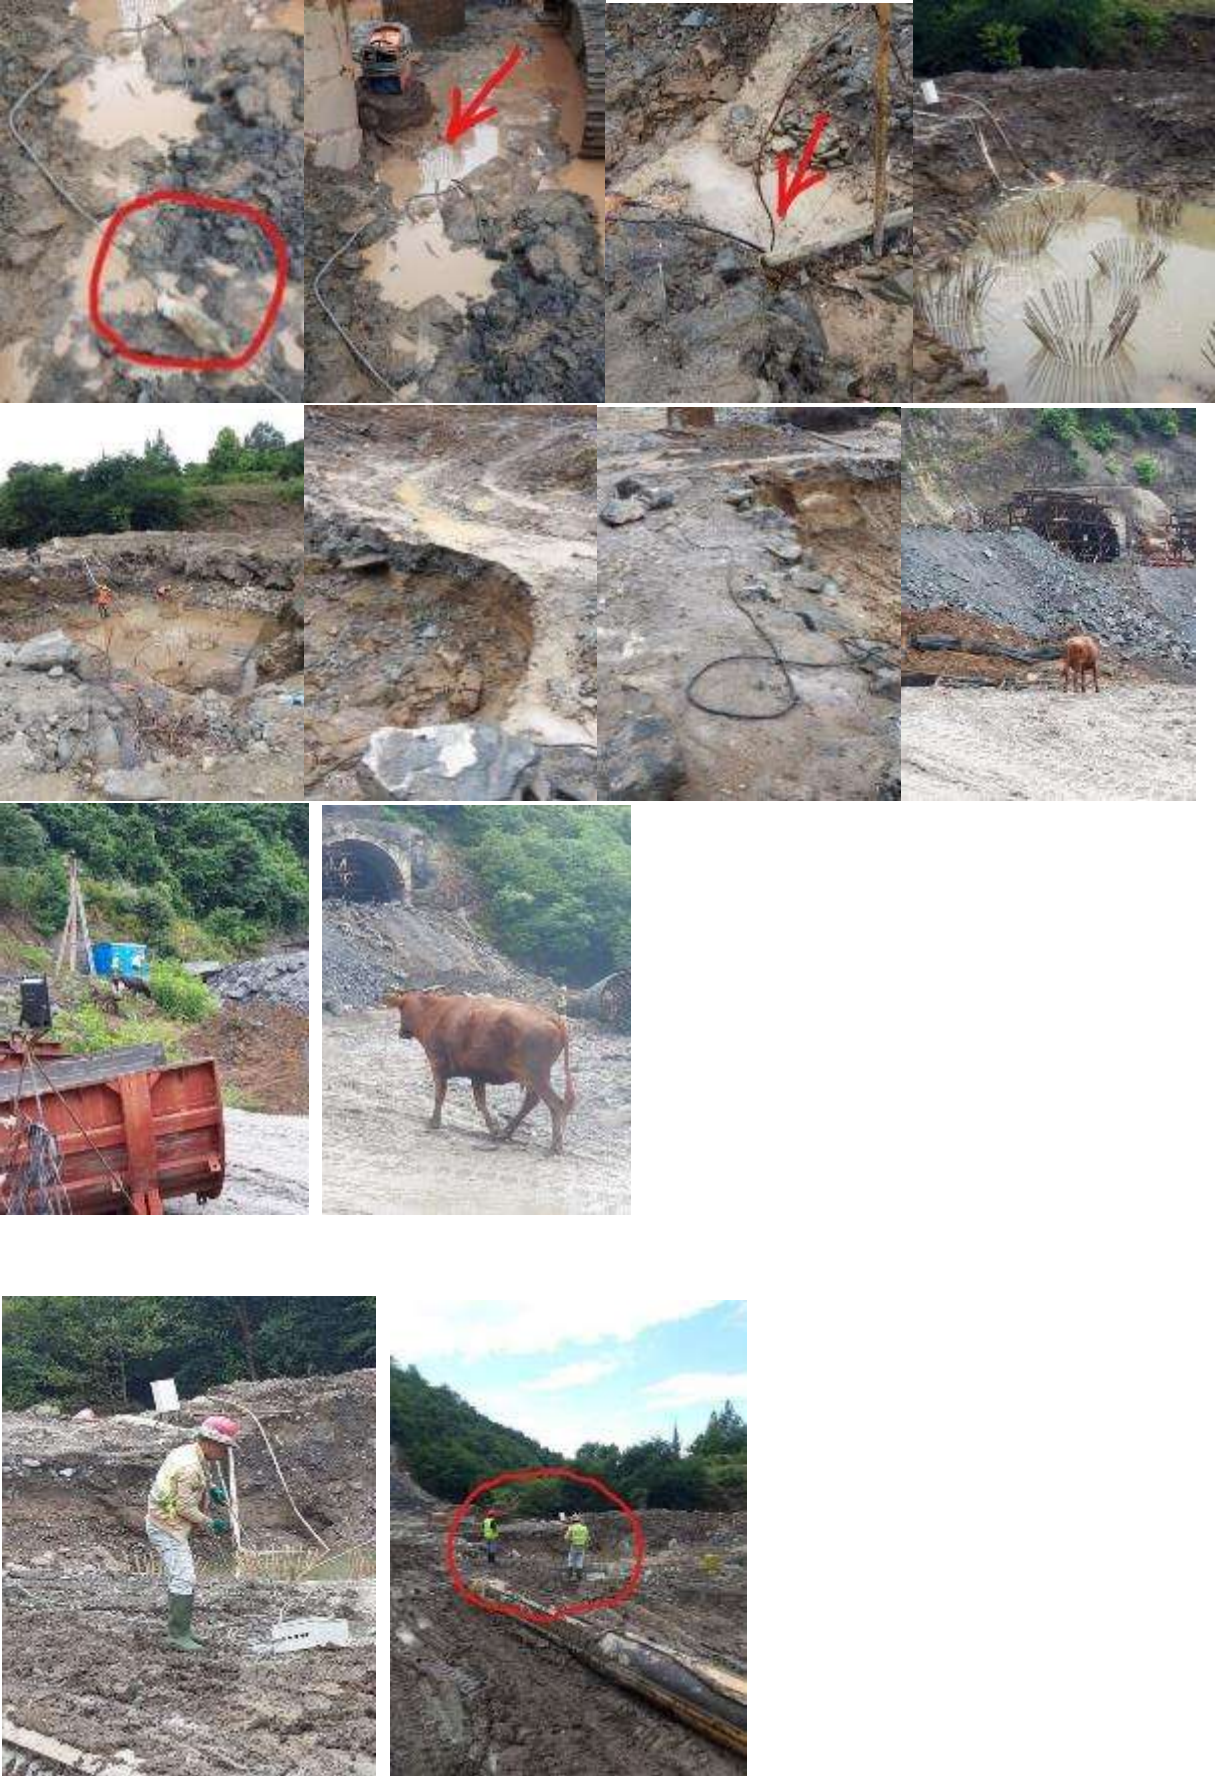
Electric cables removed from the water and fixed in the isolated box.

Picture 10: Non-compliance (Possible injury of personnel) (Bridge N3, Pier N3 and 4) – Not properly barricaded open trench (full with water) with no proper access into has been observed during site visit. There is a big risk of falling or rolling down into the open trench and getting injuries not only for the working crew members, also for the animals crossing the working area. By the way, the walls of the trench have started collapsing due to heavy rain and flooding. The electric cables, thrown in the water and mud have been found during site walk. Site responsible persons from the Contractor Company were informed about it by the Engineer and asked to solve it as soon as possible. Several non-compliances were corrected by the Contractor, for example the electric cables and switch gear were removed from the water, moved and fixed in especially arranged for this isolated box (see attached picture), but it isn't enough for fully completion of mentioned above issue. The Engineers are still waiting for feedback from the Contractor. **Issue open.**

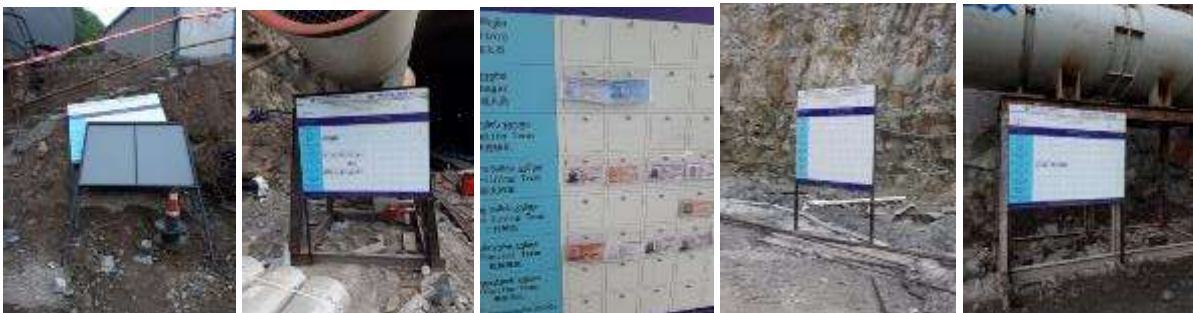
Picture 13: Good performance (Safe work process) (All tunnels) – Good performance has been observed during site visits. Effective control of the work process has been established and implemented by the Contractor. It is easy to manage the work force and be aware of what is the quantity of working personnel involved in the task inside the tunnel for effective fighting when an incident occurs. In some places, the registration boards are installed, but not functioning, because the workers aren’t hanging their ID cards and it is difficult to manage, how many persons are busy inside the tunnel for effective fighting when an incident occurs. Engineer thanked the Contractor’s management team for doing a good job and asked to continue working on improvement of workplace safety. **Issue closed.**

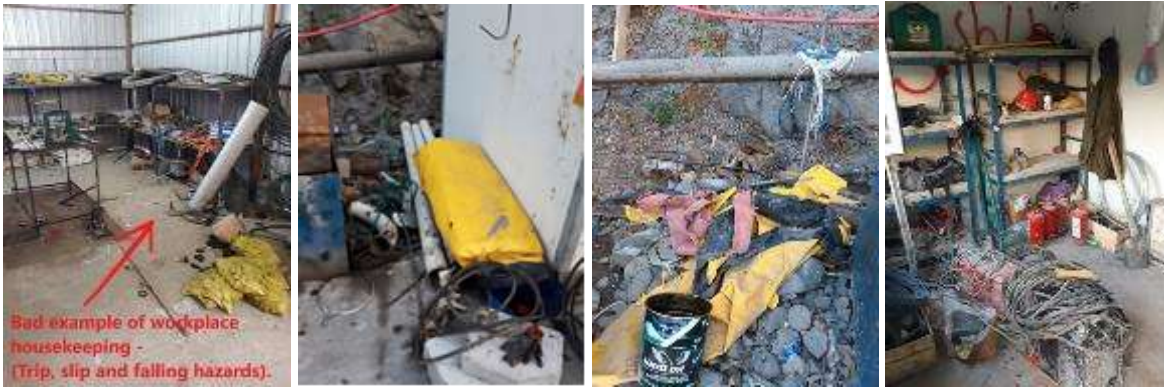
Bad example of workplace housekeeping (Tunnels #2 and 3)

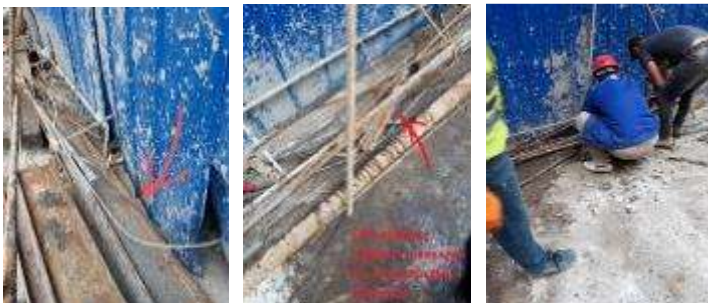
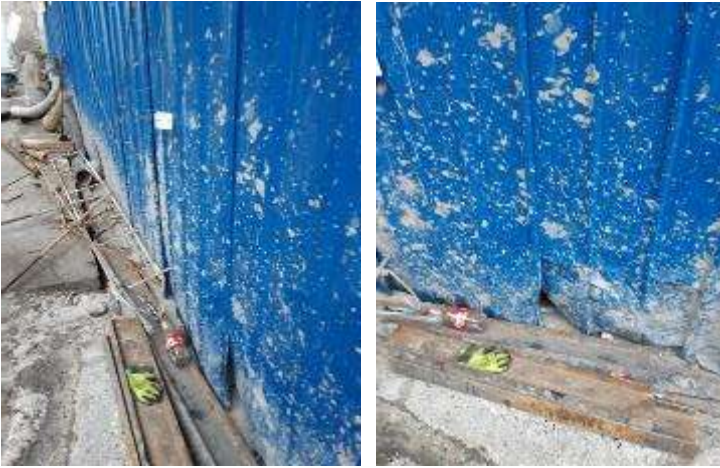
Picture 15: Non-compliance (Electrical safety) – (Workshop in Tunnel N2) – Non-compliances to H&S standards have been observed during site walk last week. It was observed that the life electric cable was passing through construction materials (Used rebar) and was pressed between steel parts. There was a big possibility that the cable could become damaged and somebody from working personnel could get electric shock there. Engineer asked Contractor’s site responsible person to switch off the power, remove the cable, elevate it and fix it on a safe height to avoid possible incidents. After some time, cable was disconnected from the power supply, collected and redirected by using safer route. **Issue closed.**

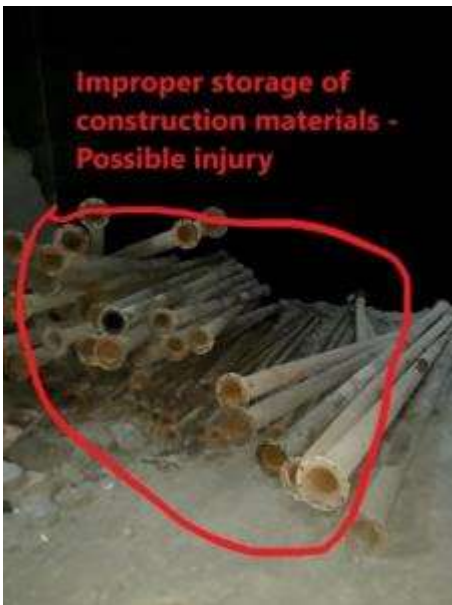
Picture 16: Improper storage of materials (Personal injury) Tunnel N3 – Violation to Company H&S rules has been observed by the Engineer during visiting the tunnel N3. It was observed that construction materials weren’t stored properly. Somebody from working crew may become stuck between the rolled pipes and become injured there. Engineer asked Contractor’s site responsible person to pay more attention on workplace safety to avoid possible incidents from happening. Engineer is waiting for feedback from the management of Contractor’s team. **Issue open.**

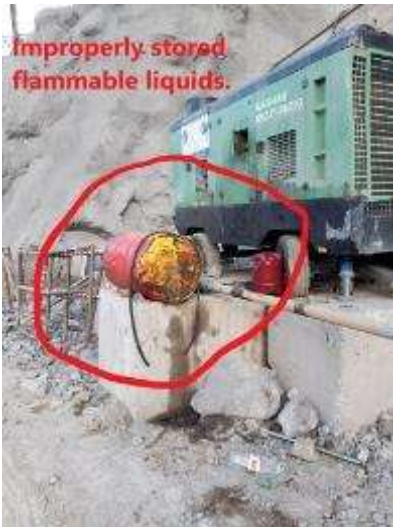
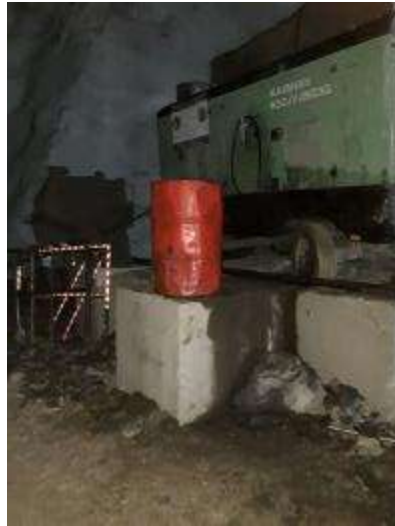
Bad observation (Oil spillage)(Tunnel #2).

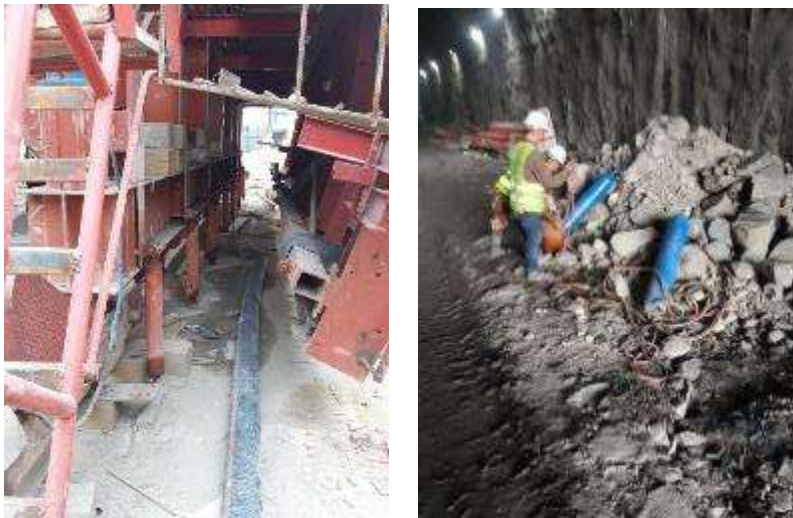
Picture 18: Non-compliance (Improper storage of materials-Possible incident) (Tunnels #3, 4 and 5) –

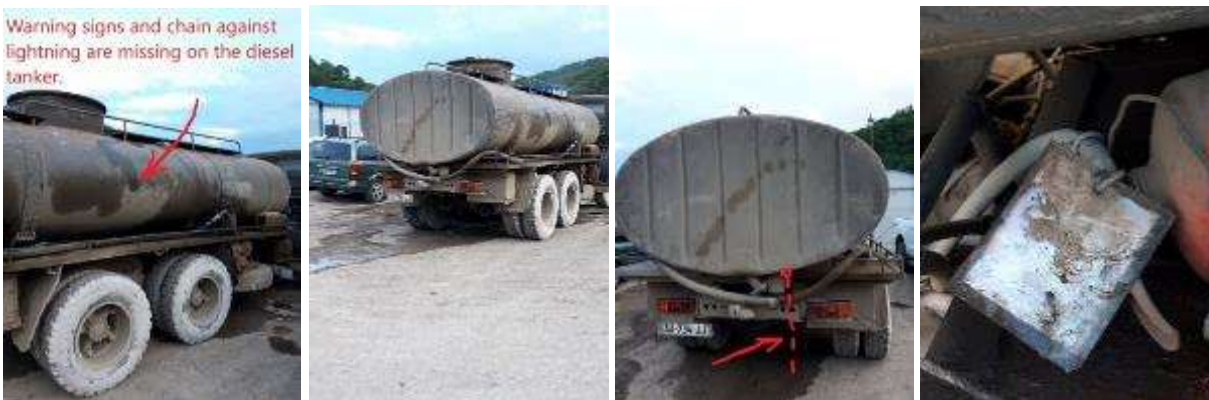
Picture 19: Non-compliance (possible fire) (Workshop at tunnel #3) - The diesel tanker with no warning signs on it and missing anti-lightning chain has been observed during visiting the site. Also, the fire

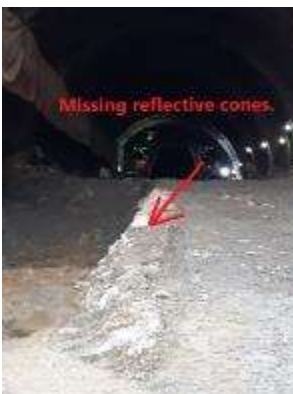
Bad observation (Tunnel #5)

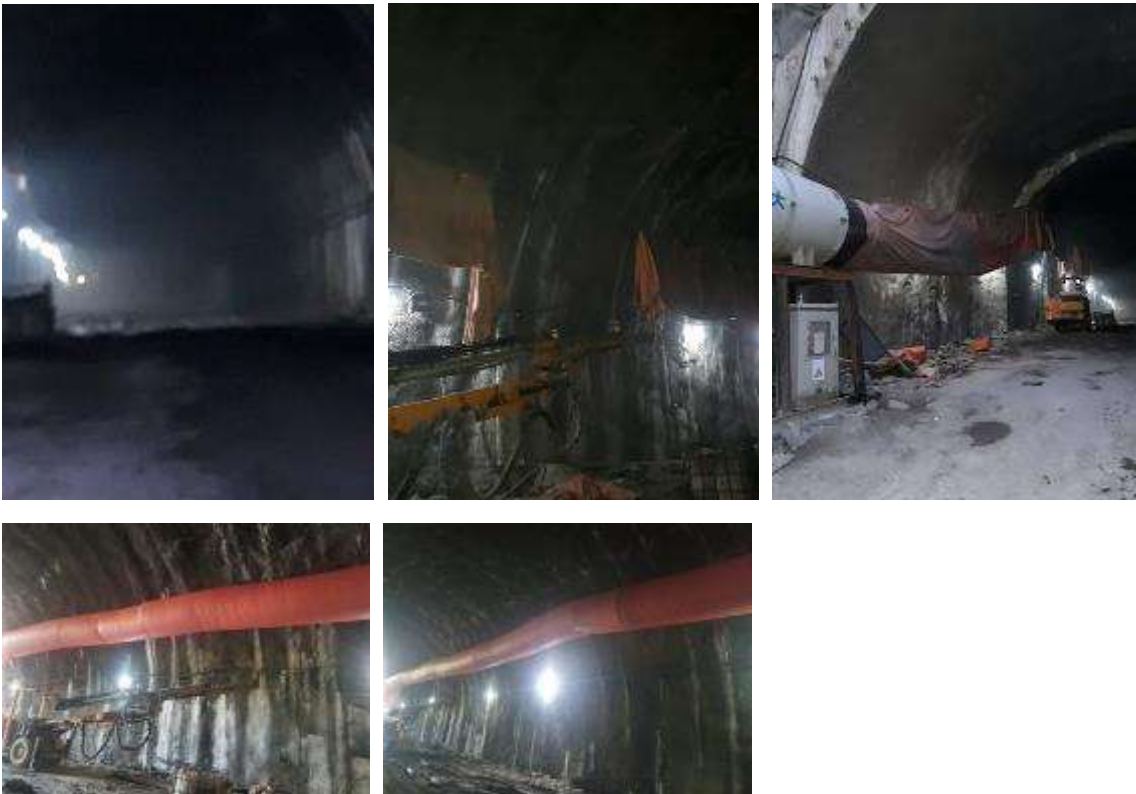
Picture 22: Non-compliance (Poor ventilation-Possible injuries) -Tunnel #2AT- Non-compliance to H&S regulation has been observed during site inspection of tunnel #2. The level of oxygen was very low due to a destroyed ventilation fan (the level of oxygen was tested by tester). Engineer decided to stop the work, because the working personnel, involved in the task inside the tunnel, could get hurt and be injured there. Responsible persons from the Contractor Company were called to site and Engineer has explained that due

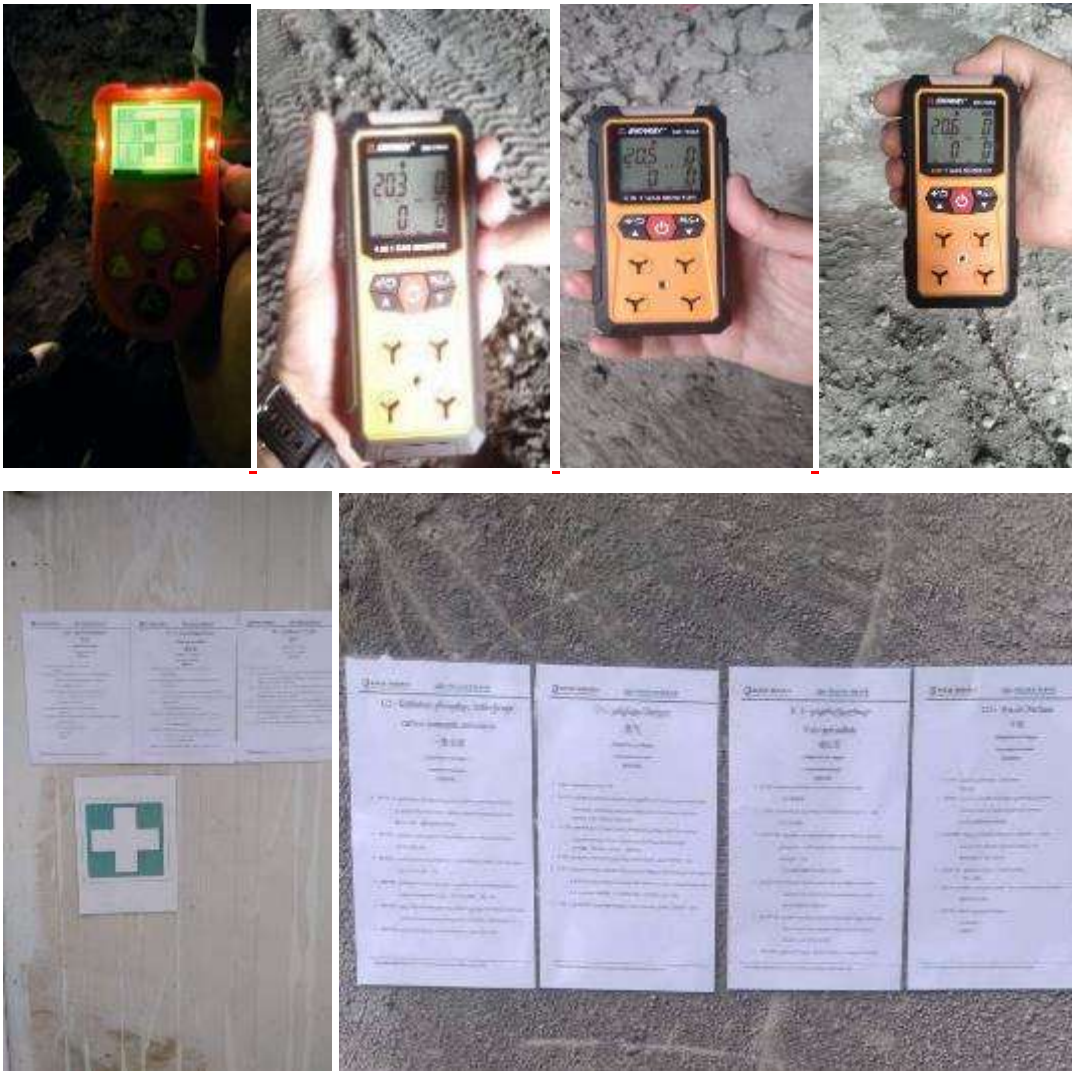
Picture 23: Good observation (Compliance to work process) Tunnel №2 AT, Tunnel №5 AT and TA - Information about the air concentration norms are placed at the entrances of the each tunnels. All the tunnels are equipped with air/gas measuring equipment and air concentration levels in the tunnel is under regularly monitoring (During the specific works in the tunnel air must be systematically monitored and the information must be recorded). Air/Gas Detectors have been tested and they were in working order. A bump test involves exposing the detector's sensors to a concentration of gas that is greater than the alarm set points. During the testing, level of CO was checked up inside the tunnel, and detected increased concentration of CO. It started to flash in red color. **Issue closed.**

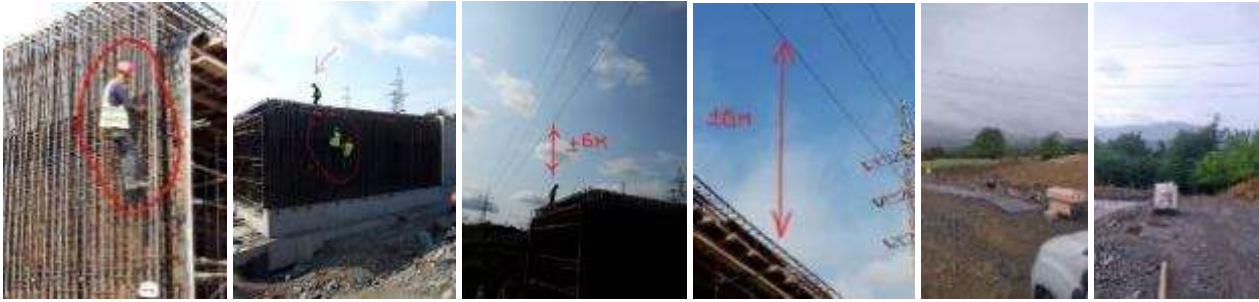
Picture 24: Overhead power lines and workplace safety (possible incident) - Culverts N4218, 4219 and 4303 – Non-compliances to health & safety rules and regulations have been observed during visiting the culvert N4303. First of all, it is dangerous to work under a high voltage power line, because the workers may accidentally touch the line when lifting, moving or installing the reinforcing bars (the distance between top of the culvert roof and overhead power line is plus minus 6m). Also there is no special staircase to reach the roof and workers are using installed steel structures as a ladder to climb up. The welding machine that workers are using at the site is partially damaged and must be changed. Based on all non-compliances, mentioned above, Engineers have decided to stop the work, until all non-compliances wouldn't be solved by the Contractor. Contractor's H&S team also was informed about it. Contractor has to solve the problems and only after that continue perform the task. Same situation is on the Culverts # 4218 and 4219 - High voltage cables are not at appropriate safe height (it is very low). Heavy machinery is working on site (crane, concrete pump and excavator) and workers are lifting 12 meter long armatures and moving it during the working process and they are getting very close to the hazard zone. First of all, this location has to be controlled by the Contractor systematically. Second, Goal post with warning tapes and warning signs must be installed. Third, safety training have to give to whole working crew, including mixer, crane, excavator and concrete pump operators, to avoid possible incidents, that already occurred in this location few weeks ago and forth, proper tools and equipment has to be delivered to the work. All safety measures have to be taken by the Contractor to avoid possible incidents. And very important recommendation from the Engineers, nobody has to work in these locations, when heavy rain. The Contractor has to take this requirements from the Engineers under own control. **Issue open.**

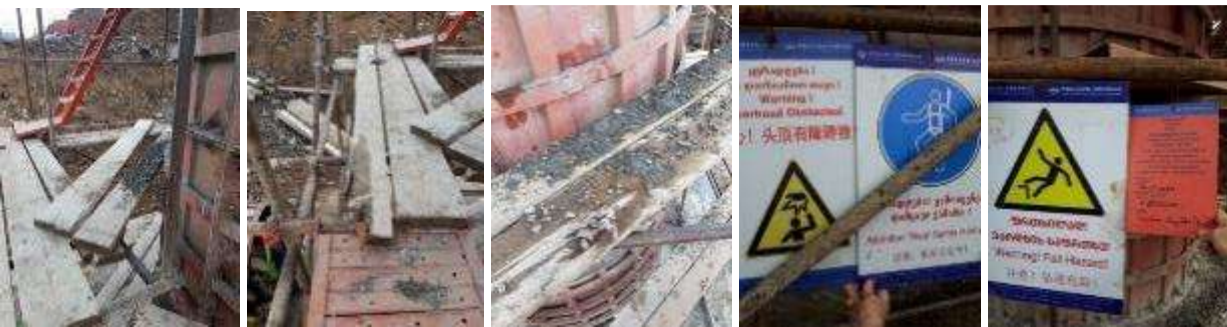
Picture 26: Non-compliances (Work at height - possible incident) – Bridge N2, pier#5 – Non-compliances to health & safety regulatin have been observed during visiting the bridge N2, pier#5. Not installed handrails on staircase. Partially rooten wooden timbers placed on walkways. It could cause possible falling or drop and injuries of the working personnel. Incorrect warning signs were fixed on the scaffold structure. The competent persons from Contractor Company were informed about these non-compliances. The Engineer has got promises from the Contractor that they would solve mentioned issues as soon as possible. The Engineer is waiting for feedback. **Issue open.**

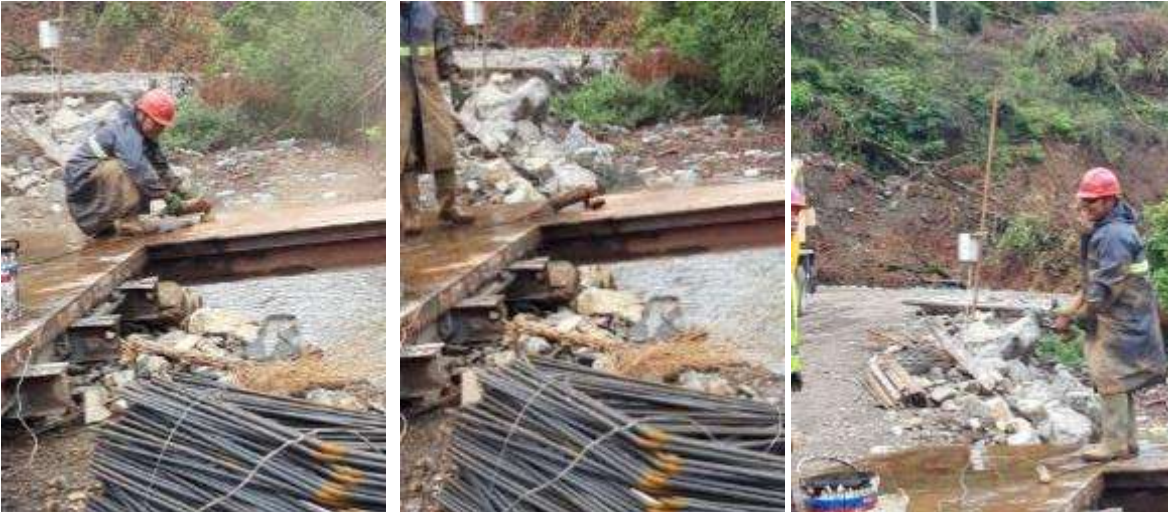
Picture 27: Non-compliance (Personal protective equipment) – Bridge N2, pier#5 – Non-compliance to health & safety rules and requirements have been observed during visiting the workplace. One of the Contractor’s personnel was using brushing machine to clean the steel plate surface and he didn’t use the safety glasses to protect his eyes from possible injury. The Engineer asked him to stop, wear safety glasses and then continue performing the task. The worker wear his safety glasses on and continue performing the task. The responsible persons from the Contractor Company were informed about it. The Engineer asked them to do workplace inspections very often to find out and eliminate all possible risks of getting injury. **Issue closed.**

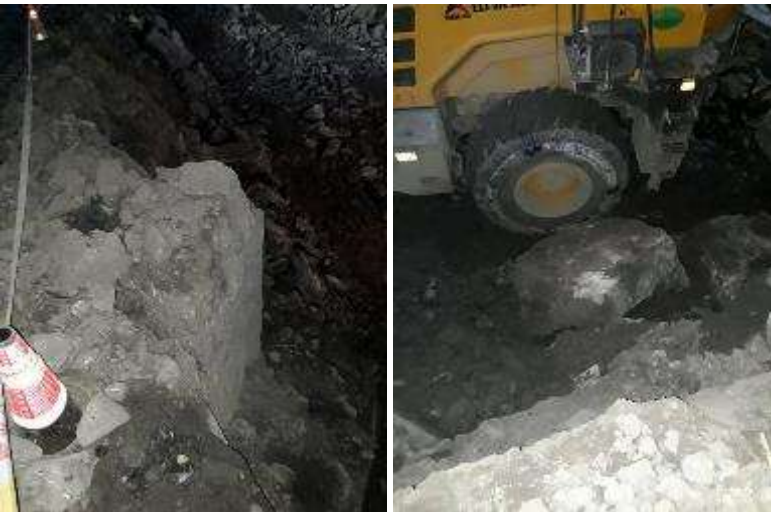
Picture 28: Non-conformance– (Possible personal injury) - (Tunnel #3 TA) – The cracked piece of big rock has been observed inside the tunnel (Pandus - access road for the drivers). Any time, because of possible vibration, it could become loose, roll down and injured somebody. The Engineer asked the loader operator to demolish this rock and remove it out from the tunnel to avoid possible injuries of working personnel. The Engineer asked responsible persons from the Contractor Company to be more attentive and do everything is necessary there to avoid such situations at workplace. **Issue closed.**

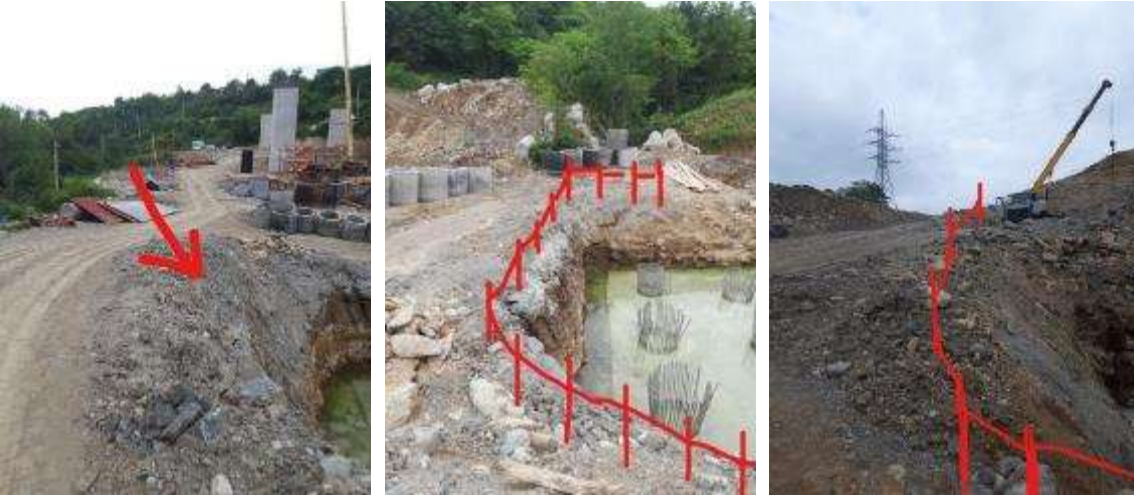
Picture 29: Non-Conformance – (Possible roll or falls) Bridge N5 – Not properly barricaded openings have been observed during site inspection. All openings have to be protected by hard barriers to avoid possible falls or rolls into. The Engineer informed about it the Contractor and asked to react on this issue as soon as possible to avoid possible incidents at workplace. The Engineer is still waiting for feedback from the Contractor. **Issue open.**

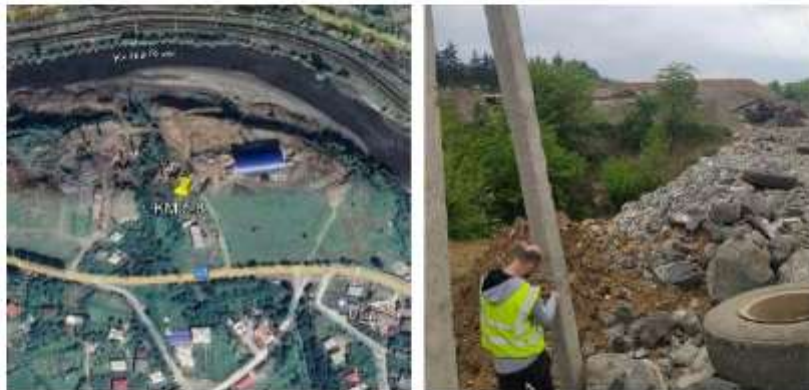
Air quality monitoring tubes were replaced at the point. While the monitoring team was on site, the works were in an active phase, rock crusher was working, and heavy machinery were often moving. Significant spread of dust was observed.
