# Semi-annual Environmental Monitoring Report

Reporting period: January - June 2021

Georgia: East - West Highway (Khevi-Ubisa Section) Improvement Project

**Loan No 3715 - GEO**

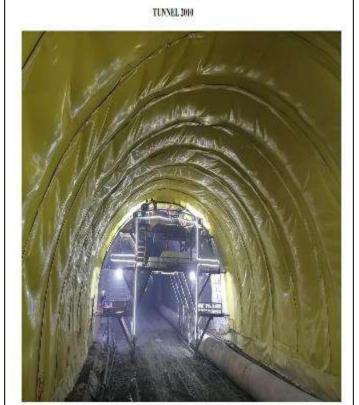
TUN#10 Ventilation is ON

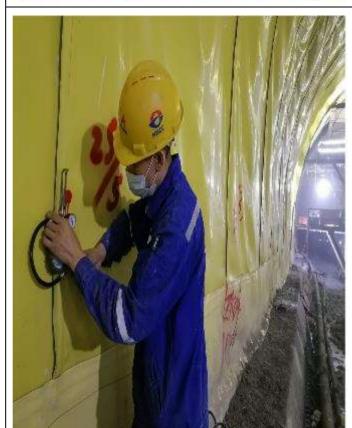
TUN 10 worker not wearing the Gloves

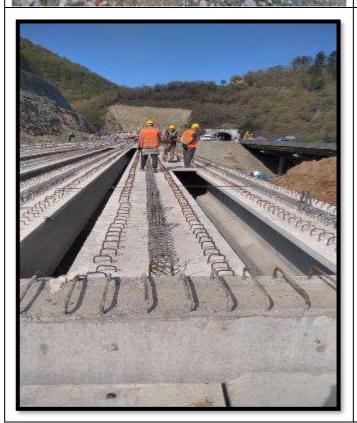
Guard rail required at Bridge# 5

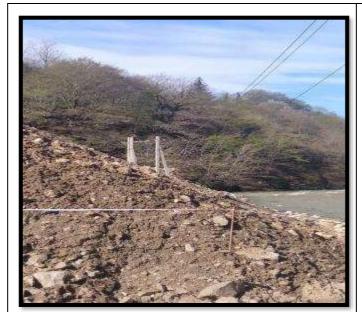
PILIPED IN THE PROPERTY OF THE	
19	Retaining Wall 2512	April 2021	High voltage lines at unsafe distance above the ground	High voltage lines shall be at appropriate, safe height from the ground	3 days	Excavated soil removed to maintain the safe distance to eliminate the arc effect	Closed
20	TUN #8	April 2021	Working platform damaged due to the stone falling in the tunnel	Platform shall be repaired and proper engineering control shall be ensured	3 days	Guardrails of the platform repaired	Closed

High voltage lines can cause arc effect

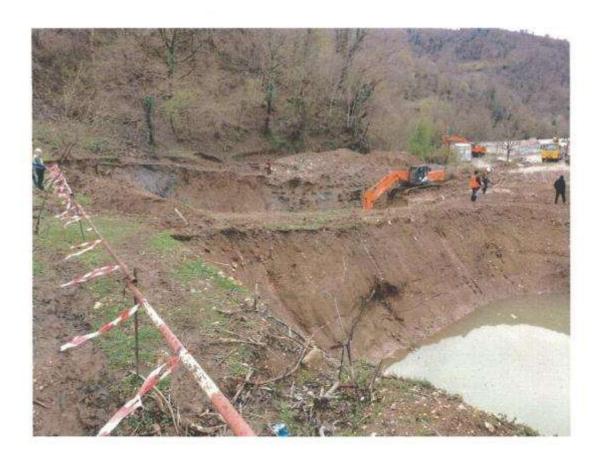
Despite the requirements of the specification it has been observed that the Contractor is not stripping and stocking the topsoil accordingly.

Hereby, the Contractor is requested to execute the topsoil stripping and stocking in accordance to the Technical Specification.
