**ADB Project No: 41122-043**  
**ADB Loan/Grant No: 2560-GEO, 2843-GEO**  
**Financed by: The Asian Development Bank**

**Project:**  
**Kobuleti Bypass Road Section**  
**KM12+400-KM31+259**

**Post Construction Environmental Site Observation report**  
**(Supplement of the Final EMR)**

**September 2021**

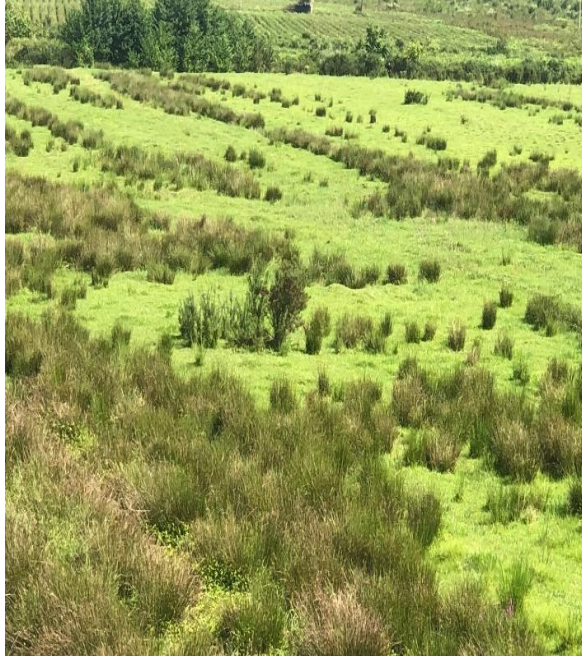
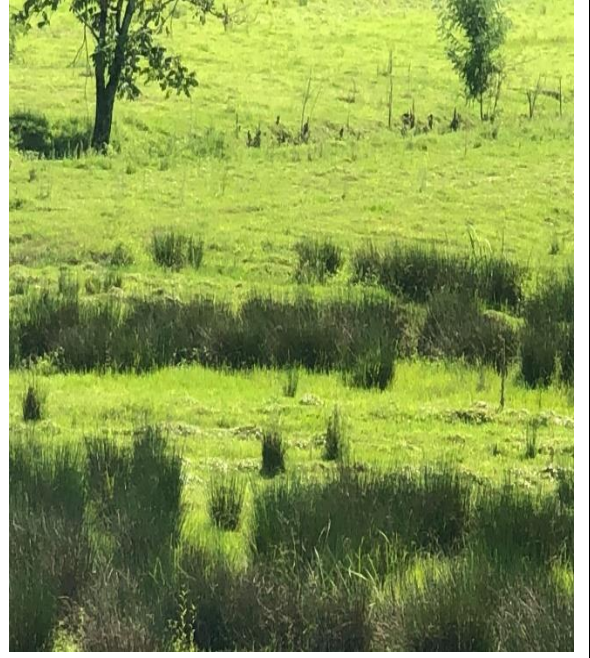
**Figure 1. Ochkhauri camp area**

1. All construction and household waste is removed from the project area (see **Figures 1 and 2**);
2. All construction camps have been dismantled and the existing infrastructure units removed from the camp area (see **Figures 1 and 2**);
3. Construction waste is completely removed from the areas adjacent to the bridges (See **Figures 9 and 10**);
4. On the slopes along the project road, as well as at the Shuagele quarry site, where additional topsoil was used and seeding/planting implemented (see **Figures 5,6,7,8**).
