Semi-annual Environmental Monitoring Report

Project Number GEO 51257-001

Reporting period: July – December 2024

Georgia: North-South Corridors (Kvesheti – Kobi) Road Project

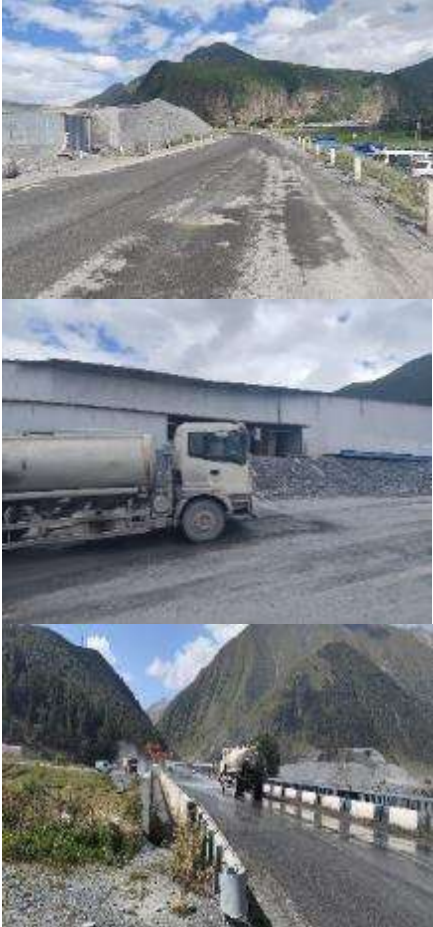
8	Kobi	August 2024	Dust on Access Road and E-117	Low	CC to sprinkle water on regular basis on access road from the tunnel, SDA3, and E-117	August 2024	<p>CC sprinkling water on regular basis in Kobi and need to be maintained all the time.</p>

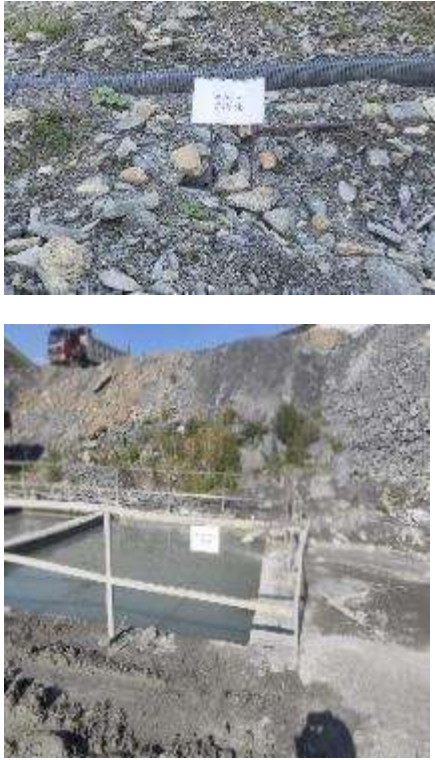
<p>9</p>	<p>Kobi and Tskere worksites</p>	<p>August 2024</p>	<p>Signage required at project facilities.</p>	<p>Low</p>	<p>Contractor to provide the signage at project facilities</p>	<p>Contractor provided the signage for hazardous waste storage area, and sedimentation ponds.</p>

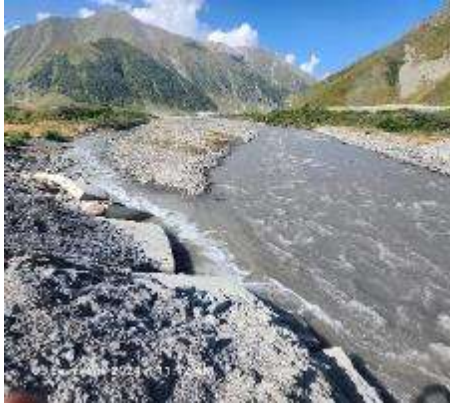
Medium	CC to stop the crusher water flowing in to the river	August 2024	Contractor stopped discharging water from crushing plant sedimentation ponds and flowing water quality improved.

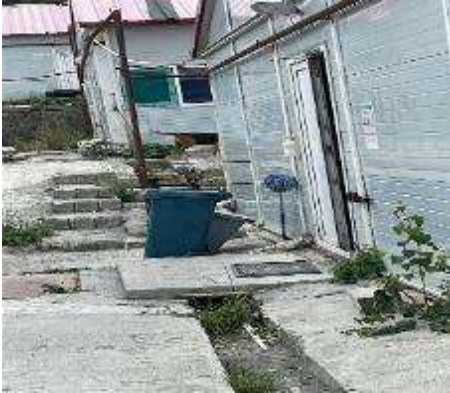
19	Campsite Kobi	August 2024	Waste containers required as the old one damaged	Low	CC to add the waste bins at the campsite	August 2024	CC added the waste bins and collecting the waste twice per day.

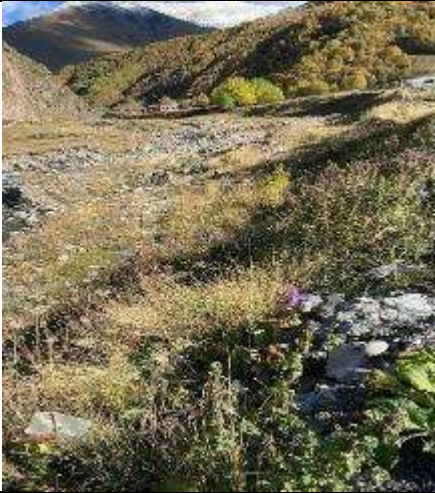
20	Kobi	August 2024	Remove the damaged waste containers from the site.  	Medium	CC to clean out the area	August 2024 - 2024	Contractor removed the damaged containers from Kobi camp.	Closed September 2024

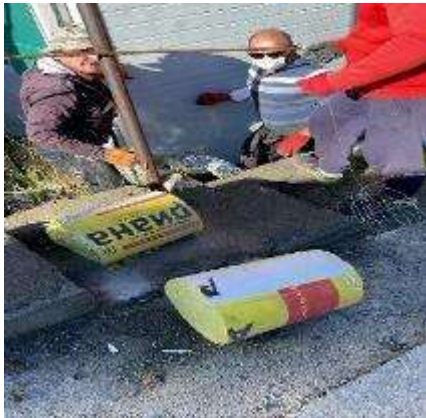
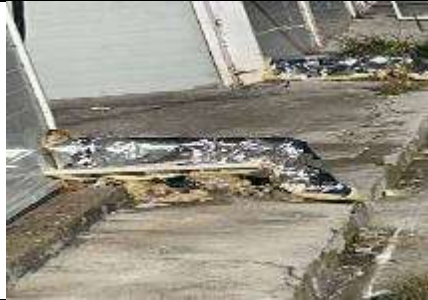
27	Kobi Campsite Engineer Residences	September 2024	Maintenance of water pipes for heating.	Low	Contractor to replace the sheet used for covering of heating pipes.	September 2024	Contractor removed the old sheets and wrapped the new sheet.	Closed September 2024

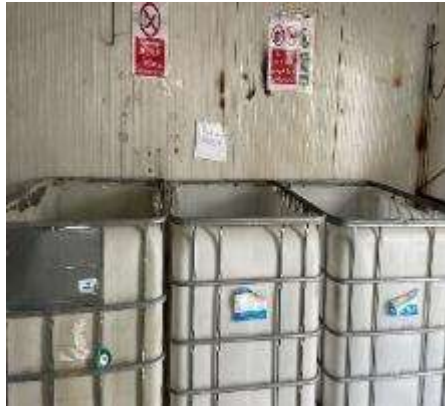
28	Kobi site	September 2024	Requirement of Hazardous waste material storage area	Medium	Contractor to provide hazardous material storage area in Kobi	September 2024	Contractor provided the hazardous material storage area in Kobi in the warehouse used for sub structures.

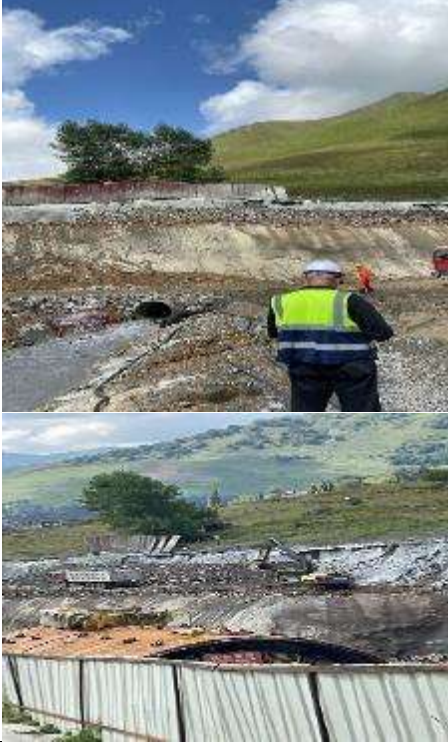
Closed September 2024.
29	Tunnel #5 South Portal	September 2024	Slope failure near Cemetery in Tskere Village	High	Contractor to stabilize the slope	September 2024	Contractor stabilized the slope to avoid further failure of slopes and build the fence along the cemetery	Closed September 2024

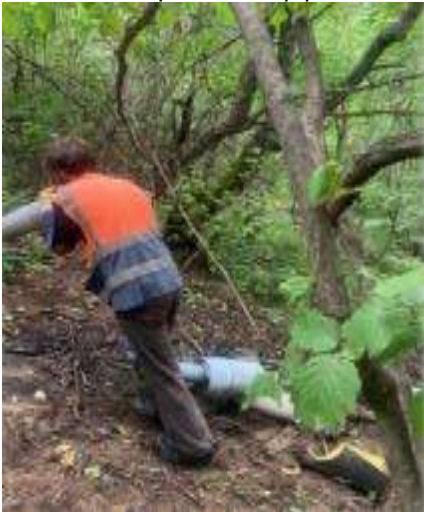
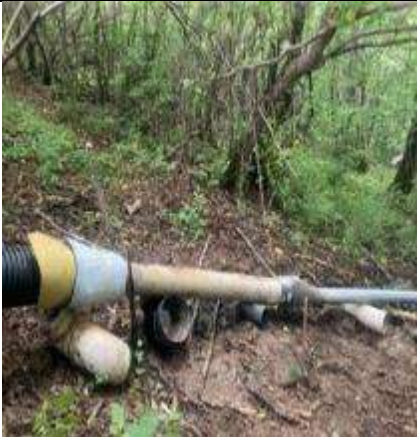
3	Camp 2	July 2024	Effluent Pipe to be repaired at STP Camp 2	Medium	Contractor to repair the pipe at STP 2	July 2024	Contractor repaired the pipe	Closed July 2024

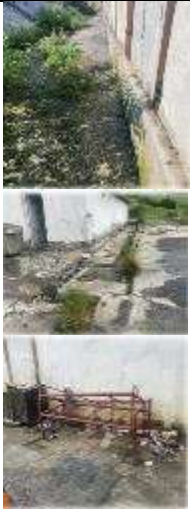
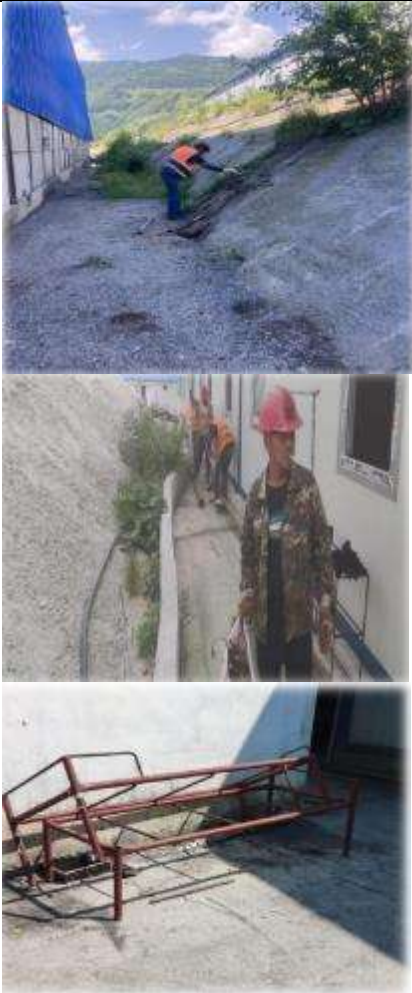
5	Camp 2 & Camp 3	July 2024	Poor housekeeping at the site	Medium	Contract to clean out all the areas at Camp 2 and Camp 3	July 2024	Contractor cleaned out the campsites.	Closed July 2024

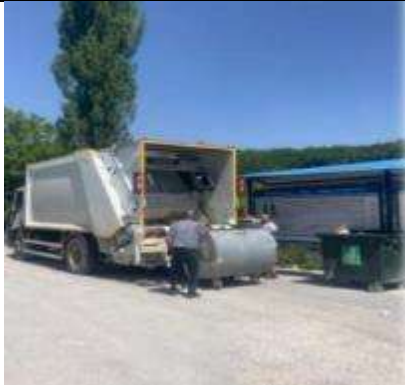
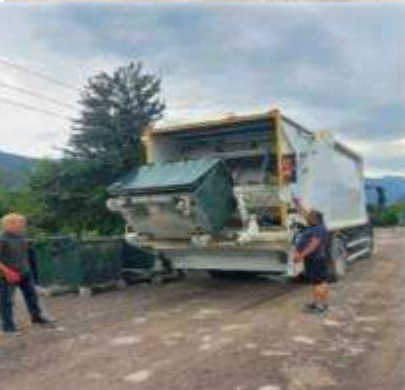
the hazardous material storage areas.		the Hazardous Material storage Area.		 	
7	Camp 1 and Camp 2	July 2024	Waste containers full of waste	Medium	Contractor to call the municipality truck to collect the waste	July 2024	Waste collected by municipality truck.	Closed

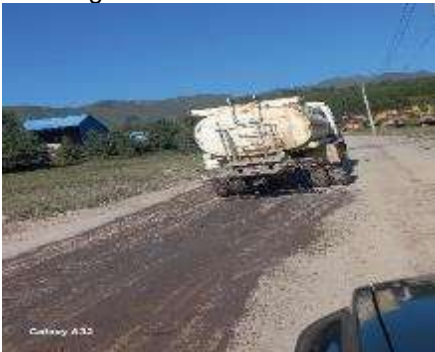
14	Didveli Plateau	August 2024	<p>Damaged water truck at plateau</p>

Low	Repair the water truck and start watering	August 2024	<p>Contractor repaired the truck and started watering</p>

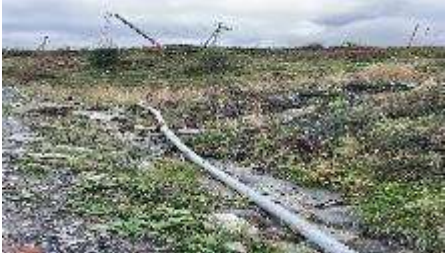
Closed August 2024
19	Camp 3 STP 3	August 2024	Broken Effluent pipe of STP 3

Low	Repair the effluent pipe of STP 3	August	Contractor repaired the Pipe at Camp 3 STP.

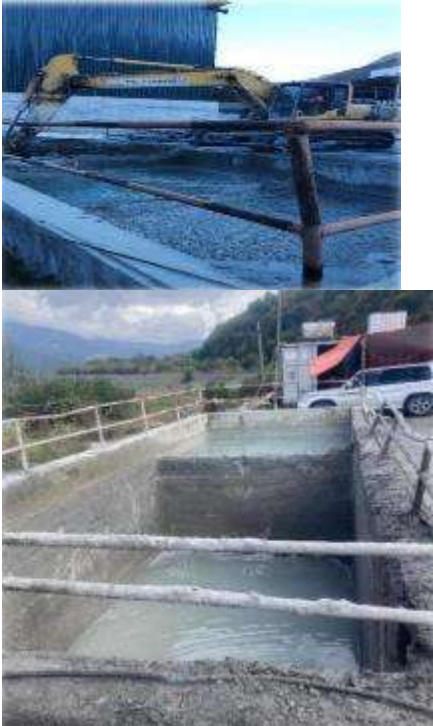
Low	Clean out the concrete washout pit	August 2024	Concrete washout pits cleaned out

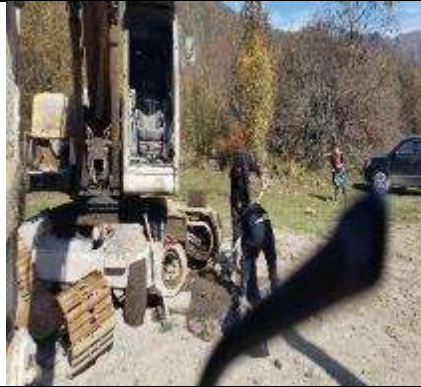
Closed September 2024
21	Near Camp 2	September 2024	Oil spill at various places. Oil leaked from broken excavator	Medium	CC to clean out the spill and treat it as hazardous material	October 2024	Oil spill cleaned out from the various places and contaminated soil stored in a hazardous material storage area.	Closed September 2024.

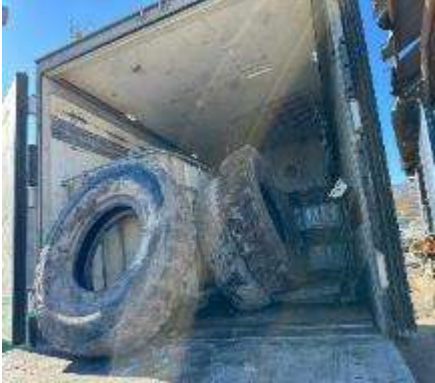
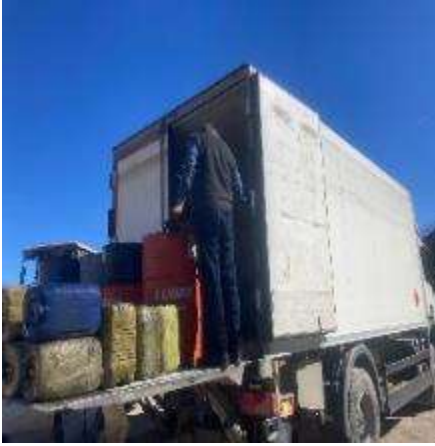
33	Construction site Plateau	October 2024	Used tires , hazardous material, oil need to be handover to the third party contractor	Medium	CC to remove the tires, used oil and hazardous material from the site	October 2024	<p>CC collected the used tires, oil and hazardous waste and handed over to the third-party contractor. 29 cubic meters of waste handed over to third party.</p>

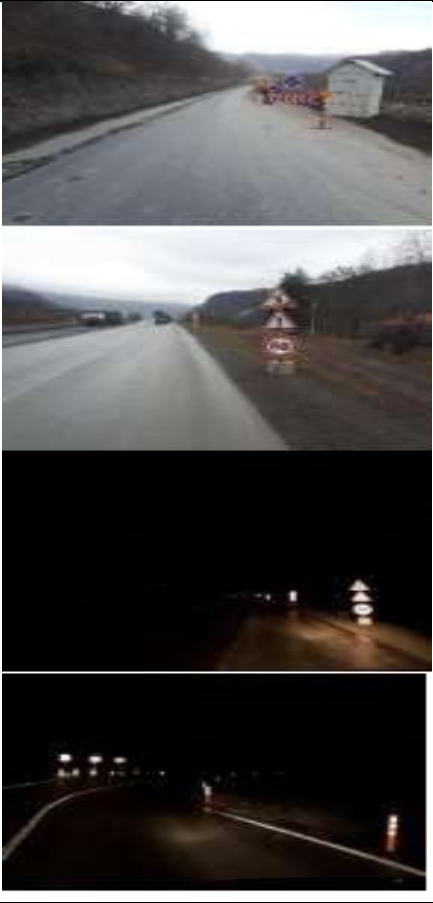
49	E-117 Highway Kavesheti	November 2024	Additional safety signs required	Medium	CC to install the additional signs as recommended by the engineer	November 2024	CC installed additional signs at the site.	Closed Nov 2024

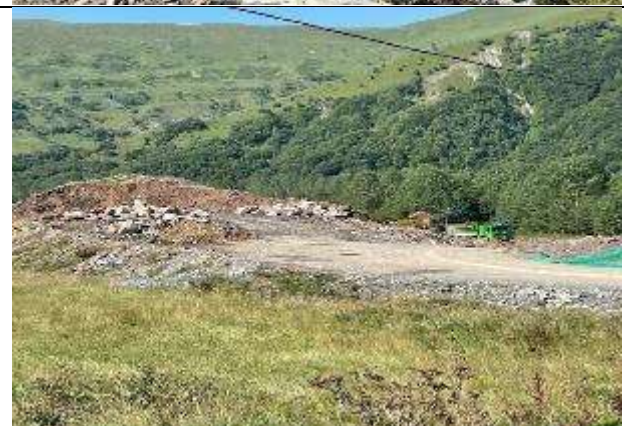
A photograph showing a pile of dirt and rocks on a hillside, with a road visible in the background.	<p>Spoil material being shifted from Benian Begoni to Kvesheti road for embankment. September 2024</p>

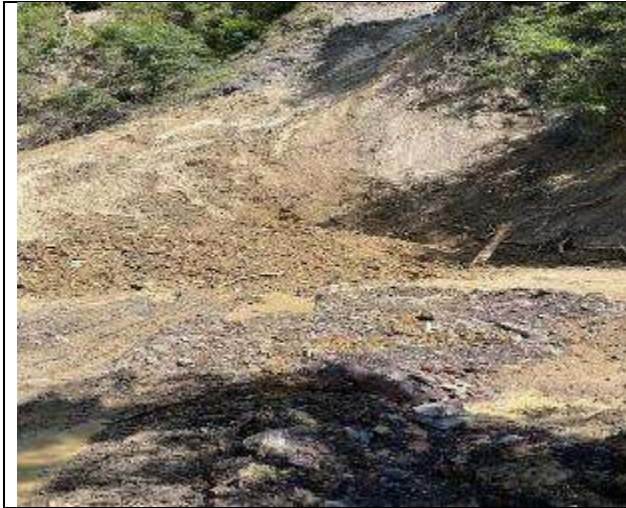
Watering in Setrubi August 2024 2024
