# Semi-annual Environmental Monitoring Report

Reporting period: July – December 2025

## **Georgia: North-South Corridors (Kvesheti – Kobi) Road Project**

Loan No GEO 3803

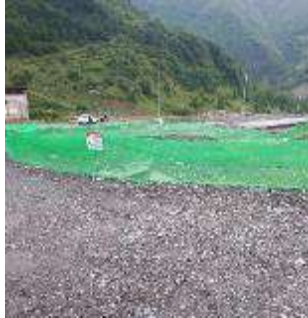
| 8 | Lot 2<br>E-117 | July 2025 | Installation of<br>fence and<br>signs to guide<br>road users | July<br>2025 | The contractor<br>to install the<br>fence and<br>signs. | July 2025 | <p>The contractor fenced the area and posted the signs</p> |

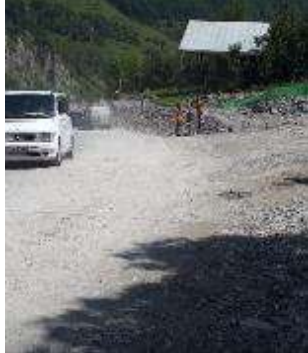
| 10 | Lot 2 Constructi on site | July 2025 | Posting of appropriate signs | July 2025 | The contractor to post appropriate signs at the site | July 2025 | <p>The contractor posted the environment signs at the s</p> |

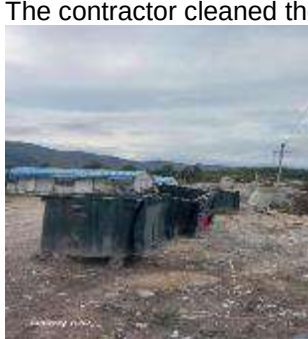
| 31 | Camp 2 Lot 2 | Sept 2025 | Cleaning of the camp 2 | Sept 2025 | The contractor to clean out the whole camp. | Sept 2025 | <p>The contractor cleaned the</p> |

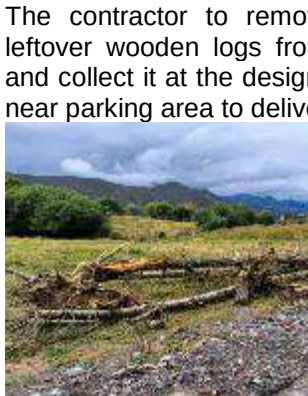
| 32 | Setrubi road | Sept 2025 | Wood waste left at the side | Sept 2025 | The contractor to remove all the wood logs from the site and collect at the designated site. | Sept 2025 | <p>The contractor to remove leftover wooden logs from and collect it at the designated near parking area to deliver</p> |

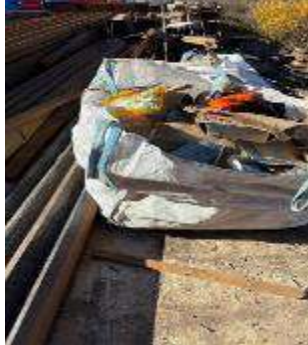
| 41 | Bridge 3 | Oct 2025 | Cleaning of the bridge 3 | Nov 2025 | Contractor to clean the surrounding area of the bridge 3. | Nov 2025 | <p>The contractor cleaned around the bridge construction area.</p> |

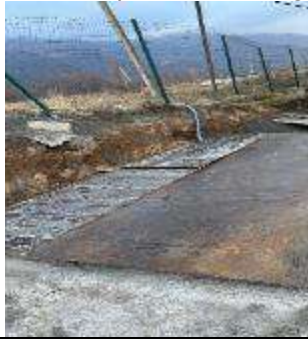
| 43 | Camp 2 Lot 2 | Nov 2025 | Wastewater management | Medium | The contractor to build additional septic tank to treat wastewater. | Nov. 2025 | <p>The contractor build the septic tank to treat the wastewater from camp2 and batching</p> |

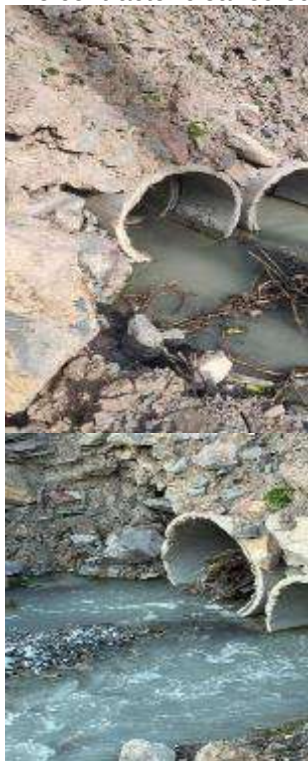
| 45 | Bridge 6 | Nov 2025 | Cleaning of the bridge 6 | Medium | Contractor to clean out the pipes for the temporary bridge. . | Nov 2025 | <p>The contractor cleaned out</p> |

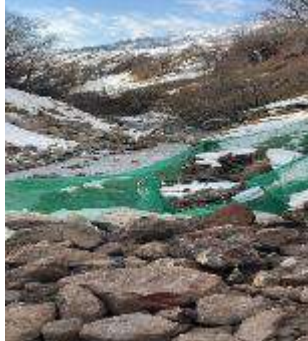
| 46 | CH 28 | Dec 2025 | Access restriction to the CH site | Medium | The contractor to restore the access to CH site | Dec 2025 | <p>The contractor fenced the site. However needs to restore the site for maintenance and repair accidental damage caused by diversion of the river so that it can cause damage to the</p> |

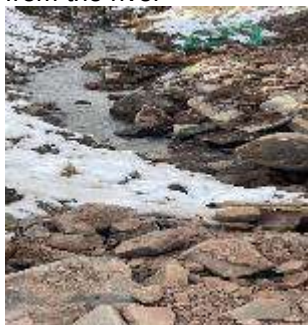
| 47 | Bridge 6<br>Khada River | Dec 2025 | Boulders in the river blocking the river flow | Medium | The contractor to take the boulders out and clean the river. | Dec 2025 | Required to take the boulders from the river<br> |

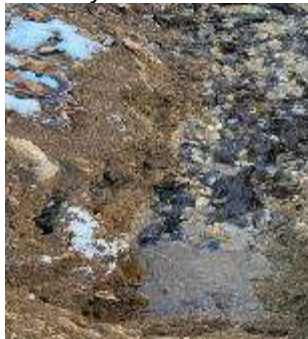
| 49 | Bedoni spoil disposal Area | Dec 2025 | Water pipe leakage | Medium | The contractor to repair the drinking water supply pipe. | immediately | Pipe repair should be completed instantly<br> |

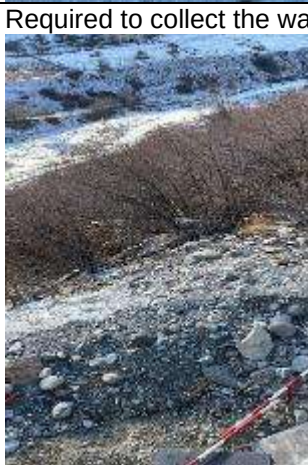
| 51 | Tunnel 1 exit, Bridge 2 | Dec 2025 | Waste on slope near bridge 2 | Low | The contractor to collect the waste from the slope | Dec 2025 | Required to collect the wa<br> |

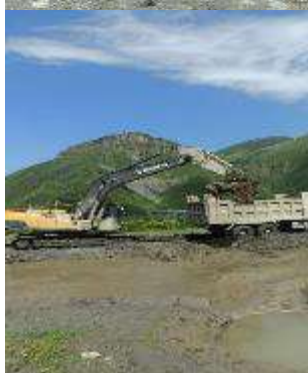
| 2 | Kobi Crushing plant | July 2025 | Cleaning of sedimentation Ponds in Crushing Plant | Low | Clean the sedimentation ponds for effective treatment of crushing plant | July 2025 | <p>The contractor cleaned crushing plant sedimentat</p> |

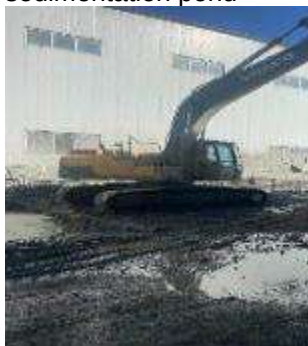
| 3 | Kobi Batching Plant | July 2025 | Cleaning of the sedimentation ponds | Low | Clean the sedimentation pits and ponds for the effective treatment of tunnel water. | July 2025 | The contractor cleaned the sedimentation pond<br> |

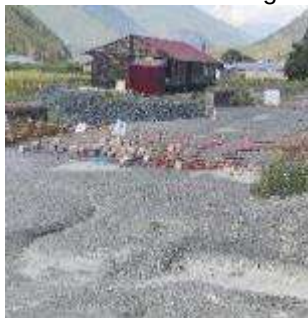
| 4 | Kobi Old Bridge | July 2025 | Broken fence at the old bridge Kobi. Restrict the movement of pedestrian and vehicles from the damaged bridge | Medium | Repair the fence of the bridge to avoid all kind of movements. | July 2025 | Contractor fenced the bridge and posted signs indicating no movement on the bridge<br> |

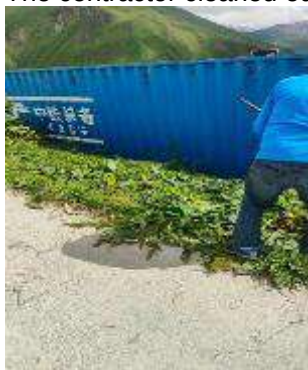
| 5 | Kobi Campsite | July 2025 | Housekeeping | Medium | The contractor to clean the camp | July 2025 | The contractor cleaned the camp<br> |

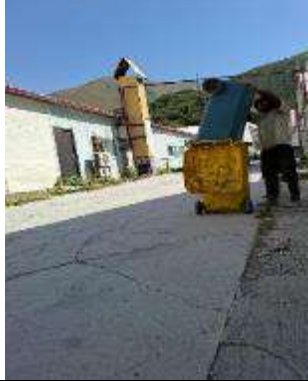
| 10 | Kobi Campsite | August 2025 | Housekeeping | Medium | The contractor to clean the camp | August 2025 | <p>The contractor cleaned out</p> |

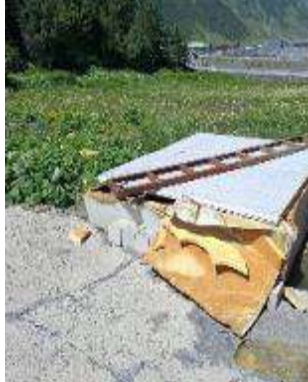
| 11 | Septic tank near Engineer office | August 2025 | Sewage system choked and needed to be repaired. | Low | The contractor to repair the sewage system from engineer camp | August 2025 | <p>The contractor repaired and</p> <p>the sewage system</p> |

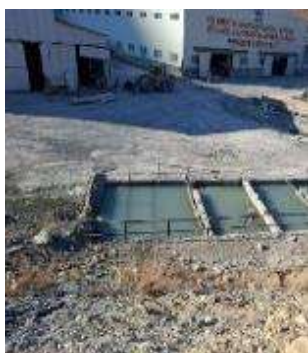
| 36 | Kobi Truck washing area and sediment ponds. | Nov 2025 | Maintenance of the truck washing area to avoid slush. | Low | The contractor to keep the truck washing area clean all the time and facility need to be maintained all the time. | Nov 2025 | <p>The contractor cleaned the area and maintained it.</p> |

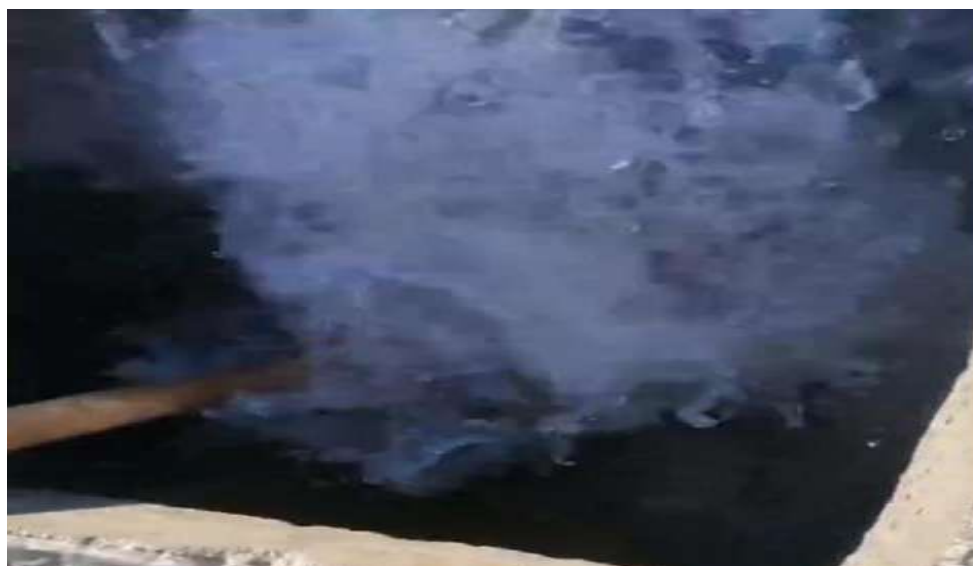
**Figure 10: A view of tunnel water in Tskere**

120. The presence of Total Coliforms observed in the Khadistskali River is due to discharge of Tskere community sewage water. However, Total Coliforms are below the maximum allowable concentration (MAC) in the surface water according to ordinance # 425 of Georgia.

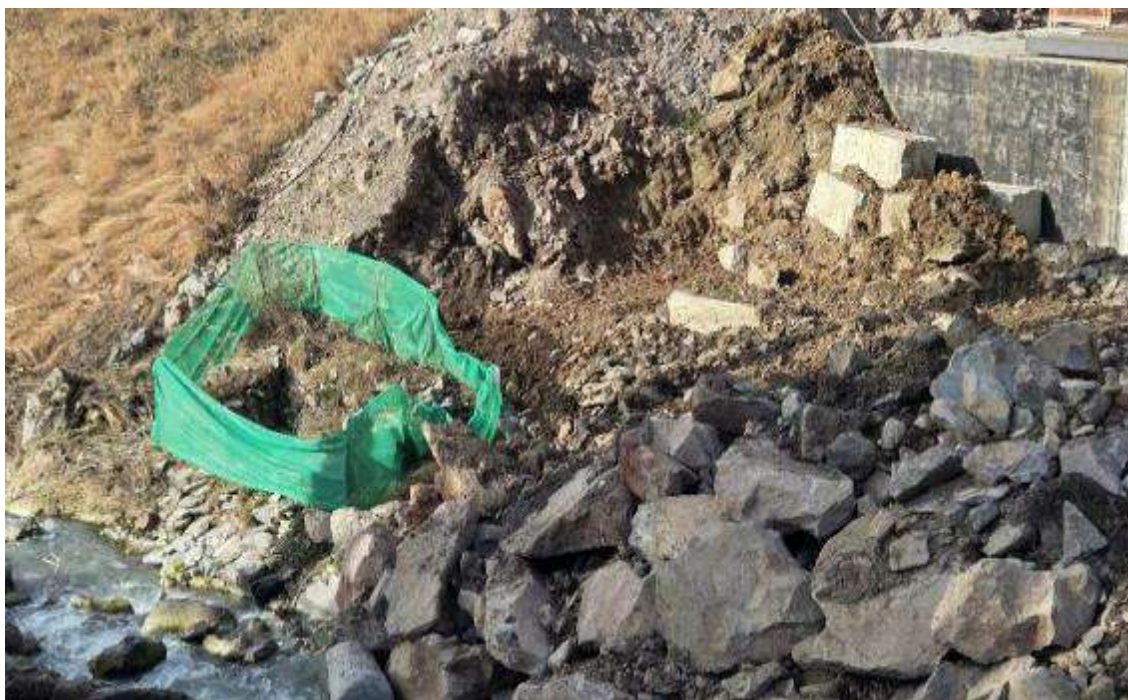
**Figure 23: Fencing of the CH 28 Near Bridge 6**

156. During the reporting period, it has been observed that Cultural Heritage Site #28 (Remains of a Water Mill), located near Bridge 6, was being negatively impacted by construction activities. Specifically, the diversion of the Khadistskhali River during these works has led to erosion and the partial washing away of the cultural heritage site. Additionally, the operation of heavy construction equipment in close proximity poses a further threat to the site's physical preservation. In accordance with cultural heritage protection regulations and project requirements, we request that the Contractor immediately implement necessary measures to prevent further damage.
