**BI-ANNUAL ENVIRONMENTAL MONITORING  
REPORT**

**Loan No. 02560 – GEO  
JANUARY – JUNE 2016**

**REPUBLIC of GEORGIA: ROAD CORRIDOR INVESTMENT  
PROGRAM – PROJECT 1, CONSTRUCTION SUPERVISION OF  
KOBULETI BYPASS ROAD**

DOHWA Engineering Co., Ltd.  
Korea

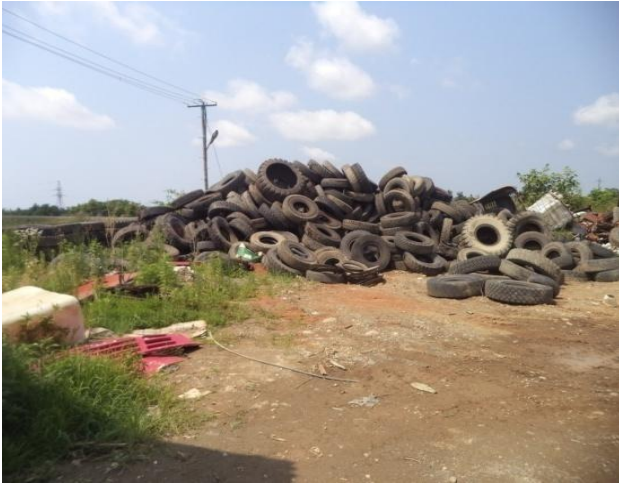
Photo 1: large number of used tires scattered

<b>Discrepancies of the Health and Safety Issue</b>	<b>Recommended Corrective measures</b>	<b>Deadline for the implementation</b>	<b>Progress</b>
There is a large number of used tires accumulated on the camp site.	Used tires and Scrap Metal should be delivered to the receiver point and the place, liberated from the waste should be restored.	July-September	
There is a scrap metal accumulated there.	Scrap Metal should be delivered to the receiver point for the utilization.	July-September	
Existing channels at the entrance of the Site, is full of used tires and construction waste made up of rubber and steel	Ditch should be cleaned from the waste and construction waste should be delivered for the utilization or on a dump site.	July-September

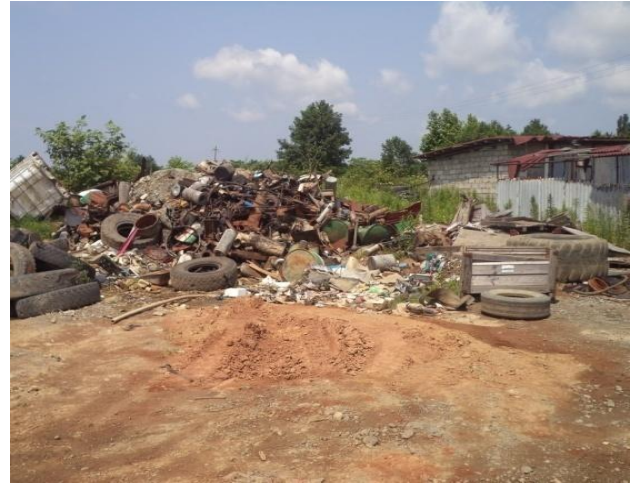
Photo 2: Scrap material accumulated at the site

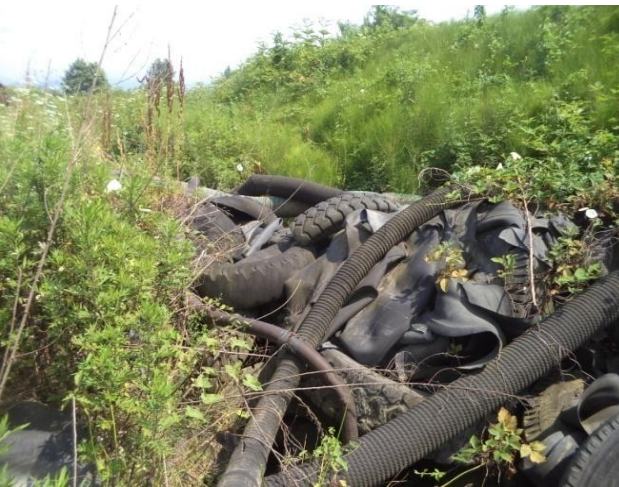
Photo 3: Channels blocked by used tires and construction  
waste

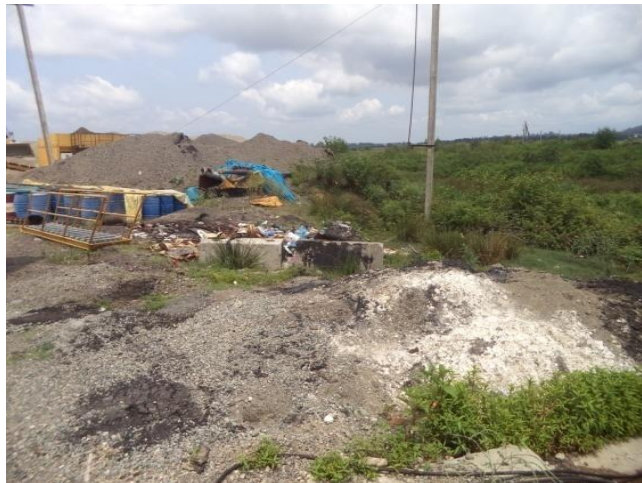
Photo 4: Construction and household waste

<b>Discrepancies of the Health and Safety Issue</b>	<b>Recommended Corrective measures</b>	<b>Deadline for the implementation</b>	<b>Progress</b>
There is a construction material and household waste accumulated on site .	Useless construction material should be delivered to the dump site.	July-September	
On the border of the Site, at the adjacent territory of Asphalt-Concrete batching plant, there is a pit, which is contaminated with the water, containing oil.	Contaminated water should be discharged from the pit and should be poured into the capped metal barrel for the reuse and the pit should be backfilled with the sand-gravel.	July

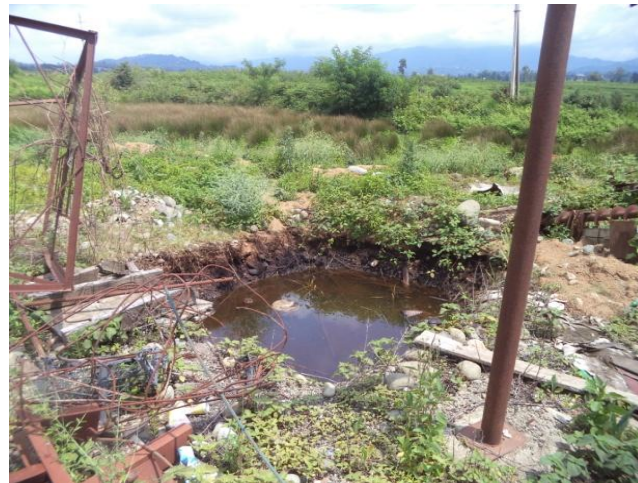
Photo 5: Water pond contaminated with oil

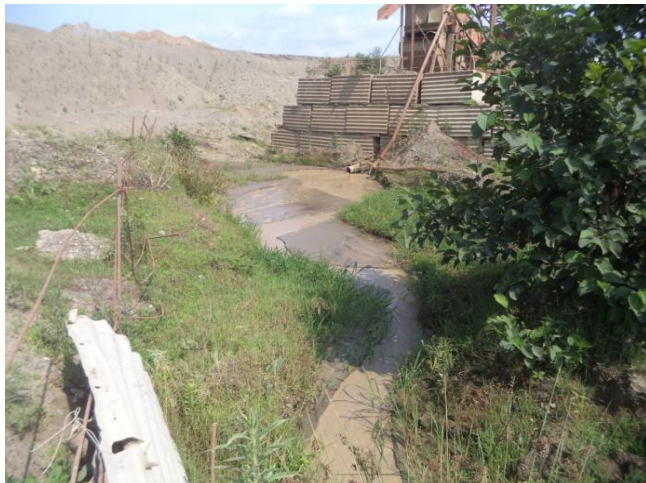
Photo 6: Basin of crushing plant full of silt

Discrepancies of the Health and Safety Issue	Recommended Corrective measures	Deadline for the implementation	Progress
Basin of the Crushing Plant is full of silt and cannot perform its function . Also the water inside the channel is contaminated due to this fact and the water passes in Riv. Natanebi.	Basin should be cleaned from the silt and deepened. Silt should be disposed to the Dump Site.	July-August

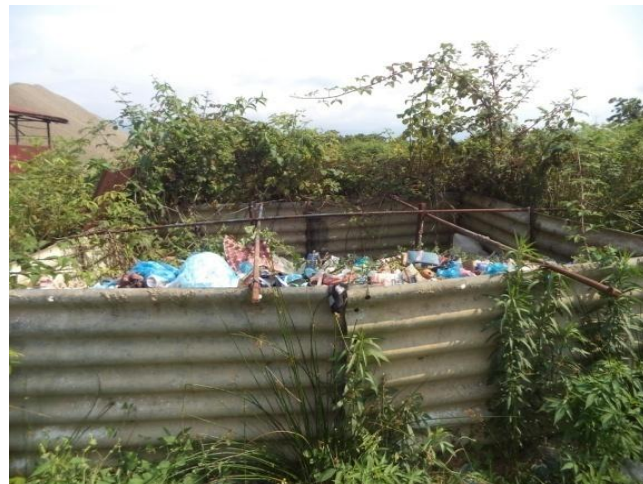
Photo 7: Accumulated household waste

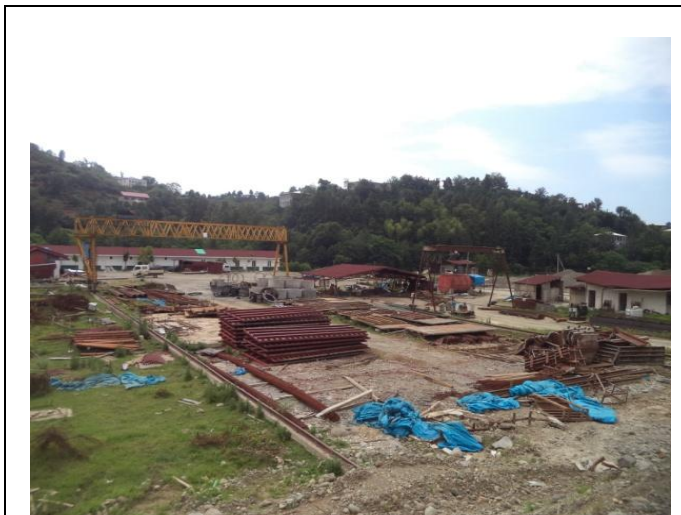
Photo 8: Scrap material scattered at the campsite

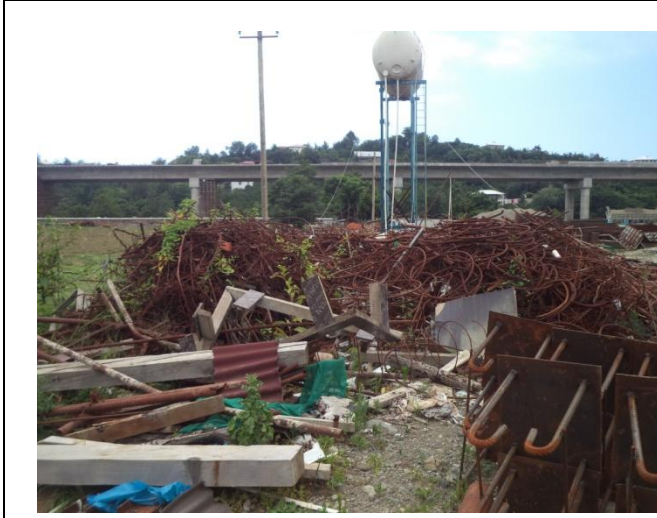
Photo 9: Scrap material accumulated on site

Discrepancies of the Health and Safety Issue	Recommended Corrective measures	Deadline for the implementation	Progress
There is a scrap metal accumulated on site	Scrap metal should be collected and disposed for the reuse	July-September	
Basin of the Crushing Plant is full of silt and cannot perform its function in normal mode	Sedimentation Basin of the Concrete Plant, should be cleaned from the silt and deepened. Silt should be disposed to the Dump Site.	July-September

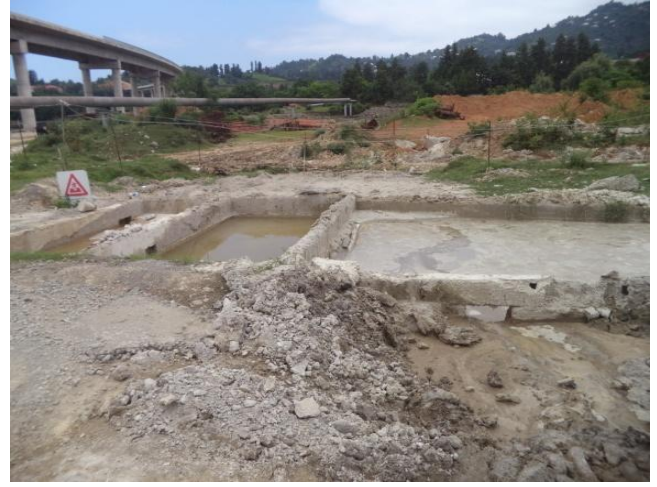
Photo 10: Basin of crushing plant is full of silt

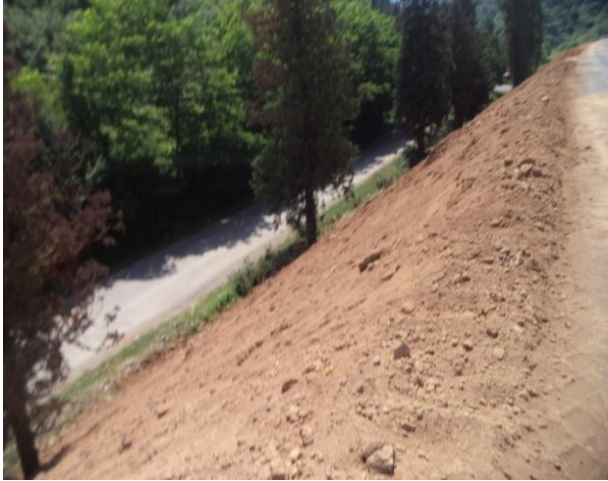
Photo 11: Slopes to be covered with top soil

Discrepancies of the Health and Safety Issue	Recommended Corrective measures	Deadline for the implementation	Progress
Some places on the slopes, where, we have identified the facts of initial ravine formation, are not covered with the top soil and backfilled with the sand-gravel.	Those places on the slopes, where, we have identified the facts of initial ravine formation, should be covered with the top soil and backfilled with the sand-gravel.	As soon as possible. July-August	
There is no grass seeding bush planting facts on the slopes, strengthened with the Gabion Walls. The activity is considered by the Technical Specifications.	It is necessary to seed the grass and plant the bushes on the slopes.	September-October	
On the adjacent territory of Bridge No.8 there are 5 cut trees. Logs of the trees cut during the construction activities are not disposed into the Dump Site as well.	Cut trees should be disposed into the Bobokvati Camp Site temporarily. As for the logs of the trees, scattered along the Design road, should be transported into the Dump Site.	July

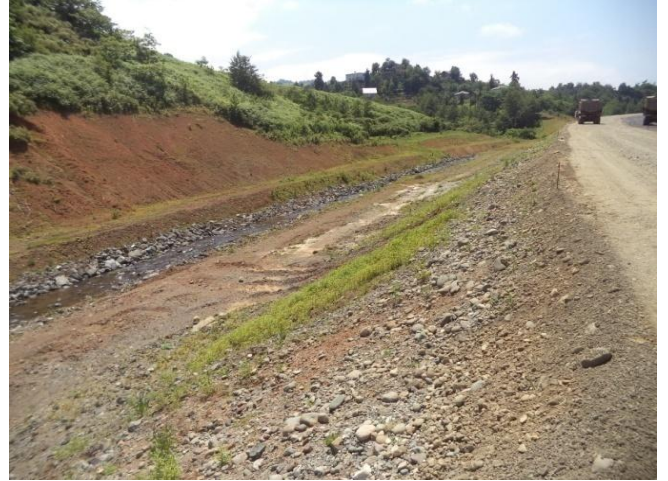
Photo 12: Slopes to be covered with top soil

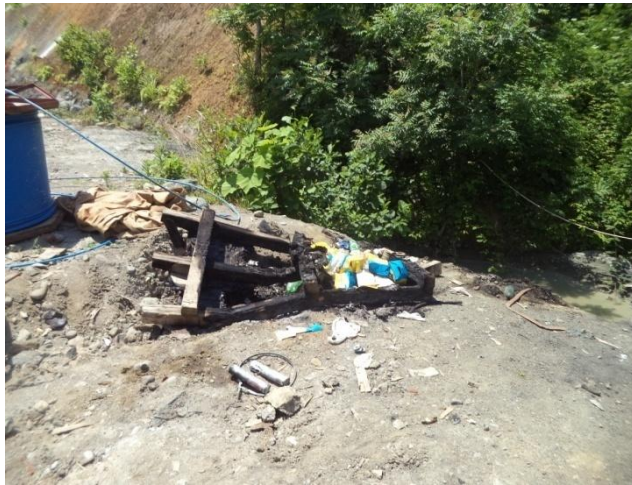
Photo 15: Fact of burning household waste in the open

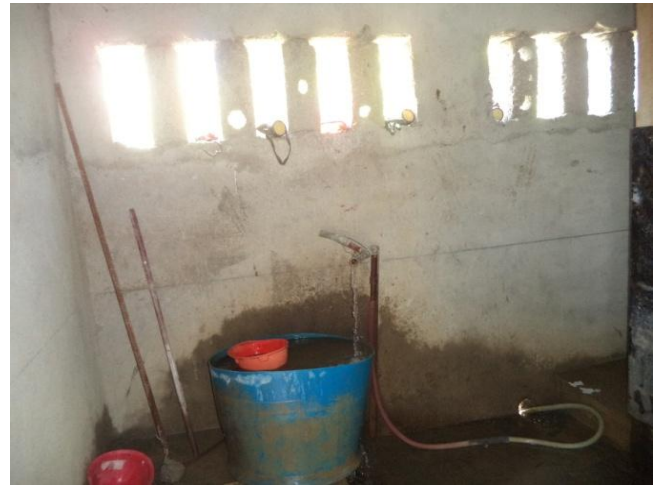
Photo 16: Taps are broken in rest rooms

<b>Discrepancies of the Health and Safety Issue</b>	<b>Recommended Corrective measures</b>	<b>Deadline for the implementation</b>	<b>Progress</b>
Water source in the rest room, is out of the order.	Water supply system should be restored in the rest room	July
