BI-ANNUAL ENVIRONMENTAL MONITORING REPORT

Loan No. 02560 – GEO
JANUARY – JUNE 2017

REPUBLIC of GEORGIA: ROAD CORRIDOR INVESTMENT
PROGRAM – PROJECT 1, CONSTRUCTION SUPERVISION OF
KOBULETI BYPASS ROAD

Prepared by: DOHWA Engineering Co., Ltd. Korea
For: Roads Department of the Ministry of Regional Development and
Infrastructure of Georgia
Endorsed by: Mr. Zaza Simonia (Deputy Chairman)

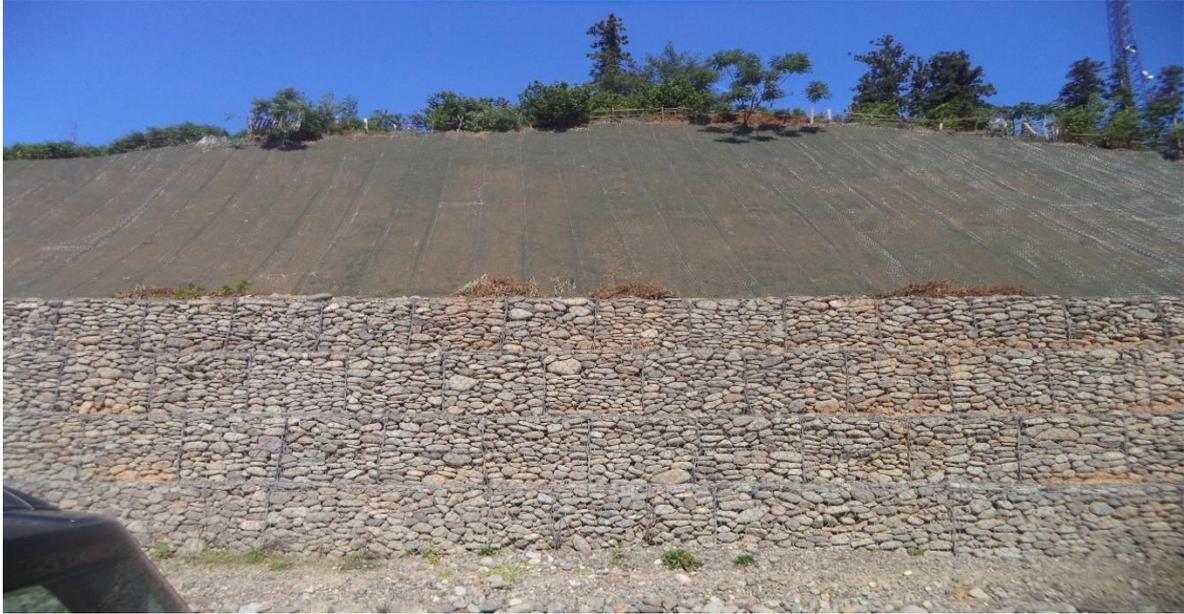
Photo 1: Strengthening of cut slope by means of gabion walls and Geo Mat

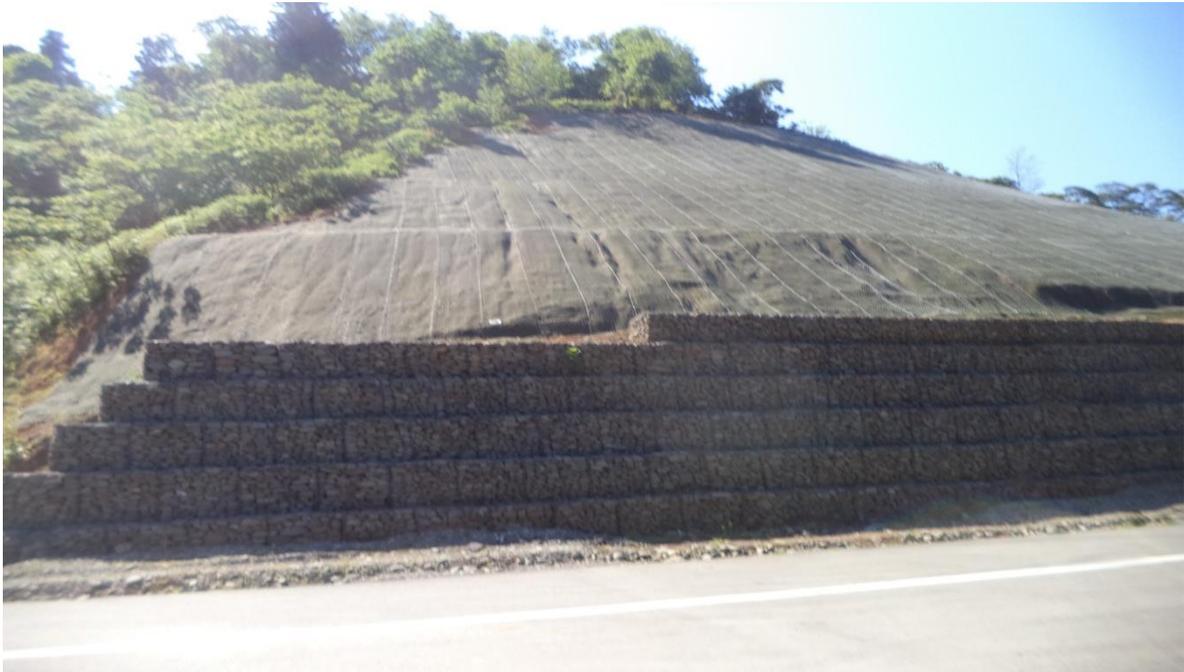
Photo 2: Strengthening of cut slope by means of gabion walls and Geo Mat

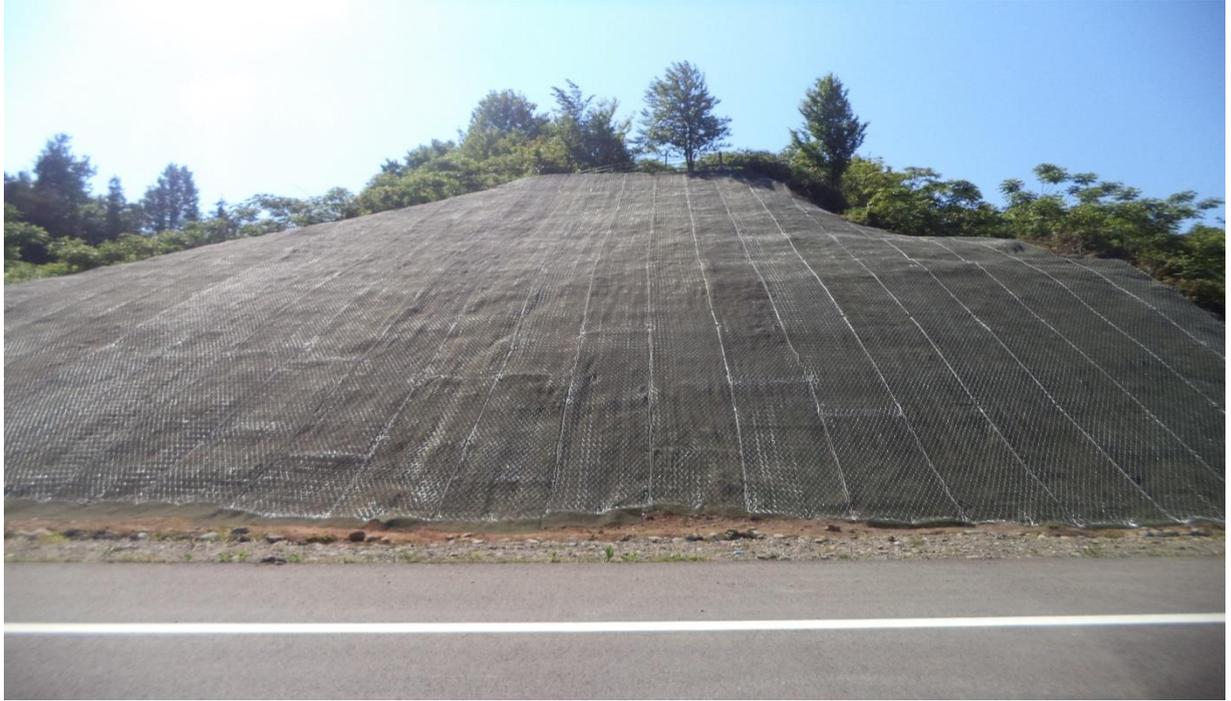
Photo 3: Strengthening of cut slope by means of gabion walls and Geo Mat

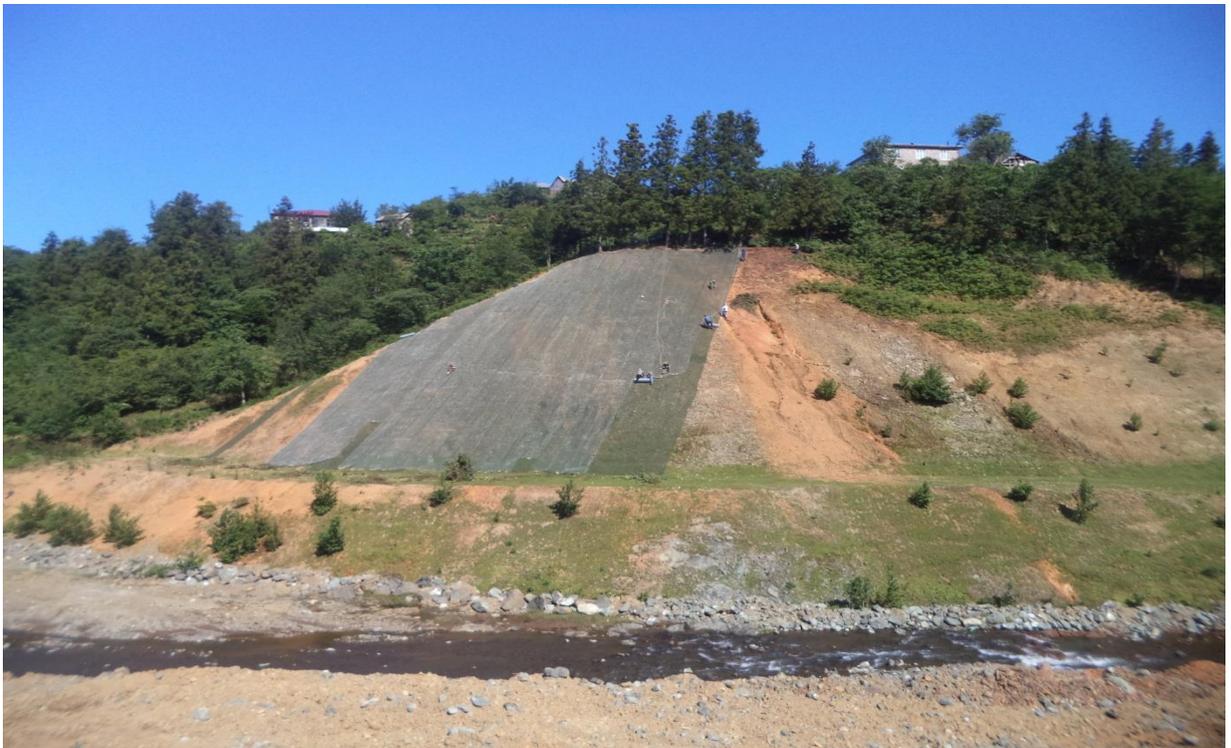
Photo 4: Strengthening of cut slope by means of gabion walls and Geo Mat

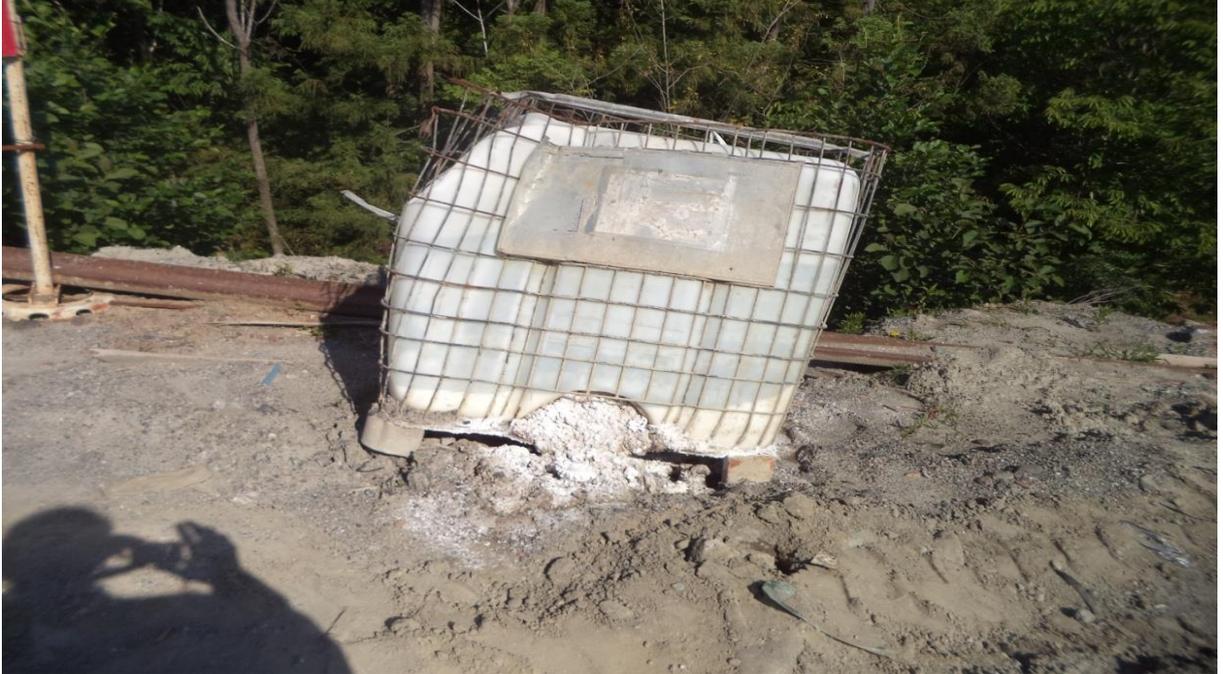
Photo 5: Abandoned container near portal #1 of Tunnel #1

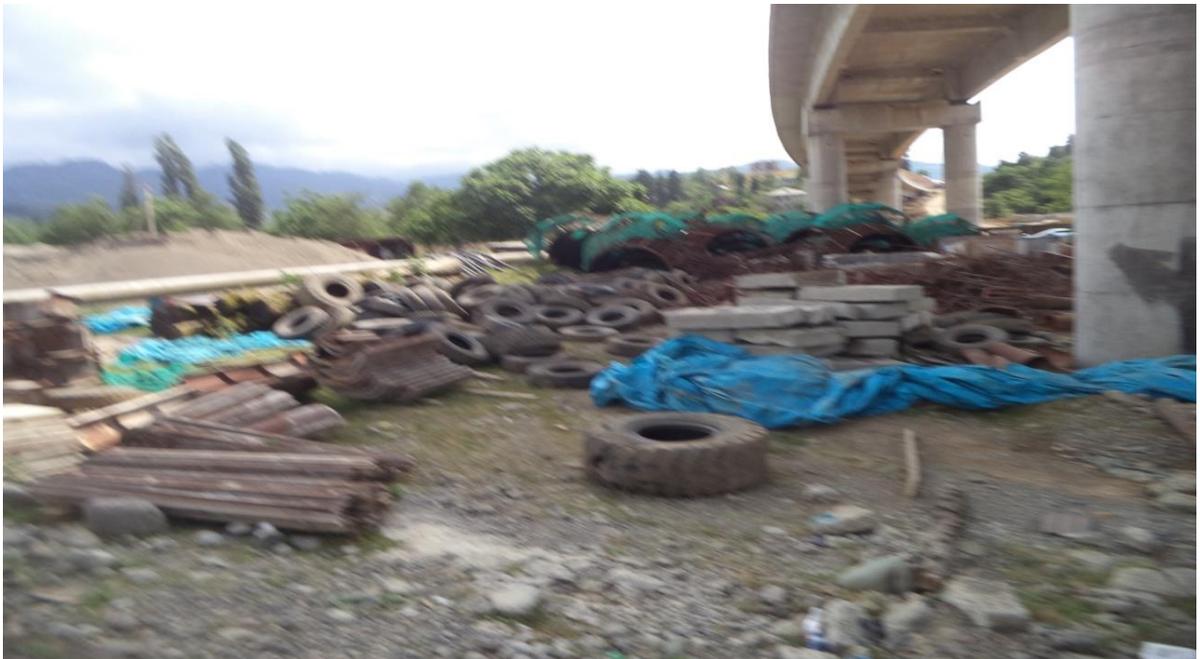
| Non-Compliances/Findings | Deadline for submission/Implementation | Implementation Status |
|---|--|--|
| 1. The Contractor failed to remove used tires and construction waste accumulated in Choloki and Chakvi camp sites. Municipal waste management at Choloki, Chakvi and Bobkvati camp sites has to be improved as well. Improper municipal waste management was observed at Choloki and Chakvi campsites. In order to improve situation in waste management at camp sites the Mission instructed SC Environmental Specialist to immediately issue Non-Compliance Notice with incorporated corrective action plan and deadlines for corrective activities for CC. In addition, it was decided to conduct on-job | Till the end of June 2017. | Disposition of waste from Choloki and Chakvi campsites are partially executed. According to the Contractor complete resolution of the issue will be done until the end of 2017 due to decommissioning processes of campsites. Household waste will be disposed from Choloki campsite in July due to decommissioning of the campsite. Household waste is disposed from the Chakvi campsite on a regular basis. Contractor was instructed verbally |

Photo 6: Used tires accumulated at the Chakvi campsite

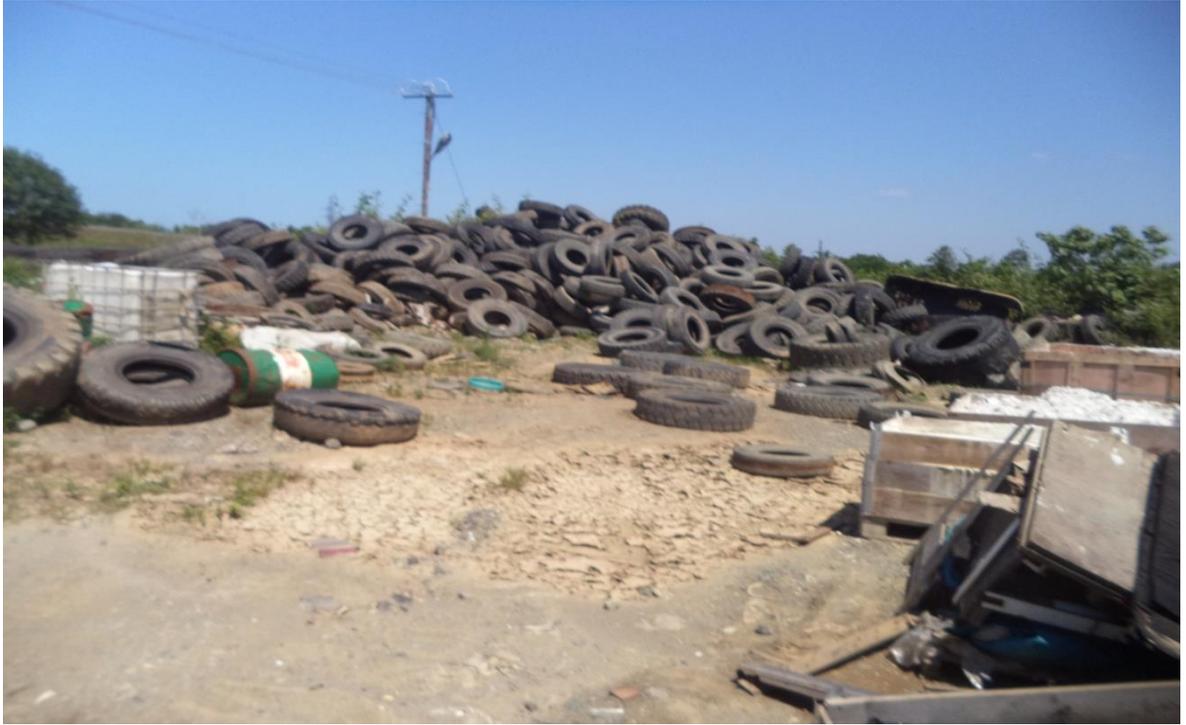
Photo 7: Used tires accumulated at the Chakvi campsite

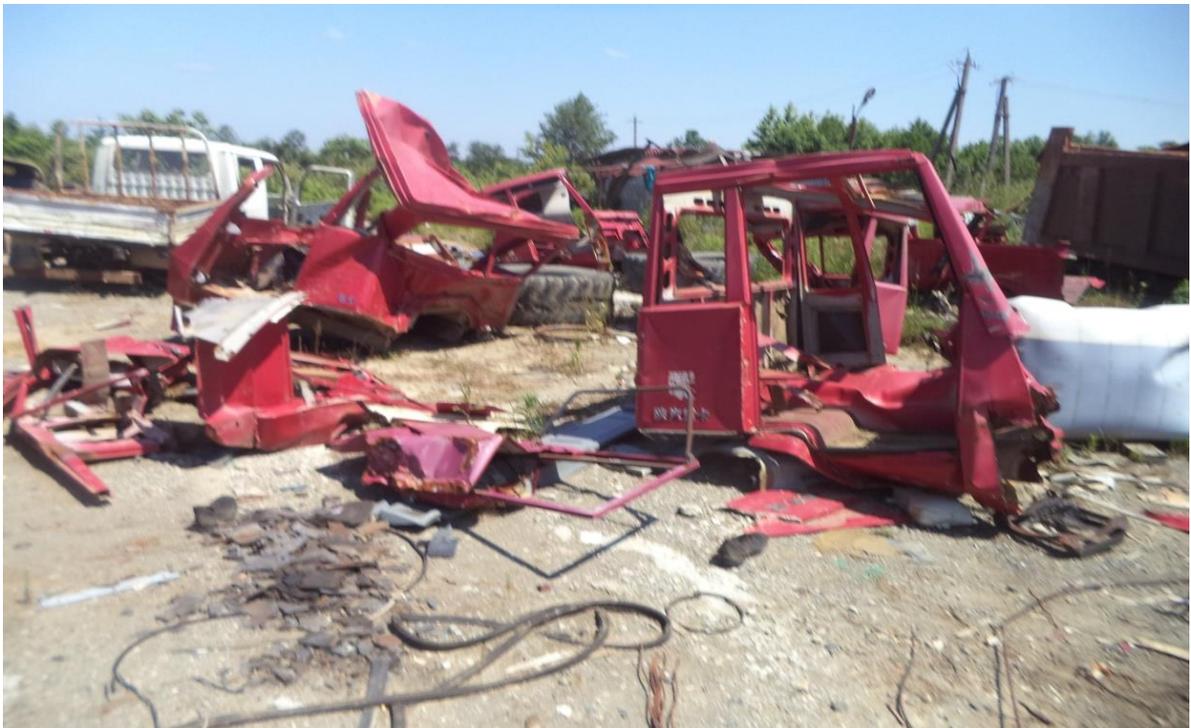
Photo 8: Scattered scrap at Choloki campsite

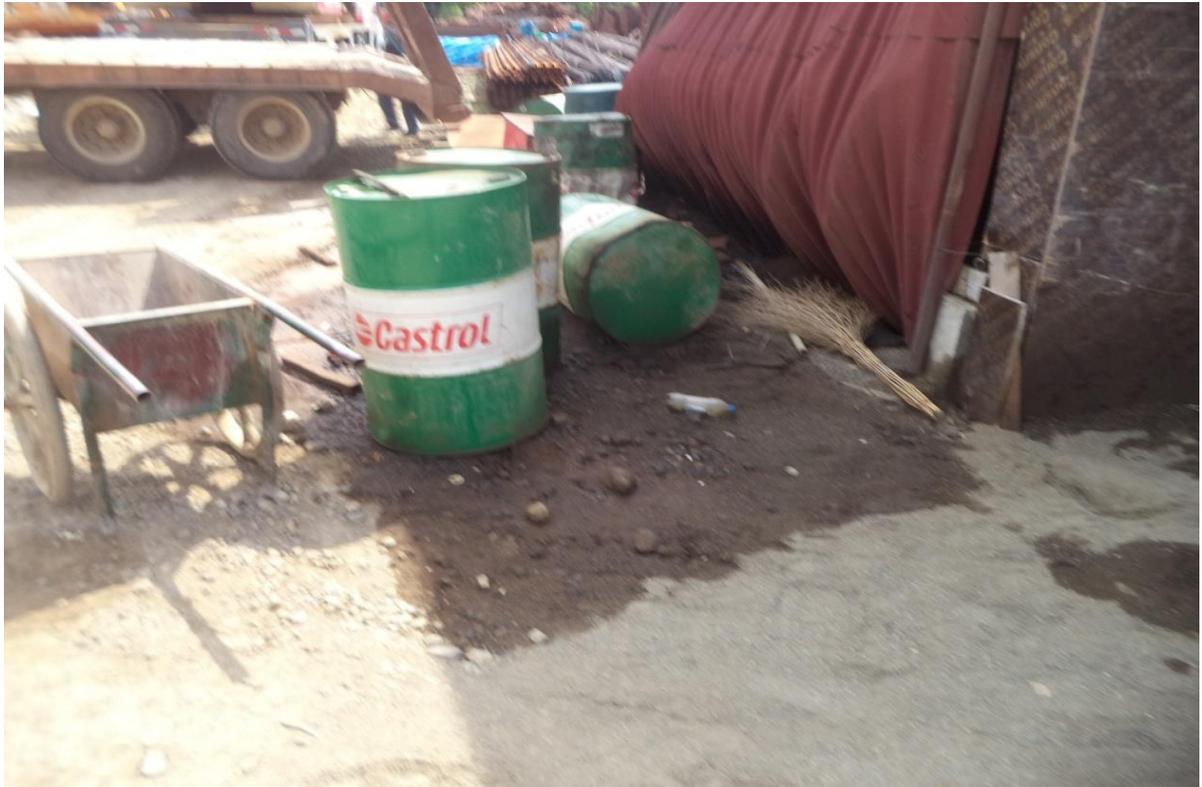
Photo 9: Contaminated soil with oil at Chakvi campsite

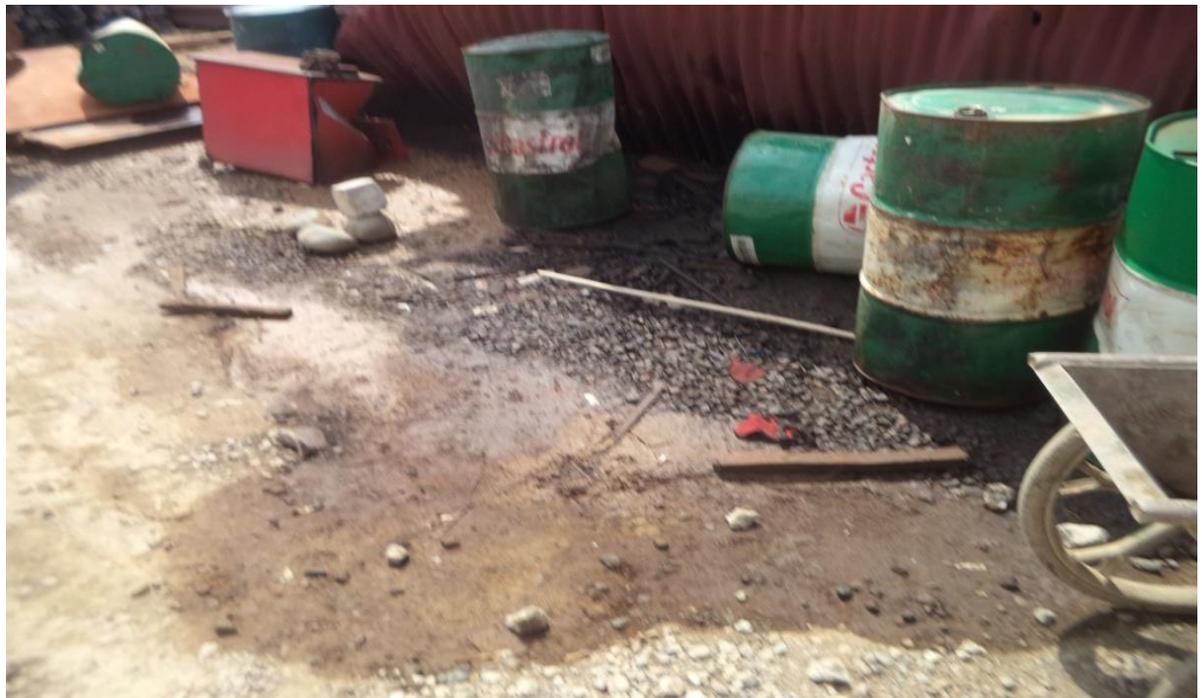
Photo 10: Contaminated soil with oil at Chakvi campsite

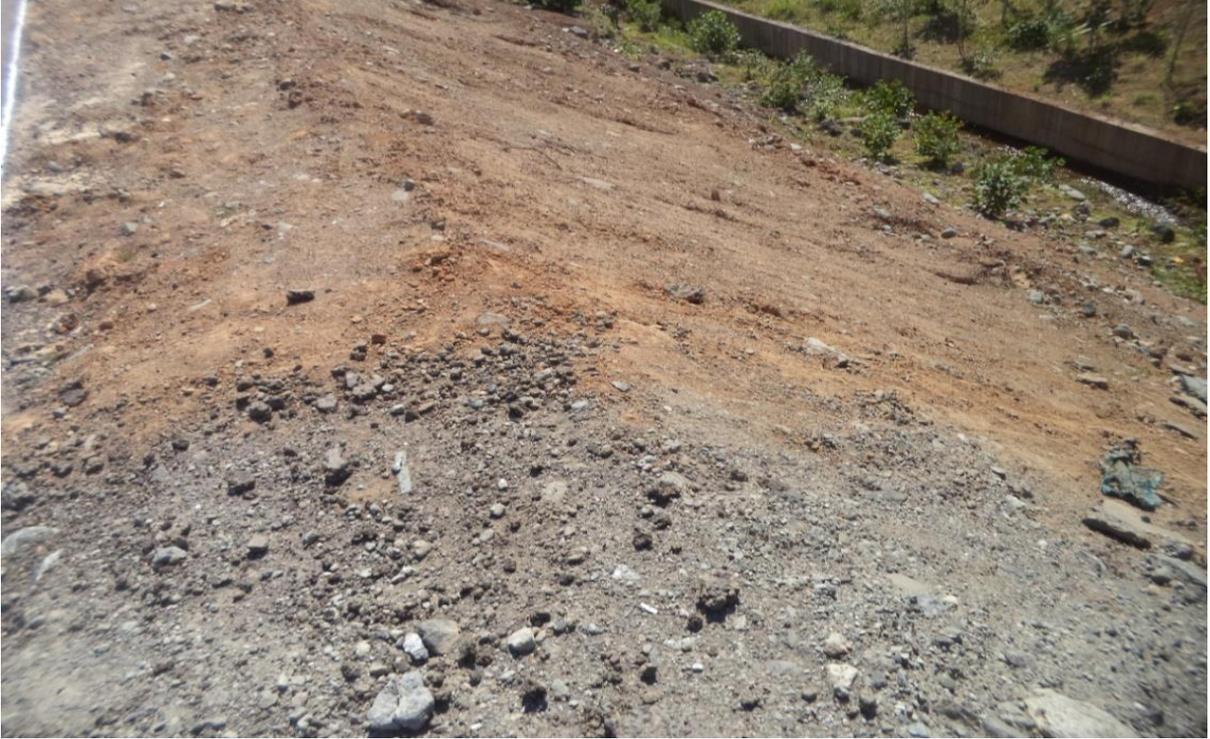
Photo 11: Embankment slopes without top soil

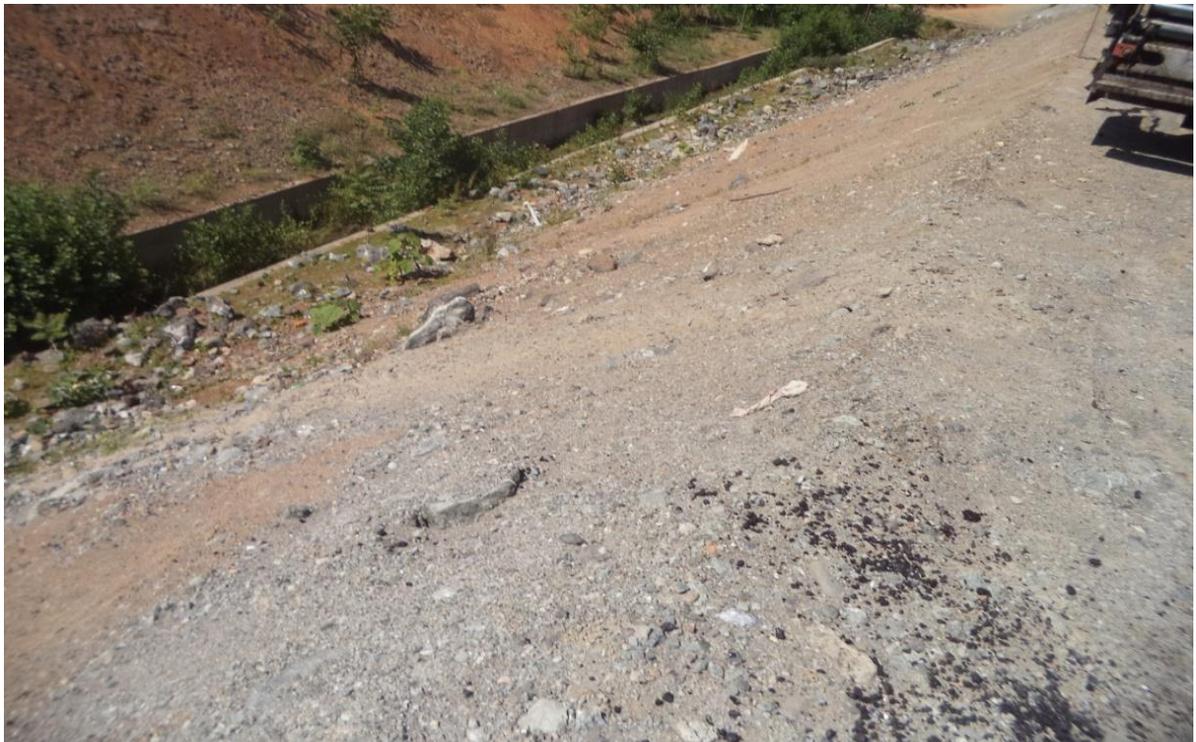
Photo 12: Embankment slopes without top soil
