# Semi-annual Environmental Monitoring Report

Reporting period: January – June 2024

## **Georgia: North-South Corridors (Kvesheti – Kobi) Road Project**

Loan No GEO 3803

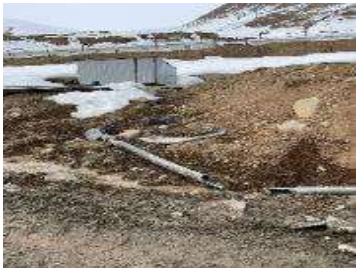
| 7 | Lot-1<br>Tskere | Feb 2024 | Broken effluent pipe of the<br>STP in Tskere<br> | Med | CC to repair the pipe | March 2024 | CC repaired the pipe<br> | Closed<br>March 2024 |

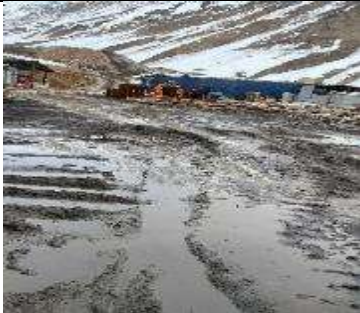
| 9 | Lot-1 Tskere | Feb 2024 | Scrap placed on the topsoil in Tskere | Med | Material should be placed in the designated area | March 15, 2024 | CC placed the material in the designated area near batching plant. | Closed March 2024 |

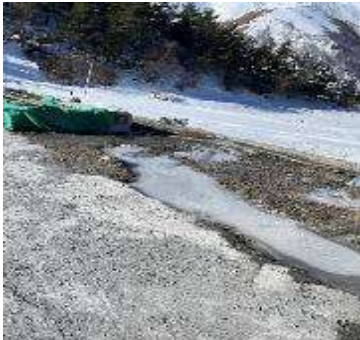
| 10 | Lot-1 Kobi | Feb 2024 | Septic tank leaking in front of engineer office causing nuisance<br> | Med | CC to repair the septic and install the new line up to main septic tank to avoid overflowing | March 2024 | CC installed the pipe and repaired septic tank<br> | Closed |

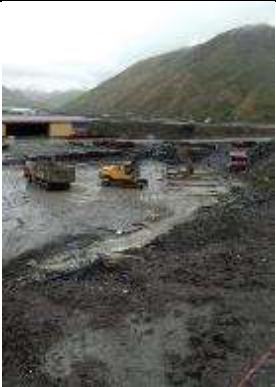
| 23 | Lot-1<br>Kobi<br>Behind<br>Segment<br>plant | June<br>2024 | Used oil drums, containers,<br>and tyres behind segment<br>plant in Kobi | Medium | Remove the used drums,<br>containers, arrange the<br>tires in a proper way. | ASAP | <p>Cc handed over the<br/>used drums, containers<br/>to third party, arranged<br/>the tiers in proper<br/>manner by covering<br/>with the ventilation tube</p> | Closed<br>June 2024 |

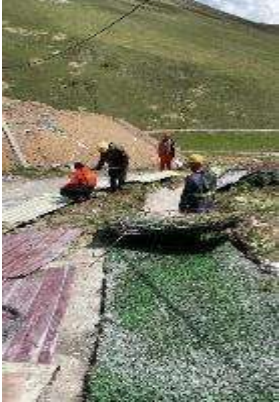
| 24 | Lot-1 Tskere | June 2024 | Repairing of the water channel carrying the tunnel water | Medium | CC to repair the water channel along access road to avoid flooding | June 2024 | CC repaired the water channel.<br> | Closed June 2024 |

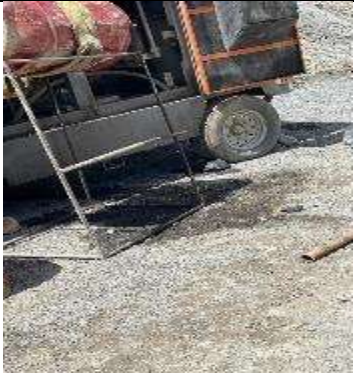
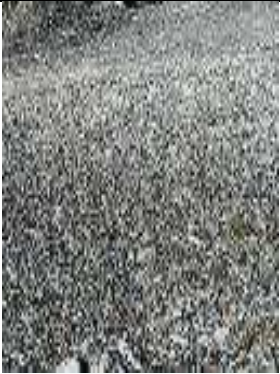
| 27 | Lot-1 Car wash Area | June 2024 | Car wash area to be developed to avoid car washing in TBM Tunnel | Low | CC to arrange the car wash area in designated site near sedimentation ponds in Kobi | June 2024 | CC developed the car washing area near sedimentation pond in Kobi and started vehicle washing overthere. | Closed June 2024 |

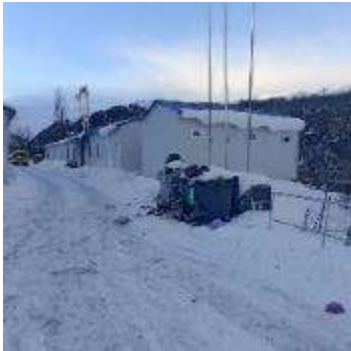
| 34 | Lot-2 campsites 1 | Jan 2024 | <p>Poor housekeeping and waste collection</p> | High | CC to collect the waste by calling municipality truck | ASAP | <p>CC cleared the snow from the access road so that the truck can reach to the waste containers.</p> | Closed Jan 2024 |

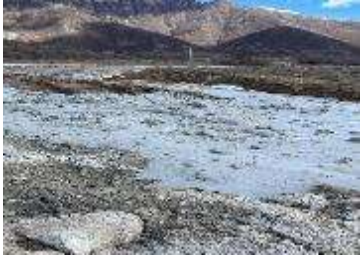
| 44 | Lot-2 BP 2 | Mar 2024 | Land contamination near BP 2<br> | Med | Clean out the washout pit and surrounding area | Mar 2024 | CC cleaned out the area<br> | Closed<br>March 2024 |

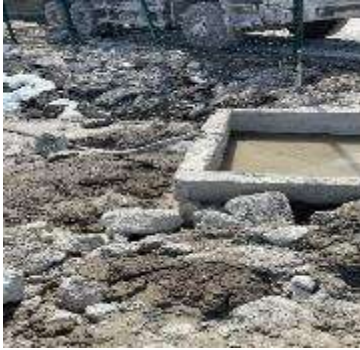
| 50 | Lot-2 BP 2 | Mar 2024 | BP 2 Storm water pipe maintenance<br> | Med | Contractor will repair storm water management pipe and make sure no water will be going to private land.<br><br>Kitchen water should go to the STP and not allowed flowing towards batching plant as according to permit kitchen water should be flowing only through STP | March 2024 | Action required | Pending |

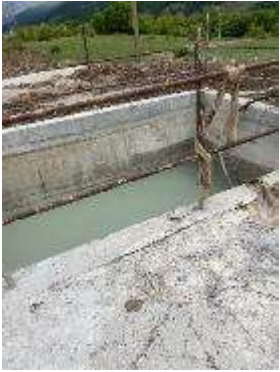
| 53 | Lot-2 BP 2 | April 2024 | Concrete washout pit cleaning required | Med | Clean out the washout pit and maintain it | April 2024 | Contractor cleaned out the washout pit<br> | Closed April 2024 |

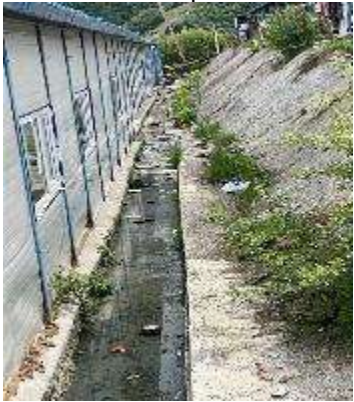
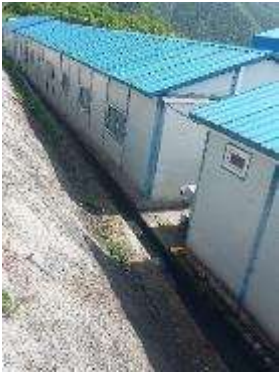
| 60 | Lot-2<br>Camp 2 | May 2024 | Waste thrown in the drainage<br>line behind camp<br> | Low | Clean the drainage line<br>by collecting the waste | May 2024 | Cc cleaned out the area<br> | Closed<br>June 2024 |

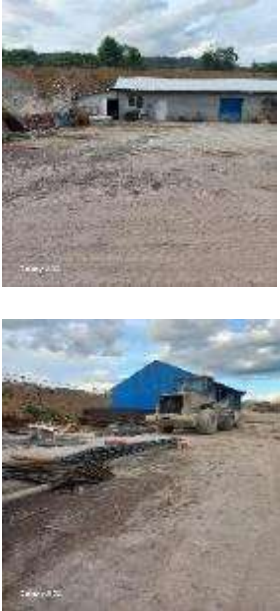
| 62 | Lot-2<br>Tunnel exit 1 | June 2024 | Poor housekeeping in front of tunnel exit 1 | Low | Clean the area Infront of Tunnel exit 1. | May 2024 | Cc cleaned out the area<br> | Closed<br>June 2024 |

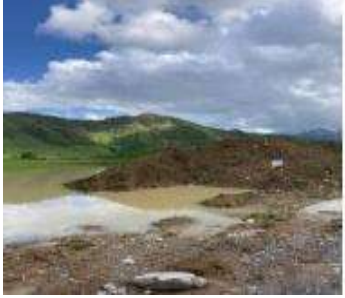
| 69 | Lot-2<br>Khada<br>Vally | June<br>2024 | Improper storage of the<br>topsoil in the RoW<br> | Low | CC for lot-2 to clean the<br>area | June 2024 | CC for Lot-2 improved<br>the storage of topsoil<br>and drainage of the<br>area. | Closed |
