# Semi-Annual Environmental Monitoring Report

Semestral Report (January – June 2024)

## Georgia: East-West Highway (Shorapani – Argveta Section) Improvement Project

Prepared by the Roads Department of the Ministry of Regional Development and Infrastructure of Georgia for the Asian Development Bank.

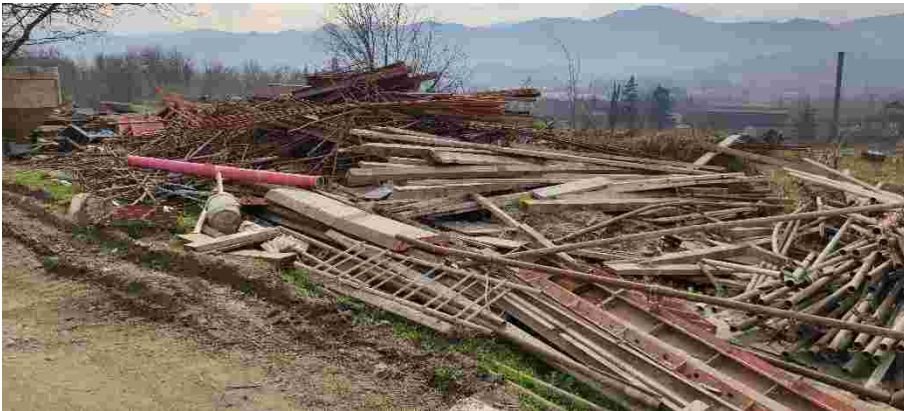
| Poor Waste Management (Worker’s Camp No 2, February 2024) | Poor Management of Discharge Water (Batching Plant No: 1 February 2024) |

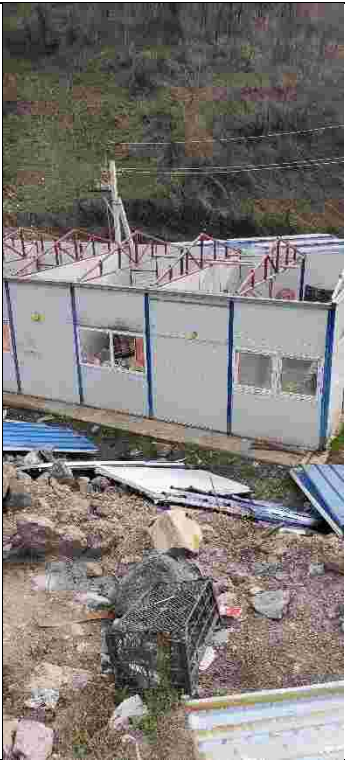
| <p>Leaking Sewage Tank (Worker's Camp No 6, February 2024)</p> | <p>Poor Housekeeping (Worker's Camp No 6, February 2024)</p> |

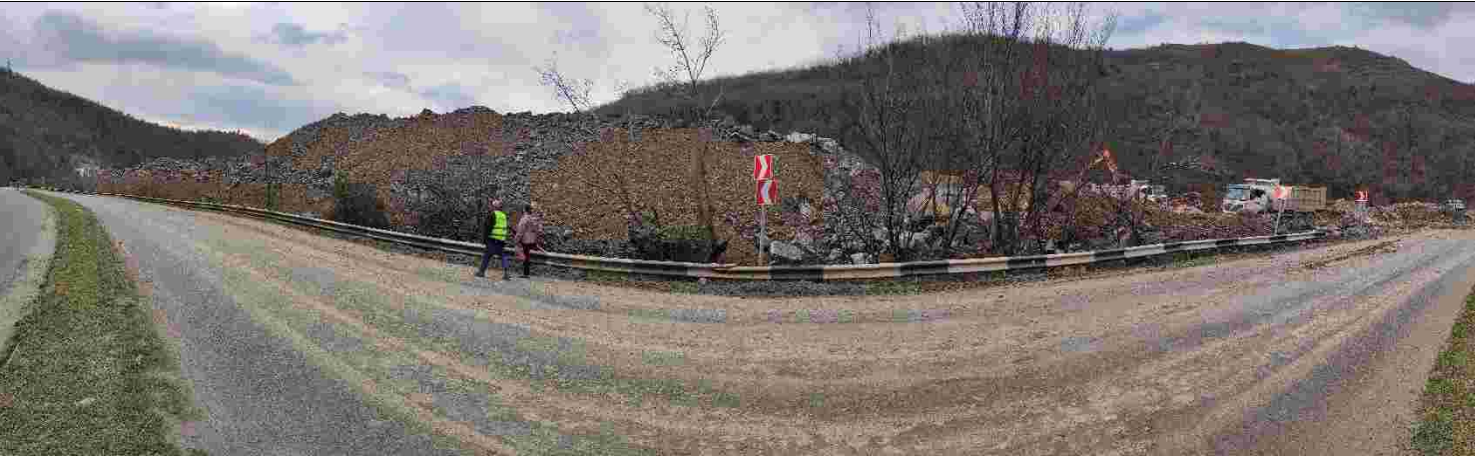
| Panoramic View of Spoil Disposal Area No:1 (Height Issue, February 2024) | |

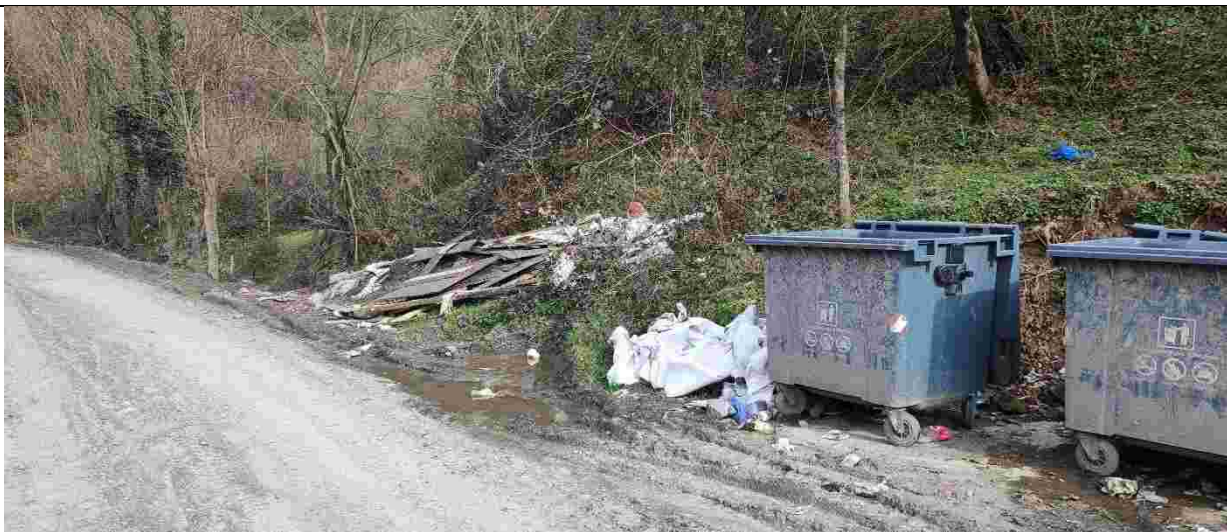
Poor Waste Management (Tunnel 4&5 Portal, February 2024)

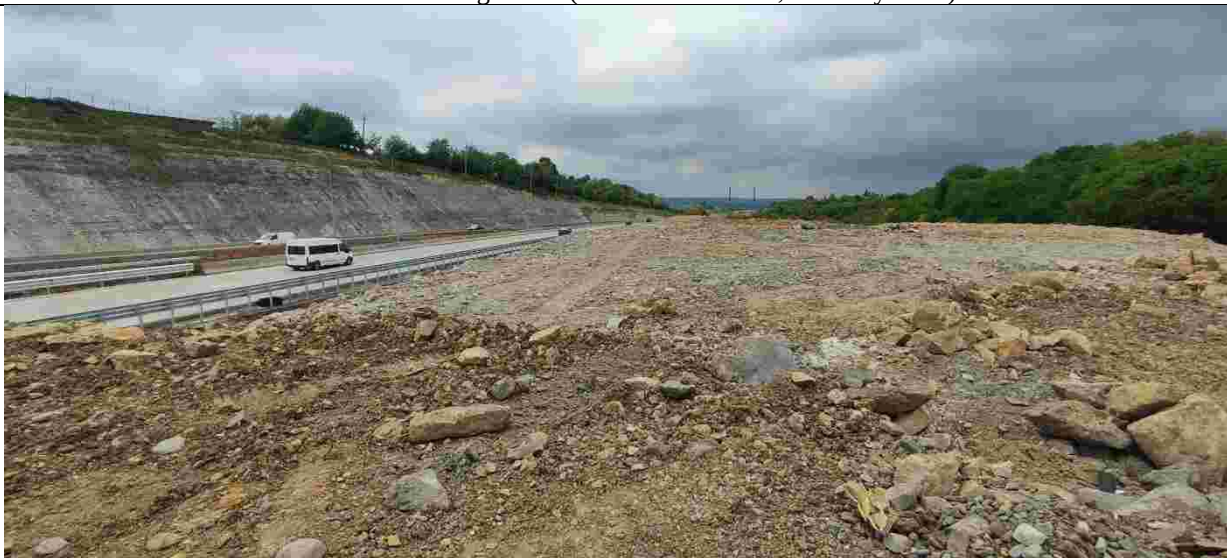
Temporary Spoil Storage (Near Tunnel Portal 5 - Argveta Site, May 2024)

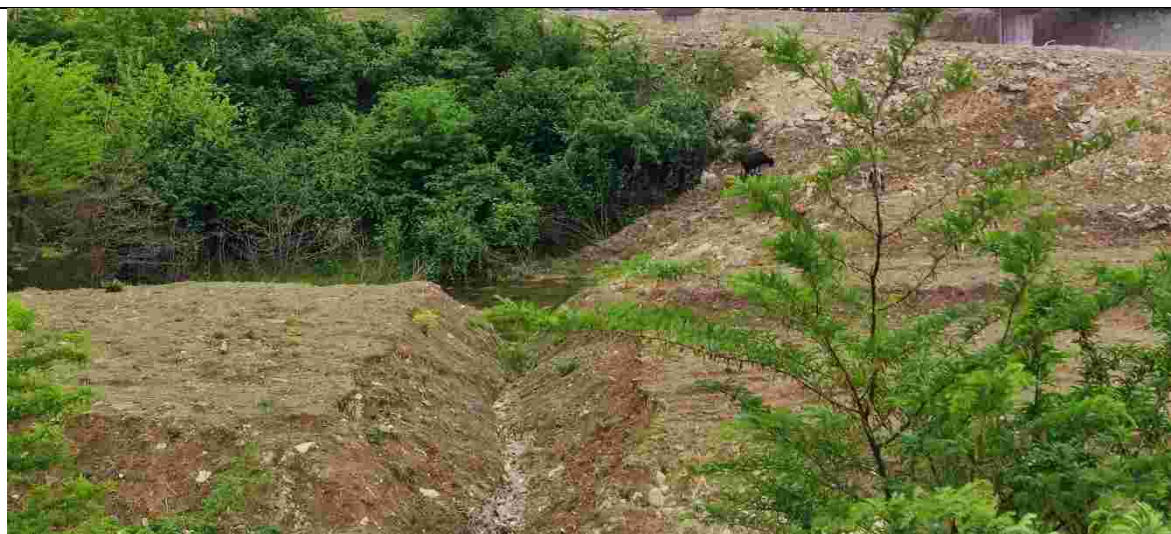
Drainage Issue for Spoil Disposal Site No: 3 (Panoramic View, May 2024)

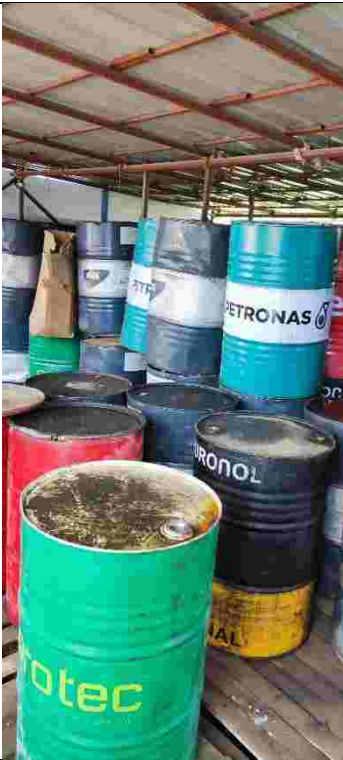
| <p>Hazardous Waste Storage Area (May 2024)</p> | <p>Riverbed and Embankment Reinstatement Issue (Bridge No: 1, May 2024)</p> |

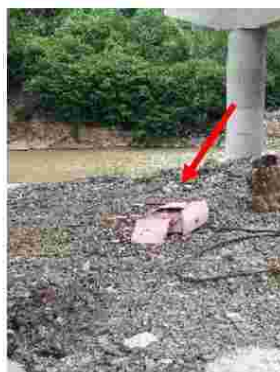
Workshop (Bridge N1)

Damaged, not properly locked, with limited access, not labeled and thrown on the ground electric distribution boxes, electric supplied devices and extension cables have been observed.

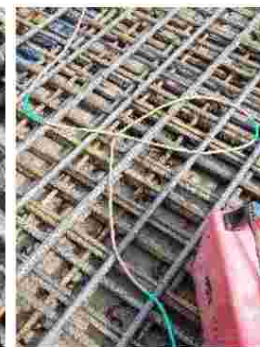
**Bridge N1 TA –** *Damaged in many places the extension cable has been observed during site inspection. After verbal warning given to the Contractor, all damaged places have been repaired.*

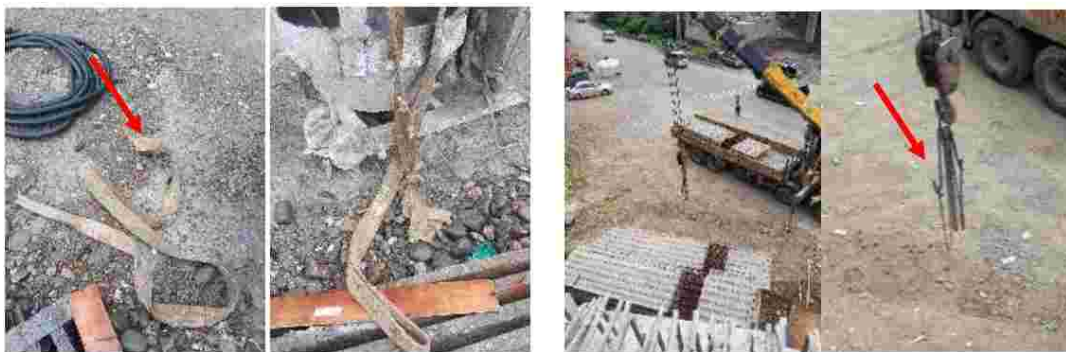
**Picture 3: Positive and Negative observation – Lifting safety (All tunnel and bridges)** – Good and bad (Including handmade) quality lifting equipment has been observed during site inspection. The Engineer has asked the Contractor's site responsible persons to take care of this issue and pay additional attention at to avoid the possible incidents and injury of working personnel. Issue isn't solved yet.

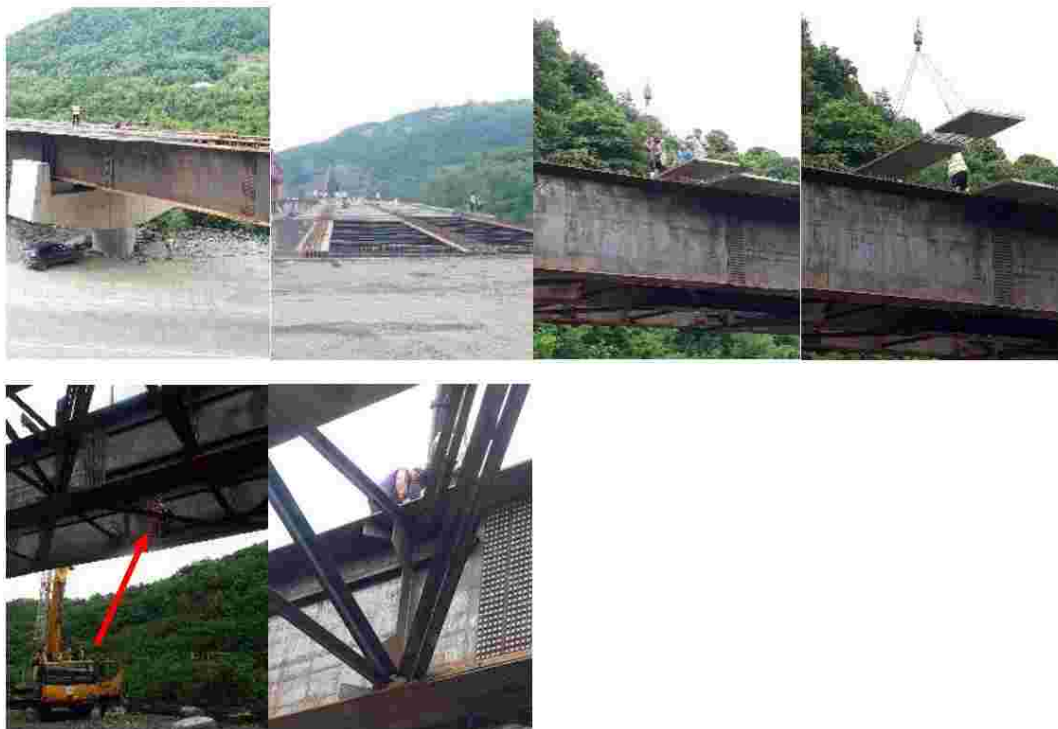
**Bridge N1 TA –** The workers in an unsafe position have been observed during site inspection. They didn't wear the fall arrest equipment while performing the task at the elevated height. Proper PPE must be worn to avoid the possible fall and personal injury.

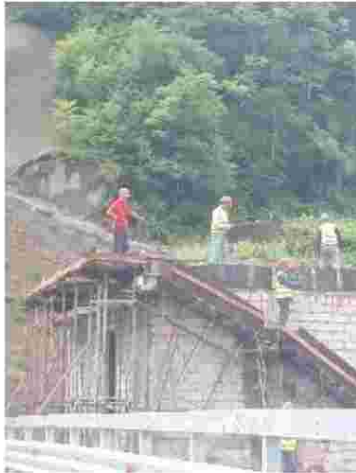
**Tunnel portal N3 AT (Argveta side) -** The workers in an unsafe position have been observed during site inspection. They didn't wear the fall arrest equipment while performing the task at height. It is strictly forbidden to stay on the basket when working. It could cause the possible fall and personal injury. It has also been observed that no handrails were installed around to protect the workers from the possible falls. The Contractor has to pay additional attention to this issue in order to avoid the incidents at the workplace.

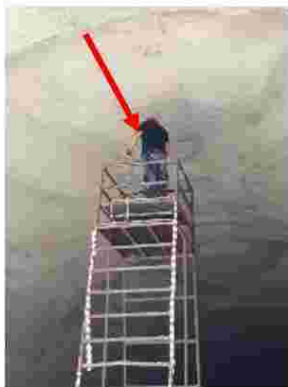
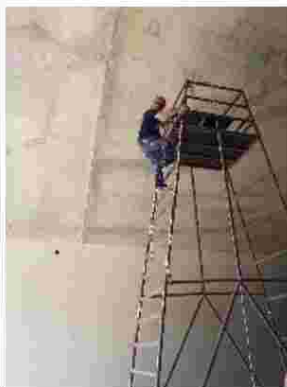
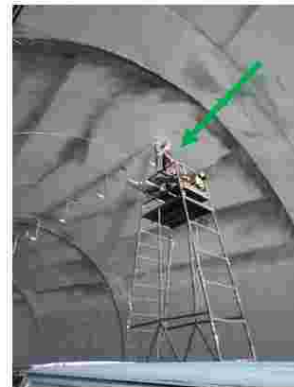
**Tunnel N1 AT -** The worker didn't wear the fall arrest equipment (safety body harnesses) when working at the elevated height. After a verbal warning given to him, he weard the safety body harness and returned back to the work.

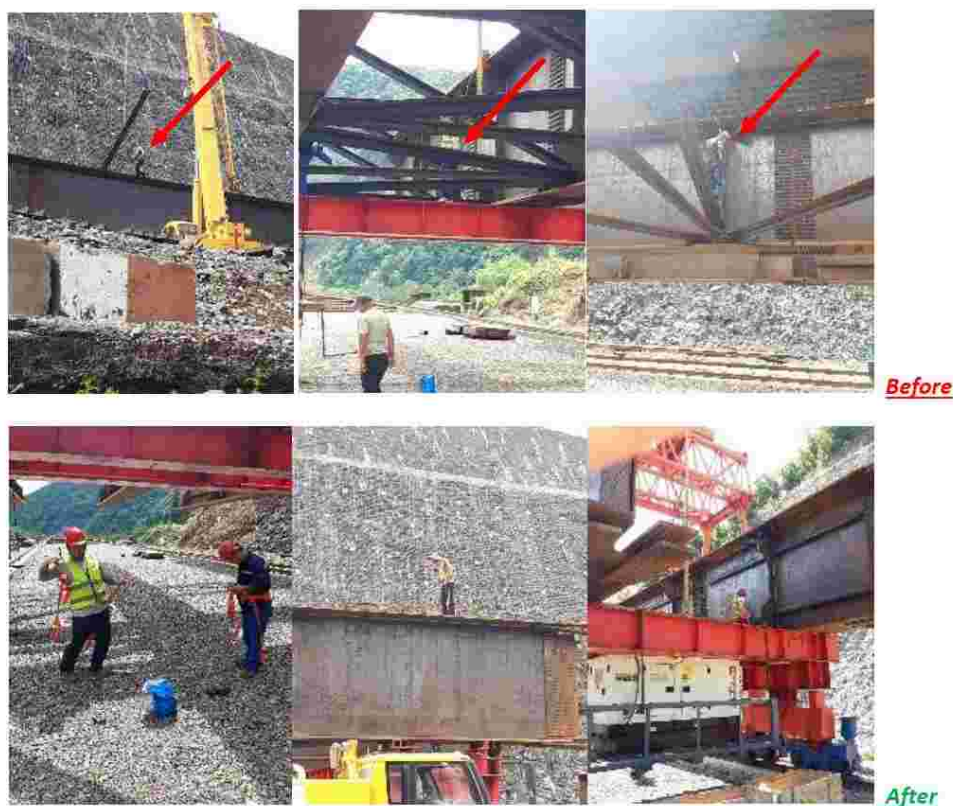
**Workshop (Bridge N2-Tbilisi side) – The workers in an unsafe position have been observed during site inspection. They didn't wear the fall arrest equipment while performing the task at the elevated height. One wrong step may cause the possible fall and personal injury. After a verbal warning given to the workers, they have wear the safety body harnesses and returned back to the work.**

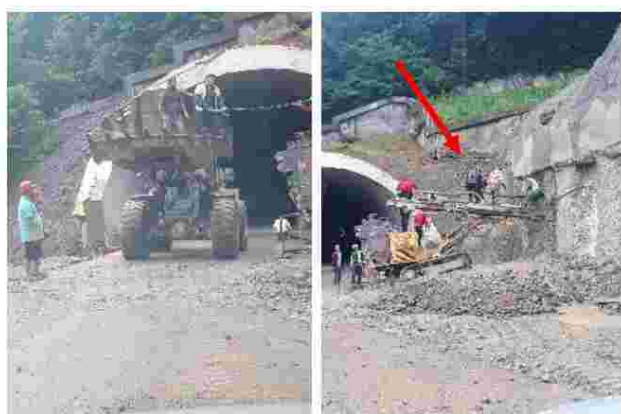
**Drilling of piles (Tunnel N1 AT-A) –** The workers (With no proper PPE) were standing on top of the drilling machine and bucket of the loader to perform (To pull the hoses into the drilled hole) the task at the elevated height. It is strictly forbidden to use the Construction machinery as a platform to perform the task at height. One wrong step may cause the possible fall and personal injury. Proper tools and equipment must be used to ensure the work process safety.

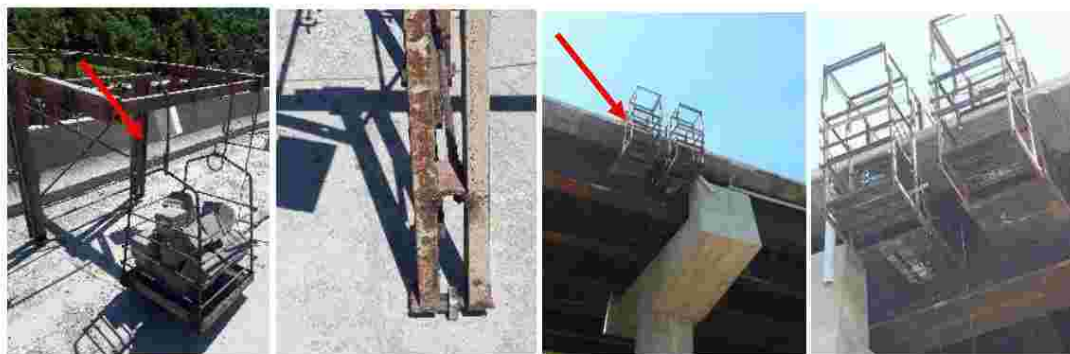
**Picture 5: Negative observation – Tools and equipment - (Bridge N2 TA and AT) –** Despite several warnings, given to the Contractor regarding use of handmade steel structures (with no proper access, no handrails and guardrails), the Contractor still continue violation to the H&S regulation and continue using these structures to perform the work at the elevated height. Correct tools and equipment must be used in order to avoid the possible incident and personal injury at the workplace. All tools and equipment must be in good (Factory-made or should meet the standards) working condition in order to avoid the possible incident and personal injury. **Non-compliance isn't solved yet.**

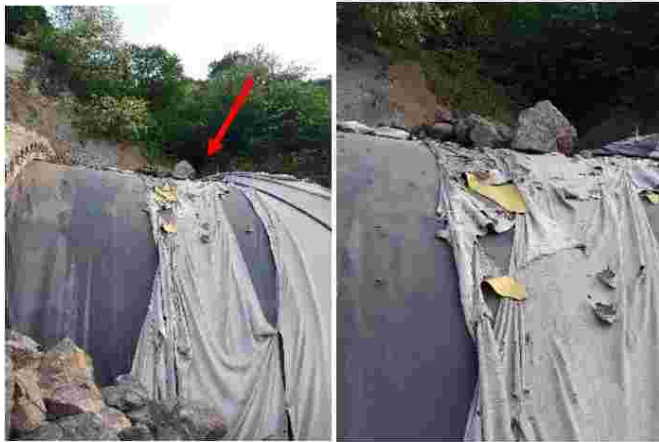
**Picture 6: Non-compliance – Tools and equipment – (Tunnel portal N1 AT-A) –** It has been observed that the pieces of rocks were accumulated on the top of the tunnel portal. Even a small vibration or physical contact may cause the possible roll down and somebody from the working personnel performing the task near the tunnel may get injured there. All rocks must be removed immediately to avoid the possible incident at the work place. **Non-compliance isn't solved yet.**

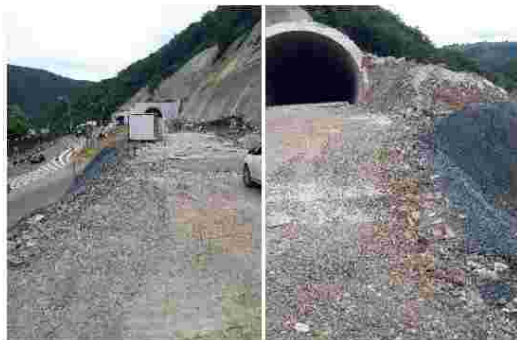
**Access to the Tunnel N1 AT-T – No hard barriers and no warning signs are installed all along the slope to protect the workers from possible fall.**

**Picture 8: Non-compliance – Workplace safety – (Bridges and Tunnels)** – It has been observed that the edges of slopes and edges of main road aren't well protected from the possible fall or rolling down the hill. The hard barriers and warning signs must be installed near the edge (All along) of the slope and main road in order to warn the drivers or pedestrians about the possible fall or rolling down the slope hazards. Non-compliance isn't solved.

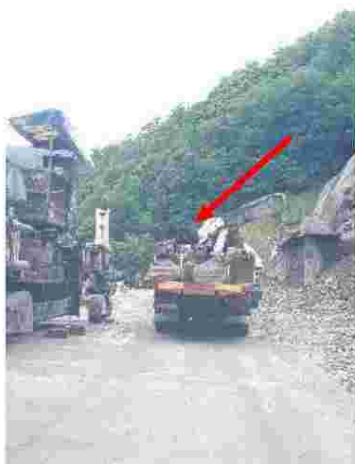
**Picture 9: Non-compliance – Driving safety (Access to the Tunnel N2 TA)** – It has been observed that the worker was sitting on the trunk of the truck while it was moving. It is strictly forbidden to sit on the truck when it is moving, because the one wrong step or the wrong maneuver of the truck may cause the possible fall and personal injury. All necessary safety precautions must be taken by the Contractor to avoid the possible incident and injury of the working personnel. Non-compliance isn't solved yet.

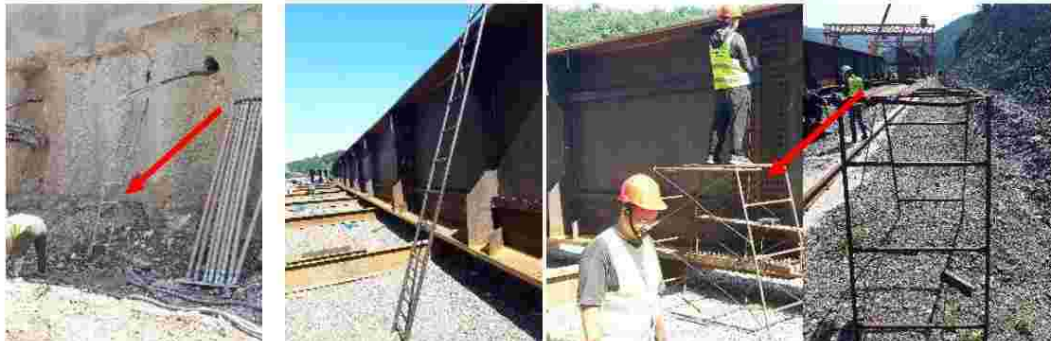
**Picture 10: Non-compliance – Workplace safety – (Tunnels and Bridges)** – Use of handmade ladders and working platforms at the workplace have been observed during site inspection. Use of such equipment may cause the possible fall and personal injury. Correct type (Factory-made) working equipment must be used in order to avoid the possible incident and injury of the working personnel. **Non-compliance isn't solved.**

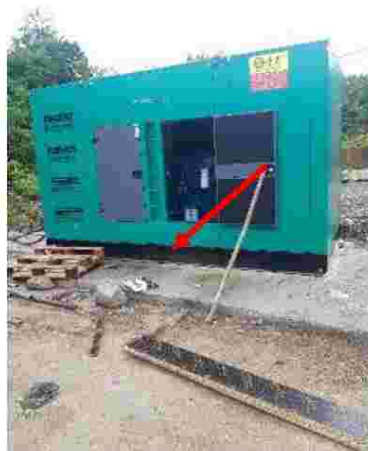
**Picture 11: Negative Observation – (Tunnel №3 ATA)** – **No positive changes have been made by the Contractor in this regard seems last weeks.** No fire extinguisher has been placed near the working Generator. Careless use or possible spark may cause the incident and possible fire. A few fire extinguishers must be placed near the working Generator to localize the fire in time if such incident will take a place. **Non-compliance isn't solved yet.**

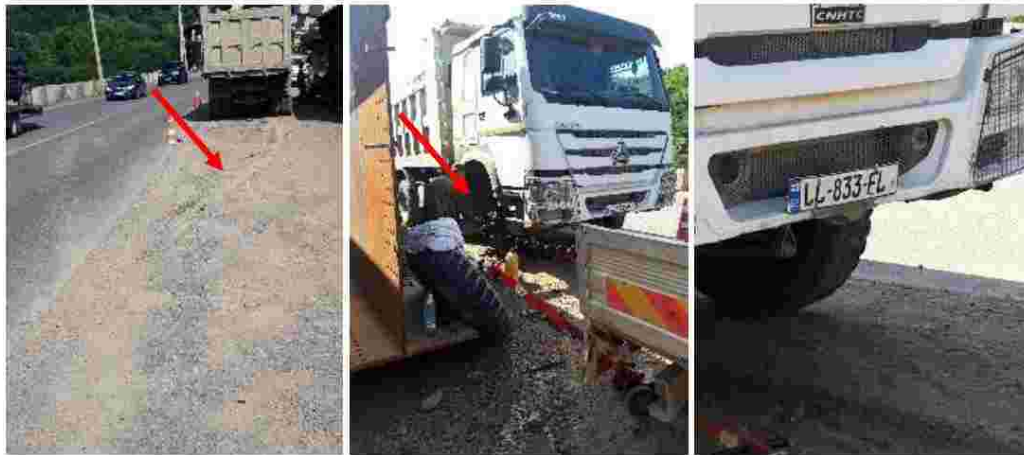
**Picture 12: Negative Observation – Driving safety (Main road (E60))** – Additional attention to the Company trucks must be paid from the Contractor's side, because the use of damaged and not properly repaired trucks may cause the traffic related accident and possible personal injury of the drivers and pedestrians as well. One of the examples has been given in the pictures attached below. The tire became loose on the truck while it was moving. Nobody got injured and it didn't cause the traffic accident as well. The Contractor has to pay additional attention to this issue in order to avoid the possible incident and injury of the working personnel. **Non-compliance isn't solved.**
