# Social Monitoring Report

Bi-Annual Report  
January to June 2020  
July 2020

GEO: Batumi Bypass Road Project  
Financed by the Asian Development Bank and Asian  
Infrastructure Investment Bank

Prepared by SMEC International Pty Limited for the Roads Department of the Ministry of Regional Development and Infrastructure of Georgia and the Asian Development Bank.

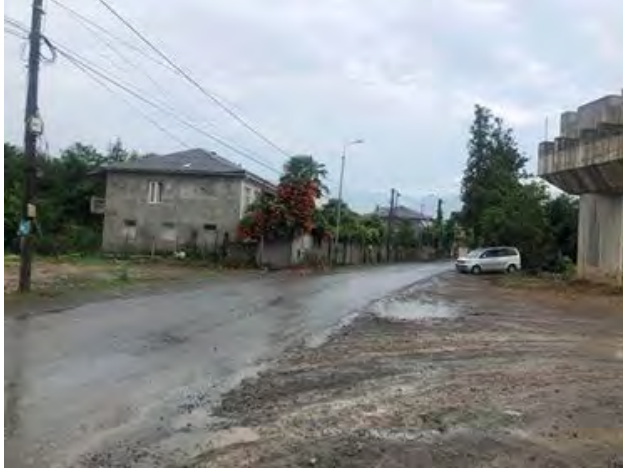
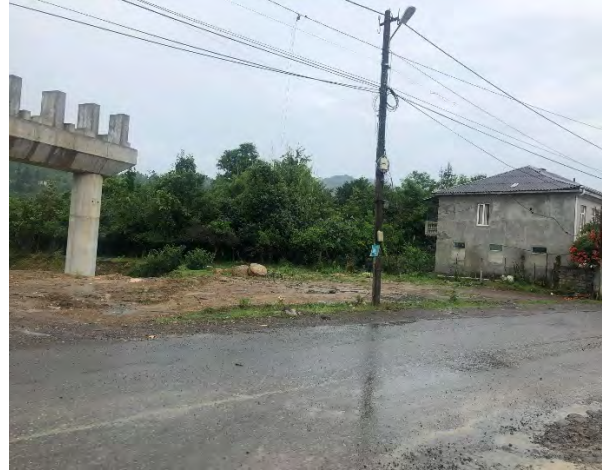
**Photos from construction site**

35. During the reporting period houses of [redacted] (distance from RoW 16.20m) and [redacted] (distance from RoW 9.34m) were acquired. In case of [redacted] (distance from RoW 5.2m) acquisition procedures have extended as the family is not happy with the offered compensation amount. The repeated assessment of the property from Samkharauli National Forensics Bureau is awaited. Temporary relocation agreement of Bzekenava family completed as there is no activities implemented by the Contractor on Bridge No. 5.

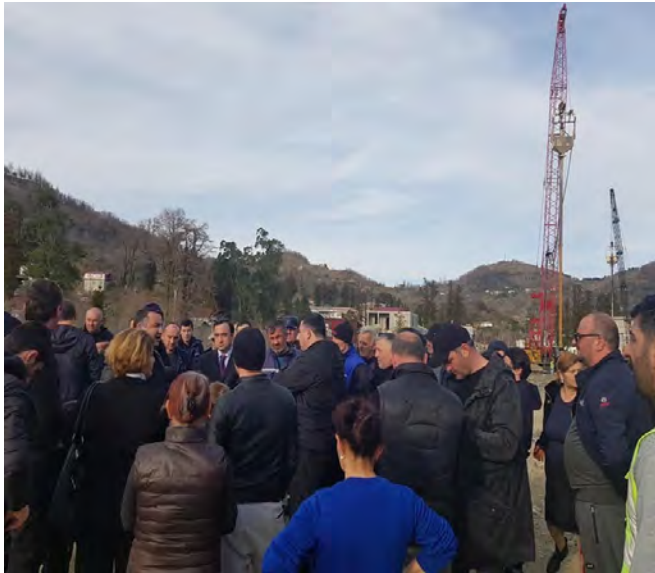
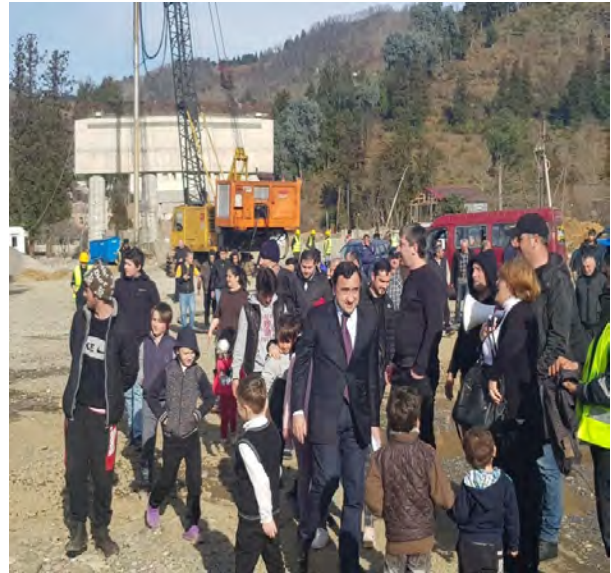
**Demonstrations at the Stone Column Construction Site**

49. Finally, on May 3, representatives of Road Department visited the Site together with the vibration measurement equipment from Bridge Testing Centre of Georgian Technical University. The vibration was measured during operation of two stone column rigs. National Forensics Bureau named after Levan Samkharauli will analyze the existing condition of the structures and results of vibration measurement and will issue its conclusion.

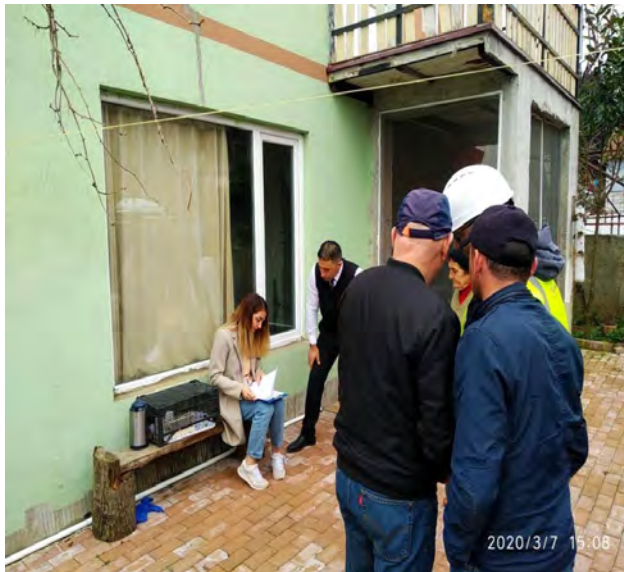
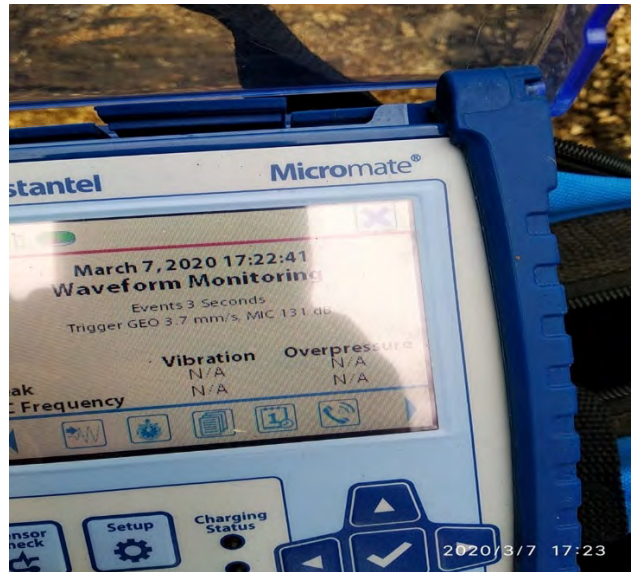
**Vibration measurement at Bridge No. 3 Area**

50. The local residents adjacent to Bridge No. 3 have also expressed dissatisfaction due to excess levels of vibration caused by drilling machine and excavator which according to their opinion resulted in development of the cracks in their houses. As a follow up on 5th and 7th March vibration measurements have been carried out in the presence of Project Manager from RD during operation of drilling rig and excavator. Field measurements did not show any high levels of vibration.

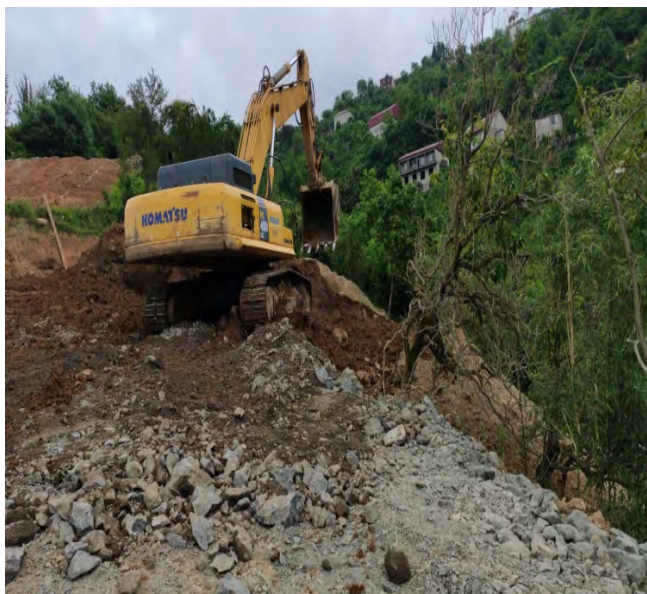
**Removal of dumped soil from land plot**

52. In April 2020 Mr. [redacted] claimed that the land plot under his ownership was damaged due to the construction activities (BR-10). In accordance to the agreement between the Contractor and citizen [redacted] the Contractor dumped the soil in the land plot of citizen [redacted] whose land plot is bordering the land plot of the Complainant ([redacted]). As per [redacted] statement the border between the land plots was violated and part of the soil was placed in the land plot of citizen [redacted] damaging perennial plants. The Contractor was instructed to carry out the necessary survey works to identify the border between the land plots, remove the dumped soil if placed within the boundary of the complainant's plot, and ascertain the damage incurred by the Complainant. In May the land plots were measured, and it turned out that the dumped material was within the border of citizen [redacted] with whom the Contractor had agreement. However, during the rain the dumped soil will be washed out and slid in the neighboring land plot. Considering this fact, the Contractor was instructed to remove the dumped soil. By 21 June 2020 the Contractor has removed the soil dumped in [redacted] land plot and constructed entrance in the land plot by car.

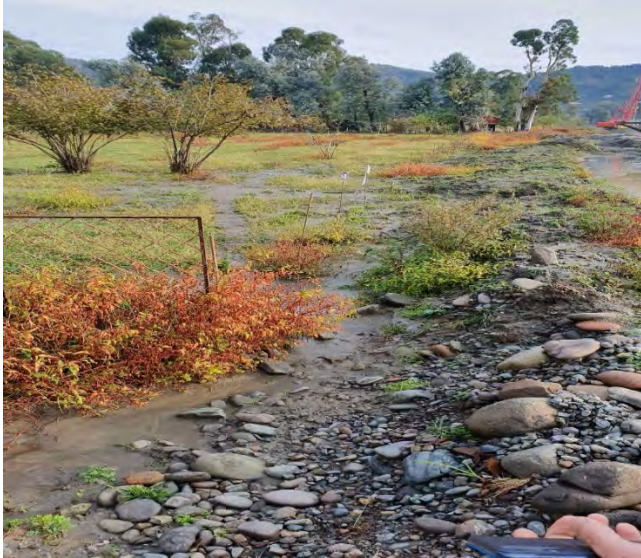
**Flooded land plot owned by adjacent to stone column construction site**

No.	Reference No.	Subject and Description	Follow-up
1	5015001/2/1101 dated 04.11.19	adjacent to stone column area expressed dissatisfaction as her land plot was flooded due to inadequate drainage at the construction site. As a result, plants and fence were damaged, and drainage channels inside the land plot were blocked by material from the construction site.	The Contractor reported by letter No. GEO/BB/965-20 dated 14 March 2020 that he could not access the land plot and some of the damage was not caused by construction activities. However, during a site inspection the Engineer's representative observed otherwise. Currently the channels are cleaned, and the fence has been restored by the Contractor. Compensation for the damaged plants is remaining.
2	5015001/2/1107 dated 05.11.19	The land plot of , was flooded. As stated by the Complainant harvest	
2	5015001/2/1215 dated 30.12.19	, resident adjacent to stone column area was expressing dissatisfaction as her land was flooded due to inadequate drainage at the construction site.	The Contractor did not report any actions taken by him. During site inspection of the Engineer the complainant reported that she did not receive any damage, however, she cleaned her land plot and yard from the flood material by herself.

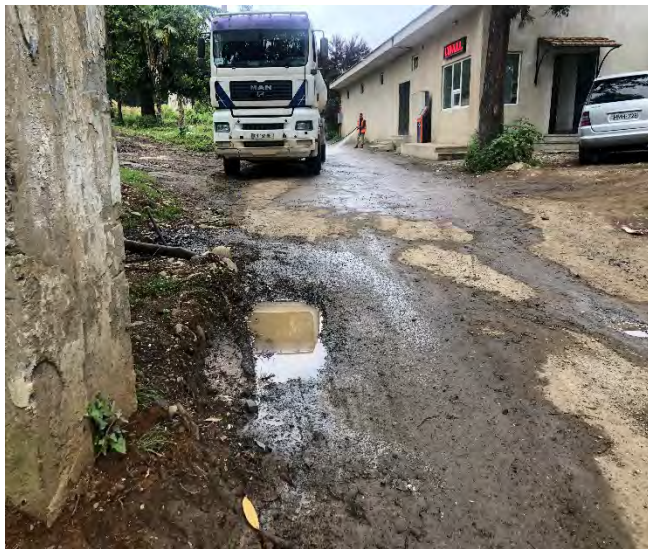
**Washing the tires of the dump truck**

54. It was reported in the previous Semi-annual SMR that numerous claims were received by the local residents concerning pollution of the local roads intersecting with the access roads to Bridge N3, Tunnel N3, Tunnel N4, Bridge N5 and Bridge N7. To prevent this the Contractor took mitigation measures such as washing the tires of the cars and added special crew who is responsible for regular cleaning of the roads.
