Bi-annual Environmental Monitoring Report

Project name: Kobuleti Bypass Road Section KM12+400-KM31+259

ADB Project No: 41122-043
ADB Loan/Grant No: 2560-GEO, 2843-GEO
PIU Name: Roads Department of Georgia
Country: Georgia

Project Start Date: 26th November 2013
Project End Date: 25th June 2018
Reporting Period: Jul - Dec 2018

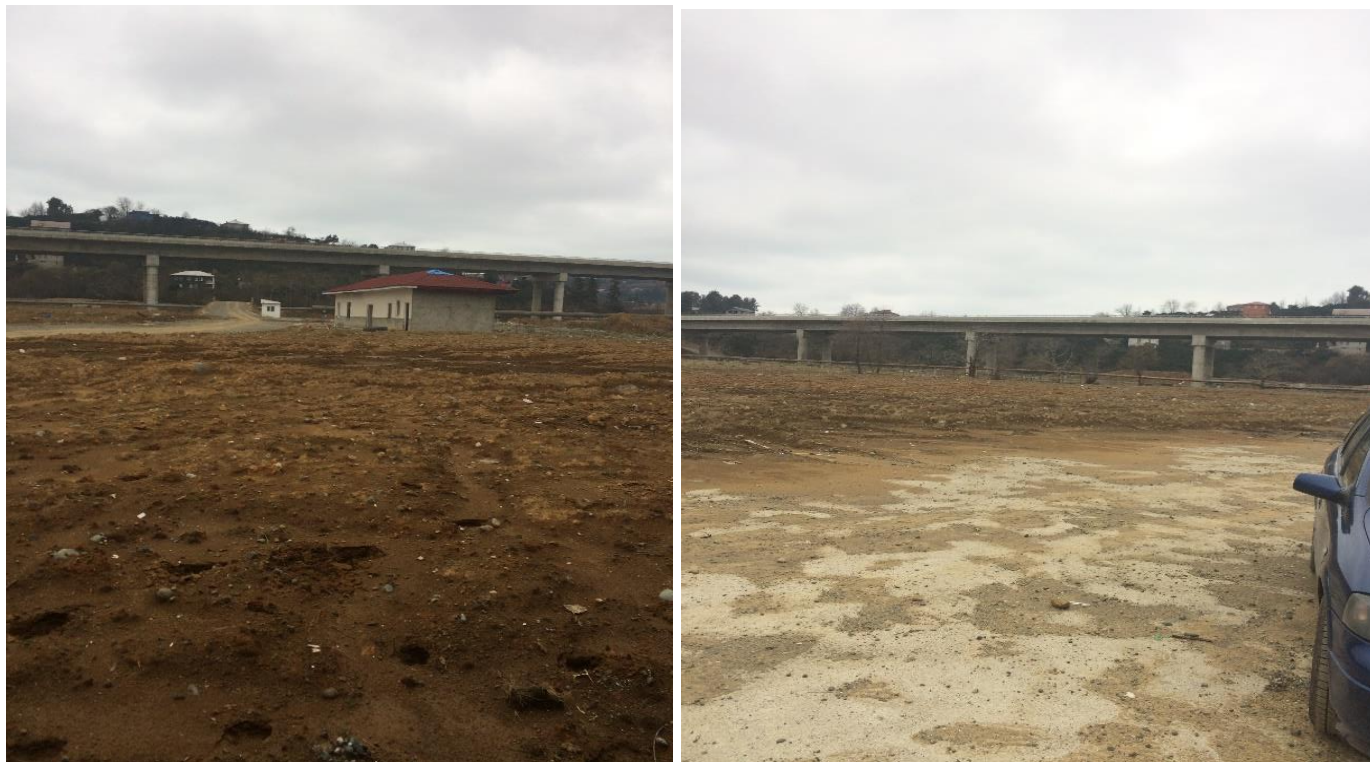
Photo 1, 2: Chakvi Camp Area

Chakvi campsite: The territory of Chakvi camp site belongs to 5 owners, during the clearance of campsite, the owner made additional requests to the Contractor and the requests were constantly changing. The Contractor plans to execute the clearance work as soon as the owner finally confirmed his requests. Polluted soil testing completed in August 2018 (see Appendix 6), and cleaning of the territory was done in October, 2018. The Contractor has transported all polluted soil 20 m³ to the Lanchkhuti Campsite for temporary storage in December 2018. At the appropriate time, the Contractor will notify the toxic object handling company which is cooperative with Ltd “Corporation Sinohydro Branch in Georgia” to carry away and handle it.

- CC to continue slopes stabilization and reinstatement process – Q2 2019.
- CC to finalize ground leveling at Chakvi camp site and to issue take-over certificates to 5 owners – Q1 2019.
- Contractor to submit test results of contaminated soil at Chakvi camp site and completed form of Corrective Action Plan – Q1 2019.
- CC to continue reinstatement of Shuagele quarry site – Q1-Q2 2019.
- SC/PIU to prepare Final EMR for Jan-Jun 2019 reflecting corrective actions implemented by CC.
- CC to submit evidence in form of Waste Transfer Note (WTN) from Sinohydro at Lanchkhuti Campsite of transfer of contaminated soil to final destination if completed during the reporting period.

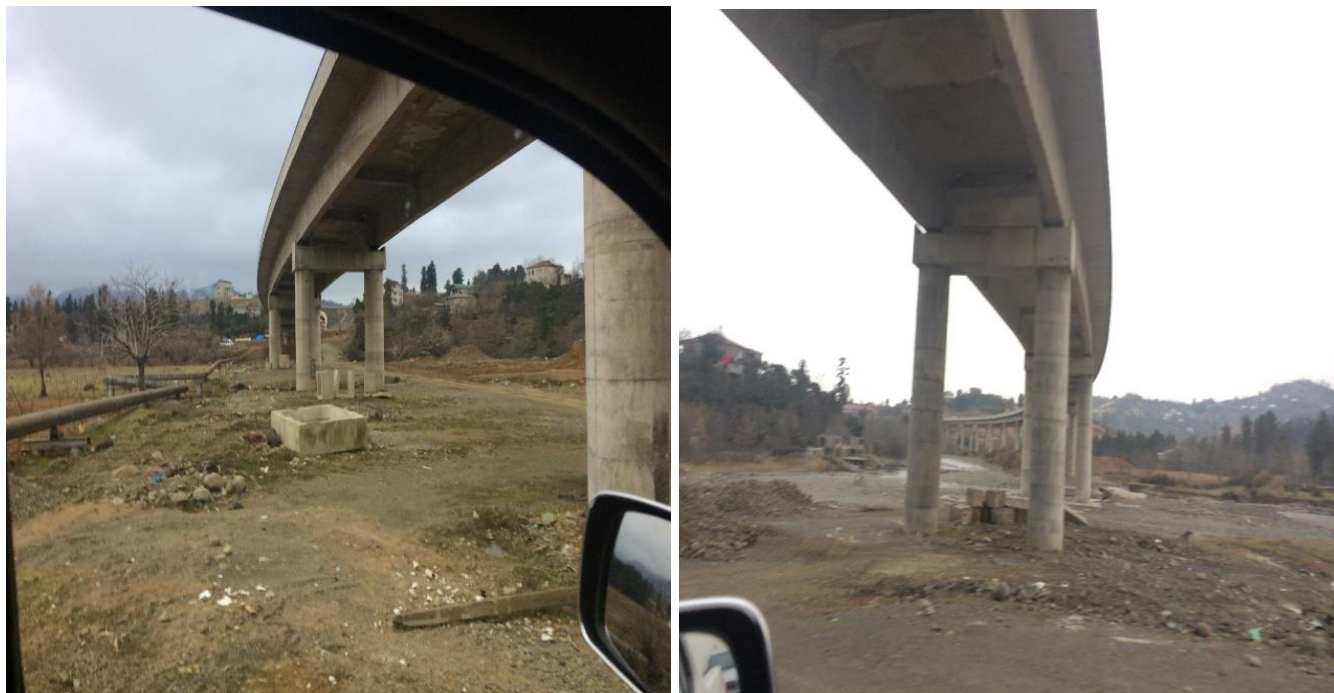
Photo 2. Bridge #9 – Incorrect landscaping and waste management

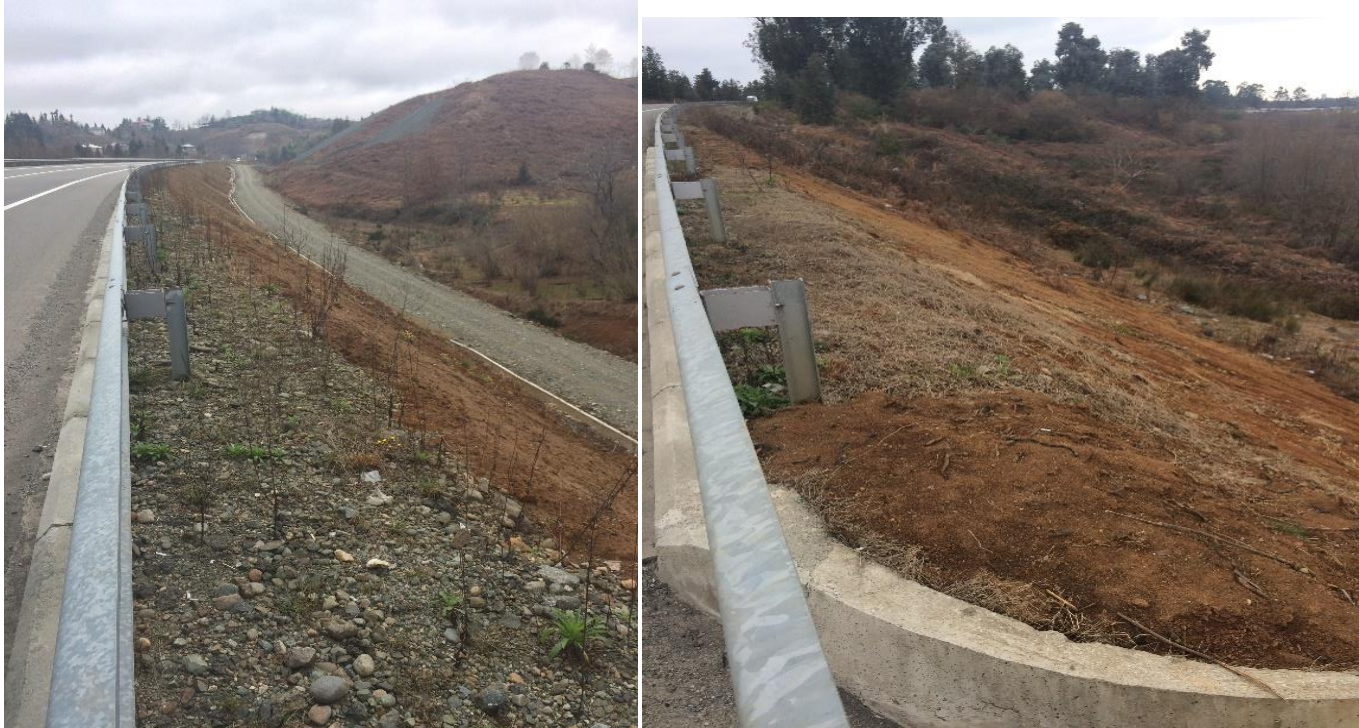
- **Slopes reinstatement/stabilization:** At some places (KP 5, KP 11,800) due to lack of top-soil no regrowth of the grass was observed. The identified slopes will be reseeded, but will not work well unless topsoil used. It was recommended by ADB Mission that it is necessary for slopes stabilization spreading topsoil and seeding the grass. The contractor is planning to use additional topsoil and seeding the grass at early spring (in March-April) 2019.
- **Quarry site:** Some progress in reinstatement of Shuagele Quarry site located near riv. Dekhva was observed, in particular most trees planted previously (2017-2018) grew well, but landscaping activities still need to be implemented, including covering of rocky hills with top-soil and seeding the grass. The contractor is planning to use additional topsoil and seeding the grass at early spring (in March-April) 2019.

Photo 3. Slopes stabilization/reinstatement (KP 5 and KP 11,800)

#	Non-conformance	Corrective actions	Deadline	Responsible organization/person
1.	At certain places of road at section KM12+400-KM31+259 slopes are damaged, spreading of top-soil and seeding of grass has not been executed.	Backfilling of slopes and seeding	Will be executed in April 2019	Contractor
2	During the period September-October 2017, in purpose of re-cultivation of Shuagele quarry area, the 1350 numbers of different sort of trees has been planted. Unfortunately most of the trees has died (see photo 9).	Contractor was instructed (letter 18056-0090) to count damaged trees and instead of died ones to plant new trees accordingly.	Ongoing, will be executed before the end of April 2019	Contractor
