Semi-Annual Environmental Monitoring Report

Reporting Period: July-December 2023

Georgia: Batumi Bypass Road Project

Loan Number: 3520-GEO Project Number: 50064-001

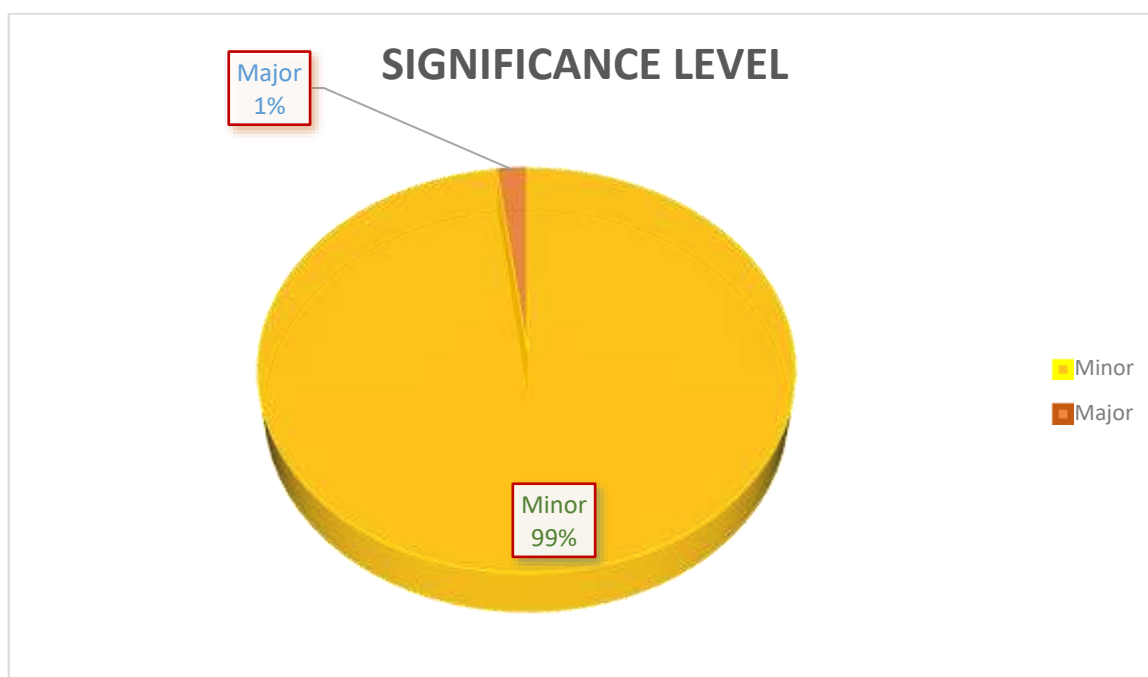
Figure 4. Summary of Non-Conformance by Significance Level

43. Building upon the information provided in Table 6, Figure 4 below delineates the environmental issues categorized by significance levels, ranging from Minor to Major. The Engineer conducts individual assessments for each issue based on the scale of violation and its impact on the environment. Figure 4 visually represents the percentage

distribution of minor and major environmental issues observed during the reporting period.

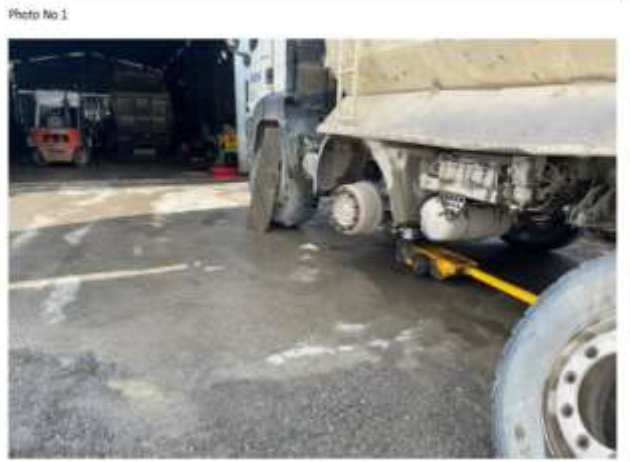
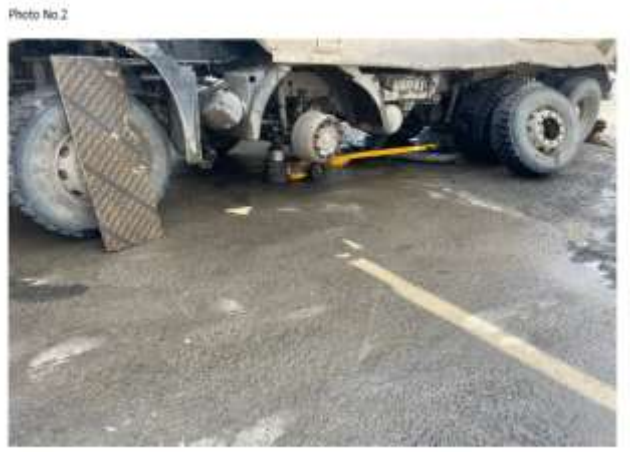
Environmental Non-Conformance Report (ENCR)	
Part 1 – Non-Conformance Description:		
Reference Number:	ENCR_153	
Project Name:	Batum Bypass Road Project	Date raised: 28.07.2023
Contractor Name:	POLATYO! & MAPA JOINT VENTURE	
Location:	Tunnel No. 2 Entrance Portal	
Non-Conformance details:		
Fuel leakage from fuel tank and generator.		
Requires clean-up and installation of a tray underneath the tank and generator to contain any spillage.		
Oil and other hazardous liquid spillage at vehicle/plant maintenance area.		
Spillage needs to be cleaned up and the area requires a perimeter bund to prevent off site pollution.		
Engineer's Representative: Michael Holics	Signature:	
Part 2 – Corrective Actions (attach any supporting information)		
Fuel and oil spills were cleaned. Generator placed on concrete foundation for preventing watercourse contamination by fuel oil spills.		
	Agreed Close-out Date:	02.08.2023

Contractor's Representative: Derri Miterrib	Signature:	
Part 3 – Inspection (evidence to support corrective action implementation)		
Done:		
Engineer's Representative: Michael Holics	Signature:	
Closure Date:	03 August 2023

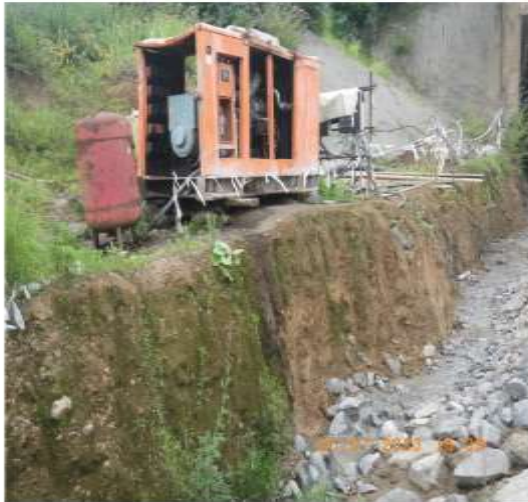
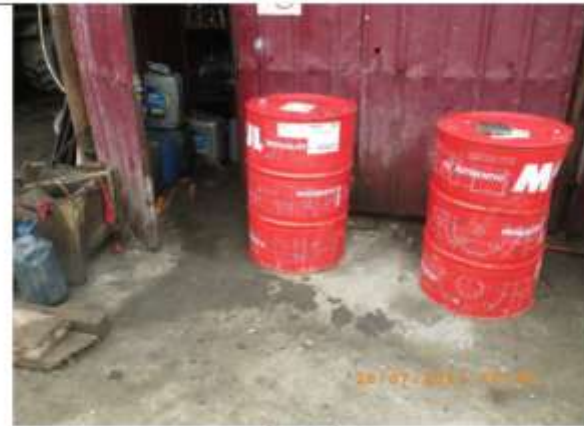
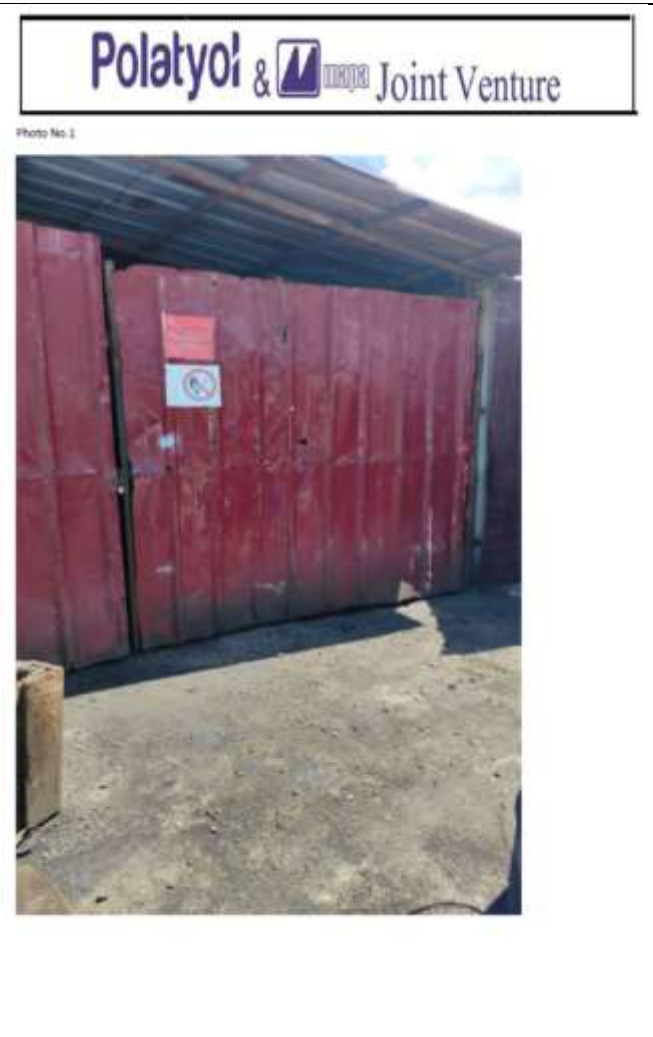
Polatyol	Environmental Non-Conformance Report (ENCR)	  <small>Member of the Sellen Group</small>
Part 1 – Non-Conformance Description:		
Reference Number:	ENCR_154	
Project Name:	Batum Bypass Road Project	Date issued: 02.08.2023
Contractor Name:	POLATYOL & MAPA JOINT VENTURE	
Location:	Tunnel No. 1 Entrance Portal	
Non-Conformance details:		
Significant oil contamination from construction vehicle. Requires soil clean-up and installation of a liner underneath the vehicle to prevent further spillage.		
Fuel/oil contamination from generator and fuel tank. Contaminated soil to be removed and disposed in accordance with hazardous waste management plan. Waste collection lorry to be installed underneath fuel tank and generator.		
Overflowing waste bin and burning of rubbish on site. Waste bin to be emptied on a regular basis and site workers to be reminded during toolbox talks that it is illegal to burn waste on site and that disciplinary measures will be implemented for repeated offences.

4	ENCR 154	02/08/2023	Tunnel No. 1 Entrance Portal	Significant oil contamination from construction vehicle. Fuel/oil contamination from generator and fuel tank. Overflowing waste bin and burning of rubbish on site.	Area was cleaned. Generator was fixed. Vehicles will be repaired only in special designated area for preventing further oil spills. Waste bin was emptied and cleaned. The toolbox talk was conducted to	07/08/2023	Closed 07/12/2023

Engineer's Representative: Michael Holics	Signature:  	
Part 2 – Corrective Actions (attach any supporting information)		
Area was cleaned. Generator was fixed. Vehicles will be repaired only in special designated area for preventing further oil spills. Waste bin was emptied and cleaned. The toolbox talk was conducted to employees about environmental safety.		
Contractor's Representative: Jaba Mahavanada	Signature:   Agreed Close-out Date: 07.08.2023	
Part 3 – Inspection (evidence to support corrective action implementation)		
Done.		
Engineer's Representative: Michael Holics	Signature:  	
Closure Date:	07.12.2023

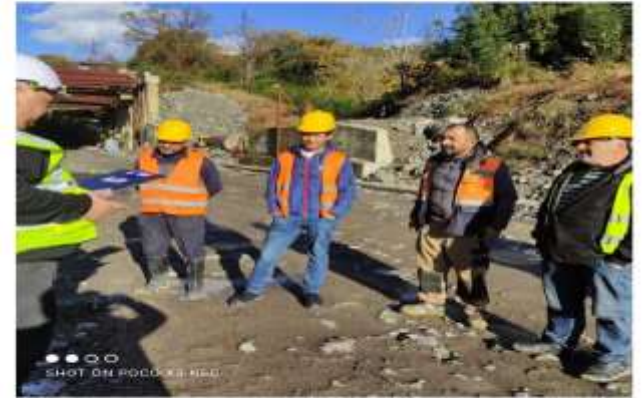
Photo No.1

Environmental Non-Conformance Report (ENCR)	
Part 1 – Non-Conformance Description:		
Reference Number:	ENCR_158	
Project Name:	Batumi Bypass Road Project	Date raised: 24-11-2023
Contractor Name:	POLATYO! & MAFA JOINT VENTURE	
Location:	Bridge No. 11/Bridge No. 11	
Non-Conformance details:		
Concrete and concrete-mixed water have been spilled from the concrete mixer trucks on the embankment slope adjacent to the start point of Bridge No. 11 and there is a small river flowing below the indicated area. Therefore, there is a danger of river pollution (see the photos No. 1, 2, 3).		
No. 11 ხიდის დასაწყისის მიდებშია კონკრეტული კლასის ფეხვრე, თვითმზღი მქარა მანქანების დაღვრილი კონკრეტი და მქარა მანქანების წყალი, მოთავსებული ავტოსადგომის მიდებშია მკარე ზონის მდინარე და არსებობს საშიშროება მდინარის დაბინძურებისა (იხ. ფოტო No.1, 2, 3)		
Suggested Corrective Action:		
გეგმიური/საჭირო მეთვრეტეობითი ქმედება:

It is necessary to clean the mentioned area from concrete waste. Moreover, it is also necessary to remove the concrete waste and place it in the disposal area for the concrete waste.		
Truck drivers and their Supervisors should be instructed and trained regarding the Waste Management Plan, so that the drivers know where to place concrete waste in order to prevent repeated spills of concrete.		
აუცილებელია ტვირთის გაწმენდა მდინარის ნაპირისკენ, ასევე საჭიროა მდინარის ნაპირის გაწმენდა და მდინარის ნაპირისკენის წესდების განხორციელება კანკარების ზონაში განთავსება.		
თვითმზღი მქარა მანქანების მძღოლებს და მათ ხელმძღვანელებს უნდა გაეცნობოდნენ და იყავნენ მოზადებული ნაპირების წარადის უკუბის მიხედვით, რადგანაც მძღოლებმა უნდა იცოდნენ, სადა მოათავსონ მქარა მანქანების ნაპირები, რათა დაევიან ავტოსადგომის კანკარების დაღვრა.		
Engineer's Representative: Davit Terzishvili	Signature:	
Part 2 – Corrective Action (attach any supporting information):

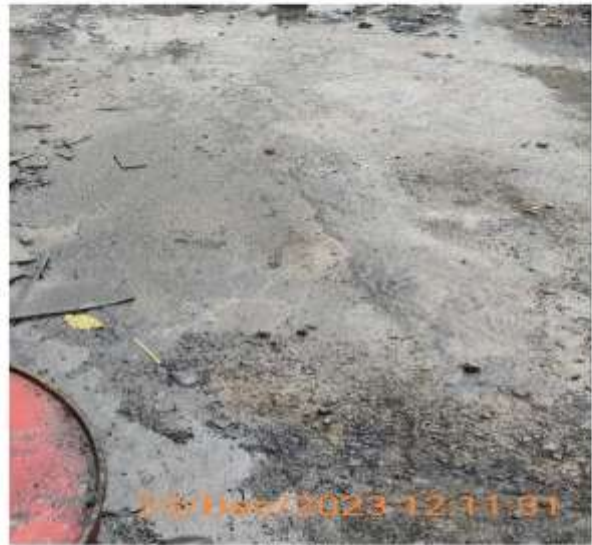
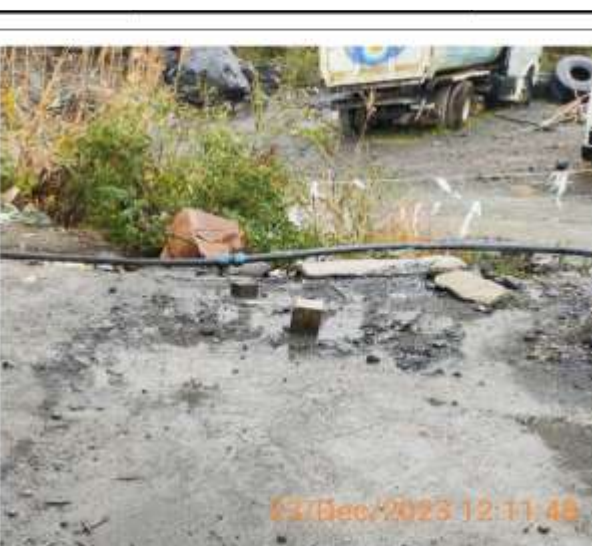
Photo No. 1

Reference Number:	ENCR_167		
Project Name:	Batumi Bypass Road Project	Date issued:	23/12/2023
Contractor Name:	POLATYOL & MAPA JOINT VENTURE		
Location:	No. 3 bridge on the way to No. 2 gate of the settlement area Bridge No. 3 End & Tunnel No. 2 Entrance Portal
