# Semi-Annual Environmental Monitoring Report

Reporting Period: July-December 2024

## Georgia: Batumi Bypass Road Project

Loan Number: 3520-GEO Project Number: 50064-001

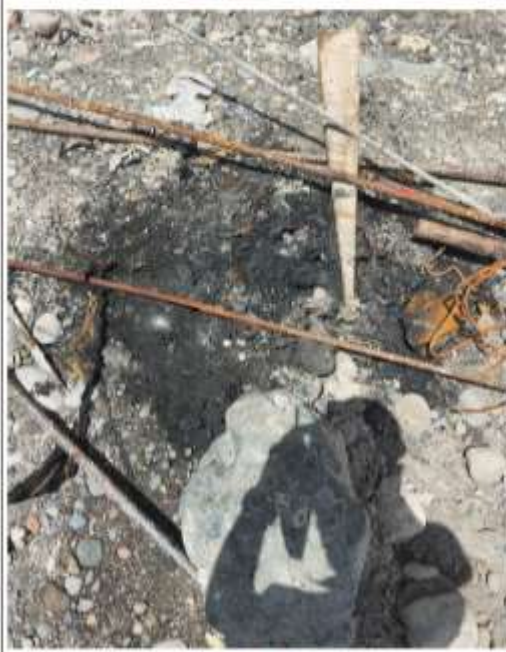
| | <b>Environmental Non-Conformance Report (ENCR)</b> | |
|---|---|---|
| Photo No. 1 | | |

| N | ENCR | DATE ISSUED | LOCATION | DESCRIPTION | CORRECTIVE ACTIONS | SPECIFIED CLOSING DATE | STATUS |
|---|---|---|---|---|---|---|---|
| 1 | ENCR 176 | 14/06/2024 | Tunnel No. 1 Entrance Portal | Construction waste placed on the ground and burning of waste on the construction site. | Area was cleaned from placed and burnt waste. Necessary training was conducted. | 16/06/2024 | Closed<br>05/08/2024 |

| | <b>Environmental Non-Conformance Report (ENCR)</b> | |
|---|---|---|
| <b>Non-Conformance Details:</b><br>The following was observed on the territory:<br>ტერიტორიაზე დაფიქსირდა<br>Construction waste placed on the ground and burning of waste on the construction site.<br>მიწაზე განთავსებული საშენებლო ნარჩენები და საშენებლო მოედანზე ნარჩენების წვა.<br><b>Proposed Corrective Measures:</b><br>შემოადგენილი-მაკონტროლებელი ჭეშმარიტება:<br>It's necessary:<br>საჭირო და აუცილებელია:<br>To clean of the territory from the placed/burned and burnt waste and to provide the regular trainings for staff concerning the proper disposal of all types of waste and the responsibility of working personnel to ensure that the proper waste disposal procedures are followed, as well as to ensure that the waste should not be burned on the construction site.<br>ტერიტორიის დასუფთავება განთავსებული და დაშვარი ნარჩენებისაგან. პერსონალისთვის რეგულარული ინსტრუქტაჟის ჩატარება. რომელიც ხაზს გასვას ყველა სახის ნარჩენების სწორად განთავსებასა და საშენებლო ელანზე მომხმარებელ პერსონალის პასუხისმგებლობის ნარჩენების სწორად განთავსების პროცედურების დაცვის უზრუნველყოფაზე და ასევე იმის უზრუნველყოფაზე, რომ ნარჩენები არ უნდა იწვოდეს საშენებლო მოედანზე.<br><div style="display: flex; justify-content: space-between;"> <div>Engineer's Representative: Davit Tevzadze</div> <div>Signature: </div> </div> | | |

| | <b>Environmental Non-Conformance Report (ENCR)</b> | |
|---|---|---|
| Area was cleaned from placed and burnt waste.<br>Necessary training was conducted.<br>ტერიტორია დასუფთავდა განთავსებული და დაშვარი ნარჩენებისგან.<br>ჩატარდა აუცილებელი სწავლება ინსტრუქტაჟით.<br><div style="display: flex; justify-content: flex-end;"> <div>Agreed Close-out Date:<br/>Date: 16/06/2024</div> </div> | | |

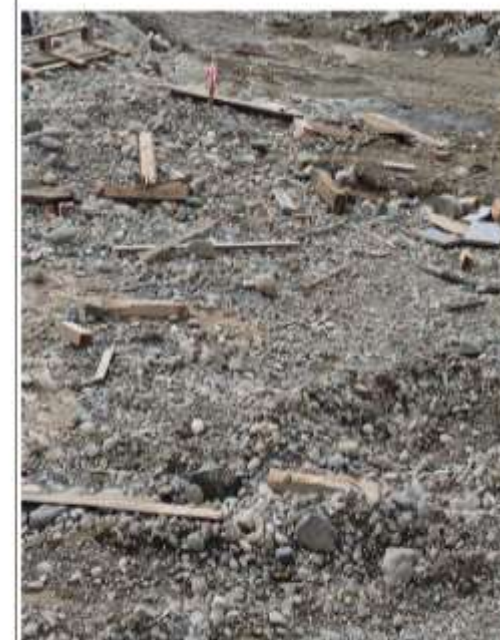
Photo No. 1

| N | ENCR | DATE ISSUED | LOCATION | DESCRIPTION | CORRECTIVE ACTIONS | SPECIFIED CLOSING DATE | STATUS |
|---|---|---|---|---|---|---|---|
| 2 | ENCR 177 | 18/06/2024 | Tunnel No. 3 Entrance Portal | Scattered construction waste and burning of waste on the construction site. | Territory was cleaned from burnt and scattered waste. Necessary toolbox talk was conducted. | 21/06/2024 | Closed<br>05/08/2024 |

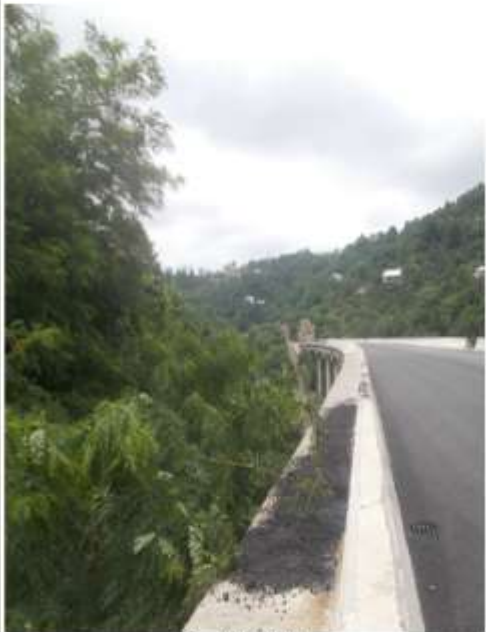
Photo No. 1 / ფოტო No. 1

| N | ENCR | DATE ISSUED | LOCATION | DESCRIPTION | CORRECTIVE ACTIONS | SPECIFIED CLOSING DATE | STATUS |
|---|---|---|---|---|---|---|---|
| 1 | ENCR 179 | 08/07/2024 | Bridge No. 10 | On the sidewalk /pavement of the Bridge No. 10, which currently does not have a guardrail, some asphalt residue/waste material is located, this material poses a hazard to vehicles and pedestrians on the local Road directly below the Bridge. | Waste asphalt was removed from 10th bridge. | 10/07/2024 | Closed<br>26/08/2024 |
