## Semi-Annual Environmental Monitoring Report

Semestral Report (January - June 2022)

## Georgia: Rehabilitation of Dzirula–Kharagauli–Moliti–Pona– Chumateleti

## Secondary Road Section (50Km)

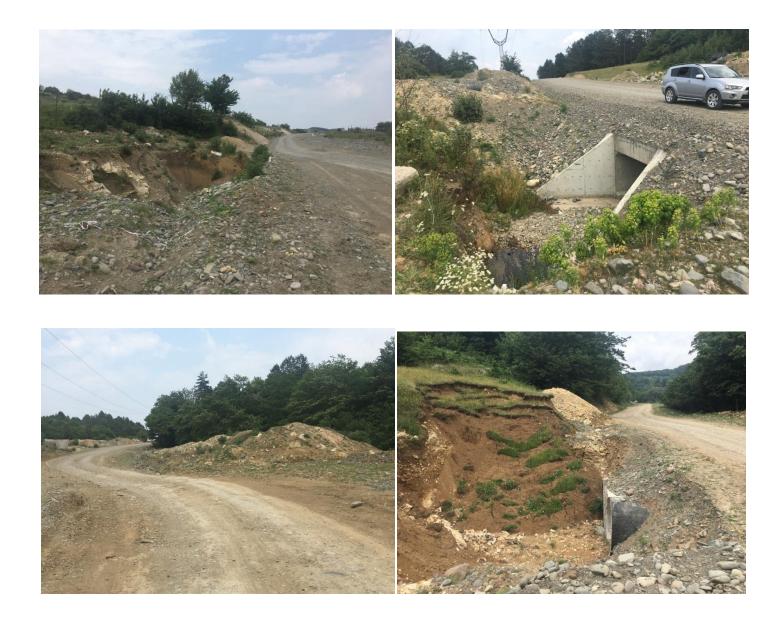
# Note: Existing non-compliances partially corrected by the local municipality. All non-compliances completely will be corrected by new CC, selected by the biding procedure. Please see below photos of the abandoned sites LOT2:

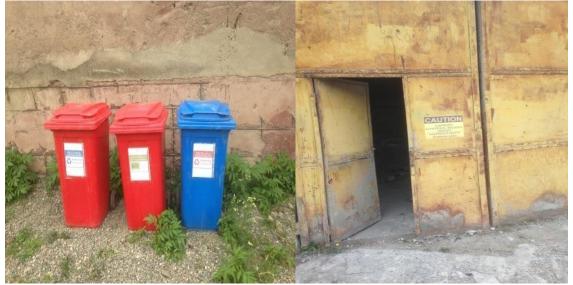
59. Insignificant amount of hazardous waste (~50kg)kept in warehouse at Kharagauli camp (special room with concrete floor and locked metal gate with warning) So there is no possibility of soil or ground water contamination. "Ecomedy" (licensed company) will remove and dispose hazardous waste from the construction sites.Domestic waste from the sites removed and disposed by the licensed contractor (Kharagauli Cleaning Service). During the reporting period spoil removal/disposal works were not carried out (LOT1).

60. Please see below photos of the Hazardous Waste Storage and domestic waste containers.

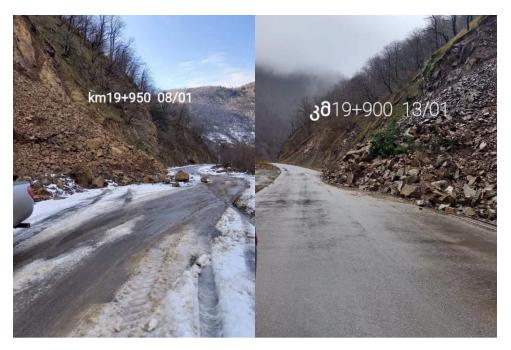
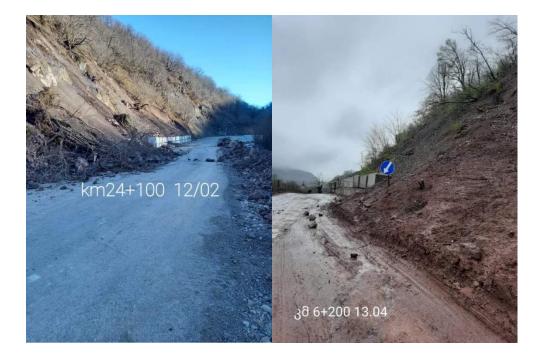
Slight landslides alongside the roadLot1

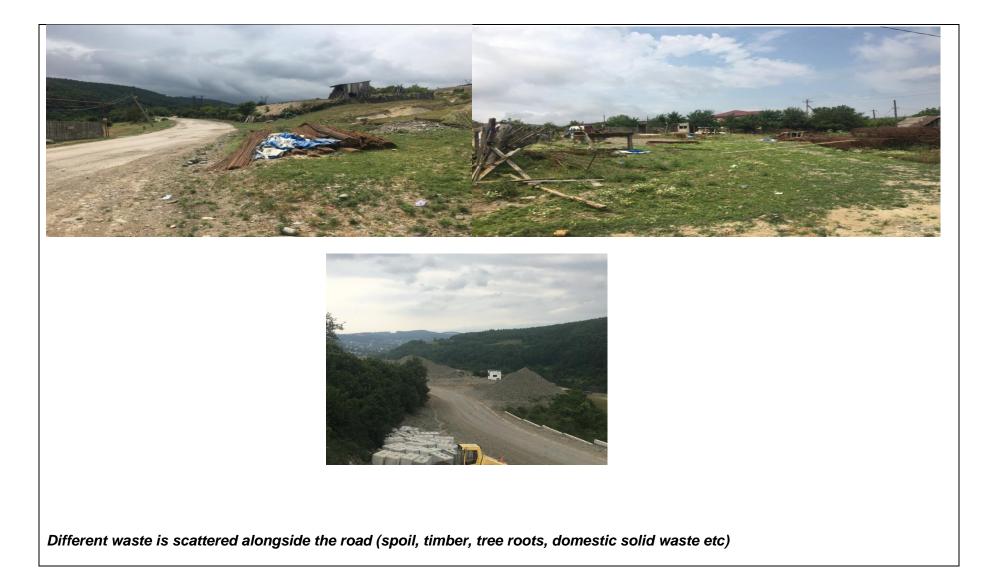
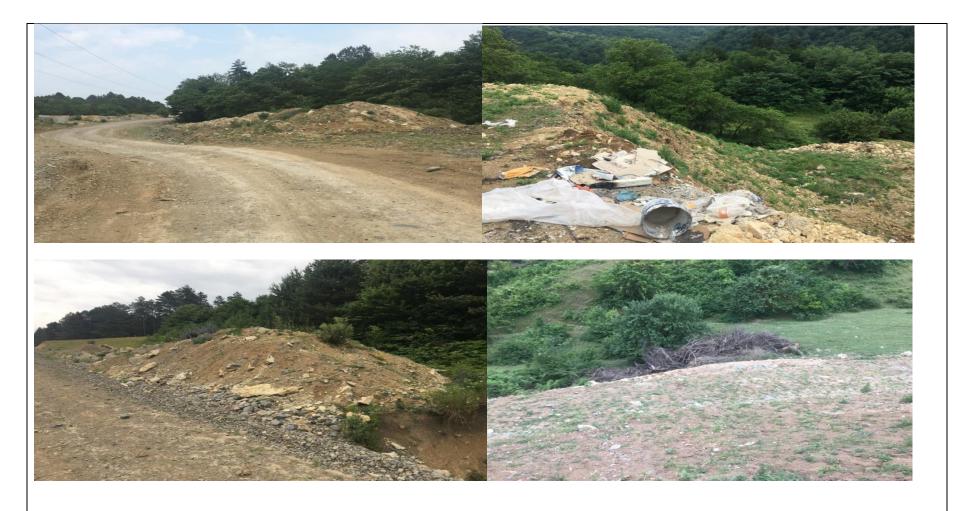
<ul> <li>Construction materials (precast concrete, rebar, timber, sand and gravel) left uncontrolled on the ground surface alongside the road</li> <li>Different waste is scattered alongside the road (spoil, timber, tree roots, domestic solid waste etc.)</li> <li>Deep cuts, trenches and pits, are without relevant barriers and warning signs</li> <li>Oil drums outdoor, leaking backhoe and scattered waste at the construction base</li> <li>Cracks on the ground surface at the spoil disposal area (landslide hazard)</li> </ul>					
Construction materials (precast concrete, rebar, timber, sand and gravel) left uncontrolled on the ground surface alongside the

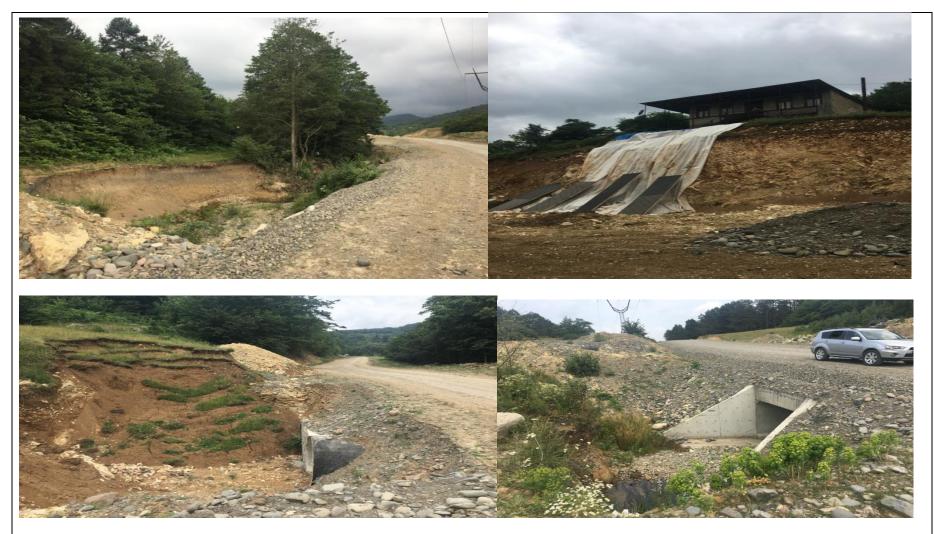
Deep cuts, trenches and pits, are without relevant barriers and warning signs

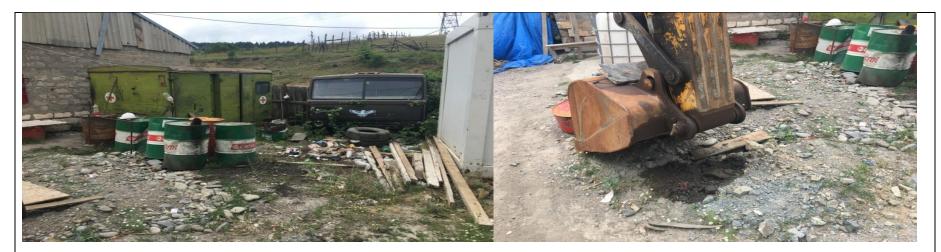
Oil drums outdoor, leaking backhoe and scattered waste at the construction base

holes.		selected yet).	
4.	Oil drums outdoor, leaking backhoe and scattered waste at the construction base	Hazardous liquid should be placed at special dedicated area for hazardous materials.	Contractor	Resolved Municipality	with local
5.	Cracks on the ground surface at the spoil disposal area (landslide hazard).	Conduct survey of ground and in case of landslide hazard elaborate relevant mitigation measures.	Contractor	Resolved Municipality	with local

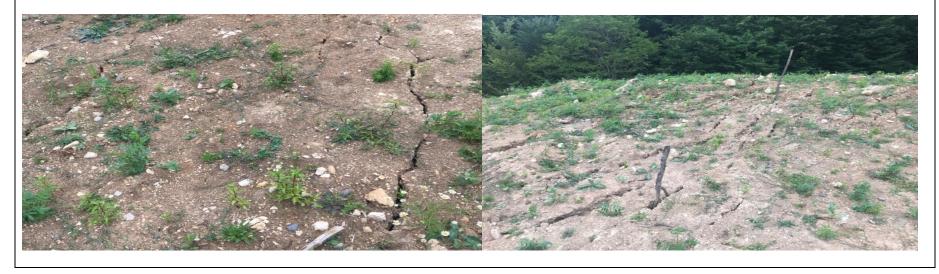
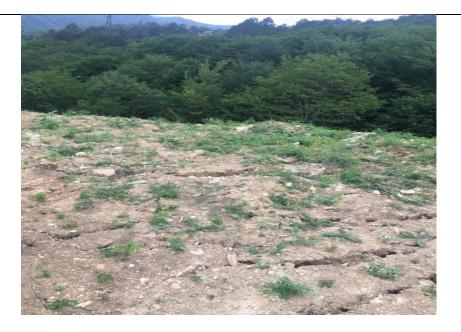
Cracks on the ground surface at the spoil disposal area (landslide hazard)
