Georgia: Batumi Bypass Road Project

Attachment 2 Construction of Bakurtsikhe-Tsnori Road Section

Semestral Report (July - December 2023)

Semi-annual Environmental Monitoring Report

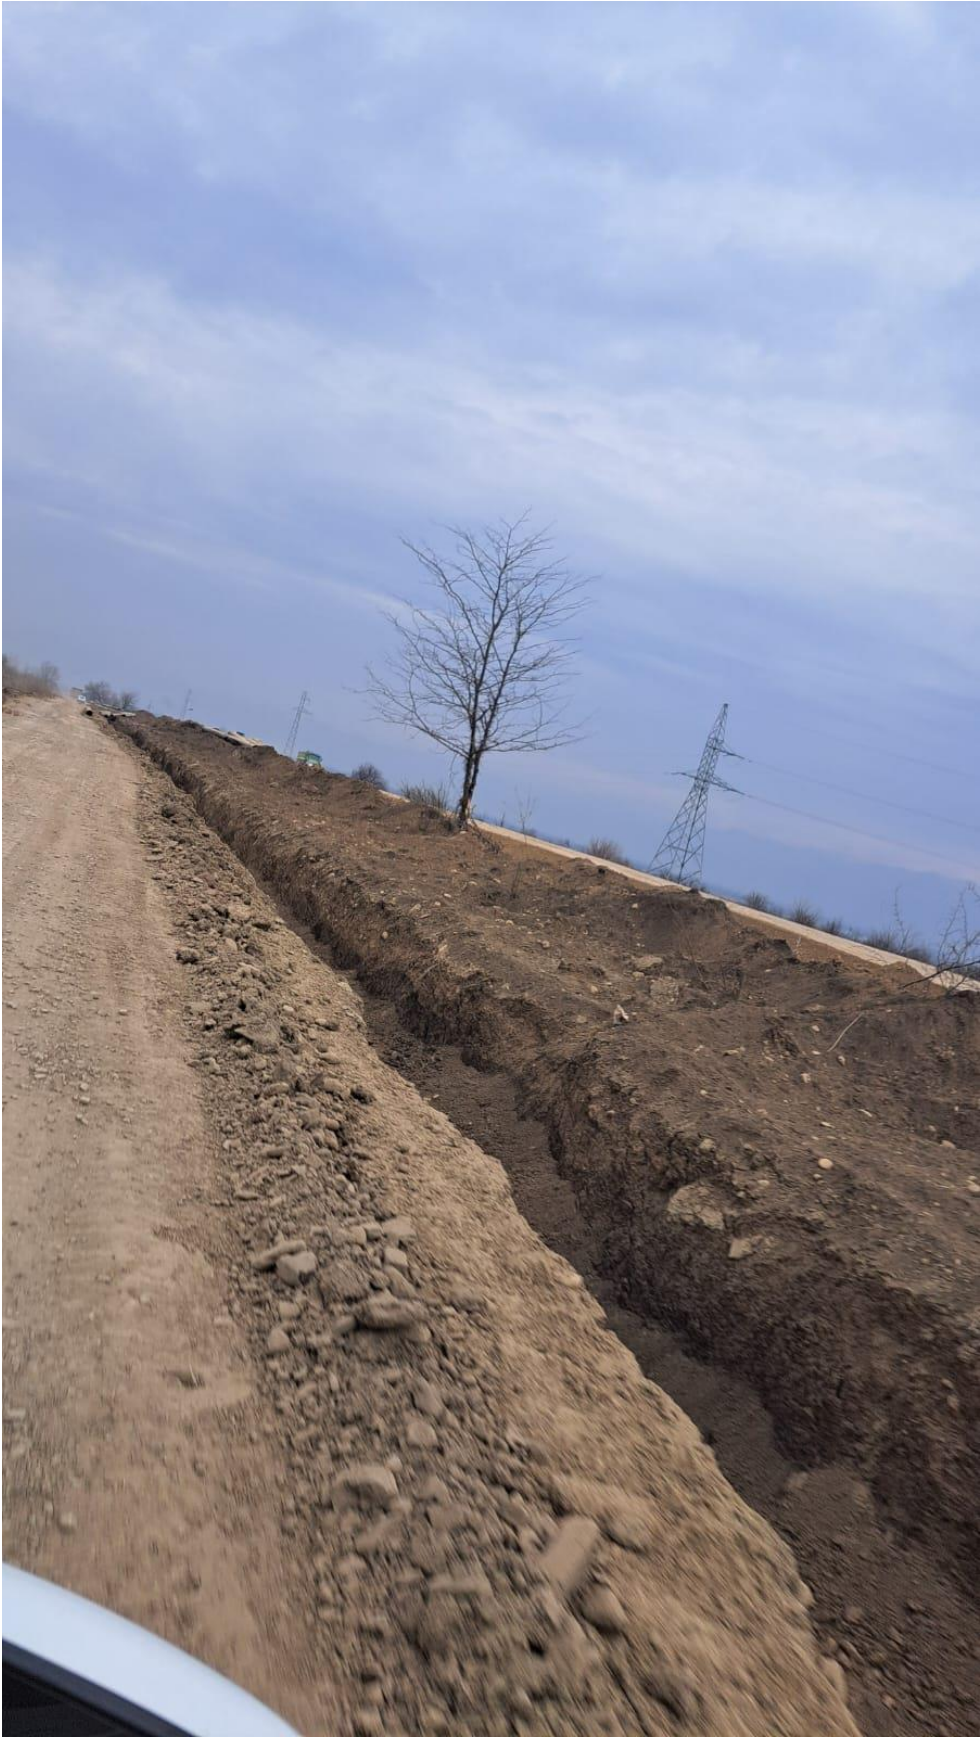
Trench for gas pipelines

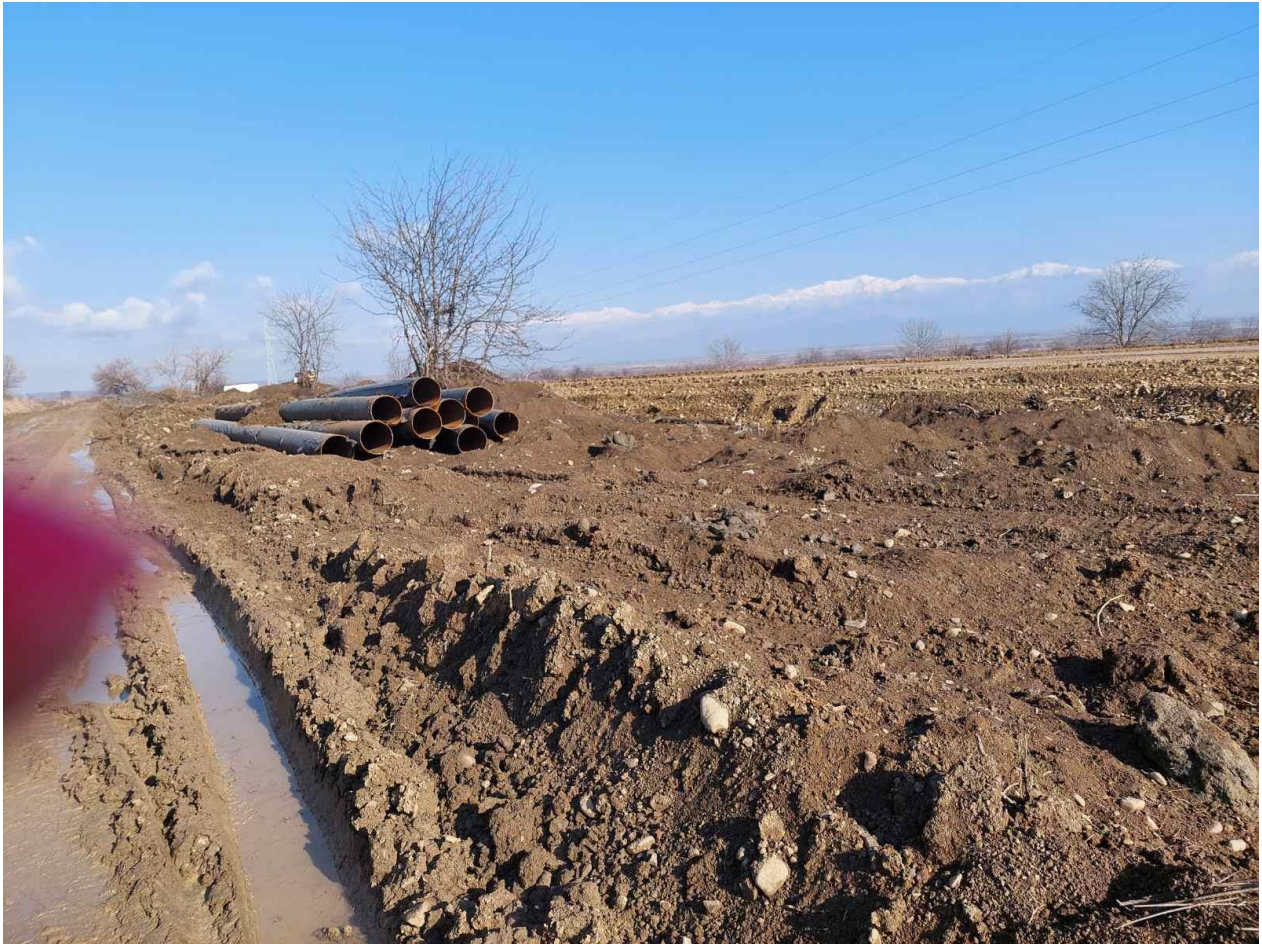
Relocation of gas pipelines is ongoing. The old pipelines will be transported by the owner – Georgian Oil and Gas Corporation

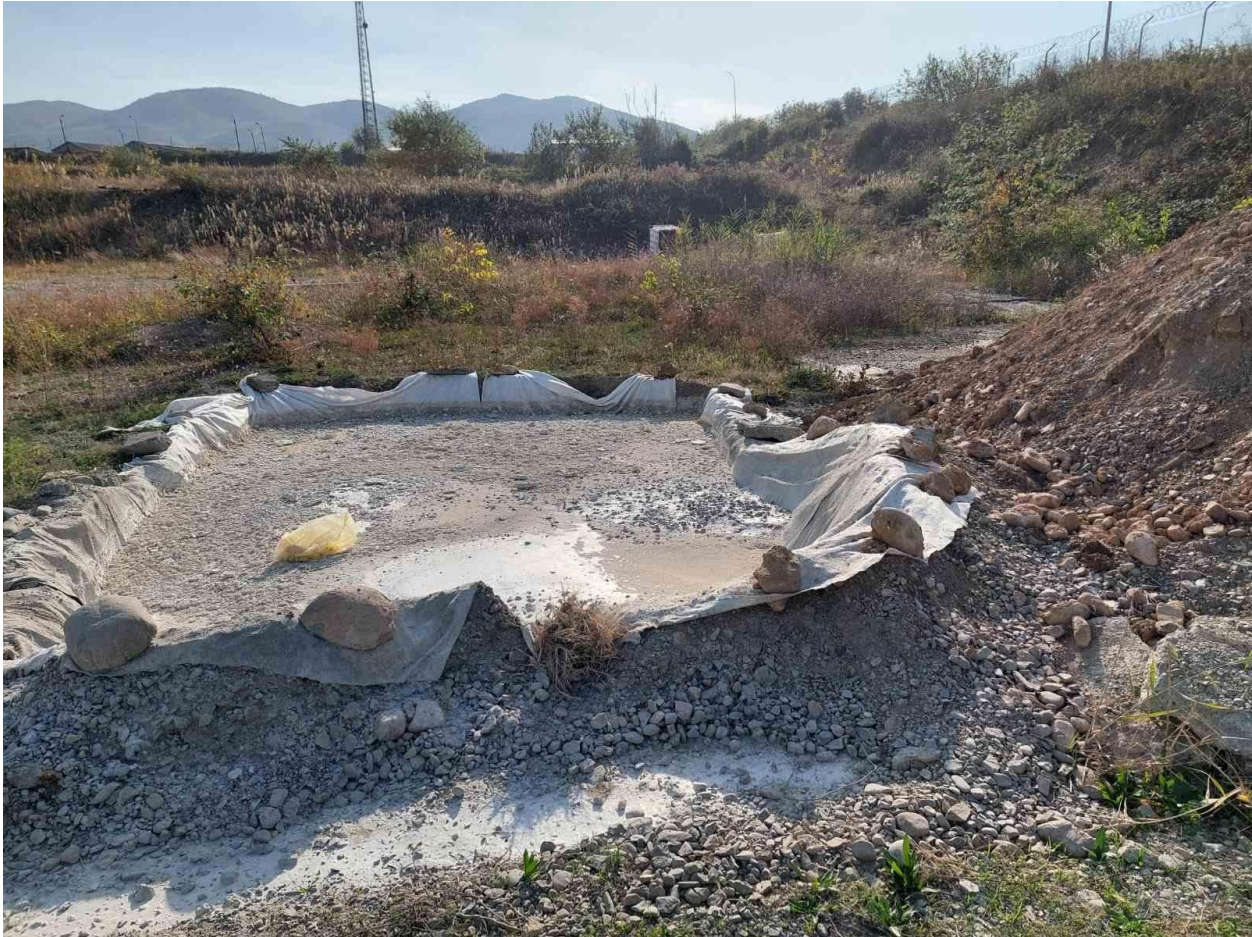
36. The Contractor has established contract with the Black Sea Group who provides the Contractor with reinforced concrete beams. The Subcontractor facility was visited by the Engineer. The subcontractor has waste management plan and hazardous waste storage area. The Engineer has requested to establish concrete washout pits. The concrete washout pits are located on the territory of the Black Sea Group. The place is not an agricultural land. It is covered with gravel and there is no topsoil. Spontaneous vegetation is developed on the gravel. The washout pits are covered with geotextile to avoid leaching of concrete particulates in the groundwater.

Washout pit covered with geotextile

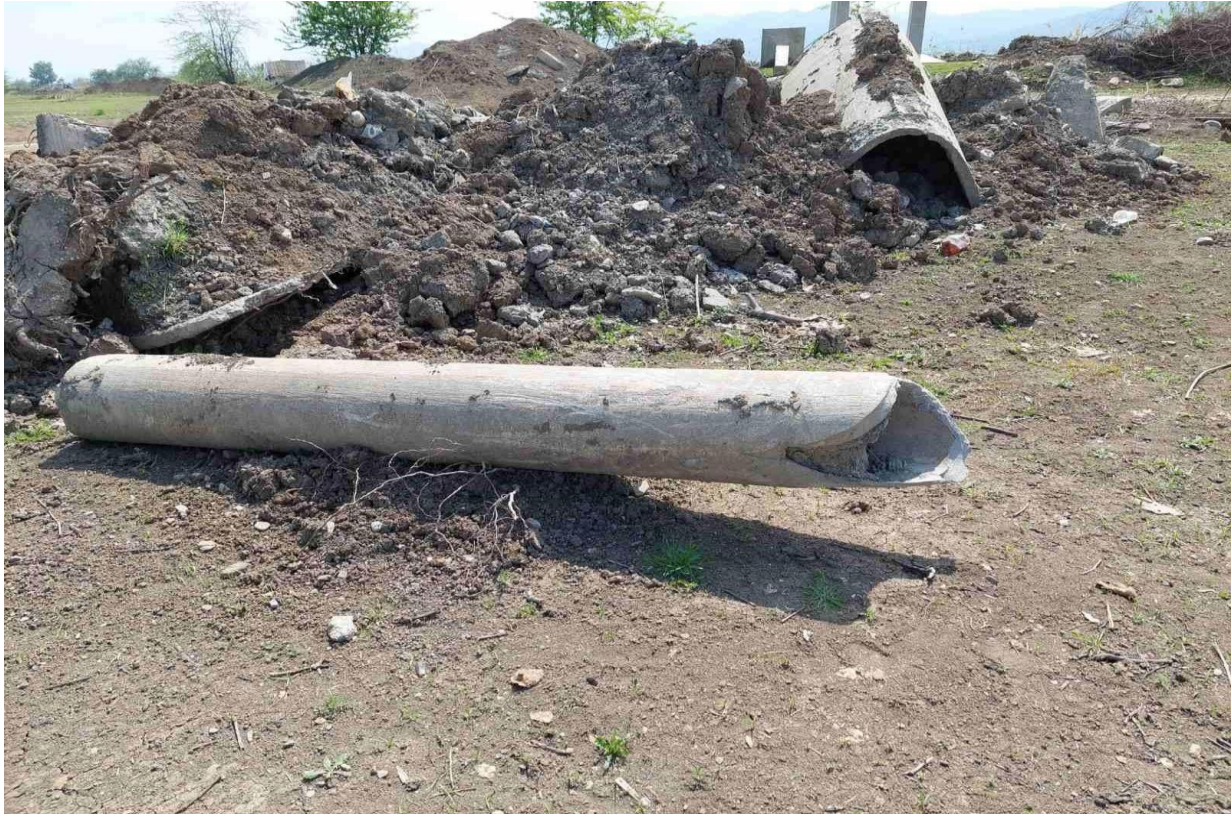
37. During the construction activities old water pipes of the Melioration were replaced with new ones. One water pipe was from asbestos material. The asbestos pipe was removed by waste company “Sanitar” and was disposed. The removed pipes were taken away by melioration since they were property of this company..

Asbestos pipe at the construction site

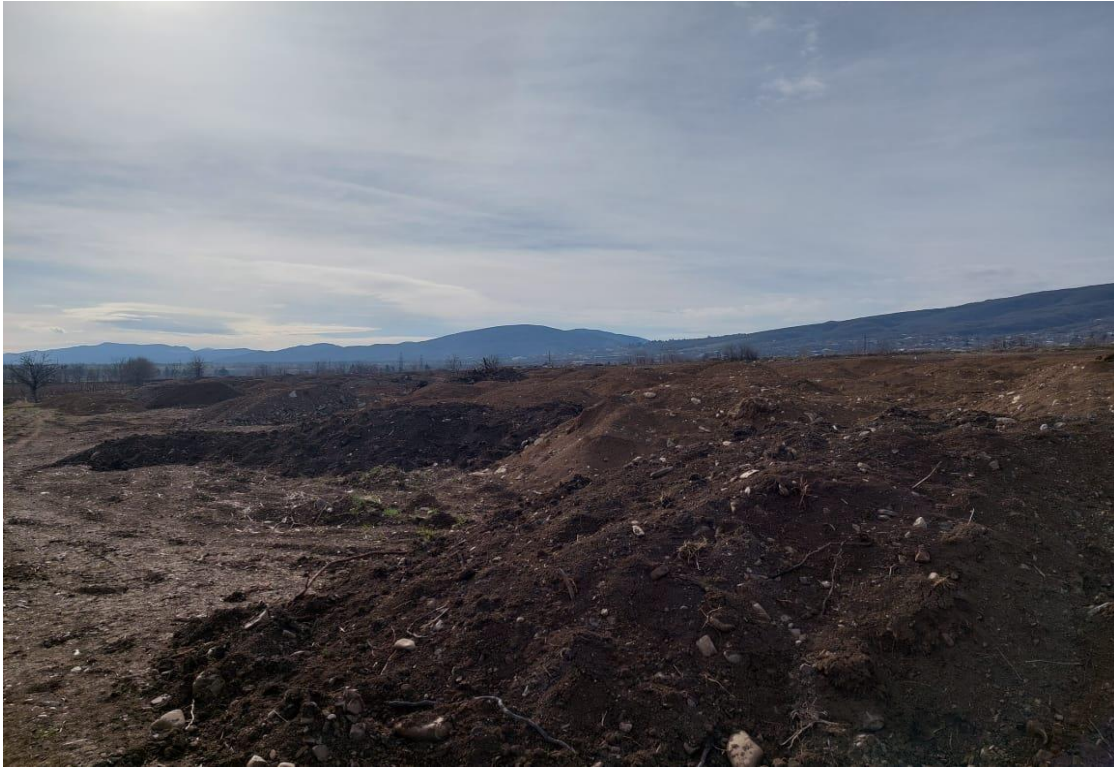
Topsoil storage area. Plot #1

27. Topsoil was removed before construction work was commenced. Topsoil is stored in three plots. Please see detailed coordinates of topsoil storage area below.

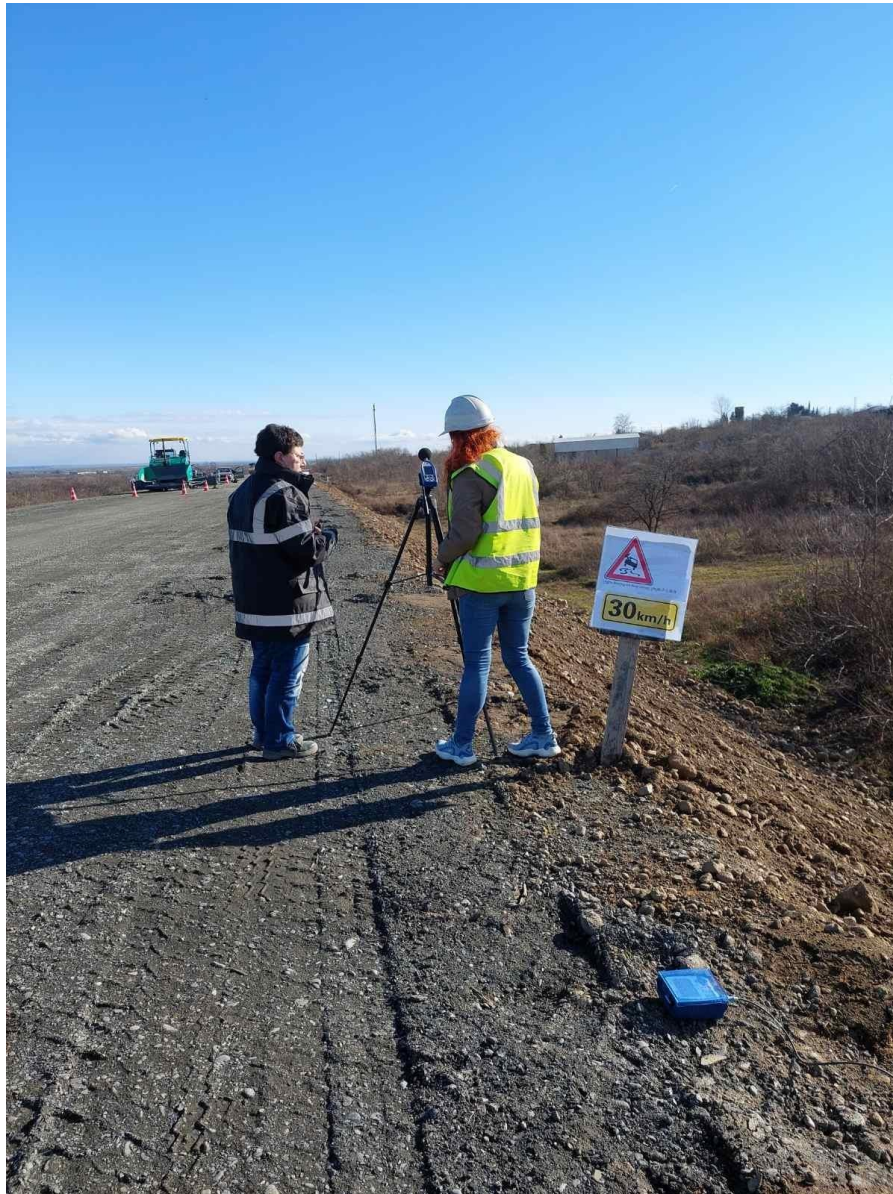
59. Environmental baseline monitoring for the quality of mediums (quality of air, and level of noise and vibration) have been provided by the Contractor. Monitoring of water quality has been quitted because there is no work which could affect water quality. Mostly embankment works are in progress. the project area is located in a distant from water source in this case amelioration water channel and has no impact on the quality of the water. Dust, noise and vibration monitoring points have been changed and are located near the sensitive receptors e.g. point 3 was monitored near the Anaga Borrow pit. Similarly point 5 was changed for dust monitoring. The point represents a road near agriculture land. Measurements of noise, vibration and dust are conducted together with the Engineer (see attached Figure)

Measurement of noise and vibration
