# Semi-Annual Environmental Monitoring Report

Semestral Report (July – December 2025)

## Georgia: East-West Highway (Shorapani – Argveta Section) Improvement Project

Prepared by the Roads Department of the Ministry of Regional Development and Infrastructure of Georgia for the Asian Development Bank.

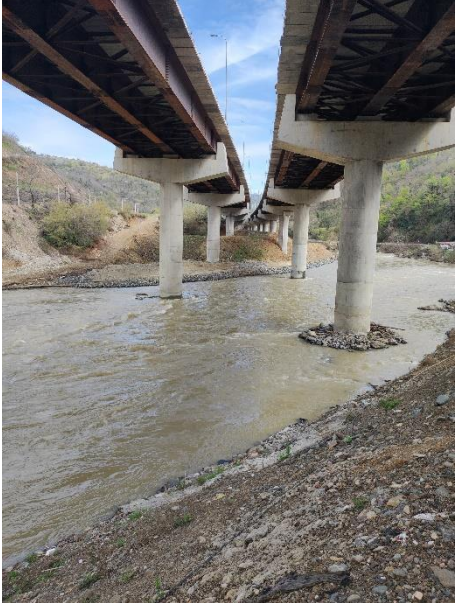
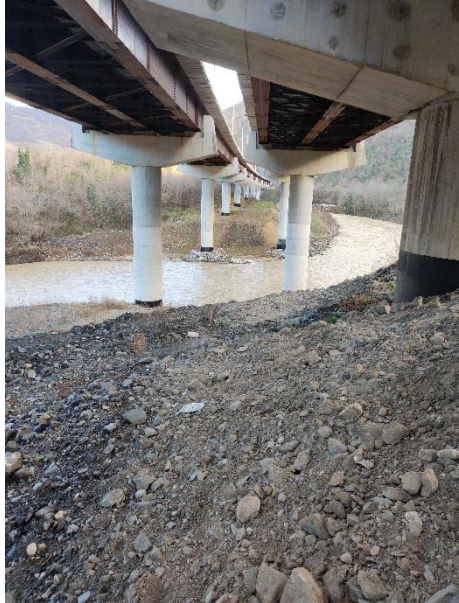
| <b>Riverbed/bank Restoration Loc 5.</b> | | <b>Riverbed/bank Restoration Loc 5.</b> | | |

35. **River Protection Measures for Spoil Disposal Areas:** At Spoil Disposal Site No. 2, all relevant works have been concluded, and the National Property Agency has officially handed over the area to another contractor for the construction of an motoway service area. For Spoil Disposal Site No. 1, the current status cannot be fully assessed, as the Contractor has not yet submitted the required information and completed activity details. Submission of this information remains necessary to confirm compliance with river protection requirements.

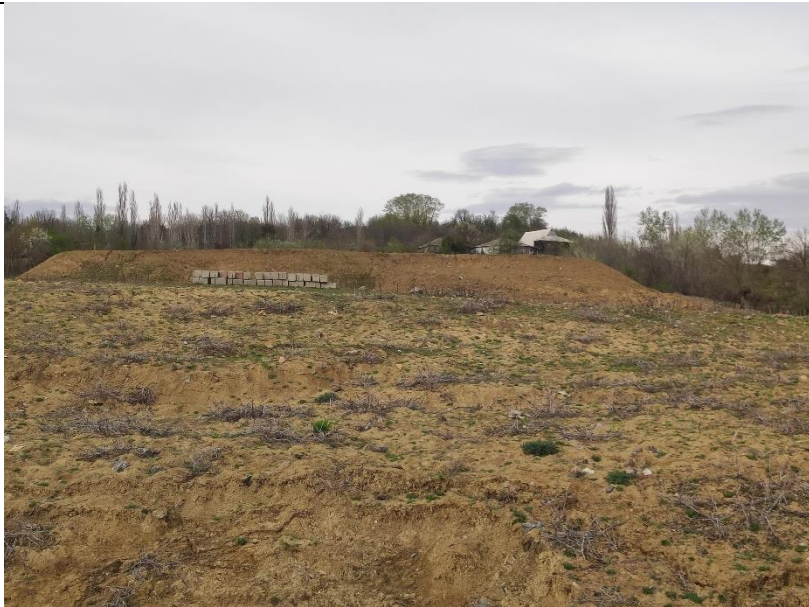
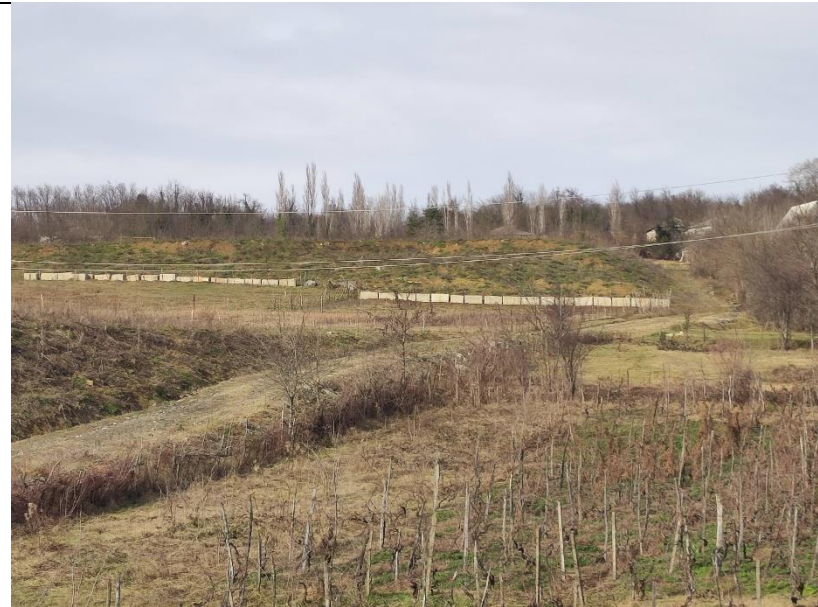
**Temp Spoil Disposal 1**

37. **Temporary Storage of Spoil Materials:** Rehabilitation has been completed at the majority of Temporary Soil (TS) storage areas, with visible revegetation of topsoil observed during site inspections. Nevertheless, a follow-up inspection is required, with particular attention to TS-1, TS-3, and TS-4, to verify the effectiveness and completeness of rehabilitation measures.

| Item ID | Issue | Issue ID | Issue Location | Required Action/Task | Responsible Party | Target Completion Date | Actual Completion Date | Status | Progress Notes / Comments |
|---|---|---|---|---|---|---|---|---|---|
| 4 | Temporary Spoil Materials Storage Management | TS-1 | Next to the road close to the interchange 4 | <ul style="list-style-type: none"> <li>Erosion and sediment control measures should be taken. Ensure that proper drainage is maintained around the storage areas.</li> <li>Topsoil replacement and vegetation.</li> </ul> | Contractor | - | - | Partly Open | The Engineer must be formally notified regarding stability concerns at the designated temporary spoil disposal area. |

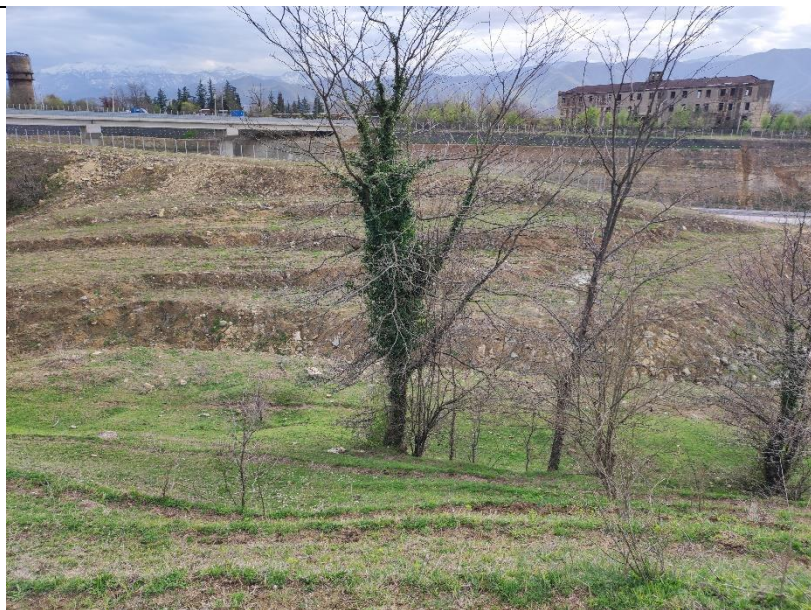
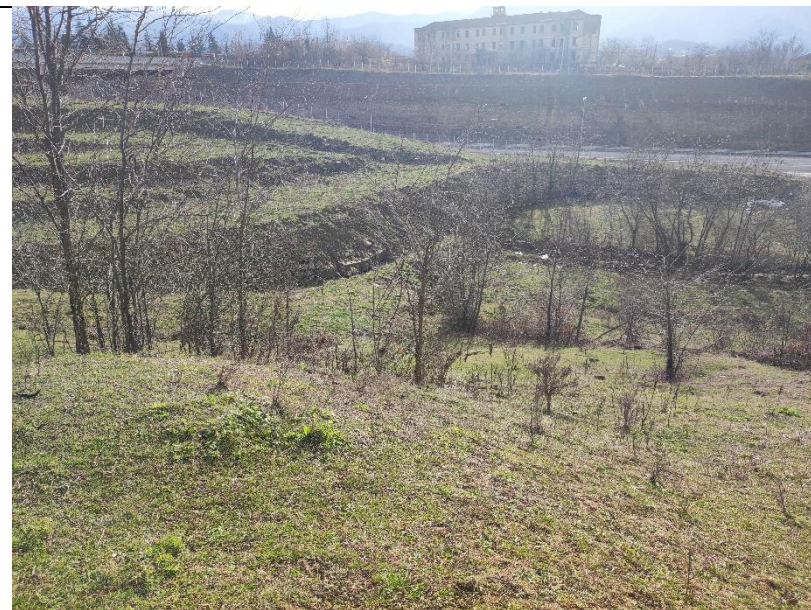
**Drainage Channel Structure for Spoil Disposal Site 3**

38. **Drainage Management at Spoil Disposal Site No. 3:** Detailed information regarding the construction and current condition of interceptor and drainage channels at Spoil Disposal Site No. 3 has not yet been provided by the Contractor. Until this information is submitted, the adequacy of drainage management measures cannot be fully assessed.

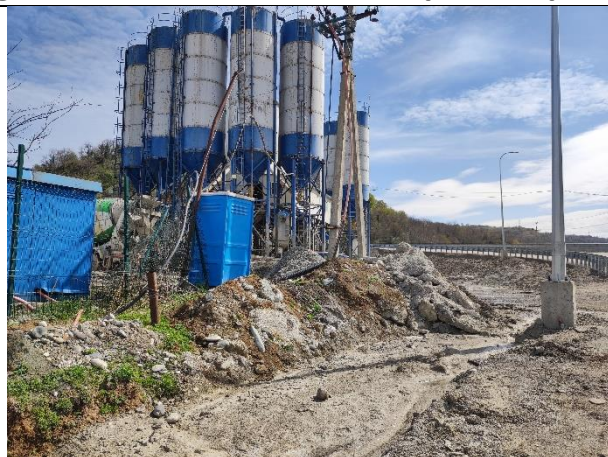
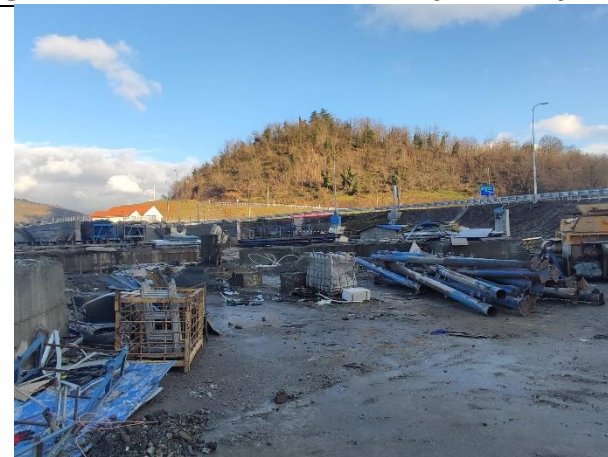
**Batching Plant**

61. While certain positive developments have been observed—such as the dismantling of the batching plant, rehabilitation of most temporary soil storage areas, and the initiation of landscaping activities—the timely and complete implementation of all PCEAP actions remains essential to achieve full environmental compliance and final site closure.

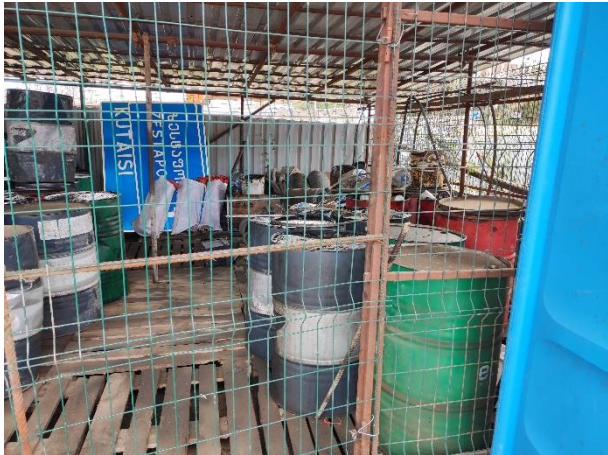
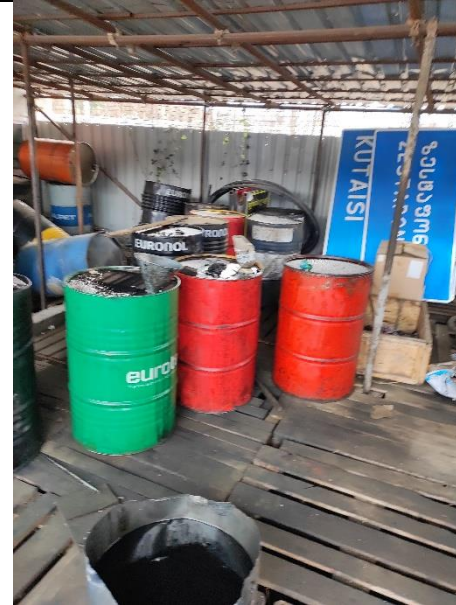
**Hazardous Waste Storage Area**

40. **Hazardous Waste Disposal:** Disposal and removal of hazardous waste from the site have not yet commenced. This issue remains outstanding and requires immediate action to ensure compliance with environmental regulations and to prevent potential environmental and health risks.

64. **Expedited Issue Resolution:** Priority should be given to unresolved issues, particularly hazardous waste disposal, scrap metal and equipment removal, incomplete spoil disposal site management, and outstanding remediation works at camps and workshops.

| 6 | <b>Hazardous Waste Disposal</b> | <b>HW-1</b> | Hazardous Waste Storage Area | All segregated hazardous waste should be sent to a licensed and certified hazardous waste management company. This item is crucial and requires immediate and focused attention | Contractor, Specialized Waste Management Company | - | - | Open | |
