Semi-Annual Environmental Monitoring Report

#9 Semi-annual EMR

Reporting period: January – June 2023

Georgia: Rehabilitation of Dzirula–Kharagauli–Moliti–Pona– Chumateleti Secondary Road Section (50Km)

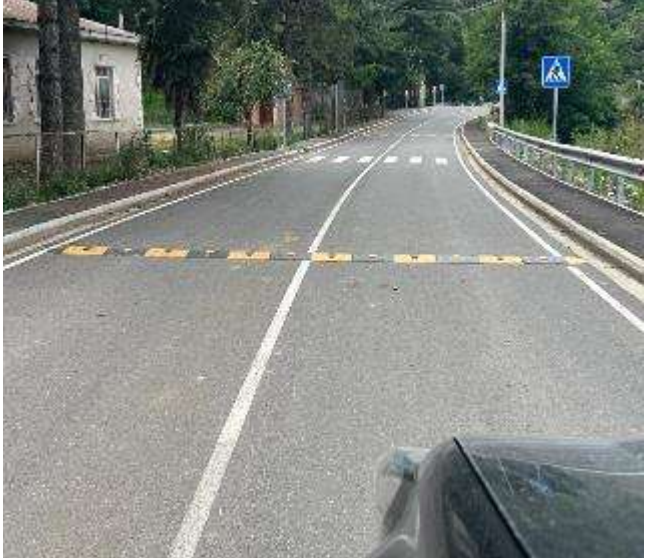
Figure 2. Arranged road signs including “lying policemen” and sidewalks and sides	Figure 3. Arranged road signs and sidewalks and sides

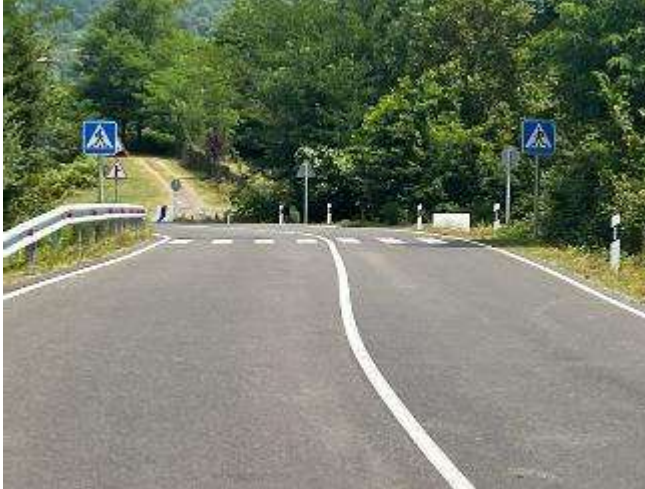
Figure 4. Arranged road signs	Figure 5. Constructed bus shelter

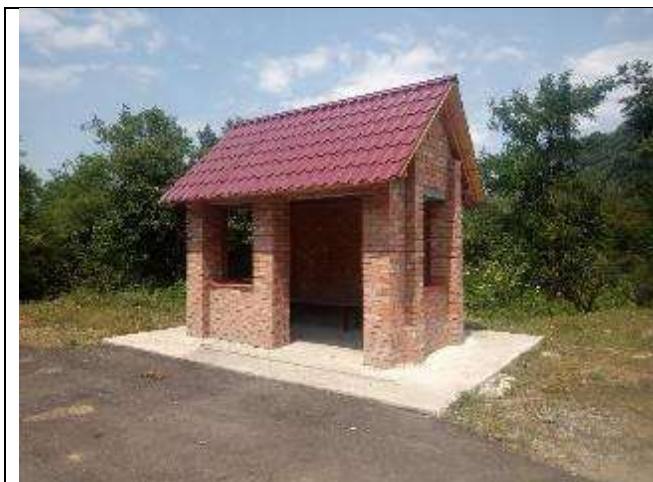
Figure 6. Constructed bus stop shelter	Figure 7. Constructed bus stop shelter

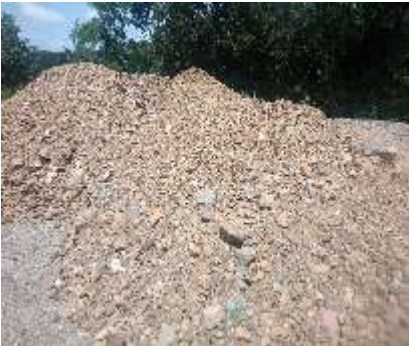
Date of SiteVisit	Staff	Detailed Findings	Required Actions	Date of Report Submitted and to whom
10.04.2023 LOT 1	SC and CC	Inert waste was disposed uncontrollably on KP 6+85 of the road

Inert waste shall be disposed on the territory preliminary agreed with the local municipality	09.06.2023 Status: Completed

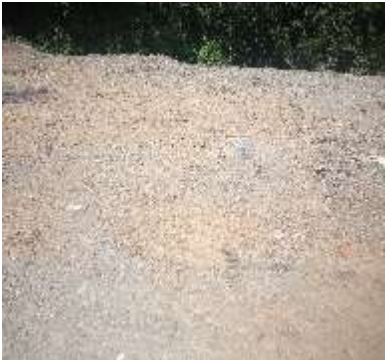
09.06.2023 LOT1	SC and CC	<ul style="list-style-type: none"> Construction waste was not segregated properly and disposed of at special dedicated area 	Construction waste shall be disposed of the camp territory by the licensed sub-contractor	22. June 2023 Status: On-going

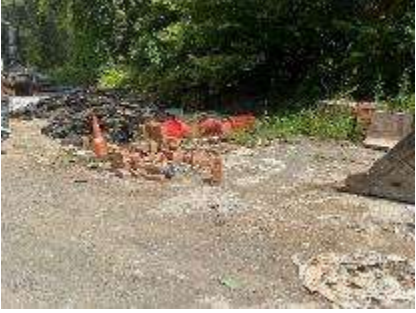
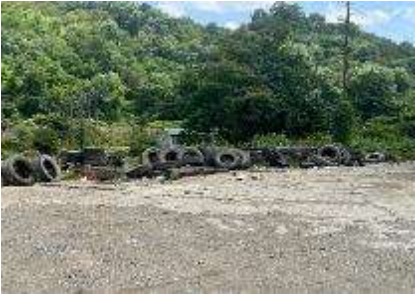
22.05.2023 LOT1	SC and CC	<ul style="list-style-type: none"> Used tires were placed uncontrollably on the territory of the camp

Used tires shall be disposed of the camp territory by the licensed sub-contractor	25 June 2023 Status: On-going

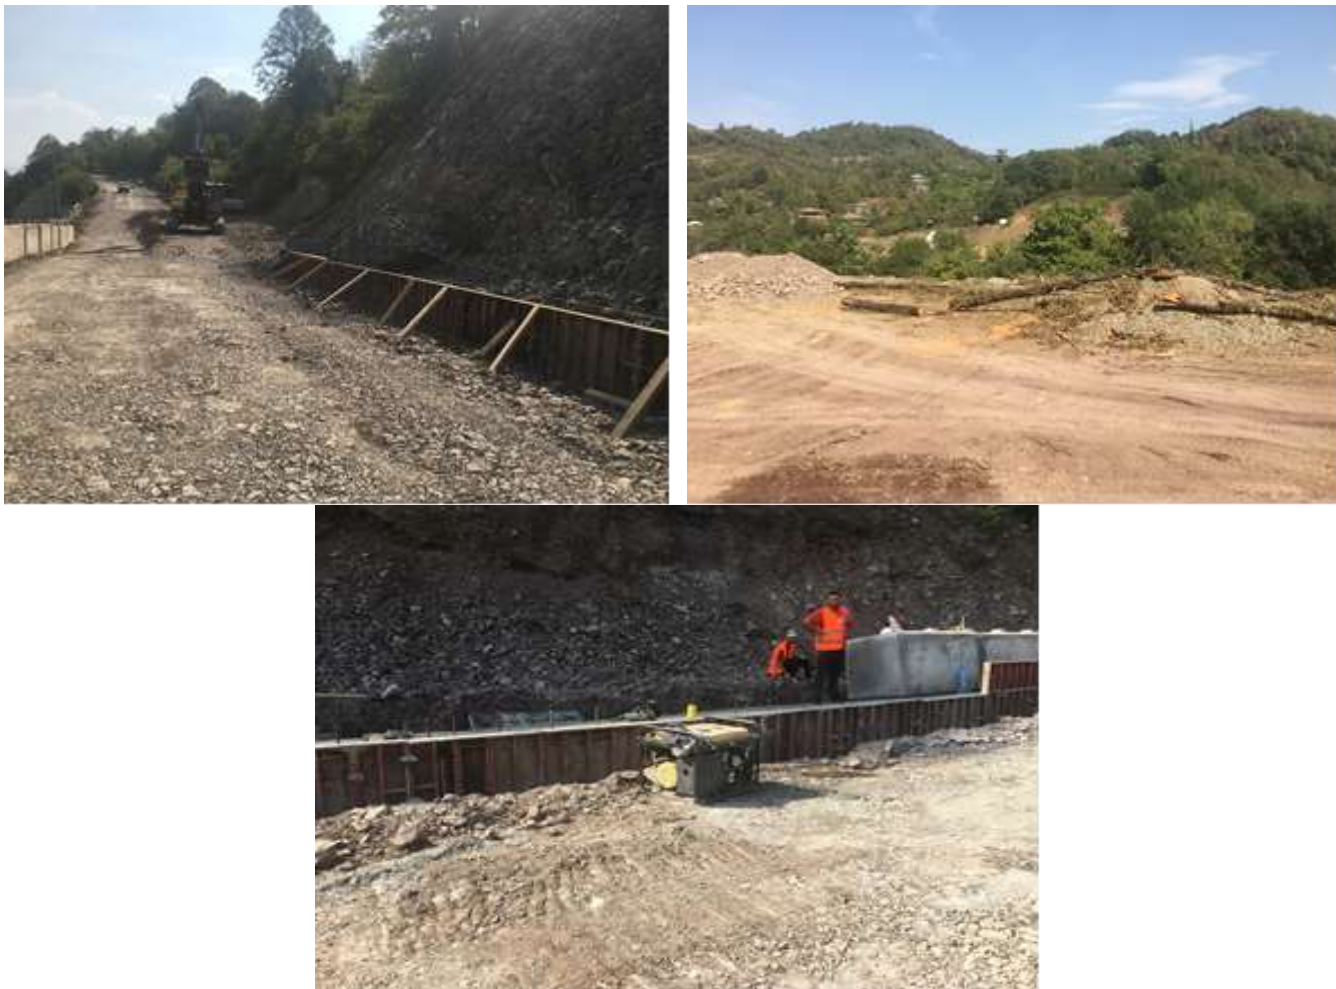
Figure 10: Abandoned sites of LOT 2

37. Existing non-compliances fully corrected by the local municipality. Please see below photos on Figure 10 of the abandoned sites of LOT 2.

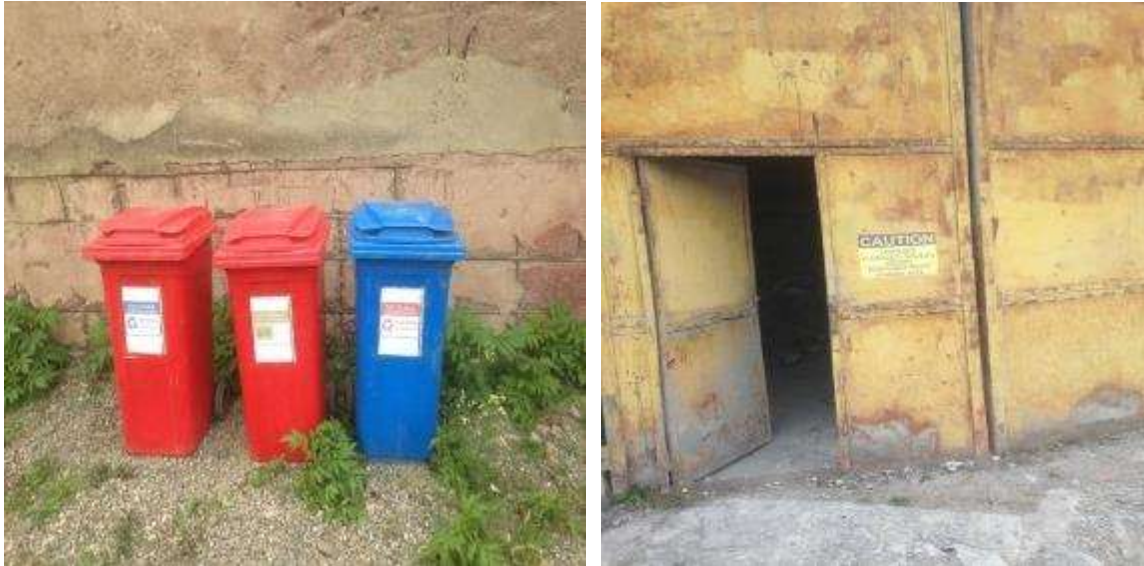
Figure 11. Hazardous and Municipal waste management (LOT 1)

54. Insignificant amount of hazardous waste (~50kg) kept in warehouse at Kharagauli camp (**special room with concrete floor and locked metal gate with warning**). So, there is no possibility of soil or ground water contamination. During Jan-Jun 2023 reporting period "Ecomedy" (licensed company) removed and disposed hazardous waste from the construction sites in May 2023. A certain amount of construction waste and used tires are placed uncontrolled on the territory of the construction camp (see **Table 8**). At this stage, the camp is being dismantled and the said waste will be removed from the camp territory during Jul-Dec 202 reporting period. 10 M³ municipal waste from the sites removed and disposed by the licensed contractor (Kharagauli Cleaning Service) in every two weeks.

55. Photos of the empty hazardous waste storage area and municipal waste containers are provided in the **Figure 11**.

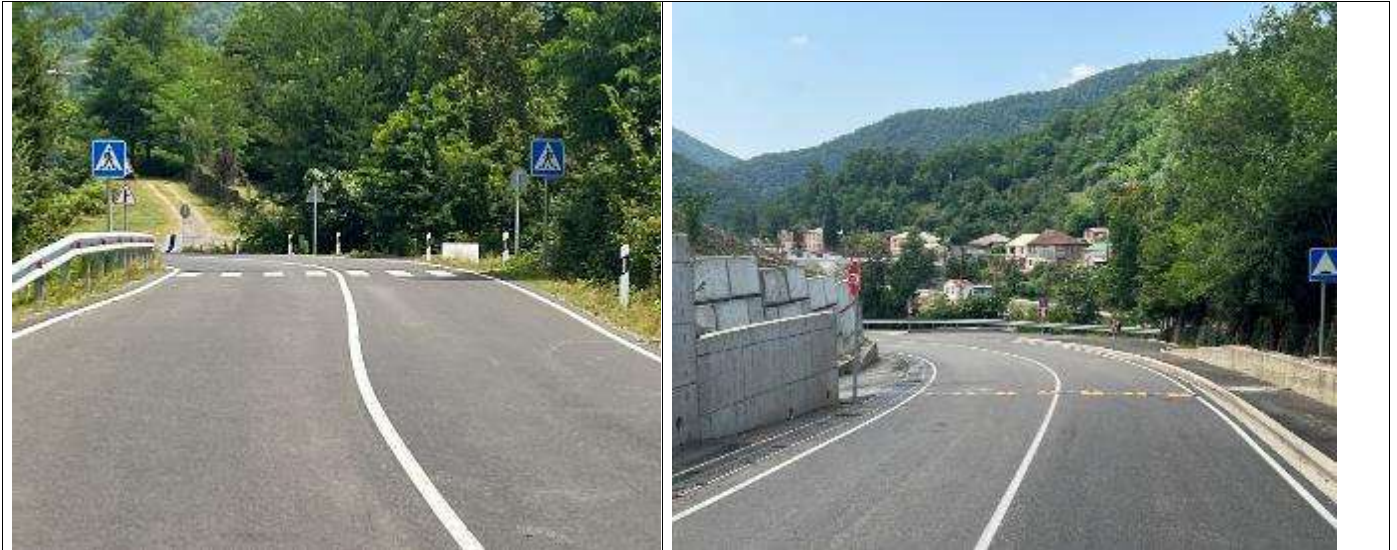
Arranged road signs

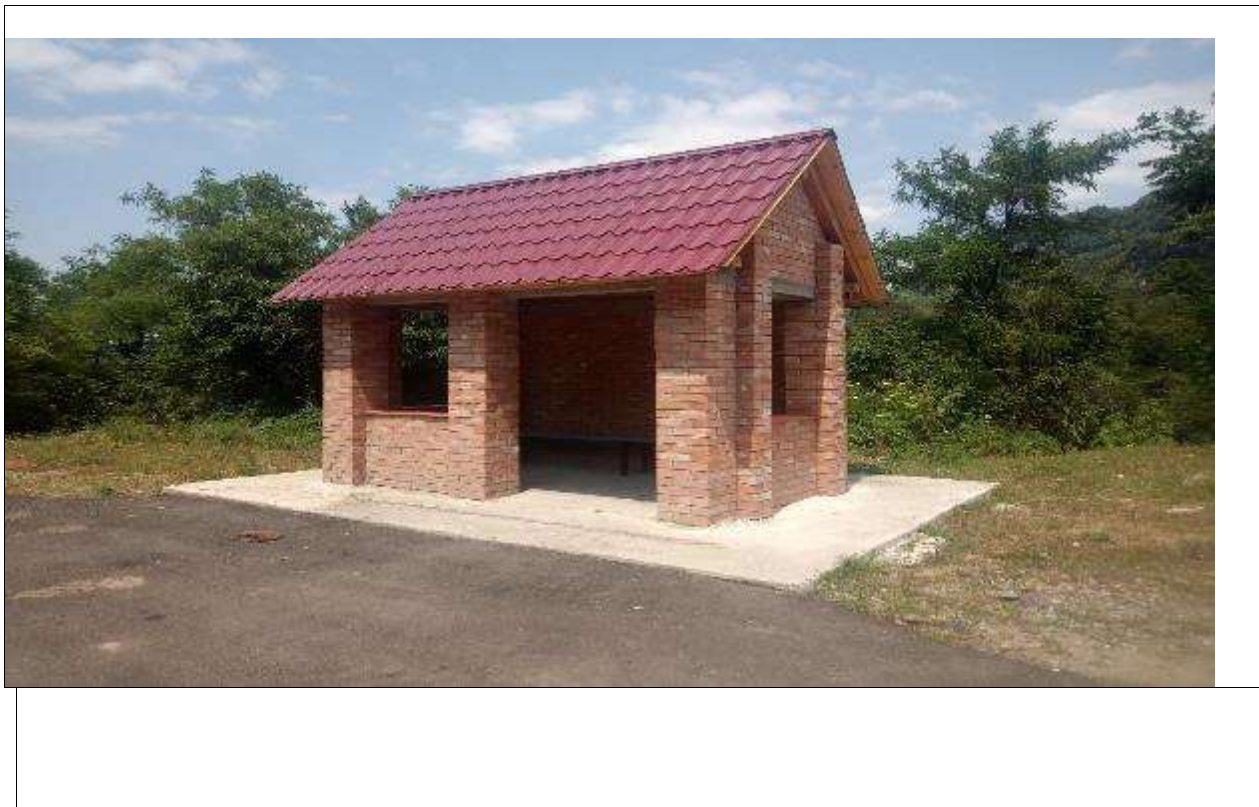
Installation of bus stop shelters

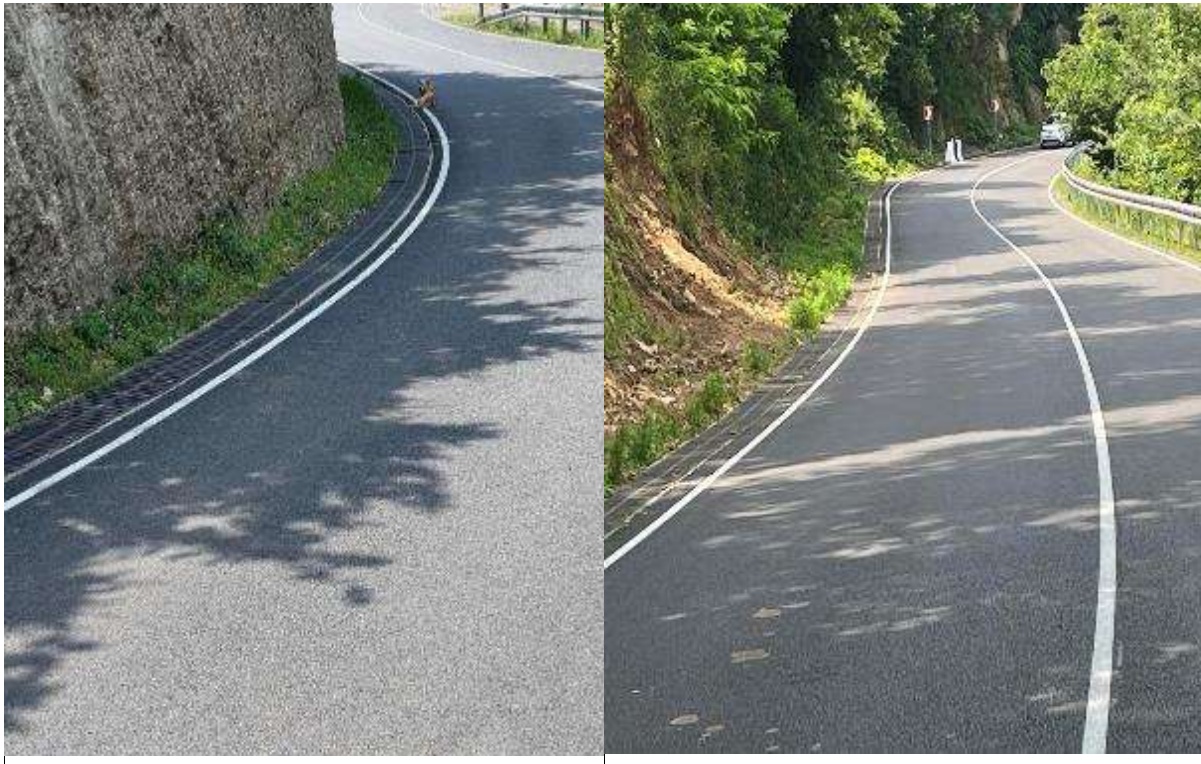
Covered drainage channels with an iron grids

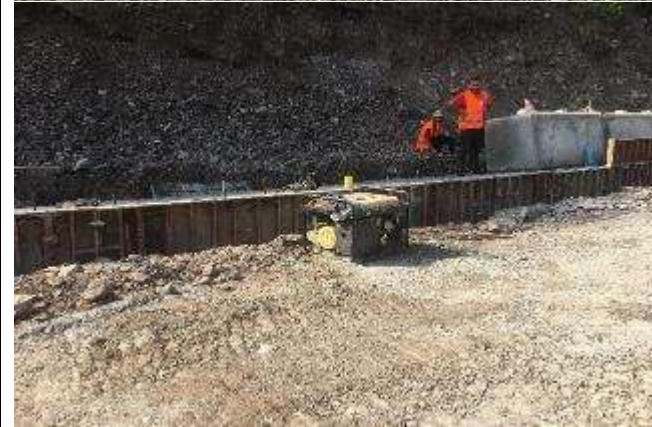
Date of site visit: 07.10.2022

Power generator without drip tray, workers without PPE

All these conditions have to be remedied within 10 days by the prime Contractor (BSG).
