**Reporting Period: July - December 2019**

**Project name: Kobuleti Bypass Road Section KM12+400-  
KM31+259**

## **Bi-annual Environmental Monitoring Report**

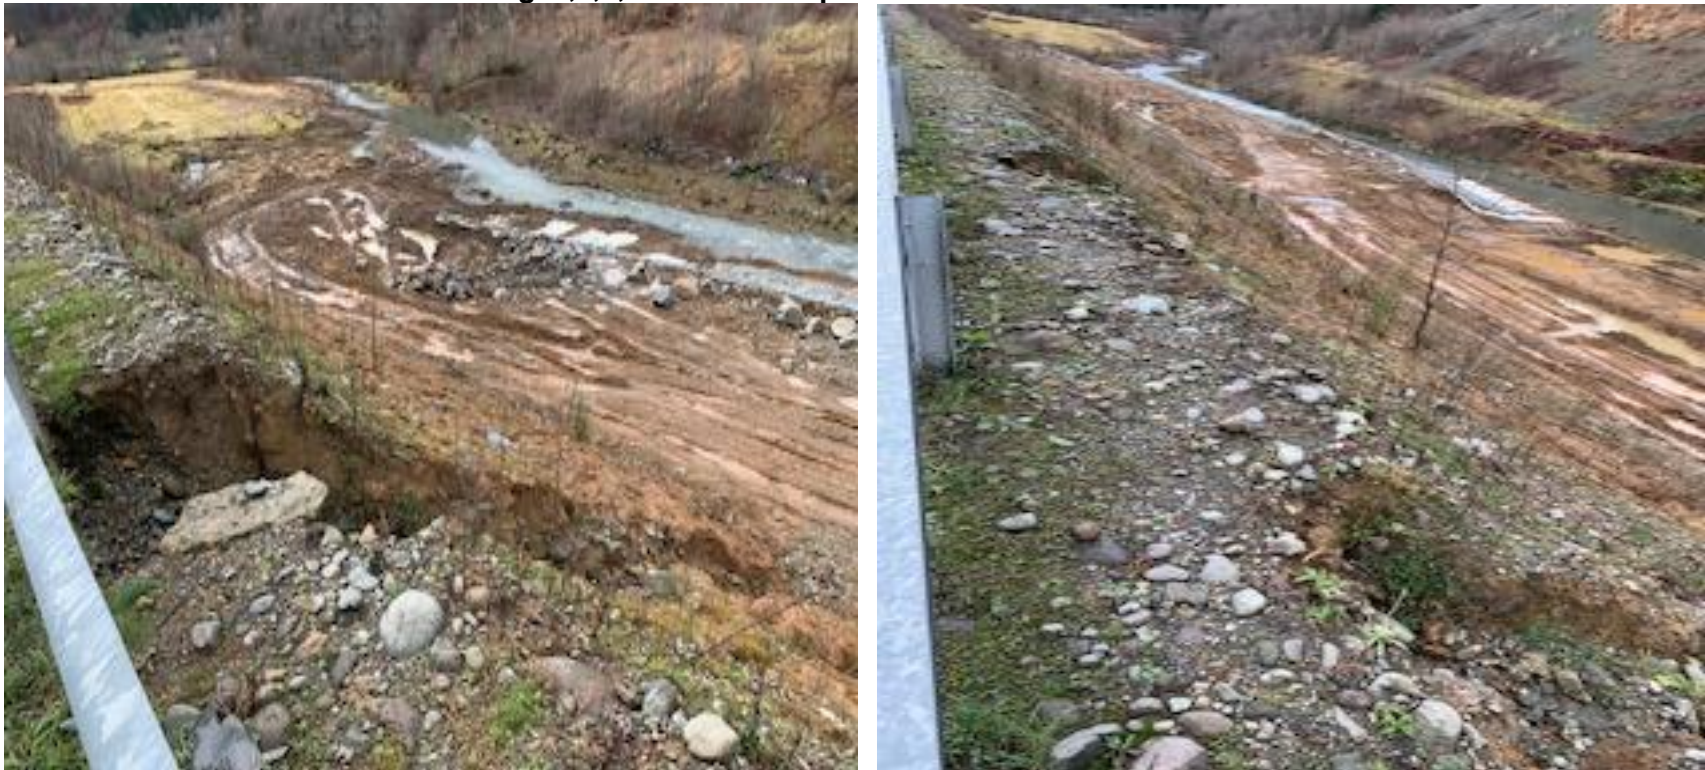
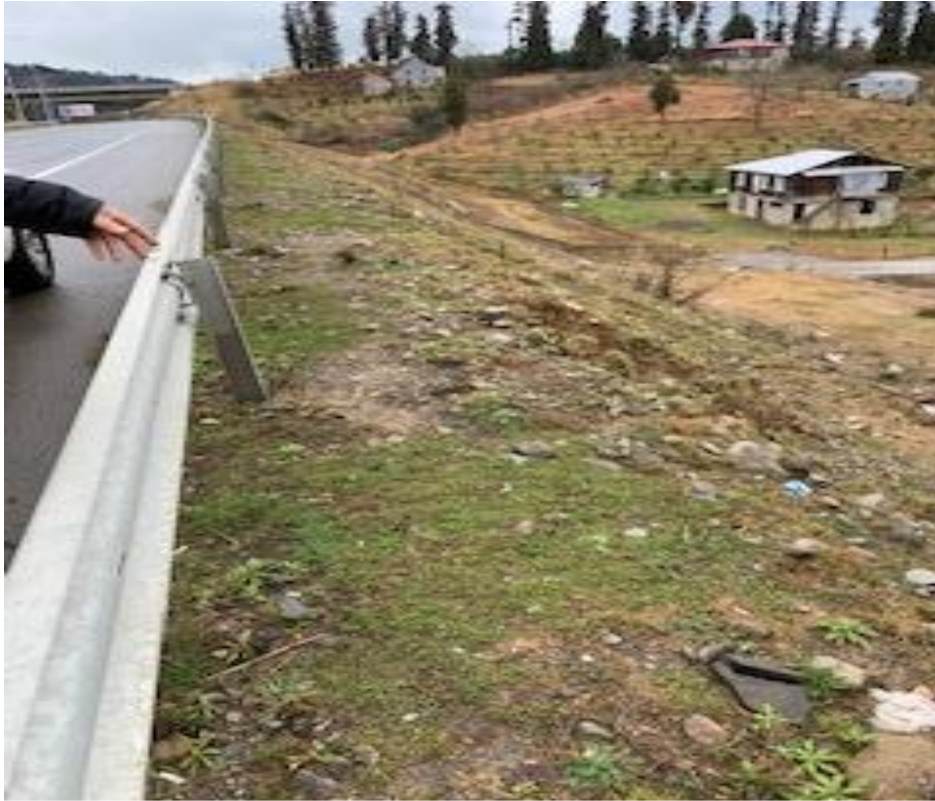
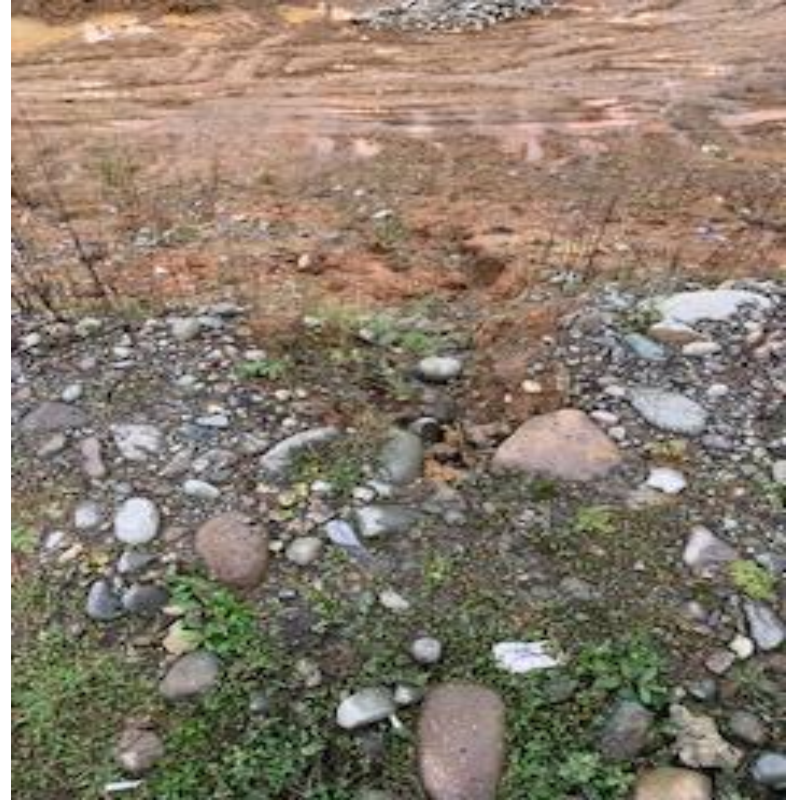
- **Slopes reinstatement/stabilization:** During the previous mission at some places (KP 5, KP 11,800) due to lack of top-soil no regrowth of the grass was observed. It was recommended by ADB Mission that it is necessary for slopes stabilization spreading topsoil and seeding the grass. In September 2019 the contractor used additional topsoil and performed seeding of the grass but there are still some places where topsoil spreading and seeding are required (**Fig.1**). Since the defect liability period was extended till the end of March ADB mission requested the Contractor to continue reinstatement activities of slopes in March 2020. Some new eroded slope sections were also observed during the site visit (**see Fig. 2, 3, 4 and Fig. 8**), Contractor was requested to reinstate eroded areas during the defect liability period and reflect statuses of corrective measures in the Final EMR due in July 2020.

**Fig. 1,2,3, 4: Eroded slopes at some sections of the road**

#	Non-conformance	Corrective actions	Deadline	Responsible organization/person
1.	CC to continue slopes stabilization and reinstatement process	CC to use topsoil and seeding for reinstatement of slopes.	Q1, 2020	Contractor

3.	CC to continue reinstatement of Shuagele quarry site	CC to use topsoil and seeding for reinstatement of quarry site.	Q1, 2020	Contractor
4.	At some places (KP 5, KP 11,800) slopes are damaged, spreading of top-soil and seeding of grass has not been executed.	Backfilling of slopes and seeding.	Will be executed in March 2020	Contractor

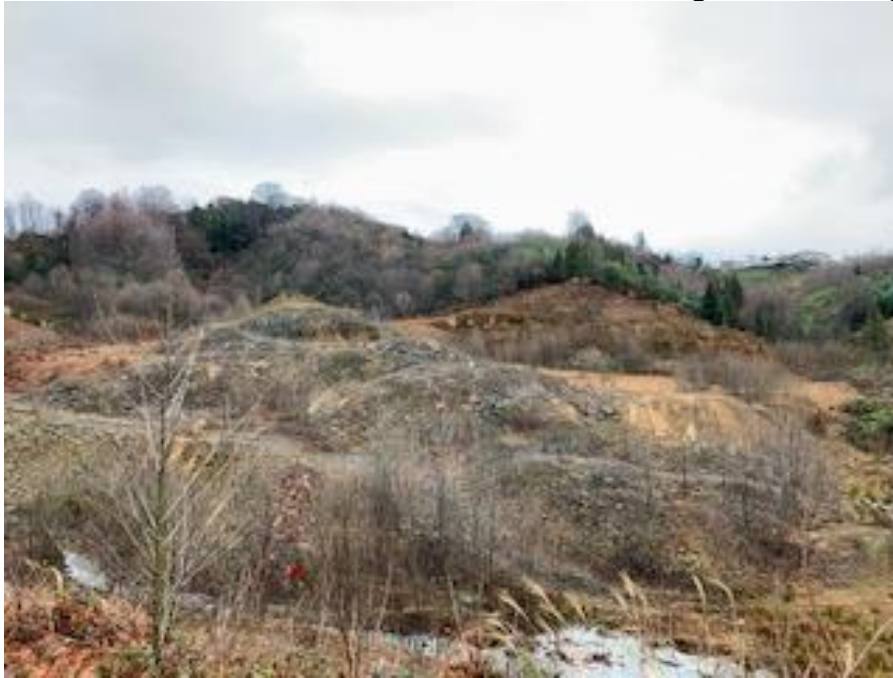
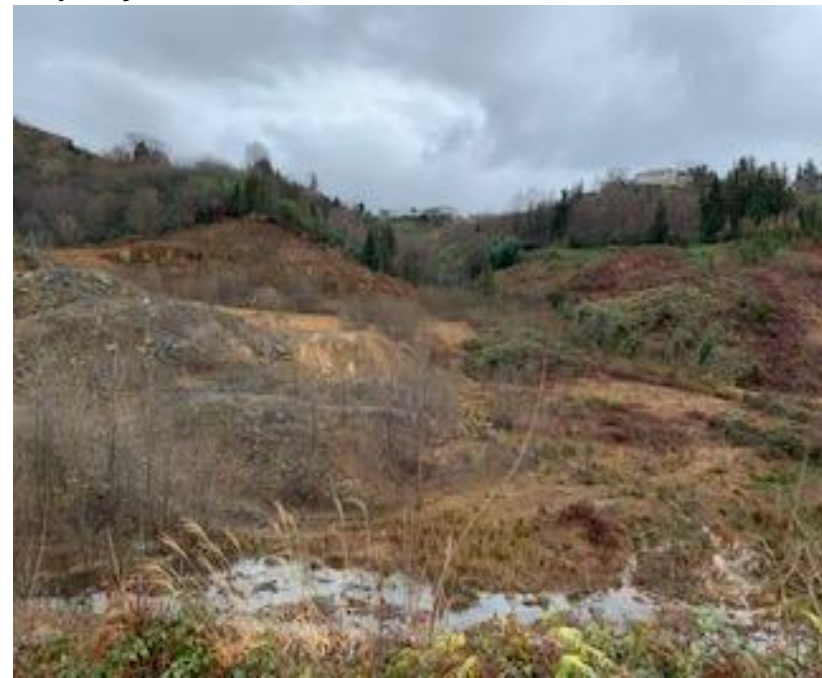
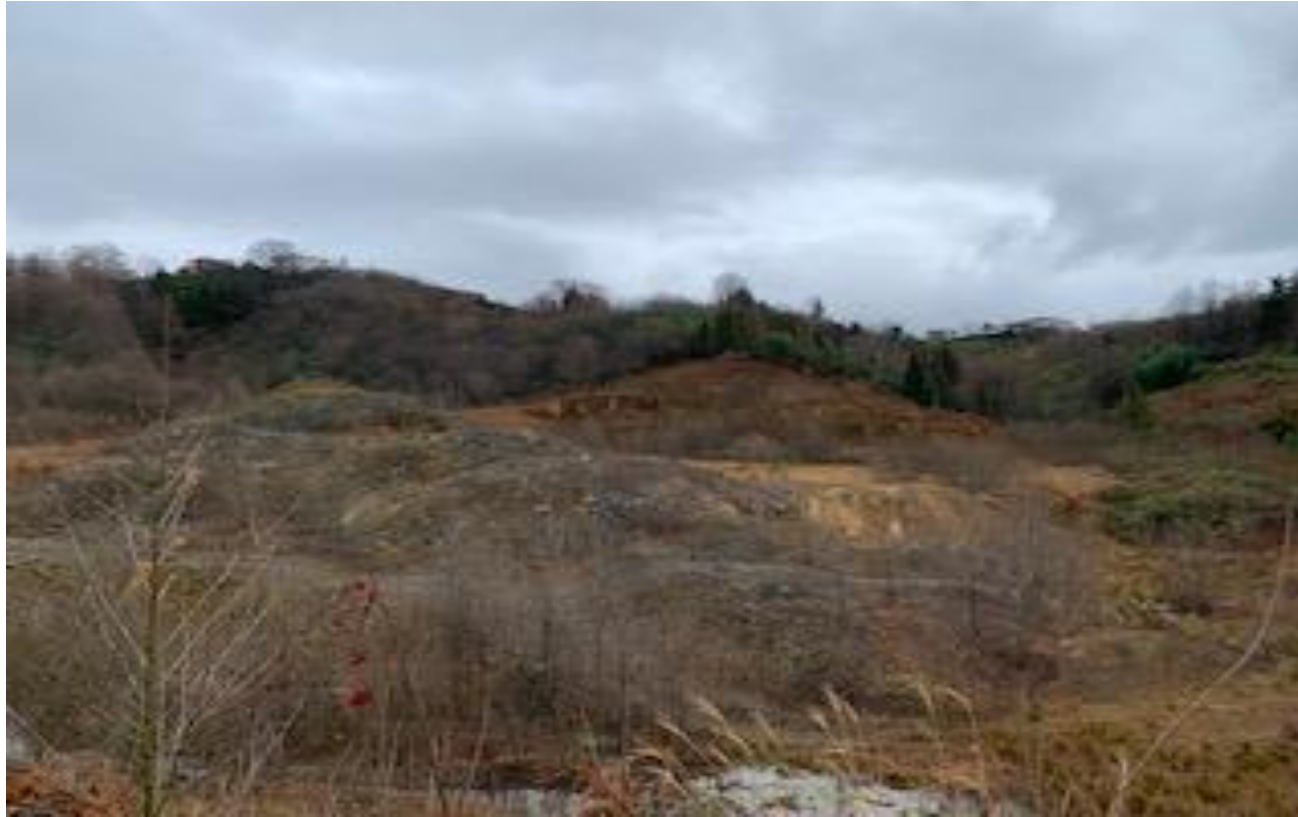
- **Quarry site:** Some progress in reinstatement of Shuagele Quarry site located near riv. Dekhva was observed, in particular most trees planted previously (2017-2018) grew well, but landscaping activities still need to be implemented, including covering of rocky hills with topsoil and seeding the grass. During the site visit it was observed that Contractor did not manage to use additional topsoil and seeding the grass in September-October 2019 (**see Fig. 5,6,7**). ADB Mission requested Contractor to use additional topsoil and seeding in March 2020 and reflect statuses of CAP implementation in Final EMR.

**Fig. 5,6, 7: Shuagele quarry site**

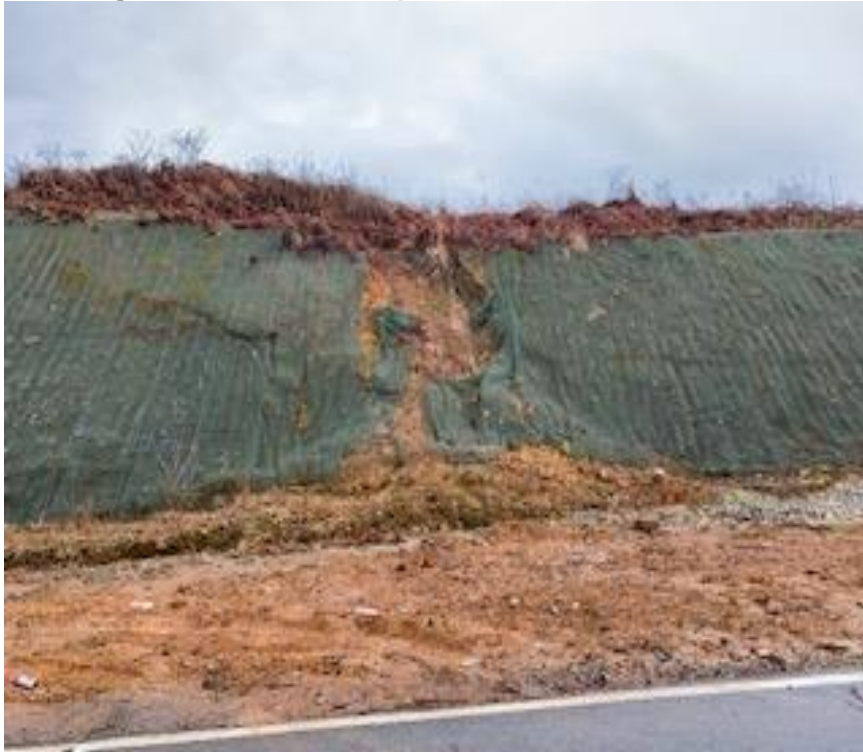
**Fig. 8: New eroded slope**

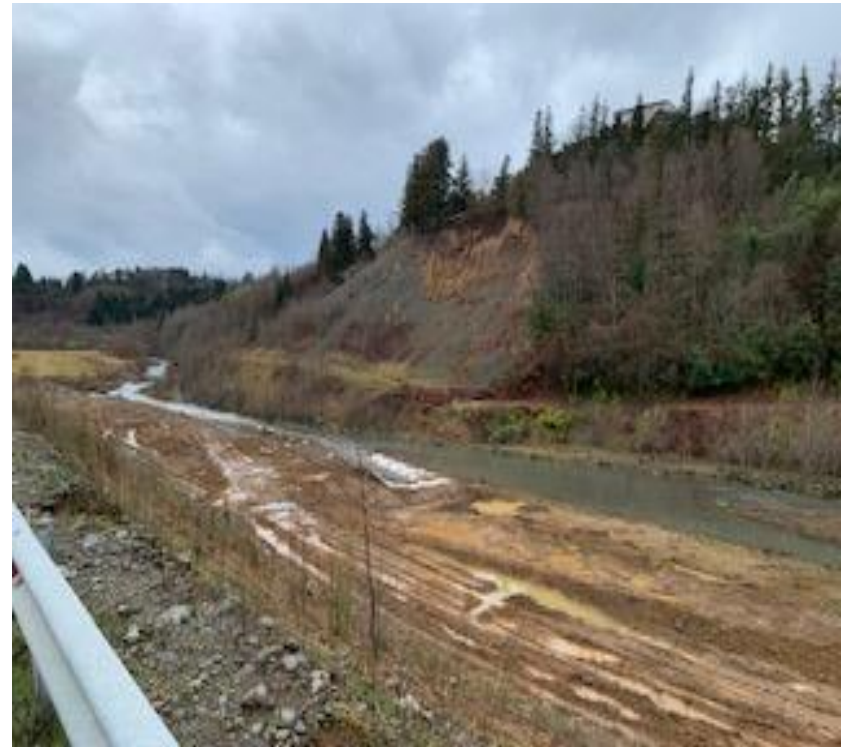
**Fig.9: Reinstated slope**
