Semi-Annual Environmental Monitoring Report

Reporting period: July - December 2021

GEO: Construction of Shorapani – Argveta Section (E60 Highway Route), Lot F4 Project

Financed by the Asian Development Bank

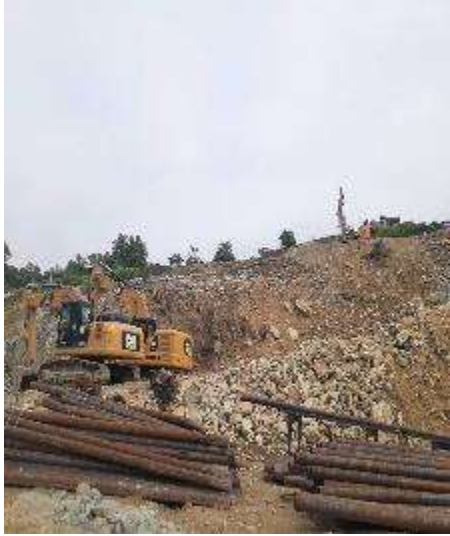
ID #	Affected Location	Date	Issue raised	Mitigation Required	Estimated time	Corrective Actions (Provide Pictures)	Status of Action
1	BP# 2	July 2021	Unprotected slope. Large boulder causing hazard to fall down	Large boulders need to be removed from the steep slopes. Slope needs to be stabilized.	One week	<p>Non-Conformance mentioned in the previous report has been corrected, large stones have been removed from the slope;</p>

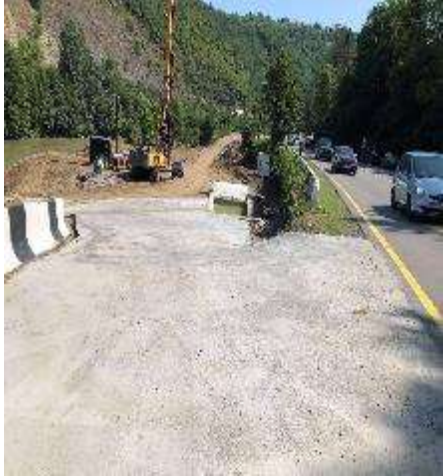
3	Bridge# 2	July 2021	Pavement of access road to bridge# 2	Access road to bridge# 2 need to be concreted Provide tire washing facility	Two weeks	Bridge №2 : Concrete was laid on the entrance road and a tire washing area arranged;  	Closed August 2021

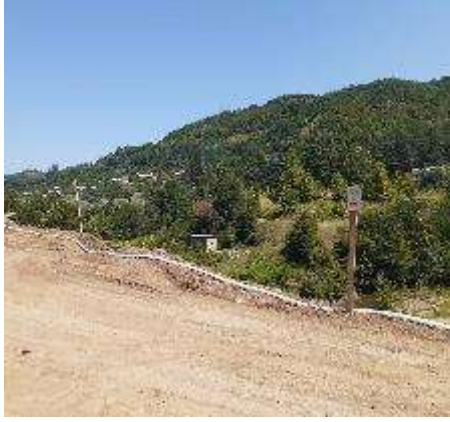
4	TUN# 3	July 2021	Issue related to safety sign installations at the slopes	Safety sign should be installed along the roads with slopes on the sides	Two weeks	Safety signs have been installed at the edge of the slope;

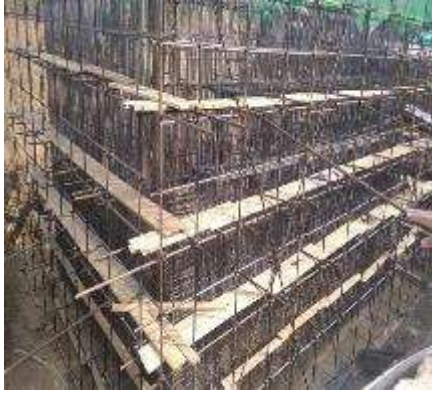
Closed July 2021
5		July 2021	Safety violation for working at heights	The safety violations mentioned in the previous reports must	Two weeks	The safety violations mentioned in the previous reports are being corrected. Workers are using protective harnesses, working	Closed July 2021

be addressed. Workers should use protective harnesses, working platform and guardrails on the scaffolding		platform and guardrails have been installed on the scaffolding;

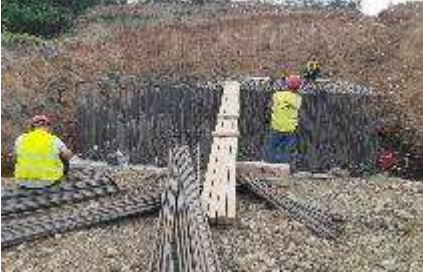
Sept 2021
8	Interchange# 2	Sept 2021	Unsafe access to bridge abutment

Safe access required in the shape small bridge with handrail		Non-conformity has been corrected and safe bridge has been installed, with protective railings;	Closed Sept 2021
9	BP# 2	Sept 2021	Poor housekeeping observed at the workshop	Workshop need to be cleaned out	One week	The armature workshop is regularly being cleaned of waste;	Closed Sept 2021

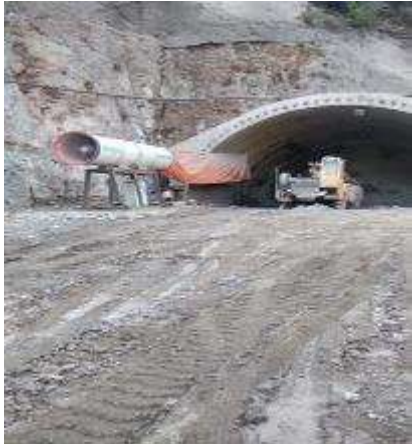
10	TUN# 2	Oct 2022	Installation of ventilation System for Tunnel # 2	Ventilation system must be installed on the both portals of Tunnel #2 before atarting of any blasting activity; Its required that ventilation system will be turned on when there are works carried out in the tunnel;	Two weeks	Ventilation system has been installed on the both portals of Tunnel #2

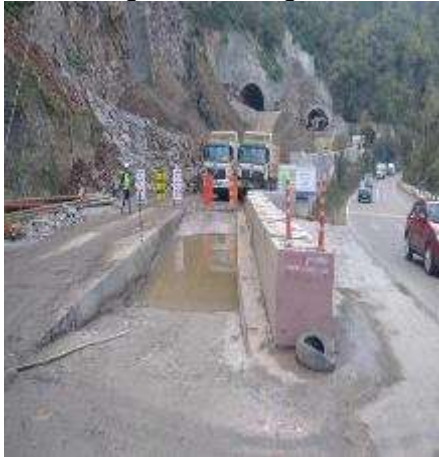
11	TUN# 2 East portal	Oct 2021	Safety procedure need to be followed before starting blasting	All of the safety procedures need to be followed for blasting .works, except Mobilization of ambulance on the blasting sites.	Two weeks	<p>Tunnel №2 East Portal. All of the safety procedures are followed for blasting works, except the mobilization of ambulance on the blasting site; Recommendation: There should be an ambulance presented on site during the blasting works.</p>

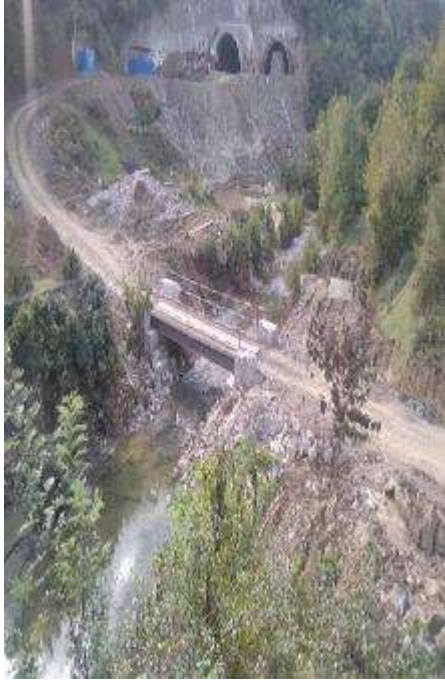
12	TUN# 3	Oct 2021	Access bridge for TUN# 3 need to be rehabilitated for the vehicles crossing	Access bridge on the River bridge is required for the passing of vehicles	3 weeks	<p>Tunnel №3 Crossing Bridge : The access bridge to the third tunnel, bridge over the river Borimela, has been reconstructed;</p>

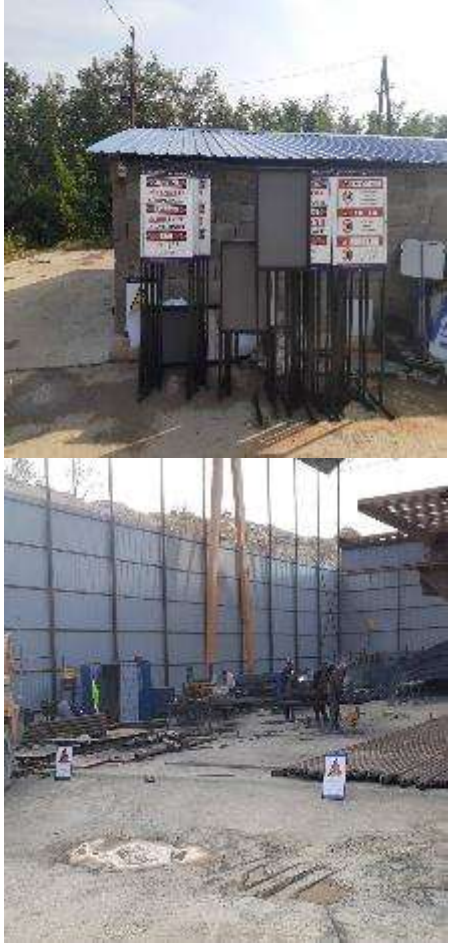
and must be chained		 	
14	Project site	Oct 2021	Missing safty signs	Safety signs must be installed at the site made of solid material	One week	Safety signs made of solid material are placed on the cabinets and at various sites	Closed Oct 2021

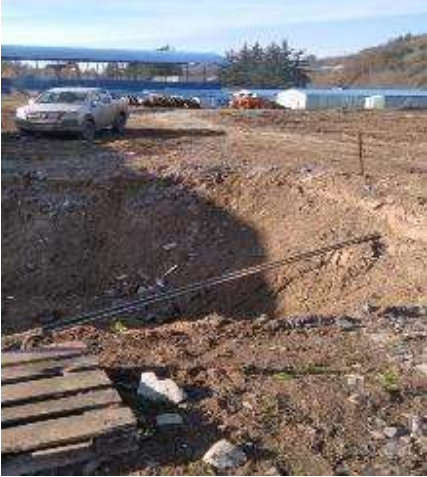
15	Interchange # 1	Nov 2021	Fencing of the deep excavation posing the risk of fall	The openings must be fenced with solid barriers, appropriate warning signs	Two weeks	Action pending	Open

2. Fencing of the deep excavation posing the risk of fall	All deep excavation should be fenced	CC	immediately
3. Personnel do not use special personal protective equipment	CC to provide the complete PPES and enforce to wear	CC	Q 1 2022

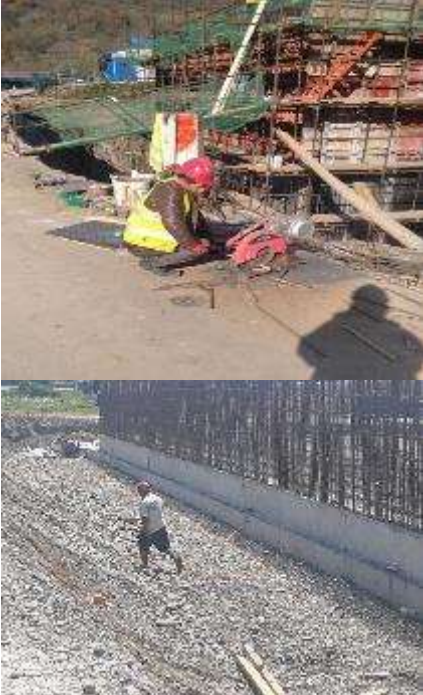
must be installed, there is a danger of not only for personnel to fall in but also for cars.			
16	Bridge# 3	Nov 2021	Personnel do not use special personal protective equipment,	it is required to use face shield when cutting the armature, as there is a high risk of facial damage. It is not allowed to perform special works without appropriate personal protective equipment.	Immediately	CC to provide the PPEs and strict enforcement required to wear PPEs	Open

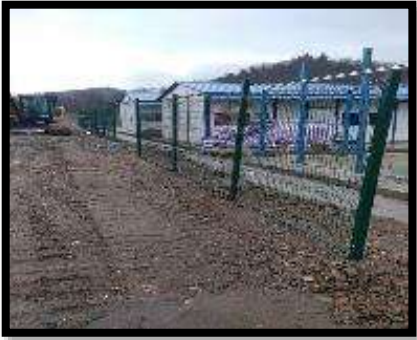
17	BP#1 and Camp 3	Nov 2021	Fencing of the batching plant and campsite required to restrict the unauthorized entry	CC to Fence the camp# 2 and BP# 1 territory	Two weeks	Contractor fenced the required territory	Closed Nov 2021

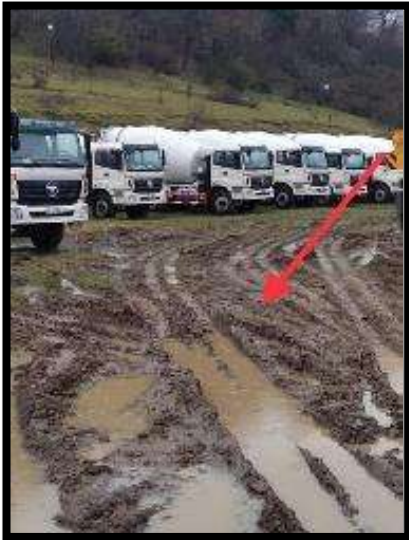
18	BP# 1 Camp# 3	Dec 2021	<p>Access road used for heavy machinery parking must be graveled at BP#1</p>

<p>CC to gravel the road to avoid the slush caused during the wet season and mud carried out by vehicles to main highway</p>	1 week	Action required	Open
19	Culvert 4301	Dec 2021	<p>Poor house keeping at various sites</p>

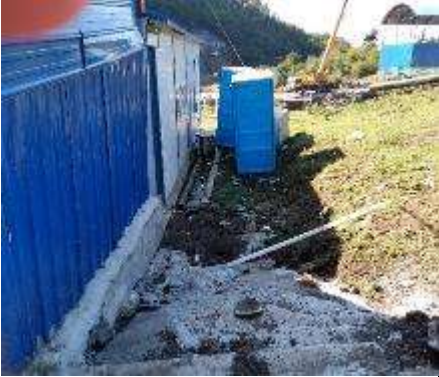
<p>Housekeeping needs to be improved and waste needs to be collected from the site</p>	1 week	<ul style="list-style-type: none"> - Waste collected - Site supervisors and managers notified and instructed 	<p>Closed Dec 2021</p>

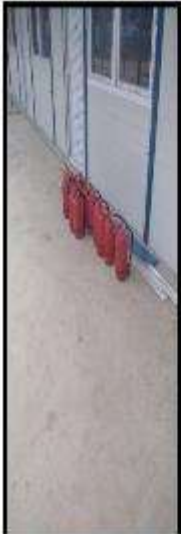
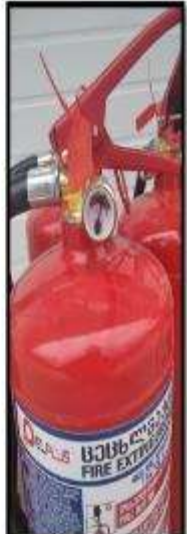
22	Project site	Dec 2021	Fire extinguishers are not at site	Fire extinguishers must be at site and installed as per national regulation		Fire extinguishers are at site now and after inspection will be distributed to sites	Closed Dec 2021

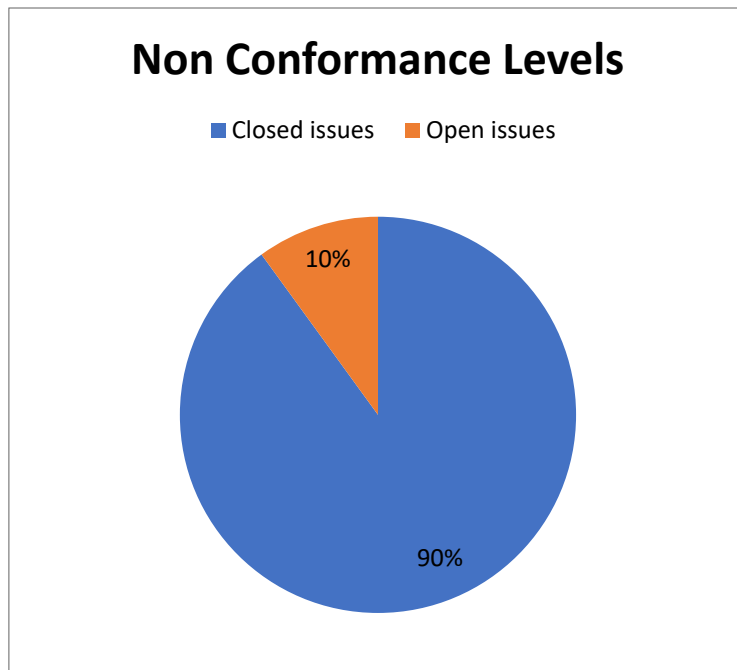
Figure 5: Non-Conformance levels during the Project

44. Data on the number of closed and open issues is presented in Figure 5. This data is based on the issues that were observed and have been closed or remained open during the Project.

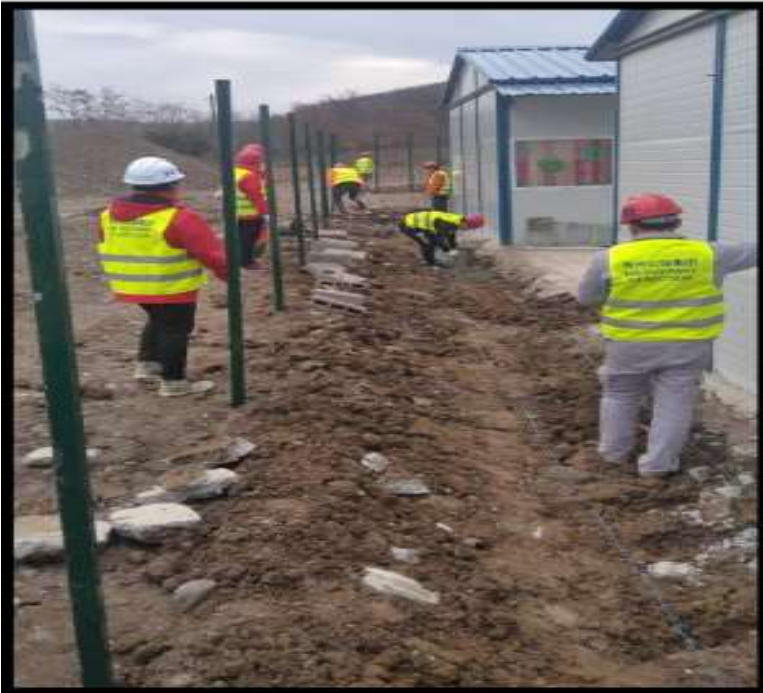
A photograph showing several construction workers at a site. They are wearing high-visibility yellow safety vests, hard hats, and other protective gear. They are standing on a dirt path next to a building under construction. Green metal posts are visible in the foreground, likely for a fence or structure.	<p>Workers wearing PPE</p>

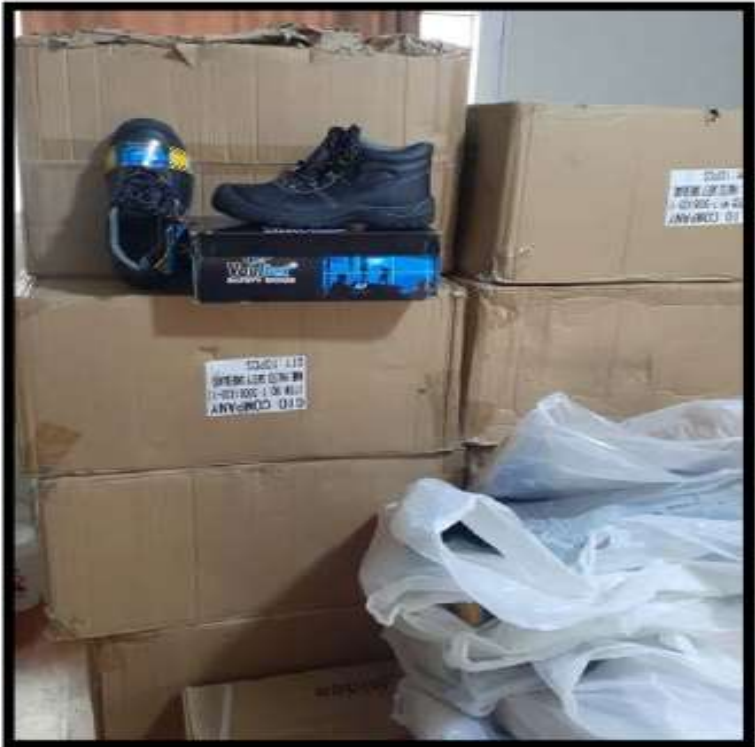
A photograph showing various pieces of personal protective equipment (PPE) stored in cardboard boxes. Visible items include a pair of black safety boots, a pair of blue safety shoes, and a pair of blue safety glasses. The boxes are stacked, and some have shipping labels.	<p>PPE at the site</p>

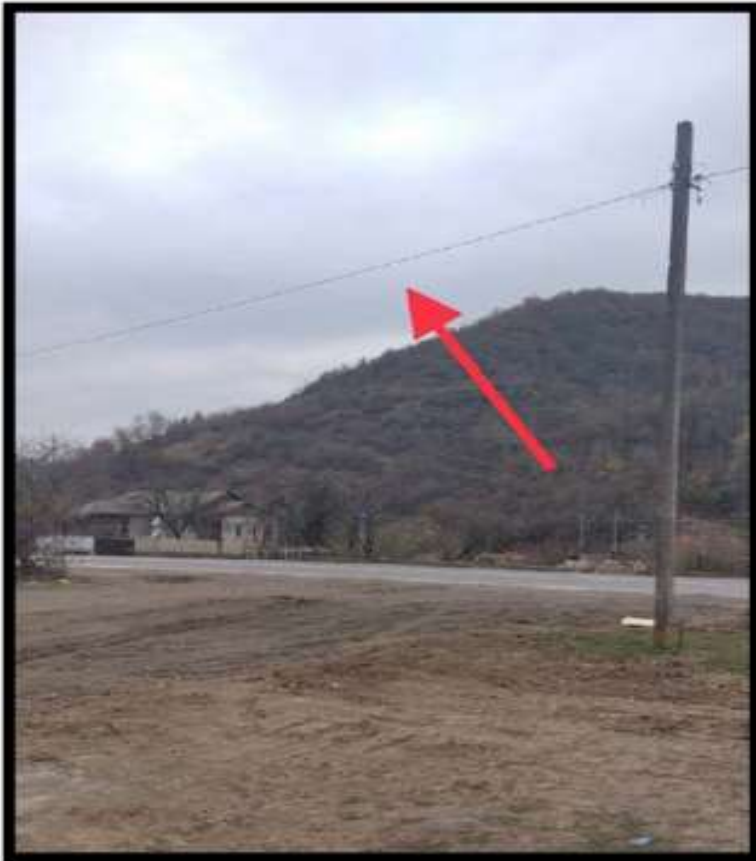
Safety Goal Post required

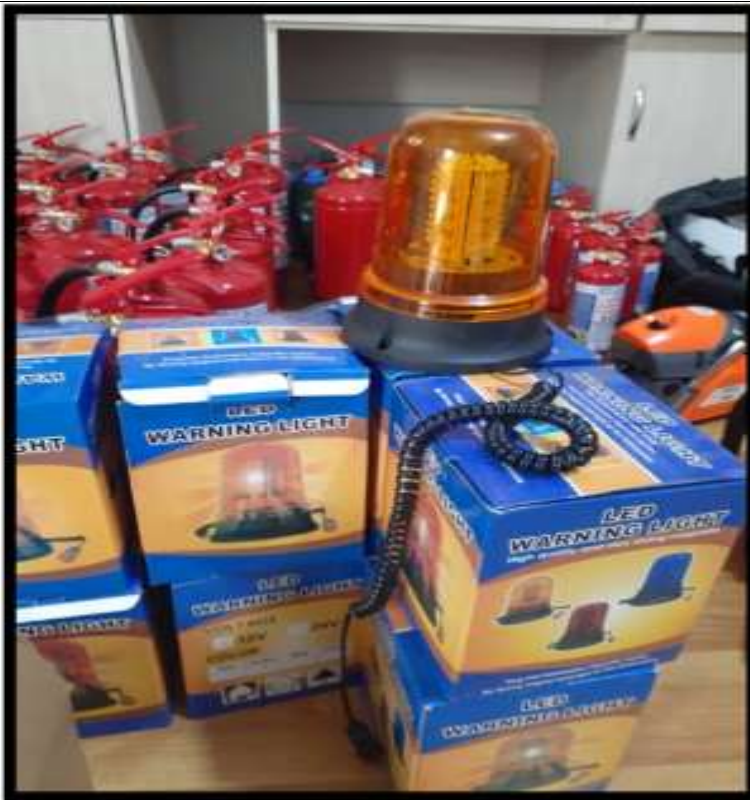
Flash becon lights to be installed on heavy vehicles

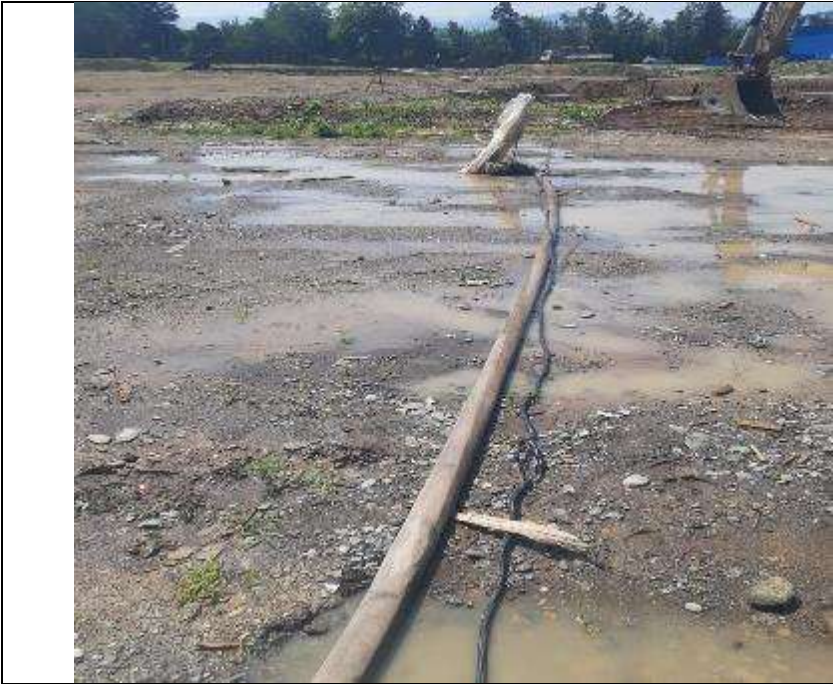
<p>Opening must be filled and lighting must be proper inside the tunnel</p>
 	<p>Scaffolding required guard rails</p>

Electrical Cables laid at the ground

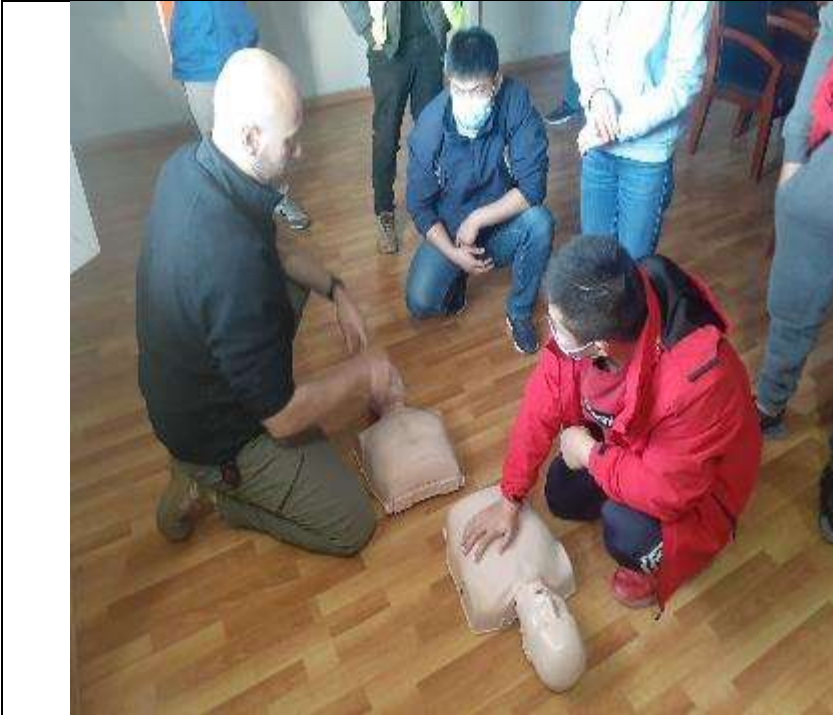
First aid safety training

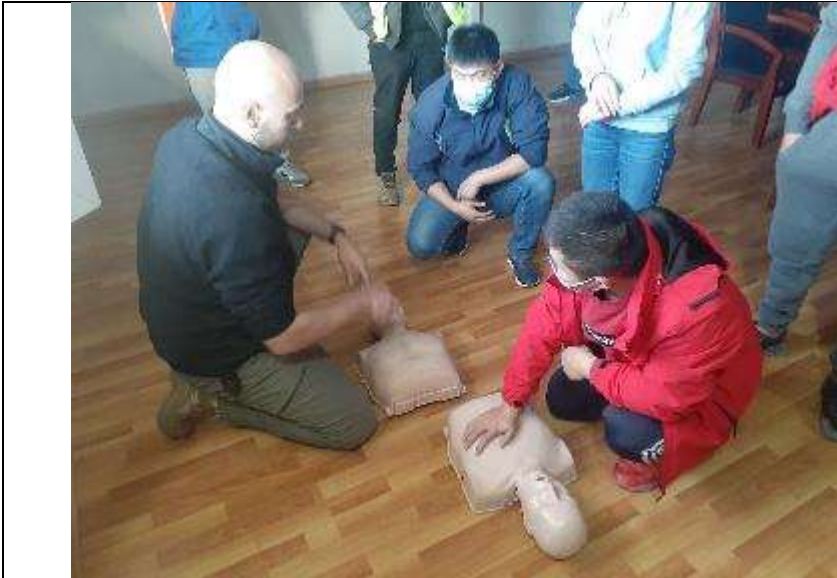
First aid training at site

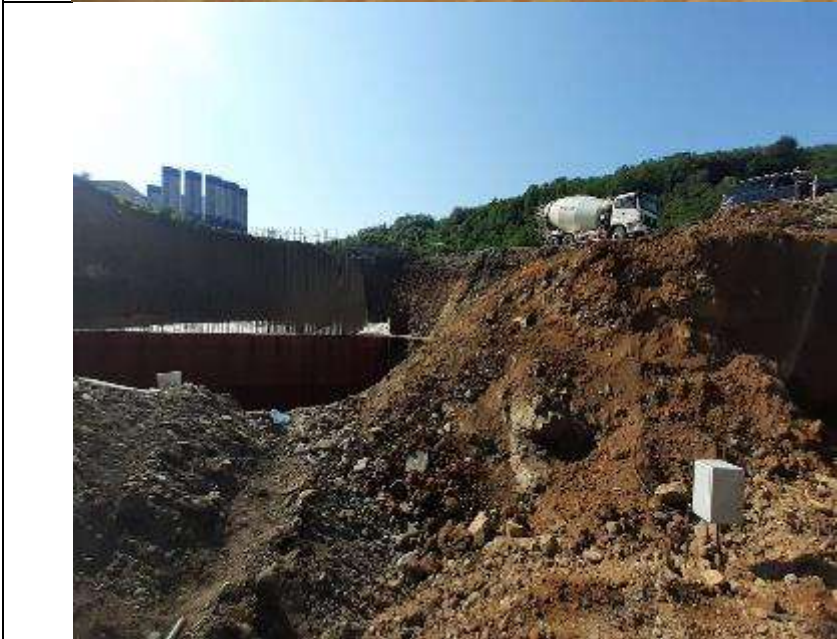
Missing safe pathway to reach at the site

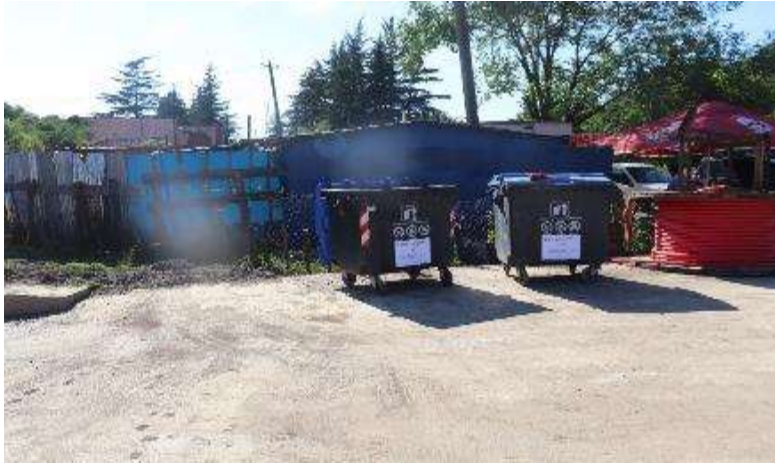
Waste Containers
labelled for domestic
waste

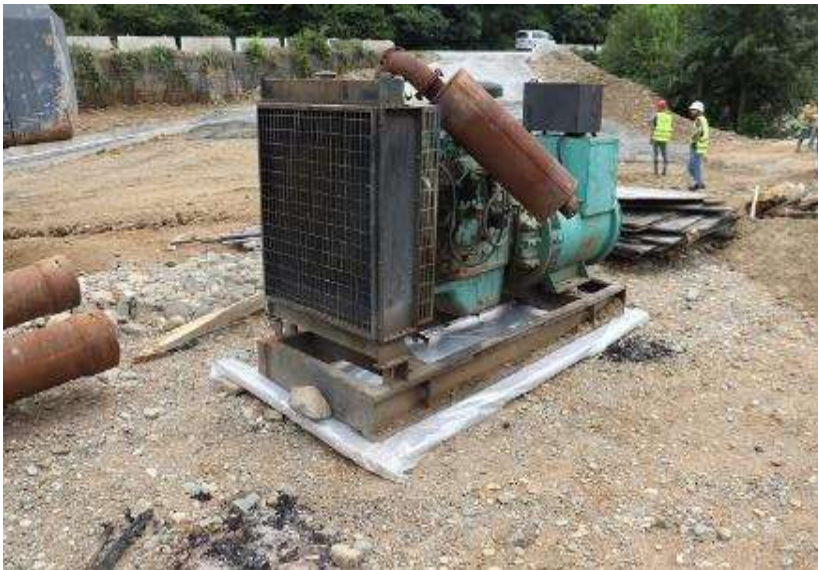
Drip Tray provided for
the Generator

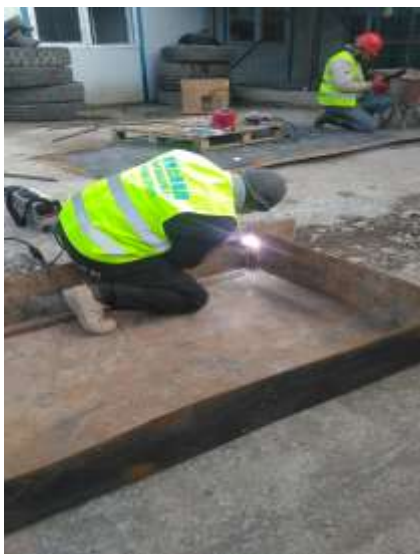
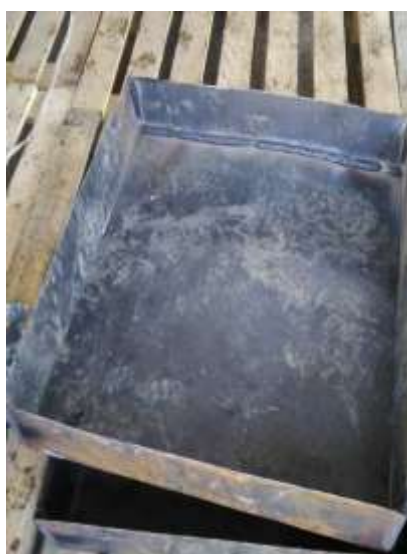
CC started the
manufacturing the drip
trays at the site. And
started providing for
secondary containment
under generators.

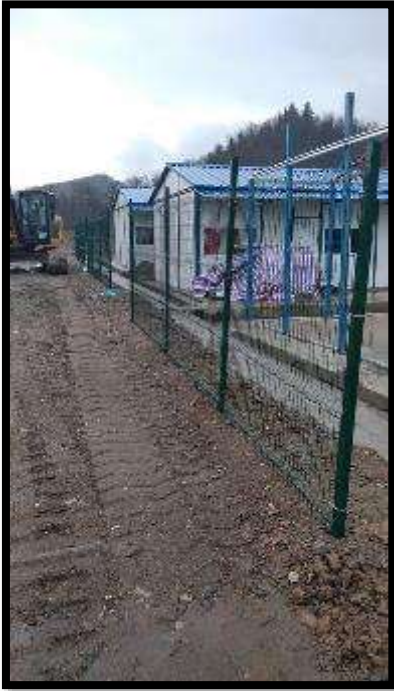
Concrete Plant №1 and Camp №3

Photo 1. Concrete Plant №1 and Camp №3: **Good Observation:** Accommodation camp fencing procedure is in the progress;

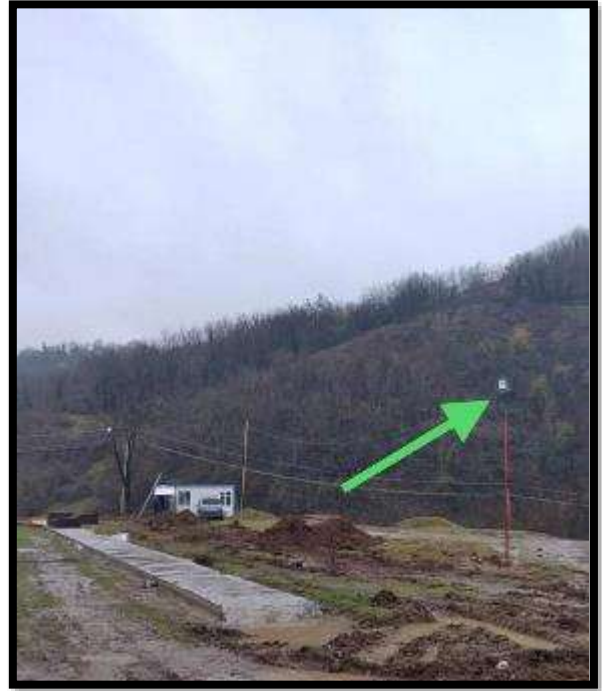
Photo 2. Concrete Plant №1 and Camp №3: **Good Observation:** Camp territory is appropriately illuminated;

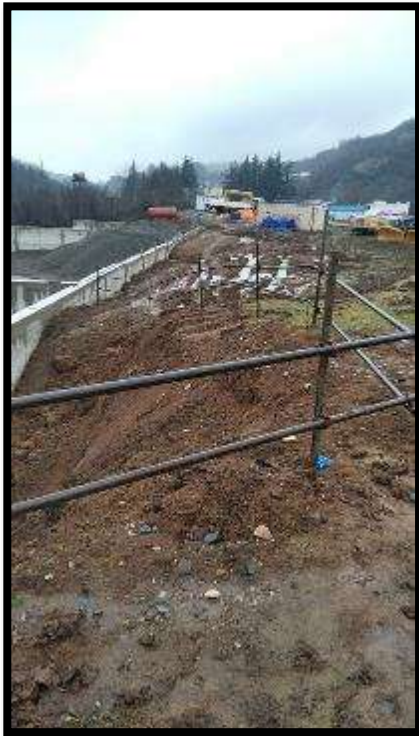
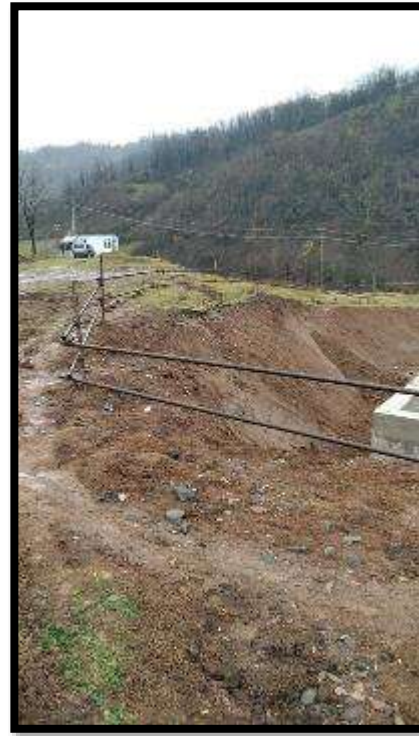
Photo 3. Concrete Plant №1 and Camp №3: **Good Observation:** Excavation area has been enclosed with protective guardrails;

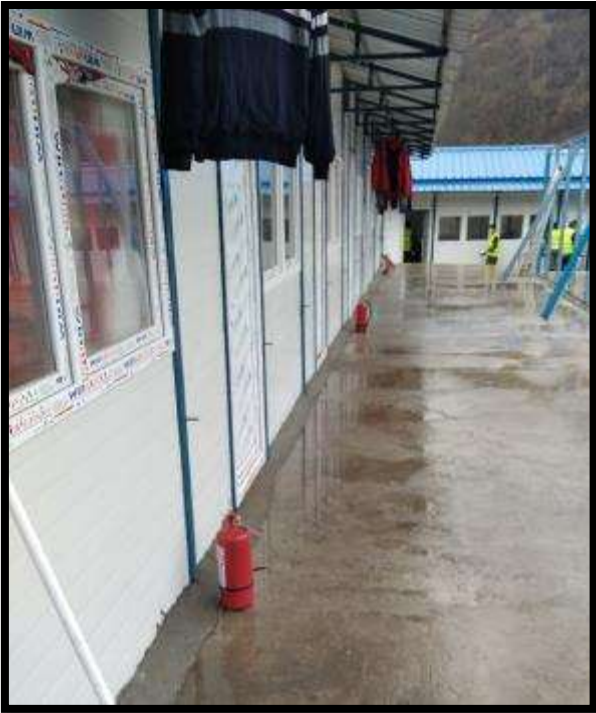
Photo 4. Concrete Plant №1 and Camp №3: **Non-Conformance:** Fire extinguishers must be placed in special, protective boxes;

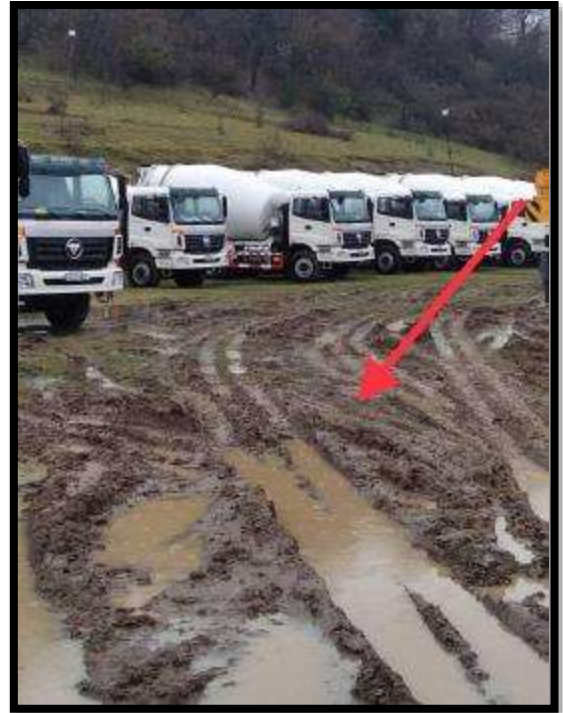
Photo 5. Concrete Plant №1 and Camp №3: **Non-Conformance:** Territory used for heavy machinery parking must be graveled;

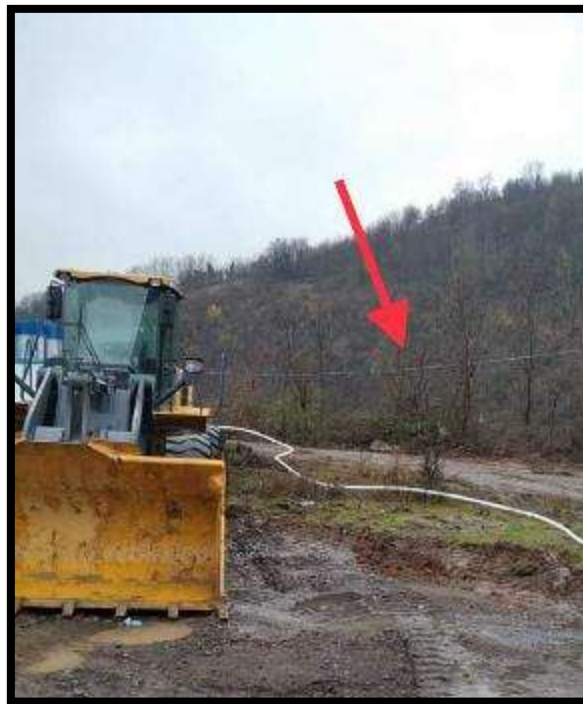
Photo 6. Concrete Plant №1 and Camp №3: **Non-Conformance:** Electrical cable must be raised at appropriate, safe height;

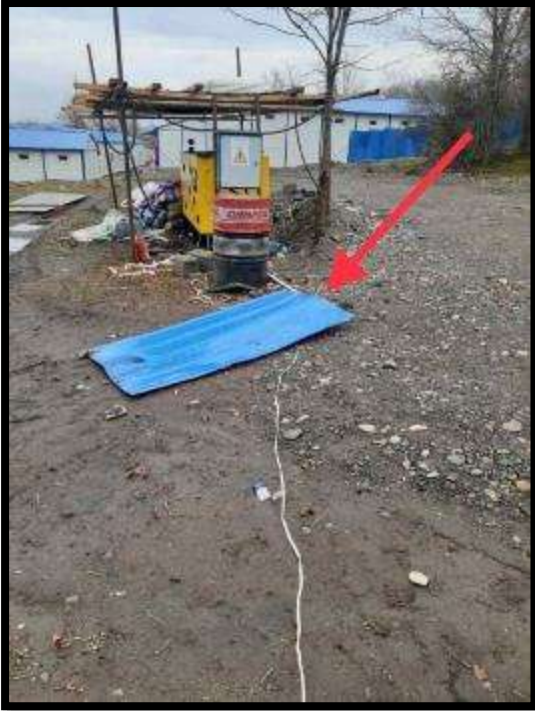
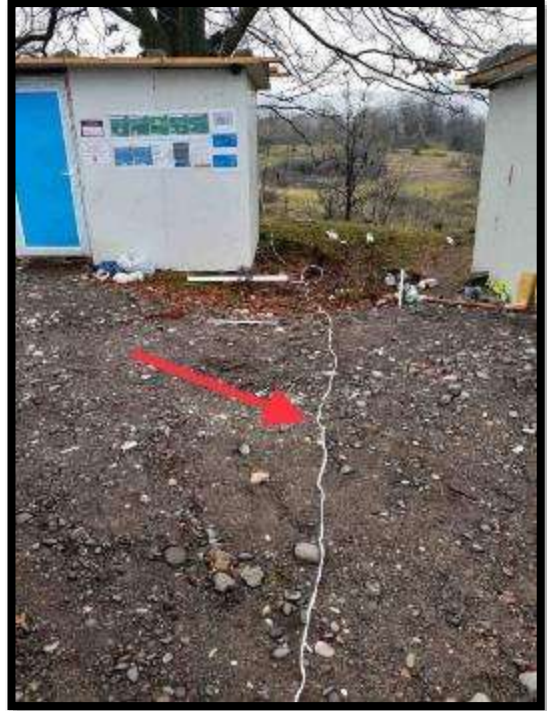
Photo 1. Camp №6: **Non-Conformance:** Electrical cable is placed on the wet ground and also sharp piece of metal plate is placed on top;

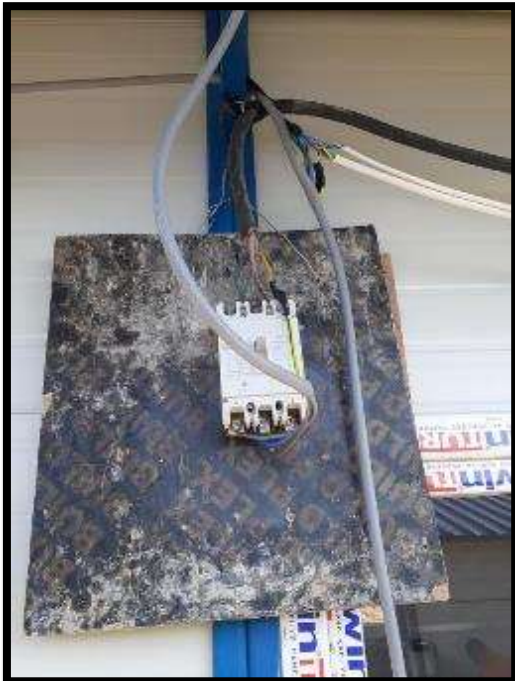
Photo 2. Camp №6: **Non-Conformance:** Electrical switches and relays must be put in a special box. Box must have lock and safety sign;

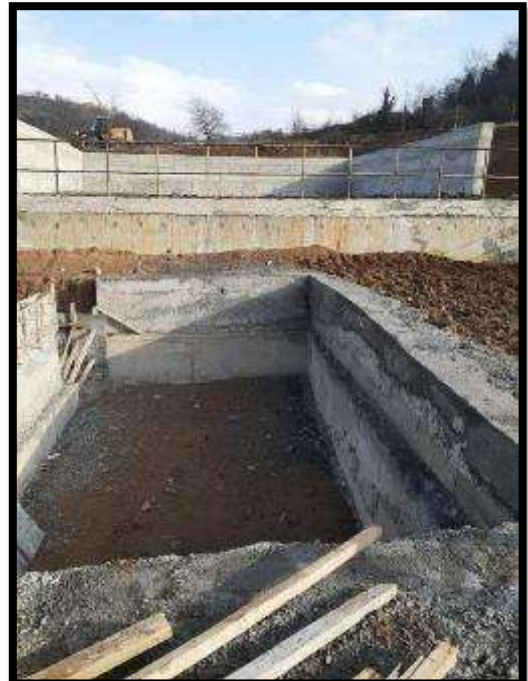
Photo 1. Concrete Plant №1: **Non-Conformance:** Excavated area/opening must be enclosed with protective guardrails;

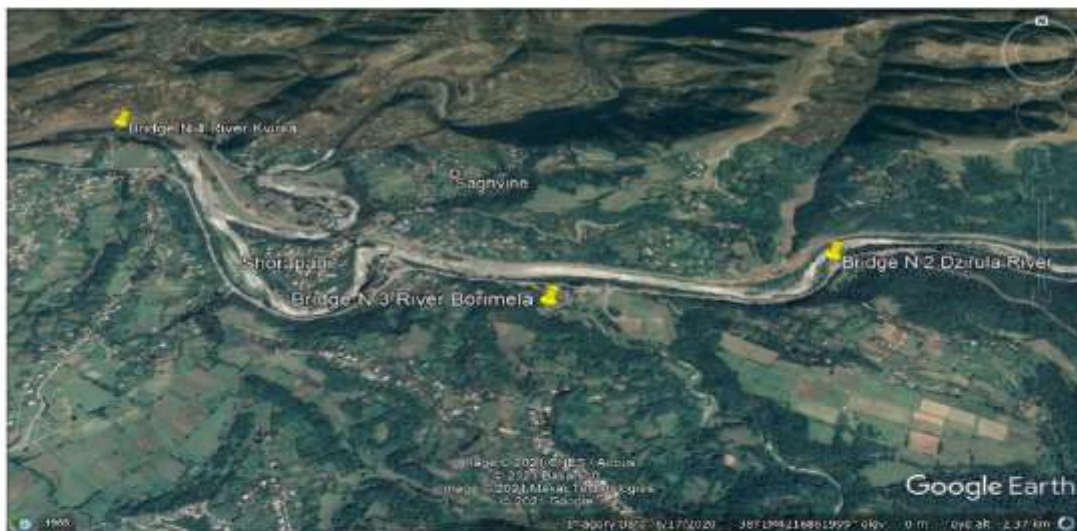
Figure 2-1 Surface water monitoring locations

Water monitoring locations proposed by the client are reflected in Table 2-, and in Figures 2-1. The monitoring was undertaken 50m up and downstream from each location.

Monitoring Locations	Coordinates	Monitoring Date
River Kvirila (Bridge N4)	340316.57 4663074.32	27/06/21
River Borimela (bridge N3)	342153.91 4661762.47	27/06/21
River Dzirula (bridge N2)	343185.48 4662005.84	27/06/21

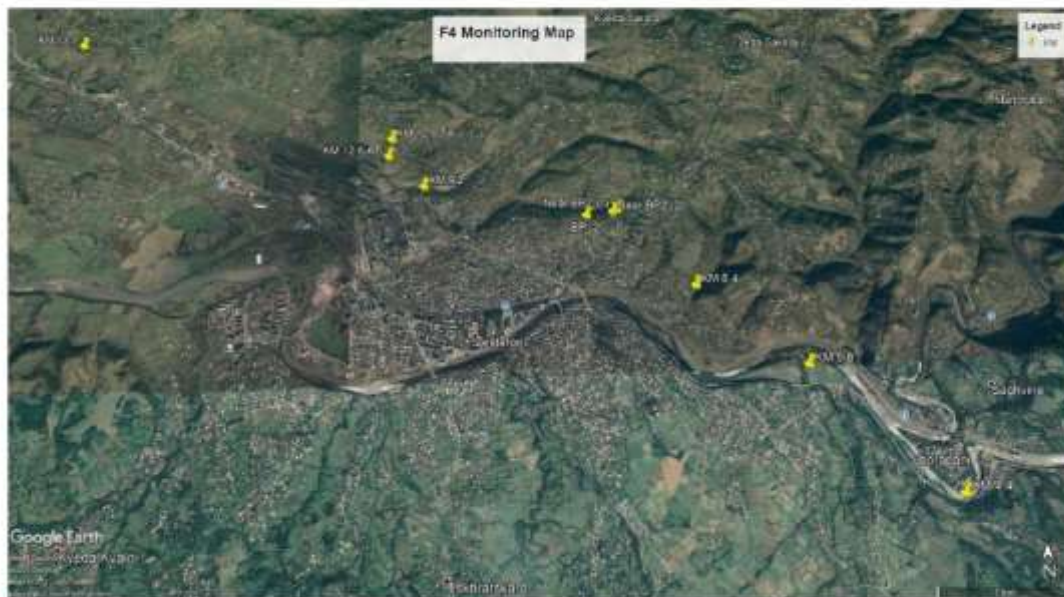
Figure 2-1 Noise, Vibration and Ambient air quality monitoring locations

There are 12 monitoring points along F4 section of the E-60 highway, on which dust, noise, vibration and air quality measurements were performed. GPS Coordinates of monitoring points are shown in the Table 2-1 and general overview on satellite map (Figure 2-1).

#	Point	X	Y	Conducted work/measurement
1	Puti road	341661.50	4661536.33	vibration, dust, noise
2	KM 4.4	341323.49	4661735.23	NO _x , SO _x , dust
3	KM 5.8	340323.98	4662868.69	NO _x , SO _x , dust, noise
4	KM 6.4	339493.72	4663649.74	NO _x , SO _x , noise, dust
5	Batch plant 2	338617.08	4664404.19	NO _x , SO _x , noise, dust, vibration
6	Near BP_2 (1)	338896.97	4664445.93	vibration
7	Near BP_2 (2)	338855.12	4664424.67	vibration
8	Near BP_2 (1) - opposite	338914.56	4664415.78	vibration
9	KM 12.6 AT	336852.00	4665151.00	NO _x , SO _x , dust, vibration
10	KM 12.6 TA	336881.01	4665342.12	NO _x , SO _x
11	KM 13.3	333856.00	4666662.00	NO _x , SO _x , noise, dust, vibration

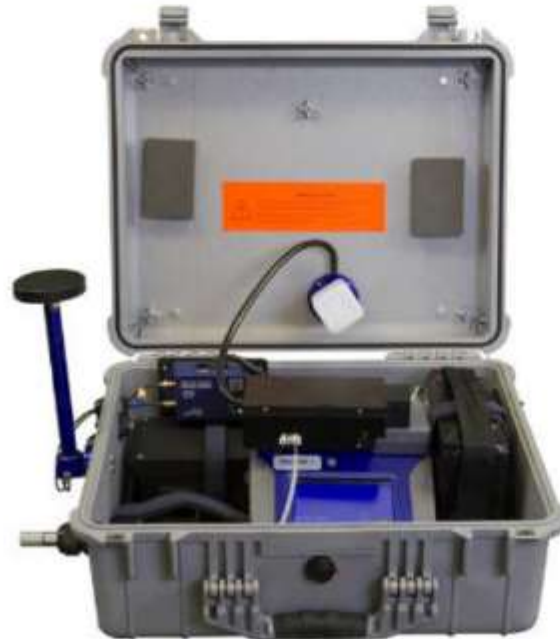
Figure 3-1 Dust Monitoring equipment

The photos below show the used equipment for Dust monitoring and Zero Calibrator.

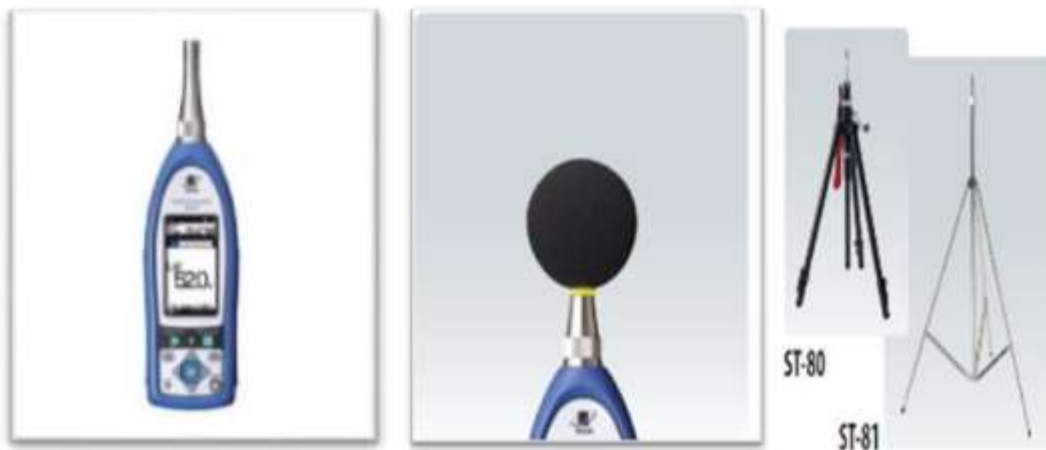
Figure 3-3 Noise monitoring equipment

- Rion NL-52, First class noise measurement device;
- Windscreen, WS-16;
- Tripod;
- SD Card;

Noise measurement range: 0-133 dB

Noise measurements were done for one 30-minute session for each monitoring points.

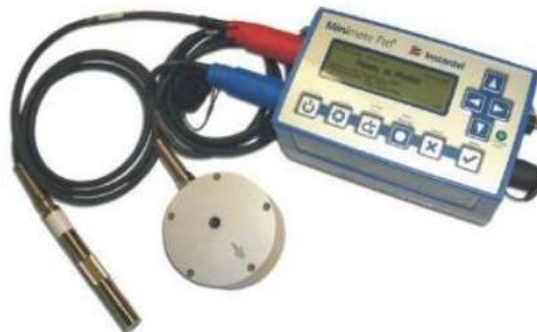
Figure 3-4 Vibration monitoring equipment

As it was already described above, after recording the Vibration Waveform session, the device saves the session to the integrated hard drive. After what, the session is transferred to the Personal Computer and processed using special program called Blastware, which is also created by the Company InstanTel. The program created event report, which includes vibration waveform graphs, timing and other detailed information about the recorded session.

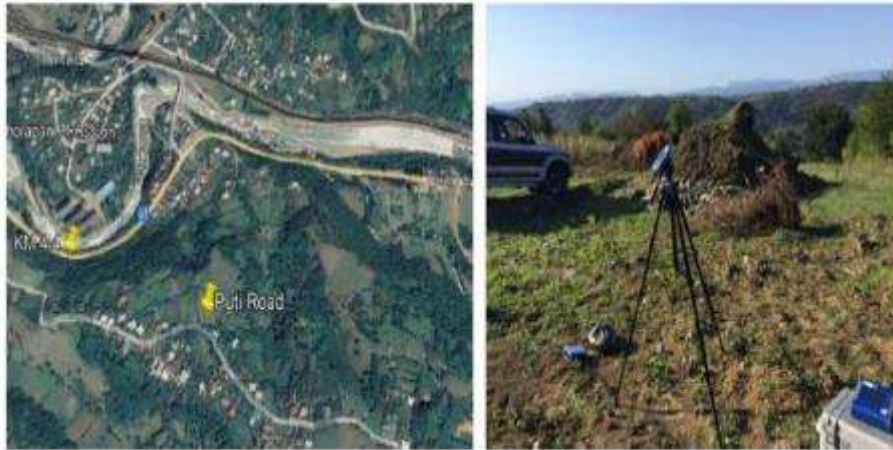
Figure 5-7 Point N1 Puti Road

The construction of a rural road is planned on this monitoring point. No construction or other works were carried out in the area during the monitoring process. The point is close to a narrow driveway where rare movement of cars and cattle were observed. Vibration, noise levels and dust concentrations in the air were measured.

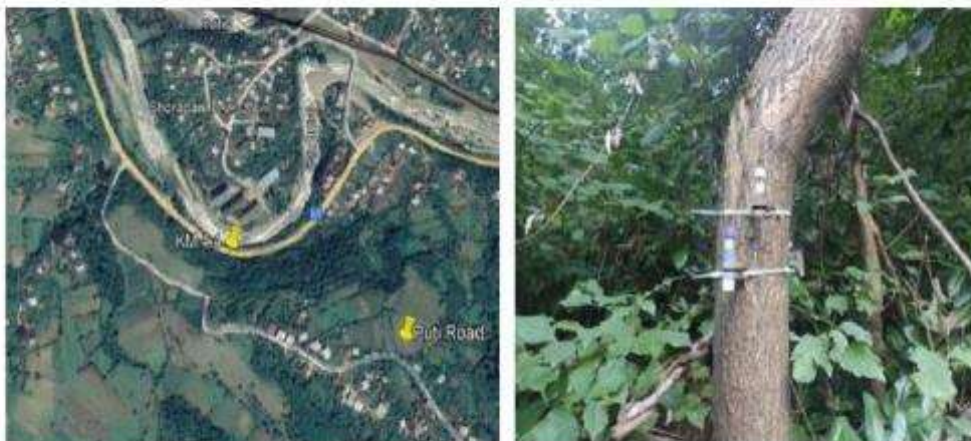
Figure 5-8 Point N2 KM 4.4

No construction work was carried out at the monitoring point, however, the point is located on the existing E-60 highway, on the side of the road, therefore, in the vicinity, there is heavy traffic, and the project transport is moving. Air monitoring tubes were replaced and dust concentration in the air was measured on the spot.

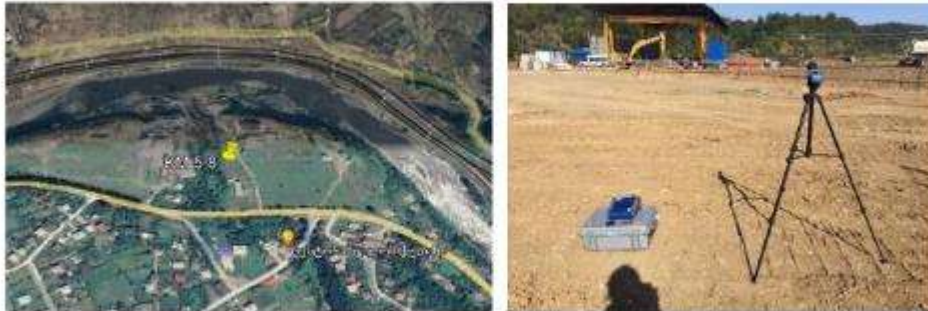
Figure 5-9 Point N3 KM 5.8

Air quality monitoring tubes were replaced, dust concentration in the air and noise level were measured at the point. While the monitoring team was on site, the construction works were in an active phase: The equipment was working and the bridge parts were in the process of being built.

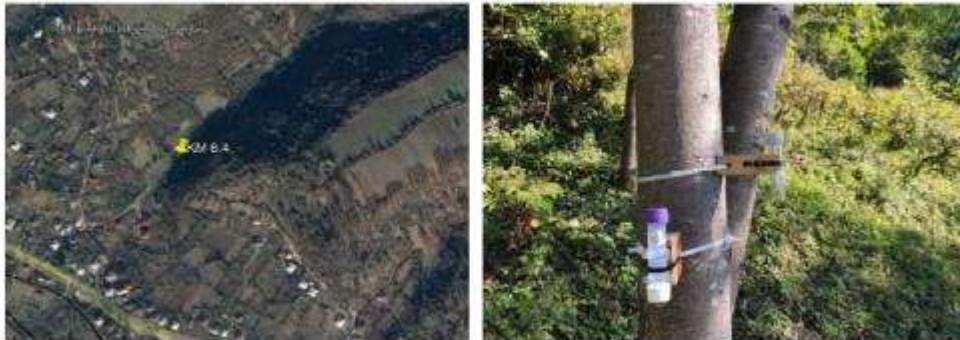
Figure 5-10 Point N4 KM 6.4

This monitoring point is located away from the road. Air quality monitoring tubes were replaced on site and noise level and dust concentration in the air were measured. During the monitoring, some construction noise was heard at the measurement point.

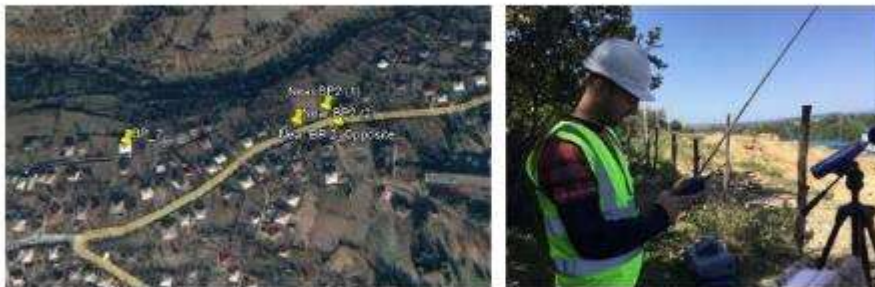
Figure 5-11 Point N5 Batching Plant N2

Air quality monitoring tubes were replaced at the monitoring point. Noise, dust, and vibration levels were measured. Only one JCB type special equipment worked in the monitoring process. Other construction works were not observed during the on-site monitoring.

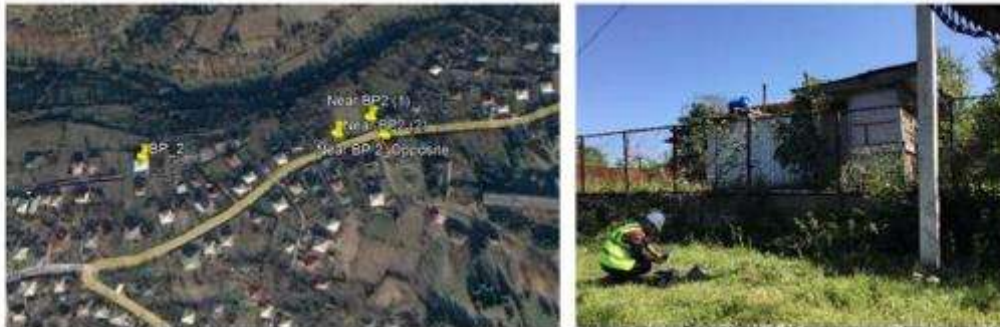
Figure 5-12 Point N6 near Batching Plant N2 (1)

This point is located near the access road of the Batch Plant #2 and Workers' Camp #3. Vibration was measured at the monitoring point. No active works were carried out near the sampling point, no construction equipment was moving. It should be noted that the monitoring point is a few meters away from the road, on which both cars and trucks are actively moving.

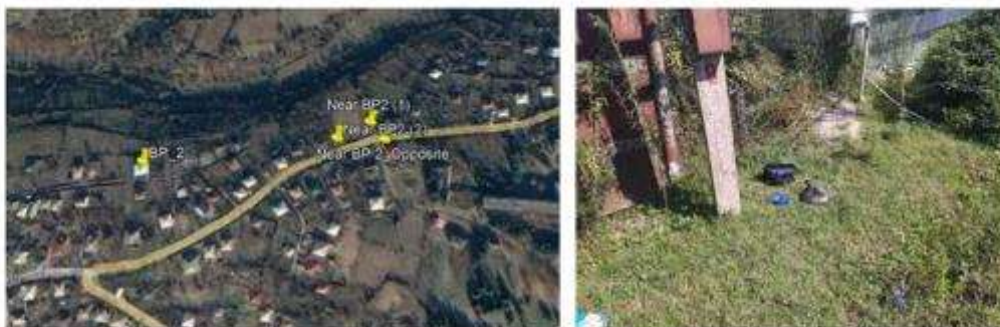
Figure 5-13 Point N7 Near Batching Plant N2 (2)

At the monitoring point, vibration was measured. As in the previous case, the point is located near the road and therefore traffic is frequent.

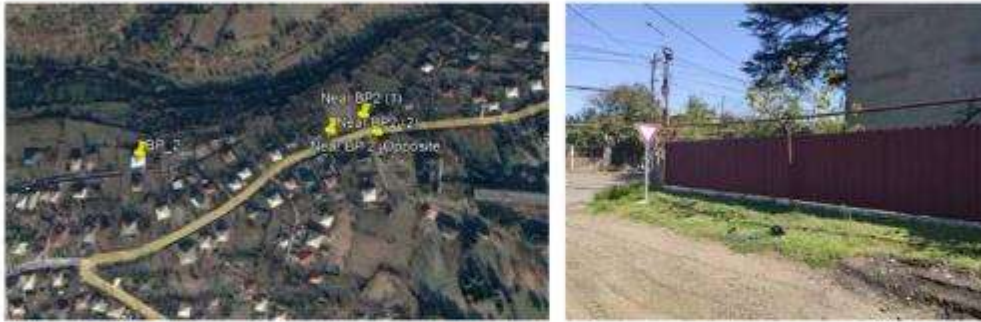
Figure 5-14 Point 8 Near Batching Plant N2 (1) Opposite

Vibration was measured at the monitoring point. No construction work was carried out in the vicinity, although active traffic was observed on the road.

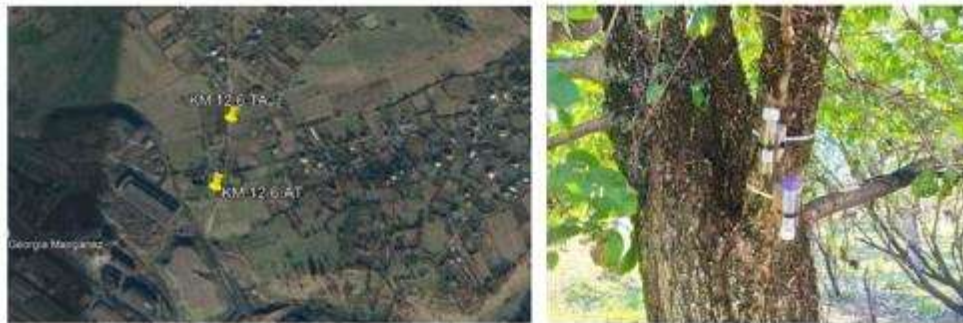
Figure 5-15 Point 9 KM 12.6 AT

The monitoring point is located near the Ferroalloy Plant, where a road interchange is planned for the future. No construction works were carried out in the area. Air quality monitoring tubes have been replaced and dust concentration and vibration level were determined.

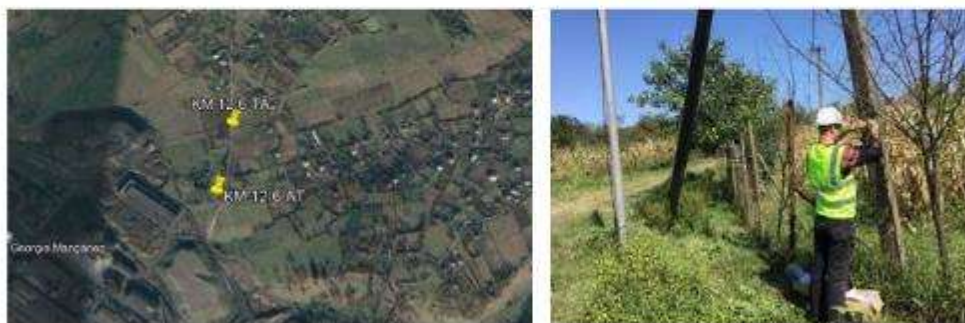
Figure 5-16 Point N10 KM 12.6 TA

The monitoring point is located near the Ferroalloy Plant, where a road interchange is planned for the future. No construction works were carried out in the area. Air quality (NOx and Sox) monitoring tubes have been replaced.
