Semi-Annual Environmental Monitoring Report

Reporting period: July - December 2021

GEO: Construction of Shorapani – Argveta Section (E60 Highway Route), Lot F4 Project

Financed by the Asian Development Bank

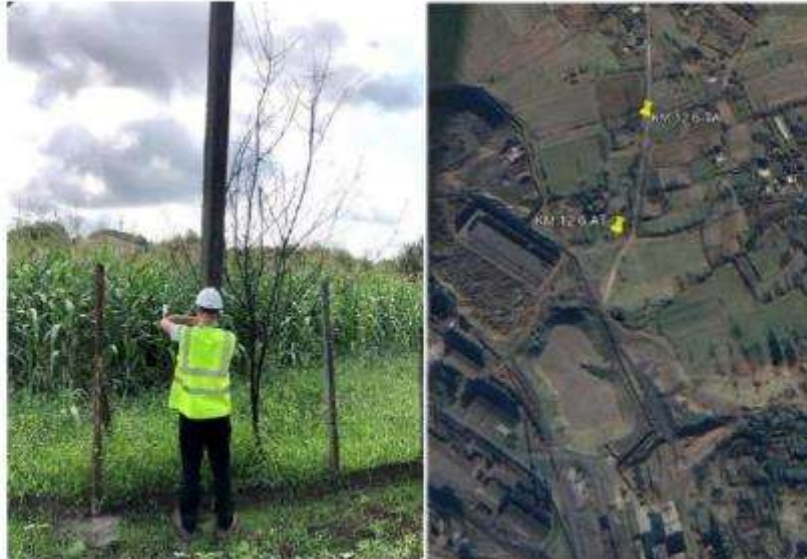
Figure 5-17 Point 11 KM 12.6 TA

Air quality monitoring tubes were replaced at the monitoring point. No traffic or any kind of construction work were observed in the vicinity of the area.

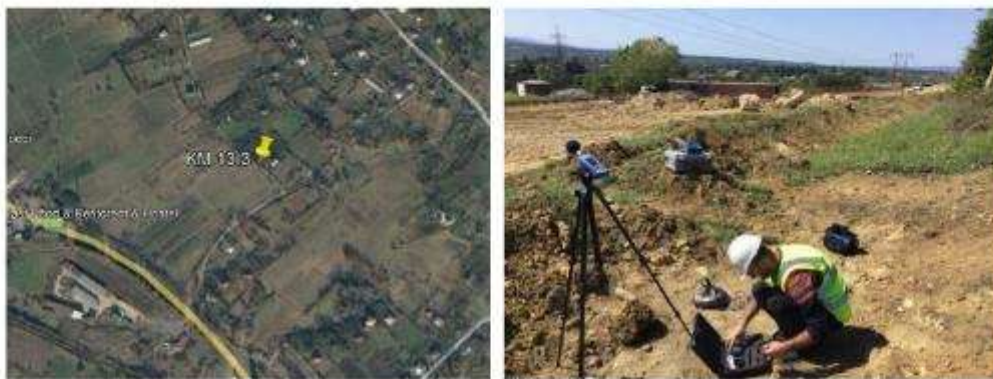
Figure 5-18 Point 12 KM 13.3

Dust, noise, and vibration levels were measured and air quality monitoring tubes were replaced at this point. No work was carried out during the monitoring.

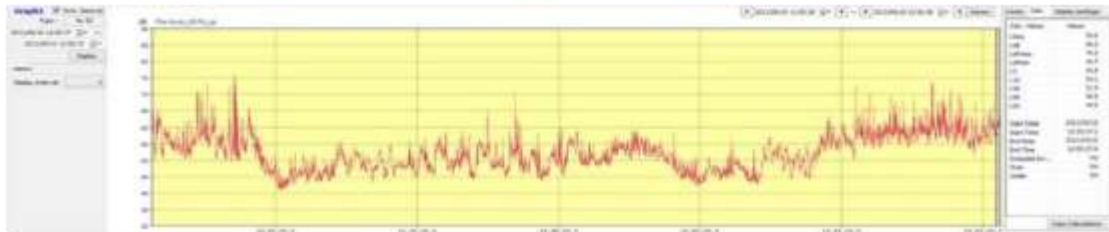
Figure 6-1 Batching Plant N2

Exceeding of the permissible noise level is observed at points BP 2 and KM 5.8, so it is important to plan and implement appropriate mitigation measures.

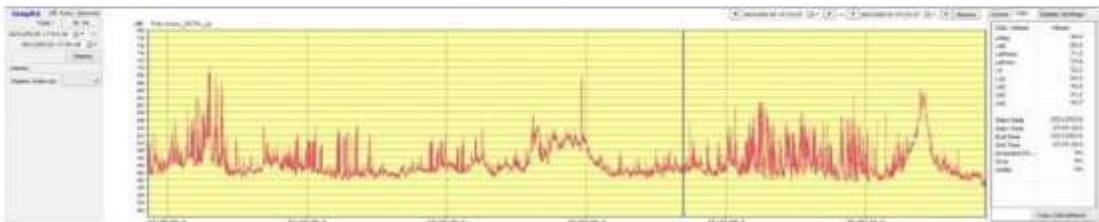
Figure 6-5 Pulli Road

No working process was observed at the other points. It should be noted that during the monitoring works near the village Puti (Puti road), cattle were moving near the monitoring point and some peaks may be caused by the noise of a cow bell. Noise measurement diagrams are given below:
