# Semi-Annual Environmental Monitoring Report

#14 Semestral Report

Reporting period: January - June 2025

## **GEO: Construction of Khevi-Ubisa Section (E60 Highway Route), F2 Project**

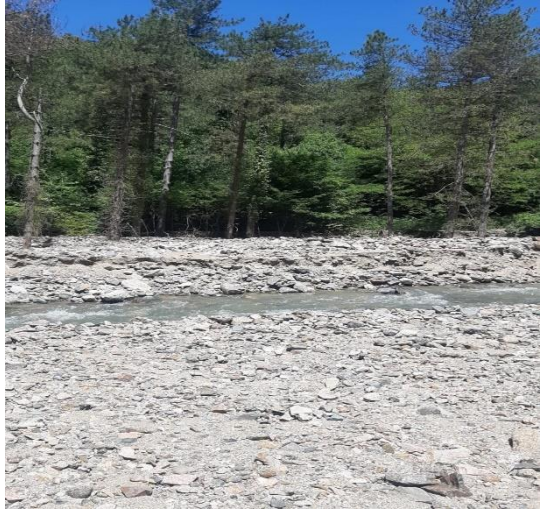
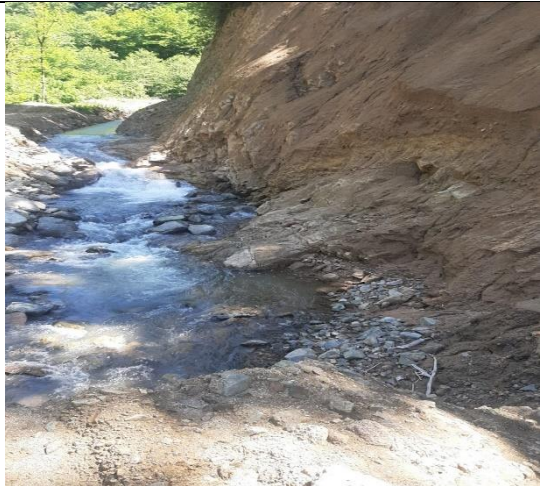
| ID # | Issue | Action required | Responsibility | Target date | Description of Resolution | If not yet resolved, indicate the reason why and specify further required |
|---|---|---|---|---|---|---|
| 1 | River protection works required along river Dzirula at 7 sites including: SDS# N6, N7, N11, N12, N15, N16, N17 | CC to start river protection works parallel with construction activities | Contractor | Up to completion of excavation works at Chumateleti-Khevi F1 project. | <p>The contractor has completed rehabilitation work at six sites.</p> <p>SDS#11 is currently in use by GOG fouded projecht and will be rehabilitated once project finishes excavating and dumping soil at SDS#11.</p> | <p>On Hold</p> <p><u>Out of seven, six sites completed.</u></p> |

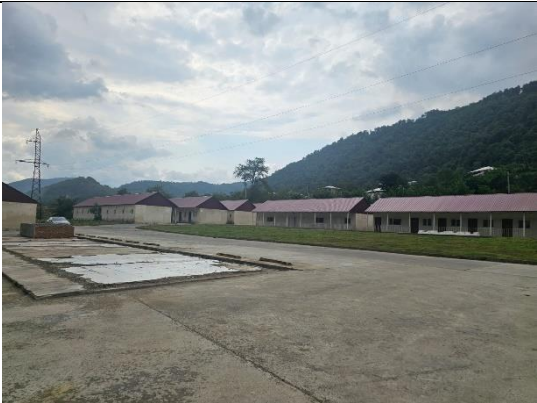
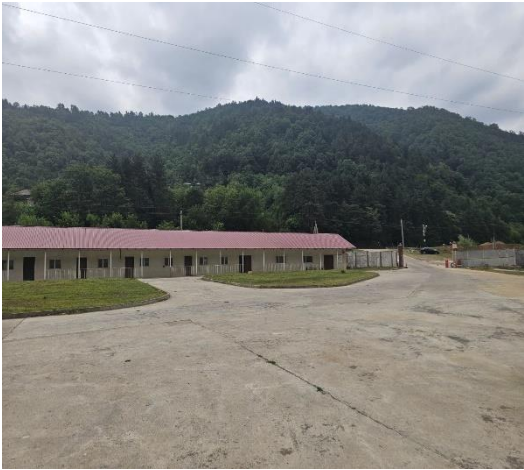
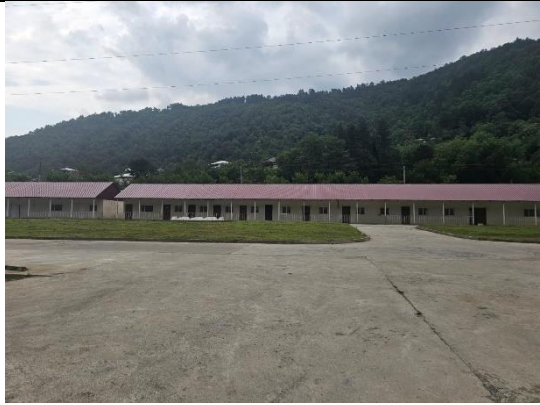
| 3 | Decommissioning works at main campsite | CC to implement re-cultivation /reinstatement activities according to the approved recultivation plan at the site designated for Main Campsite in village Boriti, | Contractor | February | <p>Still in use for accommodation and office works and the contractor will use until the completion of the local roads and other project related works. One part of the building is given for the 112 Emergency services.</p> | <p>On Hold up to completion of DNP period.</p> <p>RD has intention to keep that building for</p> |

| | | Kharagauli municipality | | | | the services. Emergency |

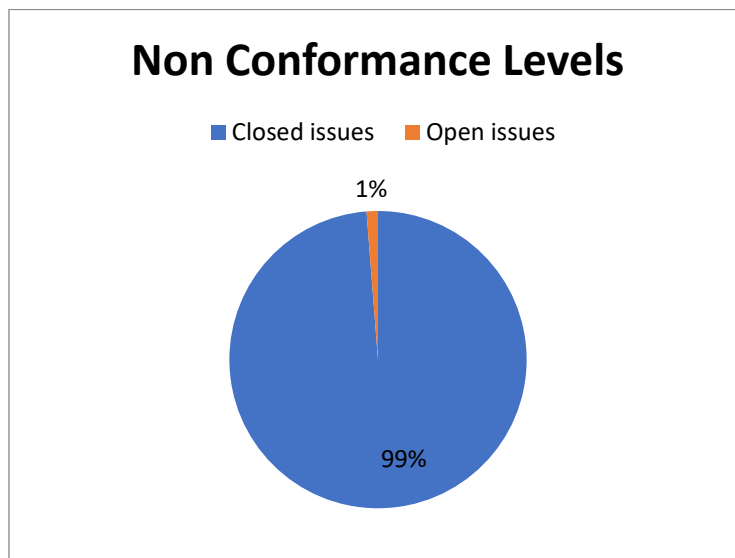
**Figure 3: Non-Conformance levels during the Project**

50. Data on the number of closed and open issues is presented in Figure 3. This data is based on the issues that were observed and have been closed or remained open during the Project.

51. During the project's duration, there were a total of three hundred twenty-three (323) issues identified. Out of these, three hundred twenty (320) issues have been resolved.
52. The remaining three issues on hold are as follows:
1. Rehabilitation and recultivation of the main camp.
  2. Decommissioning of Batching Plant #3 will be postponed until the end of the DNP period for repair and maintenance work.
  3. SDS#11 is currently in use by GOG founded project and will be rehabilitated once project finishes excavating and dumping soil at SDS#11.

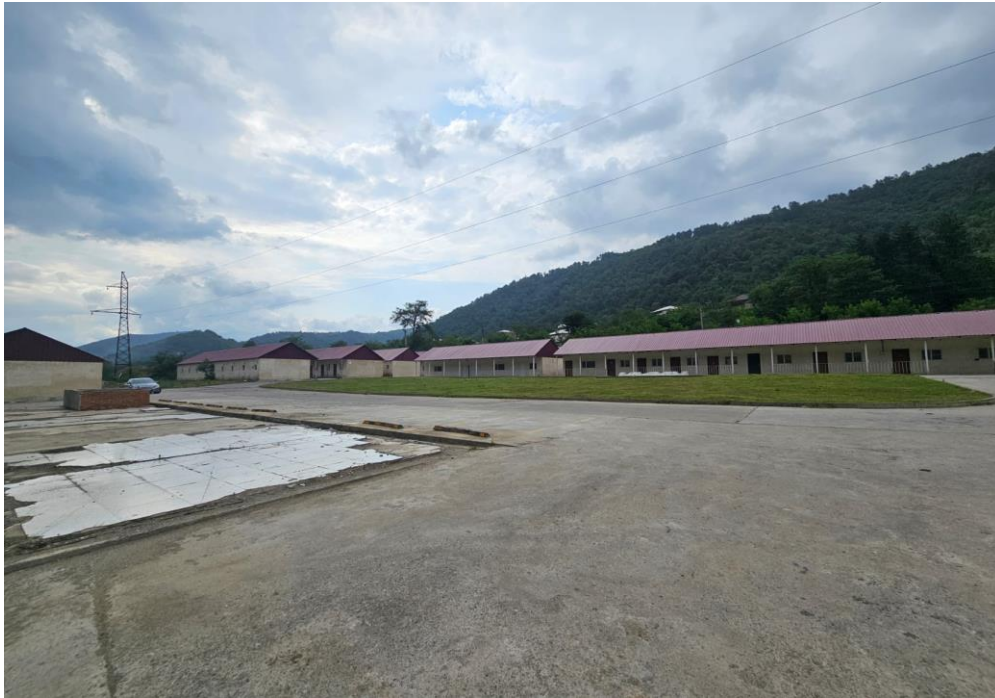
**A view of Main Camp**

85. The remaining three issues pertain to the rehabilitation and recultivation of the main camp; Batching Plant # 3 decommissioning will be on hold up to the end of the DNP period for the repair and maintenance works. SDS#11 is currently in use by GOG founded project and will be rehabilitated once project finishes excavating and dumping soil at SDS#11

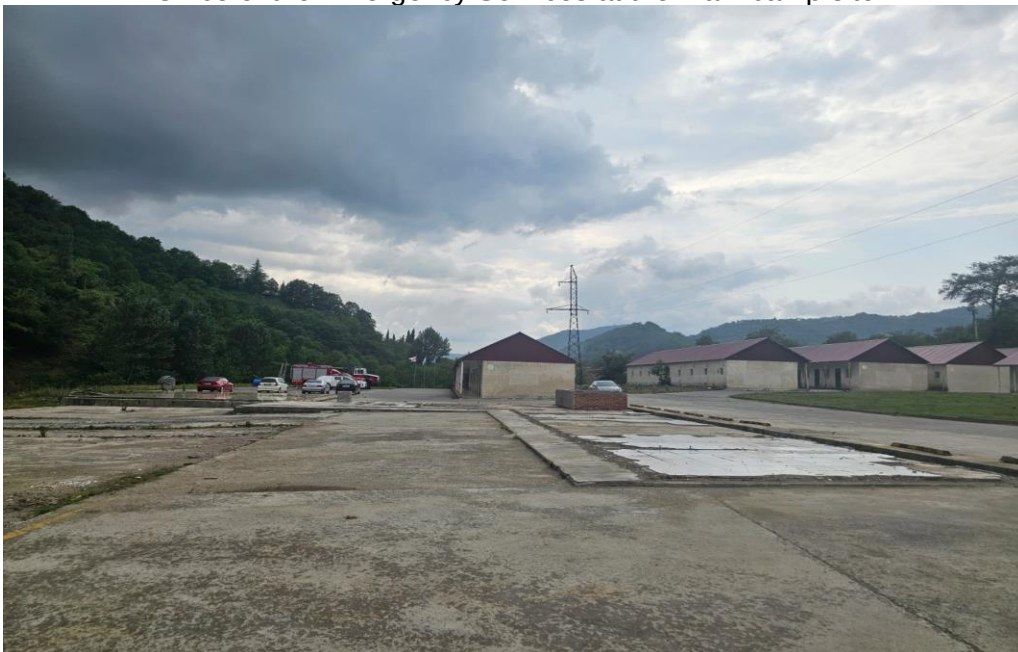
**Office of the Emergency Services at the main camp site**

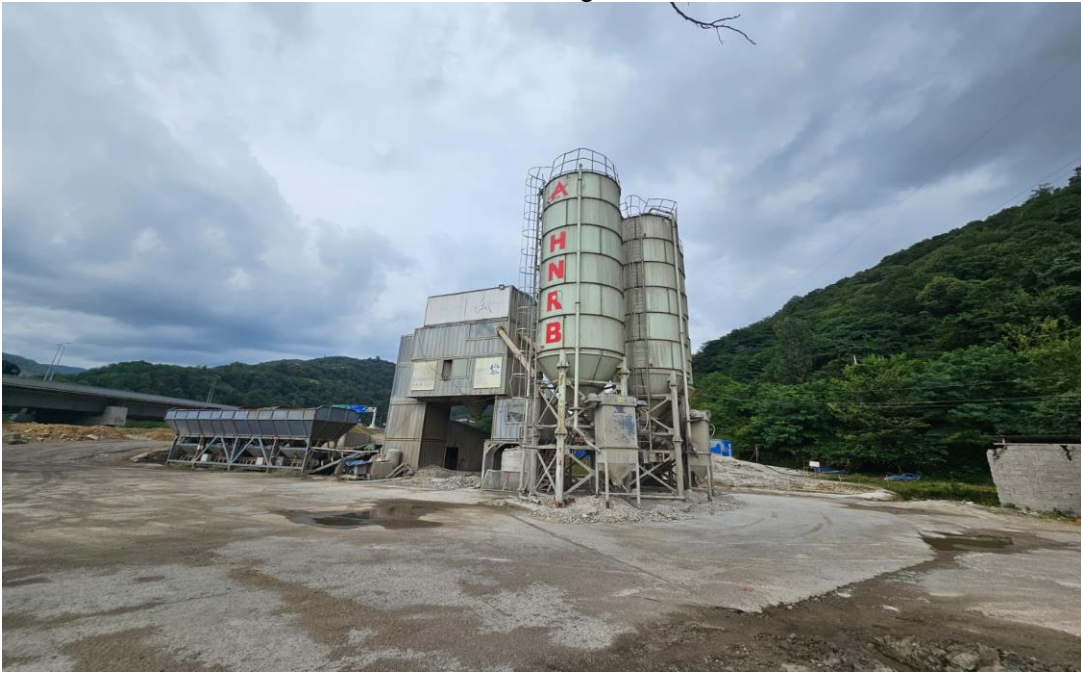
A view of the Batching Plant 3 at site.

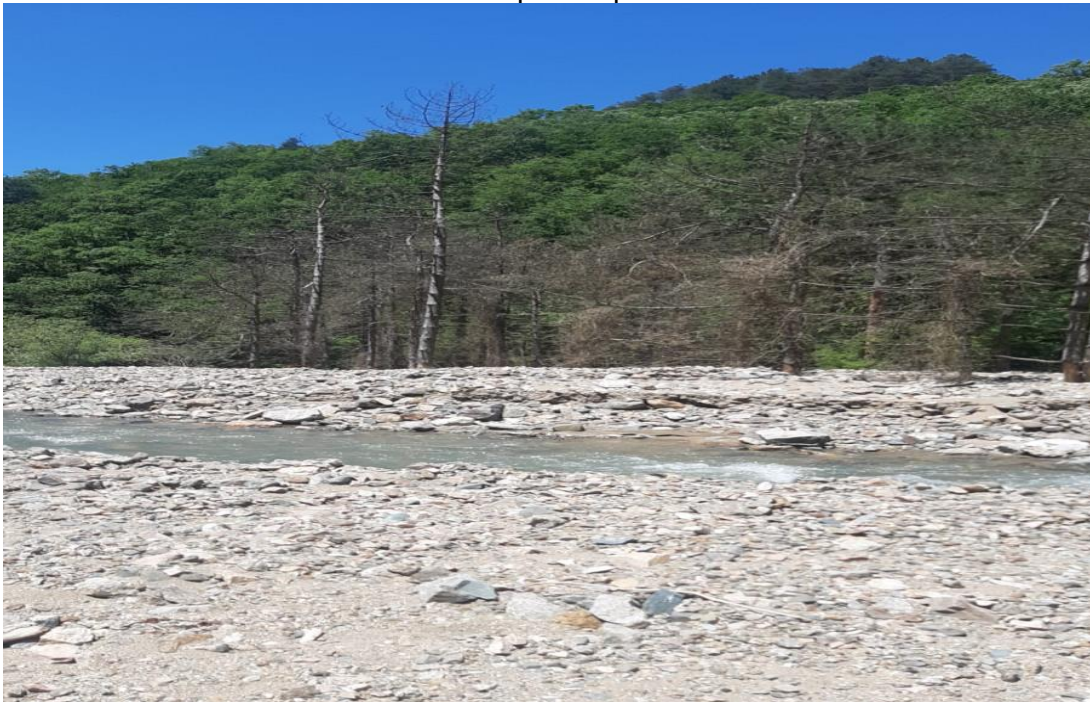
A view of the Spoil Disposal Site 11

| Recommendations | Responsibility |
|---|---|
| SDS#11 is currently in use by GOG founded project and will be rehabilitated once project finishes excavating and dumping soil at SDS#11. | CC to implement and CSC to monitor |
