Semi-annual Environmental Monitoring Report

Reporting period: July-December 2025

Batumi Bypass Road Project— Construction of Poti Bridge and Access Roads

Prepared by the Roads Department of the Ministry of Regional Development and Infrastructure of Georgia for the Asian Development Bank.

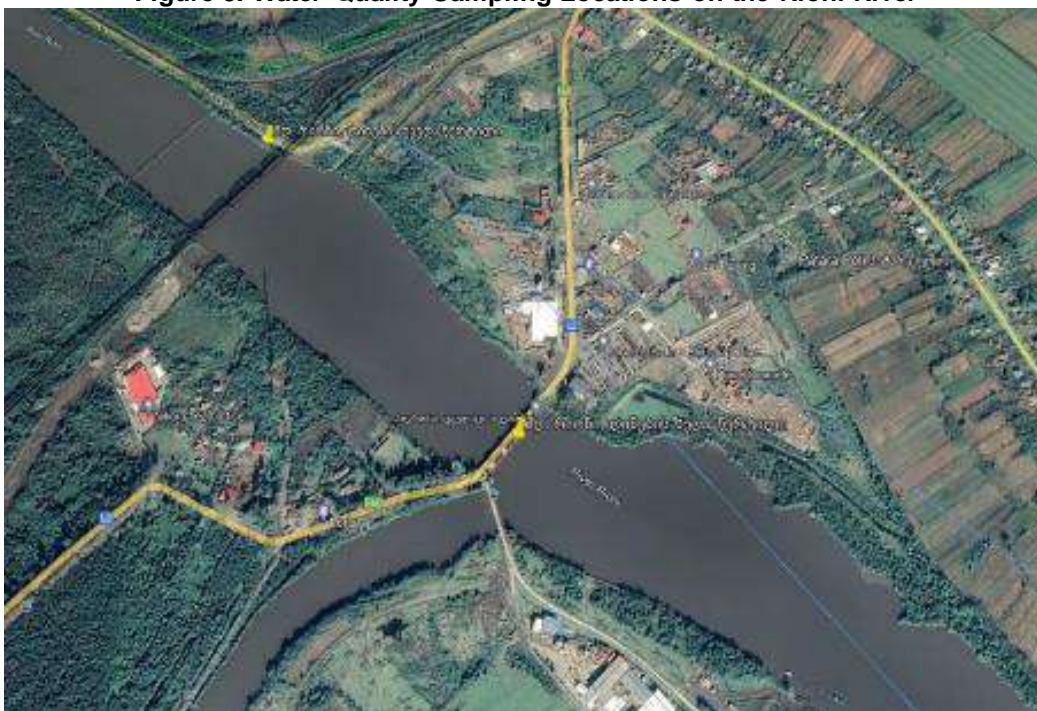
Figure 3. Water Quality Sampling Locations on the Rioni River

Location	Coordinates	
	X	Y
River Rioni downstream	722788	4674713
River Rioni upstream	723505	4674040

52. The results of surface water quality monitoring for the upstream and downstream sections of the River Rioni are presented in Table 7 and Table 8, respectively. During the reporting period, only the July upstream iron (Fe) concentration exceeded national Maximum Allowable Concentration (MAC) limits; this single incident appears to be an isolated anomaly, as such elevated Fe levels have not been previously recorded at the site. In addition, routine monitoring will continue, and if similar results are observed, further corrective actions will be implemented.

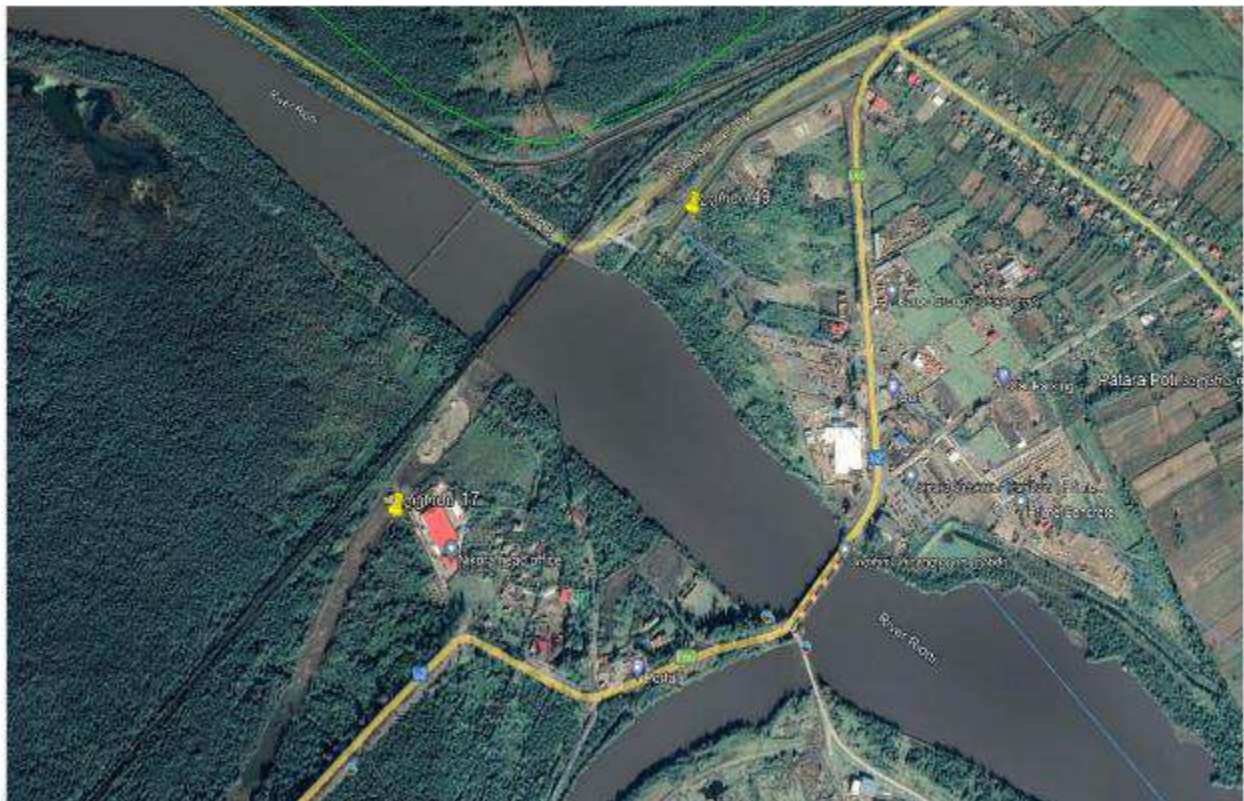
Figure 4. Noise, Vibration and Air Quality Sampling Locations

Location	Coordinates	
	X	Y
Axis 49	723230	4674705
Axis 17	722690	4674127

55. Noise monitoring results at Axis 17, as presented in Table 10, exceeded the International Finance Corporation (IFC) noise level standards during the month of August. However, according to the U.S. Federal Highway Administration's Noise Measurement Handbook, indoor noise levels may be reduced by up to 25 dB(A) when windows are closed. It is also noted that the nearest receptor at this location is the Nikora Meat Production factory, which is classified as a less noise-sensitive facility compared to residential areas.

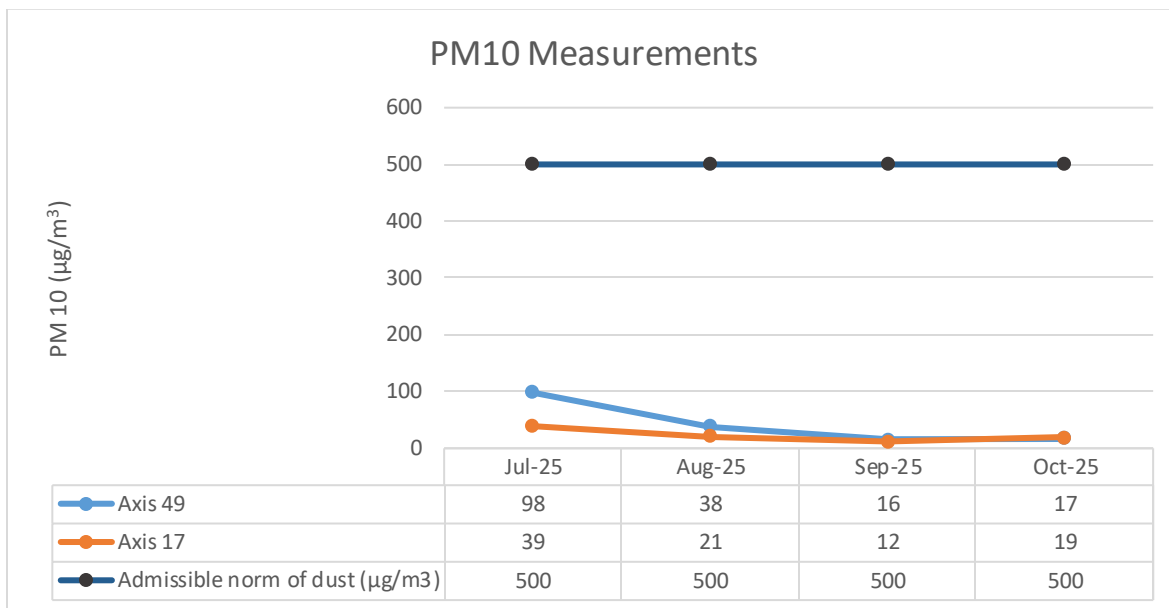
Figure 8. PM10 Measurement Results

Location	Session	PM2.5 (µg/m ³)	PM10 (µg/m ³)	PM Total (µg/m ³)	Admissible norm of dust (µg/m ³)
Axis 49	Jan-25	53	77	84	500
	Feb-25	11	19	23	500
	Mar.25	18	22	25	500
	Apr-25	22	37	62	500
	May.25	11	19	31	500
	Jun-25	13	18	22	500
Axis 17	Jan-25	46	62	75	500
	Feb-25	17	24	31	500
	Mar.25	24	29	33	500
	Apr-25	38	57	81	500
	May.25	9	21	37	500
	Jun-25	16	23	39	500

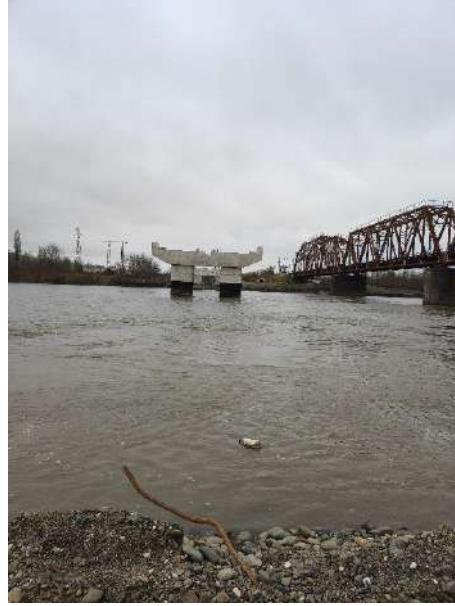
Panoramic view of the bridge pier location near the Rioni river

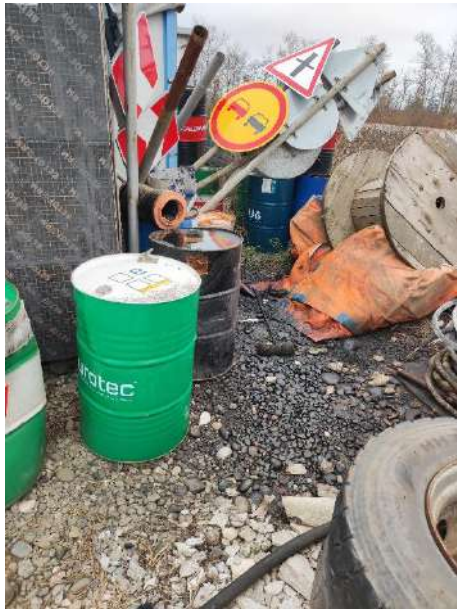
Improperly stored hazardous waste

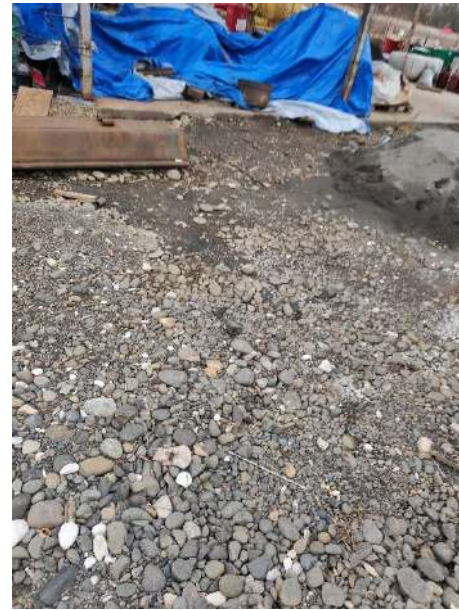
29. The second NCR addressed the ongoing issue of oil and fuel spills observed in key operational areas, including the Material Storage Area, Workshop, Vehicle Maintenance Area, and Fuel Filling Area. Repeated instances of uncontained spills represented a violation of the Environmental Management Plan and Hazardous Waste procedures, creating a significant risk of soil and surface water contamination and regulatory non-compliance.
30. After the NCR was issued, a comprehensive cleanup of all identified oil and fuel spills was carried out across the site. All oil-contaminated materials were collected and transferred to a licensed hazardous waste contractor for proper disposal. The Contractor was instructed to strengthen spill prevention measures, improve housekeeping in operational areas, and ensure the availability and use of spill response kits to prevent recurrence.

Oil spills near material storage area

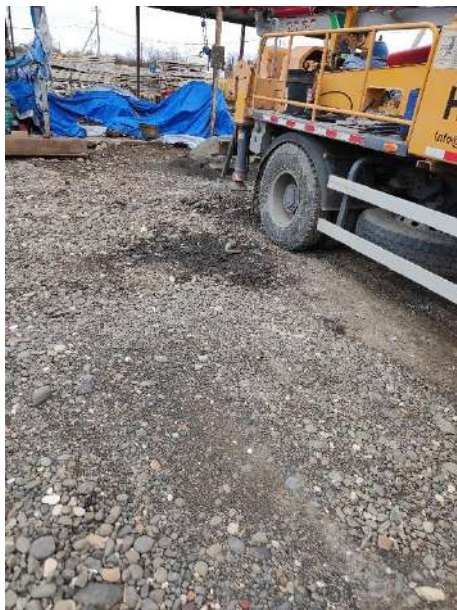
Oil Spills near unused truck

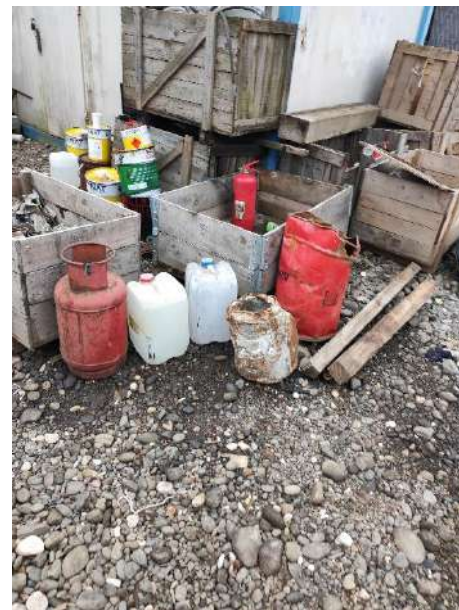
Improperly stored hazardous waste

76. Following the issuance of the Non-Conformance Report (NCR), all hazardous waste and oil drums were removed from the site via a contract with a specialized disposal firm. Waste Disposal Receipt and photographic evidence of the removal are provided in Supporting Documet 9.

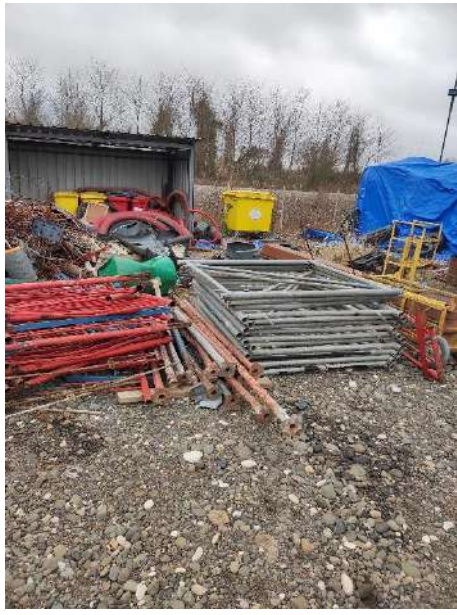
Hazardous waste storage area

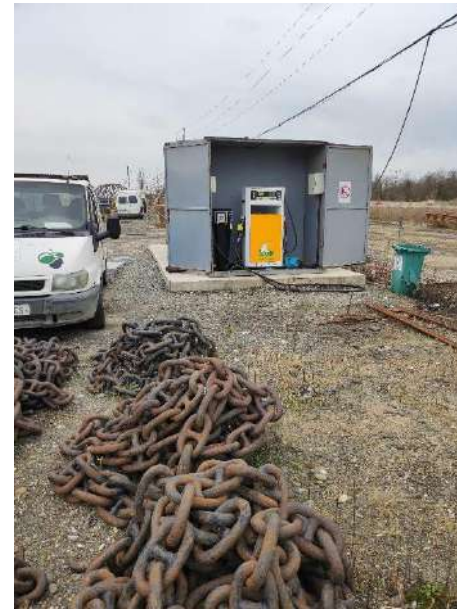
Fuel Station on Site (with minor oil spills)

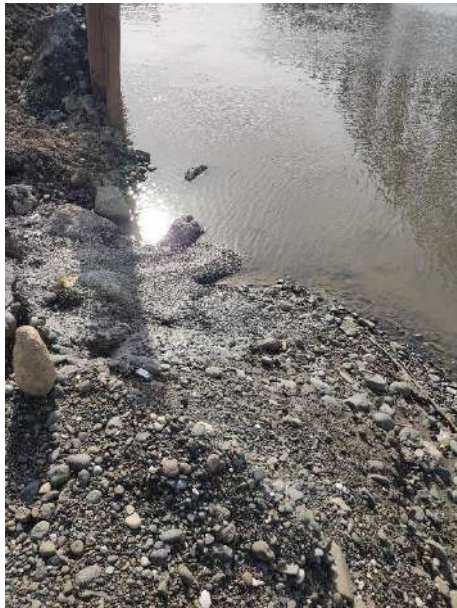
28. The first NCR was issued in response to the discharge of concrete slurry and construction debris from the peninsula area into the Rioni River. Accumulated residues were observed along the riverbank of the artificial island, presenting a direct risk to surface water quality and indicating non-compliance. Following the issuance of the NCR, the Contractor undertook

Cement Residues in the River on the Peninsula

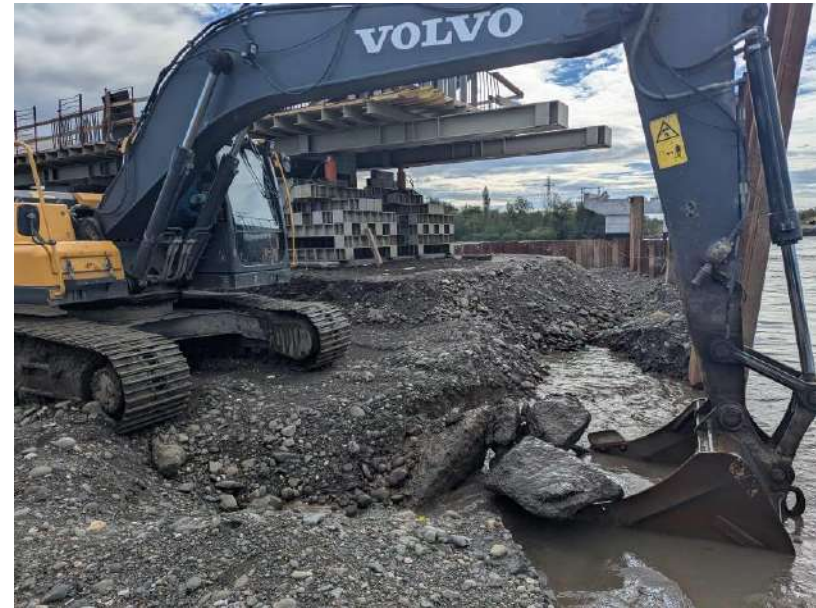
Clearance and remediation activities on the peninsula following the issuance of the NCR

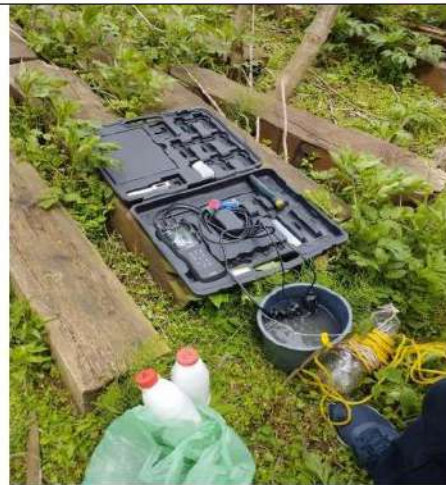
Fig. 4.1.4 - Multiparameter Water Quality Meter

- Surface water - Multiparameter Water Quality Meter, LAQUA Horiba WQ-330; Turbid meter HANNA HI 98703

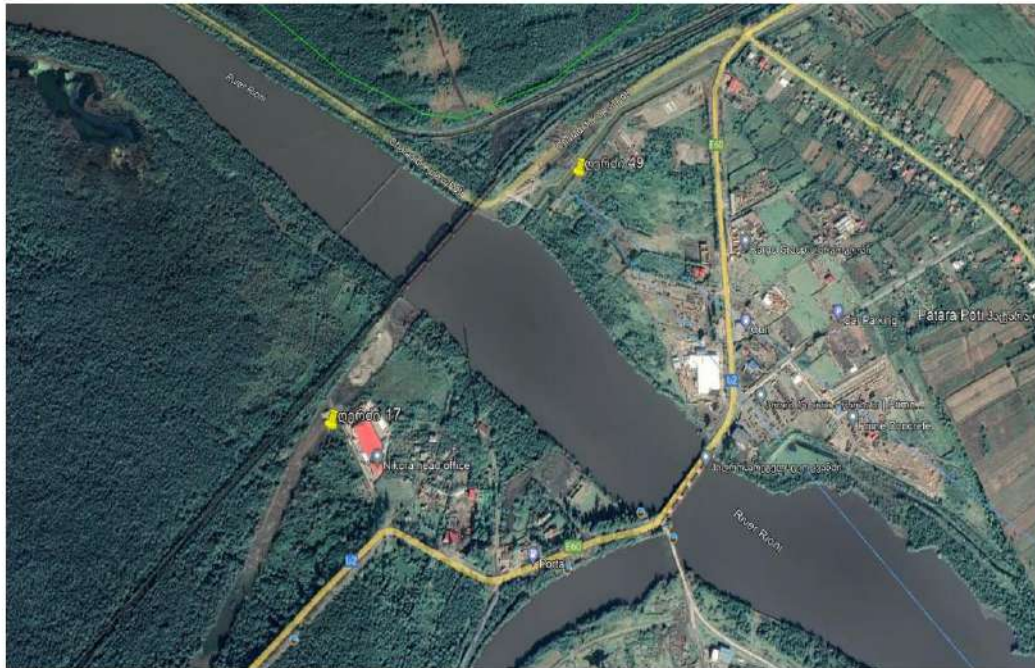
Fig. 4.1.7 - Location of monitoring points for noise, vibration, dust and other pollutants in ambient air

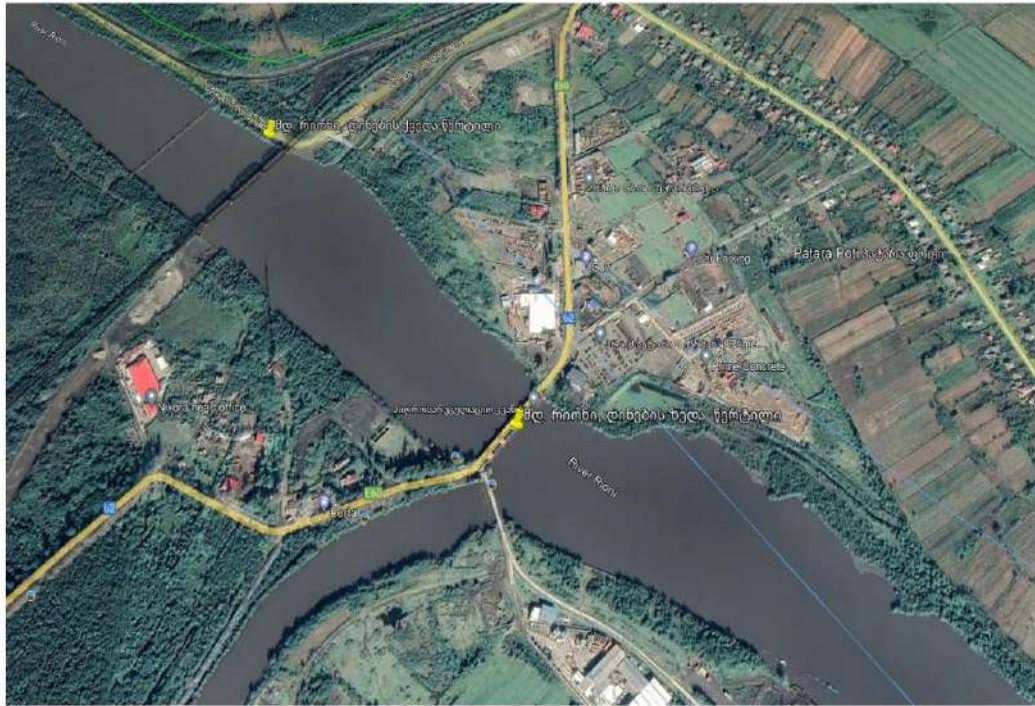
Monitoring point		
#	Location	GPS coordinate
1	Riv. Rioni downstream point	X - 722788 Y - 4674713
2	Riv. Rioni upstream point	X - 723505 Y - 4674040

Fig. 4.1.8 - Location of monitoring points of water taken from Rion River

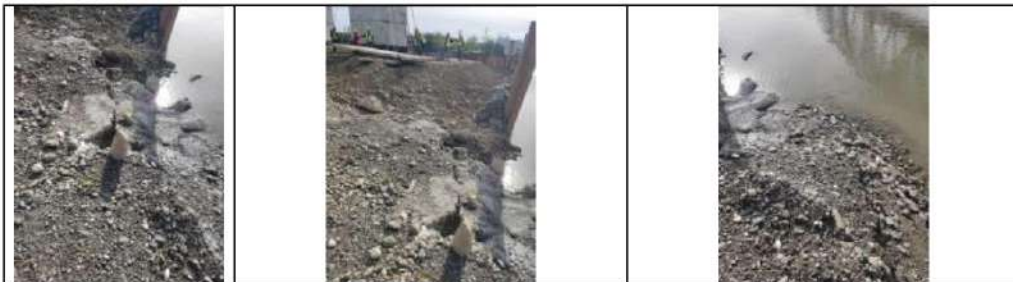
პენისულას ტერიტორიიდან რიონის მდინარეში დაფიქსირდა ბეტონის ნალექისა და ნამსხვრევების ჩაშვება. ხელოვნური კუნძულის სანაპირო ზოლზე ამჟამად შეინიშნებოდა დაგროვილი ნარჩენები, რაც წარმოადგენს პირდაპირ გარემოსდაცვით საფრთხეს და მიუთითებს სამშენებლო მასალების არასწორ განთავსებაზე. აღნიშნული ქმედება არღვევს ობიექტის გარემოსდაცვითი მართვის გეგმას და დადგენილ ნარჩენების მართვის პროცედურებს, რაც იწვევს წყლის დაბინძურების რისკს

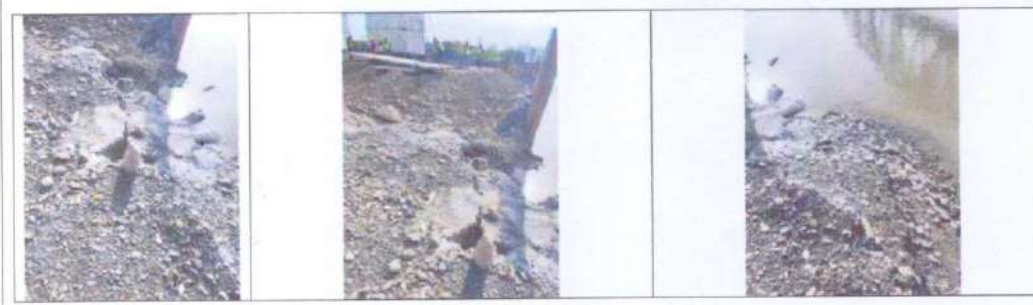
პენისულას ტერიტორიიდან რიონის მდინარეში დაფიქსირდა ბეტონის ნალექისა და ნამსხვრევების ჩაშვება. ხელოვნური კუნძულის სანაპირო ზოლზე აშკარად შეინიშნებოდა დაგროვილი ნარჩენები, რა წარმოადგენს პირდაპირ გარემოსდაცვით საფრთხეს და მიუთითებს სამშენებლო მასალების არასწორ განთავსებაზე. აღნიშნული ქმედება არღვევს ობიექტის გარემოსდაცვითი მართვის გეგმას და დადგენილ ნარჩენების მართვის პროცედურებს, რაც იწვევს წყლის დაბინძურების რისკს
