# Bi-annual Environmental Monitoring Report

Reporting period: January – June 2018

## Republic of Georgia: Batumi Bypass Road Project Financed by the Asian Development Bank

SMEC International Pty Limited

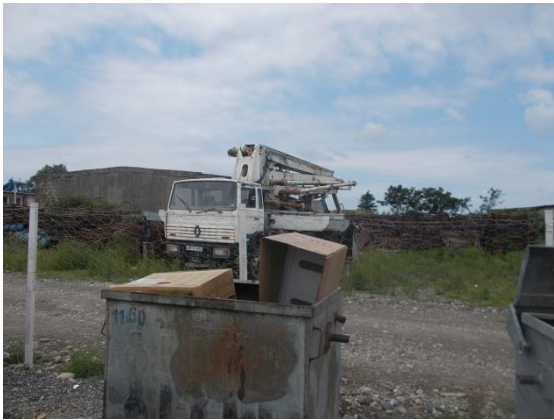
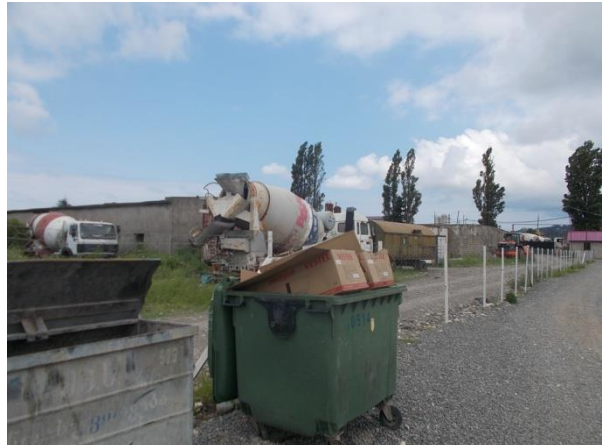
**Picture 3**

- ▶ Several times overfilled garbage containers were detected on the office-living campsite (*picture 3, 6*);
- ▶ Overfilled garbage container was detected on the Contractor's Construction Site (*picture 12*);
- ▶ On the territory of office-living campsite, there are two asbestos pipes, which are considered as the hazardous waste (*picture 2, 4*);
- ▶ There are empty cement bags on the construction site (*picture 11*);
- ▶ There are remnants of gypsum board on the construction site (*picture 5*);
- ▶ The little amount of metal scraps are detected on the construction site (*picture 14*);
- ▶ There are used tyres on the section km12+800 of the construction site (*picture 20, 21*);
- ▶ There are stumps of the cut trees on the section Km 12+800 of the construction (*picture 18*).

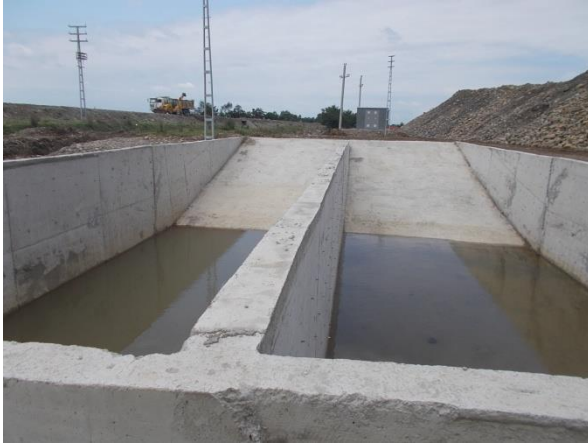
**Picture 7**

- ▶ Access roads to Bridges and Tunnels (*Picture 15, 16, 34, 35*);
  - ▶ Territory of the construction site, installation of batching plant (*picture 9, 10*); installation of sedimentation traps (*picture 7*), Installation of crushing plant (*picture 8*);

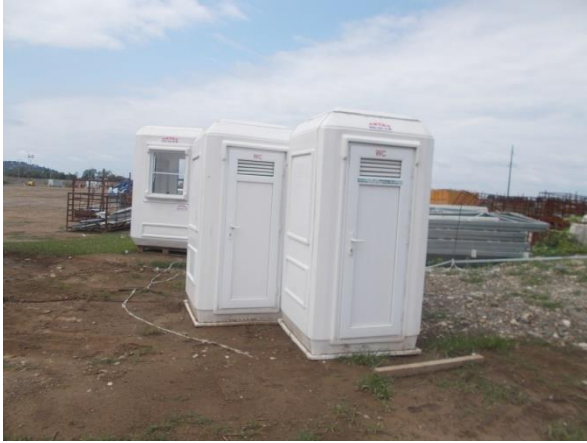
**Picture 13**

- ▶ Concluding the Agreement on removing of household waste;
  - ▶ Concluding the Agreement on delivery/installation of the Fire inventory;
  - ▶ Provision of Bio Toilets for the Construction Sites (*picture 13*);

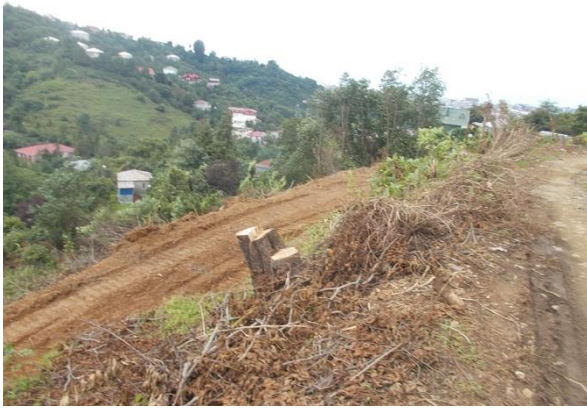
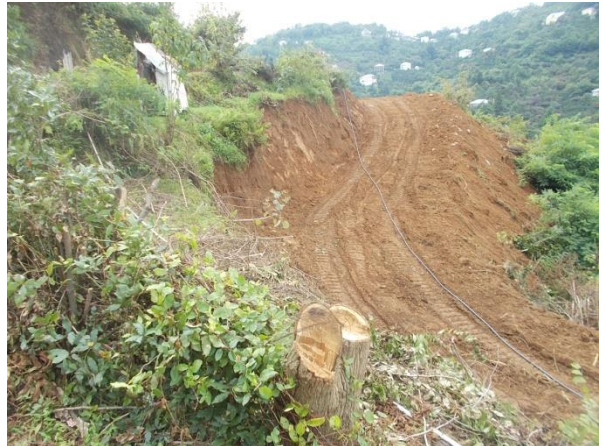
**Picture 15**

- ▶ 4<sup>th</sup> interchange, top-soil removal, storing and other works (*picture 19, 22*);
  - ▶ Nearby territory of the 4<sup>th</sup> tunnel (km8+600) (*picture 15, 16, 42*);

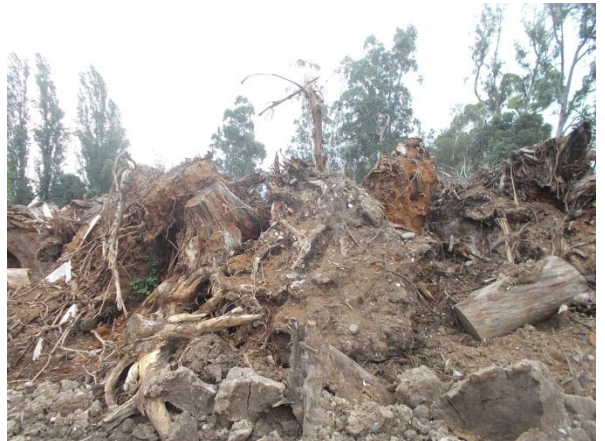
**Picture 18**

Currently, debris of demolished buildings and stumps of cut trees, located on the territory of the 4<sup>th</sup> interchange (km 12+800), are not removed into the dumpsite (*picture 18, 23– 33, 36*). The Contractor has not yet concluded the agreement with the local municipality about assigning the territory for the dumpsite. The Engineer demanded from the Contractor to conclude above mentioned agreement in a written form and to present it for review.

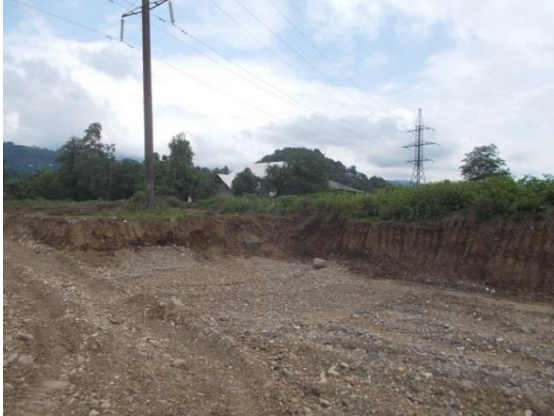
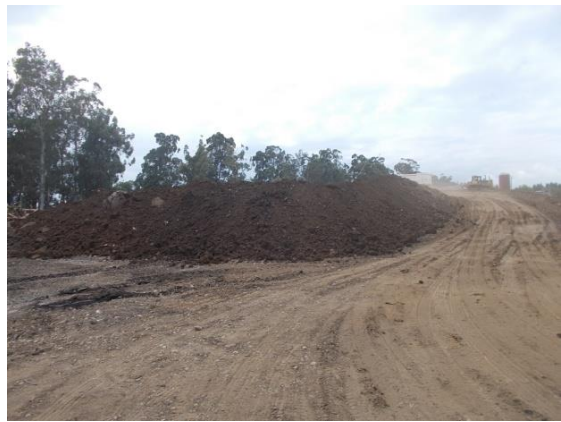
**Picture 19**

- ▶ Provision of safety equipment for the working personnel;
  - ▶ Top-soil removal and storing (*picture 19, 22*);
