Semi-Annual Environmental Monitoring Report

14th № Semestral Report

Reporting Period: January-June 2024

Georgia: Batumi Bypass Road Project

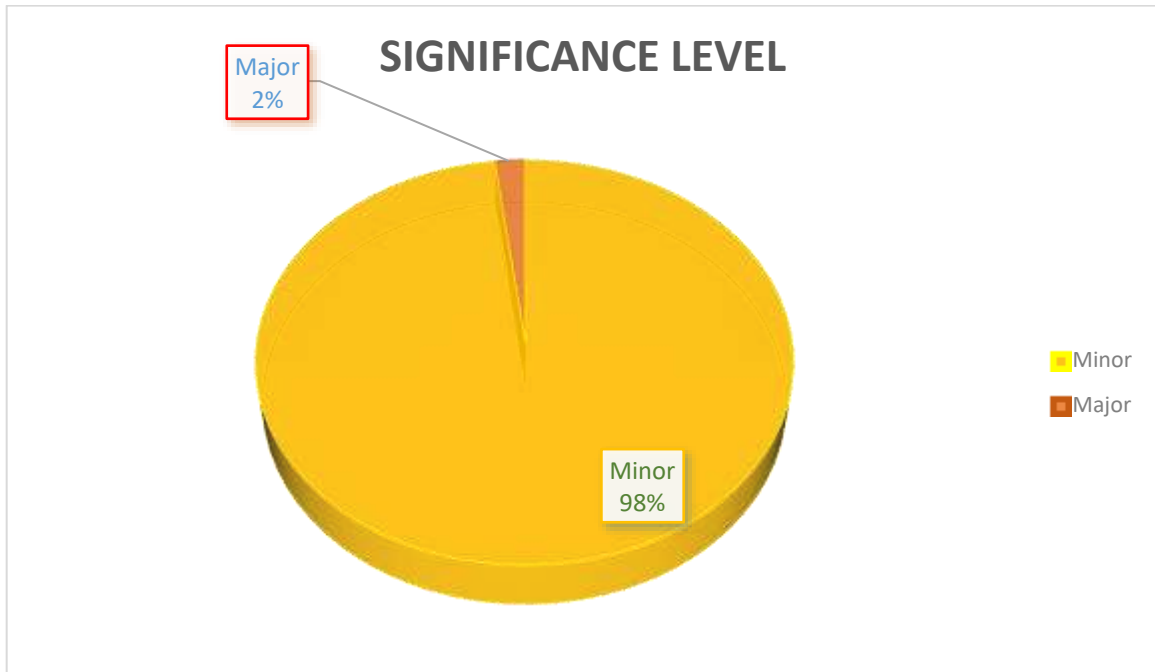
Figure 4. Summary of Non-Conformance by Significance Level

40. Building upon the information provided in Table 6, Figure 4 below delineates the environmental issues categorized by significance levels, ranging from Minor to Major. The Engineer conducts individual assessments for each issue based on the scale of violation and its impact on the environment. Figure 4 visually represents the percentage distribution of minor and major environmental issues observed during the reporting period.

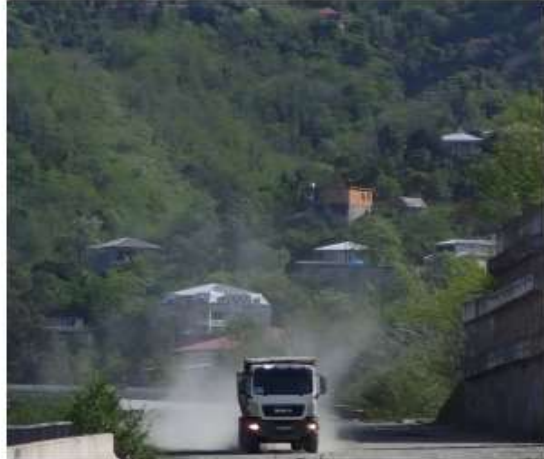
Photo No. 4- Earth road

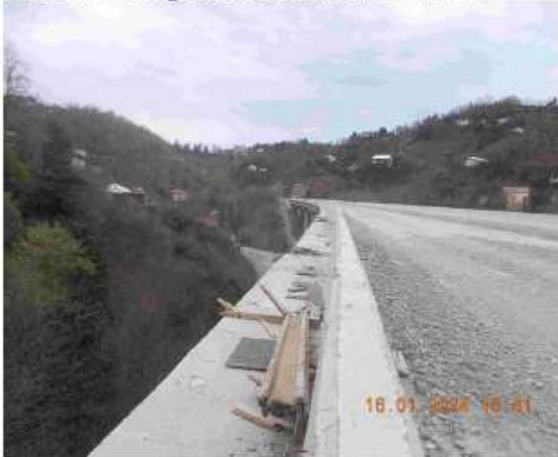
Photo No. 5- Bridge No. 10 shoulder and sidewalk

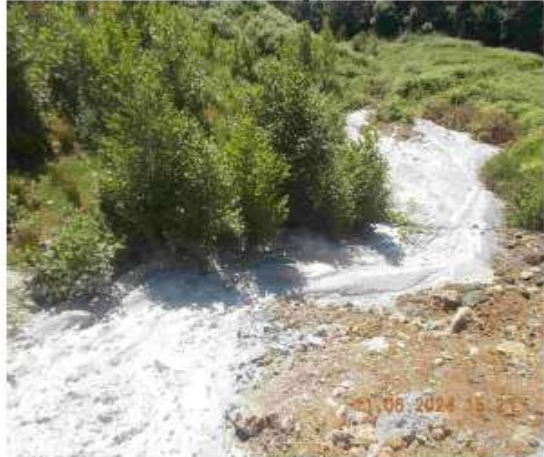
Photo No. 6- Tunnel No. 2 Exit portal

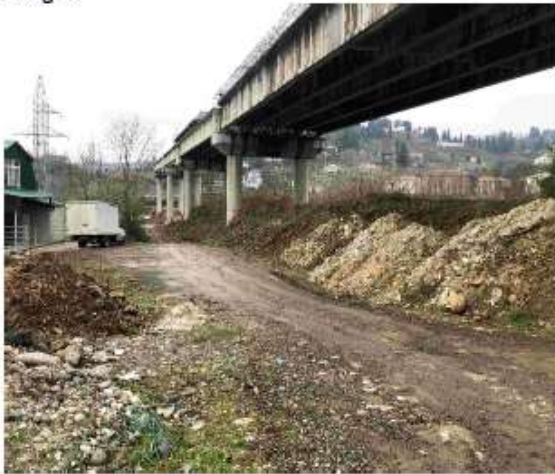
Photo No. 7- Excavated soil and rock material placed under bridges

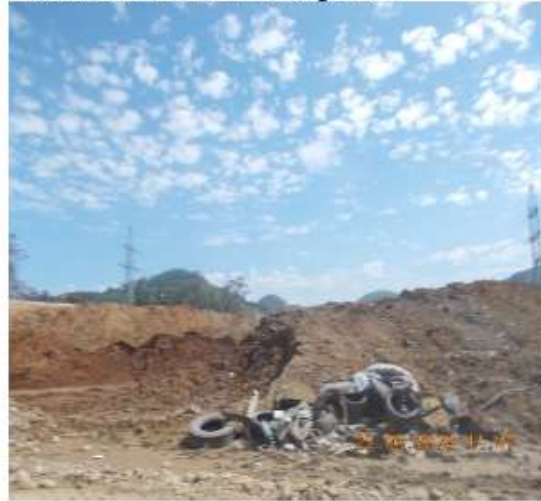
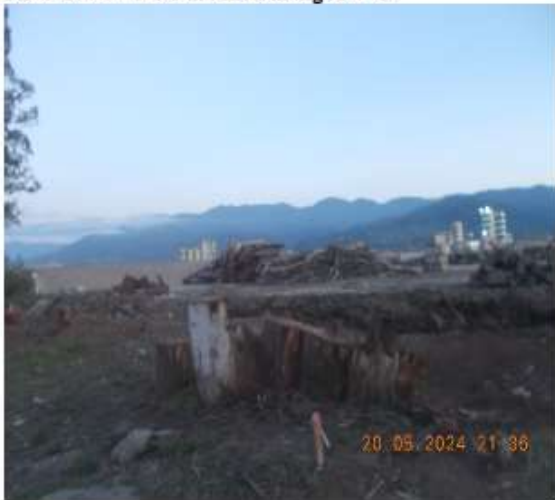
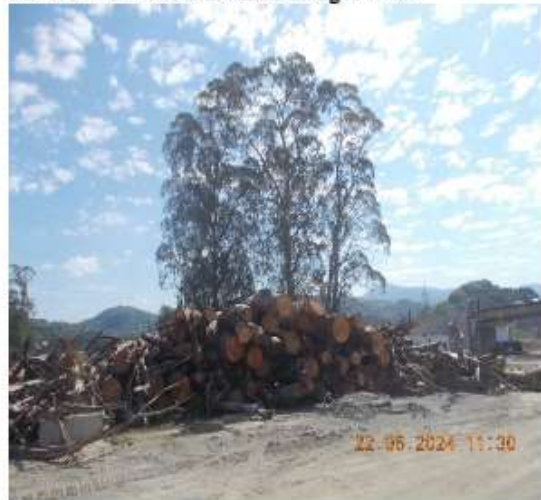
Photo No. 8- Near the Interchange No. 4.

Photo No. 9- Near the Interchange No. 4.

Photo No. 10- Near the Interchange No. 4.

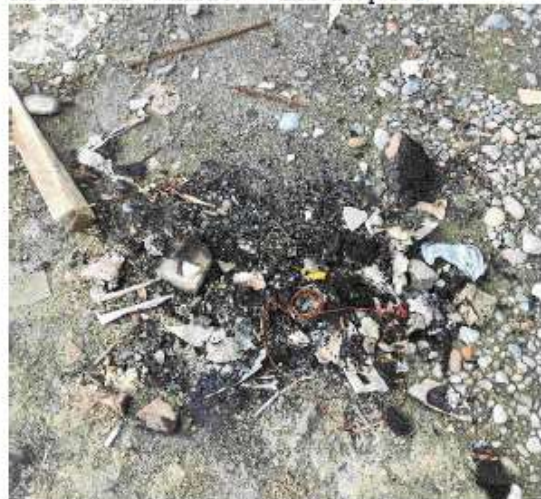
Photo No. 12- Tunnel No. 3 Entrance portal

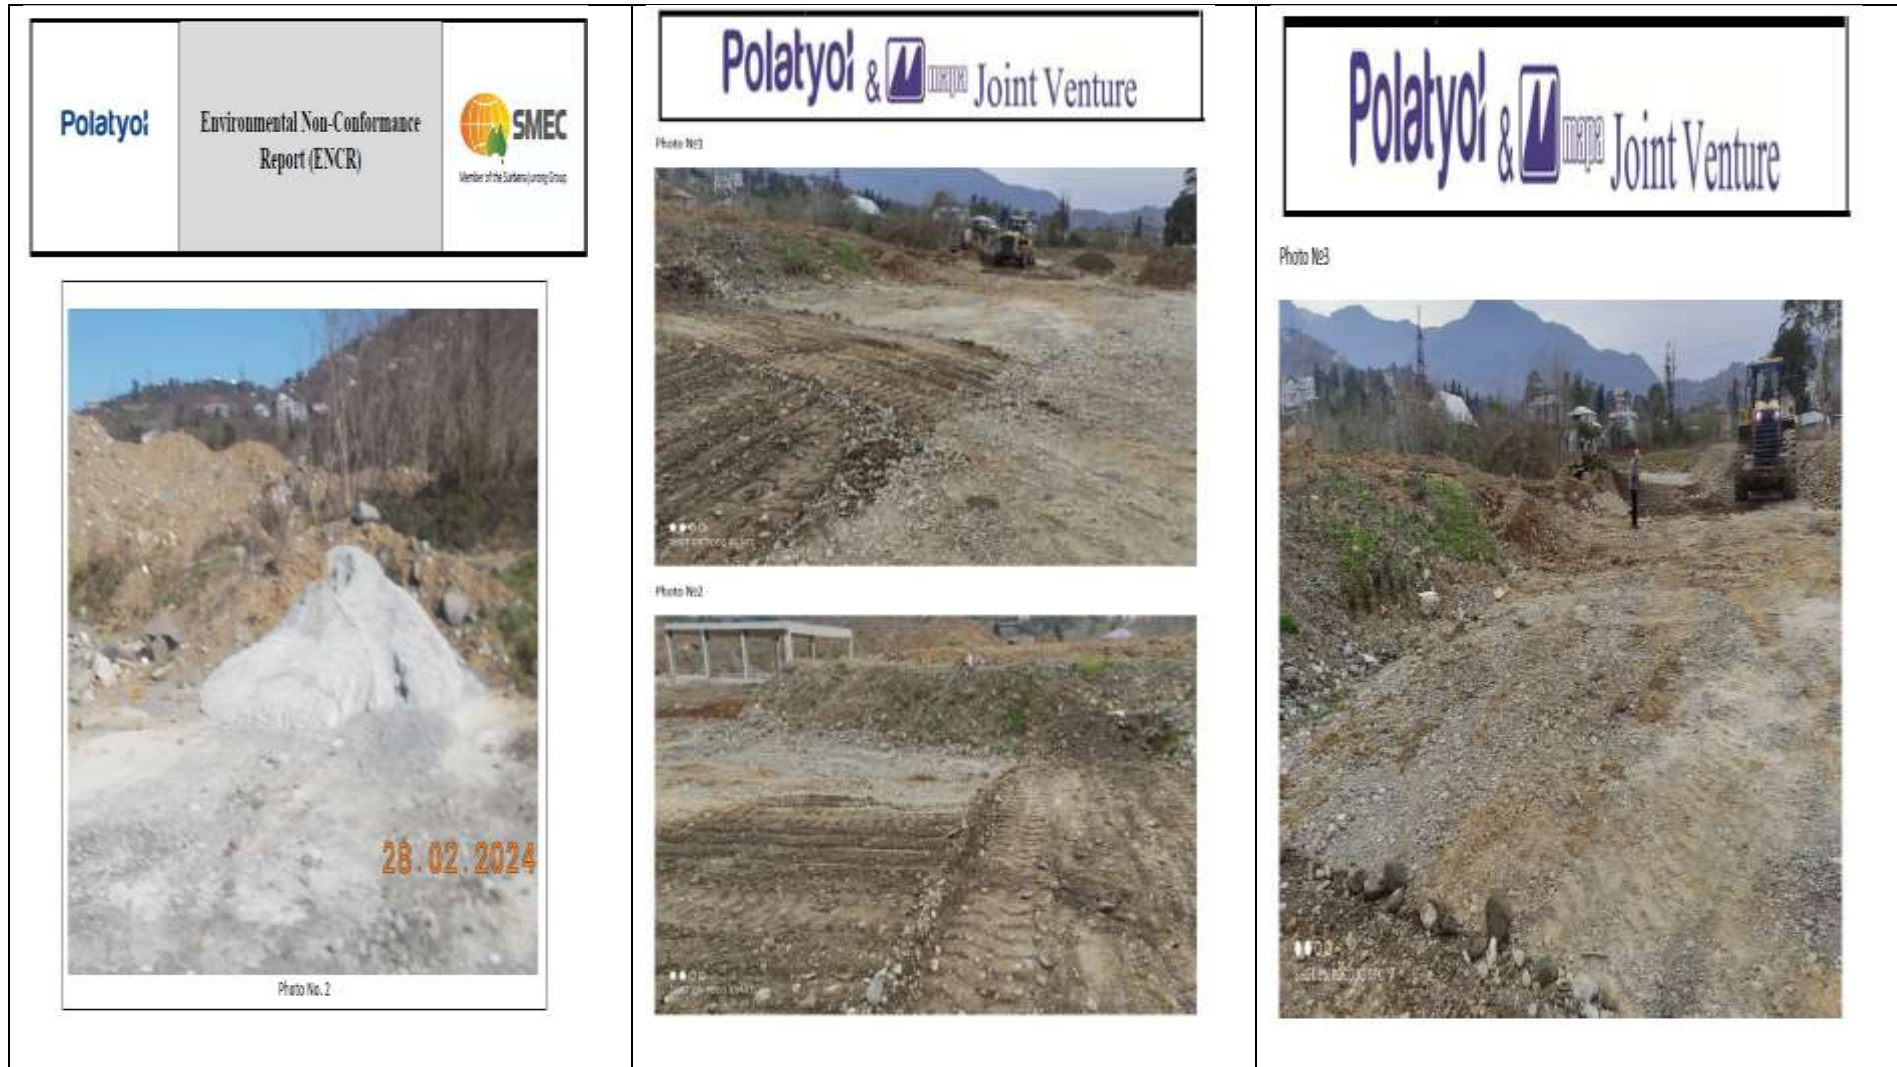
Photo No. 1

Polatyo!	Environmental Non-Conformance Report (ENCR)	SMEC Member of the Saurana Group
Part 1 – Non-Conformance Description:		
Reference Number:	ENCR_164	
Project Name:	Bishara Bypass Road Project	Date raised: 28/02/2024
Contract Name:	POLATYO! & MAPA JOINT VENTURE	
Location:	Adjacent to the Tunnel Control Center under Construction / მძებნარეკვე ვერისების მართვის ცენტრის მიდებნარეკვე	
Non-Conformance details:		
<p>The following was observed in the area:</p> <p>ტერიტორიაზე დაფიქსირდა:</p> <p>1. Soil pollution with oil products. ნავთობპროდუქტთა ზიანის დაზიანება.</p> <p>2. Waste concrete spilled out of concrete mixer. ბეტონის თვითმზღო მანქანისა და მანქანის ბეტონის ნარჩენის დაზიანება.</p> <p>Proposed Corrective Actions:</p> <p>შემოთავაზებული გამოსწორებელი ღონისძიებები:</p> <p>1) The removal of the contaminated soil with oil products is necessary and it should be transported and disposed at temporary disposal of hazardous waste collection area. In case of unforeseen situations, an oil absorber should be provided.</p> <p>ავტონომიური მოხმობის საფრთხილგამაფრთხილებელი ზიანის მოხმობის დაზიანებული ზიანის დაფიქსირდა იქნას და განთავსდეს სახიფათო ნარჩენების შეგროვებისა და დროებითი განთავსების ადგილზე, ზემოთ მოხმობილი უნდა იყოს მოხმობილი ავტონომიური მოხმობის საფრთხილგამაფრთხილებელი.</p> <p>2) It is necessary to clear the area from concrete waste. It is also necessary to remove the concrete waste and place it in a pre-determined waste concrete disposal area.</p> <p>ავტონომიური ტერიტორიის გაწმენდა ბეტონის ნარჩენისაგან. ასევე, საჭიროა ბეტონის ნარჩენის გასწმენდა და ბეტონის ნარჩენისაგან წინასწარ განსაზღვრულ განთავსების ზონის განთავსება.</p> <p>The concrete mixer truck drivers and supervisors should be informed and trained on the Waste Management Plan, and the truck drivers should know where to place the concrete waste to prevent the occurring spills.</p> <p>თვითმზღო ბეტონის მანქანების მძღოლებს და მათ ხელმძღვანელებს უნდა განხორციელონ და იცნონ მოხმობილი ნარჩენების მართვის გეგმის მიხედვით, რადგანაც მძღოლებს უნდა იცნონ, სად მოათავსონ ბეტონის ნარჩენები, რათა თავიდან აიცილონ განხორციელებული დაზიანება.</p>

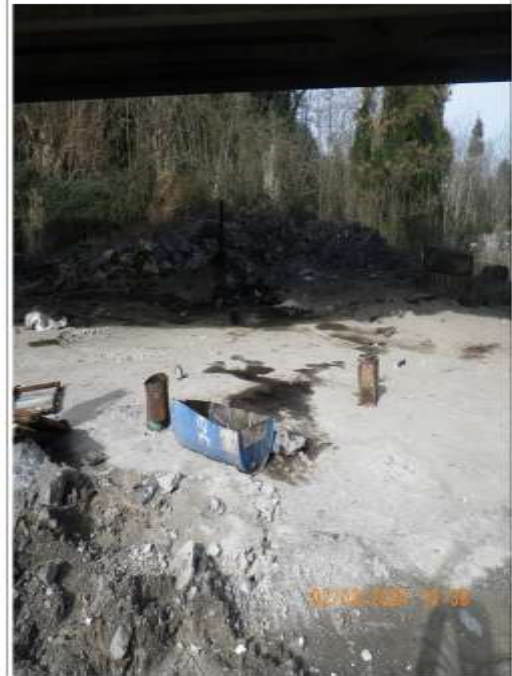
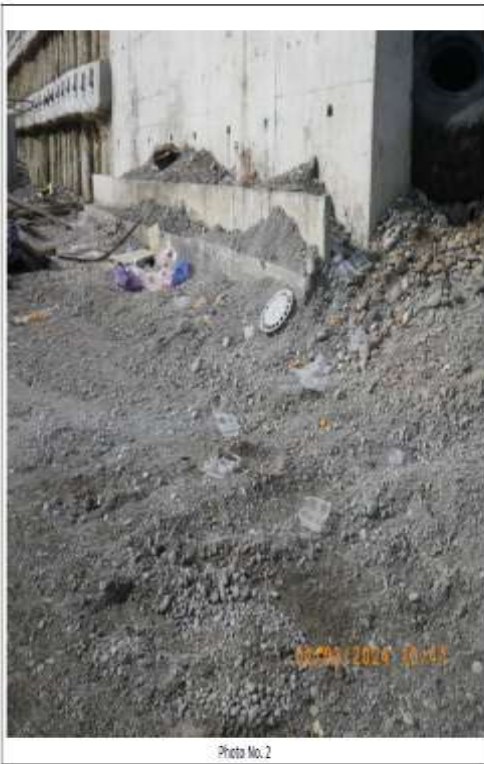
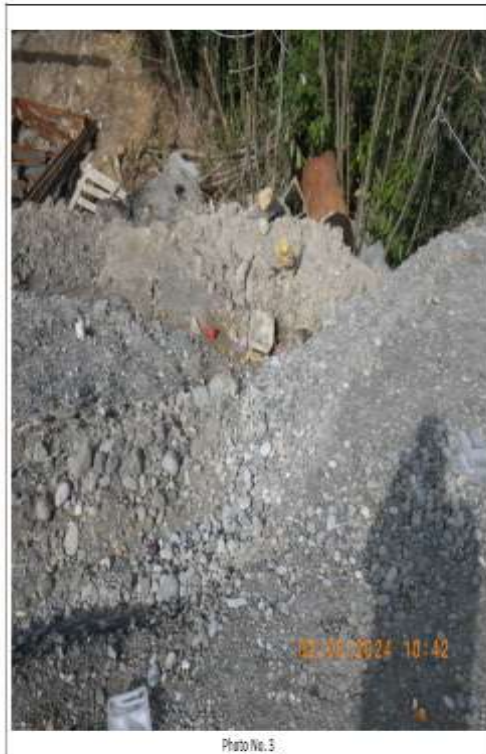
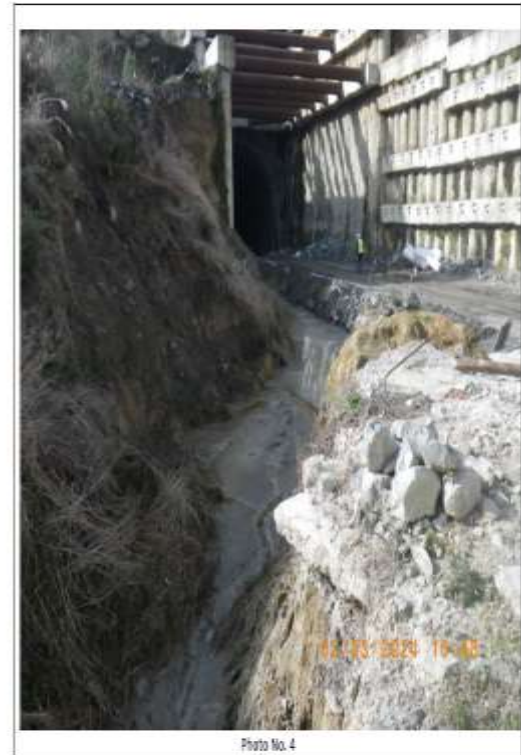
Polatyo!	Environmental Non-Conformance Report (ENCR)	SMEC Member of the Saurana Group
Part 1 – Non-Conformance Description:		
Reference Number:	ENCR_165	
Project Name:	Botana Bypass Road Project	Date raised: 04/03/2024
Contractor Name:	POLATYO! & MAPA JOINT VENTURE	
Location:	Under Bridge No. 1 near Tunnel No. 1 Entrance Portal and in Vicinity of Tunnel No. 1 Entrance Portal / No. 1 კვანძის შესასვლელი პორტალი, No. 1 ბრიჯის ქვეშ და No. 1 კვანძის შესასვლელი პორტალის მიმდებარე	
Non-Conformance details:		
<p>The following was recorded დაფიქსირდა:</p> <p>Hazardous waste (oil/lubricants) spill from vehicle/plant maintenance (Photo 1); disposal of household waste (including plastic lunch boxes) on the ground due to absence of waste bins on site (Photos 2 and 3); ineffective sediment ponds due to lack of maintenance (Photo 4); contamination of soil from concrete wash (Photo 5).</p> <p>ტრასპორტის/სამანქანო მოღვაწეობის შედეგად დაფიქსირდა სასაფრთხო ნარჩენები (მაგონობის/საჭმლის მასალა) (ფოტო 1); სასაფრთხო მოწყობის ხასიათი უქონი პორტალების გამო მიწაზე განთავსებული საყოფაცხოვრებო ნარჩენები (ფოტო 2 და 3); ეფექტური სედიმენტაციის აუზები არასასაფრთხო მოღვაწეობის გამო (ფოტო 4); ნარჩენი ზედაპირი გრუნტის დაზიანება (ფოტო 5)</p>

Proposed Corrective Actions:		
შეზღვევითელი/გაუმჯობესებელი ღონისძიებები:		
<ol style="list-style-type: none"> 1) Remove spilled oil/lubricants from site and store at temporary hazardous waste facility at Construction Camp site, use oil/lubricant waste collection pans under vehicles when performing maintenance activities. დაფიქსირებული სასაფრთხო ნარჩენების მოცილება და სასაფრთხო მოწყობის არსებულ სასაფრთხო ნარჩენების შეფარება და დროებითი განთავსების ადგილის გადართვა. მოღვაწეობის სანდოებისას ტრასპორტის ქვეშ სასაფრთხო დაზიანება. 2) Clean up all the rubbish from site and provide waste bins and hold regular toolbox talks to remind staff of the correct disposal of household waste. სასაფრთხო მოწყობის ნარჩენებისგან გასუფთავება და ხასიათი უქონი საჭმლის კონტეინერების რეგულარული ინსპექციები ჩატარება საყოფაცხოვრებო ნარჩენების სწორად განთავსების შესახებ. 3) Remove silt-up sediment in settling ponds on a regular basis to maintain their effectiveness. სედიმენტაციის აუზების ხაუნისგან რეგულარული გასუფთავება მათი ეფექტურობის შესანარჩუნებლად. 4) Remove concrete wash and dispose in approved location. ბეტონის ნარჩენების მოცილება და მუდმივად დასაშვებულ ადგილას განთავსება.

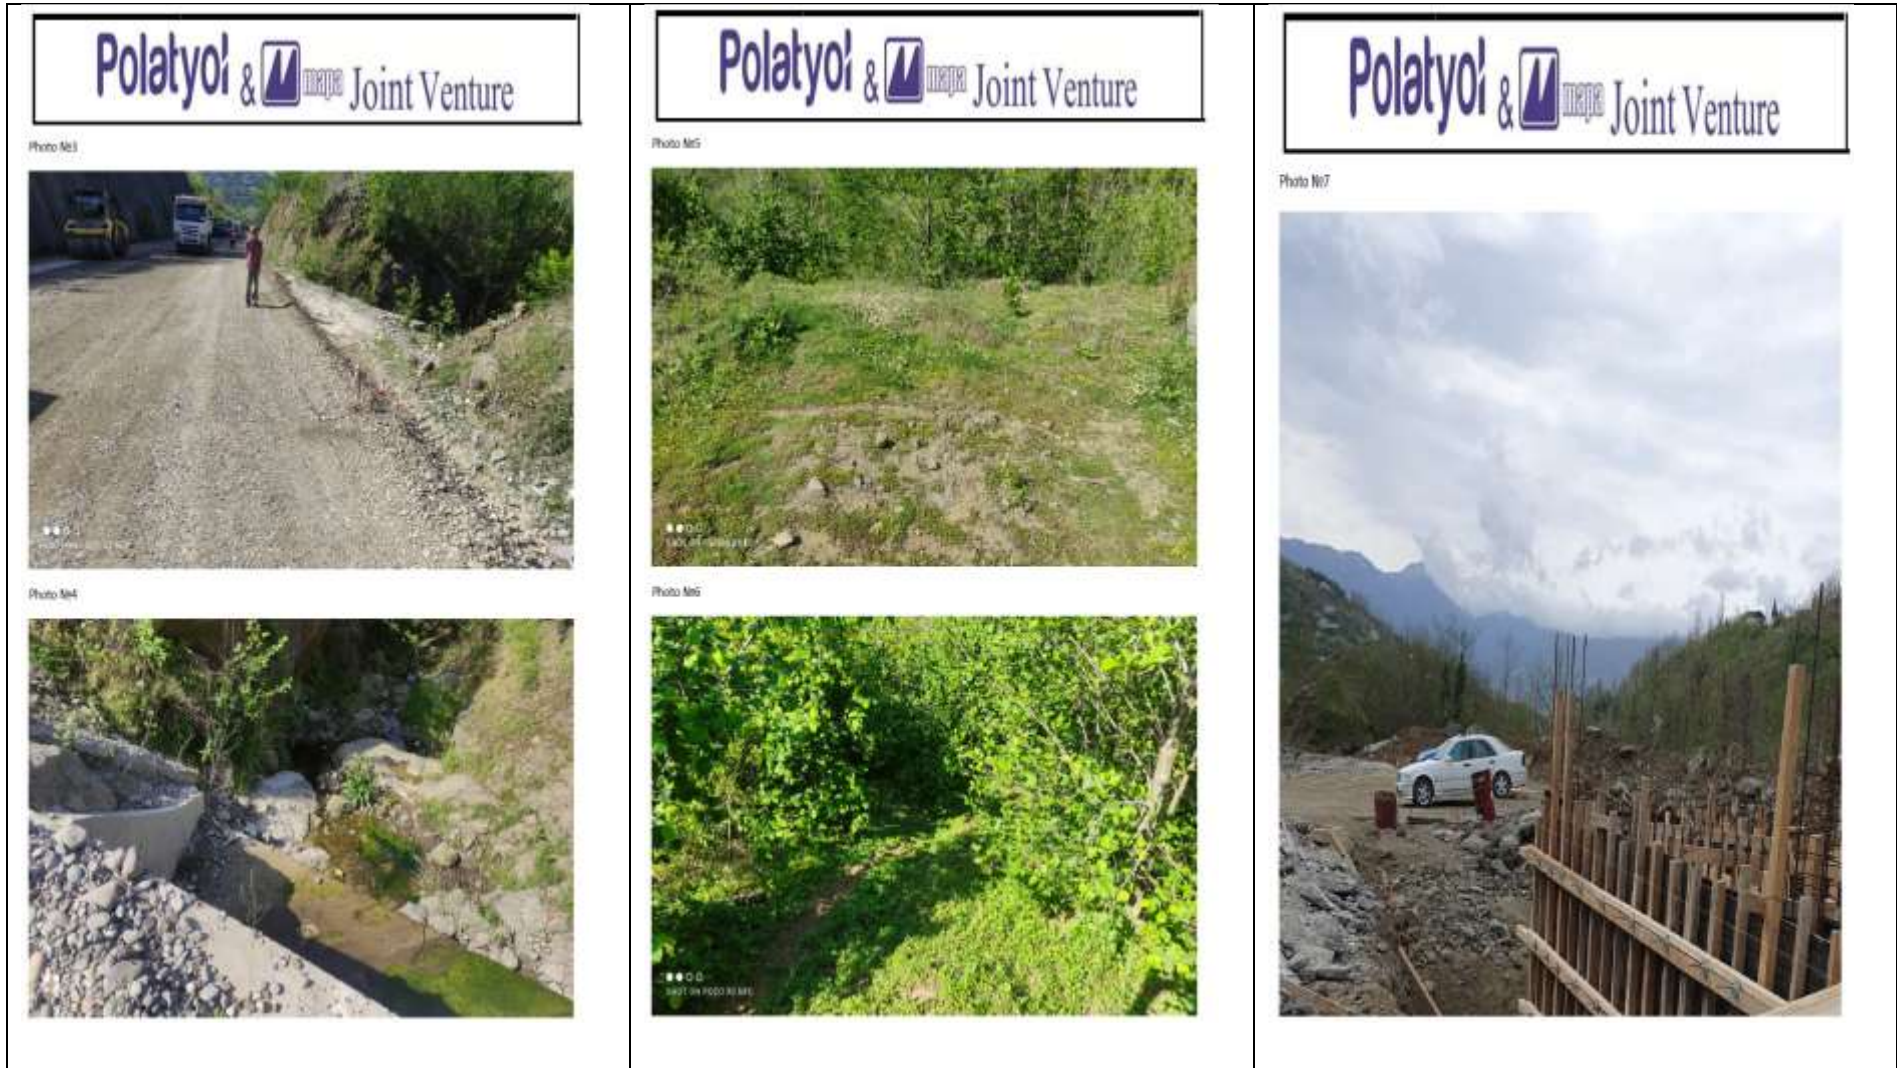
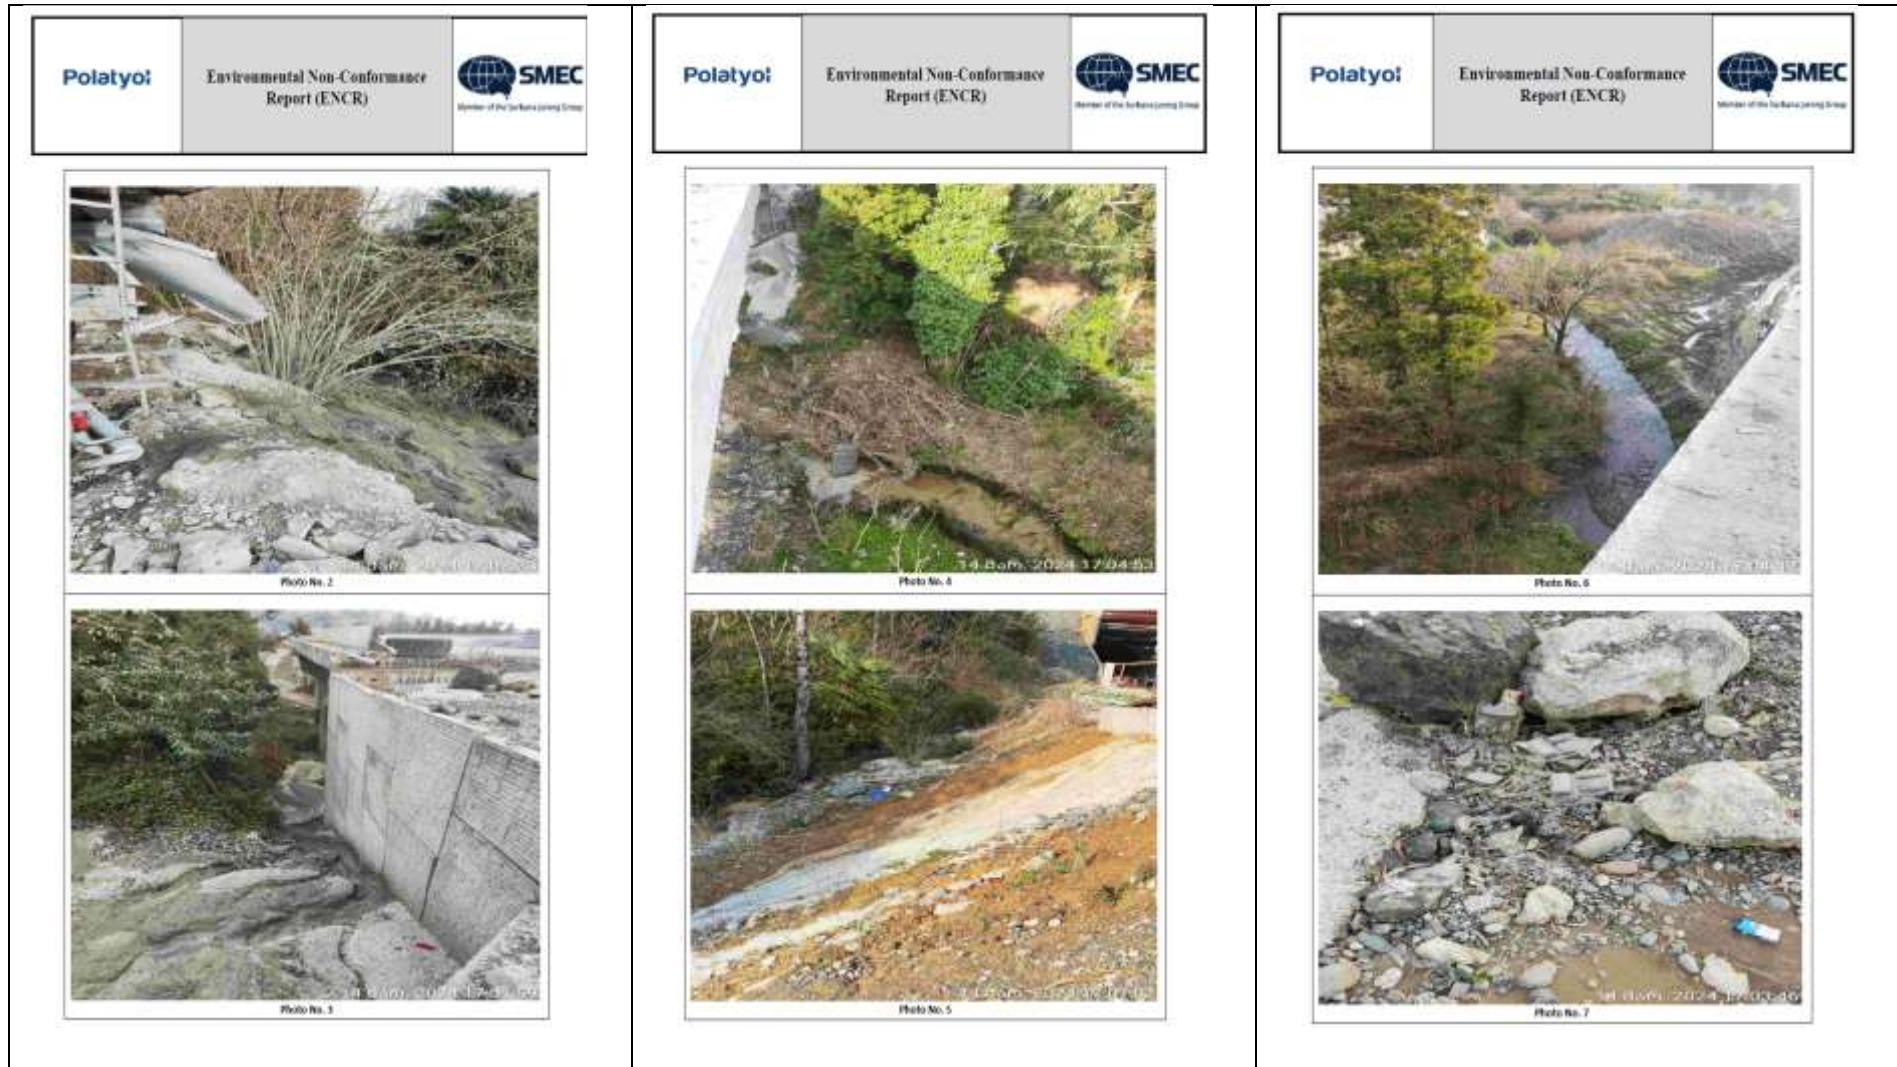
Polatyo!	Environmental Non-Conformance Report (ENCR)	SMC Member of the Sartana Group
ENCR_170		
14.03.2024 17:03:13		
Photo No. 1

Polatyo!	Environmental Non-Conformance Report (ENCR)	SMC Member of the Sartana Group
Part 1 – Non-Conformance Description:		
Reference Number:	ENCR_170	
Project Name:	Batawi Bypass Road Project	Date raised: 15/03/2024
Contractor Name:	POLATYO! & MAPA JOINT VENTURE	
Location:	Adjacent to the Tunnel No. 1 Exit Portal and Beginning of Bridge No. 3 / No. 1 ვიწრობის გამოსასვლელი პორტალის და No. 3 ხიდის დასაწყისის მიმდებარე	
Non-Conformance details:		
The following was recorded:		
ცერტიფიკატი დარღვევითაა:		
<ol style="list-style-type: none"> Concrete spilled on the ground from a concrete mixer truck, which also flows into the small river nearby (Ref to the photos No. 1, 2, 3, 4 and 5); ბეტონის თეთროვანი მასალისა და მისი დანგრეული ნაწილის ნარჩენი, სადაც დანგრეული ბეტონის ნარჩენი მიდებარე არსებულ მცირე ზომის მდინარეზე ჩვევს (იხ. ფოტო No. 1, No. 2, No. 3, No. 4 და No. 5); Household waste scattered on the ground due to the absence of a waste bin at the construction campsite and also it was observed the facts of the burning of household waste (Ref to the photo No. 7); სამშენებლო მიწაზე სანაცვ კუთხის არსებობის რაღაცის გამო მიწაზე გაბოვებული საყოფაცხოვრებო ნარჩენი და ნარჩენის წვა (იხ. ფოტო No. 7); The sedimentation basin at the Exit of the Tunnel is full (Ref. to the photo No. 8 and 9); ვიწრობის გამოსასვლელის არსებული სედიმენტაციის აუზი არის სავსე (იხ. ფოტო No. 8 და No. 9); There are used tires and other construction waste placed on the managed territory (Ref. to the photo No. 10). ცერტიფიკატი გაბოვებულია გამოყენებული სატვირთო და სხვა სამშენებლო ნარჩენი (იხ. ფოტო No. 10).

During the monitoring, the small river near the territory was visually clean (Ref. to the photo No. 6). (მიზიარებისას ვიწრო, ცერტიფიკატი მიმდებარე არსებული მცირე ზომის მდინარე ვიზუალურად სუფთა იყო (იხ. ფოტო No. 6).		
Proposed Corrective Actions:		
გეგმილი/გეგმილი-მკორექტირებელი ღონისძიება:		
It's necessary:		
საჭირო და აუცილებელია:		
<ol style="list-style-type: none"> To clean the territory from the concrete waste and remove the concrete waste to the pre-defined disposal area for the concrete waste. The toolbox talks should be arranged for the concrete mixer truck drivers and their supervisor (foreman) according to the waste management plan, in particular, the concrete mixer truck drivers should know where to place the concrete waste to prevent the further spill. ცერტიფიკატი განწმენდა ბეტონის ნარჩენისა და ბეტონის ნარჩენის გატანა და ბეტონის ნარჩენისა და ნარჩენის წმენდა განსაზღვრულ გასაფრთხილებს უზრუნველყოს თეთროვანი ბეტონის მასალის მშლელს და მათ ხელმძღვანელს უნდა განუხილონ და იყენებ

8	ENCR 170	15/03/2024	Adjacent to the Tunnel No. 1 Exit Portal and Beginning of Bridge No. 3	1) Concrete spilled on the ground from a concrete mixer truck, which also flows into the small river nearby; 2) Household waste scattered on the ground due to the absence of a waste bin at the construction campsite and also it was observed the facts of the burning of household waste; 3) The sedimentation basin at the Exit of the Tunnel is full; 4) There are used tires and other construction waste placed on the mentioned territory.	The area was cleaned from concrete waste. Sedimentation basin was cleaned. Used tires removed from site. Environmental training have been carried out for mixer drivers.	22/03/2024	Closed 30/04/2024
9	ENCR 171	22/03/2024	Slope between Bridges No. 1 & No. 2	Waste concrete poured from concrete mixer resulting in soil pollution and damage to trees.	Area was cleaned from concrete waste. Training for mixer drivers was conducted.	30/03/2024	Closed 26/03/2024

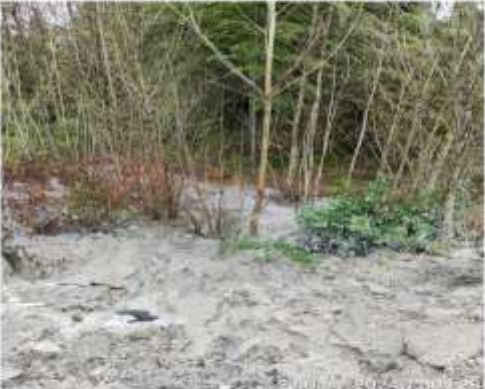
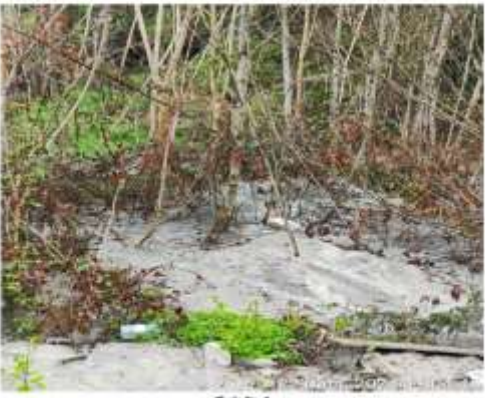
10	ENCR 172	22/03/2024	Between Tunnel No. 1 Exit Portal and Bridge No. 3	Waste concrete poured from concrete mixer resulting in soil pollution and damage to trees.	Area was cleaned from concrete waste. Training for mixer drivers was conducted.	30/03/2024	Closed 26/03/2024

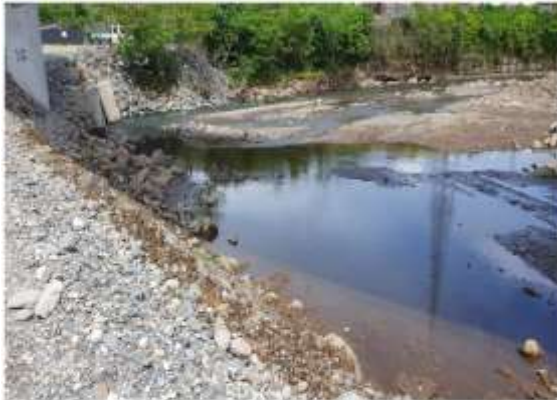
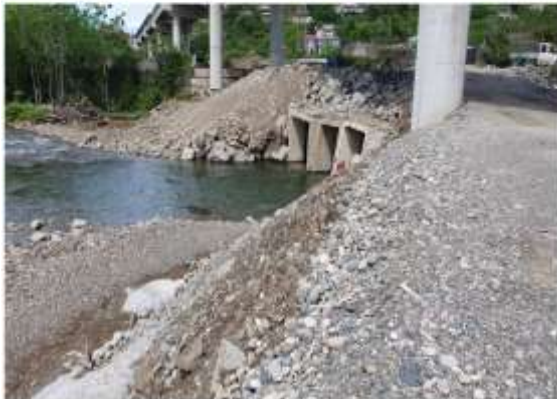
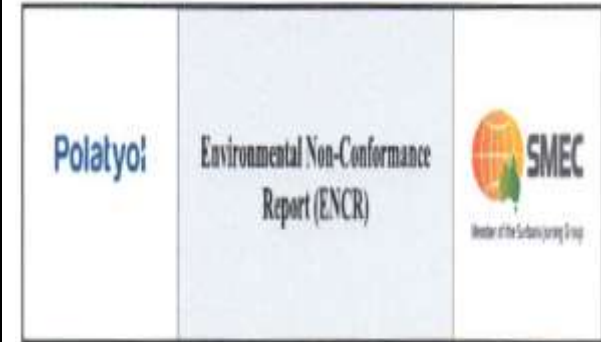
Part 1 - Non-Conformance Description			
Reference Number:	ENCR_114		
Project Name:	Bakura Bypass Road Project	Date raised:	11/06/2024
Contractor Name:	POLATYOI & MAPA JOINT VENTURE		
Location:	Tunnel No. 2 Exit Portal / No. 2 გვირაბის გამოსვლელი პორტალი

Non-Conformance details:
 The following was observed on the territory:
 ტერიტორიაზე დაინახა:
 Water mixed with cement and concrete waste poured from a concrete gutter.
 ბეტონშიანი მასლიდან მიწზე დაღვრილი ცემენტისა და ბეტონის ნარჩენი.
Proposed Corrective Measure:
 შემთავაზებული ზემოქმედებები ქვემოთ:
 If necessary:
 საჭირო და აუცილებელია:
 Clean up the area from concrete waste. Transport the waste and store in the pre-defined area designated for concrete waste disposal. Furthermore, the drivers of concrete mixers as well as their supervisor should be trained as per the waste management plan, as the drivers should know where to dump the concrete waste in order to prevent environmental damage.
 ცემენტისა და ბეტონის ნარჩენი და ბეტონის ნარჩენი დაბრუნებული ტერიტორიის გაწმენდა. ბეტონის ნარჩენის გატანა და ბეტონის ნარჩენისა და ცემენტის ნარჩენების წინასწარმანახველად განლაგების ზონაში განთავსება. აგრეთვე, ბეტონშიანი მანქანების მძღოლებსა და მათ ხელმძღვანელებს უნდა გასტრენინგო და იყავინ მოწოდებული ნარჩენების ძალიან აკრის მოხვედრა, რადგანაც მძღოლებს უნდა იყოფინთ თუ სად მოათავსონ ბეტონის ნარჩენები, რათა თავიდან ავიცილონ გარემოების დაცვა.

Part 2 - Corrective Action (attach any supporting information)
 Concrete waste and spills were removed from site.
 Necessary toolbox talk was conducted.
 ბეტონის და ცემენტის ნარჩენები გატანილი ტერიტორიიდან.
 ჩატარდა აუცილებელი საუბარო-ინსტრუქტივი
 Agreed Close-out Date: 14/06/2024
 Contractor's Representative: John Mazarandze
 Signature: *[Handwritten Signature]*

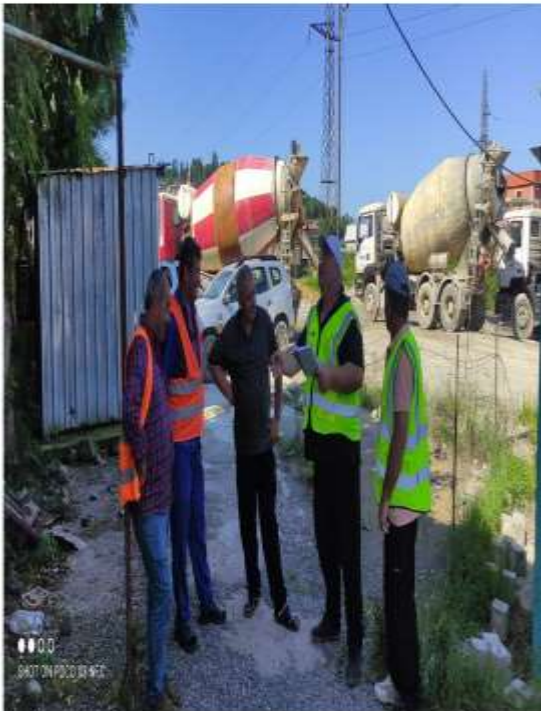
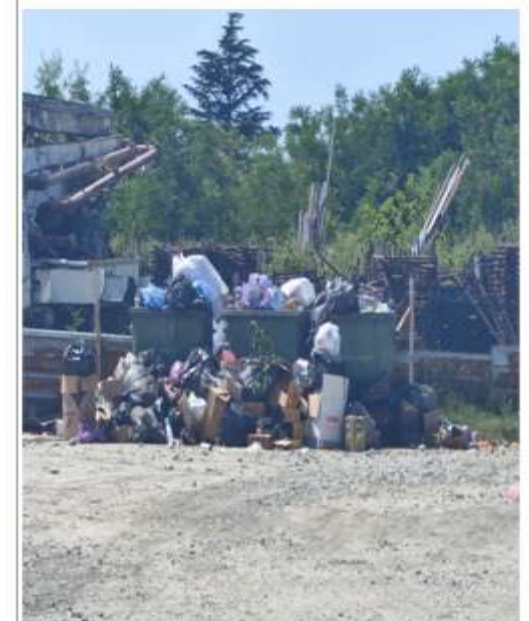
Reference Number:	ENCR_115		
Project Name:	Bahara Bypass Road Project	Date raised:	14/06/2024
Contractor Name:	POLATYOL & MAPA JOINT VENTURE		
Location:	Contractor's Office and Residential Camp Territory / კონტრაქტორის საოფისო და საცხოვრებელი სანაოსნო ტერიტორია

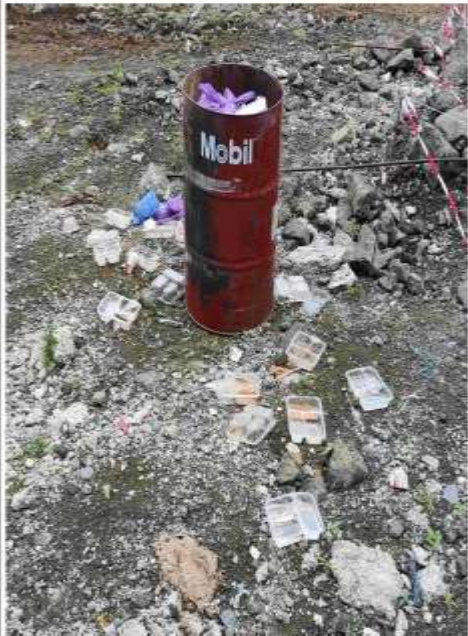
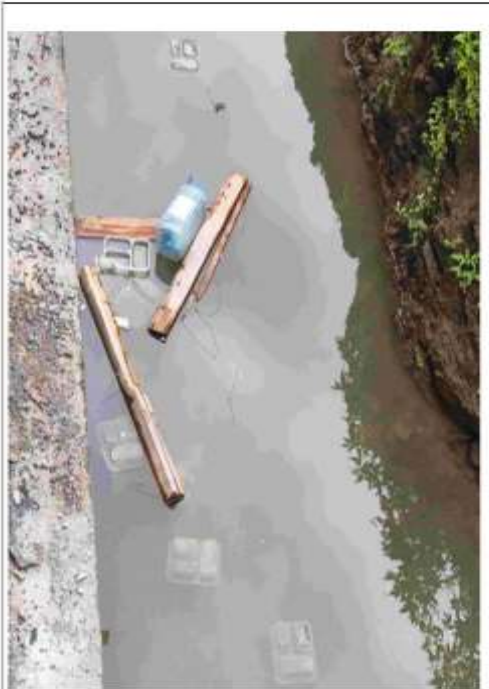
Part 1 - Non-Conformance Description:			
Reference Number:	ENCR_178		
Project Name:	Bahasa Bypass Road Project	Date raised:	18/06/2024
Contractor Name:	POLATYOI & MAPA JOINT VENTURE		
Location:	Tunnel No. 5 Exit Portal / No. 5 გვირაბის გამოსასვლელი პორტალი		
Non-Conformance details:			
The following was observed: ცუდივითივე დაფიქსირდა: Scattered construction and household waste. მიზიგასებული საშენებლო და საყოფაცხოვრებო ხარვეჭები. Proposed Corrective Measure: შემოთავაზებული-საორგანიზაციო ჰეჯევა: It's necessary: საჭირო და აკვილებელი: To clean the construction site from household and construction waste and to conduct the regular training for staff concerning the proper disposal of construction waste at the site and the responsibility of construction site personnel to ensure the compliance with proper waste disposal procedures. საშენებლო მიწვეჭის საყოფაცხოვრებო და საშენებლო ხარვეჭებისგან გასუფთავება და პერსონალისთვის რეგულარული ინსტრუქტაჟის ჩატარება, რომელიც ხაზს გასვსა საშენებლო მიწვეჭზე ხარვეჭების სწორად გამოგვების და საშენებლო უბანზე მიწვეჭე პერსონალის პასუხისმგებლობის ხარვეჭების სწორად გამოგვების პრევენციის დაცვის უზრუნველყოფა. Signature: Engineer's Representative: Davit Ievakidze
