Environmental Monitoring Report

Semestral Report: January – June 2021

Project Number: 50064-001

Georgia: Batumi Bypass Road Project

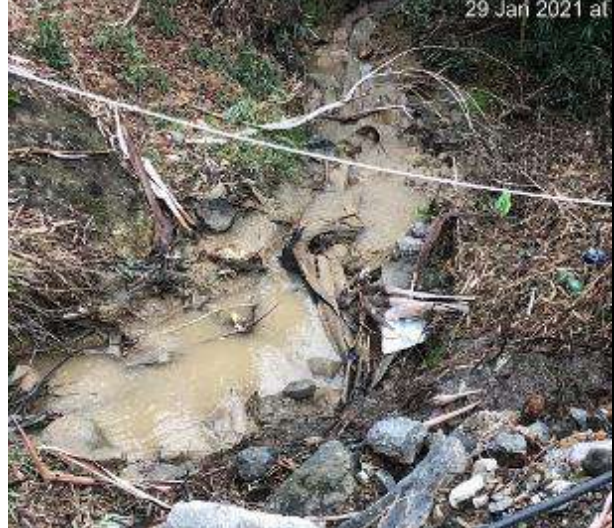
Photo 4 T4 contaminated watercourse

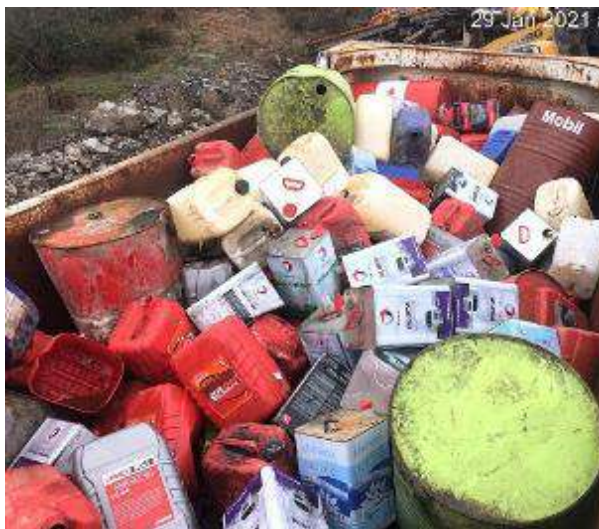
Photo 5 Tunnel 3 Improper oil storage

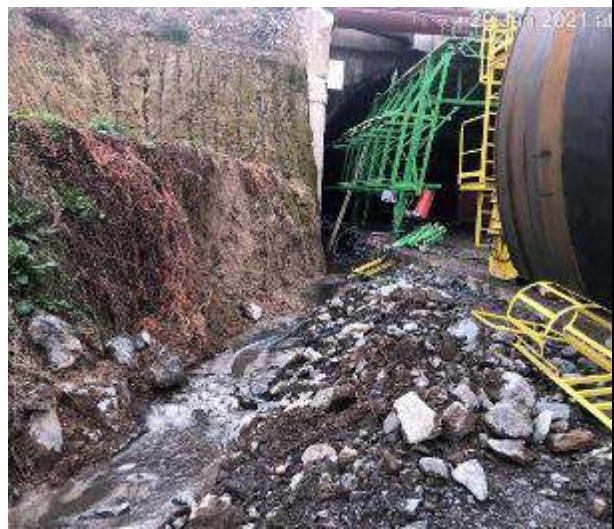
Photo 6 Tunnel 3 Bad housekeeping

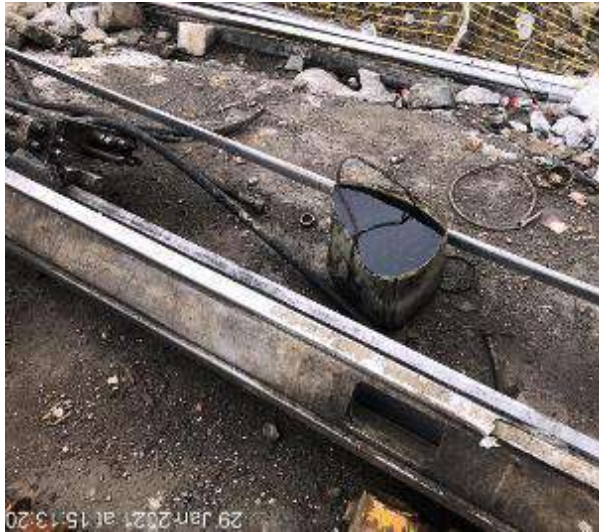
Photo 7 Tunnel 3 Improper oil storage

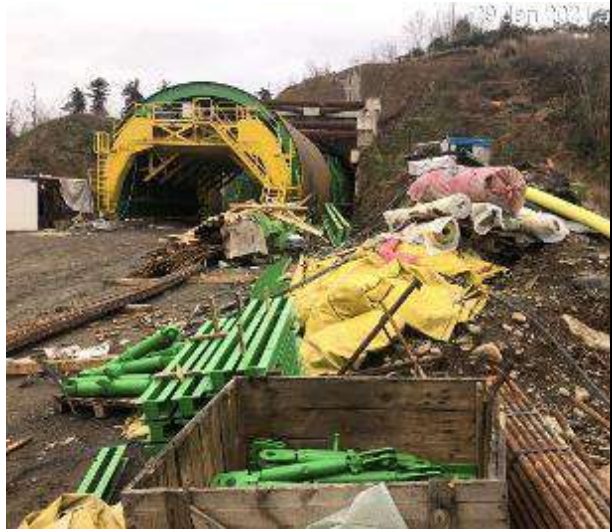
Photo 8 Tunnel 3 Bad housekeeping

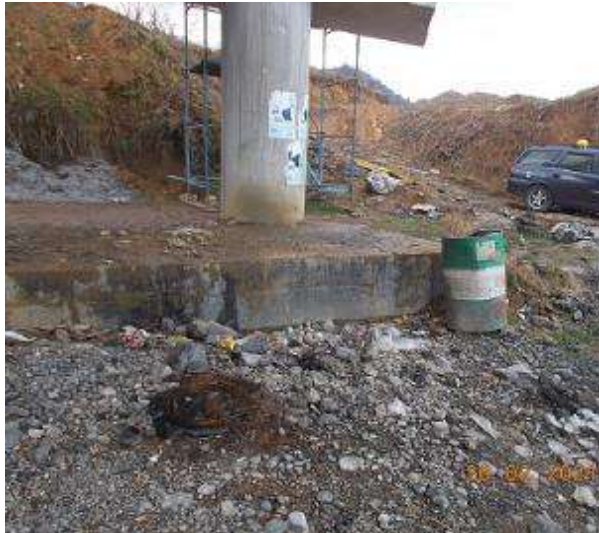
Photo 15 Bridge 6 Waste burn

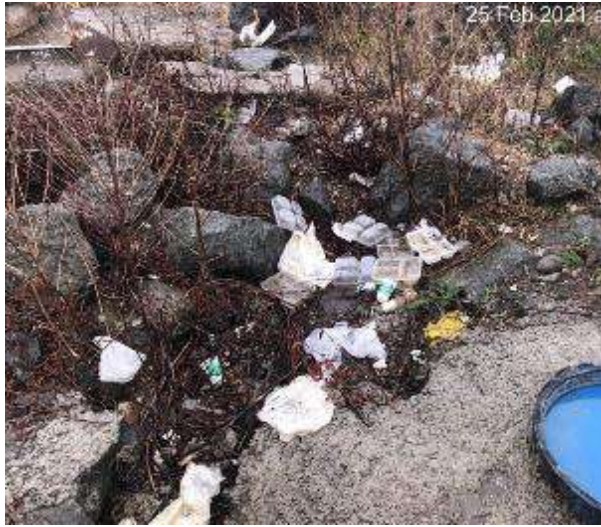
Photo 19 Precast yard Plastic waste

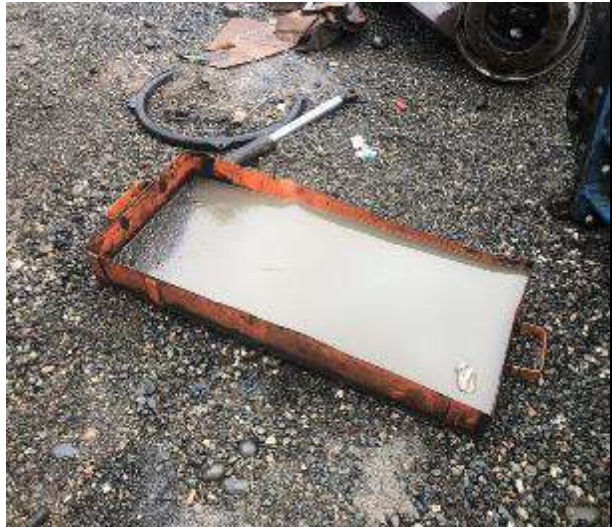
Photo 20 Plant yard Hazardous waste

Plant yard	February	Violation of hazardous waste/materials storage rules ENCR 101	Materials should be covered and stored accordingly	February	Completed

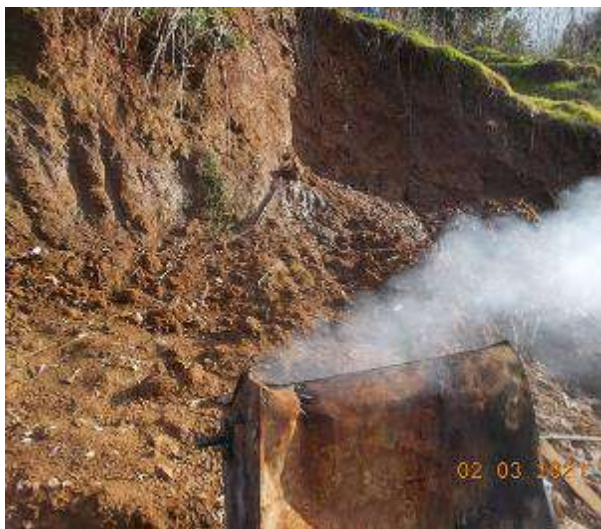
Photo 23 T4 Waste burn

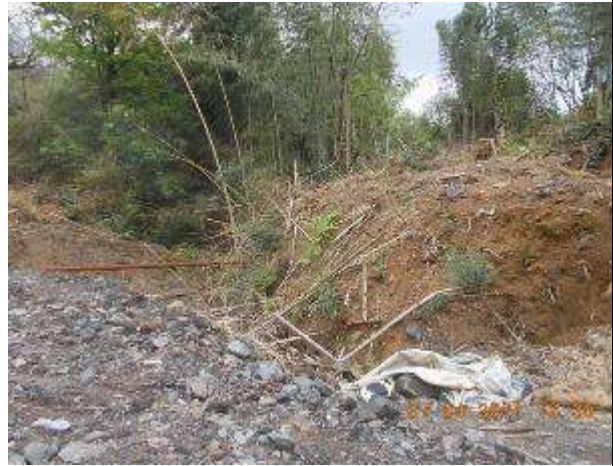
Photo 32 T1 Damaged bamboo

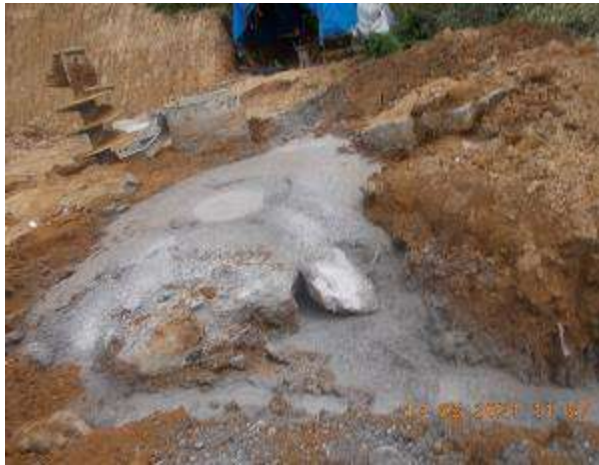
Photo 41 T2 Leaked concrete

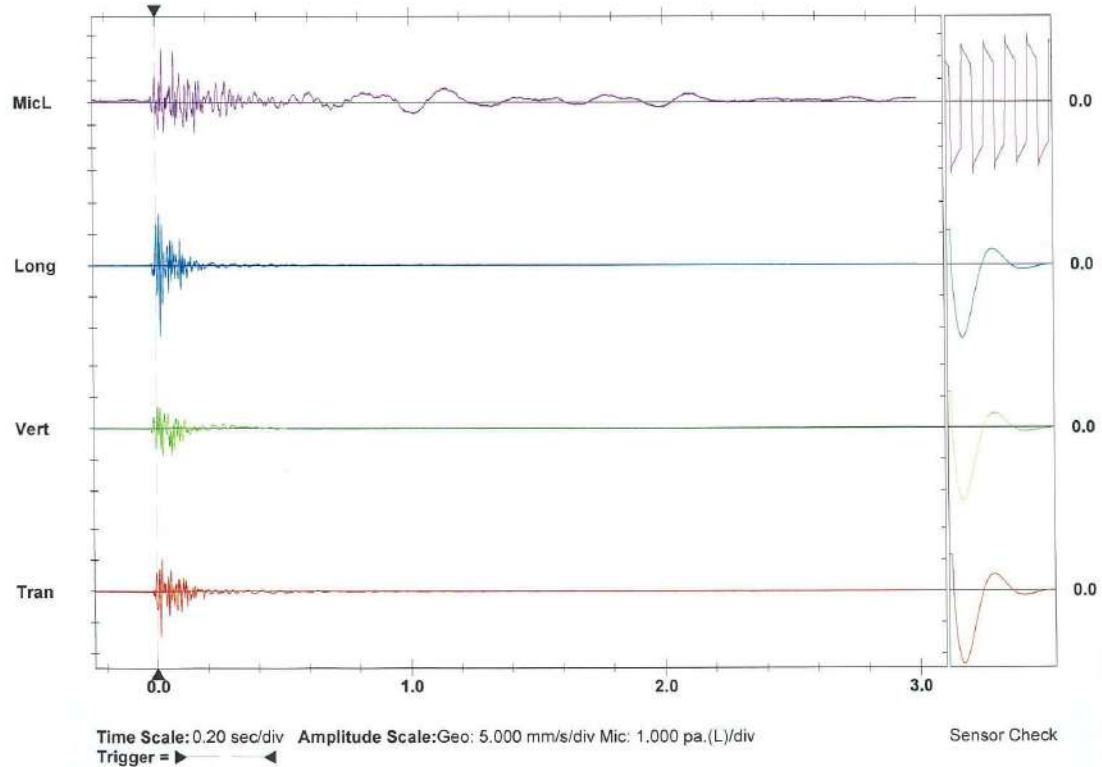
Tran	Vert	Long	
PPV	7.180	4.508	11.20	mm/s
ZC Freq	85	64	>100	Hz
Time (Rel. to Trig)	0.013	0.025	0.018	sec
Peak Acceleration	0.477	0.272	0.899	g
Peak Displacement	0.010	0.017	0.027	mm
Sensor Check	Passed	Passed	Passed	
Frequency	7.3	7.1	7.3	Hz
Overswing Ratio	4.4	5.0	4.7

Peak Vector Sum 12.10 mm/s at 0.018 sec

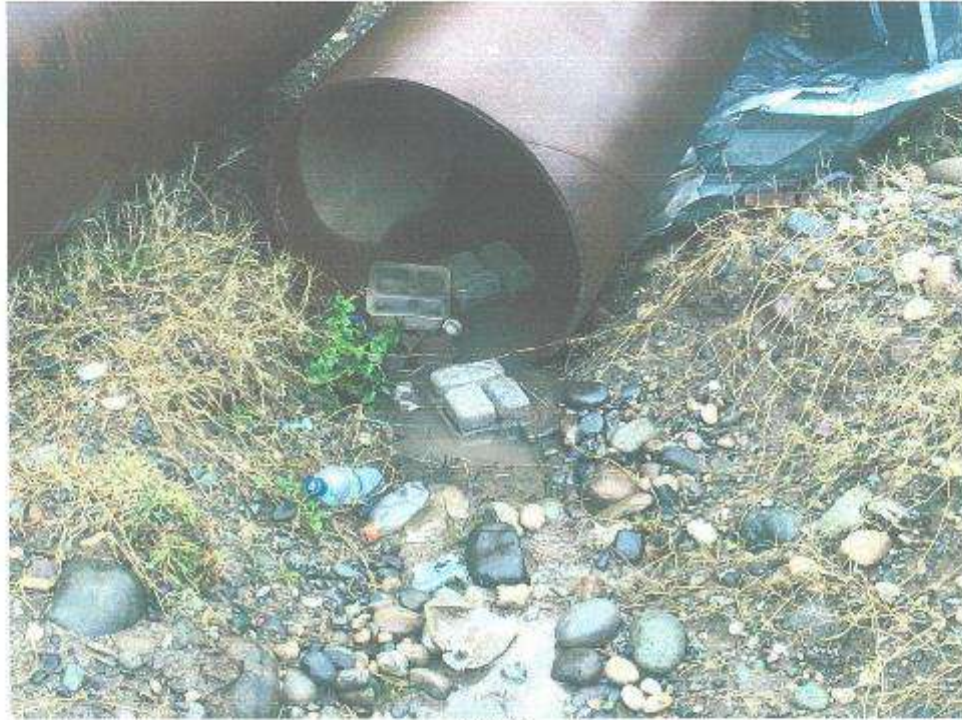
Photo 1

Part 1 – Non-Conformance Description:					
Reference Number:	ENCR_100				
Project Name:	Batumi Bypass Road Project	Date raised:	25/02/2021		
Contractor Name:	POLATYOL & MAPA JOINT VENTURE				
Location:	Plant yard				
Non-Conformance details:					
Household waste, food containers.					
Engineer's Representative: Giorgi Shiukashvili	Signature:  				
Part 2 – Corrective Actions (attach any supporting information)					
Household waste, food containers were cleaned from construction site.					
			<table border="1"> <tr> <td>Agreed Close-out Date</td> </tr> <tr> <td>Date: 04/03/2021</td> </tr> </table>	Agreed Close-out Date	Date: 04/03/2021
Agreed Close-out Date					
Date: 04/03/2021					
Contractor's Representative: Ayaz ABDURAHMANOV	Signature:  				
Part 3 – Inspection (evidence to support corrective action implementation)					
Dove					
Engineer's Representative:	Signature:  				
Closure Date:	09.03.21

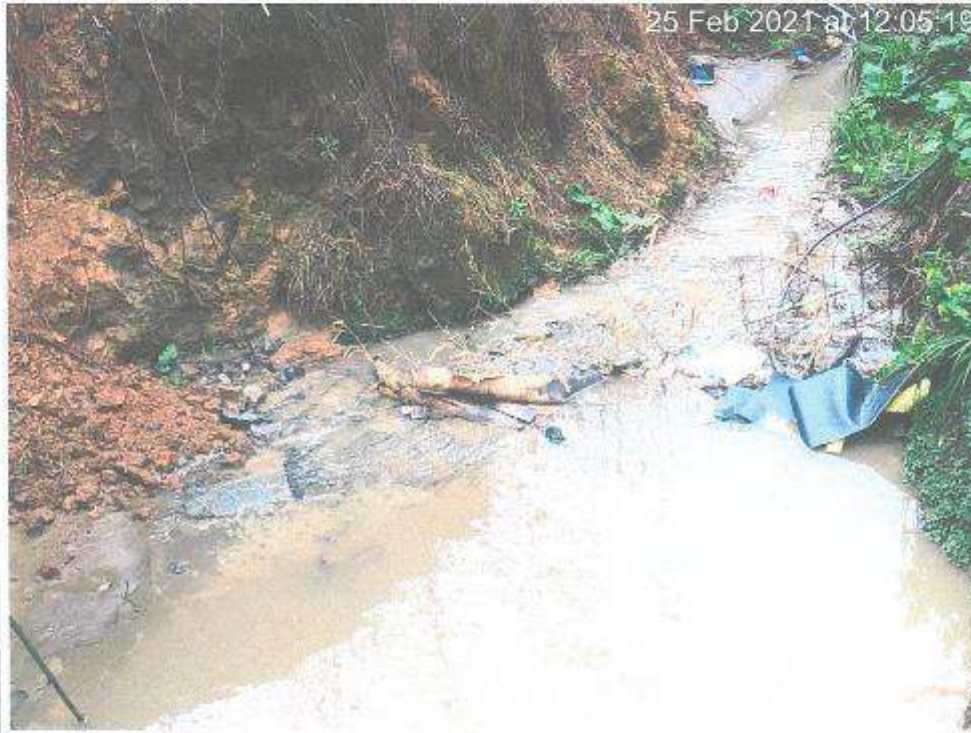
Photo 1

Part 1 – Non-Conformance Description:			
Reference Number:	ENCR_104		
Project Name:	Batumi Bypass Road Project	Date raised:	25/02/2021
Contractor Name:	POLATYOL & MAPA JOINT VENTURE		
Location:	T4 portal 1		
Non-Conformance details:			
Overfilled sedimentation basins.			
Engineer's Representative: Giorgi Shiukashvili	Signature:  		
Part 2 – Corrective Actions (attach any supporting information)			
Sedimentation basins were cleaned.			
			Agreed Close-out Date Date: 02/03/2021
Contractor's Representative: Ayaz ABDURAHMANOV	Signature:  		
Part 3 – Inspection (evidence to support corrective action implementation)			
Done			
Engineer's Representative:	Signature:  		
Closure Date:	16.03.2021

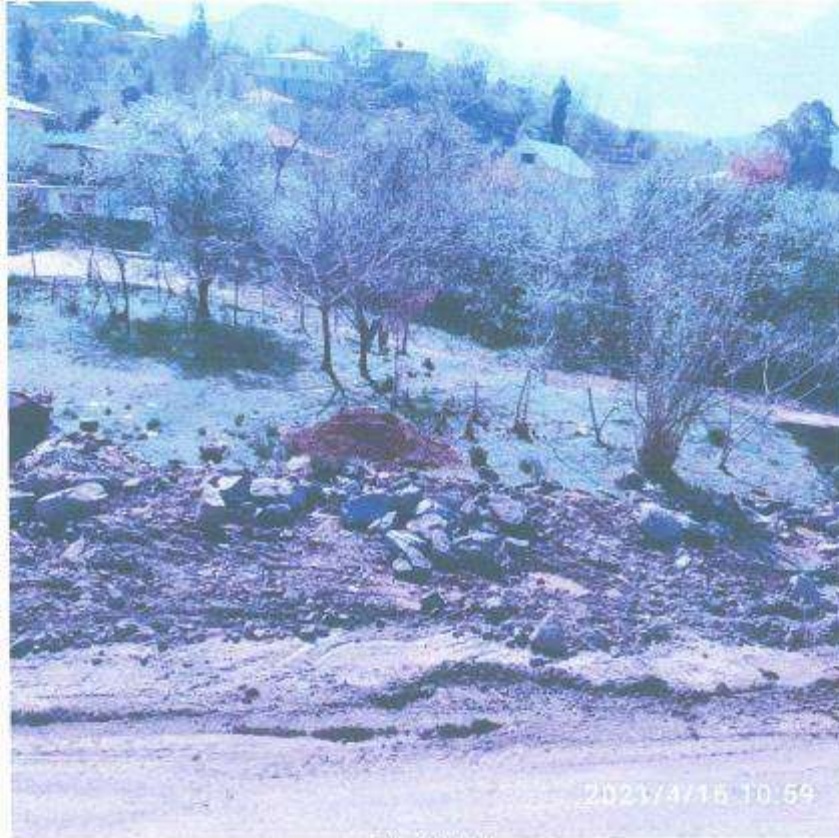
Photo No. 1

Part 1 – Non-Conformance Description:			
Reference Number:	ENCR_108		
Project Name:	Batumi Bypass Road Project	Date raised:	16/04/2021
Contractor Name:	POLATYOL & MAPA JOINT VENTURE		
Location:	Bridge No. 8 P2-P3		
Non-Conformance details:			
Plastic waste:			
Engineer's Representative: Giorgi Shiukashvili	Signature:		
Part 2 – Corrective Actions (attach any supporting information)			
Plastic waste has been cleaned from the construction site.			
			Agreed Close-out Date
			Date: 20/04/2021
Contractor's Representative: Ayaz ABDURAHMANOV	Signature:		
Part 3 – Inspection (evidence to support corrective action implementation)			
Done (Photos)			
Engineer's Representative:	Signature:		
Closure Date:	20.04.21

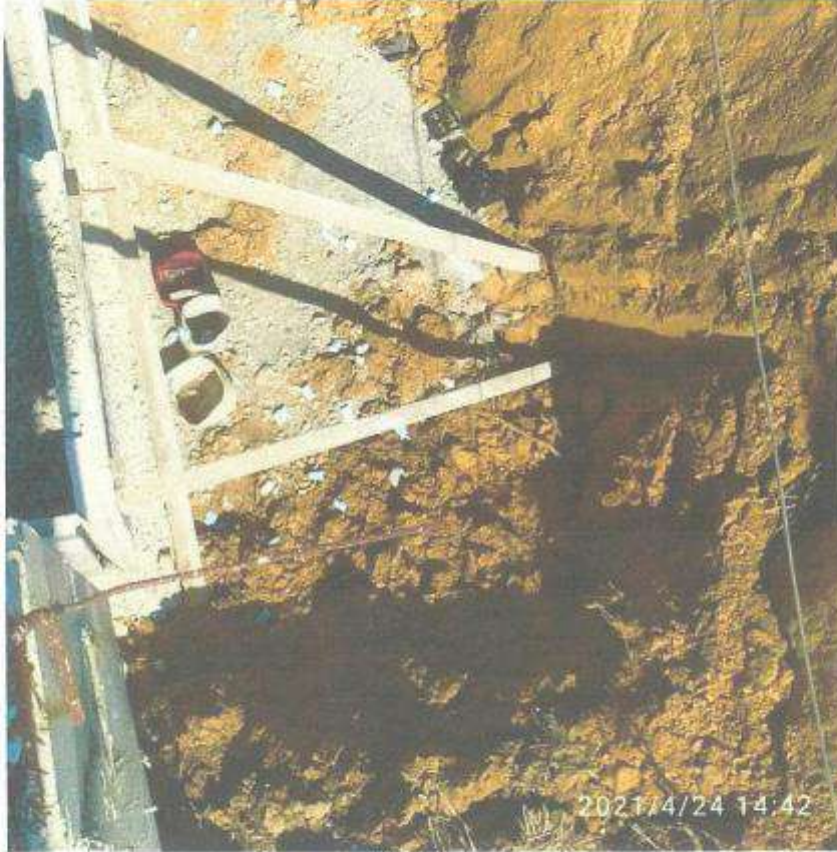
Photo No. 1

Part 1 – Non-Conformance Description:					
Reference Number:	ENCR_109				
Project Name:	Batumi Bypass Road Project	Date raised:	26/04/2021		
Contractor Name:	POLATYOL & MAPA JOINT VENTURE				
Location:	Bridge No: 8 A1				
Non-Conformance details:					
Household waste. Training required.					
Engineer's Representative:	Giorgi Shiukashvili	Signature:	 		
Part 2 – Corrective Actions (attach any supporting information)					
Household waste has been cleaned from the construction site. Training has been conducted with personnel.					
			<table border="1"> <tr> <td>Agreed Close-out Date</td> </tr> <tr> <td>Date: 30/04/2021</td> </tr> </table>	Agreed Close-out Date	Date: 30/04/2021
Agreed Close-out Date					
Date: 30/04/2021					
Contractor's Representative:	Ayaz ABDURAHMANOV	Signature:	 		
Part 3 – Inspection (evidence to support corrective action implementation)					
Done (photo)					
Engineer's Representative:	 	Signature:			
Closure Date:	30.04.21
