Semi-Annual Environmental Monitoring Report

Reporting Period: January-June 2023

Republic of Georgia: Batumi Bypass Road Project

Prepared by Roads Department (RD) for the Ministry of Regional Development and Infrastructure of Georgia (MRDI) and the Asian Development Bank (ADB).

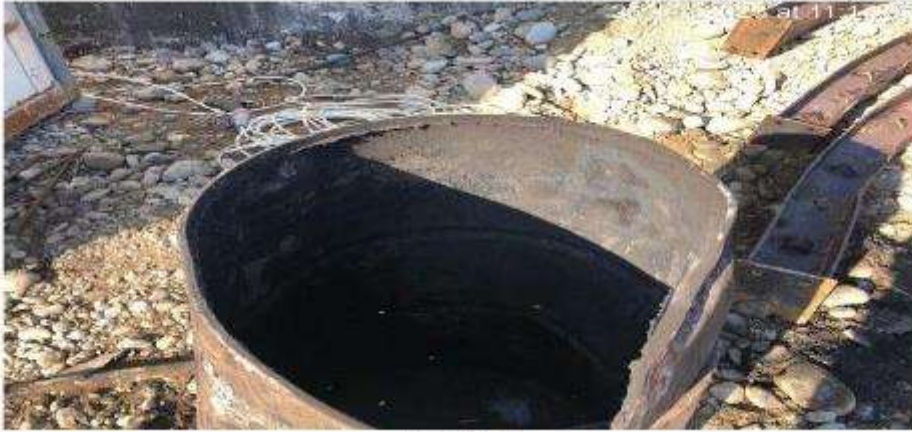
ENCR 138

Part 1 – Non-Conformance Description:			
Reference Number:	ENCR_138		
Project Name:	Batumi Bypass Road Project	Date raised:	26.01.2023
Contractor Name:	POLATYOL & MAPA JOINT VENTURE		
Location:	Tunnel No. 1 Entrance Portal		
Non-Conformance details:			
Waste burning. Overfilled waste container. Environmental training required.			
Engineer's Representative: Giorgi Shiukashvili		Signature:  	
Part 2 – Corrective Actions (attach any supporting information)			
Waste containers were cleaned. Necessary toolbox has been carried out and the employees were warned to follow environmental safety requirements.			
			Agreed Close-out Date Date: 04.02.2023
Contractor's Representative: Davit metreveli		Signature:  	
Part 3 – Inspection (evidence to support corrective action implementation)			
Engineer's Representative:		Signature:	
Closure Date:

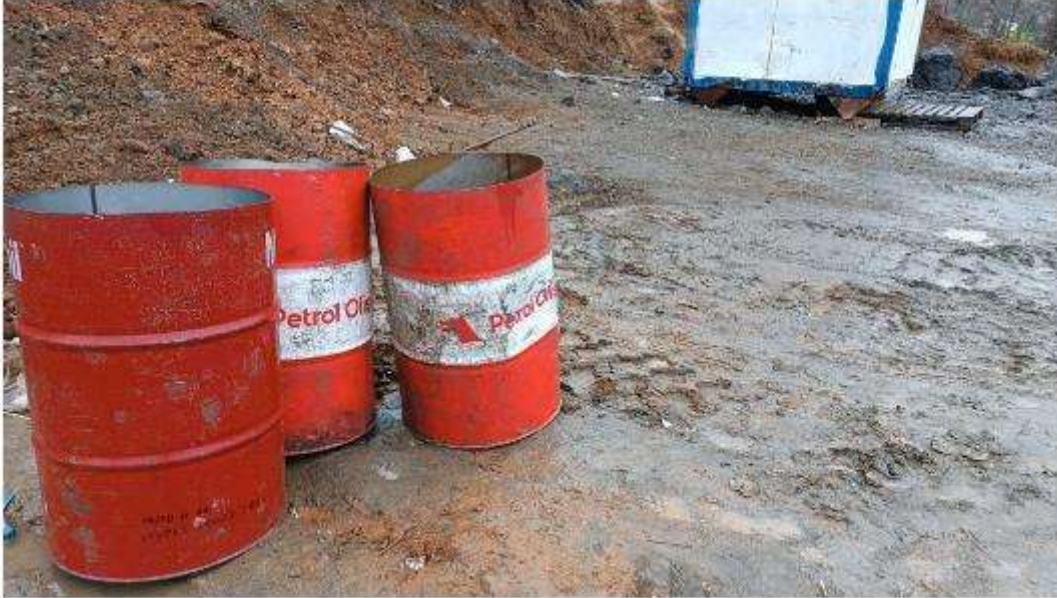
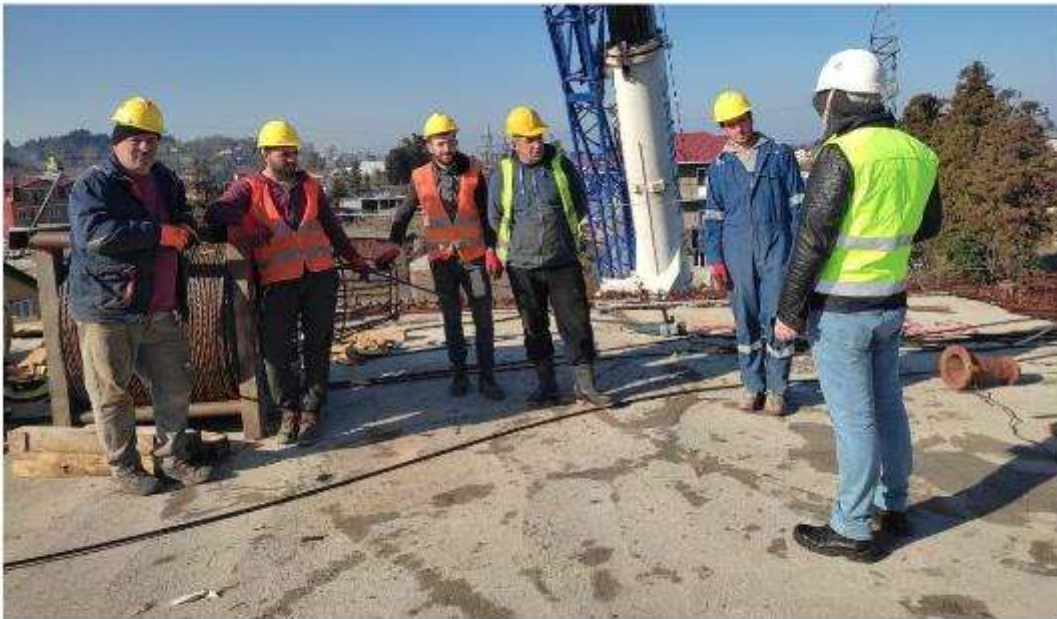
Non-Conformance details:
 Waste is burned in the waste containers.
 Environmental training is required.

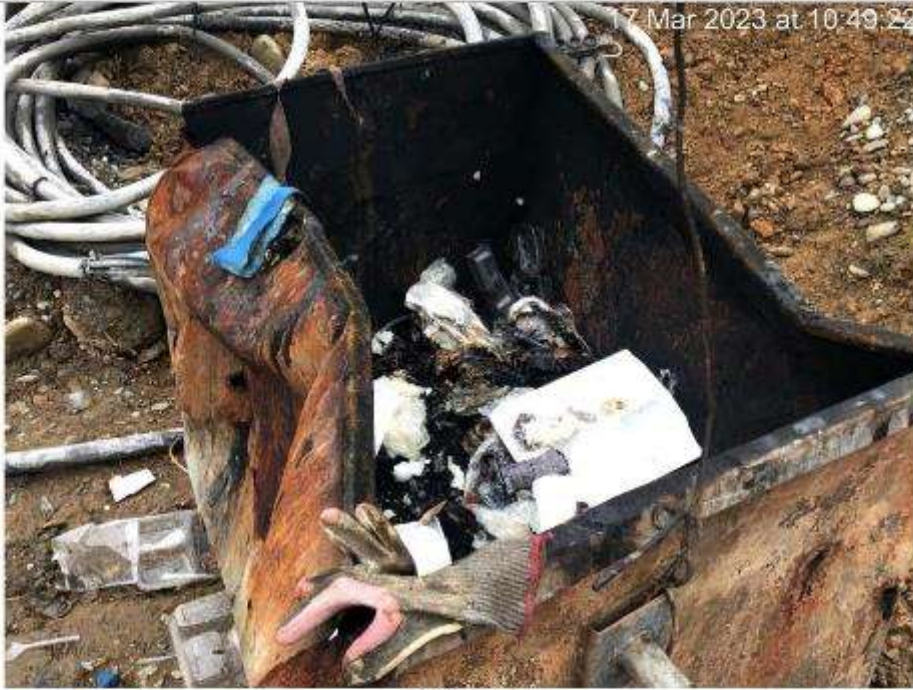
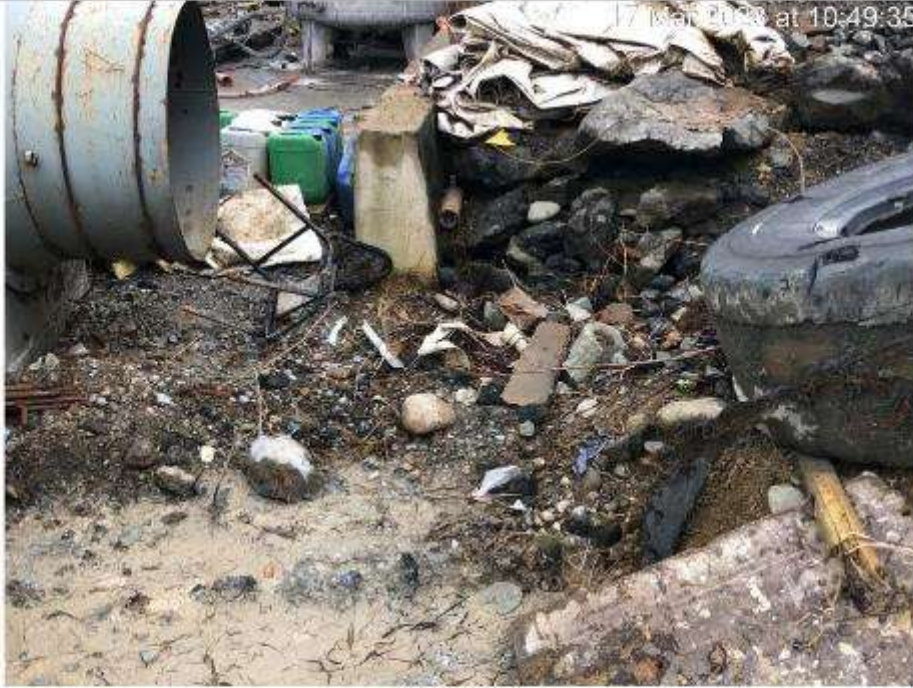
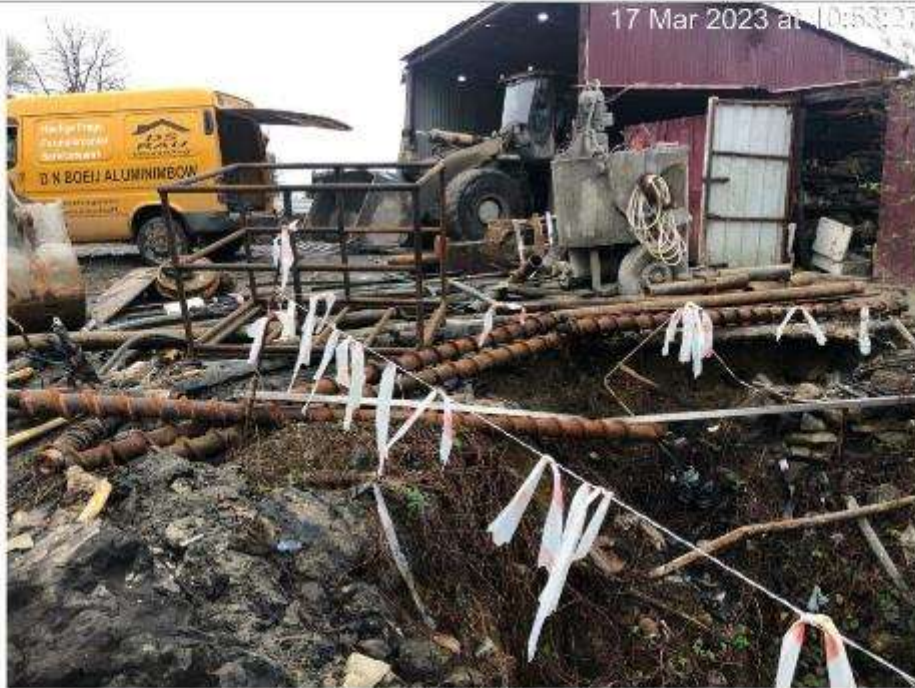
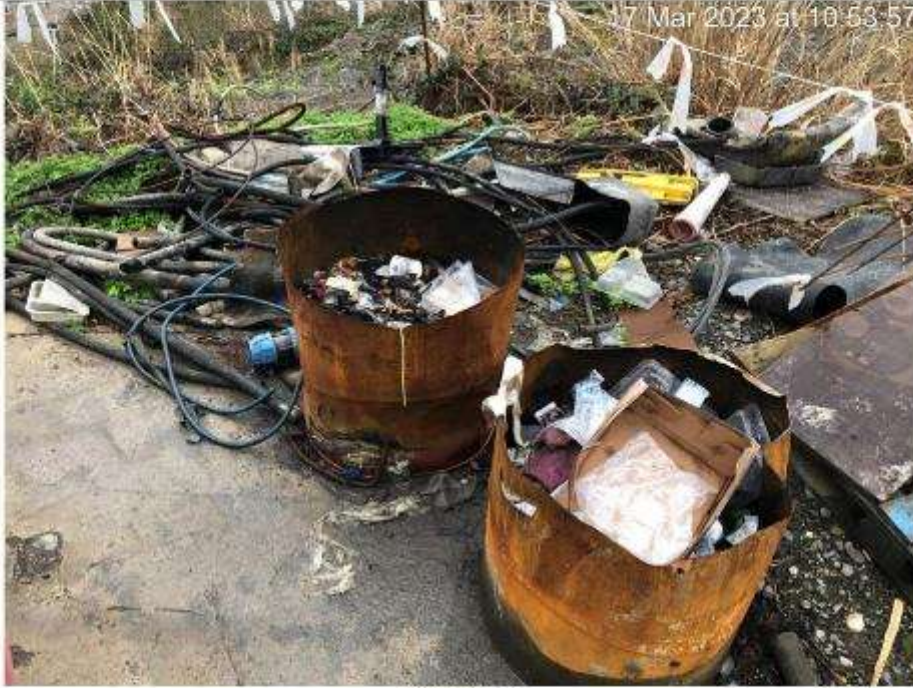
Bad housekeeping, waste burning.
Environmental training required.

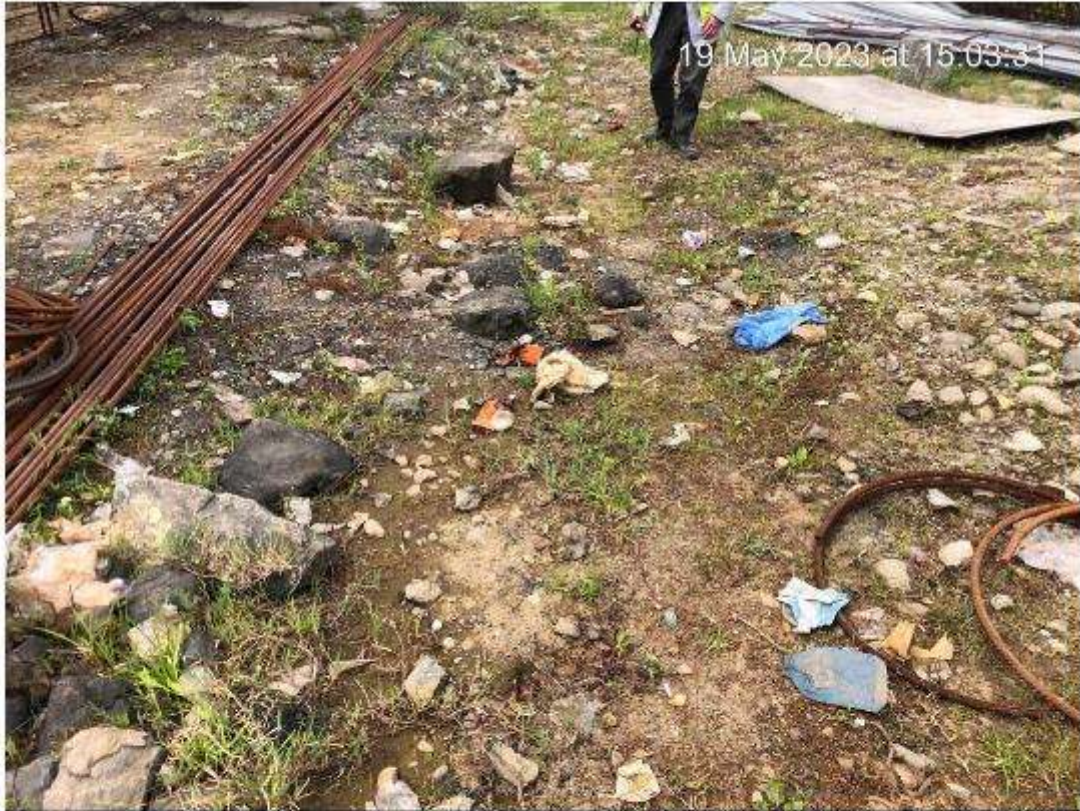
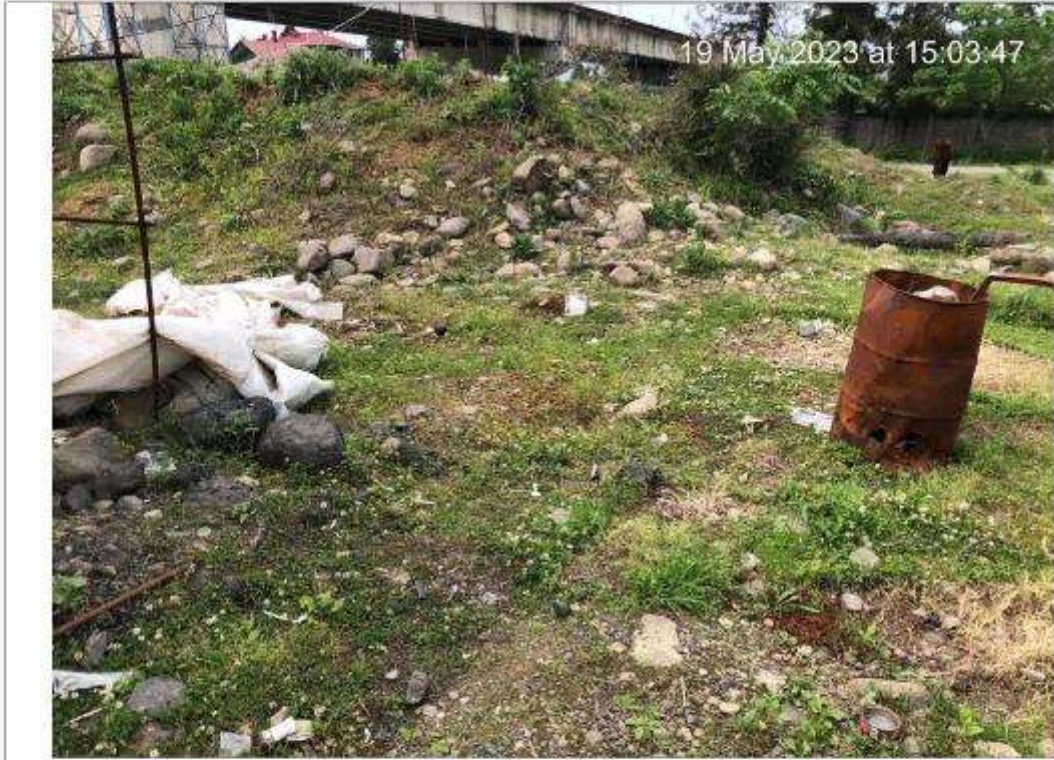
Reference Number:	ENCR_147		
Project Name:	Batumi Bypass Road Project	Date raised:	25.05.2023
Contractor Name:	POLATYOL & MAPA JOINT VENTURE		
Location:	Batching Plant No. 2

Overall housekeeping.
 Plastic waste.
 Waste burn.
 Training required.
