# Semi-Annual Environmental Monitoring Report

Loan No: 3524  
#12 Semi-annual EMR  
Reporting period: January-June 2024  
July 2024

## **Georgia: Rehabilitation of Dzirula–Kharagauli–Moliti–Pona– Chumateleti Secondary Road Section (50Km)**

#### **Post Construction Environmental Audit Report for Lot 1 and Conditions Report for Lot 2 (As of January 2024)**

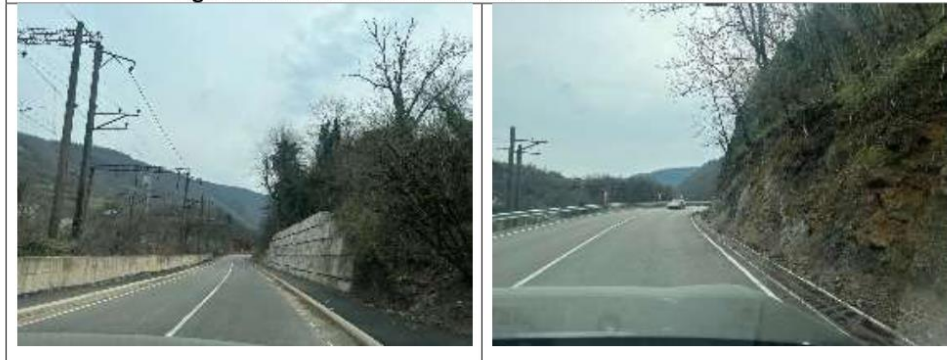
37. Construction activities for Lot 1 of the project were completed on 31 May 2023. During the audit, it was observed the Lot 1 road sections was fully paved (Figures 3 and 4). Based on visual inspection, the existing pavement was not damaged. There were no construction debris in the surrounding areas.

**Figures 3 and 4: Road Pavement in the Lot 1 Road Section**

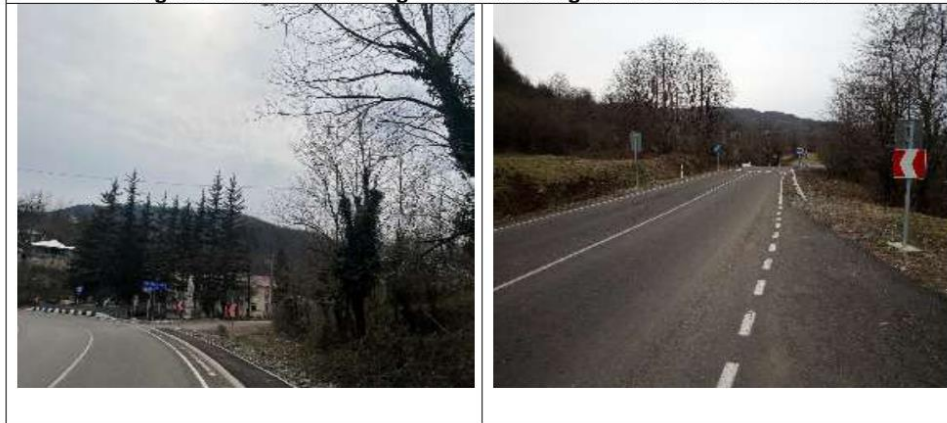
38. Road signs were installed along the project road (Figures 5 and 6). Throughout the 25 km section of the road, lanes and crossings are also marked.

**Figures 5 and 6: Road Signs on and along the Lot 1 Road Section**

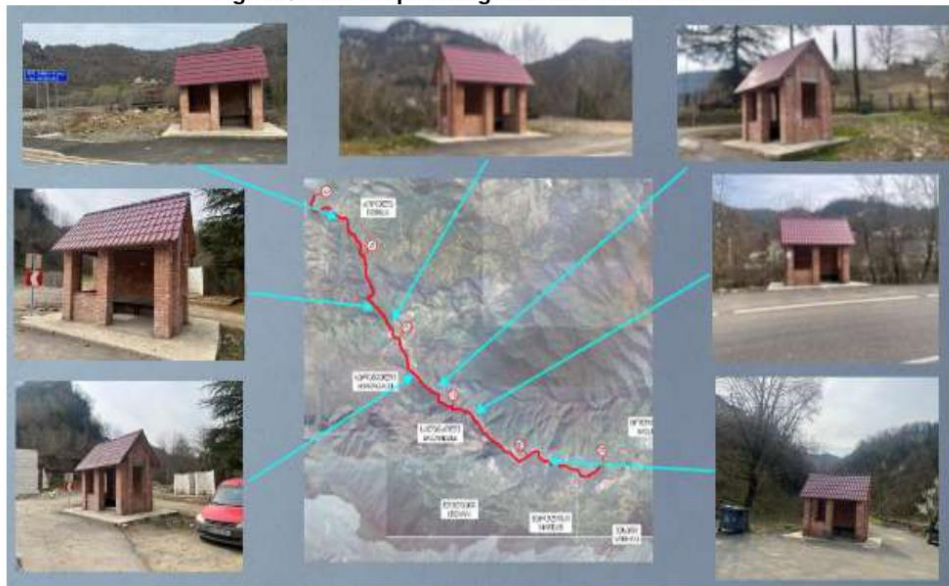
39. As shown in Figure 7, all 7 bus stops in Lot 1 road section were constructed and the surrounding areas were cleaned and rehabilitated.

**Figure 7. Bus Stops Along the Lot 1 Road Sections**

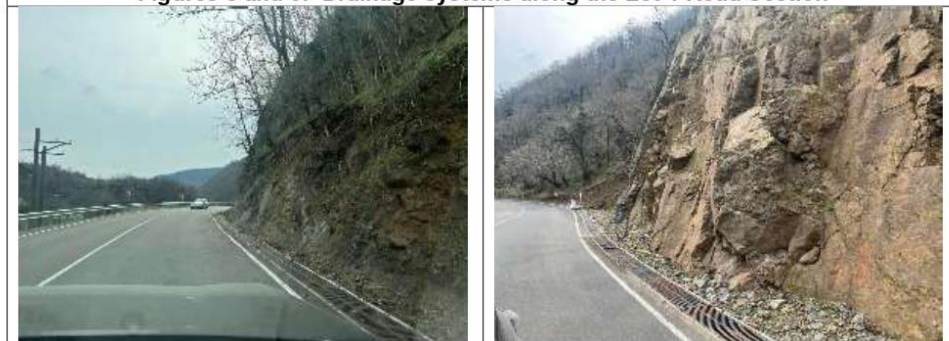
40. Figures 8 and 9 show the drainage systems and gratings installed along the Lot 1 road section.

**Figures 8 and 9: Drainage systems along the Lot 1 Road Section**

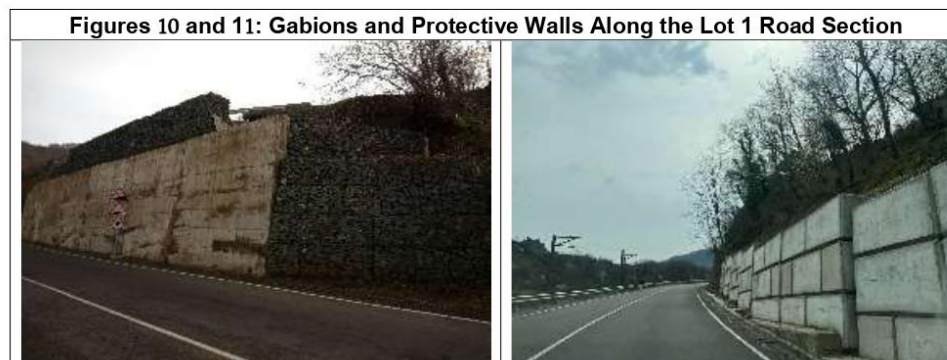
41. The construction of the gabions and protective walls envisioned by the project along the project road was also fully completed (Figures 10 and 11). The adjacent areas were cleaned, construction equipment was removed, and the construction company had completely removed construction materials from the area adjacent to the project road.

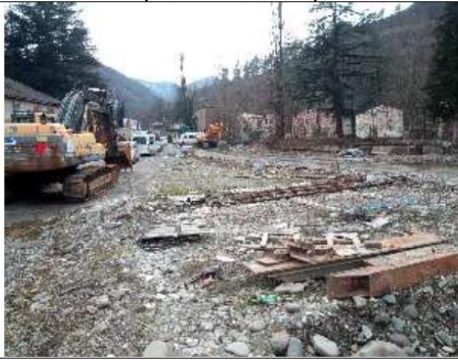
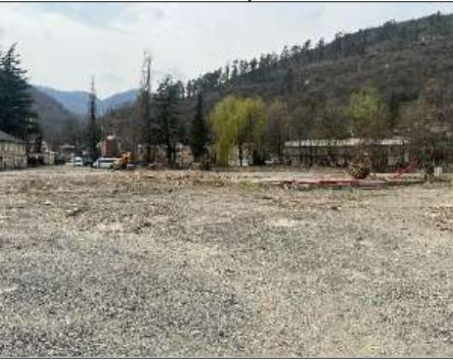
44. During the conduct of the environmental audit, it was noted that construction equipment as well as construction materials and waste were completely removed. Figures 12 and 13 to show the photos taken in December 2023 during preparation of SAEMR and March 2024 during preparation of the post-construction environmental audit report. Based on the photo-documentation, all 4 non-compliances were addressed satisfactorily.

| <p><b>Figure 12: Construction equipment and waste on the construction camp site (December 2023)</b></p> | <p><b>Figure 13: Construction camp during post-construction audit stage (March 2024)</b></p> |

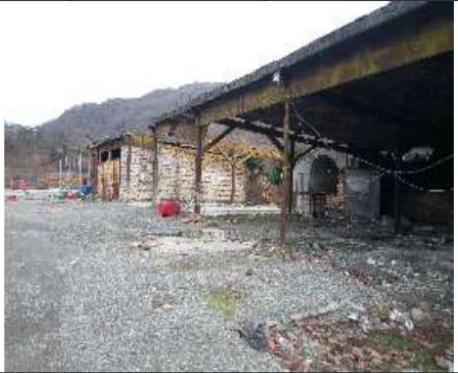
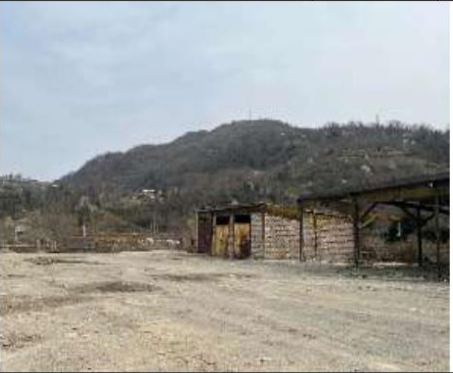
| | <b>Issues/Concerns (recorded December 2023)</b> | <b>Location</b> |
|---|---|---|
| 2. | Hazardous waste placed in the camp site unattended | Lot 1 contractor's camp |

| <p><b>Figure 14: Hazardous waste placed in the camp site unattended (December 2023)</b></p> | <p><b>Figure 15: The same area showing hazardous wastes removed (March 2024)</b></p> |

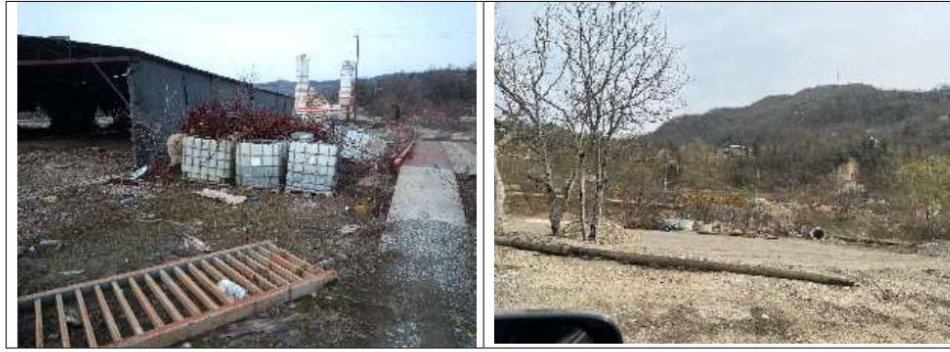
| <p><b>Figure 16: Waste placed in an uncontrolled manner as well as presence of ancillary buildings (December 2023)</b></p> | <p><b>Figure 17: The same area showing the ancillary building and wastes removed (March 2024)</b></p> |

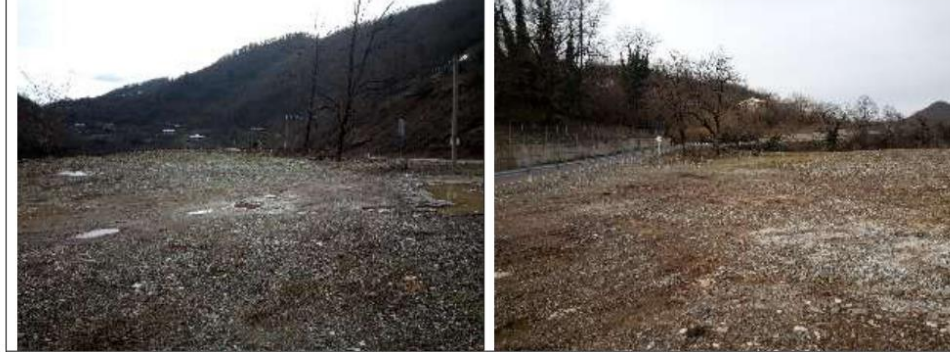
**Figures 18 and 19: Areas from which bulk materials have been removed (March 2024)**

45. **Conclusion.** The Lot 1 contractor's camp and storage areas for bulk materials have been cleaned up, restored and rehabilitated. There are no remaining works to be completed.

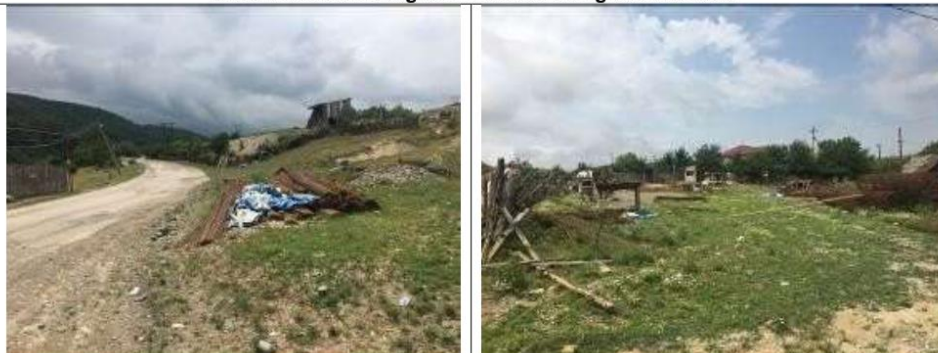
**Figure 20. Construction materials (precast concrete, rebar, timber, sand and gravel) left uncontrolled on the ground surface alongside the road**

47. The SAEMR covering period July to December 2022 reported that the recorded non-compliances of Lot 2 contractor were addressed and corrected by the local municipality. Figures 25 and 26 show the same sites after clean up by the local municipality.

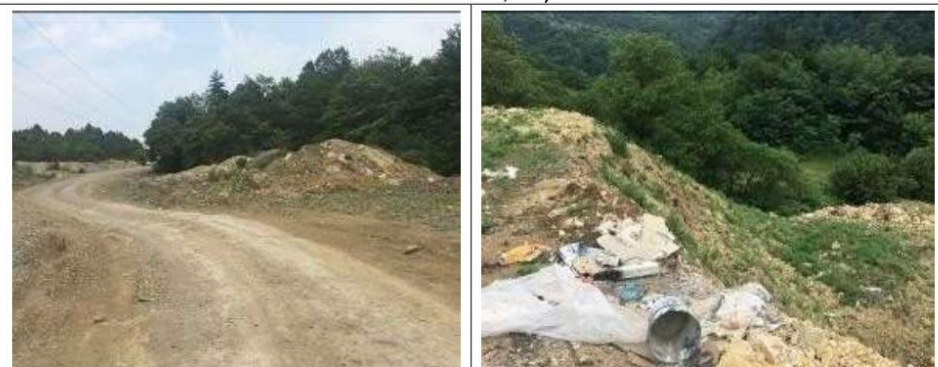
**Figure 21. Different waste is scattered alongside the road (spoil, timber, tree roots, domestic solid waste, etc)**

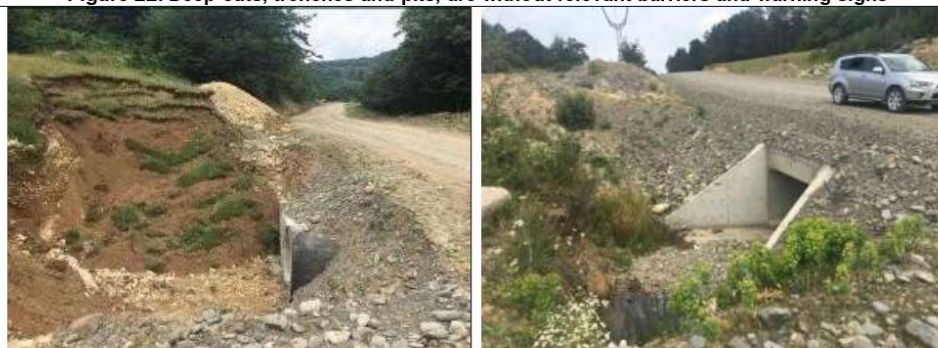
**Figure 22. Deep cuts, trenches and pits, are without relevant barriers and warning signs**

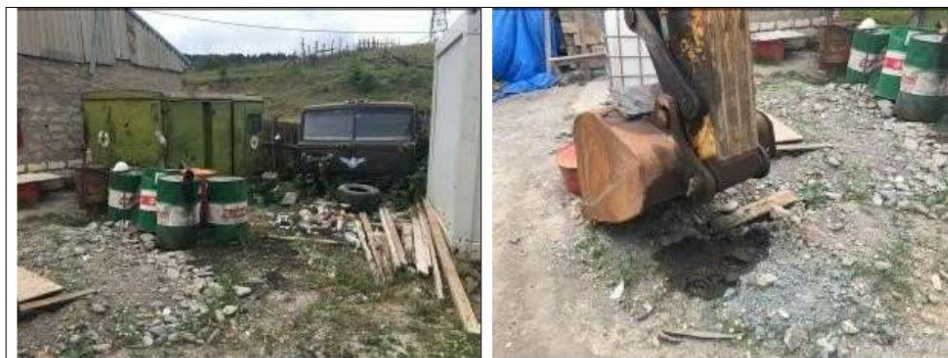
**Figure 23. Oil drums outdoor, leaking backhoe and scattered waste at the construction base**

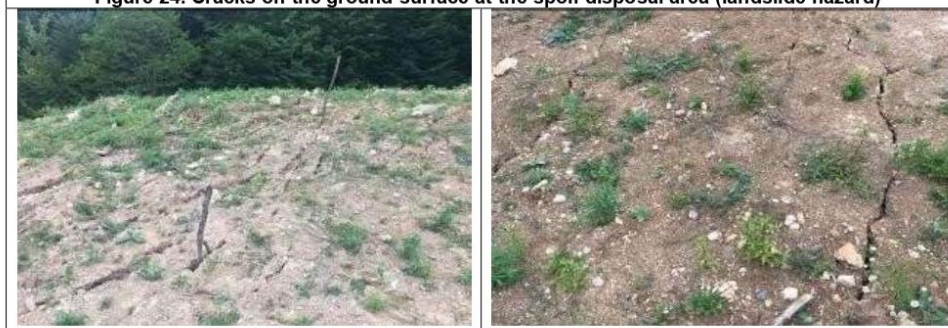
**Figure 24. Cracks on the ground surface at the spoil disposal area (landslide hazard)**

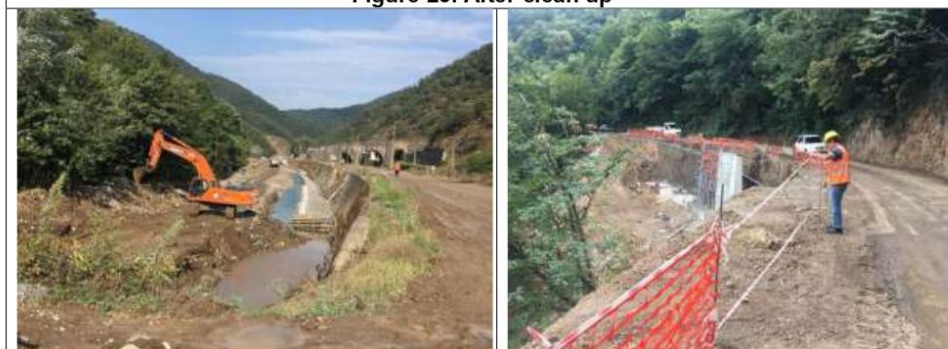
**Figure 25. After clean up**

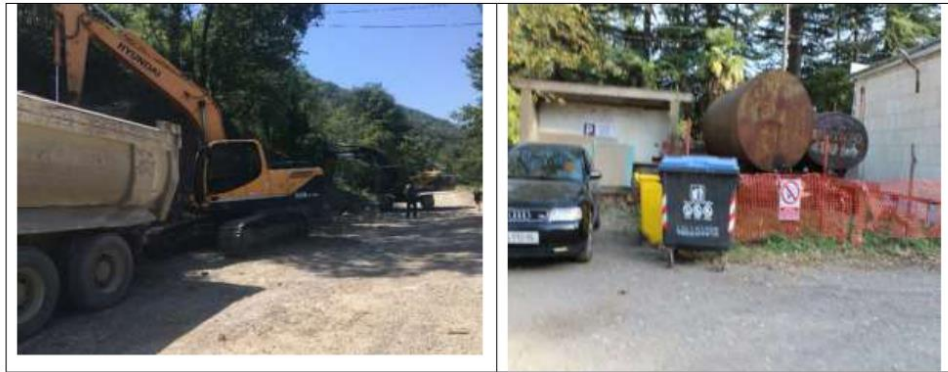
**Figure 26. After clean up**
