# Semi-Annual Environmental Monitoring Report

#12 Semestral Report

Reporting period: January - June 2024

## **GEO: Construction of Khevi-Ubisa Section (E60 Highway Route), F2 Project**

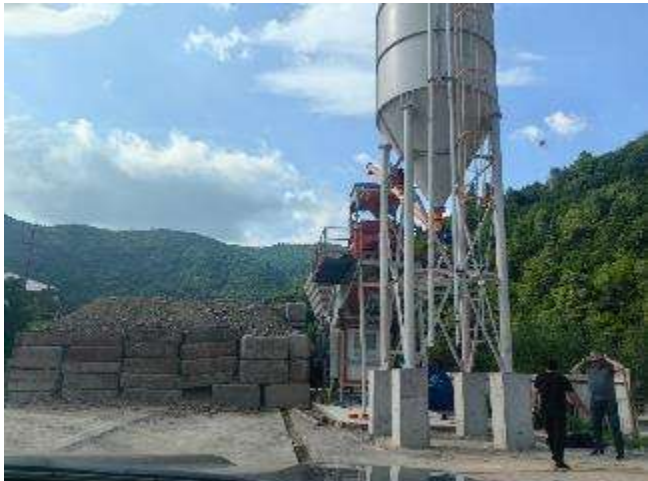
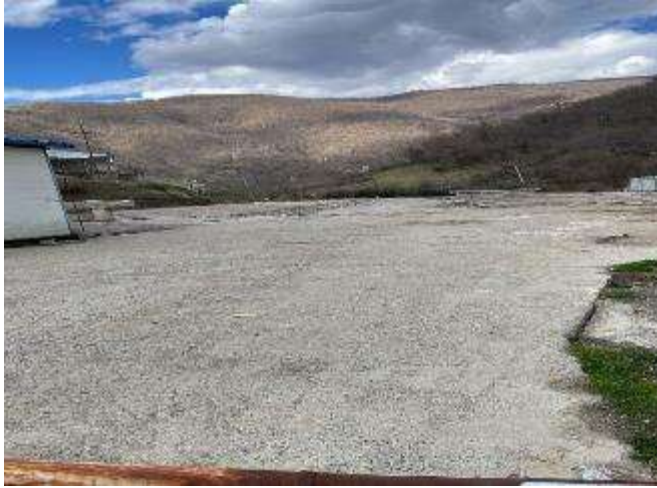
| # | Location/<br>Activity | Date | Issue/ Required<br>Action | Respon<br>sibility | Approval<br>Status | Corrective Action Taken | Corrective<br>Action<br>required | Status |
|---|---|---|---|---|---|---|---|---|
| 1 | Decommissioning and Re-cultivation of the site for sub camp 1 | March 2024 | CC to implement recultivation /reinstatement activities according to the approved recultivation plan at the site designated for Subcamp 1 in village Khevi, Kharagauli municipality | HNRB Contractor | Approved by MoEPA 05.09.2019 | Land handed over to the owner and owner established small mixing batching plant at the site.<br> | - | Completed June 2024 |

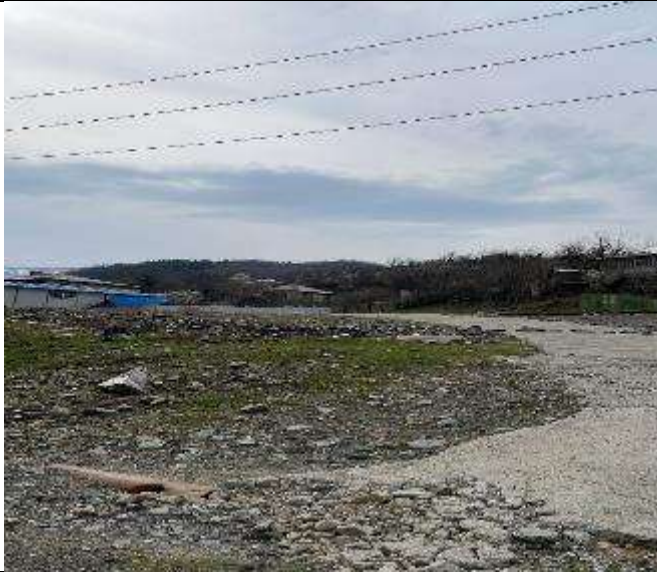
| 2 | Decommissioning & Recultivation of the site for sub camp 2 | March 2024 | CC to implement recultivation /reinstatement activities according to the approved recultivation plan at the site designated for Subcamp 2 in village Khunevi, Kharagauli municipality | HNRB Contractor | Approved by MoEPA 05.09.2019 | Land handed over to the owner and agreement signed. Agreements with the landowner attached as an Annex-4. No further Action required. | - | Completed March 2024 |

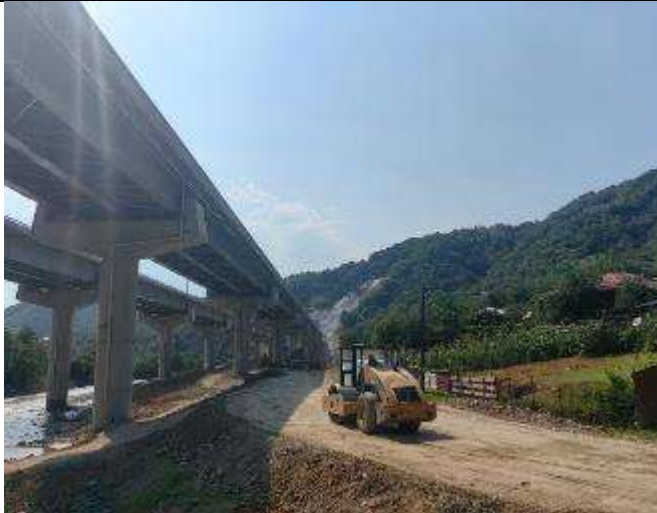
| 3 | Decommissioning & Recultivation of the site for sub camp 3 | April 2024 | CC to implement recultivation /reinstatement activities according to the approved recultivation plan at the site designated for sub camp 3 in village Vertkvichala, Kharagauli municipality | HNRB Contract or | Approved by MoEPA 05.09.2019 | Contractor cleaned the area and removed the building material f and concrete floor and started construction of local road. | - | Completed June 2024 |

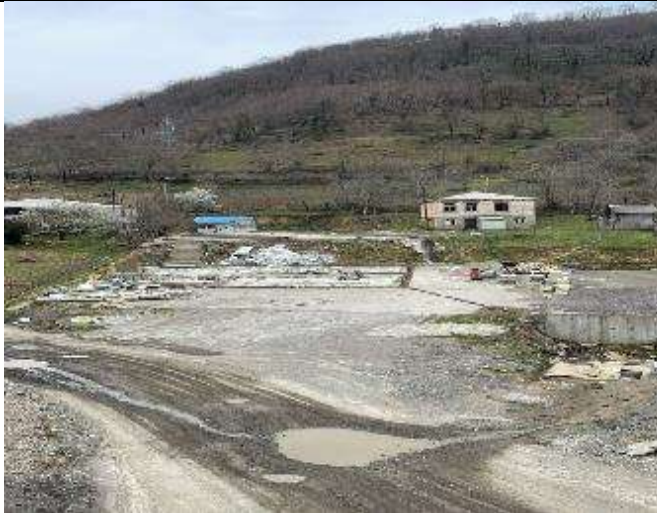
| 4 | Decommissioning & Recultivation of the site for sub camp 4 | April 2024 | CC to implement recultivation /reinstatement activities according to the approved recultivation plan at the site designated for sub camp 4 in village Sakasria, Kharagauli municipality | HNRB Contractor | Approved by MoEPA 05.09.2019 | Contractor shifted labor and their belongings, handed over the land to contractor as the owner wants to keep concrete structure and signed the agreement. No further Action required. | - | Completed. |

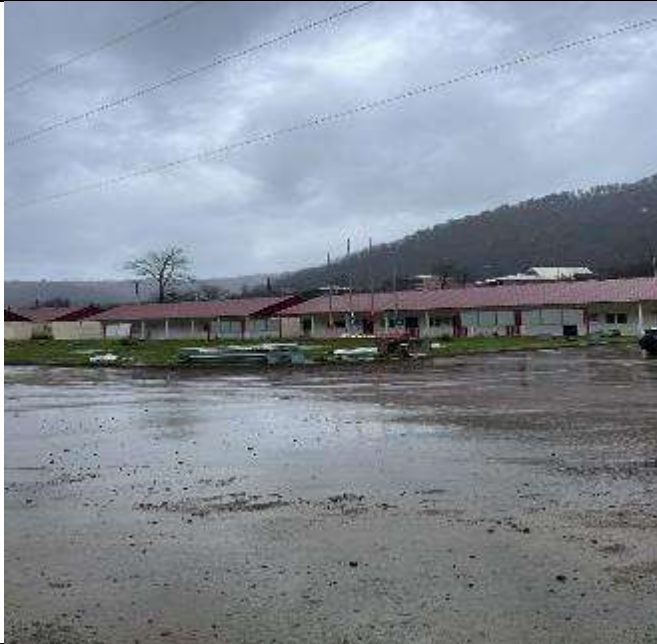
| 5 | Decommissioning & Re-cultivation of the site for the Main Campsite | April 2024 | CC to implement re-cultivation /reinstatement activities according to the approved recultivation plan at the site designated for Main Campsite in village Boriti, Kharagauli municipality | HNRB Contractor | Approved by MoEPA 12.06.2019 | Still in use for accommodation and office works and contractor will use until the completion of the local roads and other project related works. One part of the building is given for the 112 Emergency services. | Still in Use of the contractor. | In progress |

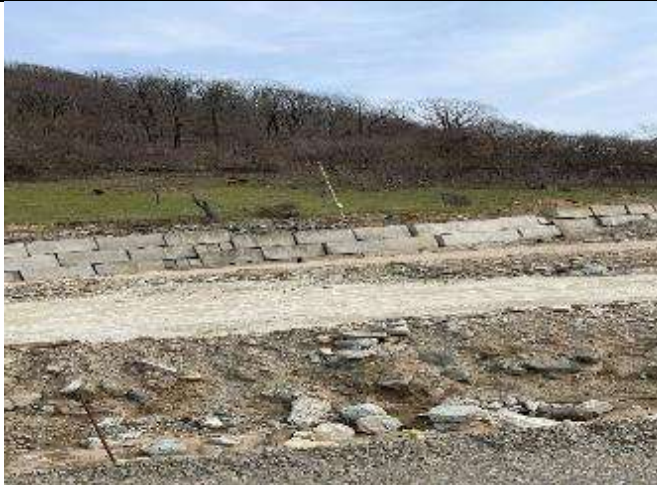
| 6 | Decommissioning & Re-cultivation of the site for Concrete Batching Plant 1 | Feb 2024 | CC to implement re-cultivation /reinstatement activities according to the approved re-cultivation plan at the site designated for Batching Plant 1 in village Khevi, Kharagauli municipality | HNRB Contractor | Approved by MoEPA 05.09.2019 | Contractor decommissioned the batching plant and provide the slope protection by placing concrete blocks and signed agreement with the owner that he want to keep the hard floor. No further Action Required. | - | Completed April 2024 |

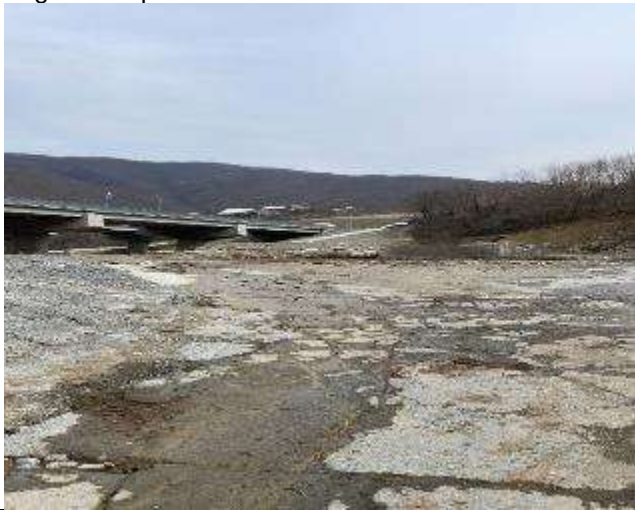
| 7 | Decommissioning & Re-cultivation of the site for Concrete Batching Plant 2 | March 2024 | CC to implement re-cultivation /reinstatement activities according to the approved re-cultivation plan at the site designated for Batching Plant 2 in village Khunevi, Kharagauli municipality | HNRB Contractor | Approved by MoEPA 12.06.2019 | <p>Contractor decommissioned the batching plant and need to remove the concrete base to bring it in to original shape.</p> | Remove the concrete base, if demanded by the owner | In progress |

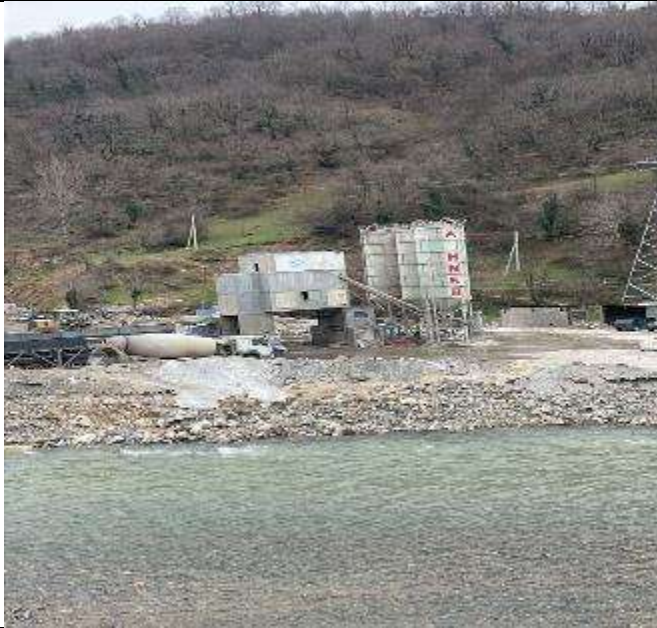
| 8 | Decommissioning & Re-cultivation of | March 2024 | CC to implement re-cultivation /reinstatement | HNRB Contractor | Approved by MoEPA 05.09.2019 | BP 3 is still in use for secondary road construction and contractor will use it until the completion of the Project. | Still in use of contractor | In progress |

| | the site for Concrete Batching Plant 3 | | activities according to the approved re-cultivation plan at the site designated for Batching Plant 3 in village Sakasria, Kharagauli municipality | | | | to complete the works on secondary roads. | |

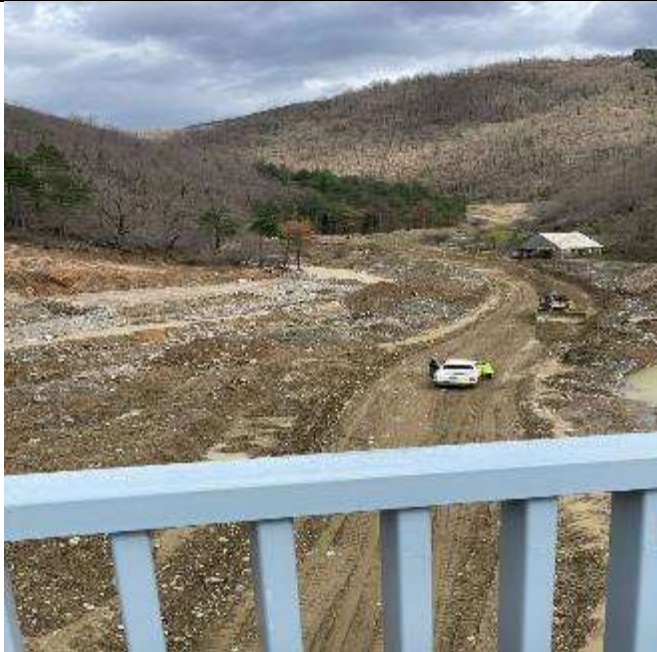
| 9 | Crushing Plant | Feb 2024 | CC to re-cultivate/ reinstate the area as agreed in the Re-cultivation Plan | HNRB | 30-03-2020 | Contractor decommissioned the crushing plant and handed over to land owner. Currently land is being used by F1 contractor. No further action required by contractor for F2. | - | Completed April 2024 |

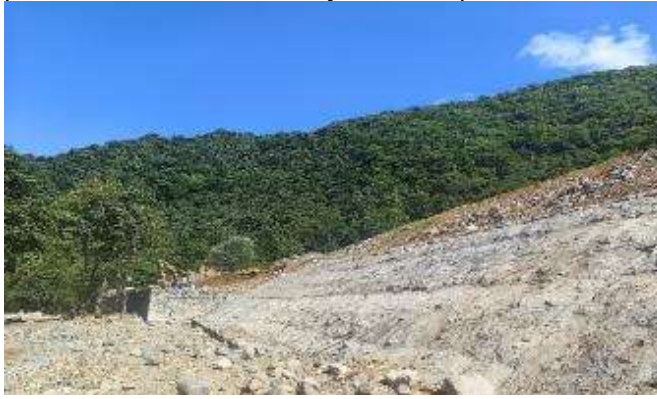
| 10 | Arrangement of river protection structures at the SDS 6 | April 2024 | CC to arrange a river protection berm at the SDS 6 according to the approved design, in village Sakasria, Kharagauli municipality. | HNRB Contractor or | Approved by MoEPA<br>02.12.2022 | <p>The contractor is currently working on the slope protection, which is currently 90% completed.</p> | Contractor to complete the slope works | In progress |

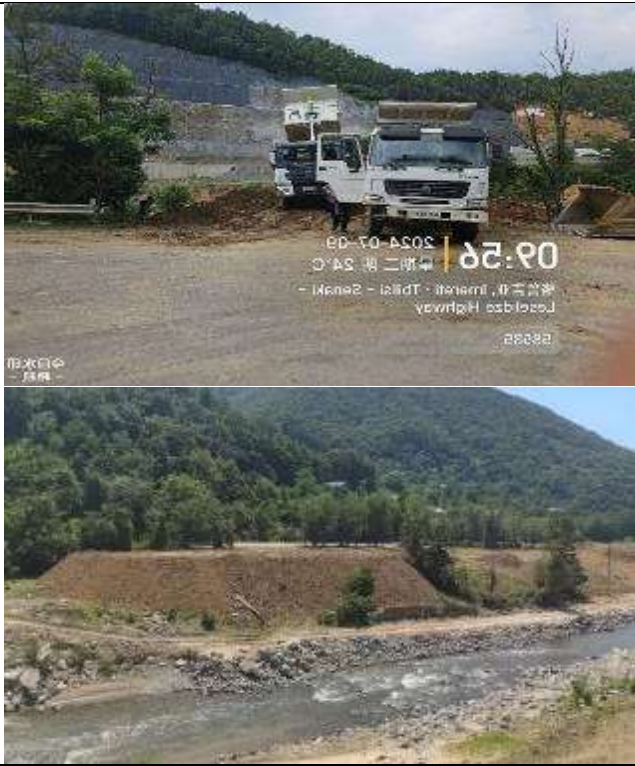
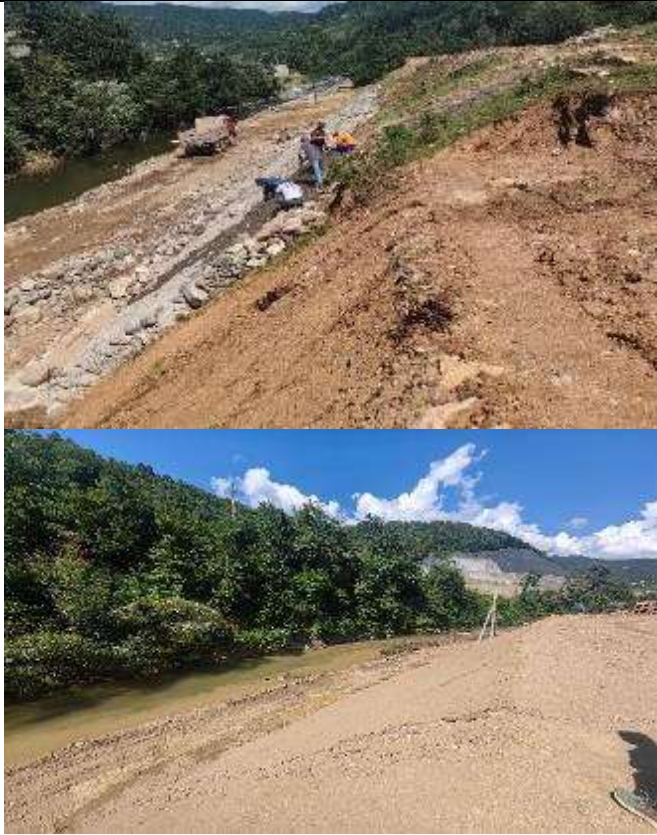
| 1<br>1 | Arrangement of river protection structures at the SDS 7 | | CC to arrange a river protection berm at the SDS 7 according to the approved design, in village Vertkvichala, Kharagauli municipality. | HNRB Contract or | Approved by MoEPA 06.12.2022 | <p>In progress</p> <p>Three months ago, F2 had arranged a large number of equipment and muck trucks to remove the waste soil in the first half, but recently F1 dumped the waste soil again, see pictures below.</p> <p>F2 has started the mortar stone slope protection of the second half of the river bank.</p> | Complete the rehabilitation works | In progress |

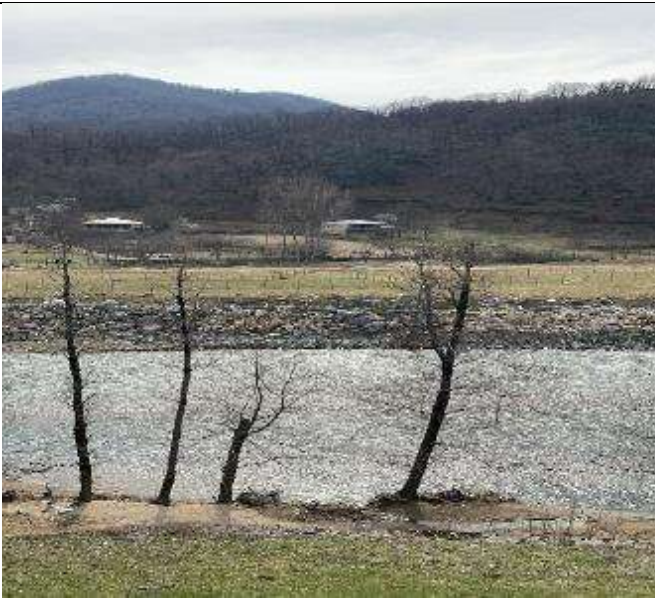
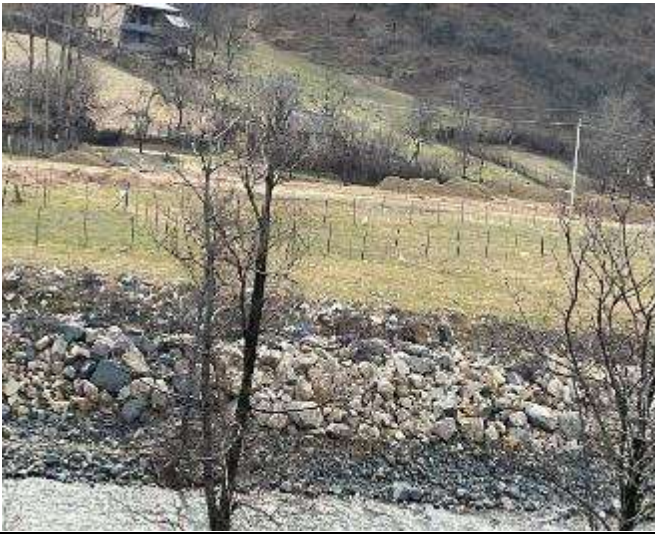
| 1<br>2 | Arrangement of river protection structures at the SDS 9 | April 2024 | CC to arrange a river protection berm at the SDS 9 according to the approved design, | HNRB Contract or | - | Completed River protection works completed; 327 trees planted. | - | Completed During pervious reporting period. |

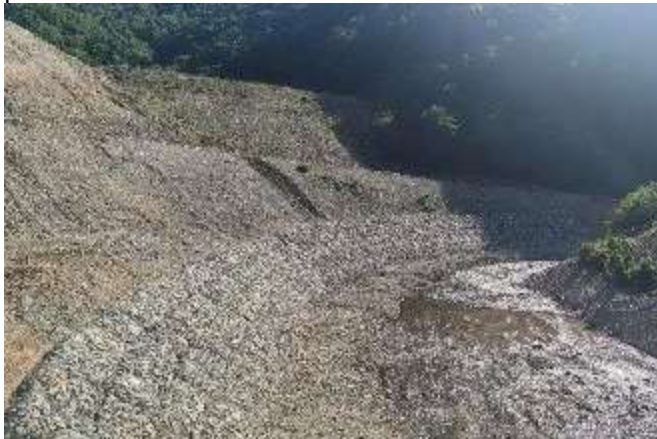
| 1<br>3 | Arrangement of river protection structures at the SDS 12 | | CC to arrange a river protection berm at the SDS 12 according to the approved design, in village Khevi, Kharagauli municipality. | HNRB Contract or | Approved by MoEPA 20.03.2021 | Completed<br>The contractor has completed the riprap slope protection.<br> | | Completed June 2024 |

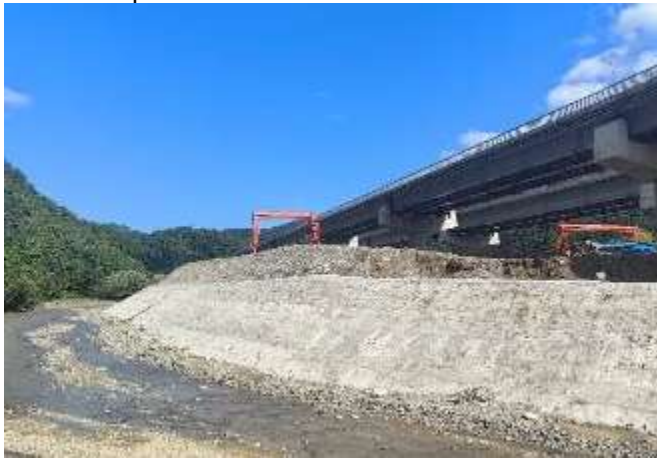
| 1<br>4 | Arrangement of river protection structures at the SDS 15 | | CC to arrange a river protection berm at the SDS 15 according to the approved design, in village Vertkvichala, Kharagauli municipality. | HNRB Contract or | Approved by MoEPA 08.08.2022 | Completed<br>Slope protection works and rock berm river protection works completed.<br> | June 2024 | Completed June 2024 |

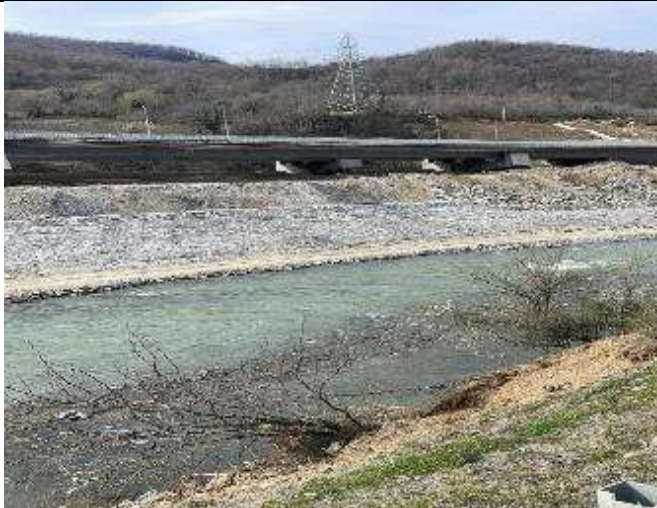
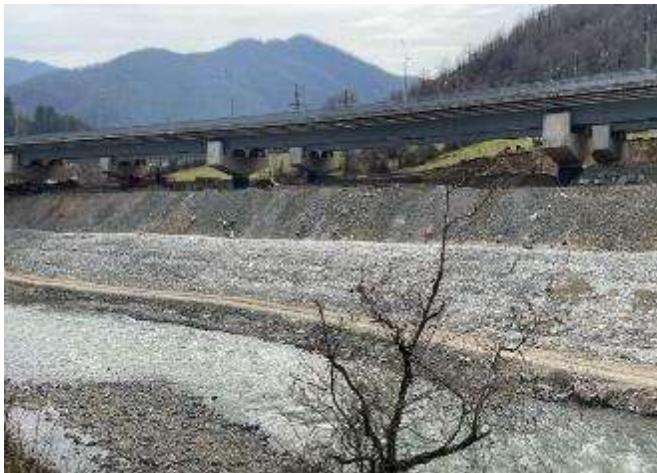
| 1<br>5 | Arrangement of river protection | | CC to arrange a river protection berm at the SDS | HNRB Contract or | Approved by MoEPA 08.08.2022 | Completed<br>Slope protection works and rock berm river protection works completed. | May 2024 | Completed June 2024 |

| | structures at the SDS 16 | | 16 according to the approved design, in village Sakasria, Kharagauli municipality. | | | | | |

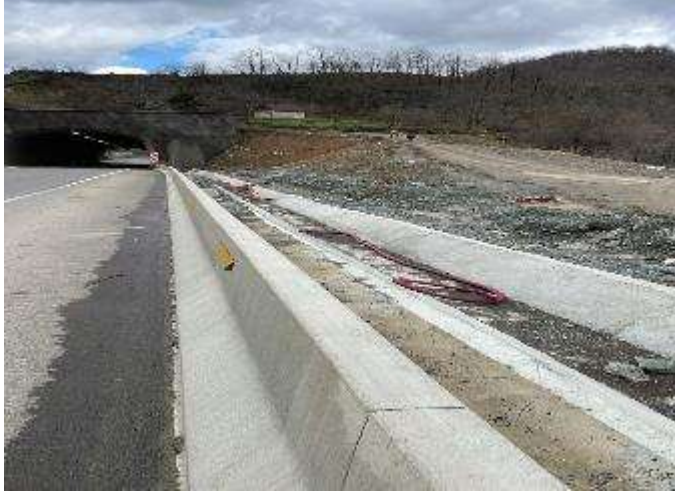
| # | Pictures | Description |
|---|---|---|
| 1 | | Cutting of Pipe pieces to be removed and drainage channel needs to be cleaned. From Tunnel 1 March 2024 |

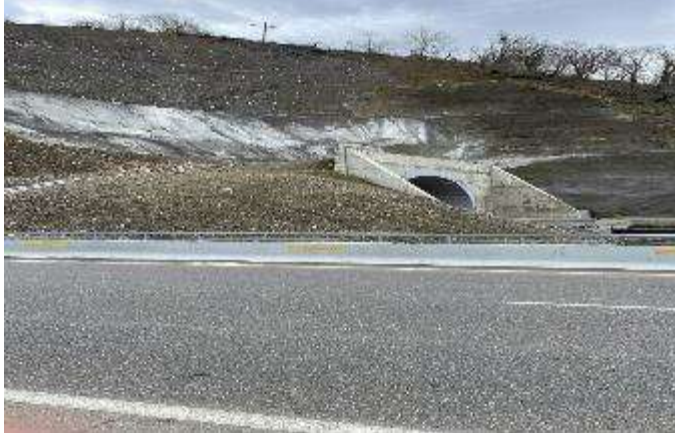
| # | Pictures | Description |
|---|---|---|
| 2 | | No Debris Observed, slope stabilized<br>Tunnel 2<br>March 2024 |

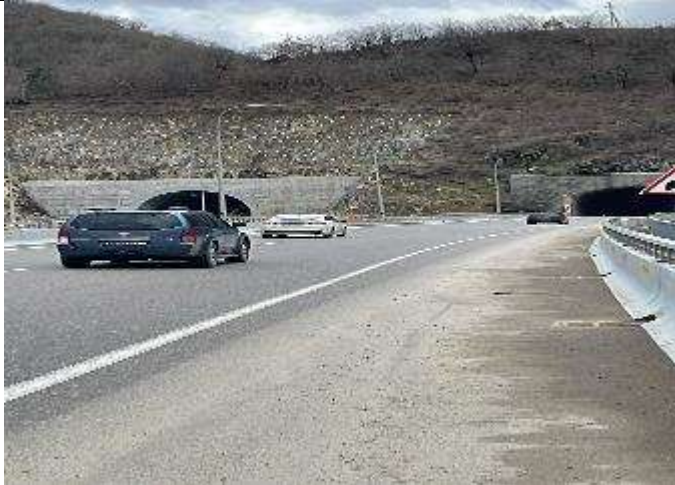
| # | Pictures | Description |
|---|---|---|
| 3 | | No debris observed, slope stabilized<br>Tunnel 3<br>March – April 2024 |

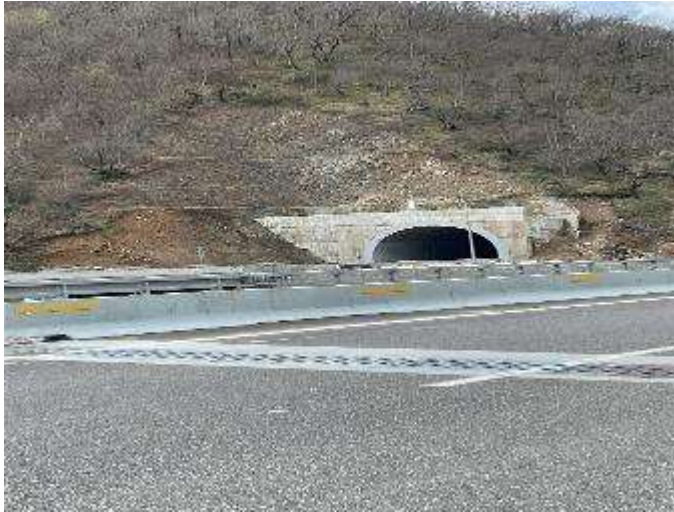
| 4 | | <p>No debris found.at TUN4</p> <p>April 2024</p> |

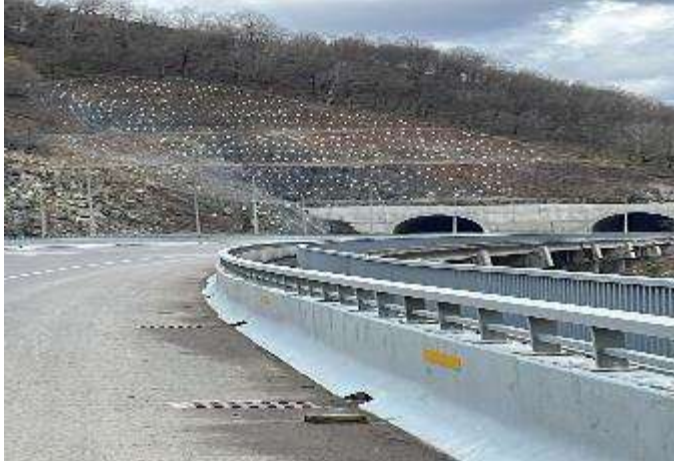
| 5 | | <p>No debris observed, slope stabilized</p> <p>TUN 5</p> <p>April 2024</p> |

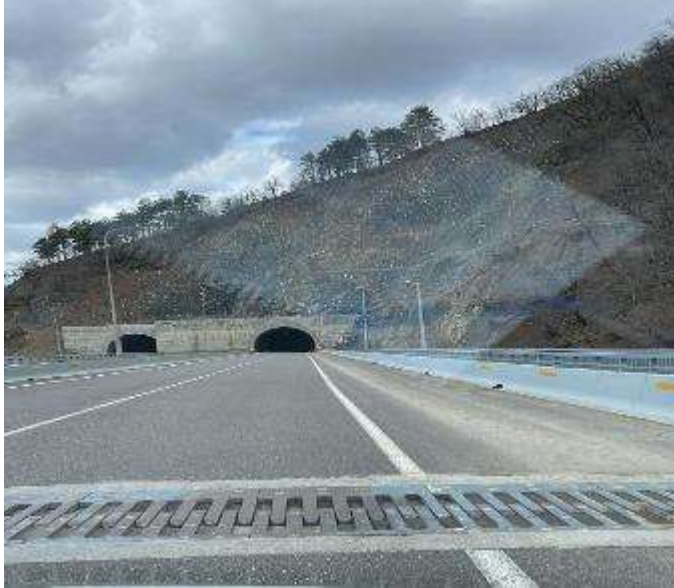
| 6 | | <p>A view of Tunnel 6</p> |

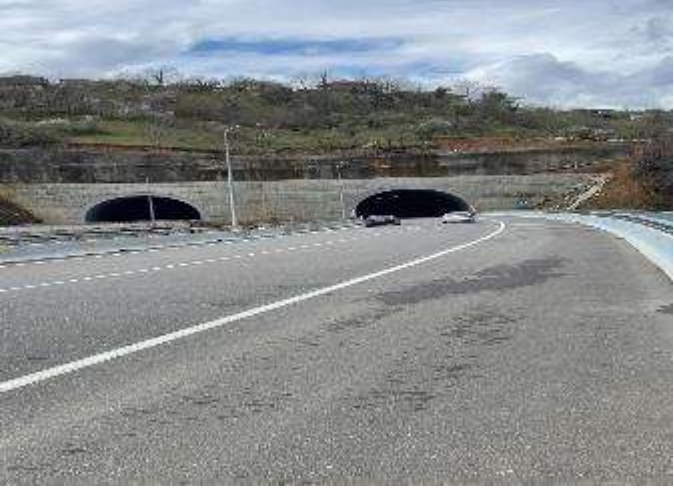
| 7 | | A view of TUN 7 no debris found |

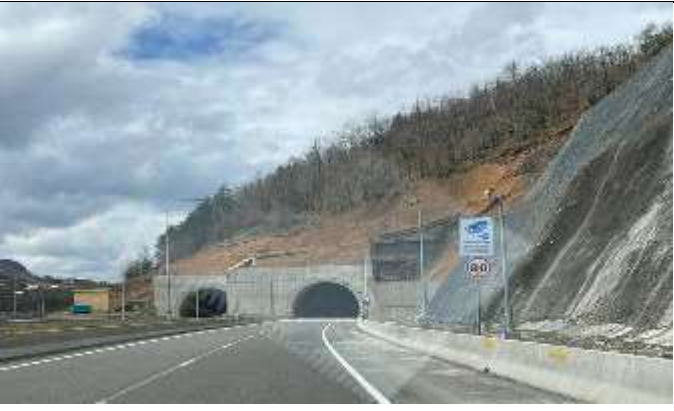
| 8 | | A view of Tunnel 8 |

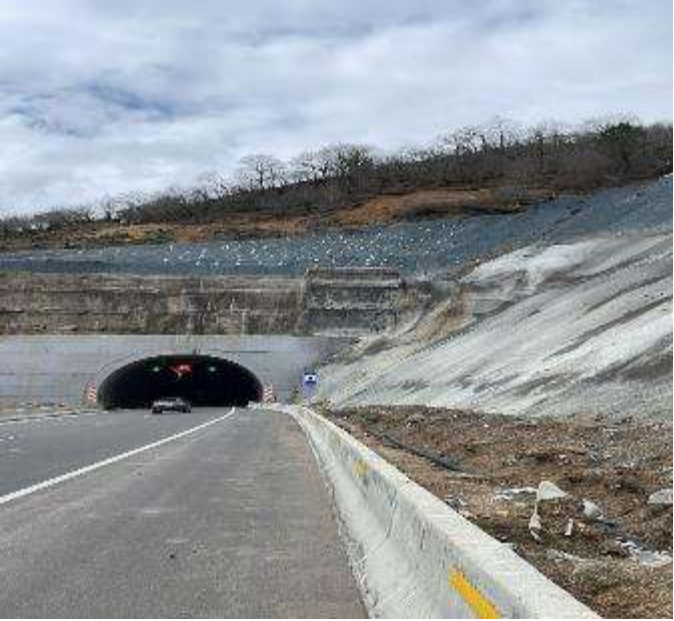
| 9 | | <p>Cleaning of the area from the sides of the tunnel required</p> <p>TUN 9</p> |

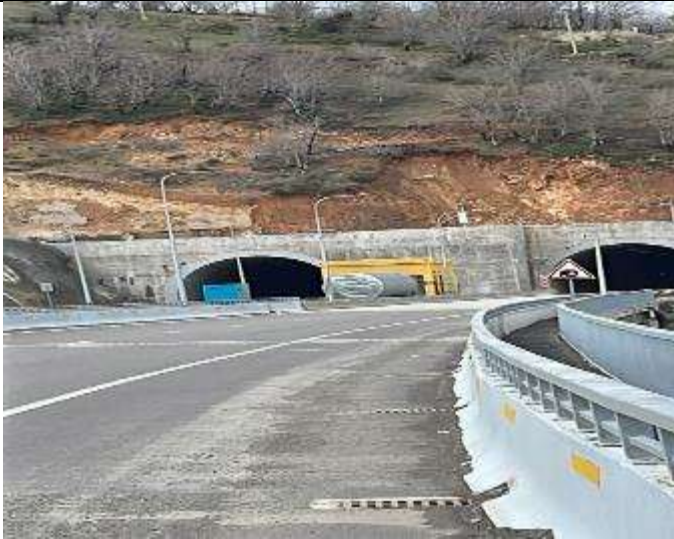
| 10 | | <p>Flume pipes to be removed between tunnel 10 &amp; 11</p> <p>May 2024</p> |

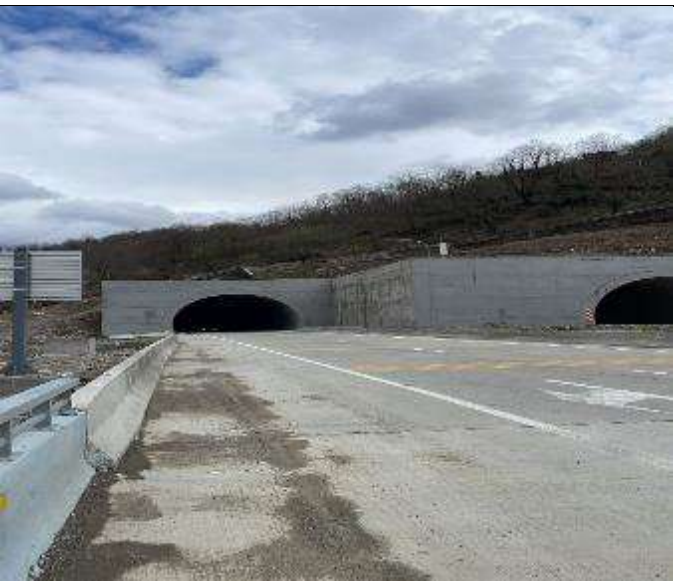
| 11 | | <p>Need to remove security box, clean the area, and remove the pipe cutting pieces between TUN 11 &amp; Bridge 18</p> <p>May 2024</p> |

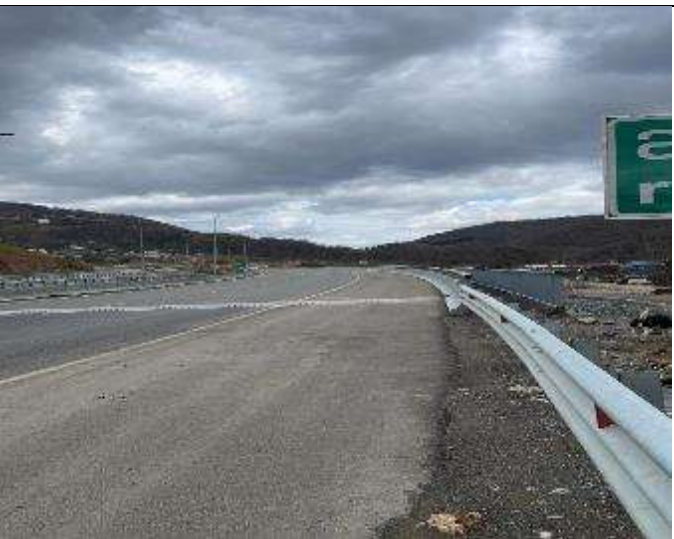
| 12 | | <p>Area needs to be levelled, debris under the bridge, used tyres under the bridge</p> <p>Bridge 1 April 2024</p> |

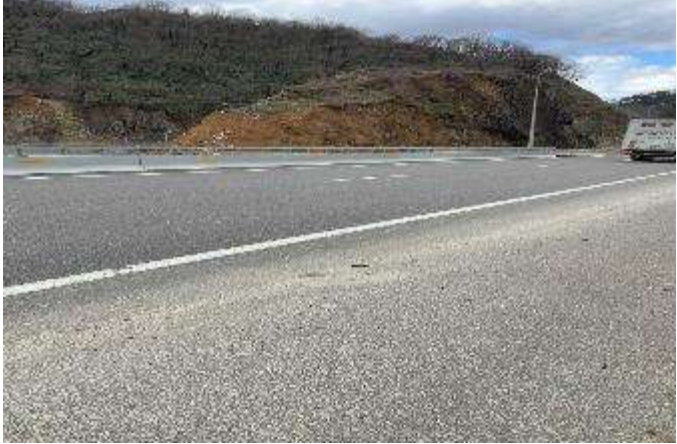
| 13 | | No debris found on the bridge |

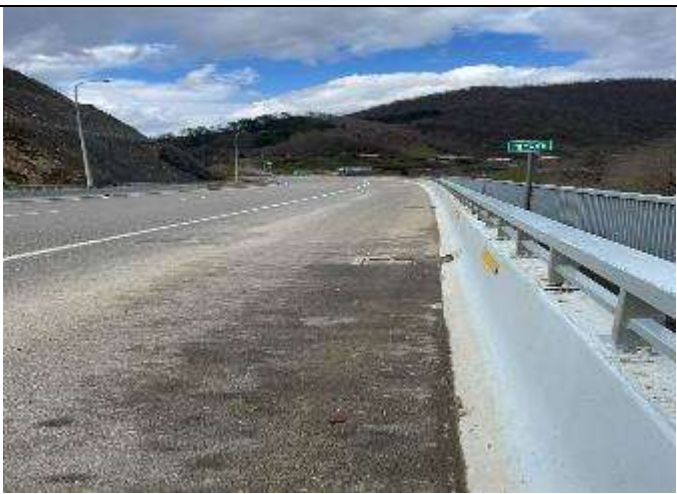
| 14 | | A view of Bridge 3 |

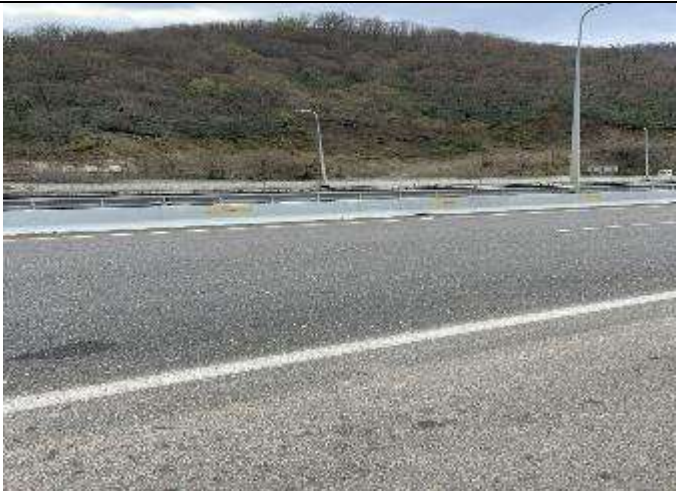
| 15 | | A view of bridge 4. No debris found<br>April 2024 |

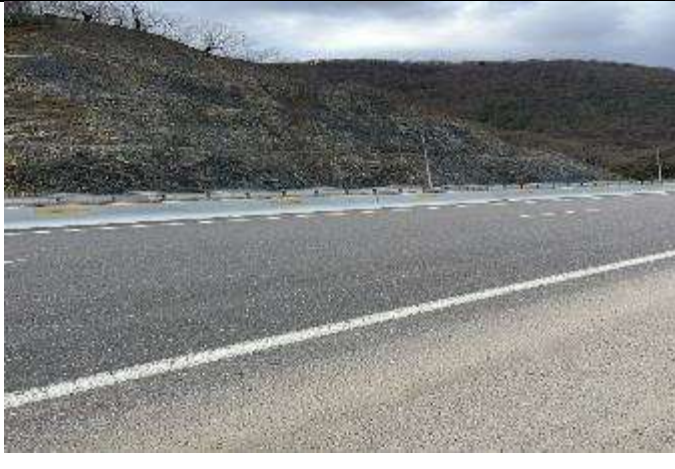
| 16 | | <p>Bridge# 5</p> <p>No debris along the bridge, slope stabilized</p> |

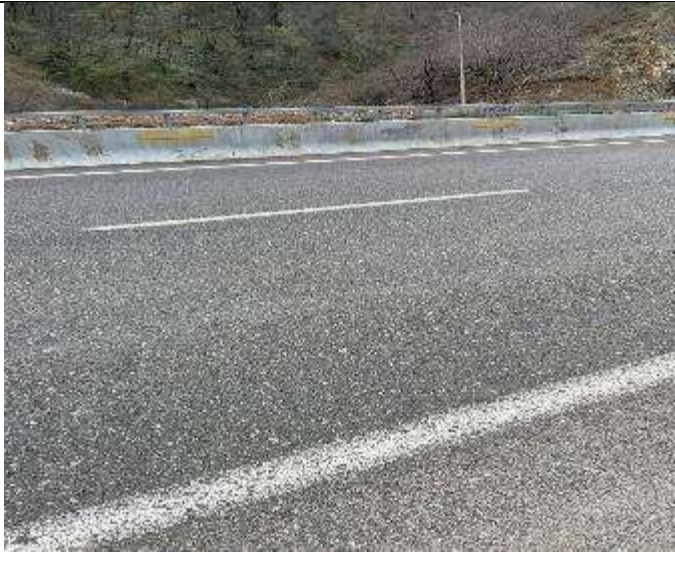
| 17 | | <p>Bridge# 6</p> <p>No Debris found on the bridge</p> |

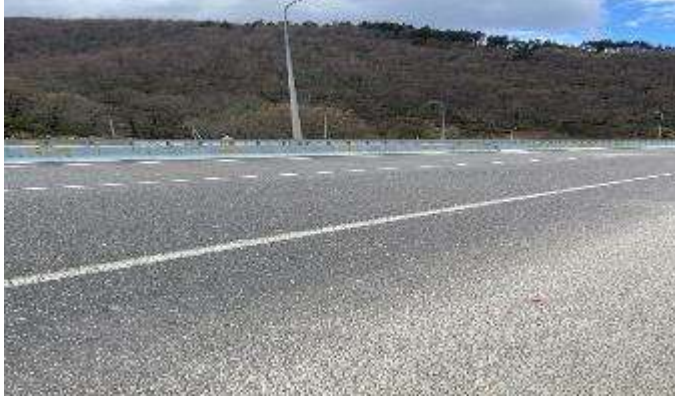
| 19 | | <p>Bridge# 8</p> <p>No Debris found along the bridge</p> |

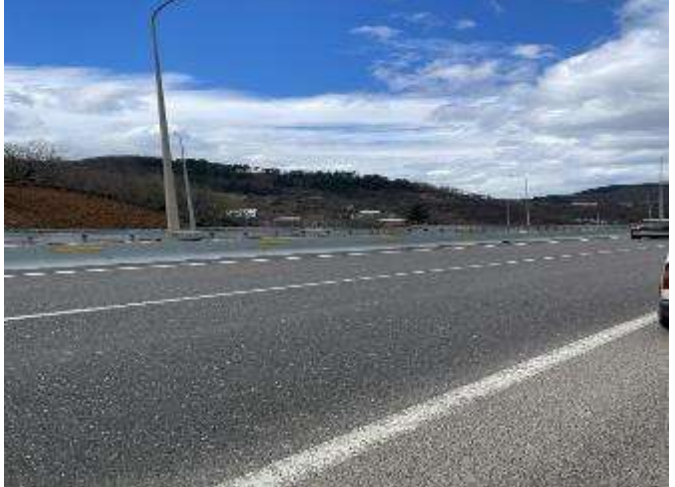
| 20 | | <p>Bridge# 9</p> <p>No debris found along the bridge,<br/>Concrete blocks inside the river along<br/>the bridge</p> |

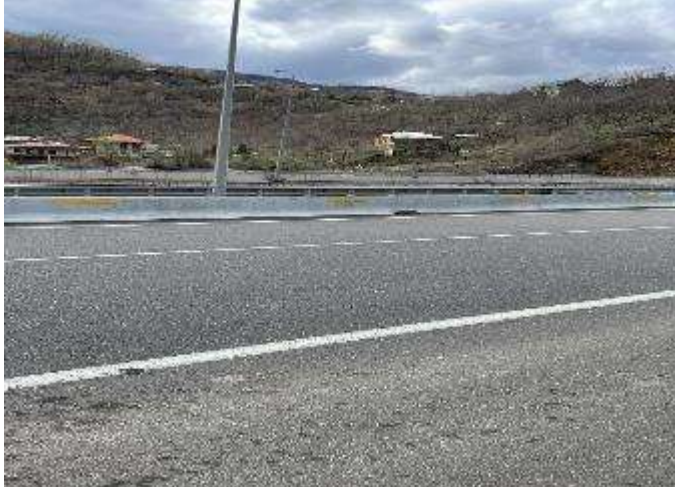
| 21 | | <p>Bridge# 10</p> <p>No debris found along the bridge</p> |

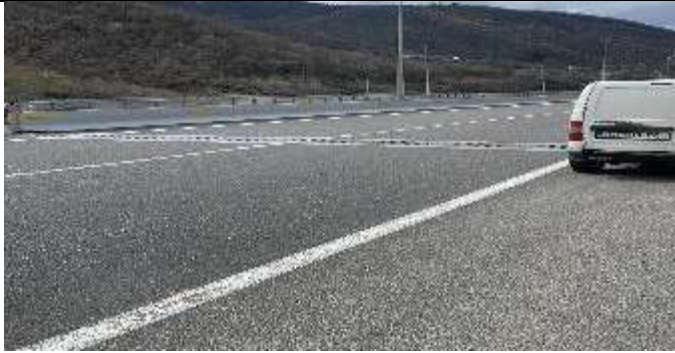
| 22 | | <p>Bridge# 11</p> <p>No debris/ waste found on the bridge, used containers to be removed from the surroundings</p> |

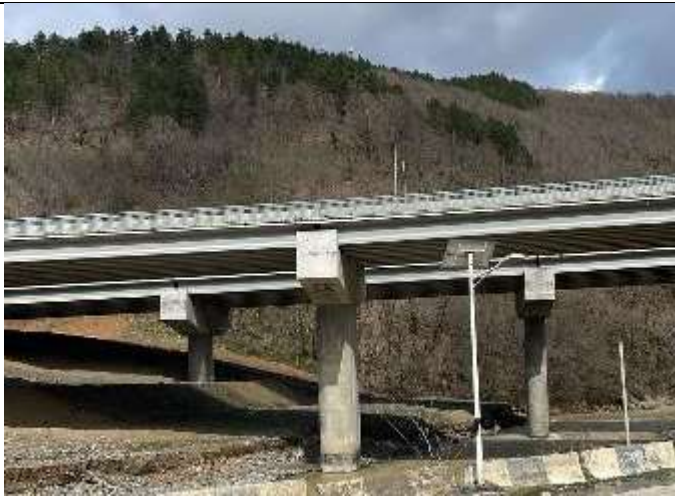
| 23 | | <p>Bridge# 12</p> <p>No debris or waste over the bridge,</p> |

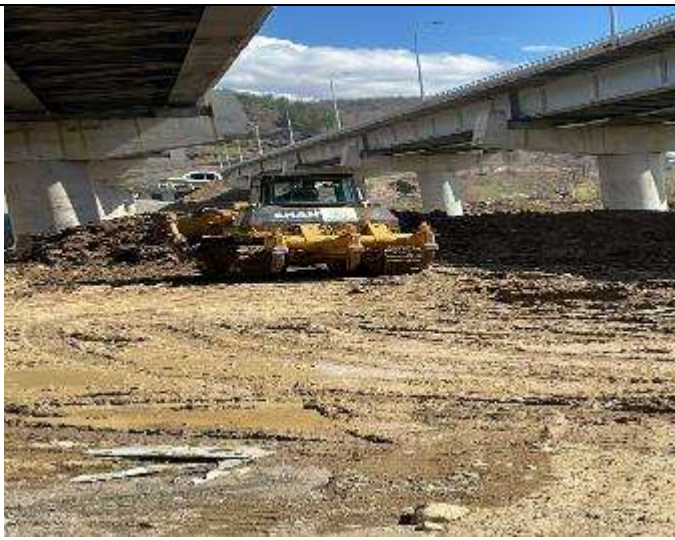
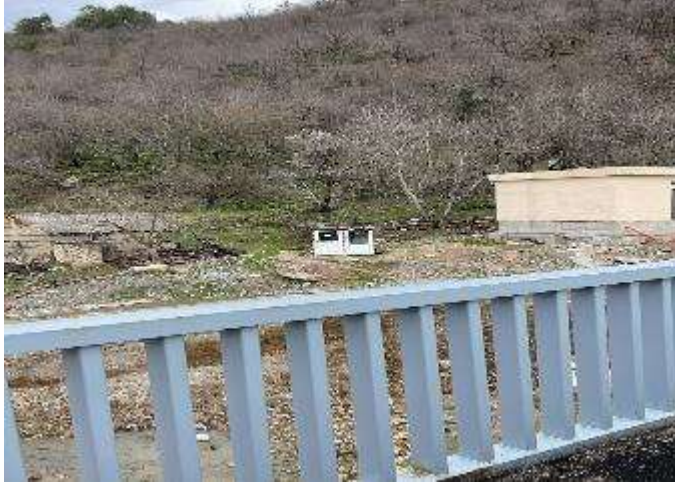
| 24 | | <p>Security box and debris to be removed from under the bridge, leveling of areas is going on, Contractor spreading the topsoil under the bridge.</p> <p>Bridge 13</p> <p>May 2024</p> |

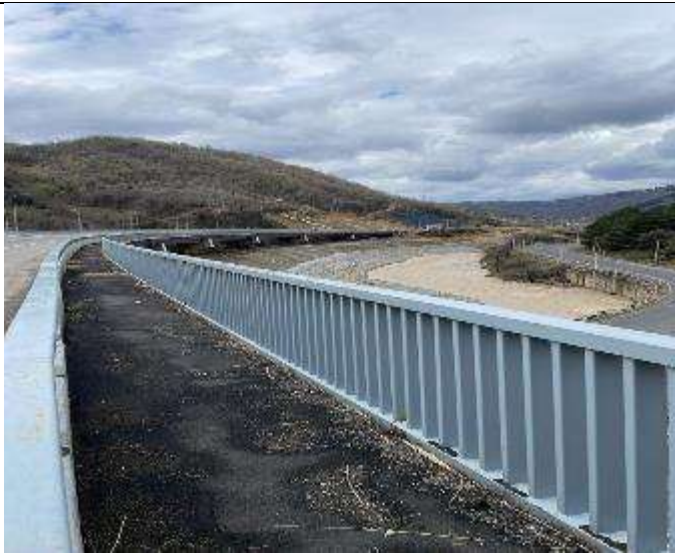
| 25 | | <p>A view of bridge 14</p> <p>Leveling of land under bridge required.</p> <p>April -May 2024</p> |

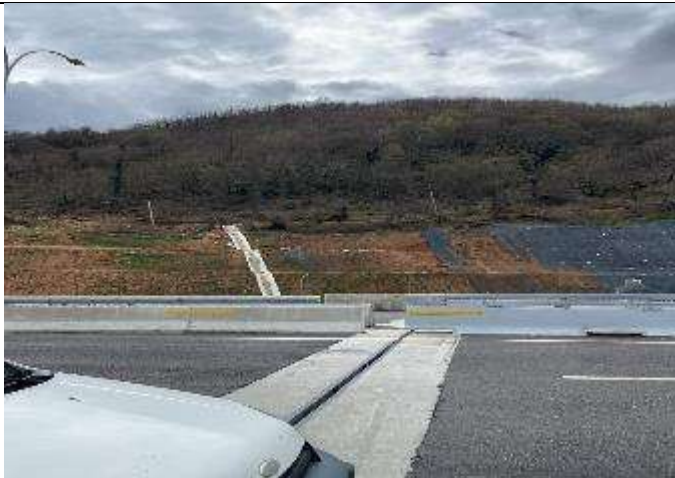
| 26 | | <p>Bridge# 15</p> <p>No Debris found along the bridge</p> |

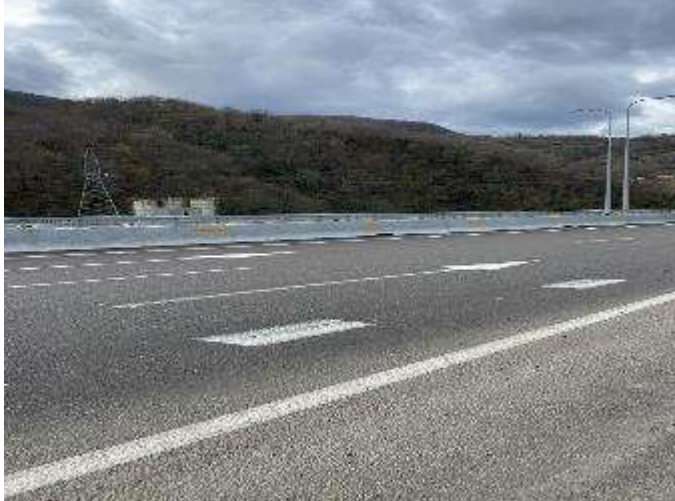
| 27 | | <p>Debris cleaning work required under the bridge 16 near BP 3.</p> <p>May 2024</p> |

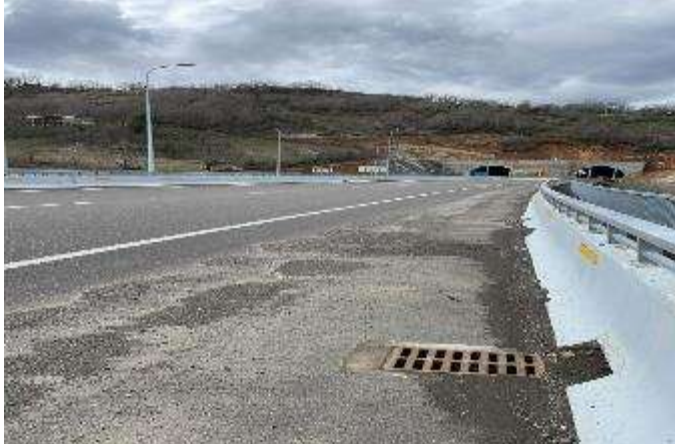
| 28 | | <p>New Jersey barriers to be removed under the bridge.</p> <p>Bridge 17</p> <p>May 2024</p> |

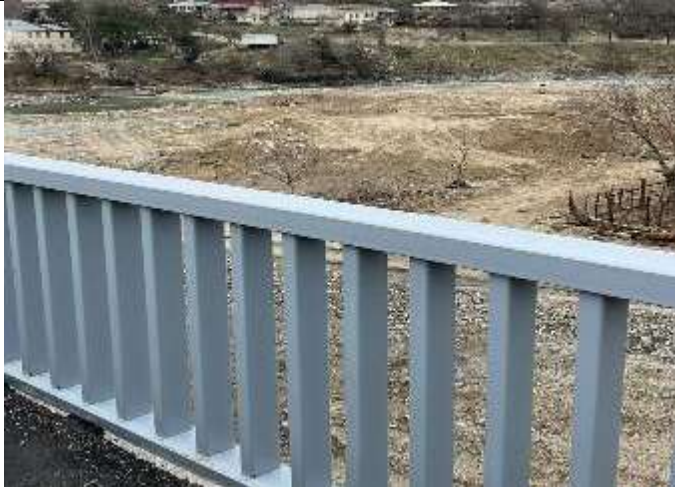
| 29 | | <p>Leveling of the land required under bridge 18</p> |

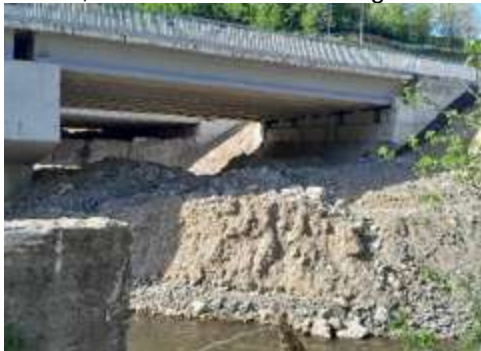
| No. | LOCATION | PICTURE/SKETCH | RECOMMENDATIONS | DEADLINES FOR CORRECTIVE ACTIONS | Respond by the CC |
|---|---|---|---|---|---|
| 1 | Under the bridge 2.1.01. Village Khevi, Kharagauli Municipality | <p>Debris, boulders under the bridge</p> | The territory should be cleaned of construction debris and the territory should be restored and leveled to bring it to original position. | 5-May-24 | |

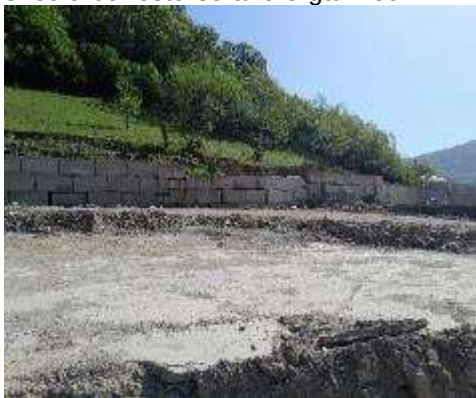
| No. | LOCATION | PICTURE/SKETCH | RECOMMENDATIONS | DEADLINES FOR CORRECTIVE ACTIONS | Respond by the CC |
|---|---|---|---|---|---|
| 2 | N1 Concrete Batching Plant. Village Khevi, Kharagauli Municipality | <p>The territory should be cleaned of construction debris and the territory should be restored and organized.</p> | Landowner asked to keep concrete base. Agreement signed between Contractor and landowner | N/A | |

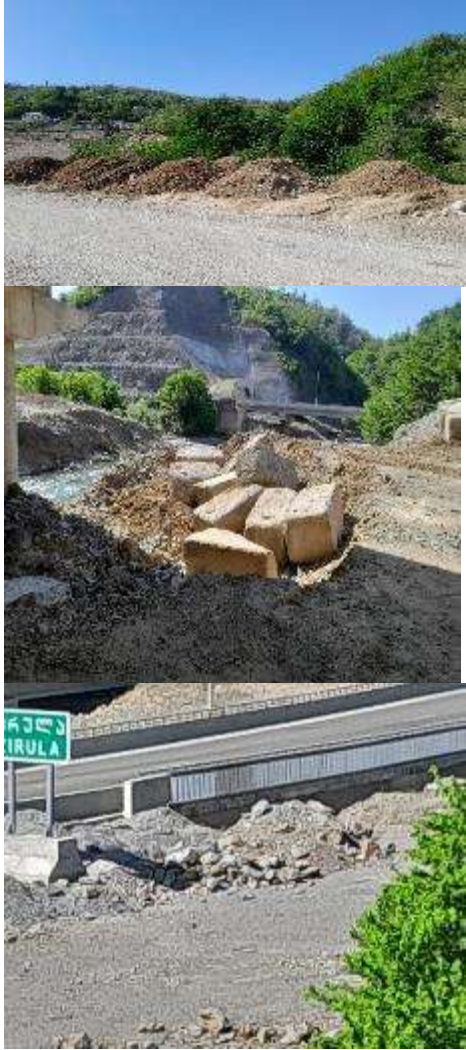
| 3 | Near the local bridge to village Nadaburi. Village Khevi, Kharagauli Municipality | <p>Debris, concrete blocks at the site</p> | The territory should be cleaned of construction debris and the territory should be restored and organized. | <p>Figure 2 Completion time 1-May-24</p> <p>Figure 3 Completion time 1-May-24</p> | The waste soil in Figure 1 does not belong to F2 Project |

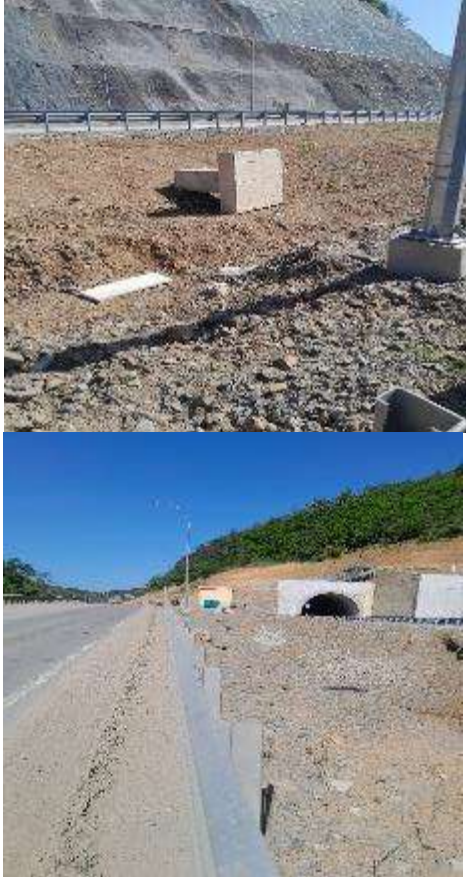
| 4 | N1 Interchange, Village Vertkvichala, Kharagauli Municipality | <p>Debris concrete waste at the site</p> | The territory should be cleaned of construction debris and the territory should be restored and organized. | Completion time 5-May-24 | |

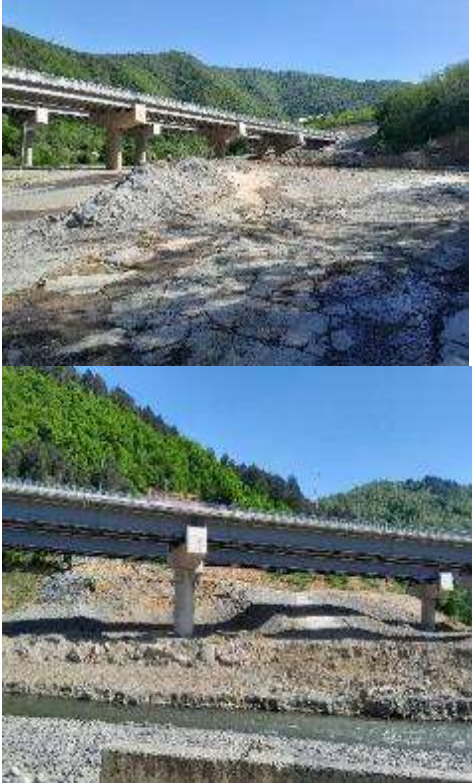
| 5 | Under the bridge 2.1.13. Village Vertkvichala, Kharagauli Municipality. | <p>Debris, concrete waste at the site</p> | The territory should be cleaned of construction debris and the territory should be restored and organized. | Figure 2 Completion time 10-May-24 | Figure 1 The landowner requested to retain the concrete base as explained by the contractor. |

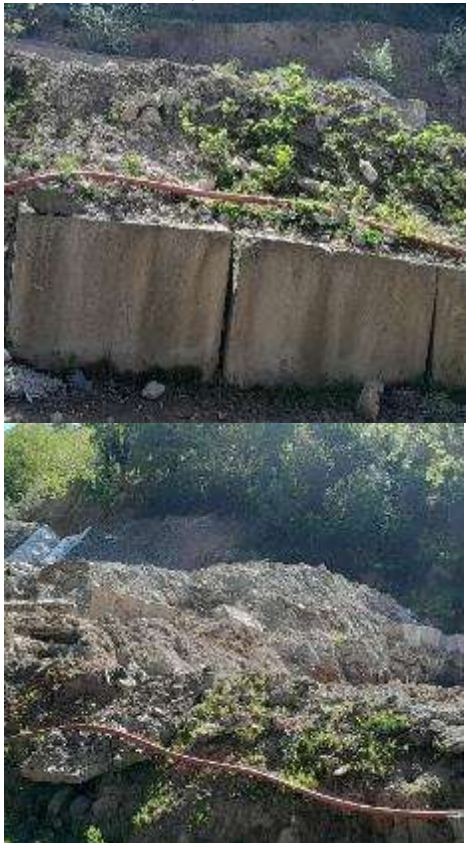
| 6 | Under the bridge 2.1.12. Village Khunevi, Kharagauli Municipality. | <p>Concrete waste, debris at the site</p> | The territory should be cleaned of construction debris and the territory should be restored and restored to it original condition. | Completion time 20-May-24 | |

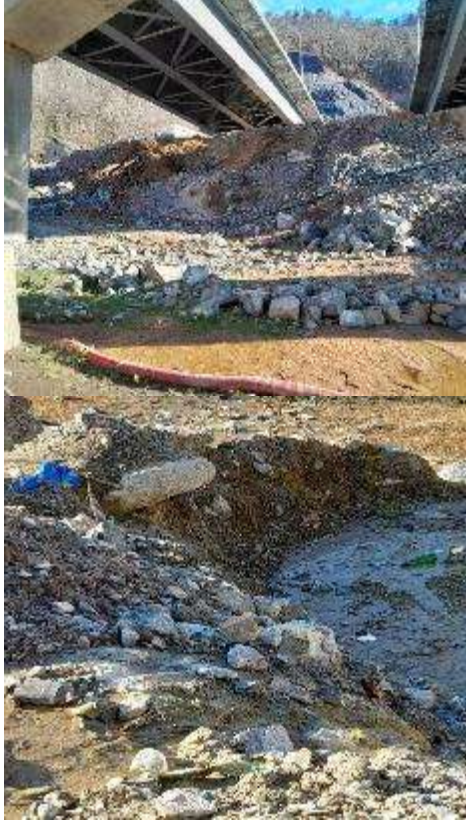
| 6 | Near the tunnel<br>2.0.09. Village<br>Sakasria,<br>Kharagauli<br>Municipality | <p>Debris, construction waste at the site</p> | The territory should be cleaned of construction debris and the territory should be restored and organized. | Completion time 25-May-24 | |

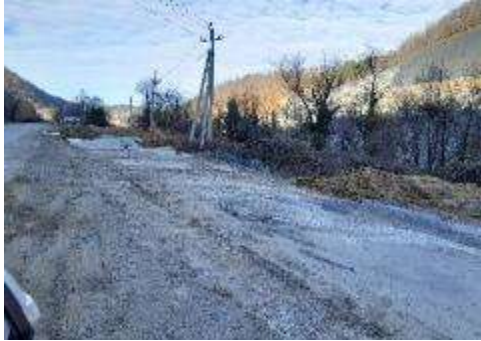
| 7 | Near the Spoil Disposal Site N7. Village Khunevi, Kharagauli Municipality | <p>Concrete waste at the identified location.</p> | The territory should be cleaned of construction debris and the territory should be restored and organized. | Completion time 25-May-24 | |

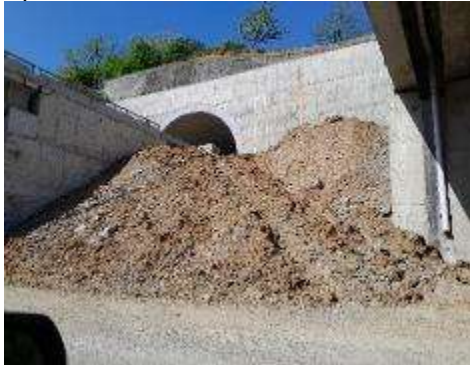
| 8 | Near the Tunnel 2.0.05. Village Khunevi, Kharagauli Municipality | <p>Spoil material and debris at the site</p> | The territory should be cleaned of construction debris and the territory should be restored and organized. | Completion time 25-May-24 | |
