# Semi-Annual Environmental Monitoring Report

#12 Semestral Report

Reporting period: January - June 2024

## **GEO: Construction of Khevi-Ubisa Section (E60 Highway Route), F2 Project**

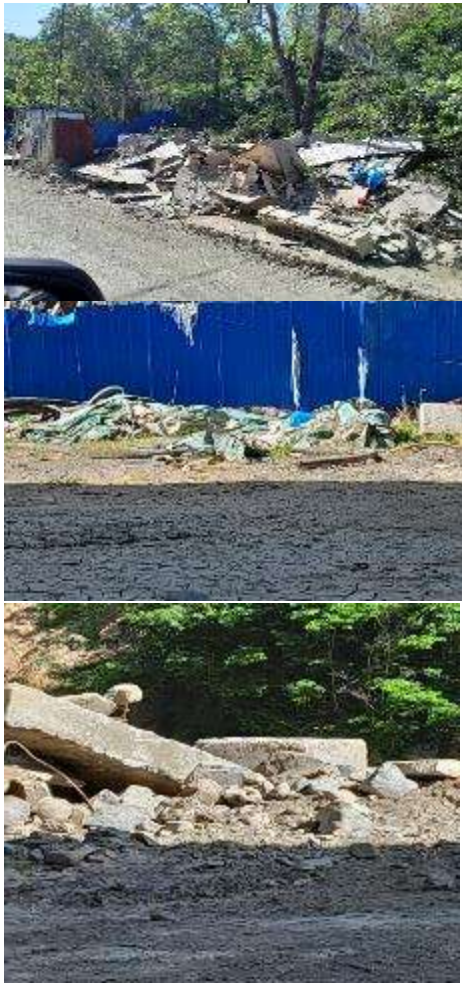
| 9 | Under the bridge 2.1.10. Village Khunevi, Kharagauli Municipality | <p>Construction waste, debris left at the site as shown in the pictures below.</p> | The territory should be cleaned of construction debris and the territory should be restored and organized. | Completion time 25-May-24 | |

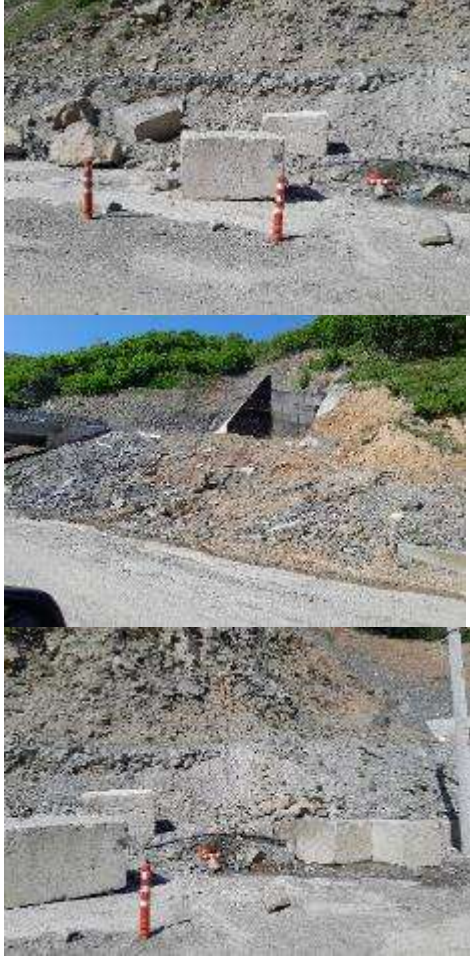
| 10 | Near the Tunnel 2.0.05, Village Khunevi, Kharagauli Municipality | <p>Concrete blocks and debris at the site</p> | The territory should be cleaned of construction debris and the territory should be restored and organized. | Completion time 2024. 30-May-24 | |

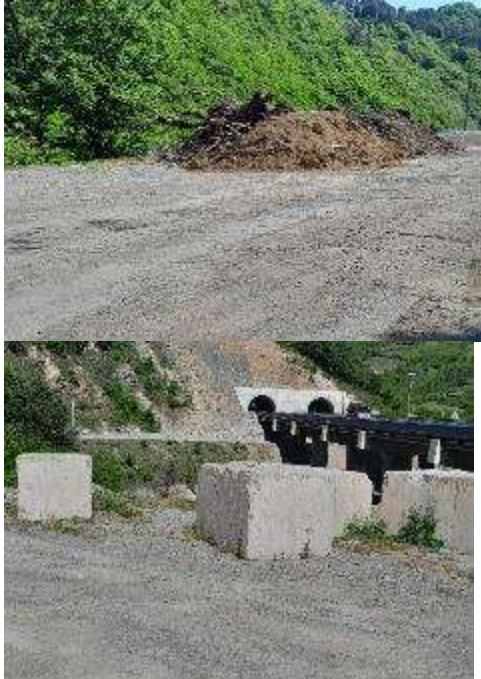
| 11 | Near the Tunnel 2.0.04, Village Khunevi, Kharagauli Municipality | <p>Concrete blocks and spoil at the identified location.</p> | The territory should be cleaned of construction debris and the territory should be restored and organized. | Figure 2 Completion time 10-May-24 | The waste soil in Figure 1 does not belong to F2 project. |

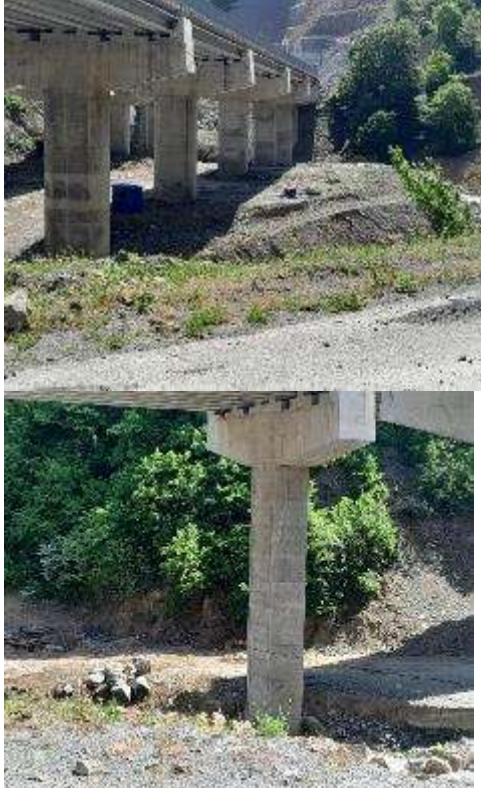
| 12 | Under the bridge 2.1.09. Village Khunevi, Kharagauli Municipality | <p>Debris left at the site</p> | The territory should be cleaned of construction debris and the territory should be restored and organized. | Completion time 30-May-24 | |

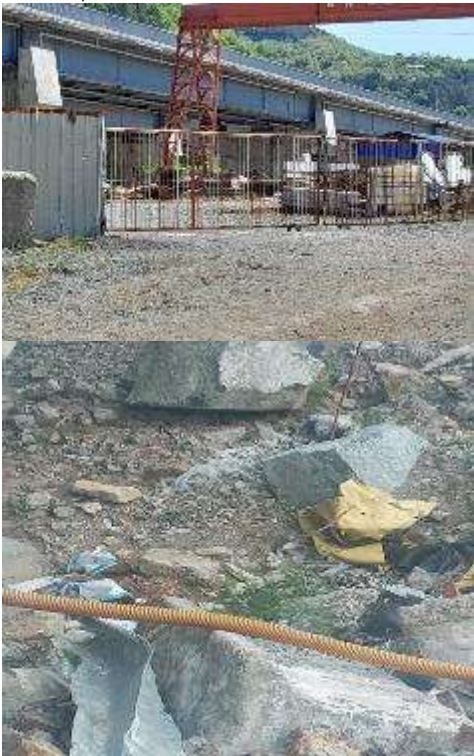
| 13 | Steel Workshop Area. Village Vertkvichala, Kharagauli Municipality | <p>Debris, construction waste at the site</p> | The territory should be cleaned of construction debris and the territory should be restored and organized. | Completion time 30-May-24 | |

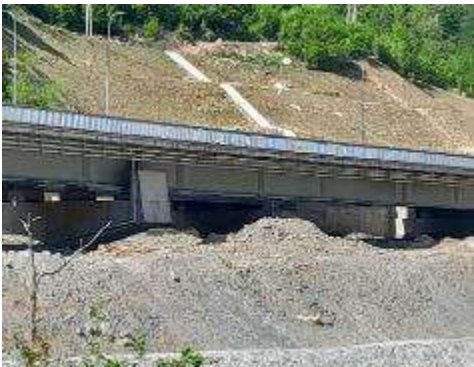
| 14 | Spoil Disposal Site N16. Under the bridge 2.1.14. Village Sakasria, Kharagauli Municipality | <p>Construction waste/ debris leftover at the site</p> | The territory should be cleaned of construction debris and the territory should be restored and organized. | Completion time 20-June-24 | |

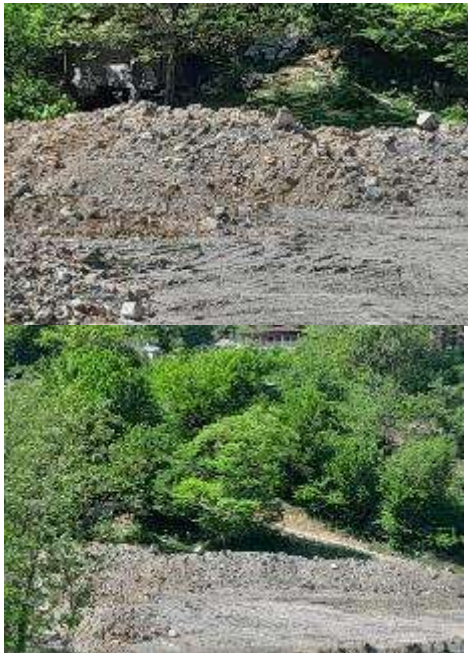
| 15 | Near the tunnel 2.0.10 (subcamp area). Village Sakasria, Kharagauli Municipality | <p>Debris construction waste at the site</p> | The territory should be cleaned of construction debris and the territory should be restored and organized. | Completion time 20-June-24 | |

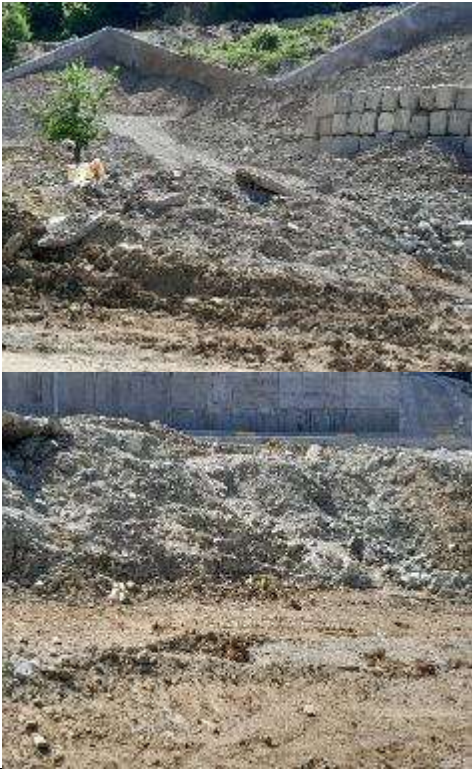
| 16 | Tunnel 2.0.11<br>AT. Village<br>Boriti,<br>Kharagauli<br>Municipality. | <p>Debris, construction waste leftover at the site.</p> | The territory should be cleaned of construction debris and the territory should be restored and organized. | Completion time 20-May-24 | |

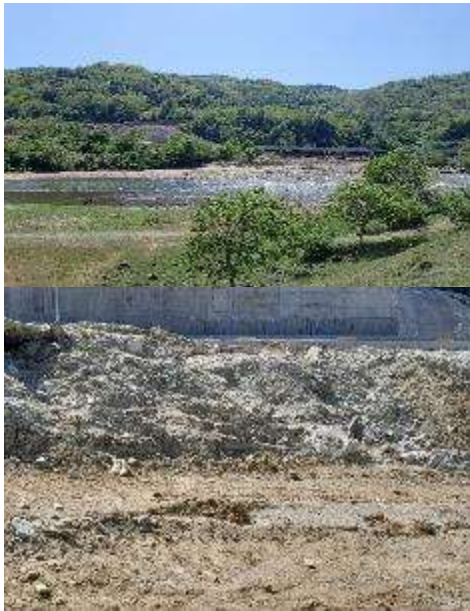
| 17 | Bridge 2.1.18.<br>Village Boriti,<br>Kharagauli<br>Municipality. | <p>Debris, construction waste, leftover the site.</p> | <p>The territory should be cleaned of construction debris and the territory should be restored and organized.</p> | <p>Completion time 30-May-24</p> | |

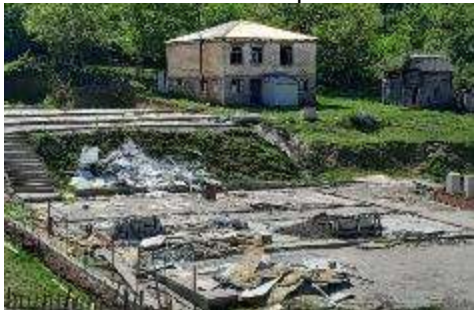
| 18 | Subcamp N4 area. Village Sakasria, Kharagauli Municipality | <p>Leftover waste near camp 4</p> | The territory should be cleaned of construction debris and the territory should be restored and organized. | Construction waste removal completion time 20-May-24 | The landowner requested to retain the concrete base. |

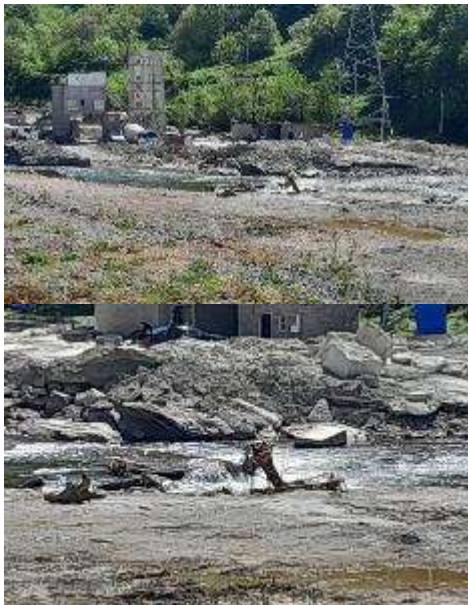
| 19 | Concrete Batching Plant N3. Village Sakasria, Kharagauli Municipality. | <p>Construction waste/ debris/ concrete block at the batching plant and along the river.</p> | <p>The territory should be cleaned of construction debris and the territory should be restored and organized.</p> <p>River bank needs to be cleaned out. All the spoil material should be dumped at the SDA 11</p> | Completion time 30-June-24 | |

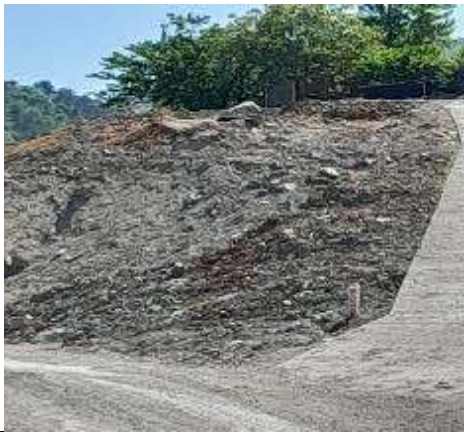
| 20 | Near the access road to the village of Sakasria, Interchange 2 | <p>Construction Waste/ debris at the site</p> | <p>The territory should be cleaned of construction debris and the territory should be restored and organized.</p> | Completion time 20-May-24 | |

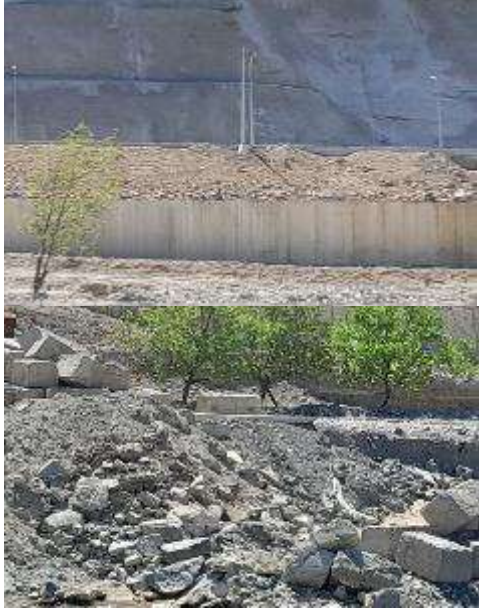
| 21 | <p>The area within the Dzirula riverbed, (between the Tunnel 2.0.10 AT and Tunnel 2.0.11 TA)</p> | <p>Construction waste, blocks at the site</p> | <p>The territory should be cleaned of construction debris and the territory should be restored and organized.</p> | <p>Completion time 20-May-24</p> | |
