Semi-annual Environmental Monitoring Report

Project Number GEO 51257-001

Reporting period: January - June 2021

Georgia: North-South Corridors (Kvesheti – Kobi) Road Project

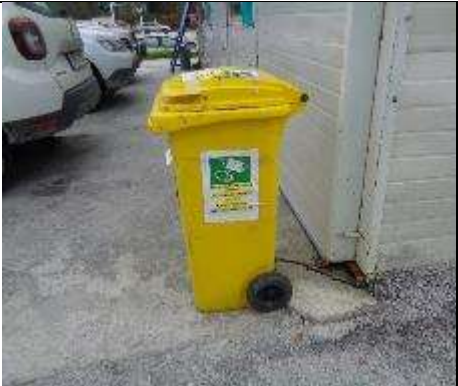
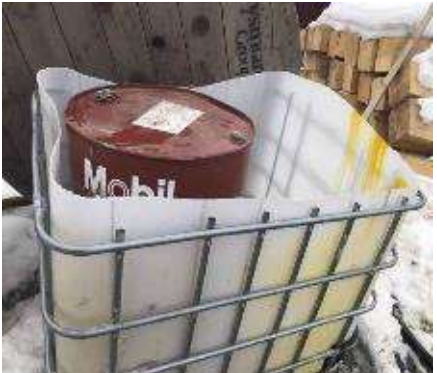
ID#	Affected Location	Date	Issue raised	Mitigation Required	Estimated time	Corrective Actions	Status of Action
1	North portal Kobi	Jan 2021	<ul style="list-style-type: none"> • Drip trays not provided under the oil drums and water reducing chemical containers • Hazardous waste containers are not provided at the site to store hazardous material. • Spill kits to be provided by the CC at the site

<p>Open</p> <p>CC to complete requirements and provide the drip trays for the chemical containers which are in use.</p>

<p>CC for lot#1 should provide dip trays, under all oil drums, chemical containers</p> <p>CC to provide hazardous waste containers at site</p> <p>Cc to provide spill kits at the site</p>	Immediately	<p>CC provided the spill kit at the site and distributed these at the site near the oil contained facilities .</p> <p>Containers for hazardous waste are provided at the site</p>

<p>Drip trays for drums are provided by cutting the used chemical containers to provide secondary containment</p>

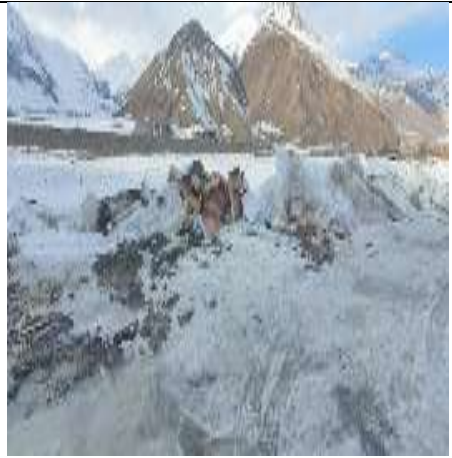
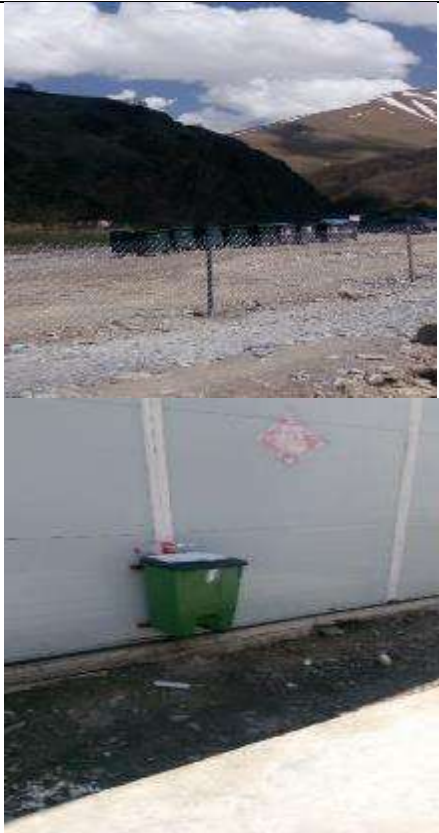
2	Campsite Lot 1	Jan 2021	Waste scattered in front of engineer's office in Kobi campsite	CC for Lot#1 should arrange proper waste disposal areas according to lay out plans	Immediately	Waste bins installed with plastic bins in it and Containers were provided from where municipality Compactor is carrying the waste on daily basis	Closed

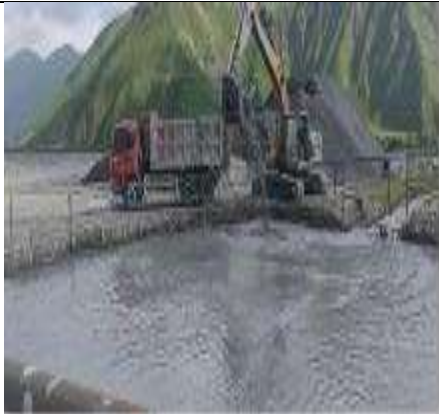
3	North portal Kobi side segment plan territory	Jan 2021	Sedimentation tank required to treat the tunnel water coming out from the emergency gallery .	CC for lot#1 should provide detail drawings and locations, where and how the sedimentation tank will be arranged	Immediately	Sedimentation Tank with the capacity of 640 m ³ / hr. provided to treat tunnel water consisting of three sections. The overall treatment system includes five ponds in series starting from collector to the sedimentation tank and then water passes through the three settling	Closed However, as volumes have increased further

<p>ponds across the road and sludge from these sedimentation tanks and ponds is being collected on regular basis and disposed of in Spoil Disposal Area # 1</p>    	<p>requirements to improve management of tunnel water are on-going and sediment management are required.</p>
--	--	---	--	--	--	--

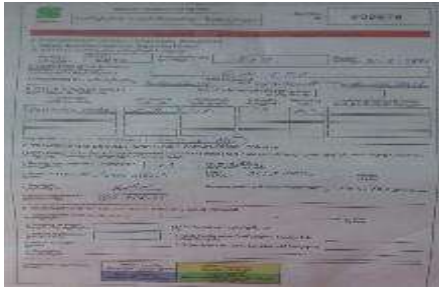
4	North portal Kobi side camp	Jan 2021	Provision of waste delivery receipts to PMCSC	CRTG should provide the record to PMCSC of handing over the waste to subcontractors	One week	Delivery receipt provided to the PMCSC and attached as Annex 11

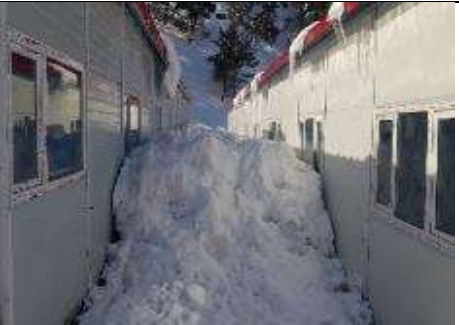
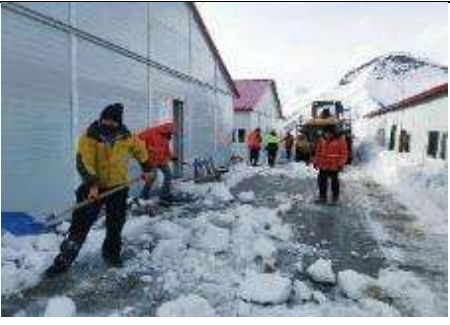
7	North portal Kobi site	Jan 2021	CC TV cameras installed but warning signs are missing  	CC to put the warning signs stating the area is being monitored by cameras	Two weeks	The surveillance cameras are installed in campsite The warning signs provided with the Cameras  	Closed
8	North portal Kobi site	Feb 2021	Snow between campsite and offices blocking the access	CC to remove snow on daily basis for the safety of pedestrians	Immediately	The snow was removed by loader immediately	Closed

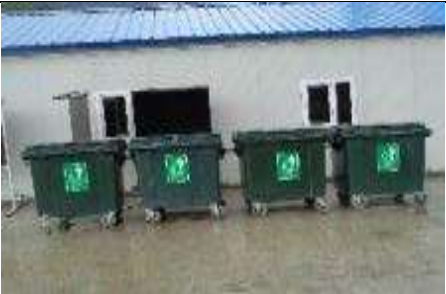
11	Lot#2 Camp 2	Feb 2021	<p>Waste scattered on site and there is no proper waste disposal area</p>  	<p>CC for Lot#2 to arrange the waste disposal area and scattered waste should be collected immediately</p>	<p>Collect and waste immediately and arrange waste disposal arrangement and bins in two weeks</p>	<p>Waste bins are provided on the Site. Toolbox trainings are conducted to the staff about waste management, its issues, etc.</p>  	Closed

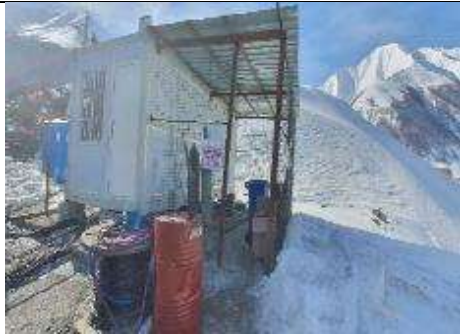
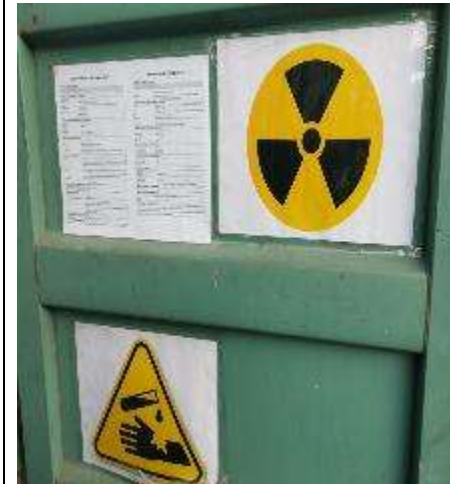
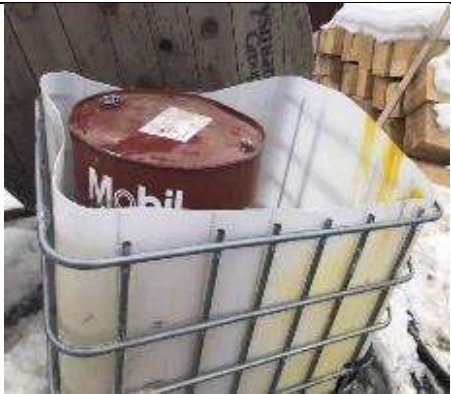
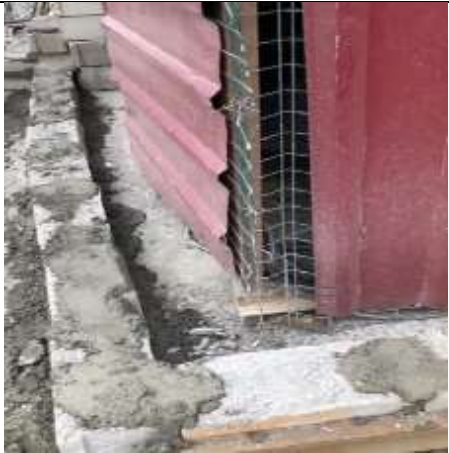
13	North portal Kobi	Feb 2021	<p>During the site visit the following non-conformities with regard to waste management good practice were observed:</p> <ul style="list-style-type: none"> i) rubbish bins were not sufficient for the project waste volumes; ii) no plastic bags were provided inside the waste bins; iii) no Material Safety Data Sheet (MSDS) and no fire extinguishers observed nearby; iv) a register of hazardous materials on site was not available; v) chemicals are stored in the open space without 	Waste management and good housekeeping practices according to waste management plan	One month	<p>Rubbish bins: Additional 10 bins (105cm*120cm*95cm) for household waste provided with 1.2 m³ capacity</p>  	<p>Open</p> <p>CC to provide Plastic bag in each container. Currently plastic bags are being provided in the bins installed in engineer's office</p>

<p>rain protection, without drip trays;</p> <p>vi) waste containers at batching plant were not placed at the special dedicated area with roofing and frost and snow can damage the containers</p> <p>vii) no drainage system is arranged around the hazardous storage area at the crushing plant and in case of spill hazardous liquid substance can pollute the soil.</p>  			<p>20 bins(70cm*45cm*30cm) with 0.1 m³ capacity were placed in accommodation area</p>   <p>8 bins (90cm*50cm*35cm) with 0.16 m³ capacity on construction area for hazardous and inert waste.</p>   <p>All bins are kept clean and washed when necessary.</p>	
--	--	--	--	--	--	---	--

The MSDS is available in the office and attached. Fire extinguish installed for flammable material

Hazardous material was removed from the Site, the documentation is available on the Site.

Chemicals in plastic containers are placed on a concrete base and covered, Furthermore the chemicals are stored in a warehouse, Drip trays for oil barrels are in use.

<p>Waste bins are placed under the covered space</p> <p>Bunds have been built around the hazardous material storage area at the crushing plant to capture and contain the chemical spill in case of spillage. The floor of the storage area is impermeable and built by concrete .</p>	
--	--	--	--	--	--	--

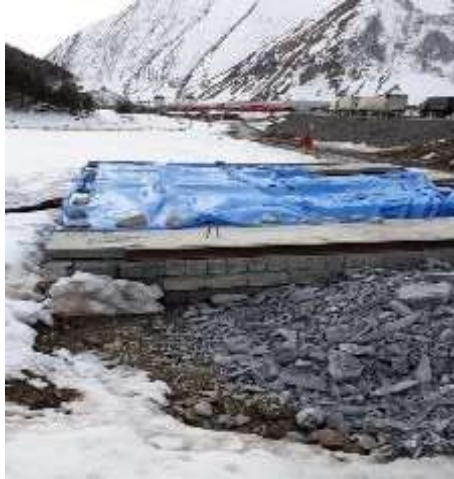
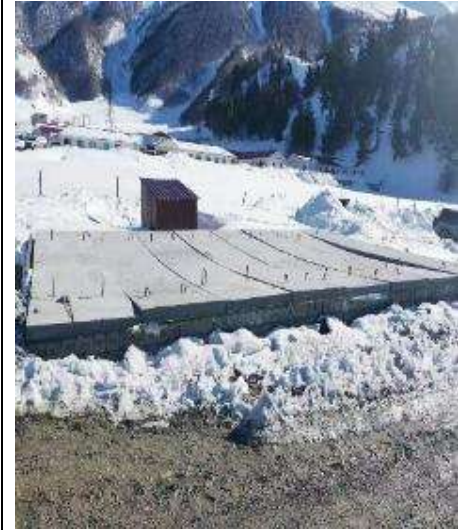
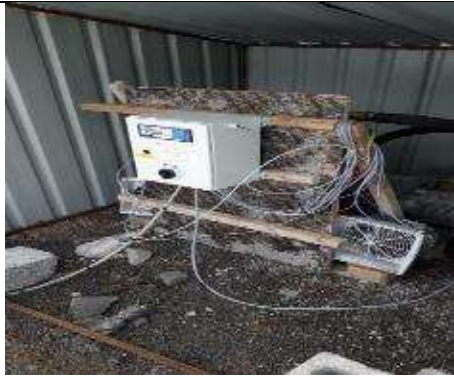
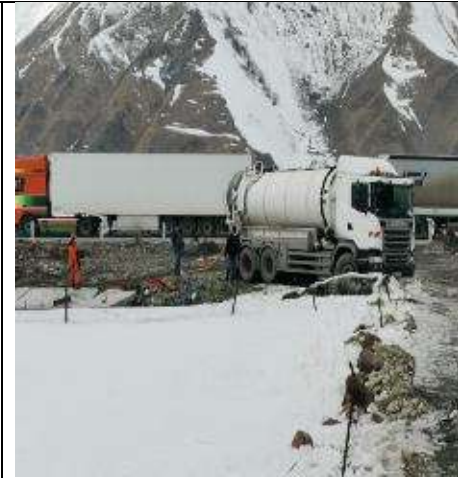
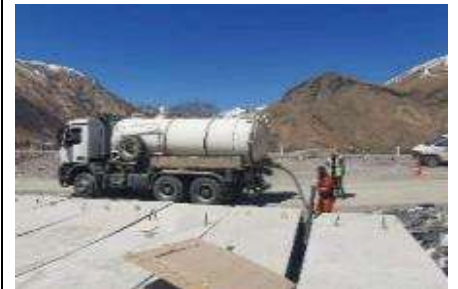
14	North portal Kobi side	Feb 2021	Sewage treatment plant (STP): The Contractor has prepared a Wastewater Management Plan. At the time of the site visit a sewage treatment plant (STP) consisting with two reservoirs with capacity 100m ³ applying biological treatment method was constructed and the sewage generated on the site comprising sanitary wastewater (sewage) and domestic wastewater (wastewater from kitchens, showers, washing facilities) conveyed to the STP for treatment). At this stage the STP is closed by concrete blocks but soon it will be closed with a roof. Fencing is also should be installed around the reservoir. In the future, the treated sanitary wastewater will be discharged into the Narovani River which flows adjacent to the Accommodation	Sewage to be treated to meet the National and IFC requirements. CC required to obtain the approval from MoEPA ASAP.	One month	<p>Treated water from the wastewater treatment plant is not discharged into the river, as there is still no MoEPA approval for the maximum permissible levels of pollutants discharged into the river from the WWTP. The contractor removes waste water from the tank by the subcontractor "Sanitary ltd". The documentation is available on the Site.</p> <p>Discussed in detail with CC in weekly progress meeting on 9-06-2021. CC replaced the old treatment plant with the new on at Septic tank which was not working properly. Cesspool truck is carrying out the sewage</p>	Open

Camp. Sludge will be pumped out and discharged into the Municipal wastewater collector. Currently, the STP does not have an oil and grease separator, which should be separately arranged for treatment of kitchen wastewater. At present, contractor is preparing report of maximum allowable discharge levels for discharged pollutants into the river Narovani to be submitted to MoEPA in February 2021 for approval. After MoEPA's approval treated wastewater can be discharged into the river Narovani after testing to meet Project standards.

Currently sewage truck also carrying the wastewater from the gutter for kitchen separately: however, CC is ready to build an oil grease trap near the kitchen

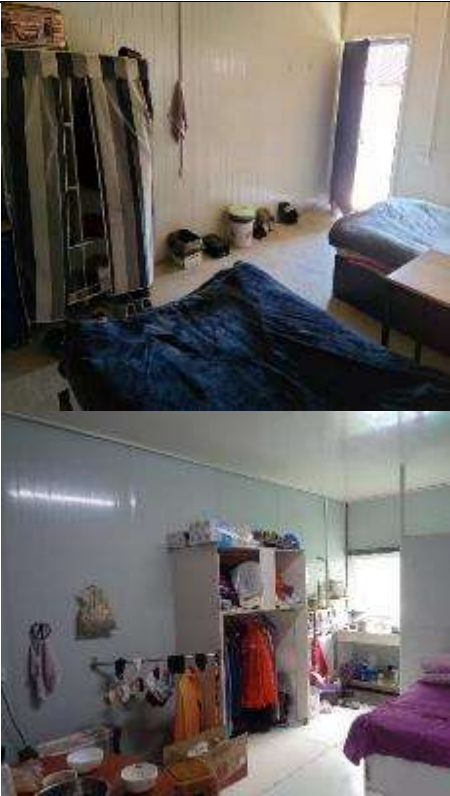
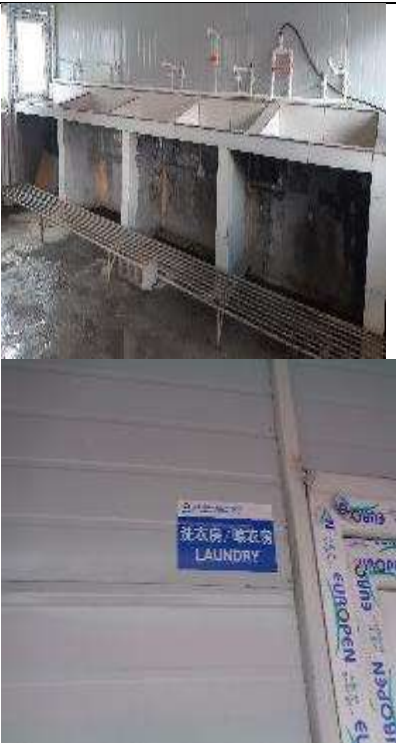
<p>iii) clothes washing room is not equipped with washing machines;</p>

<p><i>Room with Cloth Wardrobe.</i></p> <p>3) The facilities for washing and drying the clothes are equipped with sinks with hot and cold water. CC provided two washing machines which are in operation for the workers in laundry room.</p>	
--	--	--	---	--	--	---	--

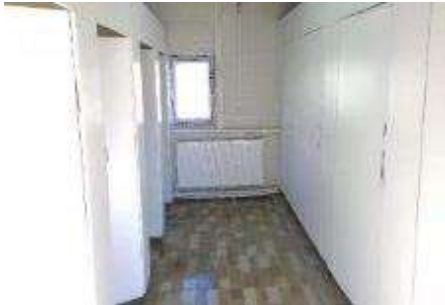
<p>iv) conditioning system is not installed and cleanliness were not kept;</p> <p>v) bathroom area, toilets and clothes washing area are located over 200 m away from the accommodation rooms;</p>			  <p><i>Washing facility</i></p> <p>4) Contractor has hired 5 persons for cleaning to ensure cleanness of the dormitories. As the construction camp is not located in the hot weather zone, the highest temperature will not exceed 25°C. Contractor does not plan to provide air conditioning system, the dormitories are provided with windows and could be naturally ventilated; In order to provide enough heat in cold weather, heating radiators are installed in each dormitory.</p> <p>5) Contractor provided toilets and bathrooms for each row of the accommodation rooms (16 rooms in each row) and they are located in about 30 m from the farthest accommodation room;</p>	
--	--	--	--	--	--	---	--

vi) in one of the rooms stray dog was observed;		<p>All toilets are being cleaned and sterilized regularly. CC provided the covered walkway in front of every line of the dormitory rooms so that the workers should not be exposed to cold winter while approaching the toilets.</p>

<p><i>New Constructed Lavatory and Bathroom for Dormitories</i></p> <p>6) CC ; has hired the licensed company British Pest Control Association (BPCA) to collect the stray dog and stray dogs have been taken by them.</p>
--	--	--	---	--	---

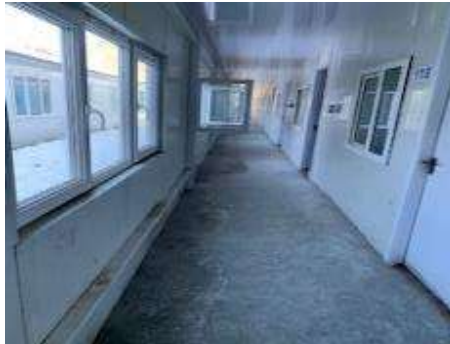
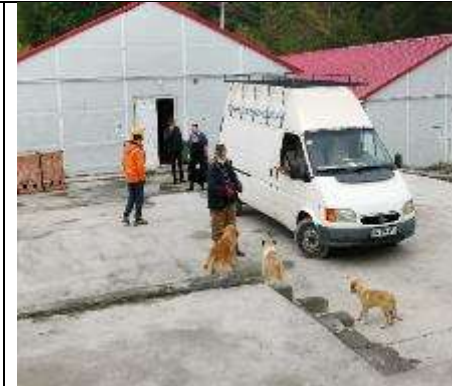
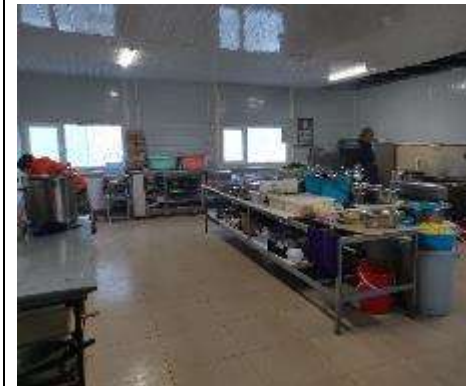
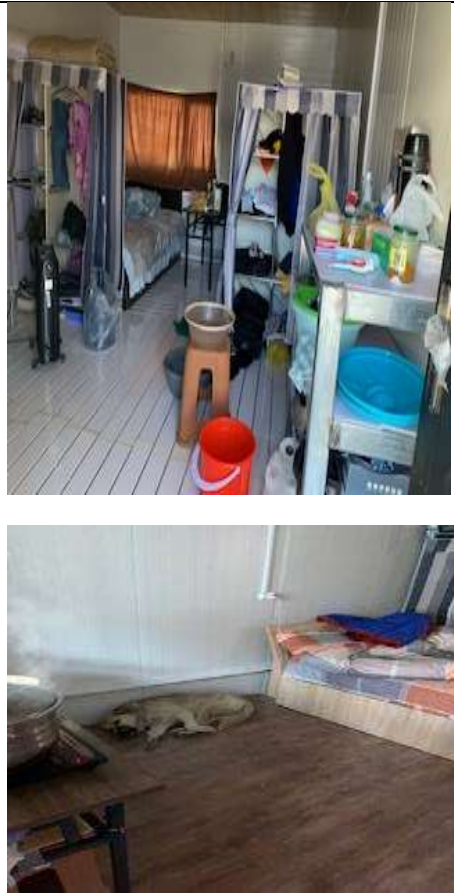
vii) in two rooms electric stoves for cooking were observed . ADB Mission required CC to improve workers' accommodation conditions maintaining good housekeeping and prohibiting presence of stray dogs and electric stoves in the room.

7. Contractor has arranged the separate kitchen for Chinese staff, Georgian staff and engineer with cooking staff. kitchen/canteen area for local staff; .

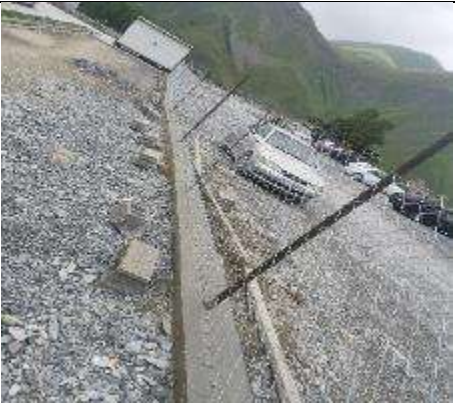
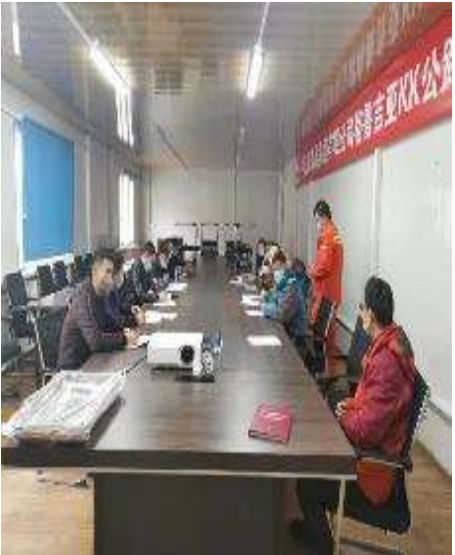
<p>iv) Visitors undergo safety inductions; however, they are not informative or always happen;</p>

<p>4) All of the visitors are to be given safety introduction before visit site.</p>

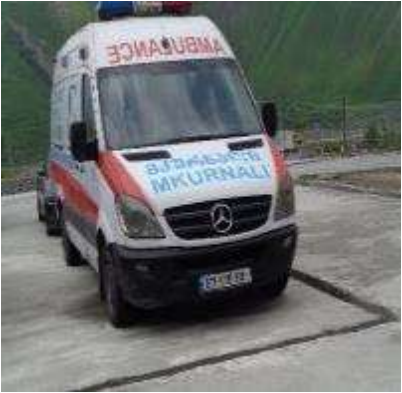
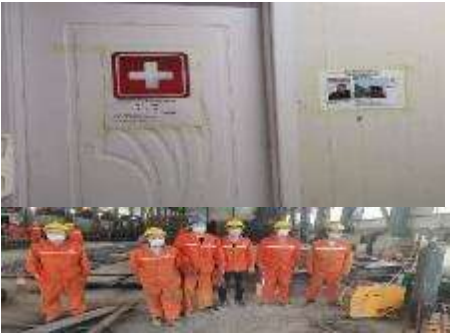
<p>v) Currently, doctor is available and medical facility is arranged on site, but ambulance is not mobilized yet, which is necessary, especially for on-going blasting activities for tunnel north portal construction works, therefore no arrangement available for transporting of injured workers to hospital;</p>			  <p>5) The doctor is on duty at site, Ambulance provided by "Mkurnali 750303" Ltd and was at site up to June2021. Currently it has been sent back to the company for updating the facilities in the ambulance.</p>

<p>Each work site is equipped with one certificated first aider</p> <p>First aid room is established and approved</p> <p>Daily Tool Box Talking is conducted to workers</p>

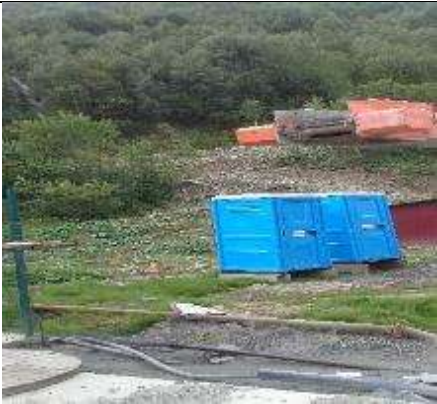
vi) Bio toilets are not available on the construction locations.

<p>6) Bio toilets are installed on site for employees</p>	
--	--	--	--	--	---	--

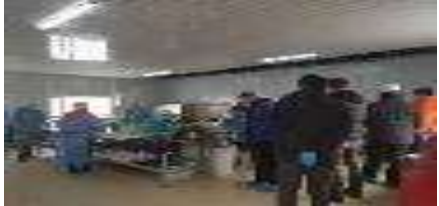
19	Campsite Kobi site	March 2021	<p>Kitchen inspection is not performed by the contractor. The contractor has to start hygienic inspection of the kitchens, canteens, food storage areas on a weekly basis. The inspection must be conducted by CRTG's doctor and HSE manager</p>	<p>CC for Lot#1 to improve hygienic conditions in the kitchen, tidy and clean kitchen. The inspection must be conducted by CRTG's doctor and HSE manager. After each inspection CRTG has to prepare report with photo evidences and it should be submitted to the PMCSCs on weekly basis.</p>	One week	<ol style="list-style-type: none"> 1) The regularly week inspection of kitchen is performed by doctor and HS manager 2) The screen window is installed to prevent the entrance of Flies and mosquitoes 3) The ground is covered by hard flooring 4) The daily cleaning is being performed by designated persons

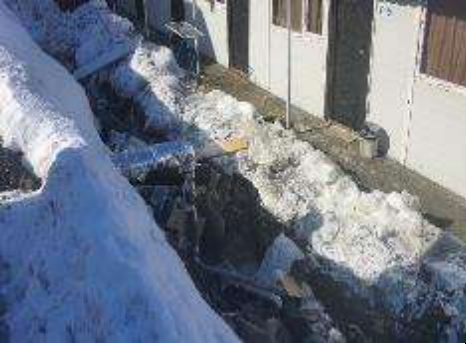
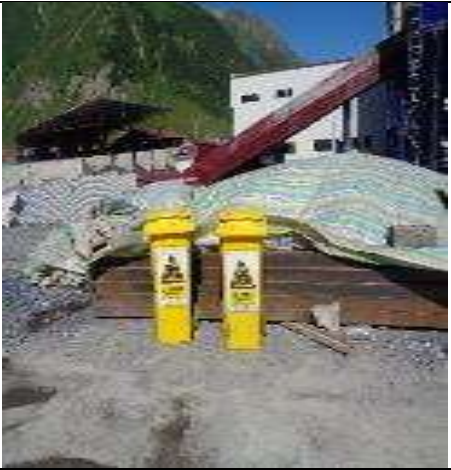
Closed
20	North portal Kobi side	March 2021	<p>Waste scattered at the site. Cleanliness and tidiness are very low standards all throughout the construction areas and Campsite. Housekeeping shall be improved.</p>

<p>CC for lot#1 to remove the waste from the site and adopt good housekeeping practices.</p>	Immediately	<p>Cleaning staff is hired, housekeeping is improved</p>	closed

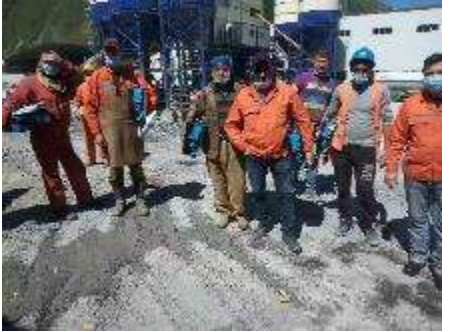
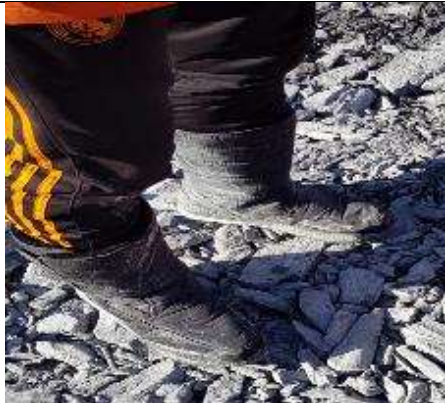
21	North portal Kobi side camp	March 2021	Almost all contractor's personnel are not equipped with proper PPE. The welders are working without special PPE; All workers are not using safety boots; none of them using ear protections in the emergency tunnel, to combat the noisy drilling activity.	CRTG should provide the PPES according to the nature of jobs for head-to-toe protection and enforcement to wear the PPEs through supervisors	One week	Special PPE s provided to welders according to the nature of Jobs Safety boots are provided to all of workers

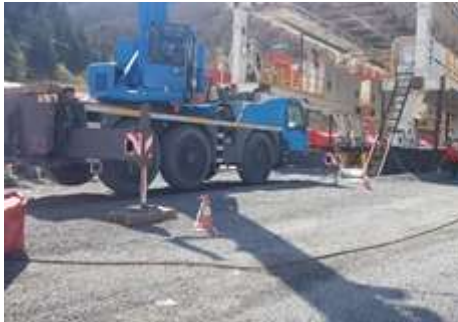
22	North portal Kobi side camp	March 2021	<p>The unsafe act was observed during the site inspection in the construction area, where preparation works for TBM is ongoing. Two persons were controlling the load by hand rather than using ropes as per good practice.</p>

<p>The contractor to stop the unsafe act and should instruct its personnel to control the load with ropes. CRTG has to improve HSE supervision on sites to Prevent similar disorders. The lifting activity must be performed according to safe lifting procedure</p>	immediately	<p>The unsafe activity was stopped immediately</p> <p>The safe lifting procedures were shared with the workers</p> <p>The OSHA company conducts rigger man training to lifting team</p> <p>The matter is being highlighted in daily Tool Box Talking</p>

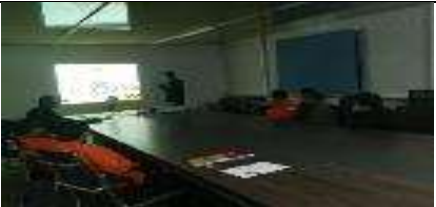
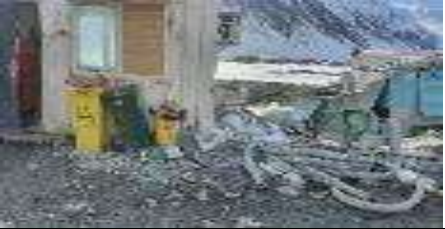
23	Lot#1	April 2021	<p>Hazardous waste scattered on the ground</p>

CC to store the hazardous material in the designated area for hazardous waste and to be collected by Ltd. sanitary	Two weeks	CC stored the hazardous material in Hazardous storage area and removed by the LTD Sanitary	Closed
24	Lot#1 Kobi Emergency Tunnel	April 2021	<p>Missing Emergency Lights</p> <p>Emergency lights are missing in the emergency tunnel. CRTG has to install Emergency lights through the tunnel</p>	CC to provide Emergency lights in the emergency tunnel immediately	immediately	<p>Emergency lights provided in the tunnel</p>

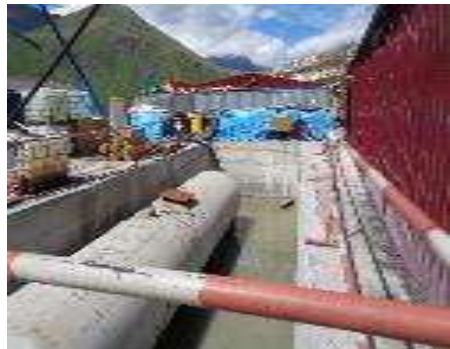
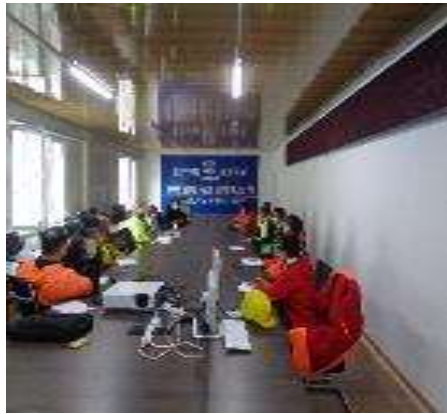
25	Lot # 1 TUN 5 (Pending from Previous Report)	May 2021	Refueling Facility Needs to be maintained Properly causing safety risk and rain water around the Tank

Refueling facility needs to be provided with roof and a wall to restrict the entry of stormwater inside	One Month	Discussed in detail with CC in weekly progress meeting on 9-06-2021

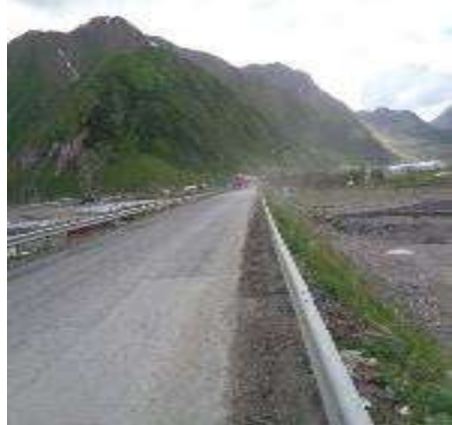
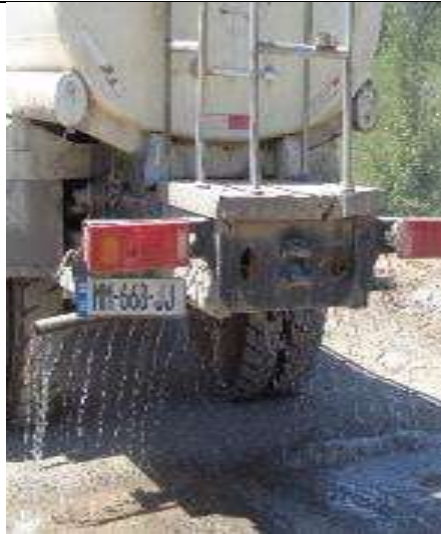
Open CC started working on that
26	Lot 1	June 2021	Fugitive dust emission due to traffic on E-117 around the construction site	CC to carryout water sprinkling on regular basis	Immediately	Water truck continuously sprinkling water at E-117 highway and the active construction sites including segment factory area, batching plant and crushing plant.	Closed

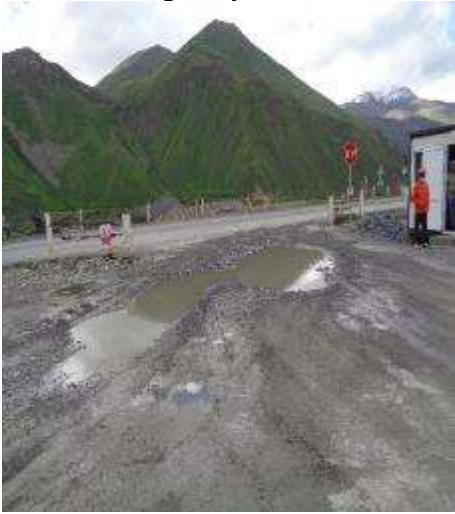
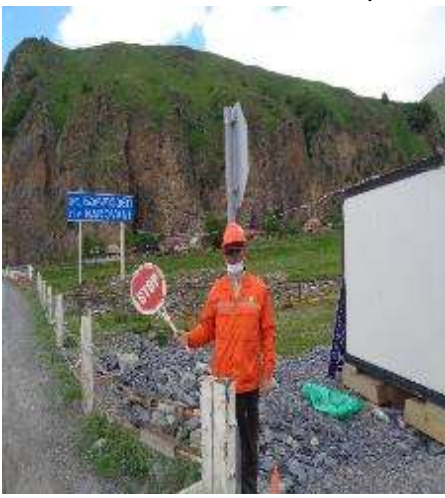
29	June 2021	Lot 1 Kobi site	<p>Flag man not performing their duty actively while vehicles crossing the E-117 highway</p>

Flag man to be on duty during the working hour	Immediately	<p>Advised the flagman to be present outside the security cabin; however, enforcement is required</p>

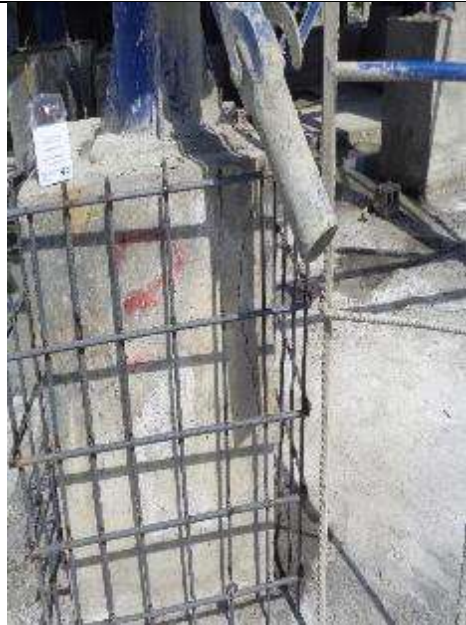
31	BP Lot 1	June 2021	Crackes in the foundation structure of Silos for Batching Plant	CC to repair the cracks and strength the structure based on distributed load on the foundation	One month	Cracks repaired by CC  	Closed

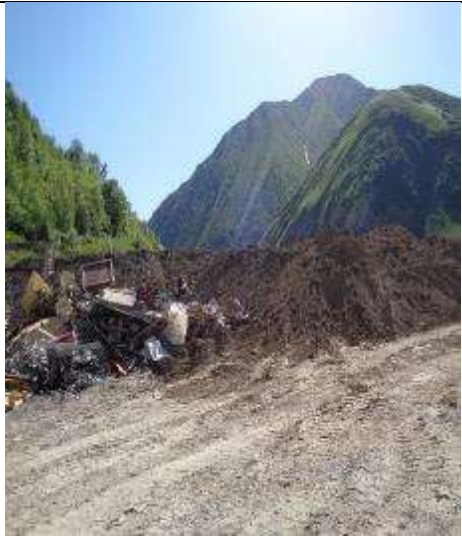
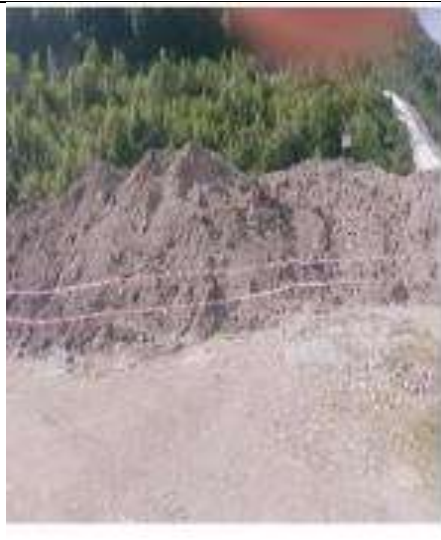
32	Behind Segment Plant Lot# 1	June 2021	CC collected the topsoil from temporary storage areas and collected behind segment factory; however storage does not meet the legal requirements	CC need to separate the scrap yard from the topsoil storage areas and fencing the soil with curtain to avoid the soil erosion with proper drainage	One week	CC stored the topsoil at one location behind segment factory. Provided the fence, signage installed. Silt fence required to avoid soil erosion. Scrap need to be separated from the topsoil by demarcating the area for the scrap	Open In progress

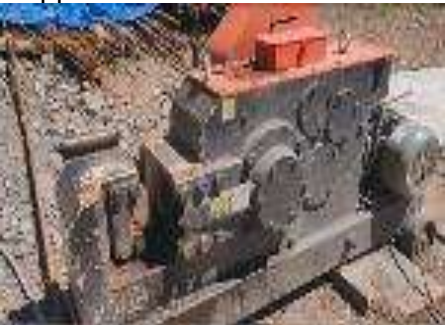
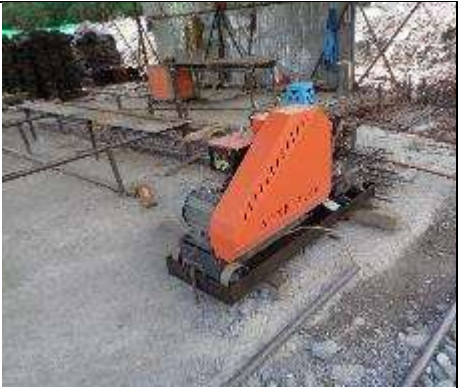
Closed
39	Lot 2 BP 2	June 2021	<p>Rebar Cutting Machine oil leakage and welding workshop on stripped/ bare land</p>

<p>Rebar cutting machine to be shifted on hard floor and repaired for the oil leakage and welding workshop need to be shifted</p>	2 Weeks	<p>CC shifted the rebar facility to hard floor</p>	Closed

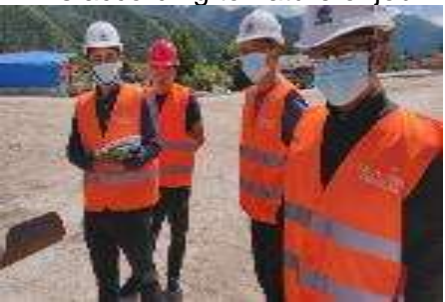
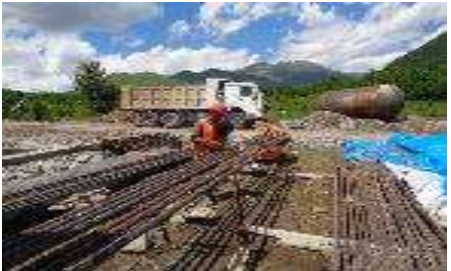
Closed
41	Lot 2 BP 2	June 2021	Workers not wearing appropriate PPEs according to nature of job

CC to provide PPEs according to nature of job and enforcement to wear it from head to toe protection	Immediately	Full set of PPEs provided for the welding activity

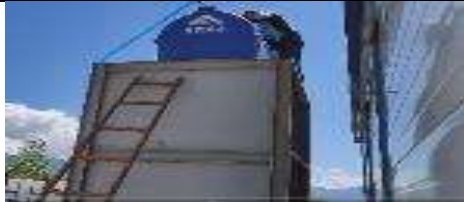
Closed
42	Lot 2 BP 2	June 2021	Access Ladder for water reservoir	Access ladder with hand rail required	One week	Access Ladder provided with handrail, Area Fenced	Closed

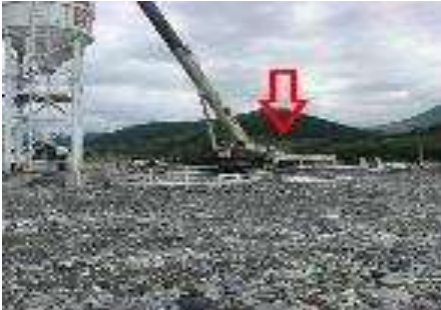
43	Lot 2	June 2021	<p>Unsafe lifting operation for concrete slab</p>

<p>Safe lifting procedures required with training of the workers involved</p>	One week	<p>Safe working procedures adopted at BP 1 Lifting training provided to the staff The mentioned equipment was removed from the site.</p>

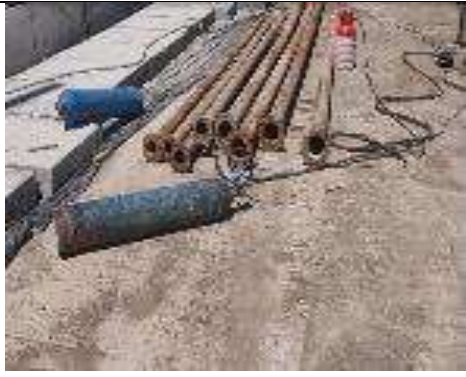
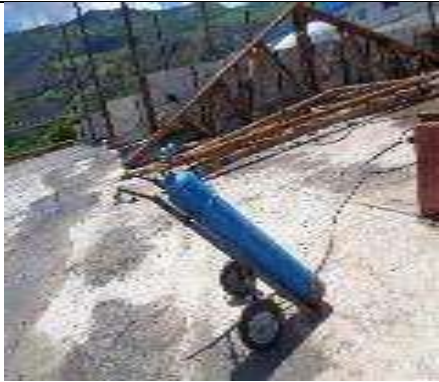
Closed
44	Lot 2 Camp 2	June 2021	<p>Oxygen Cylinders Placed on the Ground</p>	<p>Cylinders to be placed in vertical position in cage and special trolley should be used for welding purpose</p>	One week	<p>Cylinders placed in cage and locked. Special trolley provided for welding purpose</p>	Closed

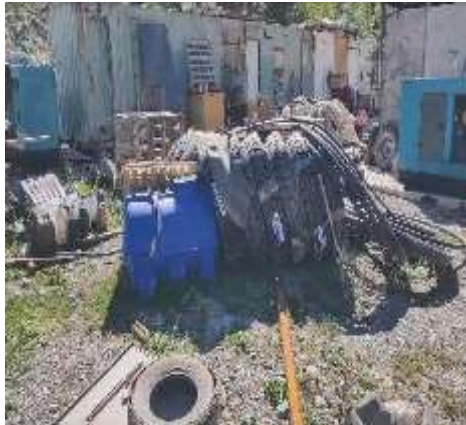
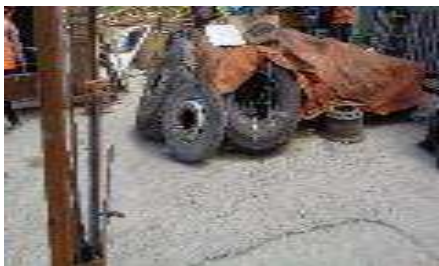
45	Lot 2 Camp 2	June 2021	Poor house keeping in parking Area

CC to build the hard floor, clean the area, waste need to be removed, generator required drip trays	One month	Concrete floor, Old tiers removed, Covered the tires

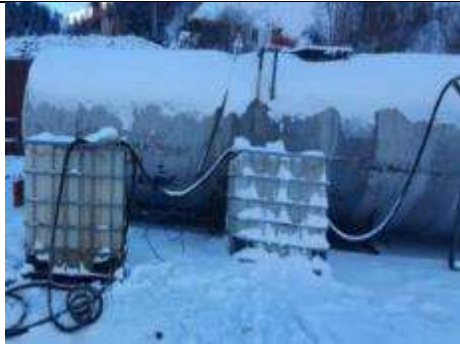
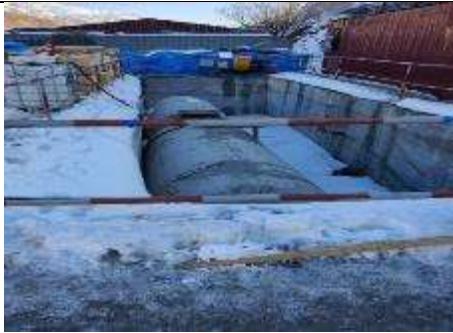
Open In Progress
Status of Open issues from the Previous reporting Period							
1	TUN# 5 North portal Kobi Batching Plant	Dec 2020	Oil spill observed at several locations, Fuel tank placed at the batching plant does not meet the fuel storage and safety requirement	Fuel tank should be placed at hard surface, covered, surrounded by bund wall and oil sump as a secondary	Jan 2021	CC for lot#1 shifted the fuel tank according to safeguard requirement. However, the NCR was not closed due to lack of covering the facility	Open In progress

containment to contain the spill

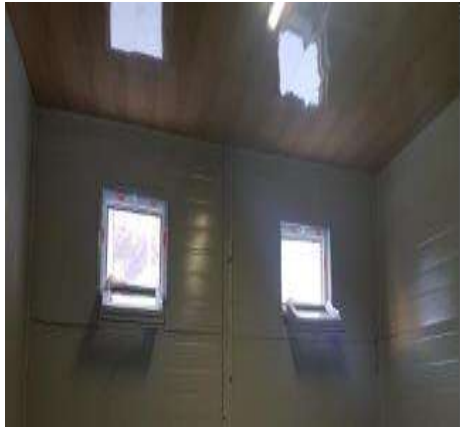
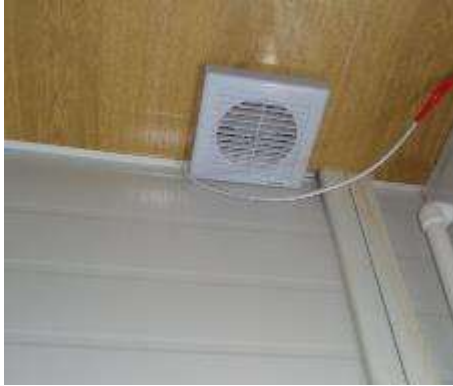
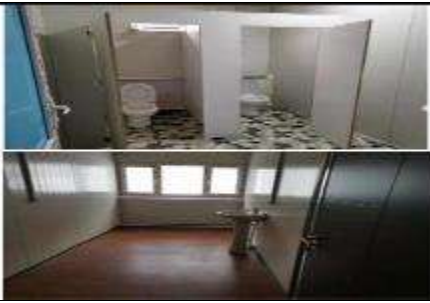
2	TUN# 5 North portal Kobi Engineer's office	Dec 2020	Unfinished lavatories at engineer's office with poor ventilations and handwash facilities and signage

CC to ensure the lavatories in good condition with sufficient quantity of hot water	One week	Exhaust Fan installed

CC appointed engineer to speed up the progress and constructed the toilets and provided the handwashing facility and marked the signs CC insured to install the ventilation fans after transportation from Tbilisi . Sufficient hot water is being provided at campsite.	Closed

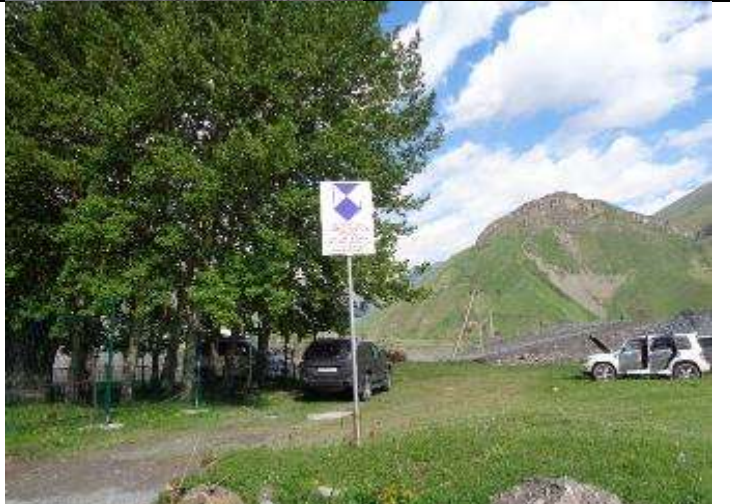
4

CH across the road Info Displayed and site fenced

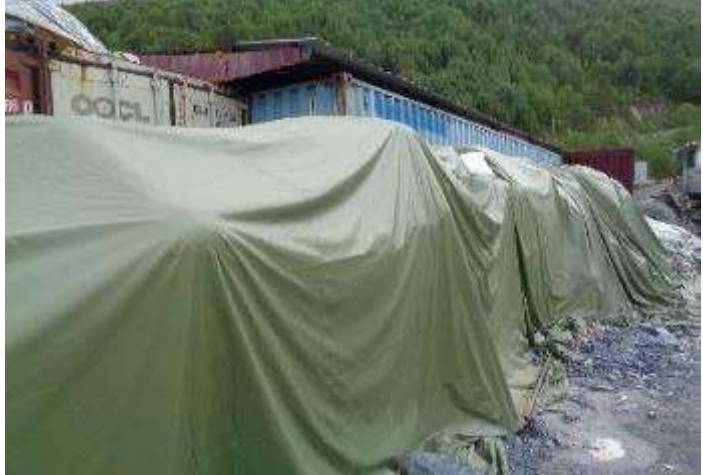
Material Covered with Tarpaulin at Lot#1

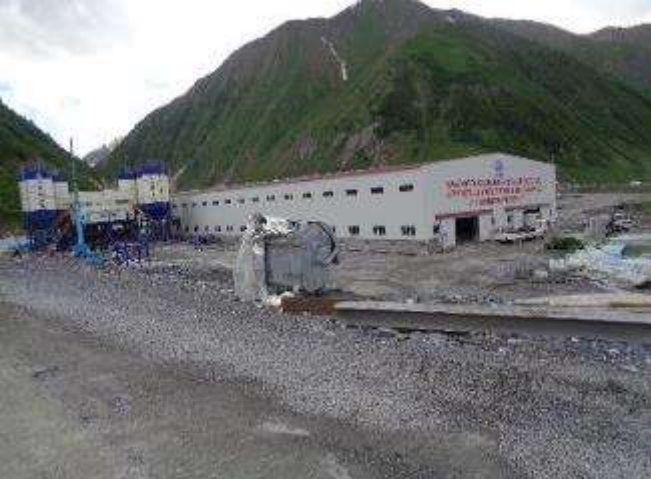
Overflowing waste from the Container at BP
18

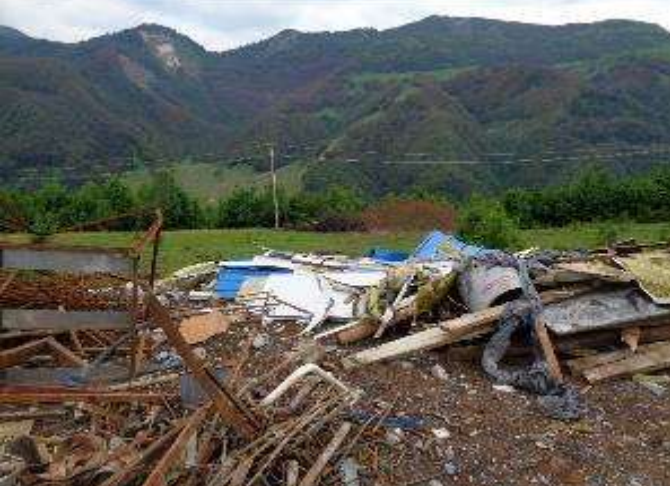
Waste scattered near the camp 2

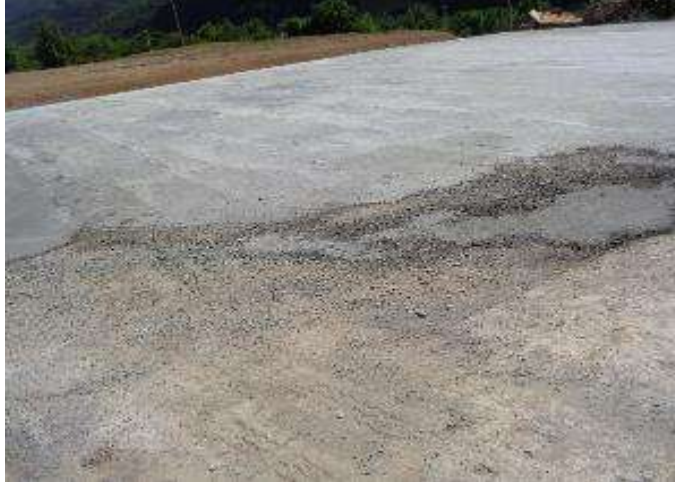
Waste removed area paved
27

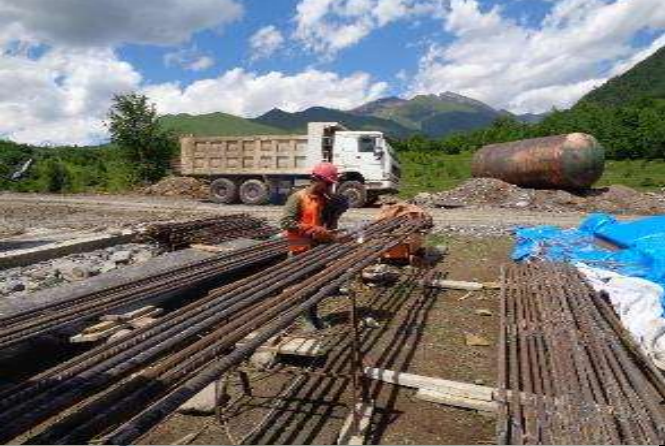
Full PPEs for welding; however, need to change the place of welding workplace
36

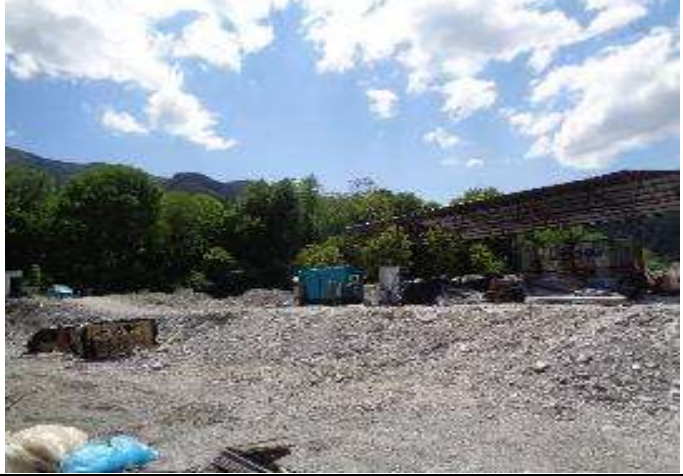
Generator requires drip tray and hard floor
45

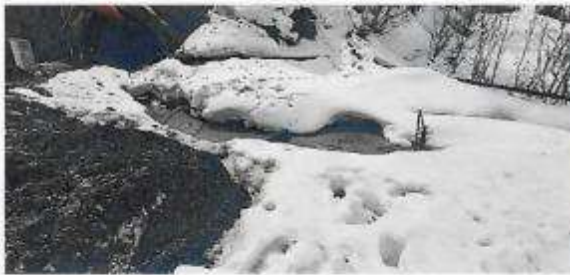
Groundwater from the emergency tunnel (near tunnel portal approximate coordinates X459372 Y4711527)

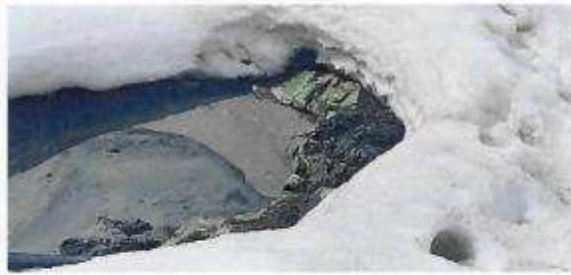
Groundwater collection pipe (near tunnel portal approximate coordinates X459372 Y4711527)

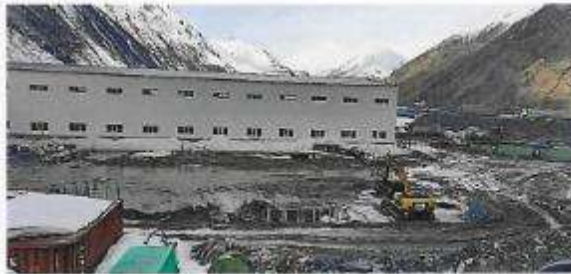
No drainages system on segment plant and batching plant area, the territory is flooded

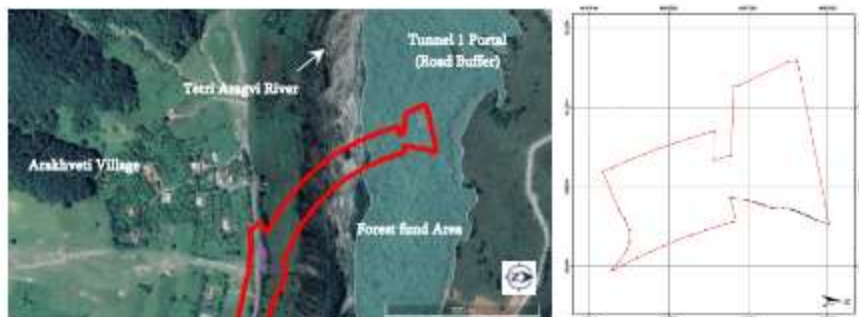
Figure 6. South Tunnel portal showing the Forest Fund Site; Survey drawing of the Forest fund Section Got within the Buffer

8550 m² area forest section on the south tunnel portal site within the buffer, gets in the direct impact zone. For project needs, in total 1127 trees and plants with 8 cm and more diameter are subject to cutting. Dominant species (98%) among above-mentioned is common hazel (*Corylus avellana*). Mostly hazel bushes with 8 cm diameter, plants with 10 cm diameter and unit specimens with 14-16 cm diameter are observed within the direct project impact zone. Following species are represented by individual specimens within the south tunnel portal zone: Common medlar (*Mespilus germanica*, d=8cm), Cherry plum (*Prunus divaricata*, d=12cm), Alder buckthorn (*Frangula alnus*, d=8cm). Less than 10 specimens of common hornbeam (*Carpinus caucasica*, mainly D= 8cm, as unit individuals- D= 12-32cm), wild pear (*Pyrus caucasica*, 6 specimens, d= 8-28cm), Litwinow Birch (*Betula litwinowii* 5 specimens, d= 20-36cm), Georgian oak (*Quercus iberica*), Red dogwood (*Theleycrania australis*, d=12cm) are observed on the mentioned site. Within the borders of the section, 27 Field maple (*Acer campestre*), 26 Grey alder (*Alnus incana*), 23 European aspen (*Populus tremula*), 15 European ash (*Fraxinus americana*, IUCN_CR, D=8-16cm) and 11 Hawthorn (*Crataegus kyrtostyla*, mostly D= 8-10cm, as unit individuals D= 16-24cm) are subject to cutting. Among plants to be cut, there are 2 units with the maximum diameter -European aspen (*Populus tremula*) d= 52cm. One specimen with the diameter of 40 and 44 cm is also observed - Grey alder (*Alnus incana*). According to the crown maple tree is distinguished among other cutting trees (d= 20-36cm, in total 26 trees). Hazel also dominates among plants with the diameter less than 8 cm.

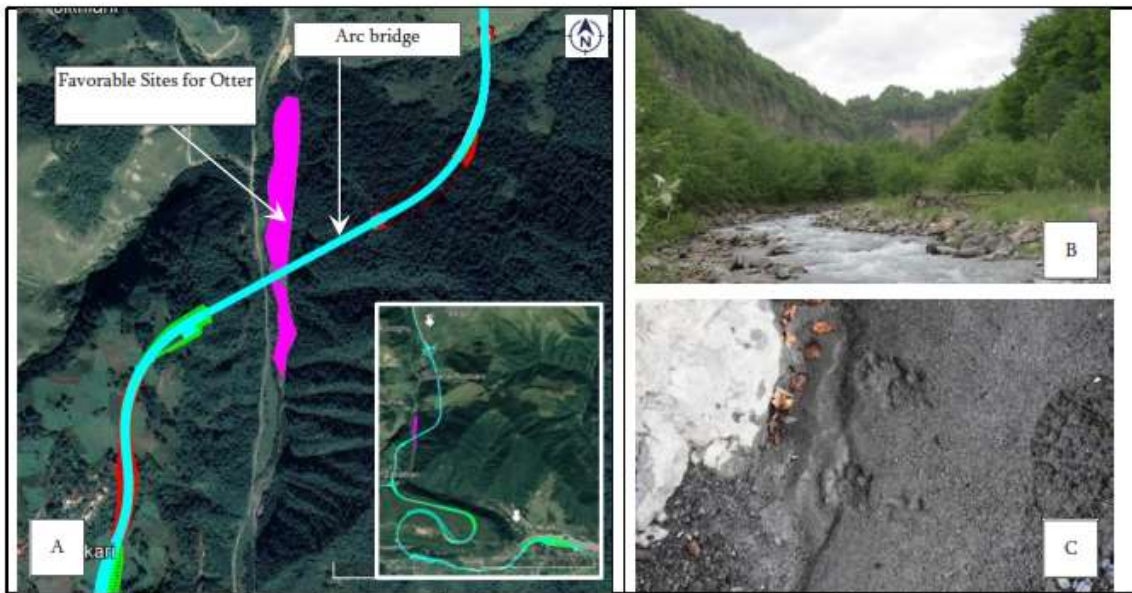
Figure 21. (A) Favorable Site for Otter within Section III Zone, (B) View of Favorable Site for Otter, (C) Traces of otter recorded on mentioned section at EIA stage

Construction of the arc bridge is not in touch with the valley bottom thus the mentioned area does not get within the direct project impact zone.

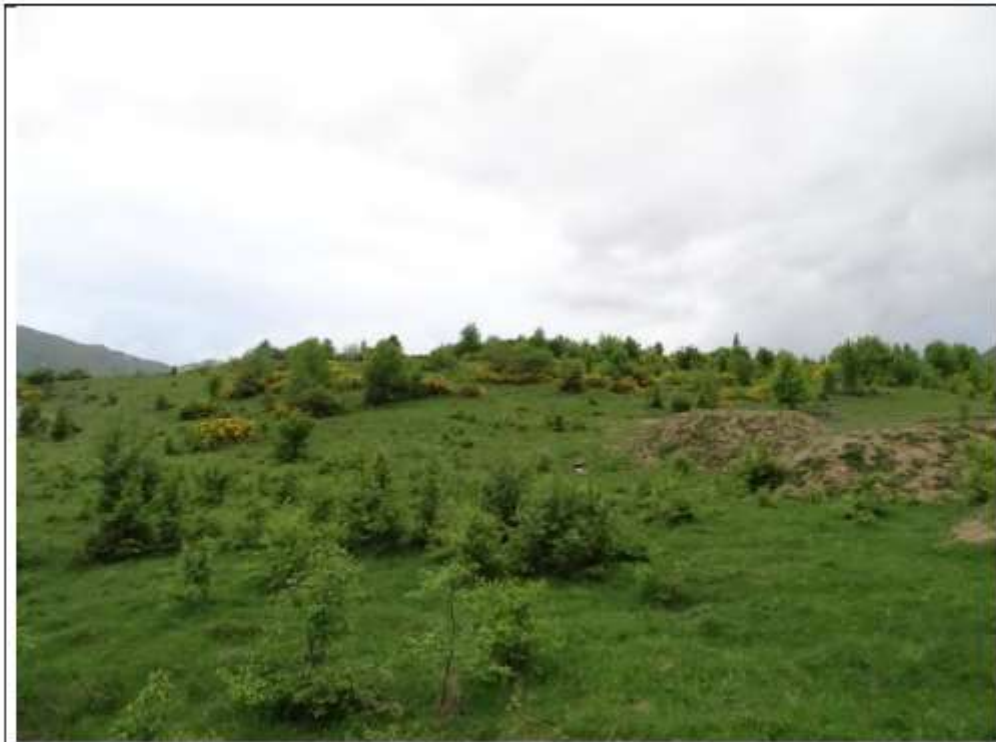
Situation before construction

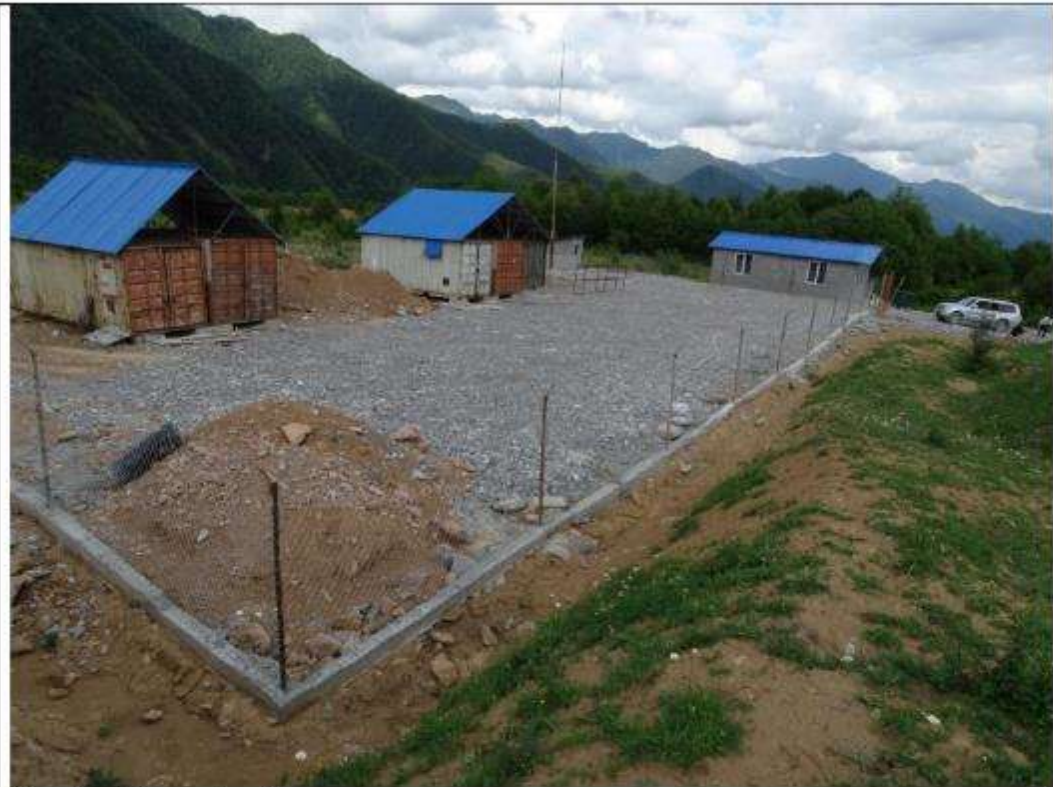
Situation after construction
