Semi-annual Environmental Monitoring Report

Project Number GEO 51257-001

Reporting period: January - June 2021

Georgia: North-South Corridors (Kvesheti – Kobi) Road Project

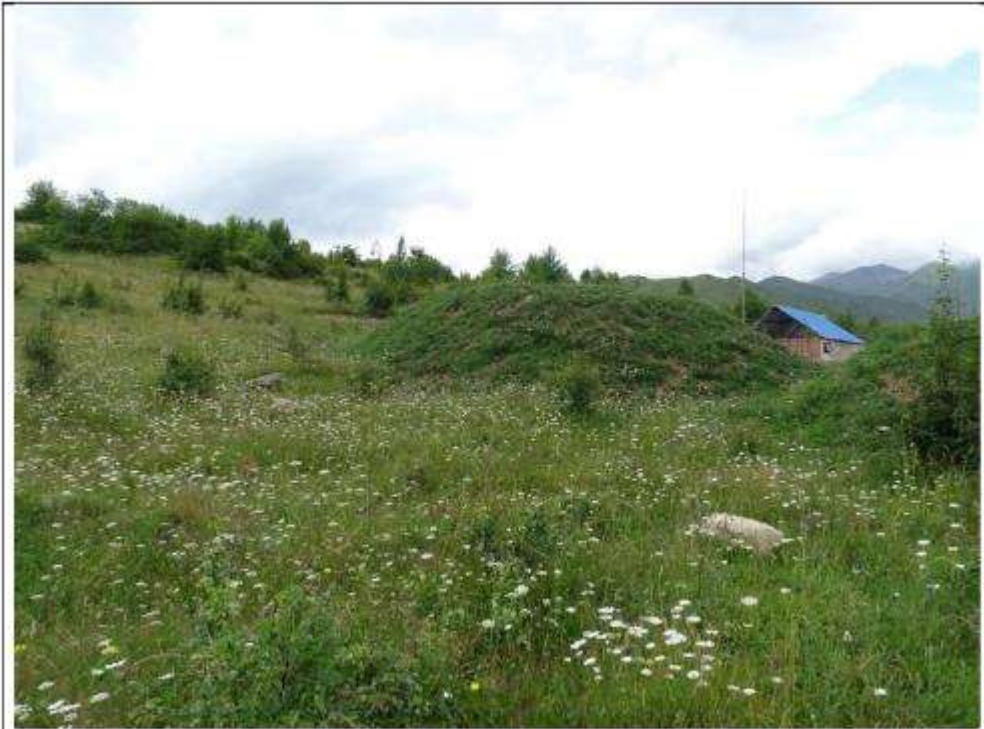
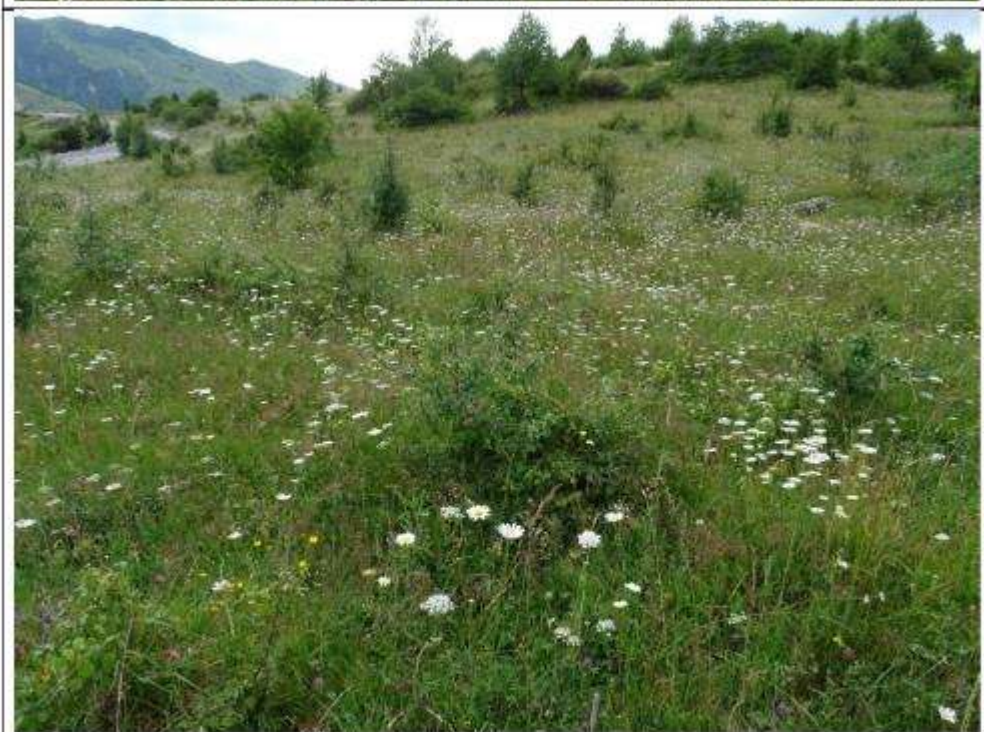
Table N2. Photo material of blasting area habitats

It should be noted that selected territory for blasting area is under high anthropogenic impact, also near this territory is secondary road.
