Semi-Annual Environmental Monitoring Report

Project Number: 53178-001

Semestral Report (January – June 2023)

Georgia: East-West Highway (Shorapani – Argveta Section) Improvement Project

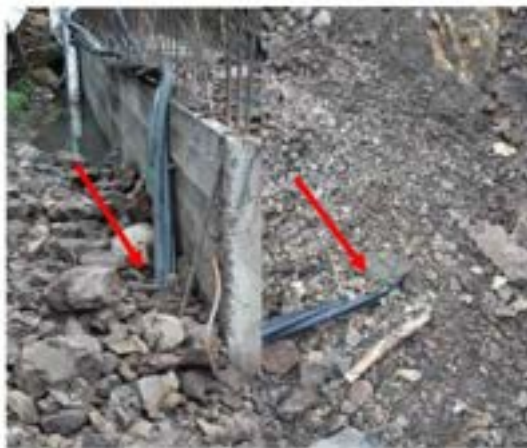
Tunnel N2AT-T

High voltage electric cables are still buried in mud and pressed between the rocks and nobody from the Contractor's Company is trying to take care of this issue. These cables must be released from the rocks as soon as possible to avoid the possible damage on the protection layer of these cables and possible injury of working personnel when touching.

Picture 1: Negative observations (Possible incident and injury of working personnel) (Tunnel N2AT-T and Tunnel N3) - The violation to H&S rules and requirements that had been observed by the Engineer in previous weeks, isn't solved yet. The power cables are still partially buried under or pressed between the rocks and mud. The loose rocks are still rolling down the hill and falling on those cables. It may cause a possible incident. Site responsible persons from the Contractor Company are informed about it. The Engineer has asked the Contractor to react on this non-compliance as soon as possible to avoid possible incident and injury of working personnel. The H&S responsible persons from the Contractor Company are also informed about it and asked to do regular inspection of working territory, to identify all non-compliances, reduce and eliminate all possible risks of incident. No positive changes have been made until now. **This non-compliance isn't solved yet.**

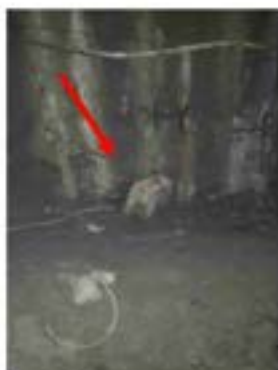
Tunnels N: 4AT-A and 4TA-A – About 1 Month this welding machine is left unattended in mud.

*Picture 3: Positive and Negative observations (Safe work process) (All Tunnels and nearby workshops) – The Engineers are still facing the violation to H&S requirement from the worker's side. They are using partially damage tools and equipment at workplaces (bending, welding and cutting machines with damaged extension cables, with a handmade switch gears and missing emergency "shut down" buttons on it). H&S representatives from the Contractor Company were informed about it many times. The Engineer has asked them to take all necessary action for to solve this non-compliance as soon as possible and avoid possible injury of working personnel, but no any positive changes had been made in this regard until now. The Engineers are still waiting for feedback from the Contractor. **Non-compliance is still open.***

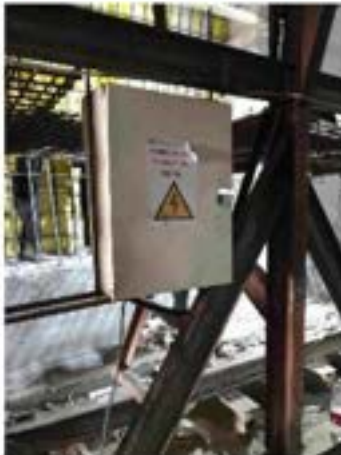
Tunnel N2AT-A – The well locked and signed up electric box has been observed.

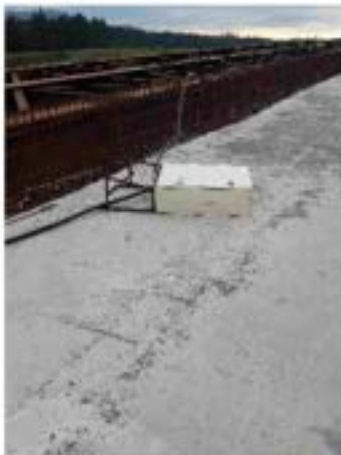
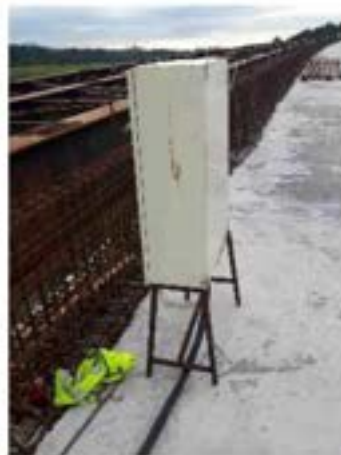
Bridge 4 (Interchange N2) – Fallen down electric box has been observed. After verbal warning, given to the Contractor's site responsible persons, it was fixed in correct position.

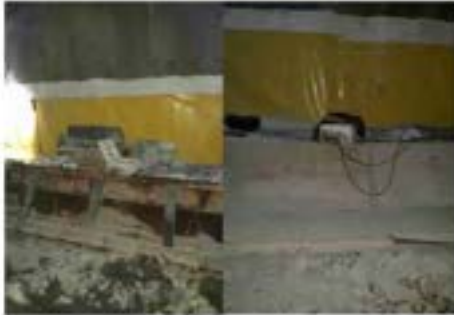
Tunnel N1AT-A

Damaged, not properly locked and thrown on the ground (floor) electric boxes have been observed.

Picture 4: Positive and Negative observations – (Electric safety - Possible injuries of working personnel) (Tunnels, bridges, Interchanges and nearby workshops): Continue violations to electrical safety rules and requirements. The Engineers are still face with electric safety related non-compliances at workplaces. Some electric panels and distribution boards are in good condition, properly locked and labeled, but most of them are in terrible condition. Not properly locked, partially damaged and thrown on the floor electric panels have been observed and continue observing by the Engineers during site inspections. The high voltage "life" electric cables have been observed passing through the reinforcing bars and are thrown in the water and mud. All these non-compliances may cause possible incidents and injury of working personnel. The Engineers are continuously informing the site responsible persons from the Contractor Company about these issues and asking to solve this problem as soon as possible. The Contractor is trying to close all these non-compliances, but it isn't enough for full completion of mentioned above problems. The Contractor has to replace or repair all damaged or not properly locked electric panels on the new one, keep an eye and continue monitoring of electrical safety related issues at workplace, do site inspections very often to reduce and finally eliminate all possibilities of having electric safety related incidents at workplaces. The Engineer is still waiting for feedback from the Contractor. Some electric related non-compliances aren't solved yet.

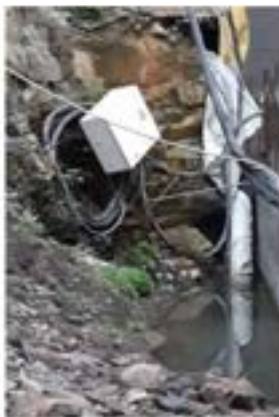
Tunnel N2 AT-T

Limited access to the electric distribution boards (Possible trip, slip and falling hazards).

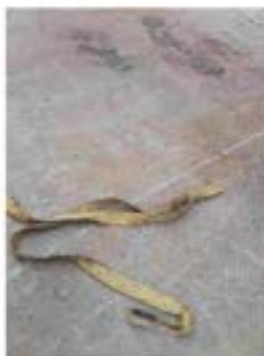
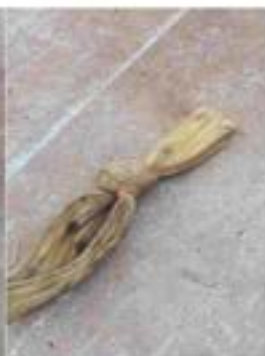
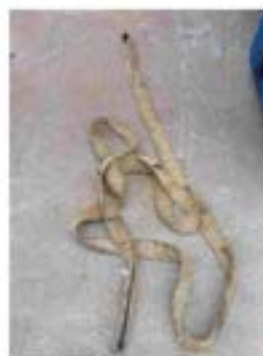
Bridge N4 (Interchange N2) – The damaged lifting belt use has been observed. After verbal warning, given to the Contractor, it was replaced with a better one.

Picture 5: Negative and Positive observations (Lifting Safety-Possible drop and property damage) (Interchanges, tunnels and workshops) – Some working crews around the project are using correct type lifting tools and equipment, but the Engineers are still facing violation to lifting safety regulations (Bad quality, cut, damaged, thrown in mud and handmade lifting tools and equipment in use) when visiting the workplaces. The site responsible persons and H&S representatives from the Contractor Company are already warned to find and remove from the site all cut or damaged lifting equipment and protect working personnel from getting hurt, but the Engineers are still facing the same situation when inspecting the workplaces. The Contractor has to pay additional attention to this issue and do an inspection of all work processes systematically to reduce and eliminate all unsafe acts and conditions. The Engineers are still waiting for feedback from the Contractor. **Non-compliance isn't solved yet.**

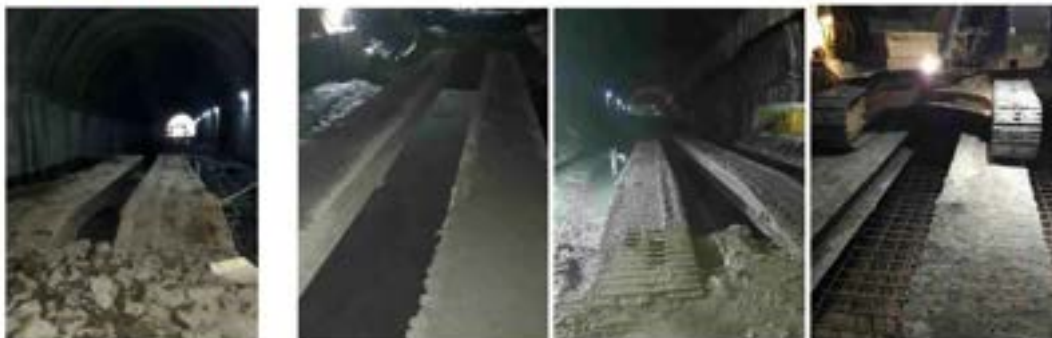
Tunnel N1 AT-A

Picture 6: Negative observations (Workplace Safety-Possible personal injury) (Tunnels) – Most of the temporary bridges, used for the movement of workers and vehicles aren't equipped with the handrails and no warning signs (informing the workers about possible hazards) are fixed around, only safety flashing cones are placed in some places. **Plus, there is a big possibility of trip, slip and fall hazards or possible slide of working machinery, because the surfaces (walkways) of that bridges are very dirty and muddy, as it shown at the picture.** The Engineers are systematically asking the Contractor to fix all mentioned above non-compliances to avoid possible falling from the bridges and injury of working personnel, but no positive changes have been made until now. The Engineers are still waiting for feedback from the Contractor. **Non-compliance isn't solved yet.**

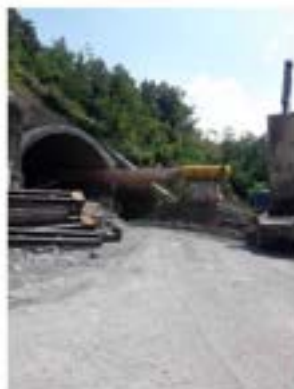
Tunnel №4 ATA - Ventilation system was turned off because of some technical reason and was partially dismantled, but later it was refixed and turned on.

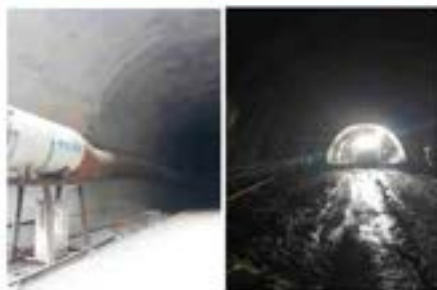
Tunnel N1AT-A

Picture 8: Negative and Positive observations (Poor Ventilation-Possible personal injury)(Tunnels) - The violation of workplace safety rules, that had been observed by the Engineer in the previous weeks, isn't solved yet. Not some many tunnel portals have been left on this project, where the ventilation system is still functioning, but the Engineers are still facing the partially cut, damaged and turned off ventilation fans when inspecting the work process. Lack of oxygen inside the tunnel could cause health related problems and possible injury of working personnel. Site responsible persons and H&S representatives and H&S representatives from the Contractor Company were informed about it. The Engineer has asked them to take an action and solve this non-compliance soon in order to avoid the possible health related problems. **Non-compliance isn't solved.**

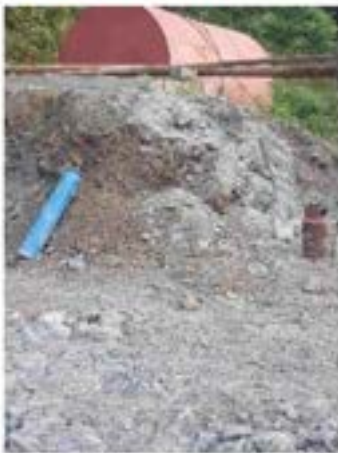
Tunnel N4TA-A

Picture 13: Negative observation – (Improper storage - Property damage) – The violation to workplace safety related H&S requirement that had been observed by the Engineer in the previous weeks is still actual. The Engineers are still facing the oxygen cylinders and propane bottles that are left inattentively at workplaces. Incorrect or accidental contact with the cylinders may cause the possible property damage and injury of working personnel. The site responsible persons from the Contractor Company were informed about it by the Engineer several time. The Engineer has asked to remove all oxygen cylinders/propane bottles that aren't in use, away from the workplaces and send it to the storage area. Also, the Engineer has asked Contractor to place all using cylinders in the trolley and replace all damaged gauges on the new one. The Engineer is waiting for feedback from the Contractor. **Non-compliance is still open.**

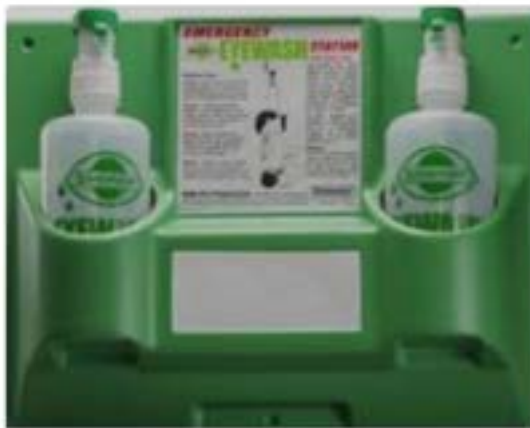
Picture 14: Non-compliances – Health care (Tunnels) – Tunneling crews aren't still supplied with eye wash stations, for effective fight against possible drops of concrete in the eyes. Information about it was forwarded to the site responsible persons and H&S representatives from the Contractor Company. The Engineer has asked them to arrange and distribute the eye wash stations to site as soon as possible to avoid possible incidents at workplace. The Engineer is still waiting for feedback from the Contractor. **Non-compliance isn't solved yet.**

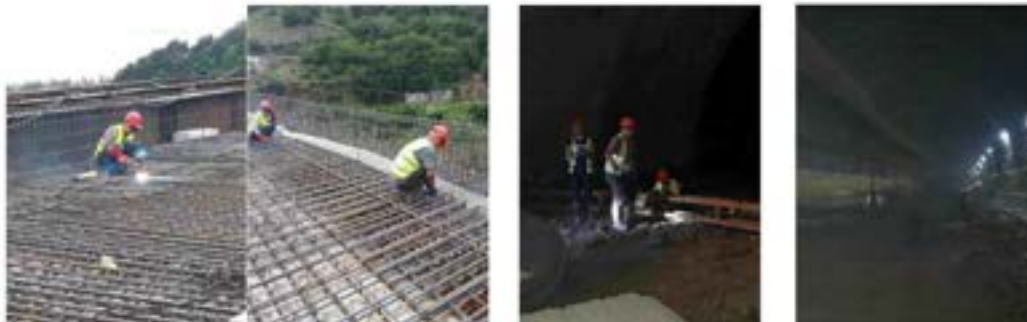
Interchange N2 (Bridge 4) and Tunnels: N3AT-A; N4AT-A: - *Workers wears the proper PPE when working.*

Picture 15: Positive and Negative observations – Personal Protective Equipment (All Tunnels) – Correct and improper use of PPE has been observed by the Engineer when inspecting the work process inside the tunnels. The workers who didn't wear the correct PPE, were warned verbally by the Engineer and the workers who wore the correct PPE, were thanked by the Engineer for caring about their own health and safety. The H&S representatives from the Contractor Company were informed about these non-compliances and asked them to pay more attention to such sensitive issue to avoid possible incidents and injury of working personnel. **Non-compliance still isn't solved.**

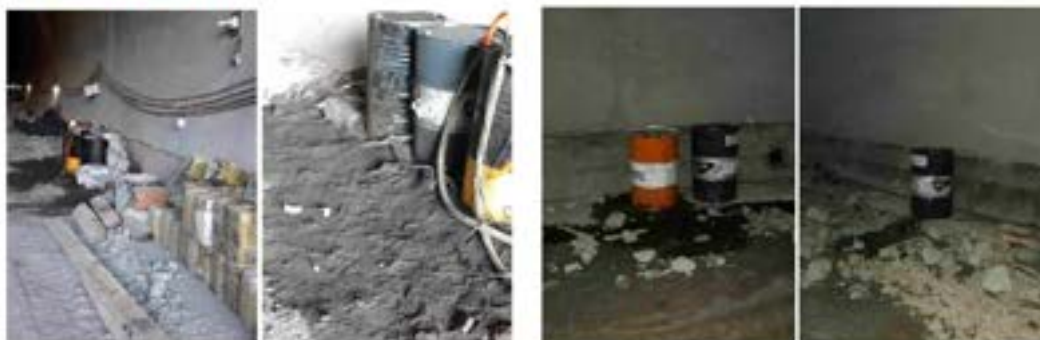
Tunnel N3AT-T

Tunnel N2AT-T

Picture 16: Negative observations (Possible contamination of soil) (Tunnels and not only) – Not properly stored oil barrels and other chemicals have been observed during site inspection. The site responsible persons from the Contractor Company were informed about these non-compliances and asked to remove all chemicals from the site and move it to the chemical storage area. All hazardous materials should be kept in especially arranged for such materials storage area to avoid the possible contamination of soil. **Non-compliance isn't solved.**

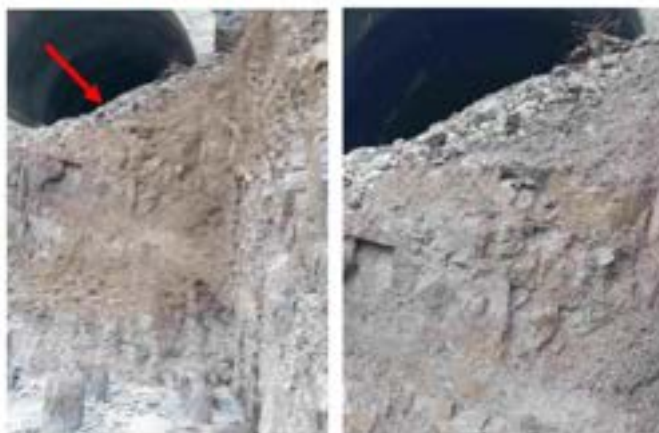
Abutment for Bridge N1 - Pieces of rocks that are accumulated on top of the hill, may roll down in any second and hit the workers, that will perform the task close to the bottom of that hill.

Picture 17: Non-compliance – Possible collapse of the slope (Tunnels: N1AT-A and N2AT-A) – No positive changes have been made seems last weeks. The Contractor has started the excavation of a slope on top of the right side of the tunnel portal and the hole has started becoming bigger and bigger (Tunnel N1AT-A). Plus, the rocks are rolling down on the access road and there is a big possibility that somebody may get injured there. Another slope (Right side from the Tunnel N1AT-A portal) is also washed by heavy rain and it may collapse in one day if the necessary safety measures will not be taken by the Contractor. Additional attention should be paid to the slope near the Tunnel N2AT-A portal (Abutment for Bridge N1), because the loose rocks are accumulated at the edge of slope. They may roll down the hill in any second and hit the workers, performing the task close to the bottom of that slope. The Contractor H&S team is aware of this case, but no positive changes have been made until today. **Non-compliance isn't solved.**

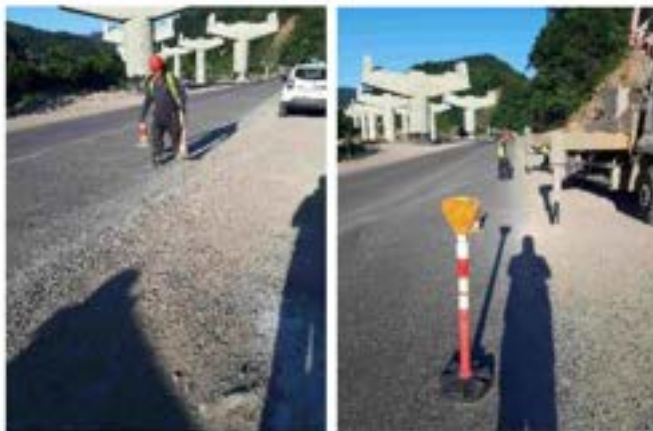
Bridge N2 Abutment – *It has been observed that the crew members were installing the safety flash cones around the pump truck before starting the concrete pouring in order to ensure the workplace safety.*

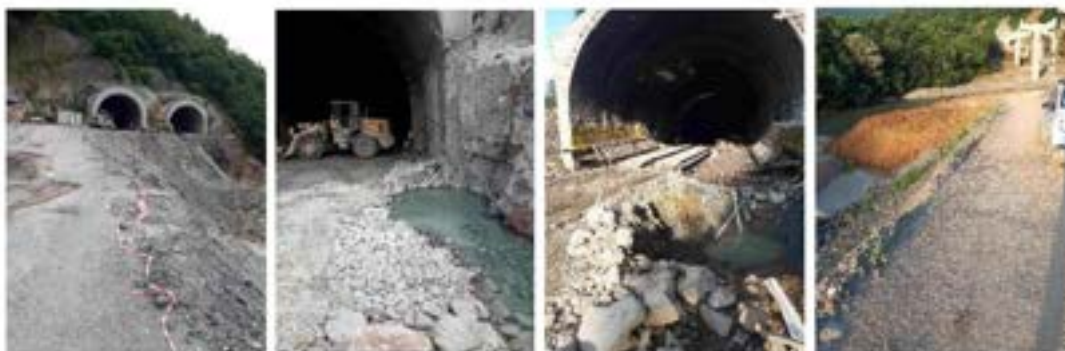
Access to Tunnel N3

Picture 22: Positive and negative observations (Workplace safety) (All Tunnels and bridges) – During site inspection it has been observed by the Engineer, that some edges of temporary access roads (Pandusses) and open holes inside the tunnels are protected by safety reflective cones, but some aren't. Site responsible persons and H&S representatives from the Contractor Company were informed about these non-compliances. The Engineer has asked the Contractor to pay additional attention to this issue in order to avoid the possible incidents and possible injury of working personnel. ***Non-compliance is still open.***
