# Semi-Annual Environmental Monitoring Report

Project Number: 53178-001

Semestral Report (July – December 2024)

## Georgia: East-West Highway (Shorapani – Argveta Section) Improvement Project

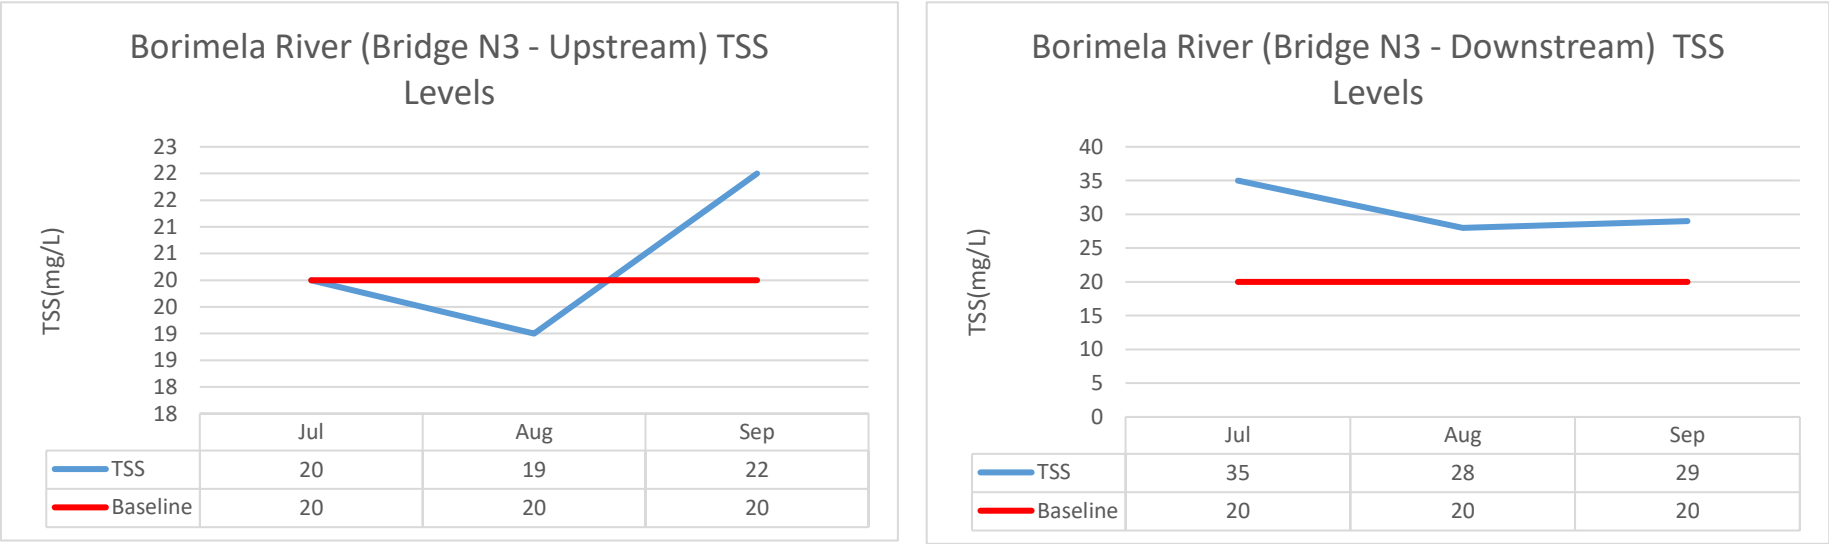
Figure 9: Borimela River (Bridge N3) Upstream and Downstream TSS Chart (July-December 2023)

68. The results are given in Table 12. TSS parameter change during the reporting period are shown in Figure 9.
69. Over several months of monitoring, the downstream Total Suspended Solids (TSS) levels in the Borimela River have been high and exceeded the baseline levels. High TSS levels in downstream monitoring can result from various factors. For instance, soil erosion due to earthmoving and excavation activities can lead to the exposure of bare soil, resulting in the runoff of eroded particles into the river. Construction sites near riverbanks can destabilize the soil, causing increased erosion and contributing to higher TSS levels. Additionally, improper disposal of construction waste, including materials like concrete and gravel, near or in the river can further degrade water quality. To address this issue, a comprehensive approach is recommended. First, implement erosion control measures like silt curtains downstream to trap sediment, sediment traps within the work zone to collect soil particles, and blankets on exposed soil to prevent erosion. Second, optimize construction practices by minimizing in-stream work, reducing dredging if necessary with proper disposal, and scheduling work during the dry season. Finally, for a long-term solution, riverbank stabilization with native plants after construction is required.

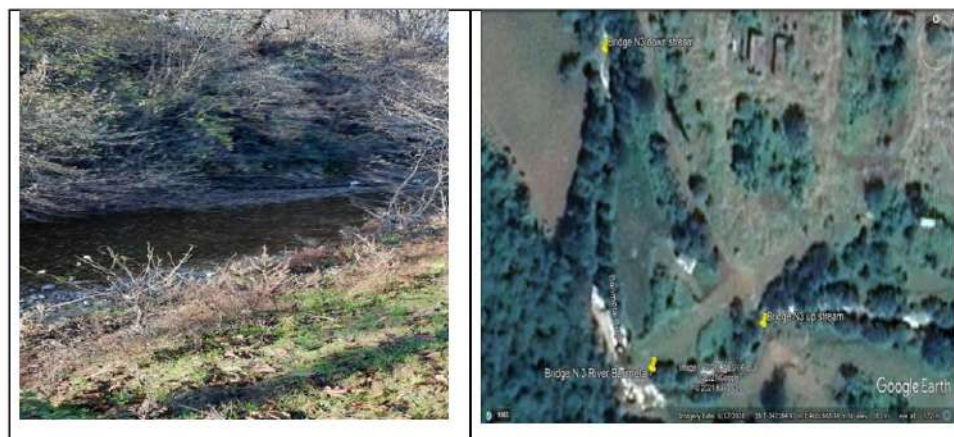
Figure 5-2 Bridge N3 downstream (Borimela River)

Increased TSS concentration at downstream sampling location, could be the result of the concrete batching plant operation which is located between up and down stream monitoring points.
