Semi-Annual Environmental Monitoring Report

Project Number: 53178-001

Semestral Report (January - June 2022)

Georgia: East-West Highway (Shorapani – Argveta Section) Improvement Project

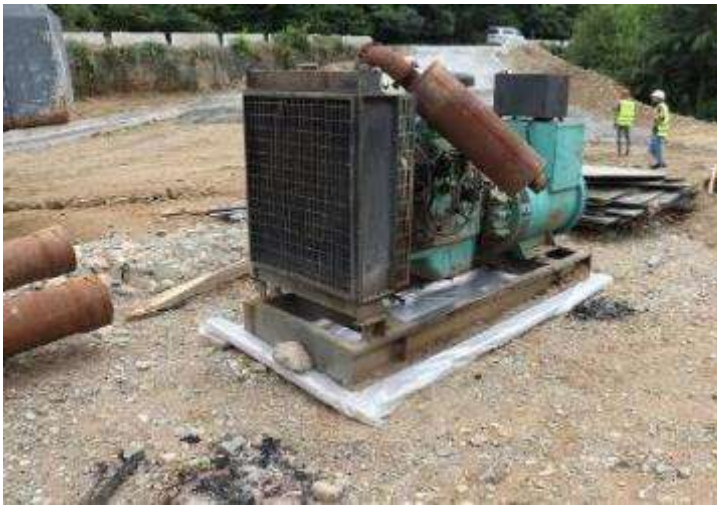
A drip Tray provided for the Generator

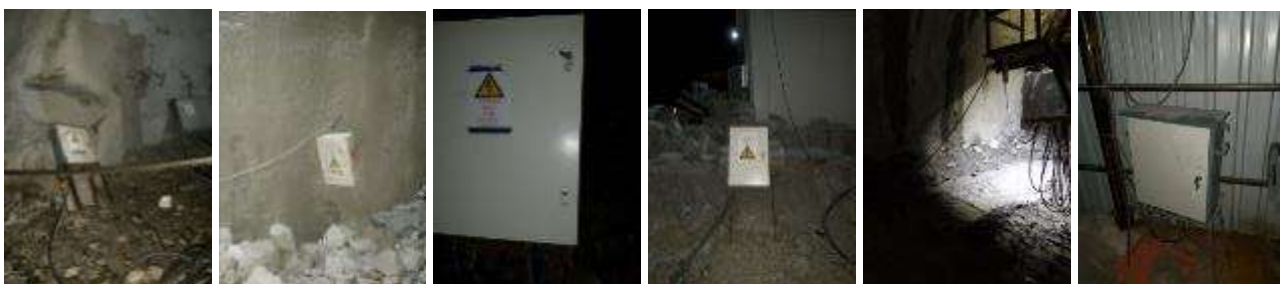
Picture 1: Non-Conformance (All tunnels): Visible changes have been made in the design of platforms and in the procedure of using steel structures. Appropriate guardrails and safety signs were fixed on some structures. Special color tags, warning workers about the procedure of how to use mentioned structures, were hung on. Systematical inspections of steel structures have to be done to ensure that the workers are following to instructions provided by the H&S team. **Issue closed.**

Good observation.

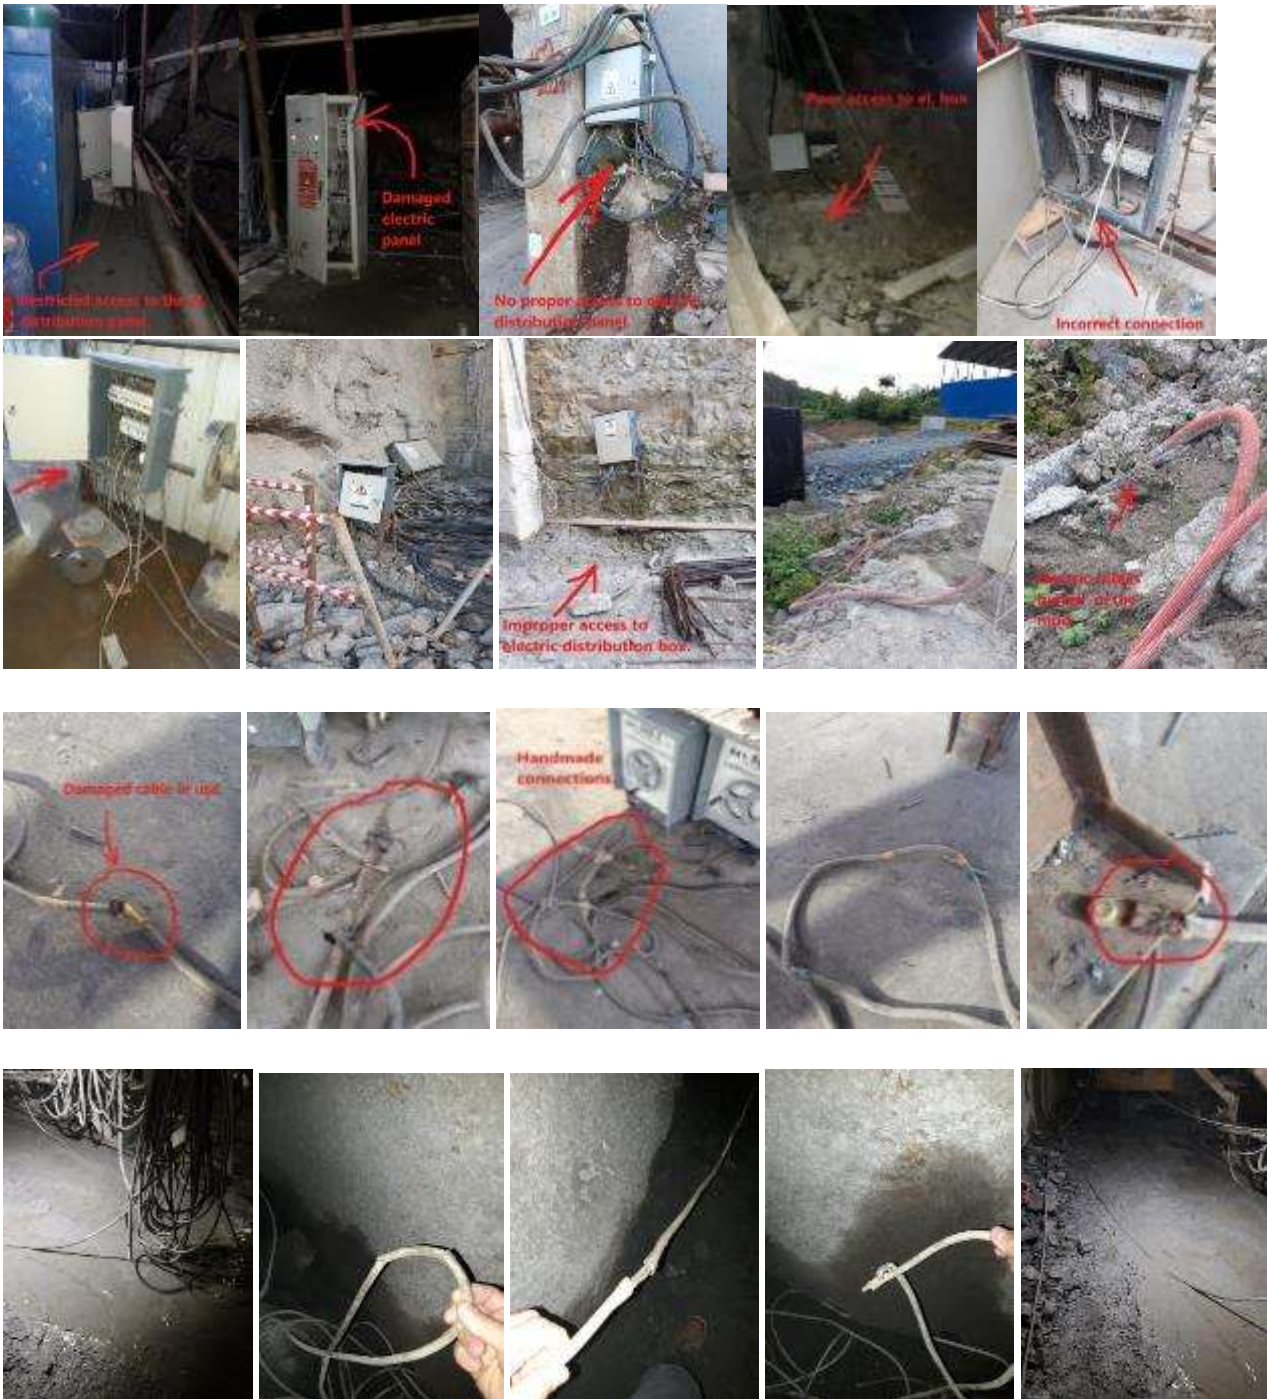
Bad observations.

Picture 2: Non-compliance – (Possible injuries of personnel) (All Tunnels and not only):
Continue non-compliances to electrical safety. Many of the electric distribution panels are still not properly locked, because of missing or damaged locks. Access to some of them is still restricted. Engineers are still finding some high voltage cables, thrown in mud or on the wet ground surface. They are continuously asking the Contractor’s site responsible persons to follow H&S rules or requirements and solve this problem as soon as possible. The contractor is trying to close this issue (See pictures), but it isn’t enough for the full completion of mentioned issue. The contractor has to continue monitoring electrical safety-related issues at workplaces and do

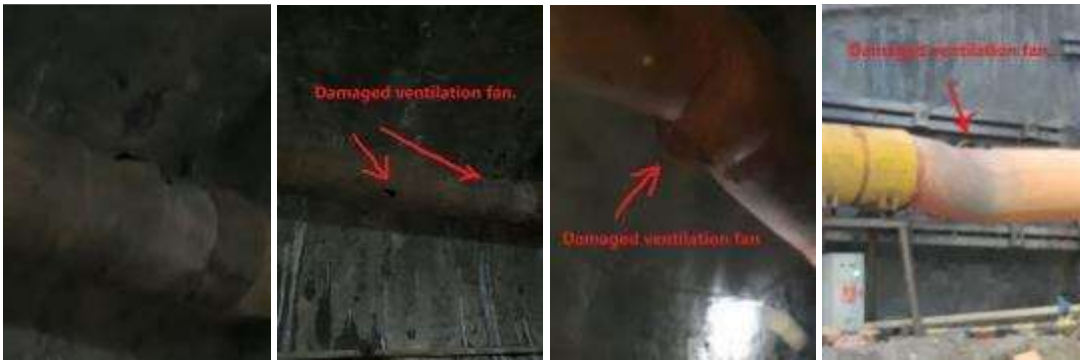
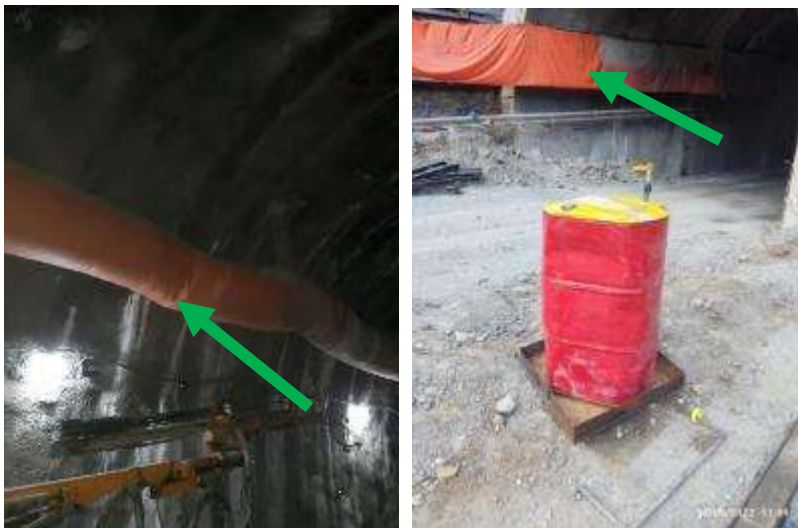
Before

After

Picture 11: Non-compliance (Poor level of ventilation) Tunnels №2 and N5 - Violation to Health & Safety rules and requirements have been observed during site walk. Day by day, the number of cut or damaged ventilation fans becomes more and more. Contractor's site responsible persons were informed about it by the Engineers. The Engineer asked Contractor's management team to pay more attention on workplace safety, particularly on ventilation level and quality of ventilation fans to avoid possible incidents at workplaces. Later on, all ventilation fans were inspected by the Engineer and it was found out that all damaged ventilation fans were repaired. Engineer thanked the Contractor for quick reaction to the above issue. **Issue closed.**

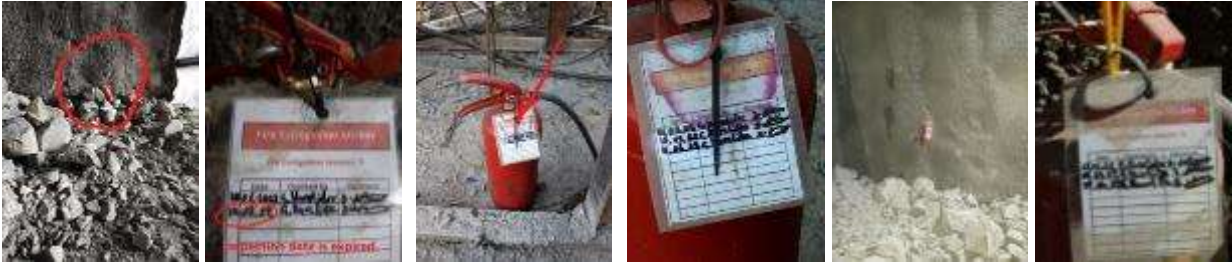
Bad observation.

Picture 12: Non-compliance (Safe work process) Tunnels №2 and №3– Non-compliances to the international Health & Safety regulations have been observed during site visit. Tools and equipment (fire extinguishers) with expired inspection dates on it have been observed during site visit. Some fire extinguishers have been found thrown in mud and dust. Engineer asked Contractor’s site responsible persons to react on mentioned above issue, organize and provide inspection of fire extinguishers to insure that all are in working order. Dirty fire extinguisher was cleaned out and hanged on visible for everybody height. Contractor has to pay additional attention on workplace safety and care about personnel’s health and safety at site. Engineer is waiting for feedback from the Contractor. **Issue open.**

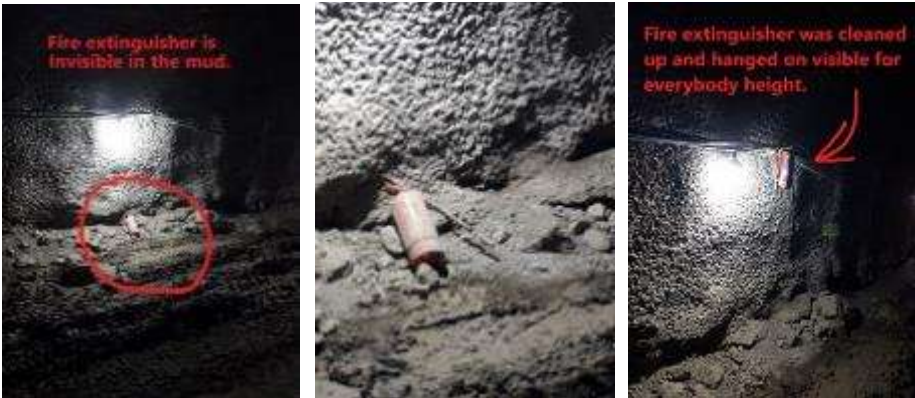
Good performance.

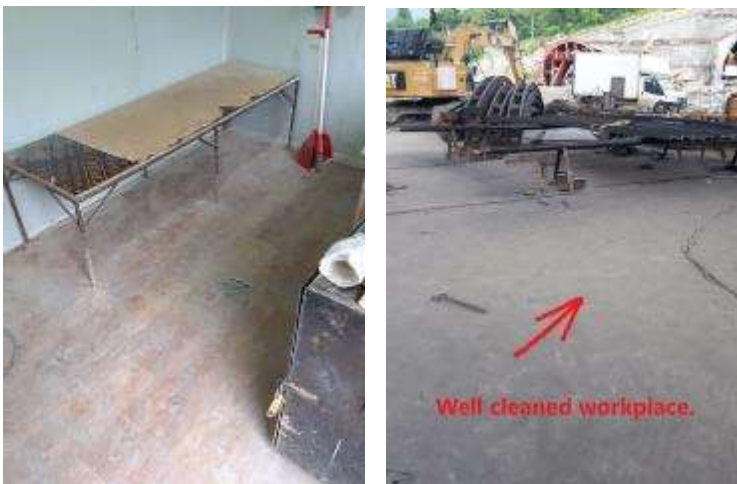
Good example of workplace housekeeping (Tunnel #5 TA and AT)

Picture 14: Workplace housekeeping (Trip, slip and falling hazards) Workshops in Tunnels №2, 3 and 5 – Bad and good examples of workplace housekeeping have been observed during visiting the tunnels. Engineer asked Contractor’s site responsible persons to follow to the health & safety rules and regulations and keep all workplaces in clean and tidy to avoid trip, slip and falling hazards. **Issue open.**

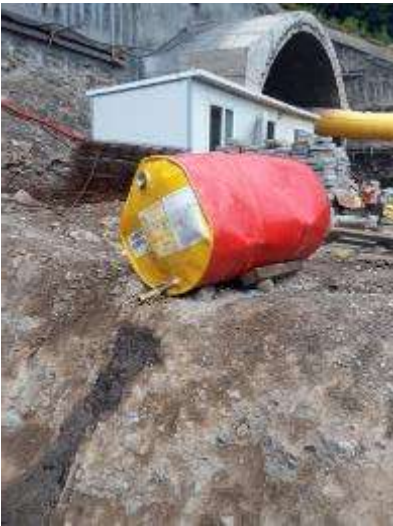
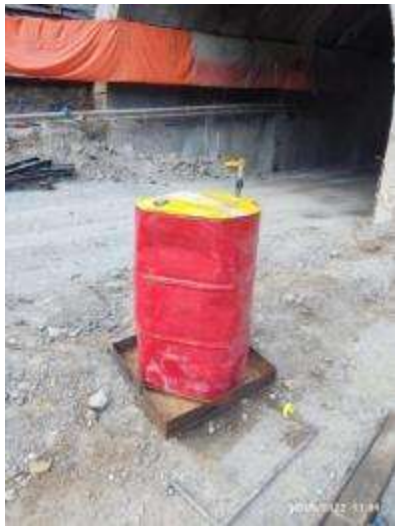
Good performance (Tunnel #5).

Picture 17: Non-compliance – (Improper storage of hazardous materials) (Tunnels N2 and 5) – Non-compliance to H&S rules and requirements has been observed during site inspection. Barrels full with flammable liquids (leaking) have been found placed at the workplace without keeping it in specially arranged for such materials drip trays. It could cause a fire or harm the environment. Engineer informed the site responsible persons from Contractor Company and asked to react on it. Later on some positive changes have been made by Contractor in tunnel #5. Barrel was moved and placed into drip tray. Another barrel with flammable liquid isn't removed yet from tunnel #2. Contractor is informed about it. Engineers are waiting for feedback. **Issue open.**

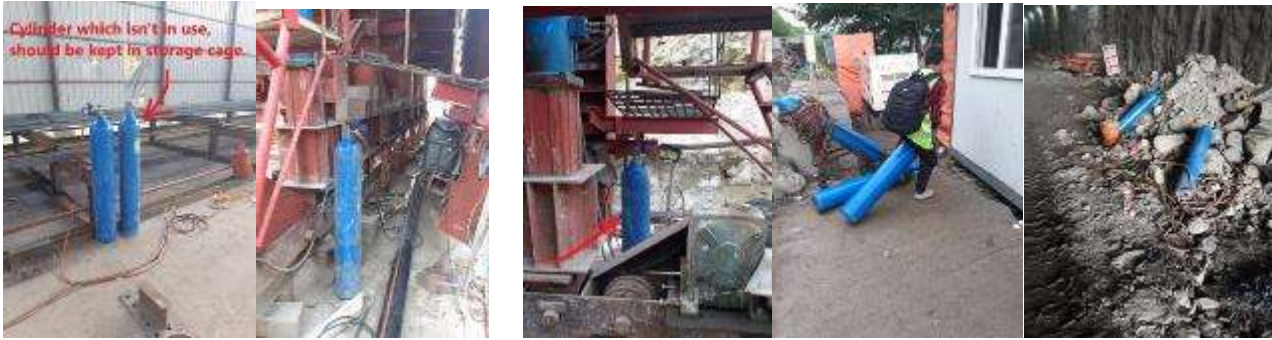
Good performance (Tunnel #3 and 5)

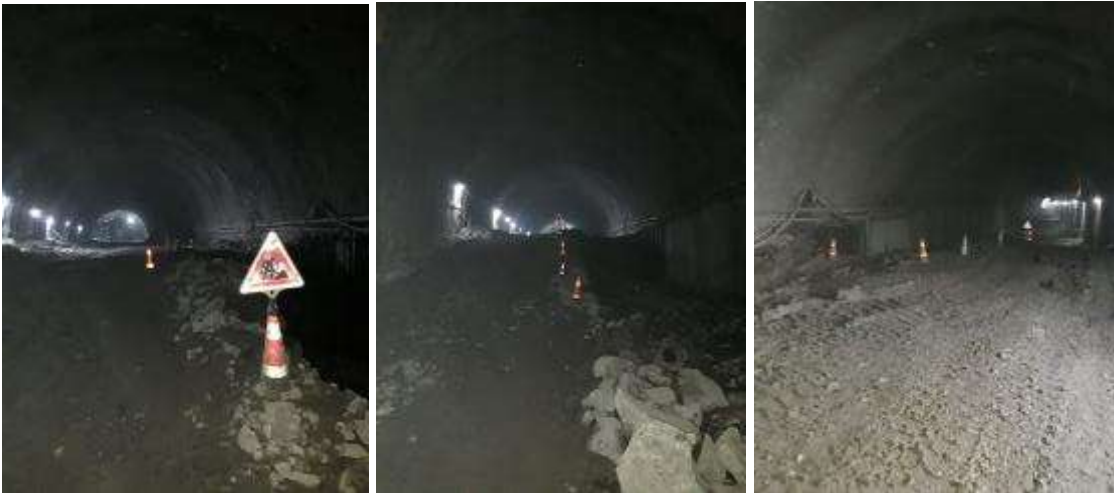
Good observation (Tunnel#2 and 3)

Picture 20: Driving safety (Possible accident) (Tunnels#2, 3 and 5) – Engineers are still observing good and bad examples of driving safety related issues during visiting the tunnels. For example, good observations have been found inside the tunnels #2 and 3 (see pictures attached). In a same time, bad example of driving safety regulation has been found in tunnel #5. Reflective cones, warning drivers about the possible hazards, were missing on the access road. Site responsible person from the Contractor Company was informed about it by the Engineer and asked to fix this issue soon to avoid possible truck related incidents inside the tunnel.

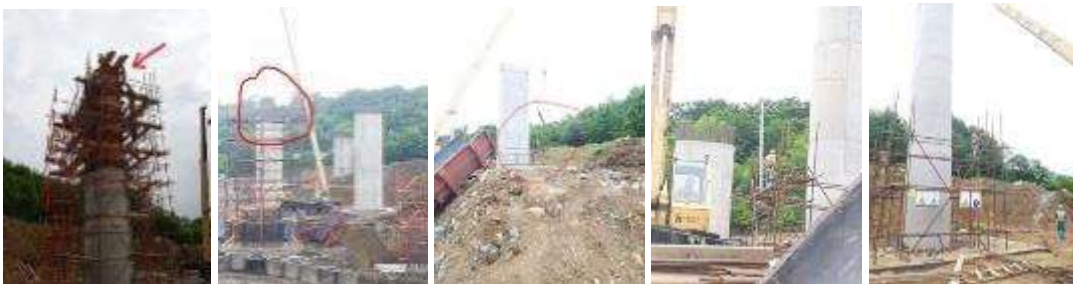
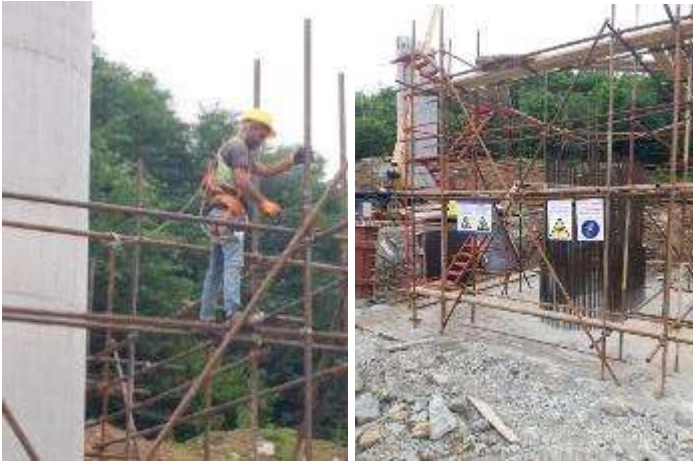
Before

After

Picture 21: Non-compliance (Work at height-possible fall) (Bridge #5) - Workers have been caught in unsafe position during working at height. They were equipped with personal body harness, but weren't connected to the pipe supports. Actually, they should fix themselves to the scaffolding pipe, to avoid possible falls, but they did not do it. Work activity was suspended for a few minutes. The Engineer asked workers to use body harness properly and fix themselves to the structure and avoid possibility of falling and only after that continue perform the job. After discussion finish, helpers wear the body harnesses on, fixed it to the scaffolding pipe and only after that continue performing the task. Later on, special warning signs, informing workers about the procedure on how to use the scaffold structure, have been fixed on. **Issue closed.**

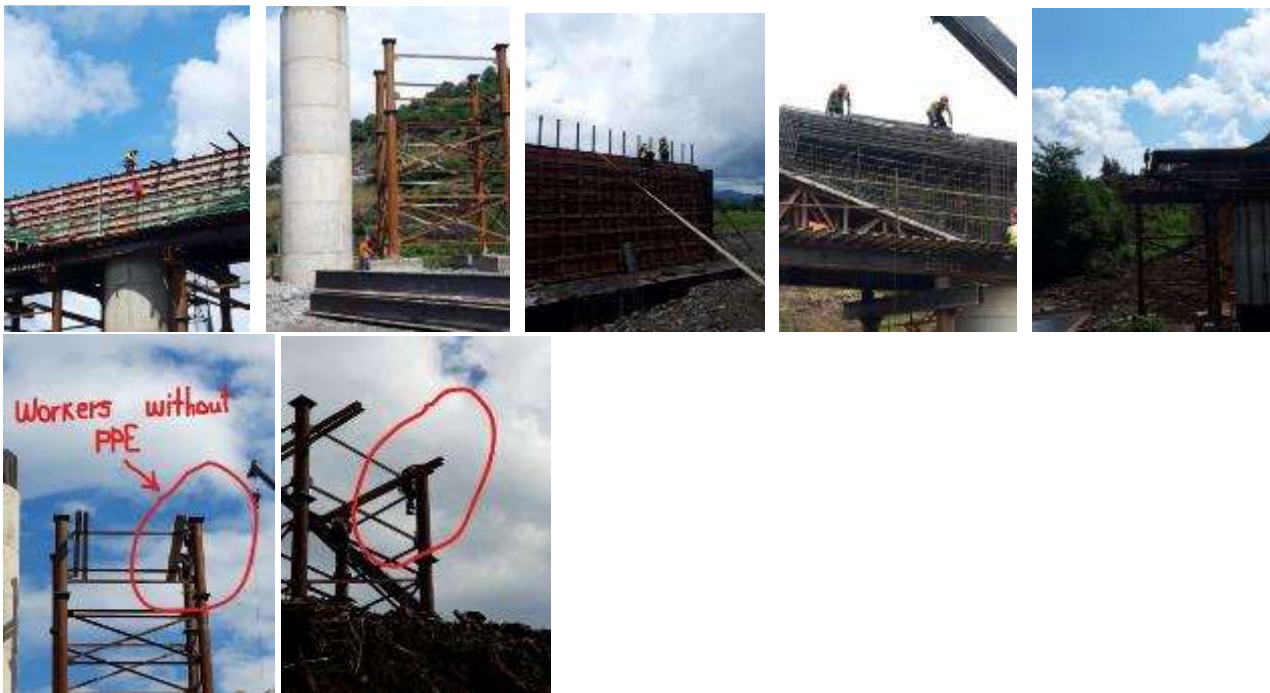
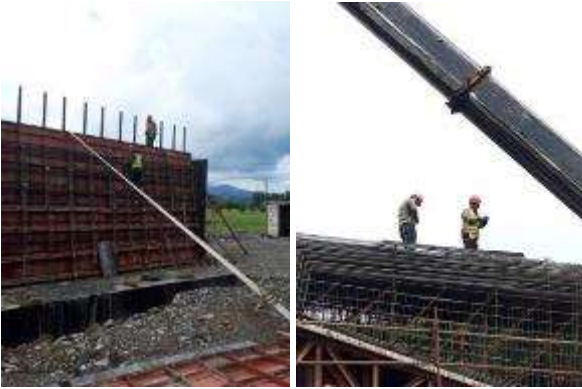
Some were moved down and some wear proper PPE.

Picture 25: Non-compliances (possible injuries) Br. N2, piers 1 and 5; Retaining wall, Pk.114 – Workers have been found in unsafe position when working at height. They weren't using fall arrest equipment properly during work process. It could cause possible injuries of working personnel. The Engineer has decided to suspend the work processes in mentioned above locations for a few minutes and gave a verbal warnings to the workers involved in the task. The Contractor site responsible persons were informed about it. The Engineer asked to pay more attention on such issues to avoid possible incidents from happening. After discussion finish, some of them have wear the body harnesses and returned to the work. Some work activities were suspended until necessary equipment shouldn't deliver to the site. It is not a first time that the Engineers are catching the personnel in unsafe position and the Contractor has to act on such non-compliances very effectively to avoid possible incidents. **Issue open.**

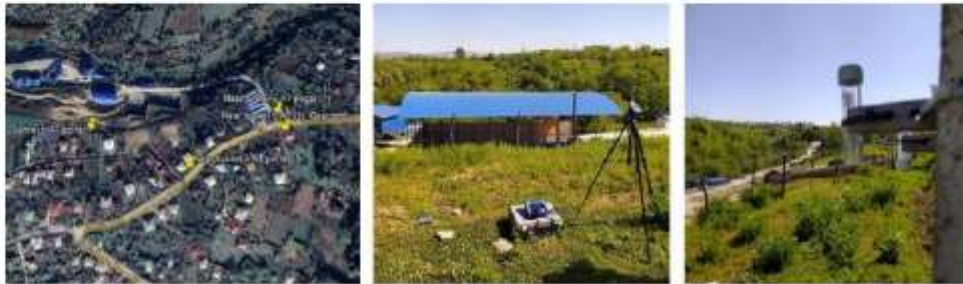
Figure 5-16 Point N8 Tunnel 5 AT portal (NOx, SOx, noise, dust, vibration)

Monitoring works at this point were conducted in two sessions, working and non working hours. Vibration, noise and dust levels were measured, and air quality monitoring tubes were replaced. During the monitoring of the work process, active works were carried out on the site, heavy equipment was moving with medium frequency and the concrete and iron structures manufacturing facility was working. During the non-working monitoring session, the work continued at low intensity for the first few minutes and then stopped altogether.

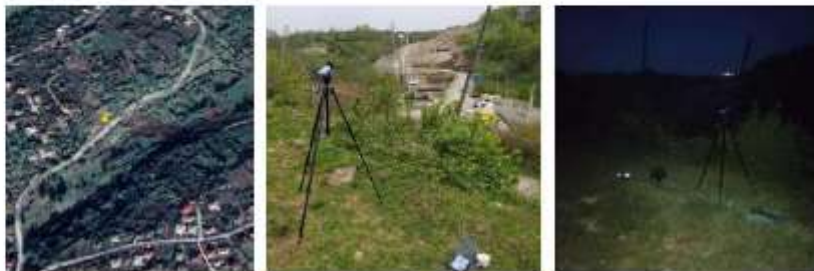
Figure 5-20 Point 12 Bridge 5 (vibration, noise)

At this point the monitoring works were conducted based on the complaint of the local residents. Vibration and noise monitoring was carried out about 50 meters away from the working area, on the edge of the road between the locals' houses and the working area. Monitoring was carried out 3 times, 2 sessions were conducted during the day and one in the evening. During the first session, the construction work was in an active phase and several types of equipment were working on the construction site, including a concrete mixer, which was used to pour concrete into the bridge pier, in addition, an excavator and a drilling machine were working. During the non-working session, all work on the construction site was suspended. During the evening session, construction materials were sorted at the beginning of the monitoring at the construction site, and then the process was stopped completely.

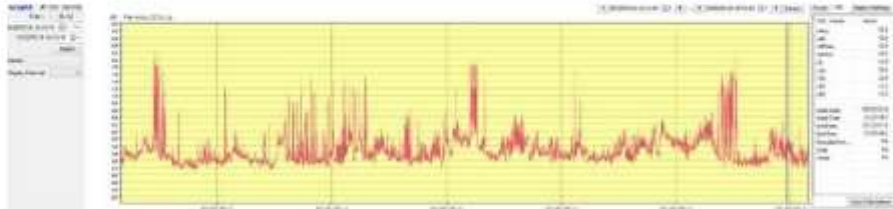
Figure 6-5 Tunnel 5 AT Portal working hours

Tunnel 5 AT portal. As it was mentioned, noise level measurement was conducted twice, during working and non-working hours. Exceedance of noise level was observed during both sessions. However, during a non-working session, exceedance is not significant (2.3 dB). As the results show, the LA90 observed during both sessions complies with the established limit, moreover, it is much lower than the limit. This fact indicates that the noise level was within the limit for 90% of the measurement time.

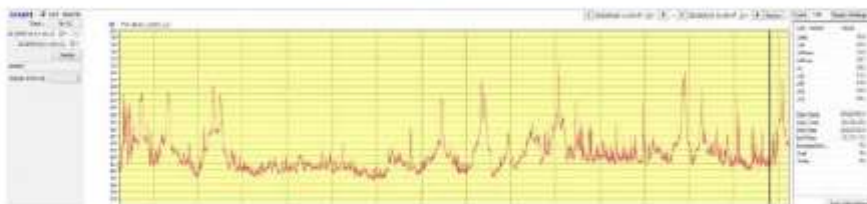
Figure 6-8 Bridge 5 Evening session

Exceedance of the permissible noise limit by 5.5 dB was observed during the evening session (standard - 45 dB). However, in contrast to the day's results, in this case the L90 value is low (39.9 dB). Accordingly, it can be concluded that the noise was not constant and for most of the time, its value was within the established limit.
