Semi-annual Environmental Monitoring Report

Project Number GEO 51257-001

Reporting period: July – December 2024

Georgia: North-South Corridors (Kvesheti – Kobi) Road Project

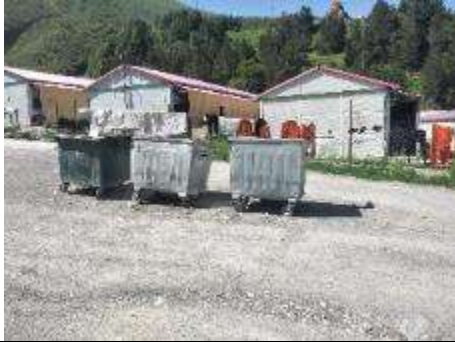
#	Locations	Date	Issue	Priority	Mitigation	Target Date	Action Taken	Status
Lot 1 Responsibility								
1	Kobi	July 2024	Poor housekeeping at Kobi Camp site, waste overflowing from the containers.	Medium	CC to clean out the area and call the municipality truck to take the waste.	July 2024	CC cleaned out the area in July 2024

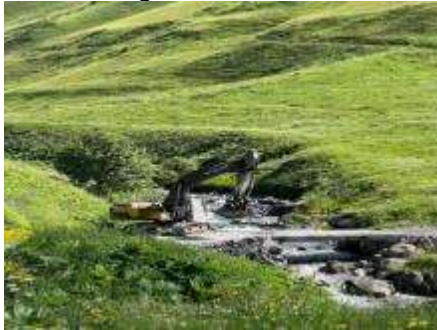
Closed July 2024
2	Khadistskali River Tskere	July 2024	River bed cleaning required to collect the rocks and sediments	Medium	CC to clean out the river bed to control turbidity in the river.	July 2024	CC cleaned out the river bed near Tskere bridge on the river.

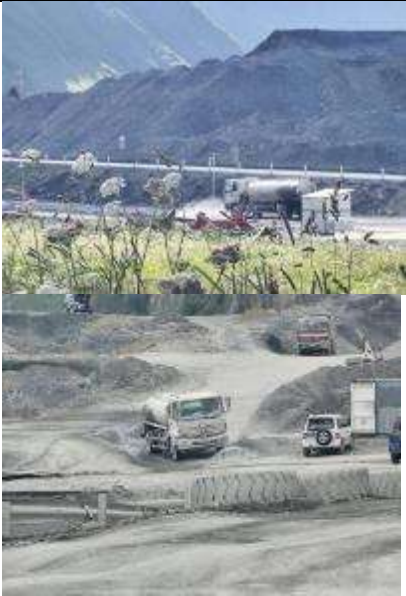
Closed July 2024
3	Kobi	July 2024	Dust on Access Road and E-117	Low	CC to sprinkle water on regular basis on access	July 2024	CC sprinkling water on regular basis in Kobi	Closed July 2024

road from the tunnel, SDA3, and E-117

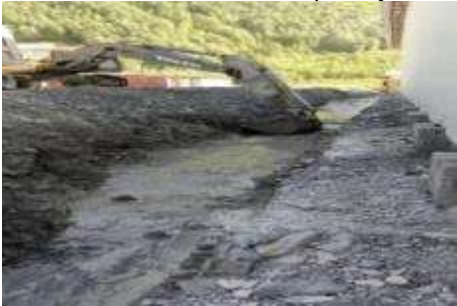
4	Kobi Batching Plant	July 2024	Sedimentations Pit need to be cleaned out at BP Kobi	Low	CC to clean out sedimentation ponds	July 2024	<p>Sedimentation Pits and drainage channel cleaned out completely.</p>

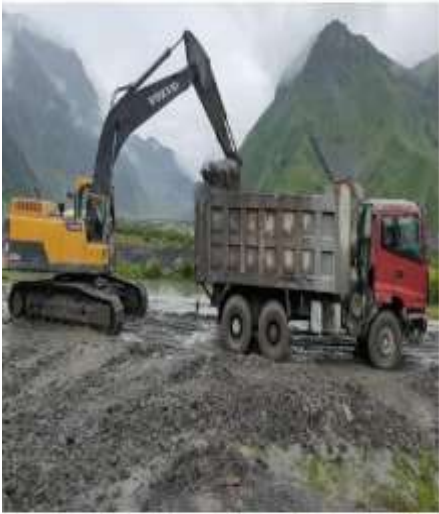
5	Kobi Crushing Plant	July 2024	Sedimentations Pit need to be cleaned out at crusher plant Kobi	Low	CC to clean out sedimentation ponds	July2024	<p>Sedimentation Pits and drainage channel cleaned out completely.</p>    	Closed July 2024

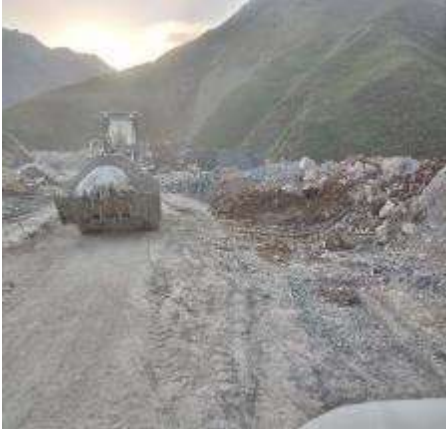
7	SDA 3, Kobi	August 2024	Plastic container thrown in SDA 3

Low	CC to remove the container from the SDA 3	August 2024	CC removed the container from SDA 3.

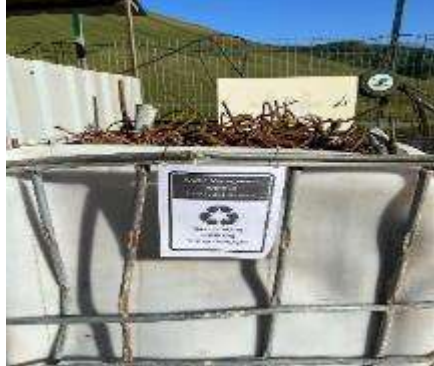
11	Tskere	August 2024	Scrap material spread at the site	Low	Collect the spread material and place in scrap yard	August 2024	Scrap material placed in container and signs installed.	Closed August 2024

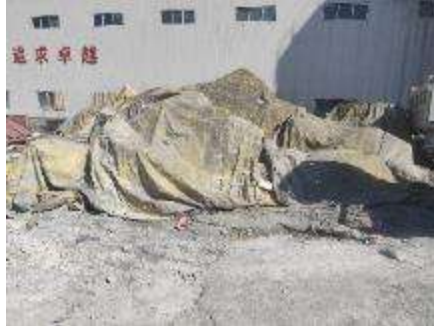
12	Kobi Behind Segment Plant	August 2024	Used containers placed in an inappropriate manner	Low	Placed the container in upright position with closed lids and cover it with tarpaulin until delivery to third party.	August 2024	Contractor arranged the plastic containers and covered it with plastic sheet to avoid water entry	Closed August 2024

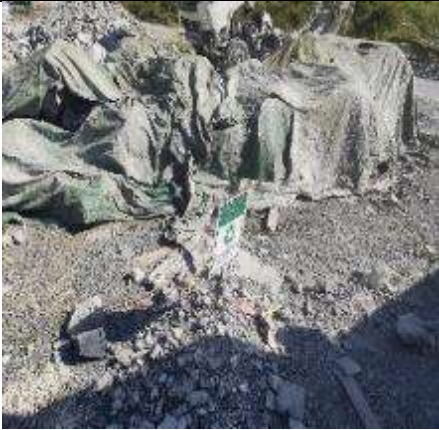
13	Kobi Behind Segment Plant	August 2024	Used tires need to be covered to avoid stagnant water in the tires	Low	CC to cover the used tires or handover to the third party	August 2024	Used Tyres covered behind segment plant to restrict the water entry	Closed August 2024

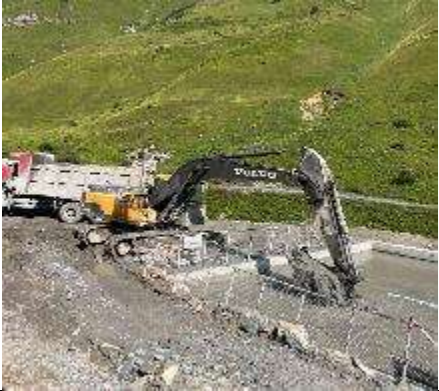
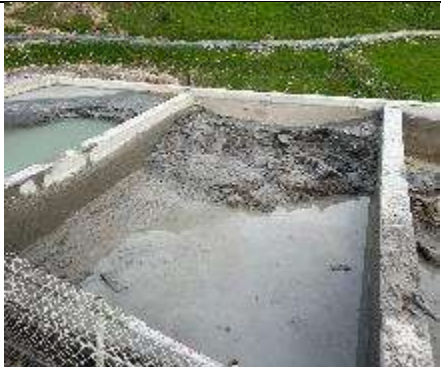
15	Tskere	August 2024	Sedimentations Pit need to be cleaned out.	Low	CC to clean out sedimentation ponds	August 2024	Sedimentation pits cleaned out completely.	Closed August 2024

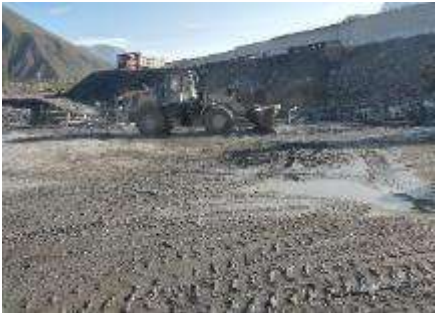
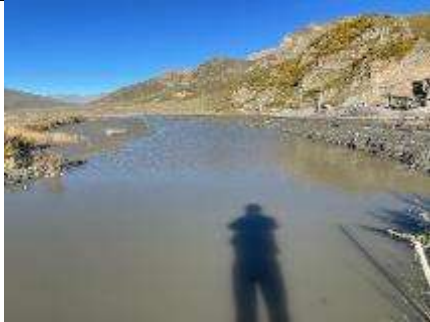
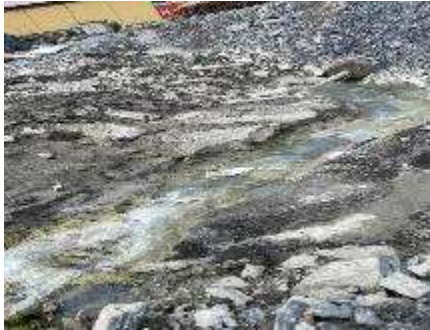
Low	CC to clean out the area	August 2024	Contractor cleaned out the area near sedimentation ponds and vehicle washing facility.	Closed September 2024
23	Campsite Kobi	September 2024	Dirty water flowing in to the river Tergi from crushing plant.	Low	CC to remove the pipe from the crushing plant	September 2024	CC removed the Pipe discharging the water into the River and cleaned the sedimentation ponds.

discharging in to the river.

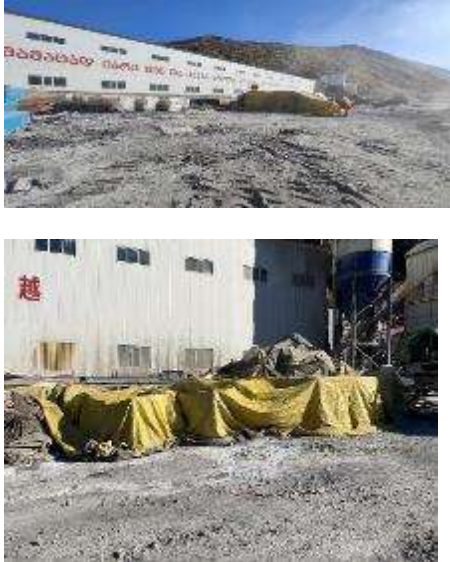
<p>24</p>	<p>KobiBehind Segment Plant</p>	<p>September 2024</p>	<p>Placement of container in appropriate manner.</p>	<p>Low</p>	<p>Contractor for Lot-1 to place the containers in upright position with closed lids and cover it with non-permeable sheets.</p>	<p>September 2024</p>	<p>Contractor arranged the containers in appropriate manner and covered it.</p>

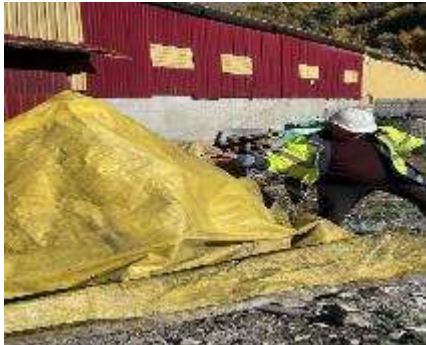
<p>Closed September 2024</p>
<p>25</p>	<p>Kobi Behind Segment Plant</p>	<p>September 2024</p>	<p>Machine not in use need to be covered.</p>

<p>Low</p>	<p>Contractor to cover the machine with tarpaulin.</p>	<p>September 2024</p>	<p>Machine was covered by tarpaulin by UBM</p>

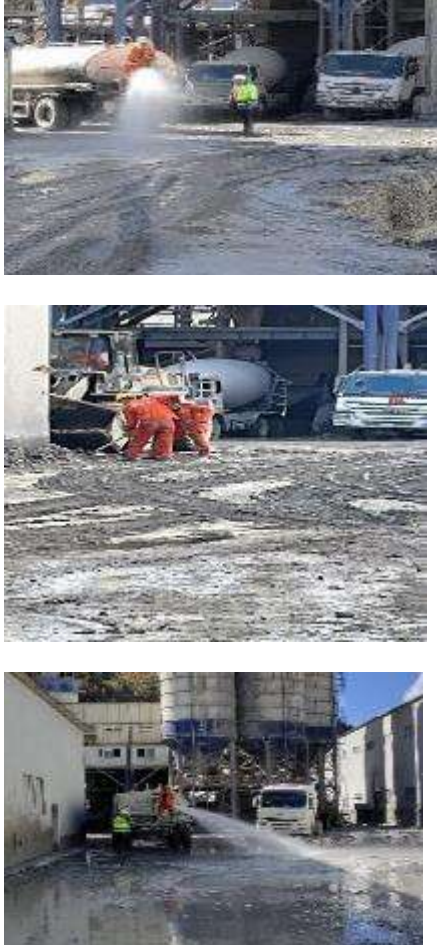
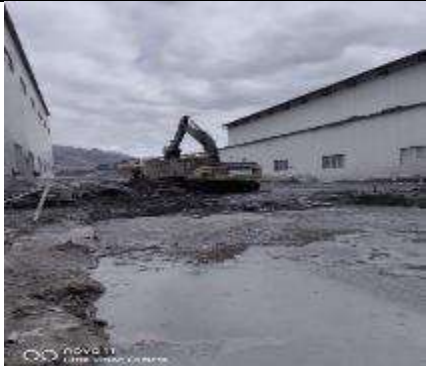
26	Lot-1 Behind segment Plant	September 2024	Slush/ sludge in the batching plant area in Kobi	Medium	Contractor to washout the area of batching plant	September 2024	<p>Contractor washed out the area of batching plant in the supervision of UBM safeguard staff.</p>

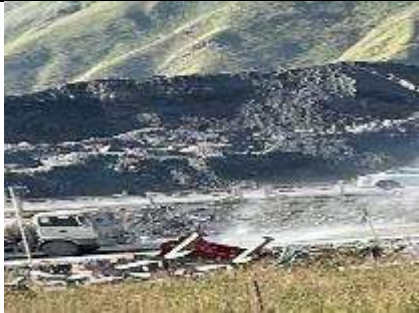
30	Kobi	September 2024	Dust along the E-117 Highway	Low	Regular water of sprinkling by the water truck	September 2024	Contractor moved the water truck and sprinkling water on daily basis. Need to maintain it.	Closed September 2024

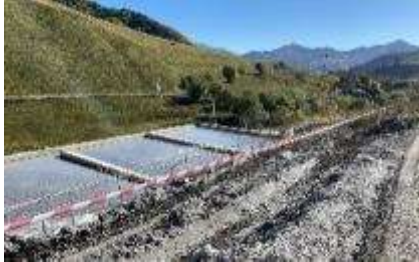
31	Sedimentation Ponds Tskere	September 2024	Cleaning of the sedimentation ponds	Medium	Regular cleaning of the sedimentation ponds	September 2024	CC cleaned out the sedimentation ponds. Fenced the ponds and posted new signs.	Closed September

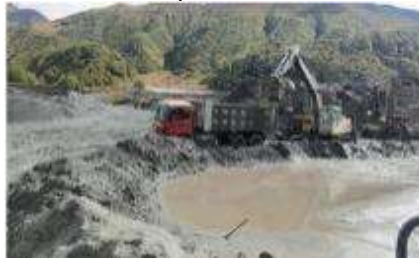
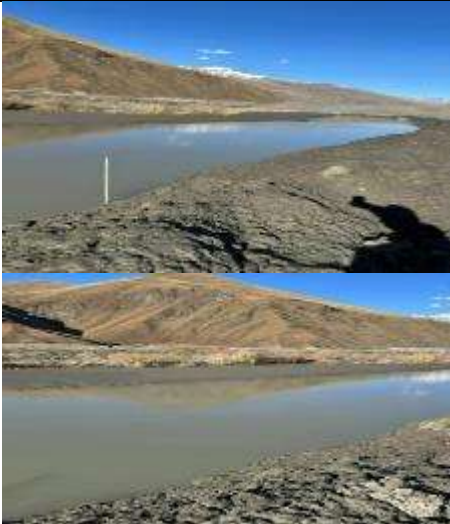
32	Kobi Crushing Plant	October 2024	Cleaning of the Crushing Plant sedimentation ponds	Medium	CC to clean out the sedimentation ponds of the crushing pants	October 2024	CC cleaned out the crushing Plant sediementnation ponds	Closed October 2024

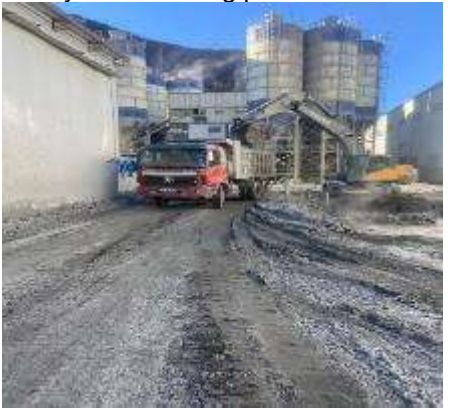
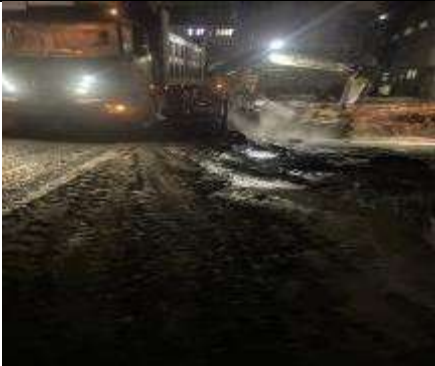
33	Batching plant Kobi	October 2024	Cleaning of the concrete washout facility.	Medium	Regular cleaning of the washout facility for the batching plant.	October 2024	<p>CC cleaned out the Concrete washout facility and batching plant area.</p>

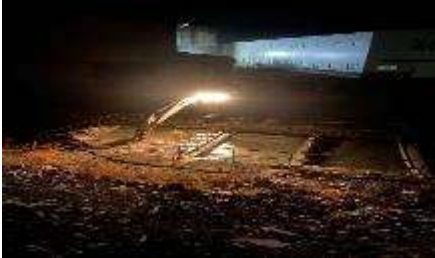
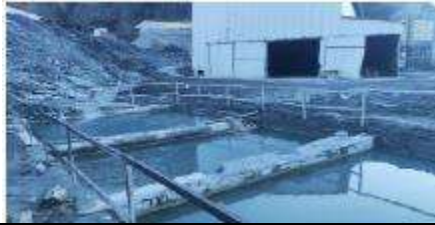
34	Sedimentation Ponds Kobi	October 2024	Cleaning of the sedimentation ponds	Medium	Regular cleaning of the sedimentation ponds	October 2024	CC cleaned out the sedimentation ponds	Closed October 2024

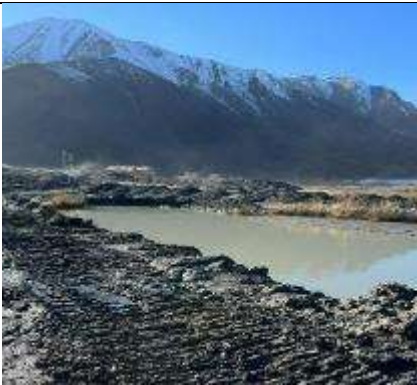
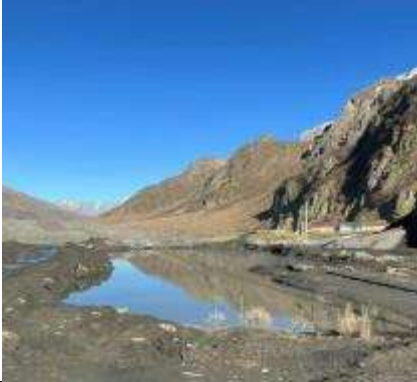
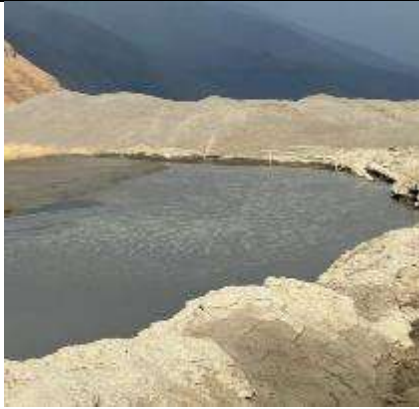
35	Sedimentation Ponds Tskere	October 2024	Cleaning of the sedimentation ponds	Medium	Regular cleaning of the sedimentation ponds	October 2024	CC cleaned out the sedimentation ponds  	Closed October 2024
36	Kobi Crushing Plant	November 2024	Cleaning of the Crushing Plant sedimentation ponds	Medium	CC to clean out the sedimentation ponds of the crushing plants	November 2024	CC cleaned out the crushing Plant sediementnation ponds	Closed November 2024

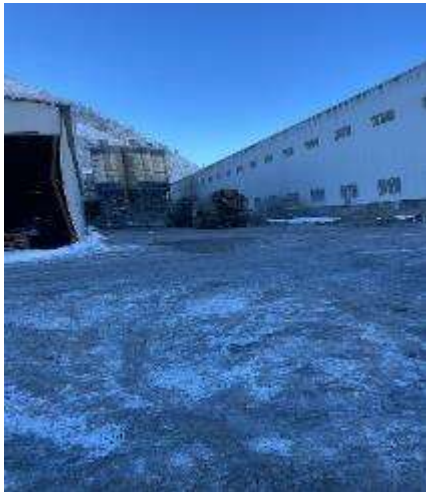
37	Batching Plant Kobi	November 2024	Cleaning of the batching plant area	Medium	Regular cleaning of the sedimentation pits.	November 2024	CC cleaned out the area.

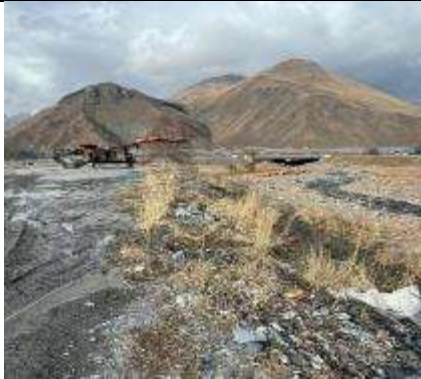
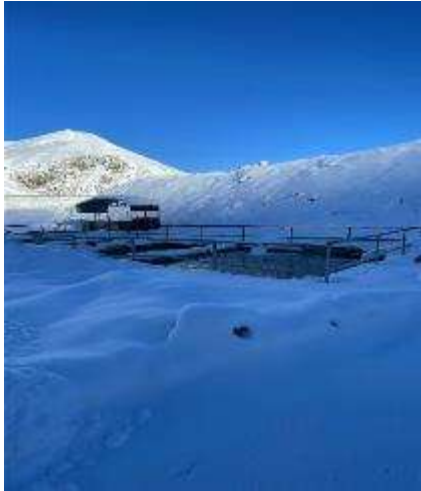
Closed November 2024
38	Sedimentation Ponds Kobi	November 2024	Cleaning of the sedimentation ponds	Medium	Regular cleaning of the	November 2024	CC cleaned out the sedimentation ponds	Closed November 2024

sedimentation ponds

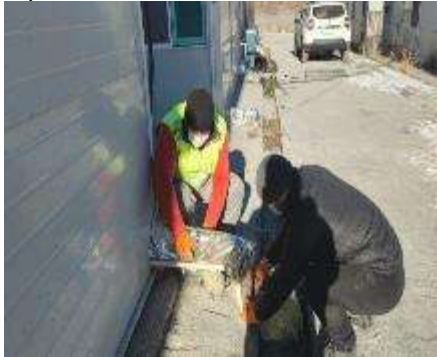
40	Kobi Campsite	November 2024	Covering of the Heating Pipe	Medium	Heating Pipes need to be covered with new sheet	November 2024	Pipes covered with the new sheet

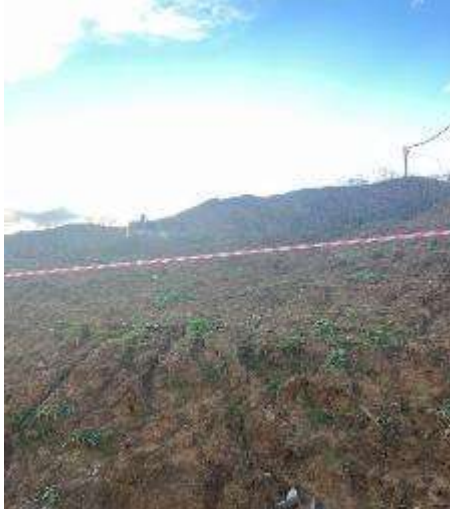
Closed November 2024
41	Kobi Campsite	December 2024	Waste overflowing from the containers in the camp.	Low	Collect the waste from the waste bins and throw in the municipality containers.	December 2024	Area cleaned out and waste collected in the wastee bins.	Closed December 2024
41	Tskere Topsoil Storage Area.	December 2024	Contractor stored the subsoil on the	Medium	Collect the waste from the waste bins and	December 2024	Contractor removed the subsoil from the topsoil and but due to snow it is not possible to inspect that all the subsoil	In progress

heap of topsoil. Potential chances of mixing subsoil with topsoil and damaging the topsoil.		throw in the municipality containers.		has been removed. After snow contractor will remove all the subsoil from topsoil.

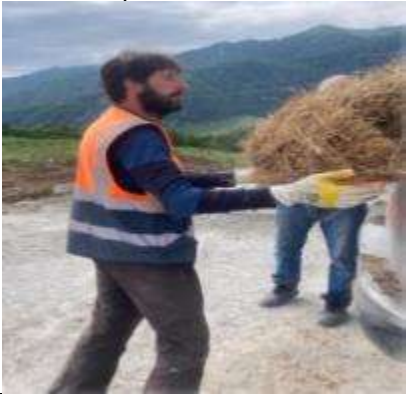
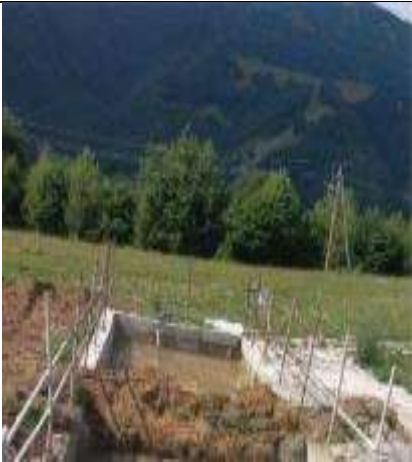
2	Batching Plant 2	July 2024	Treatment of Concrete water in the concrete washout pit	Low	Contractor to change the grass filter in the sedimentation pit.	July 2024	<p>Contractor changed the grass filter in the sedimentation pit to enhance the treatment process.</p>

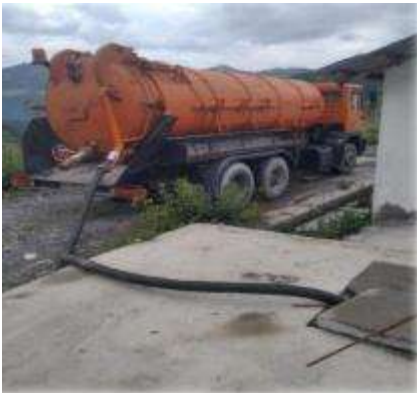
4	Camp 3	July 2024	Sewage to be collected from the septic tank	Medium	Contractor to collect the sewage sludge by calling the licensed company.	July 2024	CC collecting the sewage by calling cesspool truck.	Closed July 2024

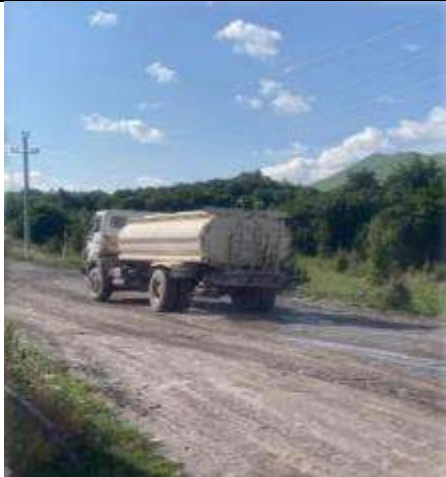
8	Access roads	July 2024	Dust on access road to Camp 2	Medium	Contractor to sprinkle water on access roads.	July 2024	Contractor started water sprinkling on access roads and need to maintain it.	Closed July 2024

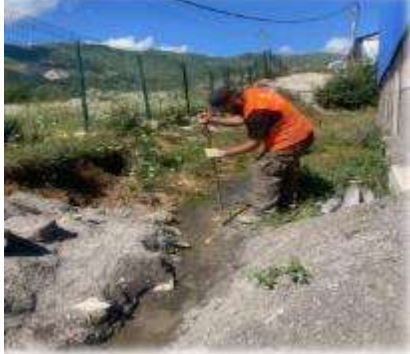
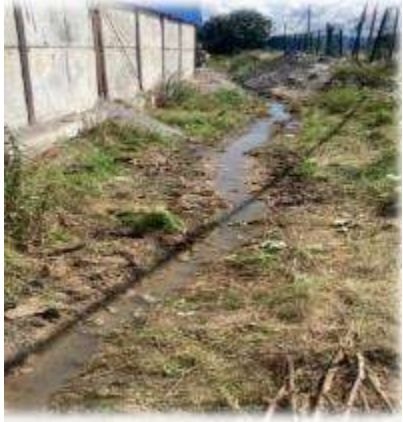
9	Camp 2	July 2024	Drainage channel choked behind the camp	Medium	Contractor to clean out the channel	July 2024	<p>Contractor cleaned out the channel</p>

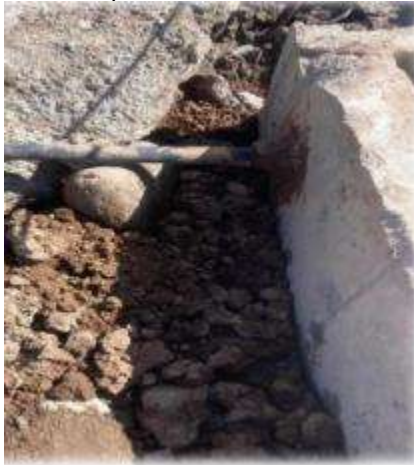
10	Batching Plant 2	July 2024	Storm water mngement at BP 2

Medium	Contractor to connect the water pipe to connect the sediment ponds to concrete washout pit to manage storm water.	July 2024	Contractor arranged and connected the pipe from sediment pond to concrete washout pit.

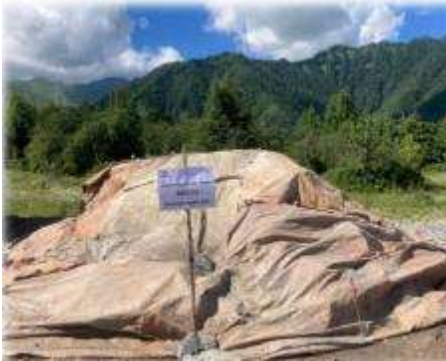
Closed July 2024
11	Tunnel 1 Exit	July 2024	Plastic waste at the tunnel 1 exit	Medium	Contractor to collect the	July 2024	Contractor collected the plastic waste covered it and posted the sign.	Closed July 2024

plastic waste and cover it before handling to the Licensed Contractor.

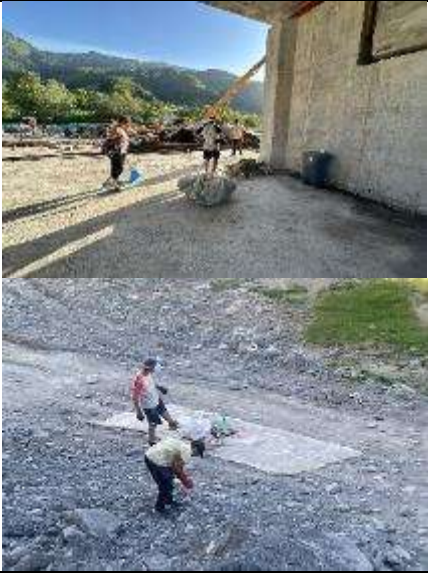
14	Didveli Plateau	August 2024	<p>Damaged water truck at plateau</p>

Low	Repair the water truck and start watering	August 2024	<p>Contractor repaired the truck and started watering</p>

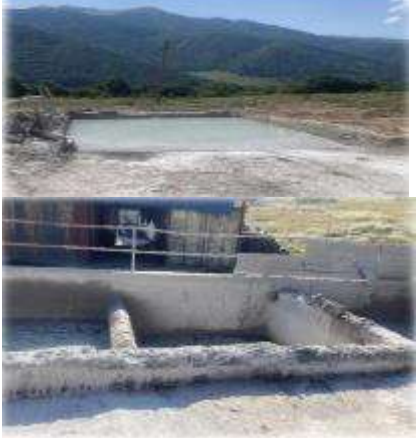
Low	Clean out the concrete washout pits for the effective treatment of concrete water.	August 2024	Concrete washout pit cleaned out

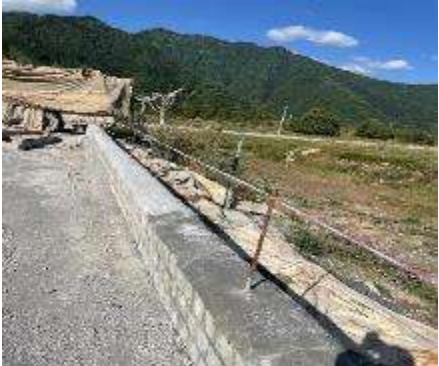
Closed August 2024
16	Batching Plant 2	August 2024	Fencing of BP 2 to restrict drainage water entering in the private land.	Medium	CC to provide the fence for BP 2 in such a way that the water should not be flowing in to private land.	August 2024	CC build the wall at the bottom to restrict water flowing towards private land and fenced the BP 2.

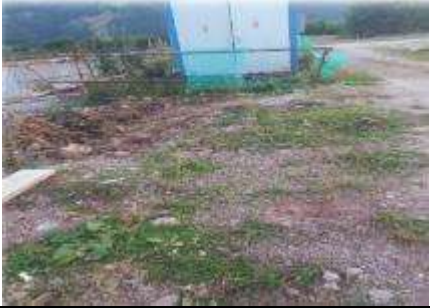
Closed August 2024
17	Tunnel 1 Exit	August 2024	Oil spill near Tunnel 1 exit	Low	CC to clean out the spill and treat it as	August 2024	Oil spill cleaned out and contaminated soil collected.	Closed August 2024

hazardous material.

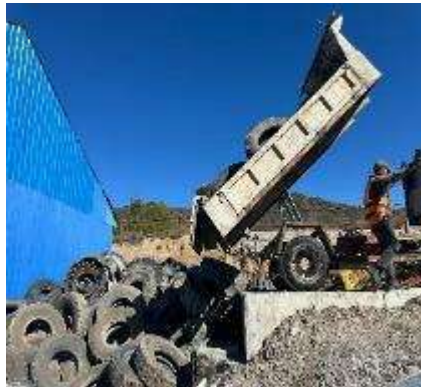
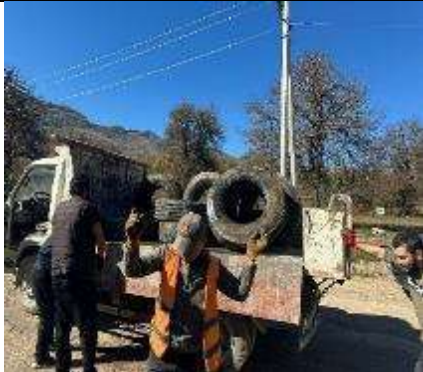
22	Construction site Plateau	September 2024	Used tires stored in the private land	Medium	CC to remove the tires from the private land and store in a designated land.	September 2024	CC collected the used tires from private land and stored these in a designated area at the tunnel 1 exit.	Closed October 2024

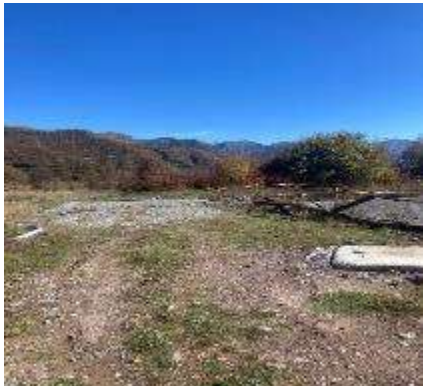
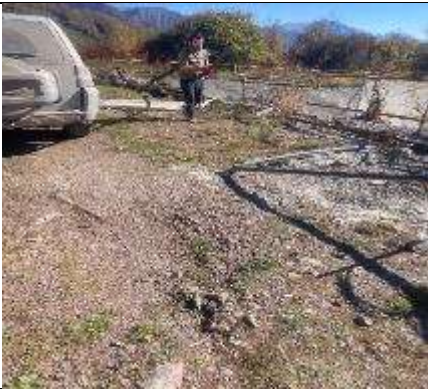
23	Above the Tunnel 1 Exit	September 2024	Poor housekeeping waste thrown on the ground near Electrical room.	Low	CC to clean the area above tunnel 1 exit.	September 2024	CC cleaned out the area and collected the waste.	Closed September 2024

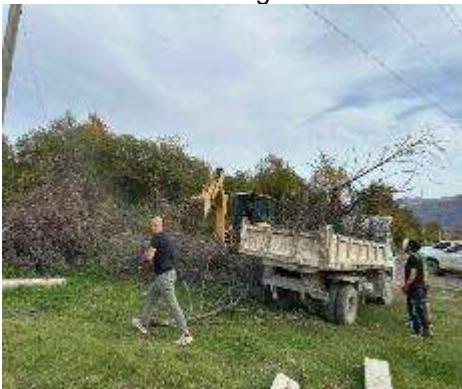
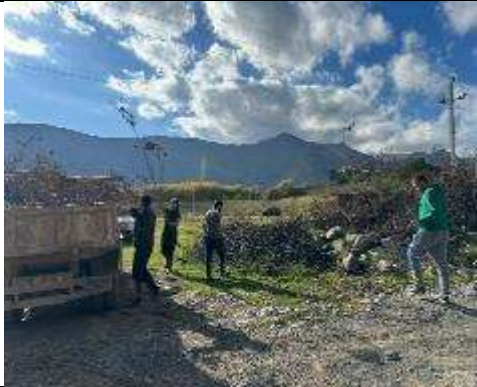
24	Gudaure Access Road	September 2024	Wooden branches leftover at the GARP from tree cuttings	Low	CC to collect all the leftover wooden branches from the GARP and store it in a designated area near Parking Lot to handover to NFA.	September 2024	CC removed all the wooden branches and stored it in a designated area.	Closed October 2024

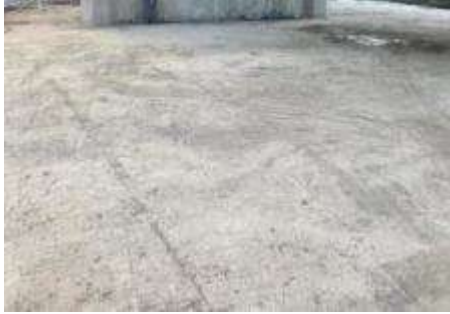
25	Bridge 2	September 2024	Poor housekeeping under the bridge 2  	Low	CC to clean out the area under the Bridge 2	September 2024	CC cleaned out under the bridge 2

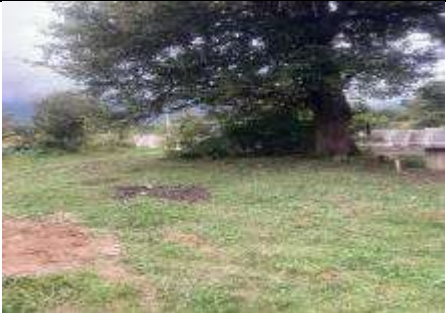
Closed September 2024
26	Didveli Plateau	September 2024	Waste spread on the private land	Low	CC to clean out the area	September 2024	Contractor cleaned out the area	Closed September 2024

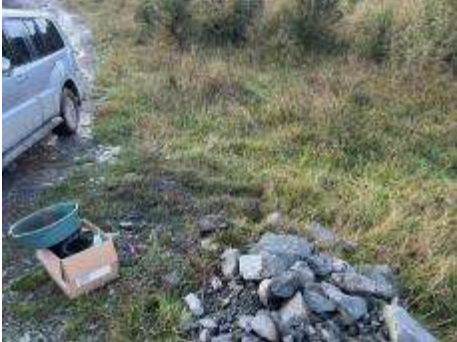
27	Didveli Plateau	September 2024	Oil filters on the ground

Low	CC to collect the filters. and store in hazardous material storage area.	September 2024	Contractor collected the filters from the access road and stored in Hazardous material storage area.

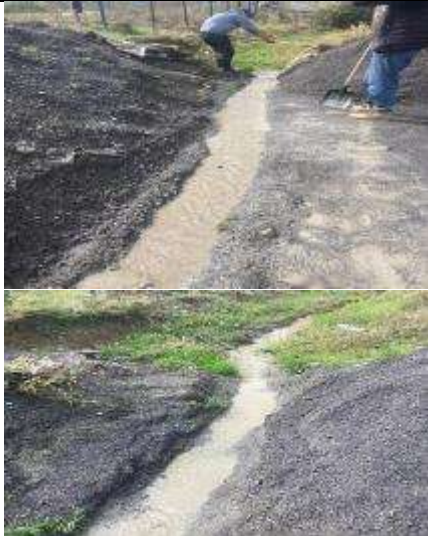
Closed September 2024
28	BP 2	September 2024	Drain clogged due to waste in the drain	Low	CC to clean out the drain and restore the drainage	September 2024	Contractor cleaned out the storm water channel at the batching plant 2 area.	Closed September 2024

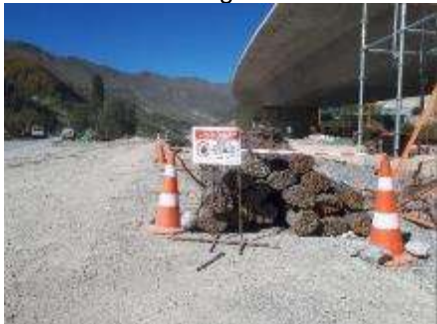
29	Construction site, Kvesheti, Plateau.	September 2024	Necessary safety and environment signs required at site	Med	CC to install all the necessary sign at the site for safety and environment	September	<p>CC installed the signs at the site</p>

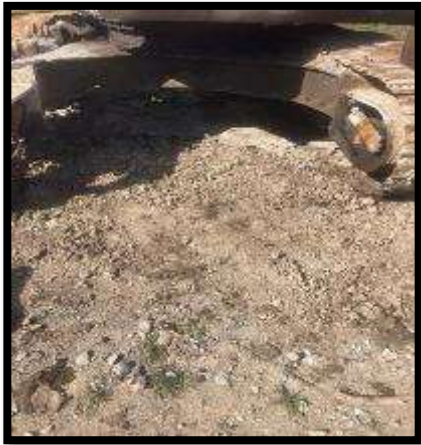
30	Sedimentation pits at Batching Plants	October 2024	Cleaning of concrete washout pit	Low	Clean out the concrete washout pits and maintain it.	October 2024	Concrete washout pit cleaned out  	Closed October 2024
31	Near Camp 2	October 2024	Oil spill at various places. Oil leaked from broken excavator	Medium	CC to clean out the spill and treat it as hazardous material.	October 2024	Oil spill cleaned out from the various places and contaminated soil stored in a hazardous material storage area.	Closed October 2024

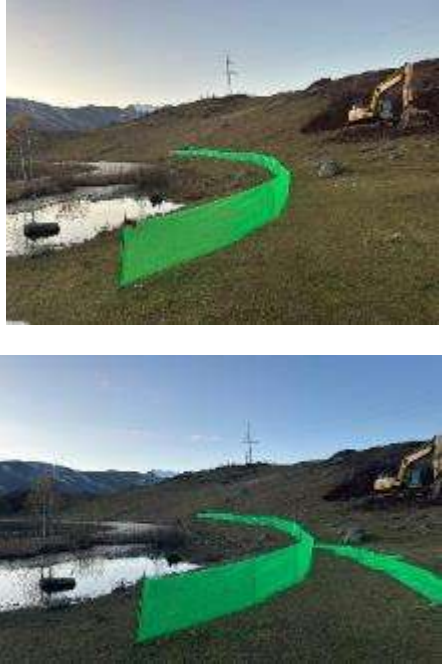
35	Plateau Lake	October 2024	Protect the lake from sedimentations and flowing spoil in to the lake	Medium	CC to protect the lake by providing fence.	October 2024	<p>CC provided the fence around the lake.</p>

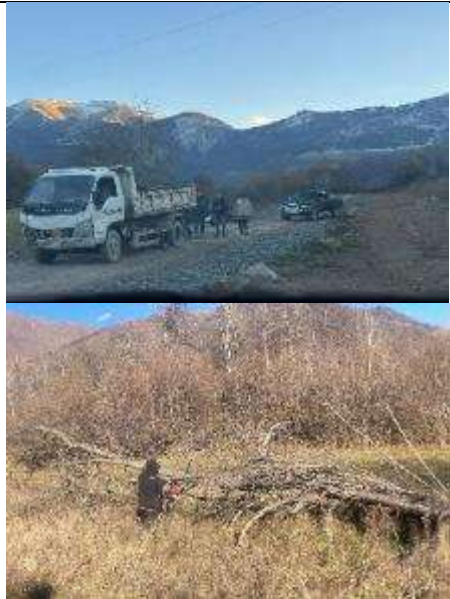
Closed October 2024
36	Gudaori Access Road	October 2024	Wooden branches leftover at the GARP from tree cuttings	Low	CC to collect all the leftover wooden branches from the GARP and store it in a designated area near parking Lot.	October 2024	CC removed all the branches and stored it in a designated area.	Closed October 2024

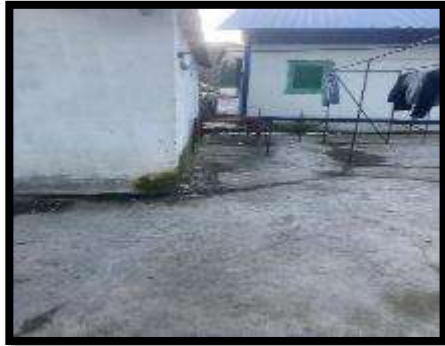
37	Camp 3	September 2024	Poor housekeeping camp 3

Low	CC to clean out the area of the Camp 3	September 2024	CC cleaned out the camp 3

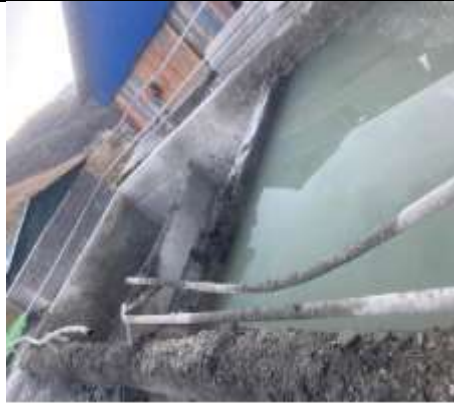
38	Camps	October 2024	Waste spread on the private land	Low	CC to clean out the area and call the municipality to collect the waste	October 2024	<p>Contractor cleaned out the area and municipality collected the waste.</p>  	Closed October 2024
39	Sedimentation pits at Batching Plants	November 2024	Cleaning of concrete washout pit	Low	Clean out the concrete washout pit	Nov 2024	Concrete washout pit cleaned out	Closed November 2024

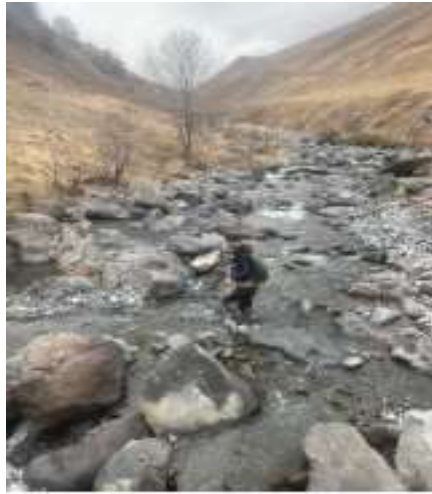
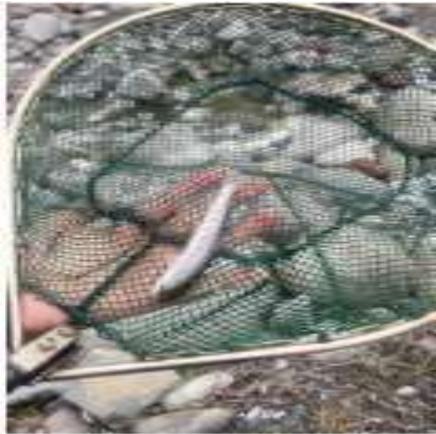
40	River Khadistskali and Aragvi	November 2024	Fish Monitoring for Autumn season.	Medium	CC to carryout fish monitoring by hiring third party	November 2024	CC canaried out fish monitoring for Autumn season. Report annexed as Annex-10	Closed November 2024

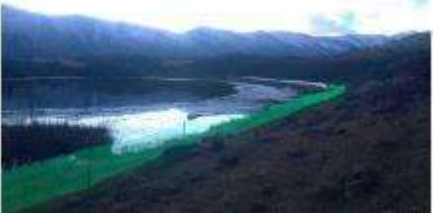
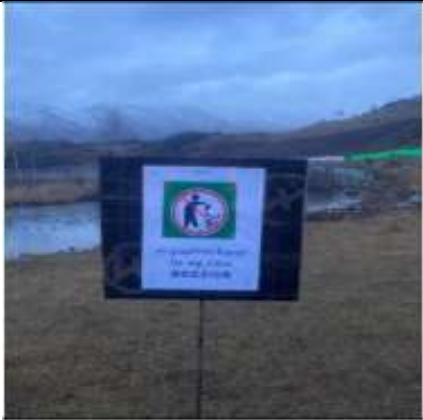
41	Plateau Lake	November 2024	Extend the fence of the lake to protect the lake from flowing rock mass	Medium	CC to protect the lake by providing fence.	Nov 2024	CC improved the fence around the lake and posted signs to protect the lake.	Closed November 2024

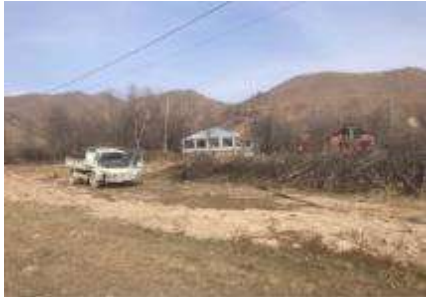
42	Handing over the wood logs to NFA	November 2024	CC to collect all the woods and hand over to NFA	Low	CC to collect all the leftover wooden branches from the GARP and handover to NFA	November 2024	CC removed all the wood logs and handed over to NFA

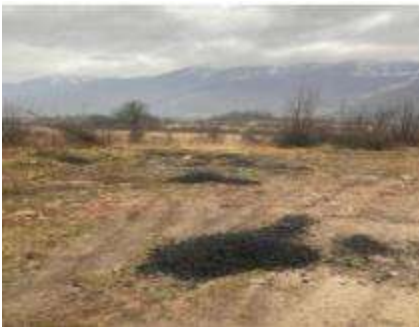
43	Construction site, Plateau	November 2024	Inert waste at the site	Low	CC to clean out the area and remove the concrete waste and asphalt waste	November 2024	CC cleaned out the inert waste	Closed November 2024

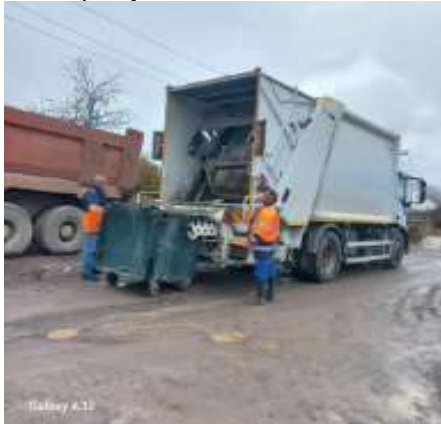
44	Campsites	November 2024	Waste containers filled with the waste	Low	CC to clean out the area and call the municipality to collect the waste	November 2024	<p>Contractor cleaned out the area and municipality collected the waste.</p>

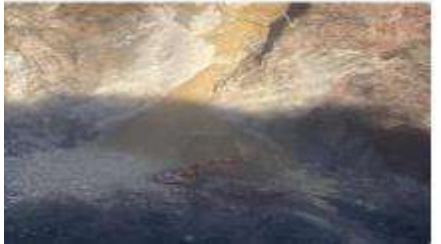
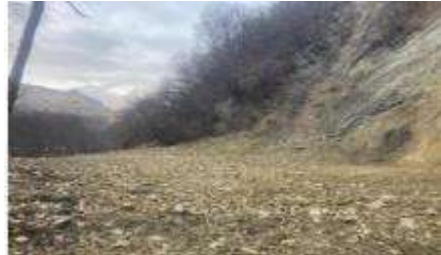
45	Bridge 3	November 2024	Rockflow mass need to be removed near bridge 3	Low	CC to collect the subsoil	November 2024	<p>CC removed the subsoil</p>

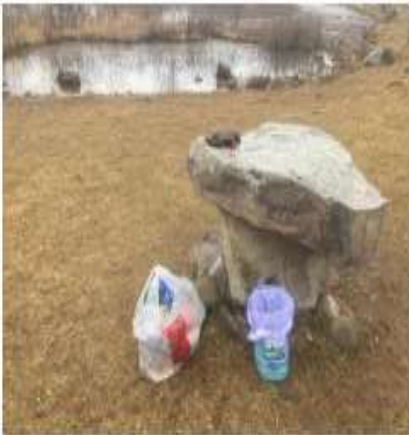
46	Plateau near the lake	November 2024	Littering near lake	Low	CC to collect the waste to avoid waste flowing in to the lake.	November 2024	CC collected the waste.

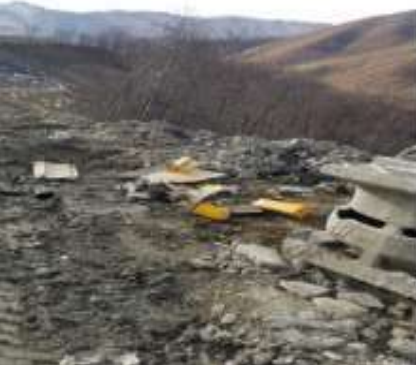
Closed November 2024
47	Plateua Construction site	November 2024	Chemical Boxes and filters on the ground	Low	CC to collect the chemical boxes and store in a designated area	November 2024	CC collected the waste and removed the chemical boxes from bridge 3

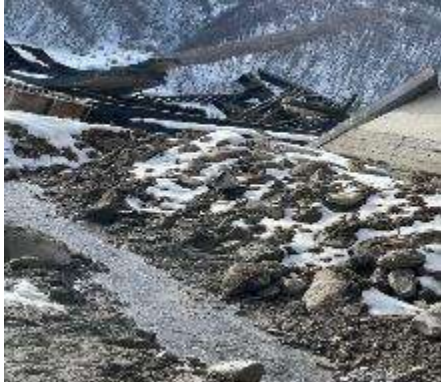
52	Didveli Plateau	December 2024	Excavation of Material Near Lake	Medium	<p>Contractor to clear the lake and avoid boulders flowing in to the lake during this week. Avoid the lake protection zone about 30 meters from the edge of the lake.</p> <p>Dedicated environment staff should be present all the time there in coordination with UBM field</p>	December 2024	<p>Contractor improved the fenced of the lake to completely protect it.</p>

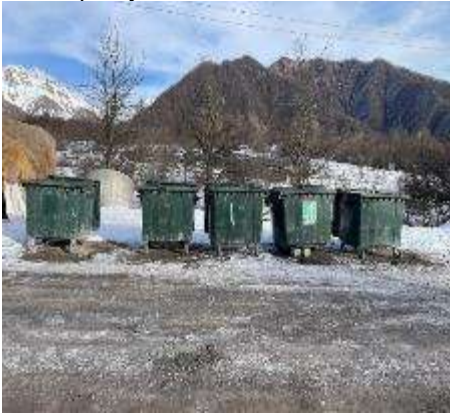
Medium	Contractor to remove broken excavator from private land.	December 2024	Contractor has collected the oil spill; however, should remove broken excavator and made arrangements to shift from private land up to December 31, 2024	Inprogress
54	Camp 2	December 2024	Waste containers filled with the waste	Medium	Container to call munciplaity to take the waste	December 2024	Municipality truck collected the waste

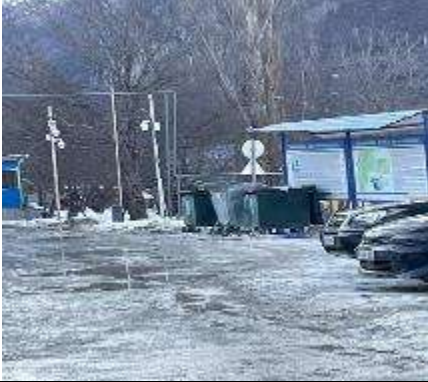
Closed December 2024
55	Camp 2	December 2024	Waste containers filled with the waste	Medium	Container to call munciplaity to take the waste	December 2024	Municipality truck collected the waste	Closed Dec 2024

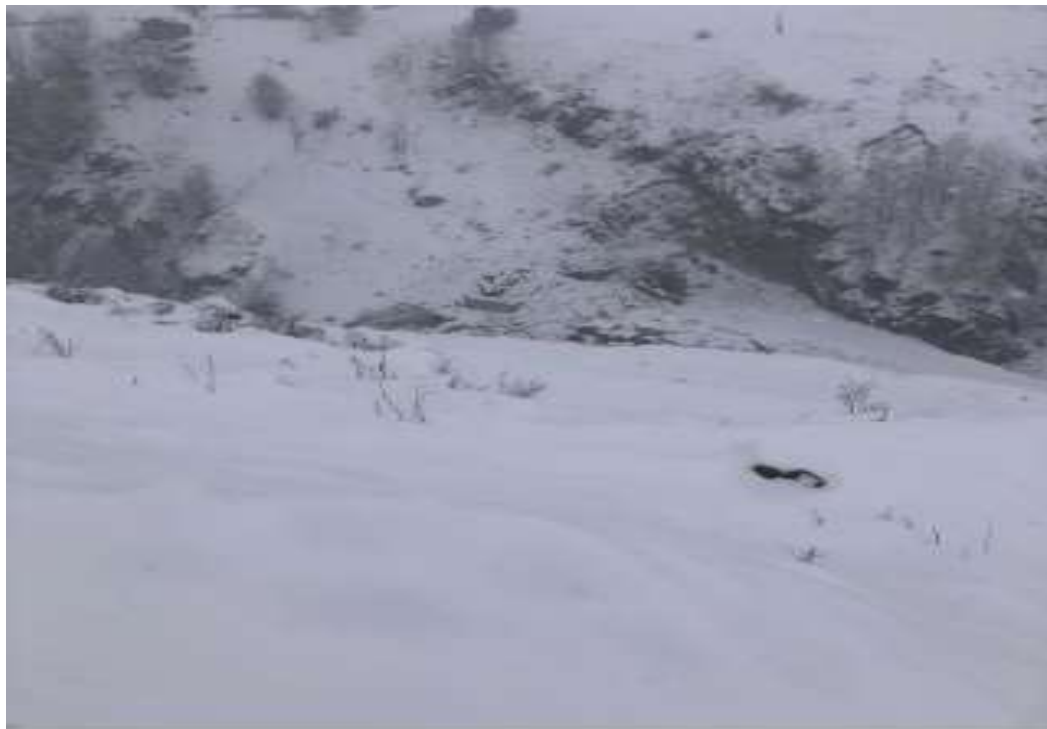
Figure 7 D: Heavy snow during December 2024 restricted ground water sampling from spring in Kobi

105. In December 2024, it was not possible to collect the sample from the spring due to heavy snow as shown in Figure 7 D.

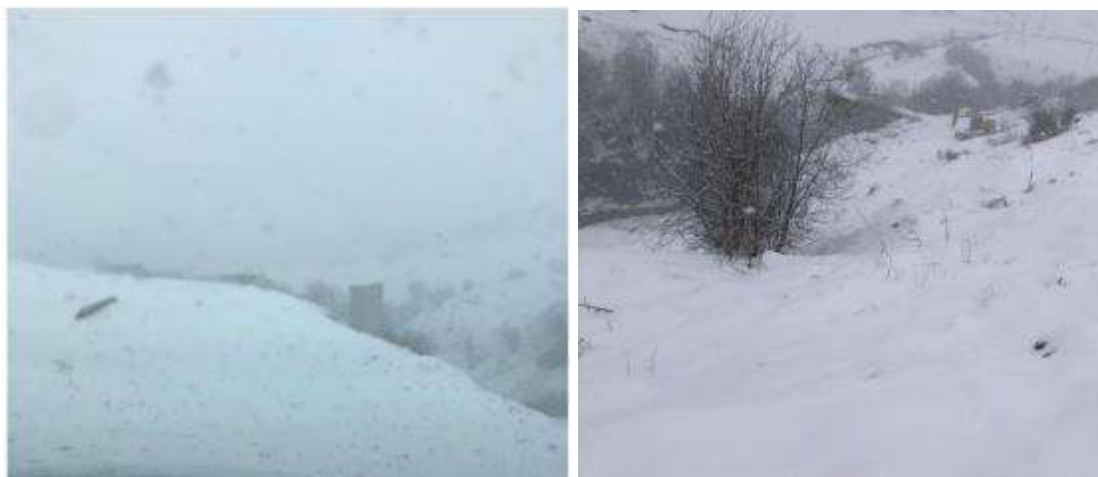
Figure 9: Heavy snow during December 2024 limited water sampling from River Khadistskali

113. In December 2024, heavy snowfall in Tskere prevented access to the River Khadistskali, making it impossible to collect water samples from both upstream and downstream locations.

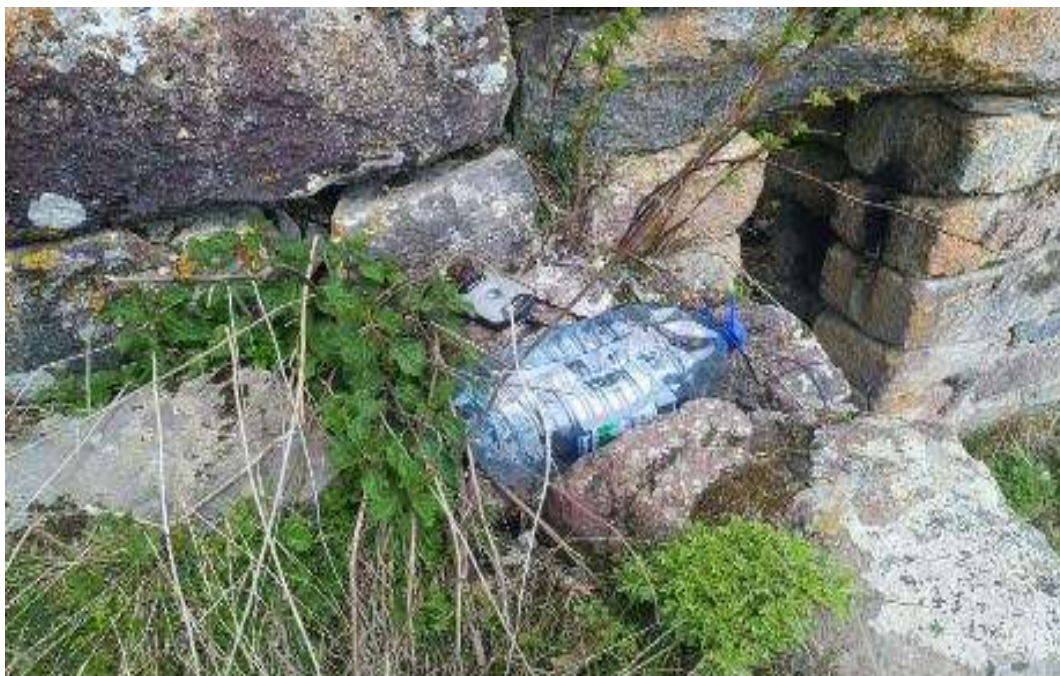
Figure 16: Continuous Vibrational Monitoring at CH Site 29, Mughere, Lot 2

131. For Lot 2, during the reporting period continuous vibration monitoring was conducted at the locations shown in the map below and mentioned in Table C. The Contractor has 5 devices for all CH sites. Vibration monitoring devices were not installed at all locations recommended by NACHP during the reporting period, as there was no need for monitoring at sites where no construction activities were taking place nearby. For the monitoring of cultural heritage sites, those places that are close to construction areas were selected.

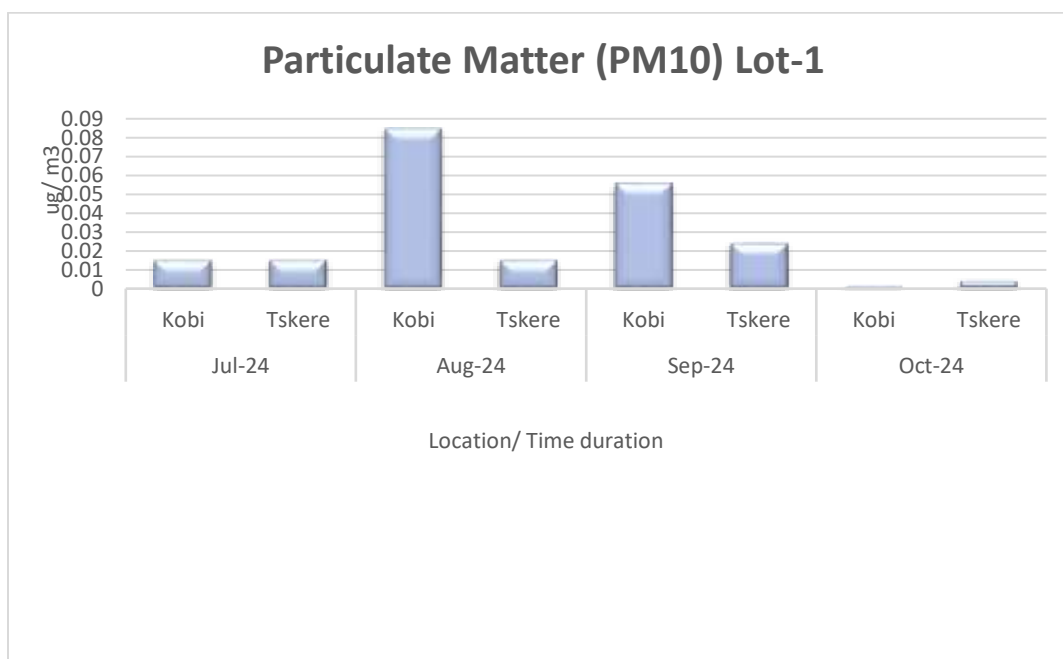
Figure 17: Dust Levels (PM10) at Lot 1 (July – December 2024)

135. PM10 levels including the concentration levels of NO₂, SO₂, CO and dust levels as indicated in Table 14A are within the national limits for air quality in Georgia and IFC guidelines (for trend of PM 10 Levels during reporting period (see figure 17). CC for Lot 1 was carrying out regular water sprinkling at Kobi; however, CC for Lot 1 is not using the access road 1 as they have access for Tskere through Tunnel 5.

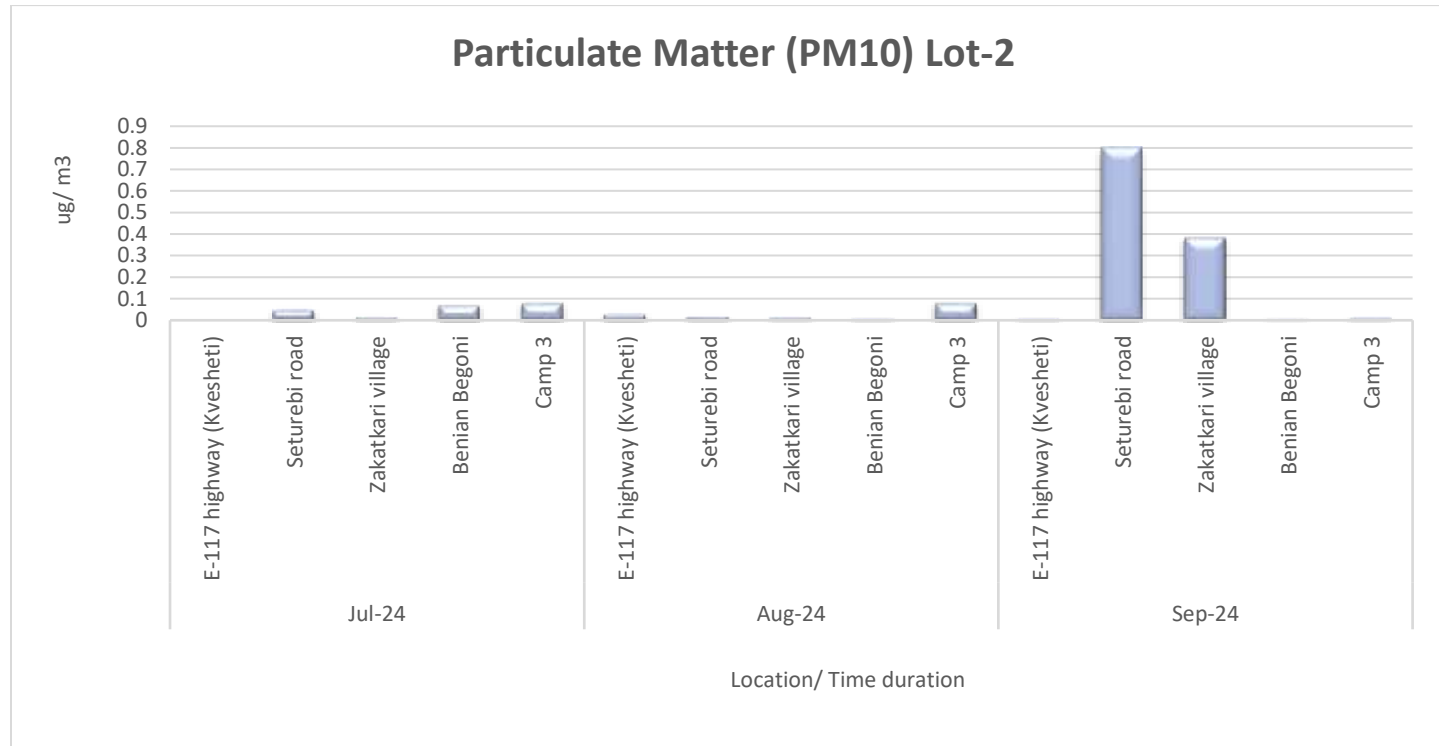
Figure 18: Dust Levels (PM₁₀) for Lot 2 (July – December 2024)

136. CC for Lot 2 monitored air quality from July to September 2024. The details of locations and results are provided in the Table 14B. All the parameters measured are within the permissible limits of IFC guidelines. Graphical presentation is shown in the Figure 18 to see the trends during the reporting period and ambient air is very clean. Fugitive dust emissions are being observed at the access road when heavy vehicles moving on the access roads during dry and windy days. Contractor is required to regularize the water sprinkling in Khada Valley and Didveli Plateau to suppress the fugitive dust during the next summer. Fugitive dust levels are the major issue in Khada Valley and Didveli Plateau at access road while vehicles travelling on access road during dry and windy days of summer season. Lot 2 has prepared dust management plan consisting of Action Plan to combat the dust and need to be properly implemented and UBM field officers should monitor on daily basis.

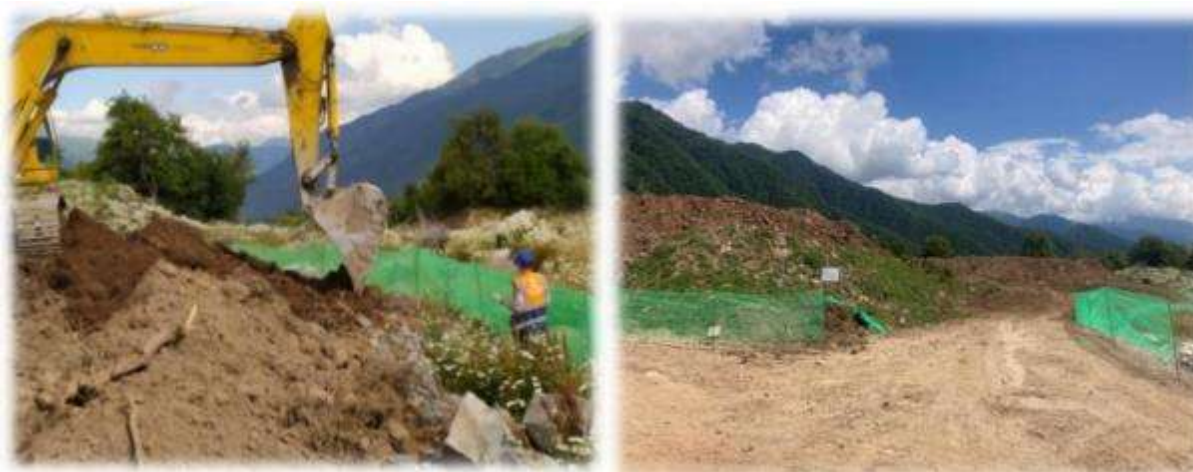
Figure 21A: Topsoil preservation October-November 2024 Lot 2

141. To avoid contamination of topsoil and preserve according to topsoil management plan, contractor for Lot 2 removed tree roots and cuttings from the topsoil stored at plateau during the reporting period. Additionally, The Lot 2 Contractor fenced off the walnut trees at SDA #3 in Kvesheti during the reporting period to protect them during construction.
