Semi-annual Environmental Monitoring Report

Project Number GEO 51257-001

Reporting period: July – December 2024

Georgia: North-South Corridors (Kvesheti – Kobi) Road Project

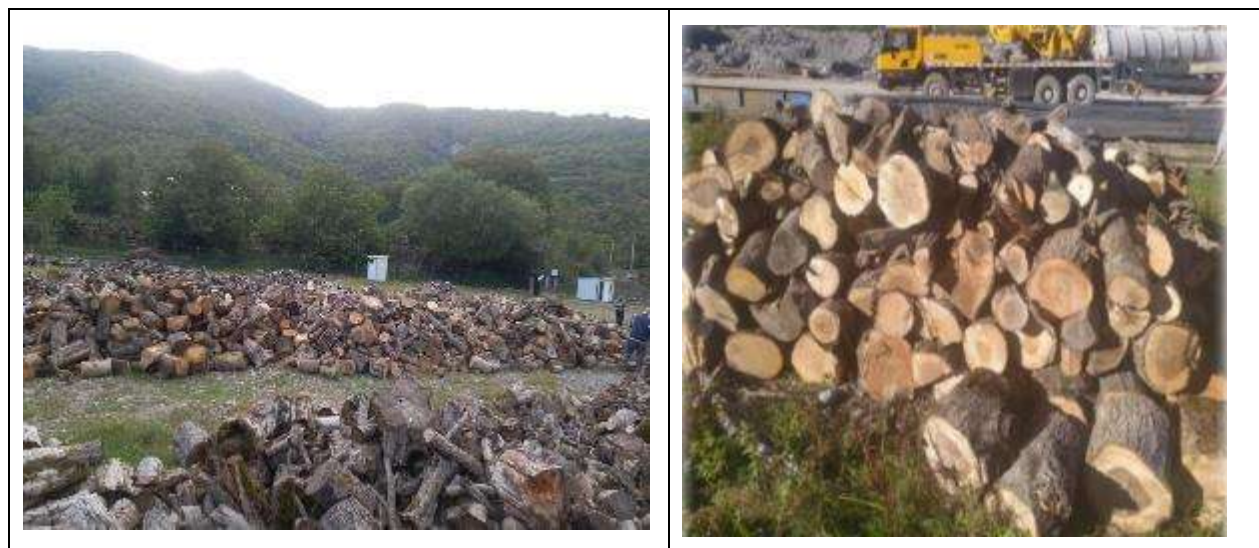
Figure 21B: Wood Logs handed over to NFA during October-November 2024

142. The contractor for Lot 2 obtained the tree cutting permit from the National Forestry Agency (NFA) from GARP RoW, stored the wood logs near parking lot and handed over 90 cubic meters of wood logs in total to the NFA during the reporting period as per the tree cutting permit requirements. The process of handing over the wood logs to NFA has been completed.

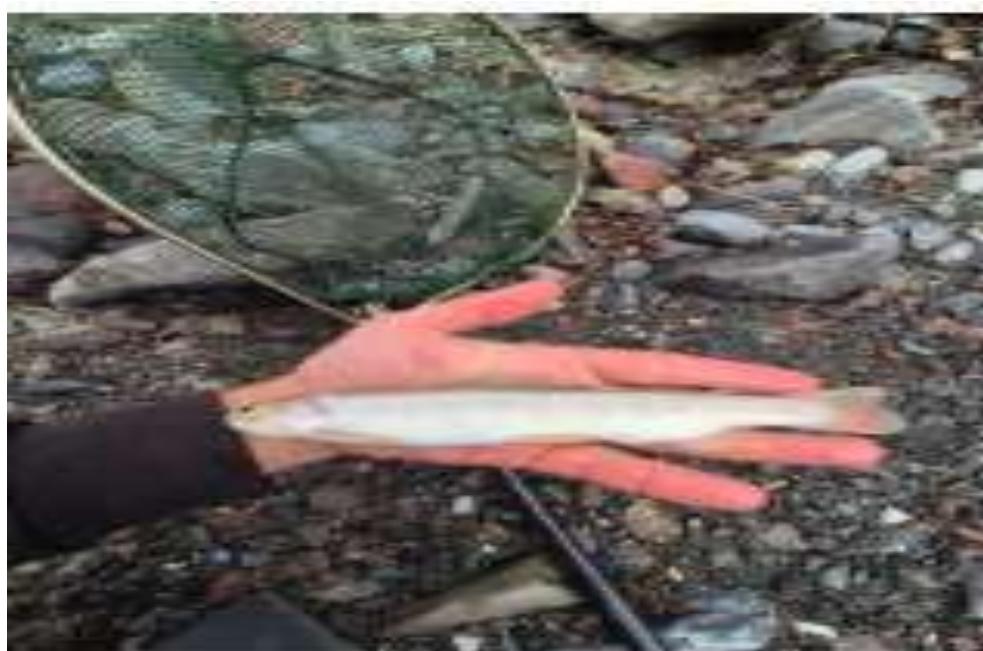
Figure 21C: Fish Monitoring in River Khadistskali and Aragvi - November 2024

143. For Lot-2 Contractor carried out fish monitoring in November 2024 in River Khadistskali and Aragvi. The findings of the fish monitoring report indicate that Caspian trout (*Salmo caspius*) were observed during the survey and are widely distributed in the upper basin of the Tetri Aragvi River and its tributaries. In recent years, several field studies have been conducted in this river basin, where trout have been recorded. It is likely that trout inhabit the project area year-round and spawn there. During the summer monitoring, Kura spirin (*Alburnoides eichwaldii*) was also observed in the project area, but it was not seen this time. Overall, the Khadistskali River has low species diversity and population density of fish.

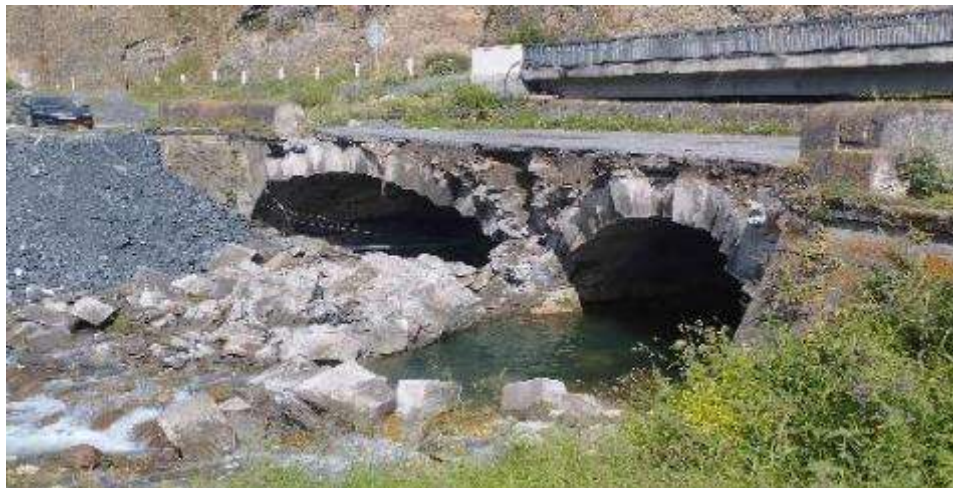
Figure 22 A: Damaged part of the Kobi Arch Bridge

145. Lot 1. Monitoring of the Kobi Arched Bridge on the Narovan/Narvan River was conducted by cultural heritage specialists from the Engineer and the Contractor. During the initial monitoring in 2020, cracks and fractures were observed in the lower part of the bridge pier located directly in the river. This damage resulted from natural conditions. To address the bridge's deteriorating condition, barricades made of small pillars were installed in January 2021 to prevent heavy machinery from accessing the bridge. A warning sign was also placed in the area. However, starting in May 2021, residents began using the bridge despite these precautions. In response, the contractor installed additional markings near the bridge. RD informed NAHCP and cultural heritage specialists from the supervisory company conducted special training for drivers to discourage its use.

146. In April 2022, a significant deterioration of the bridge pier was observed, with widening cracks and part of the pier beginning to separate from the main structure. The bridge remained in this condition until July 28, 2024, when the northern part of the bridge collapsed. This damage was not due to the project.

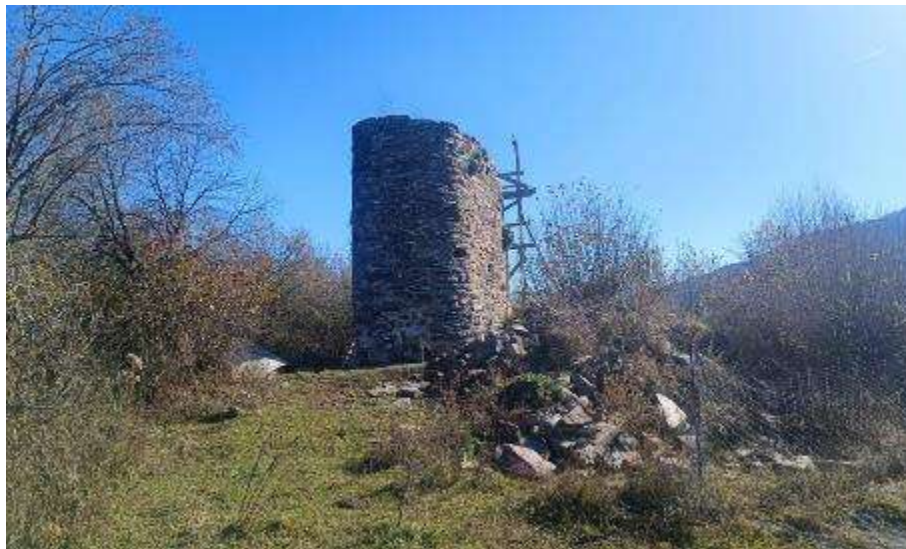
Figure 23: Conservation Works of Didveli Backed Tower (CH Site #10)

149. . The conservation project for CH #10 was delayed multiple times due to adverse weather conditions, which caused the subcontractor to fall behind schedule. The work was ultimately completed in November 2024, and the NACHP conducted a site visit to assess the completed project, which was carried out by sole proprietor Paata Basishvili. In December 2024, the NACHP

officially accepted the completed works. The conservation of CH #10 (Didveli Backed Tower) was originally scheduled for completion by December 8, 2023.

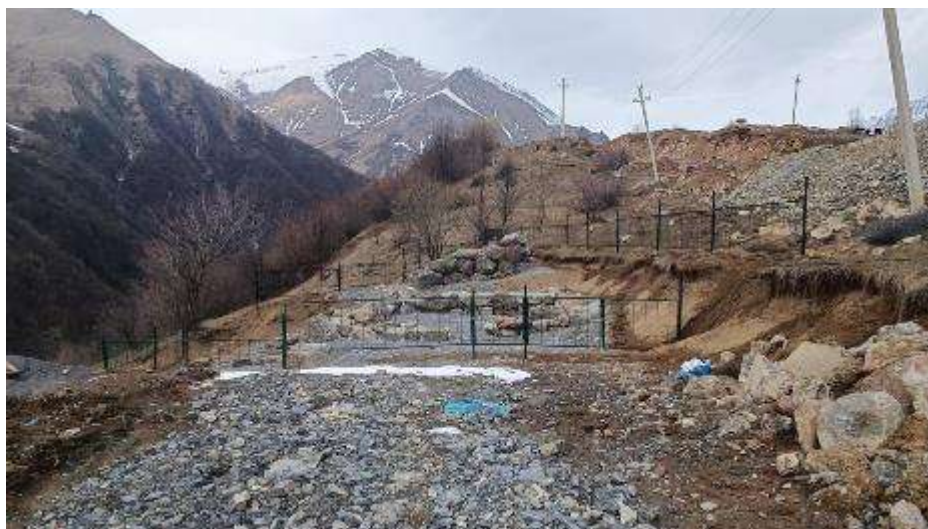
Figure 24: Relocation Completed for CH #26

150. The subcontractor proceeded with the relocation process for CH #26 (Remains of Backed Tower), The works were carried out by LTD Boni. The original location was part of the RoW, the new location was approved and predetermined by NACHP. carefully numbering each stone for tracking and identification. The placement of the numbered stones commenced systematically on the prepared platform, ensuring proper alignment and stability throughout the process. All works were closely monitored. By the end of November 2024, the relocation process was completed. The National Agency for Cultural Heritage Preservation conducted a site visit to assess and accepted the completed works.

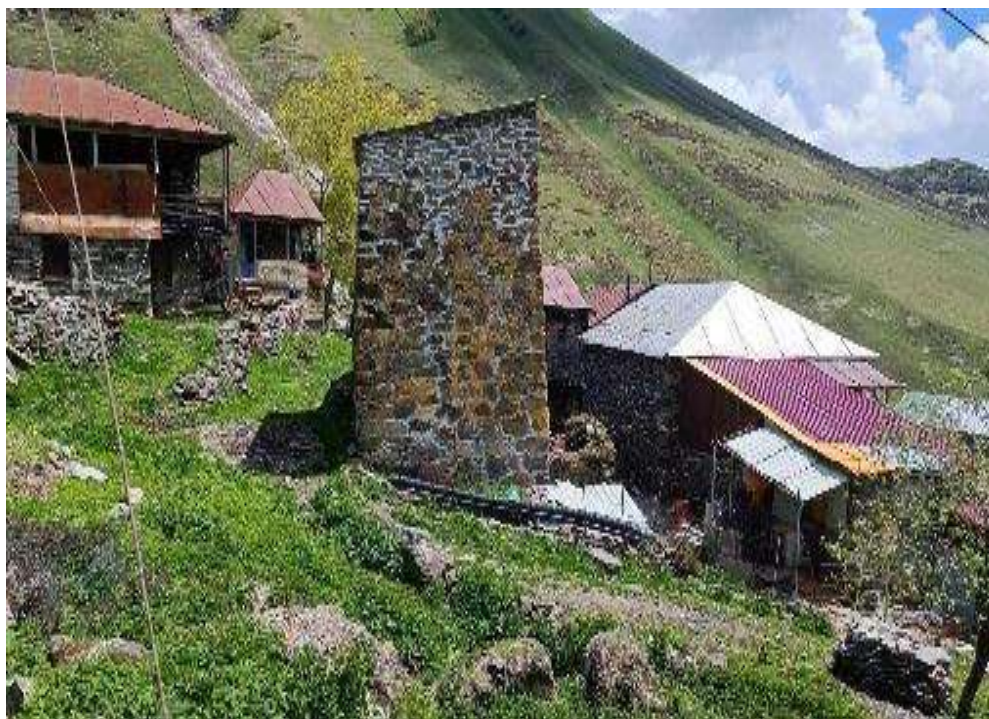
Figure 25: Completely fenced Zakaidze Ttower, Tskere

153. In the reporting period, PMCSC CH Specialists constantly monitored the identified CH Sites. Construction didn’t affect any identified CH Sites.
154. The Contractor for Lot 2 upgraded and reinforced the damaged fences around the required CH sites.

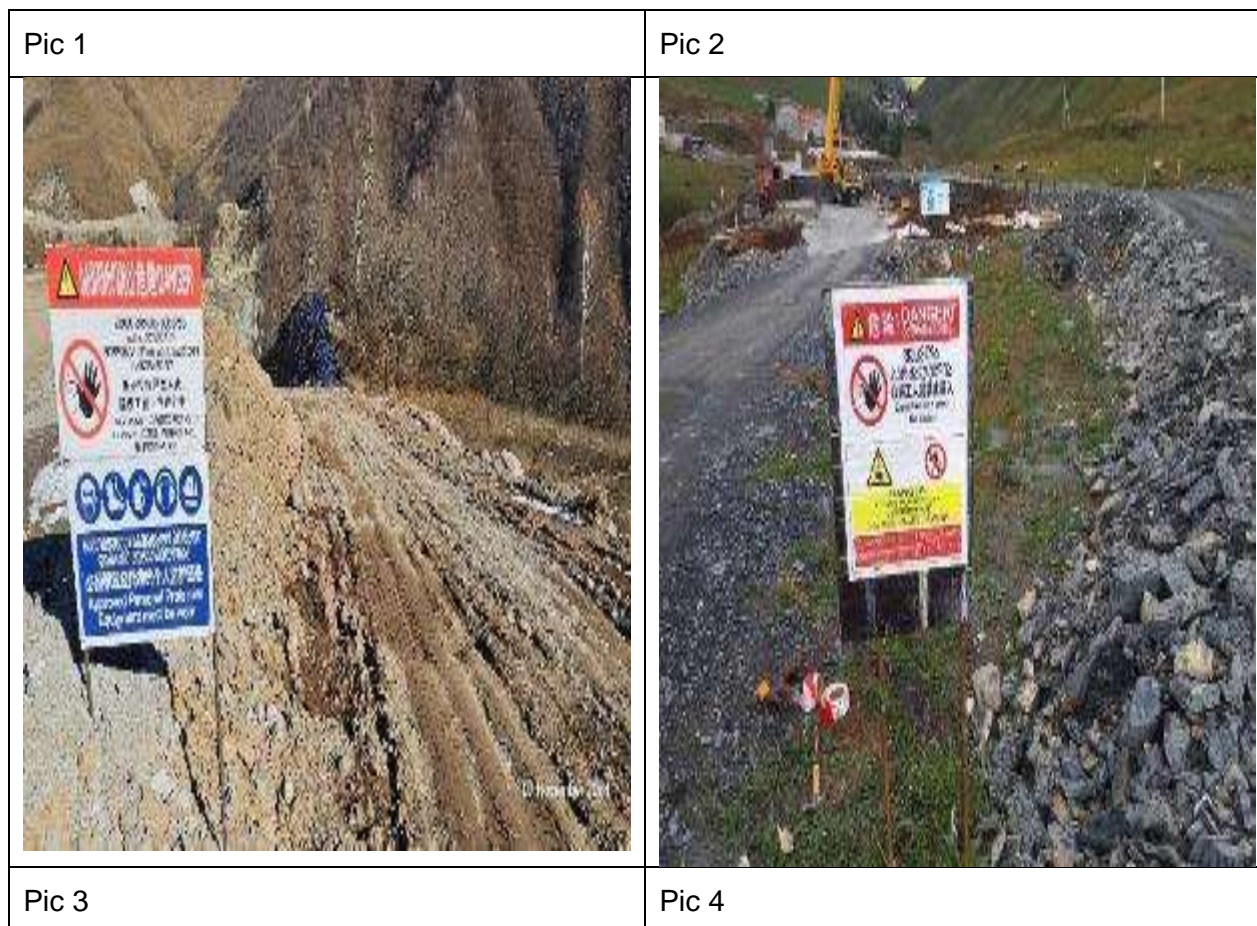
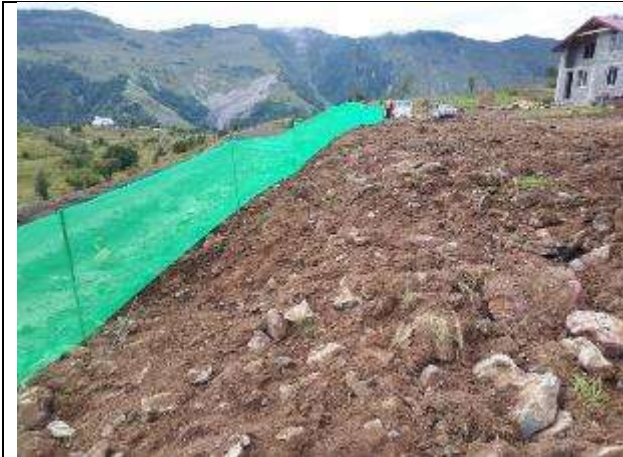
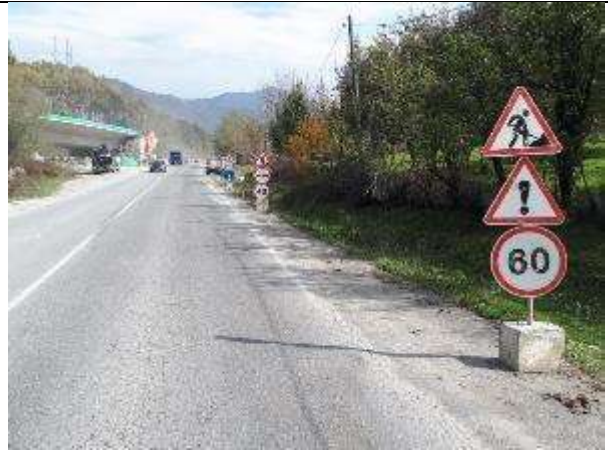
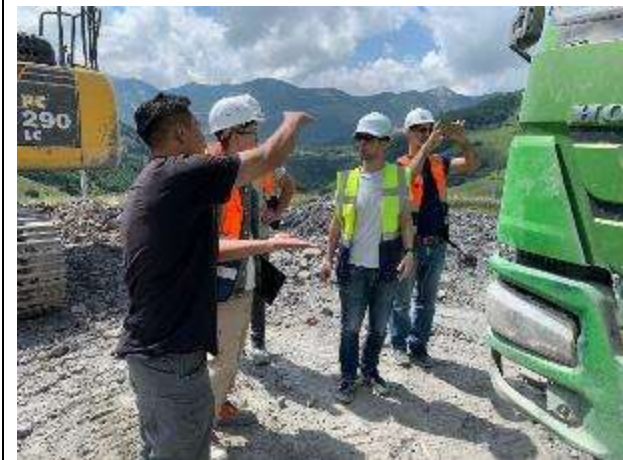
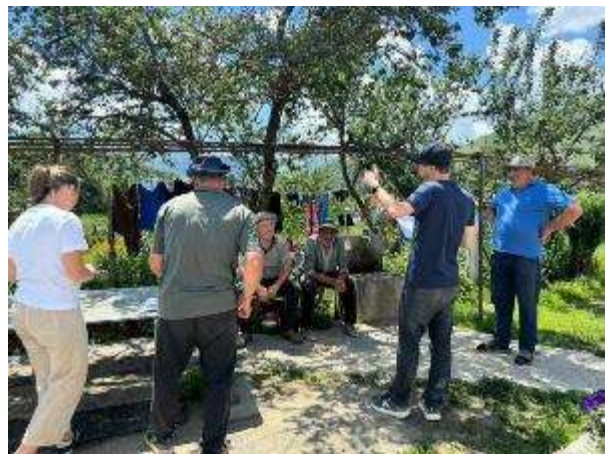
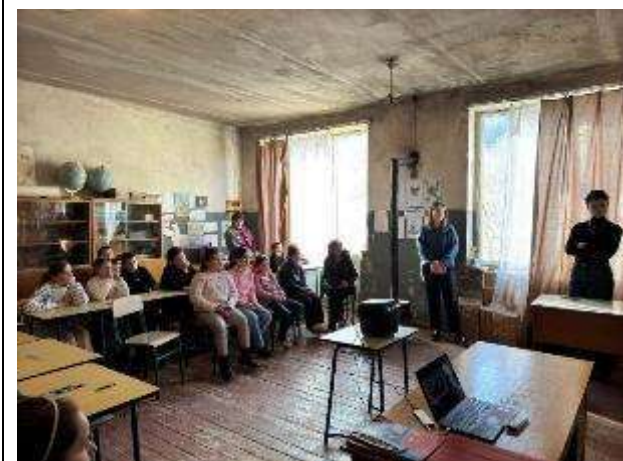
Figure 27: Community Health and Safety

159. Compliance with community health and safety was monitored during the whole reporting period by the PMCSC on a daily basis as a part of regular worksite inspections.
160. The Contractor continued to upgrade fences and warning signs across the worksites to ensure that locals are proactively informed regarding construction activities and risk associated with them. Throughout this period, the Contractor did not always manage to identify all shortcomings proactively but the PMCSC's and ADB ESM engaged timely and problems were rectified. (Pic 1, 2, Figure 27)

- Lot 2 Contractor installed the fence along the ROW in the village of Jaghmiani, which is located close to the construction of Gudauri Access Road. Local's residential house was identified to be located close to the edge of the excavation and hence, the installation of fence was of an urgent need to prevent any falls (Pic 3, Figure 27).

- Existing controls
 - Children on the ground.
 - Locals communicated their concerns which were noted, addressed and considered for the future (Pic 6, Figure 27).

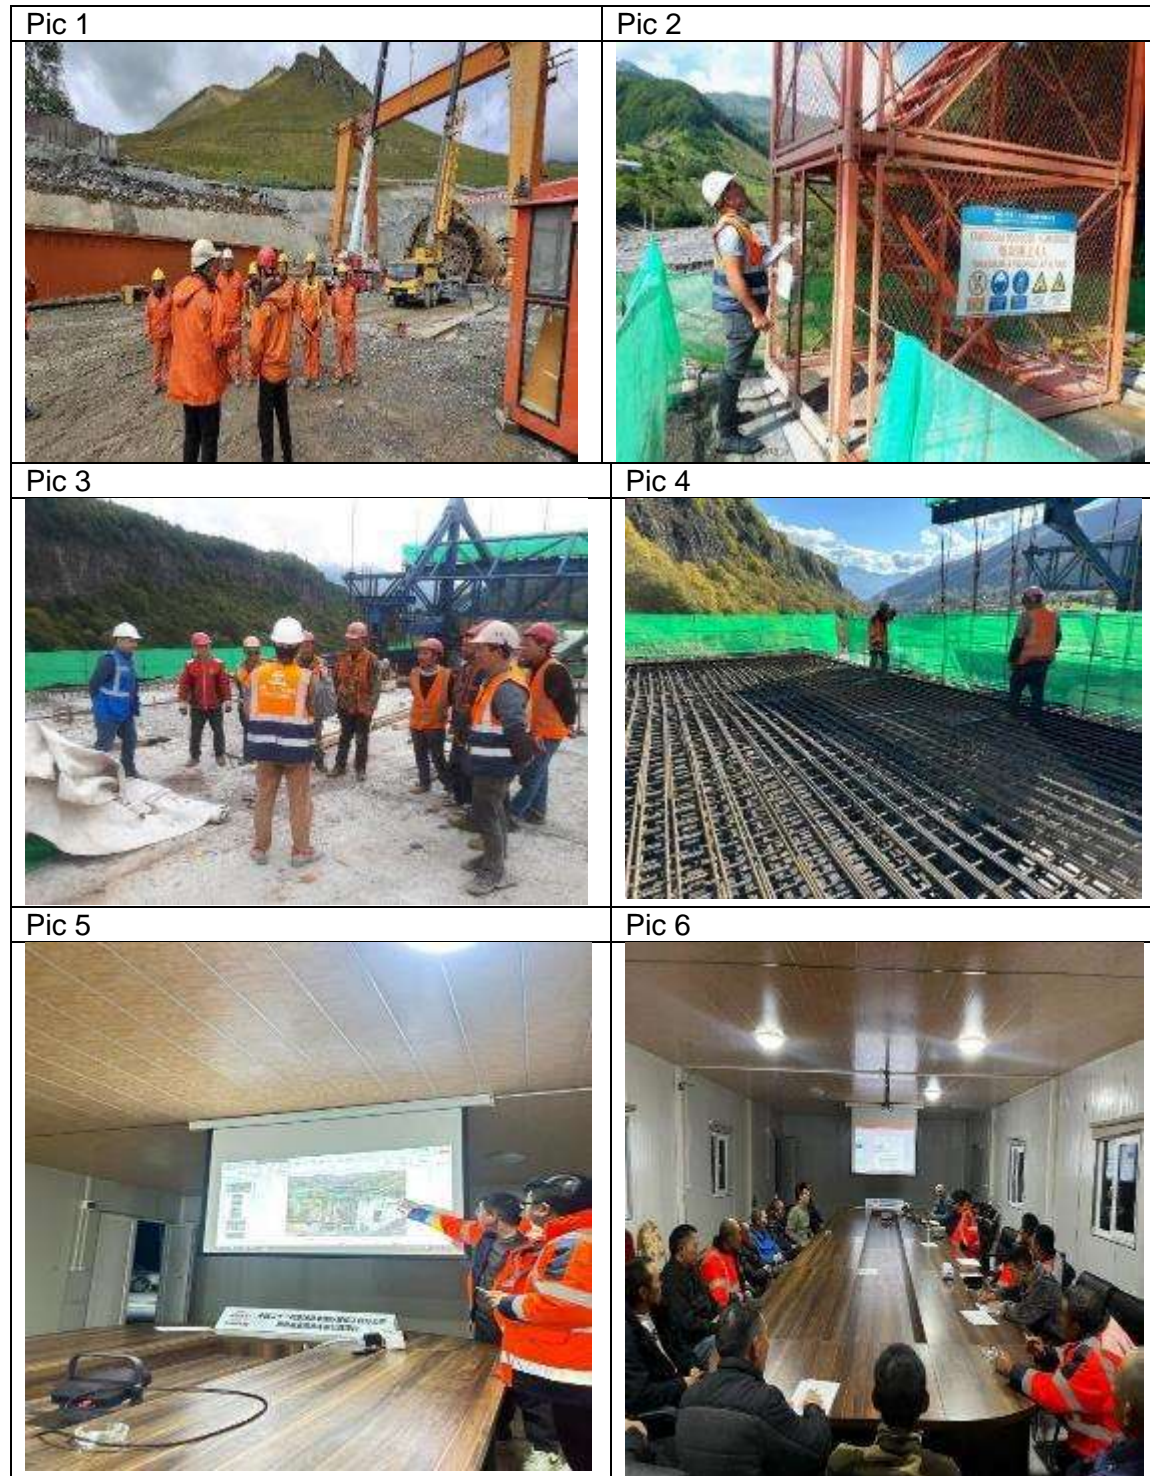
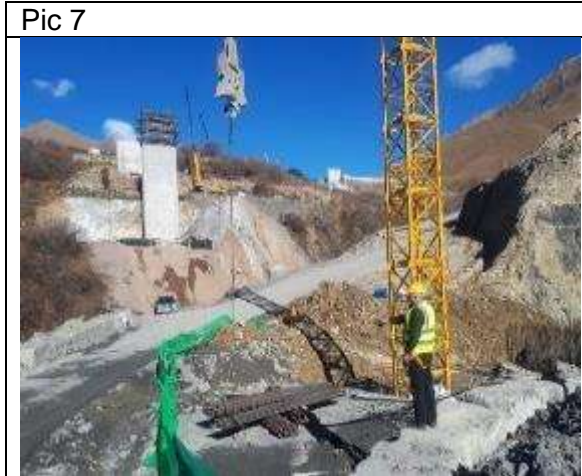
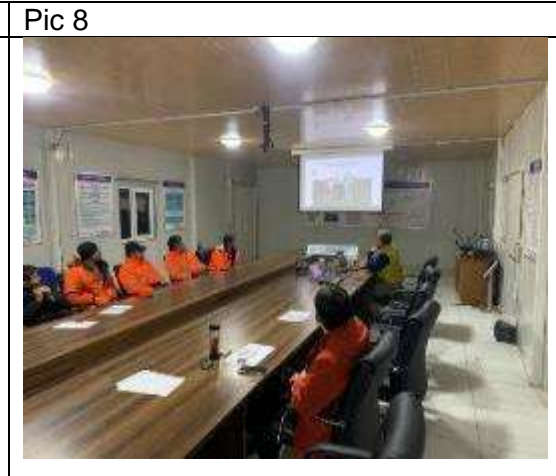
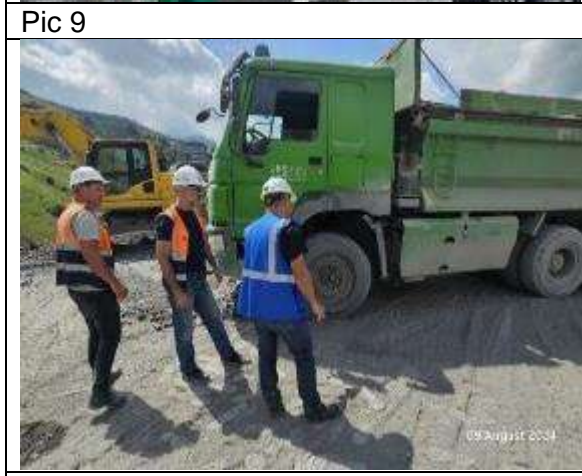
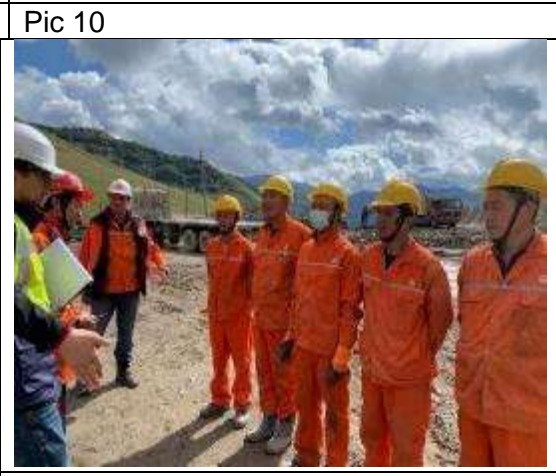
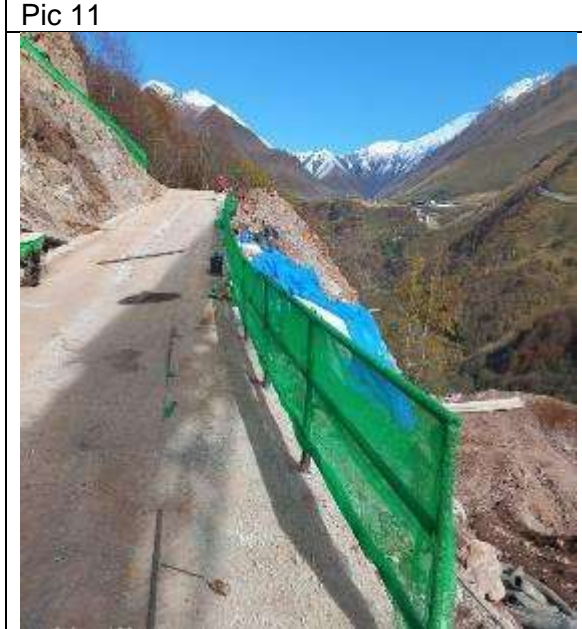
Figure 28: Health and Safety Related Trainings Conducted in the Reporting Period by Lot 1 and Lot 2

170. The Lot 1 Contractor continues to work in the main tunnel mostly on the casting of the driveway shoulders. TBM disassembling is almost completed at Tskere which required difficult lifting activities with a few tandem lifts. This activity was under the permanent supervision of the PMCSC's and RD's H&S specialists. Personnel involved in this activity were trained and toolbox talks were regularly delivered at the worksite. (Pic 1, Figure 28).

174. During this reporting period, Lot 2 Contractor completed the construction Bridge 2 main structure (casting of box girders) which was the biggest challenge for health and safety at Lot 2 section during this reporting period. This resulted in connecting all piers with each other and closing the gaps where workers had to work on the formwork platforms and use stair towers to access the bridge. The stair towers, scaffolding and guardrail systems were a subject of permanent inspection carried out by a certified scaffolder during the reporting period (Pic 2, Figure 28). In addition to it, the Contractor's and the Engineer's HS specialists carried out regular joint inspections of Bridge 2 when the results were documented. Also, regular toolbox talks were conducted with the personnel at the bridge deck targeting different tasks. (Pic 3, Figure 28).

175. Collective protective measures are prioritized over the PPE during the construction of Bridge No. 2. Proceeding from it, the use of collective protection was expanded even more. In particular, the use of administrative and PPE controls at the leading edges of the bridge where it was not practical to use collective protection, were replaced with guardrails system. Despite the fact that exposure period was extremely short and the use of guardrails at leading edges of the bridge was difficult due to technical issue, guardrails were installed at those sections as well. Hence, 100 percent of bridge edges were protected by collective protection (Pic 4, Figure 28).

180. During the reporting period, Lot 2 Contractor invited third party certified company to inspect the stationary crane which is being used for the construction of Bridge No. 5 in Khada Valley. The crane successfully passed the inspection and was certified (Pic 7, Figure 28).

184. Not quite effective management of health and safety was observed at 7+800 KM cut section at Lot 2. In particular, workers were observed working on the installation of rockfall protection metal mesh without wearing safety harnesses. The activity was stopped, and TBT delivered to the personnel. Despite this fact, this violation recurred later and hence, improvement of supervision at the spot is required.

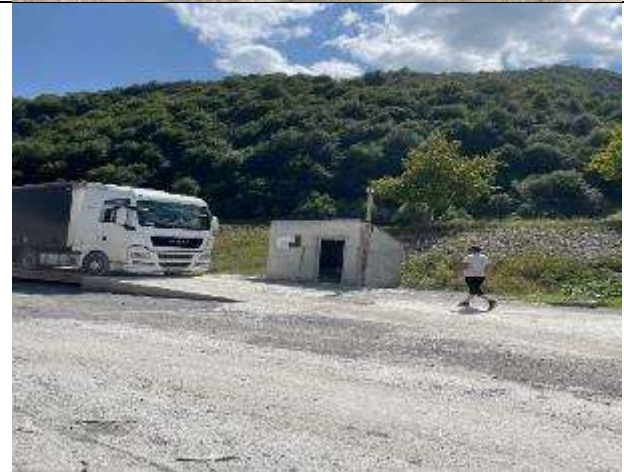
A photograph of a weighing station at a batching plant. A white truck is parked on a scale. A person is standing near the scale. The background shows a forested hillside under a blue sky with clouds.	<p>Weighing station at Batching Plant 1 September 2024</p>

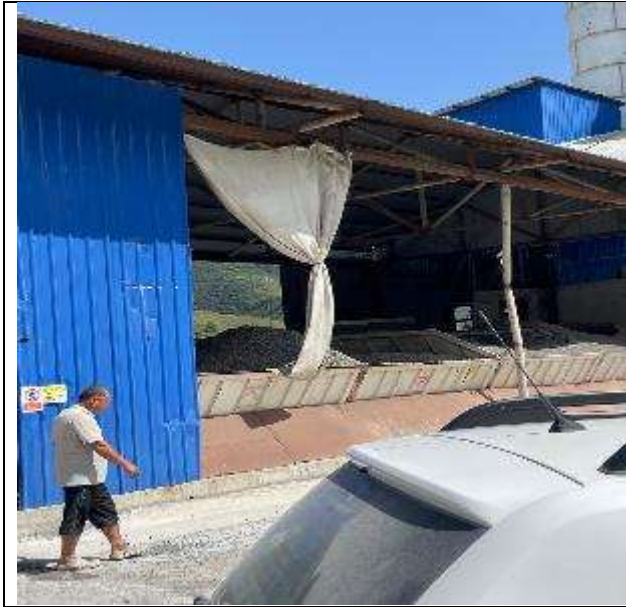
Material covered for the use in batching plant
1 September 2024

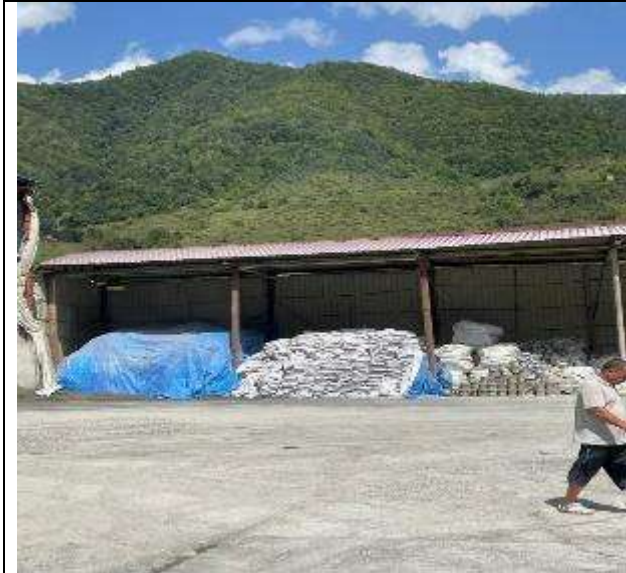
Material placed under the roof – sustainable
use of material BP 1 September 2024

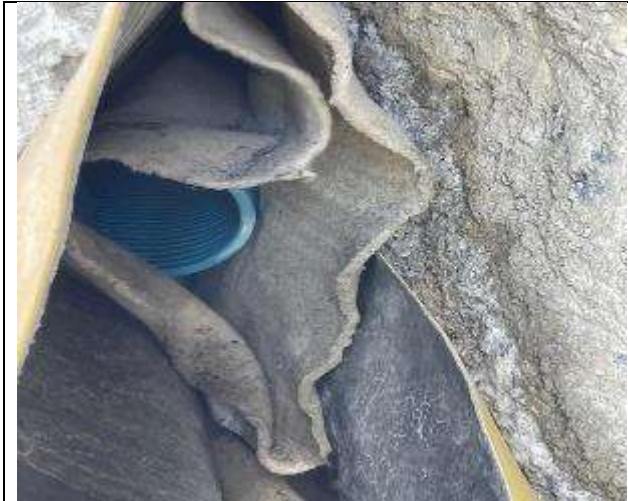
Tunnel water arrangement at tunnel after completion of linings lot-2

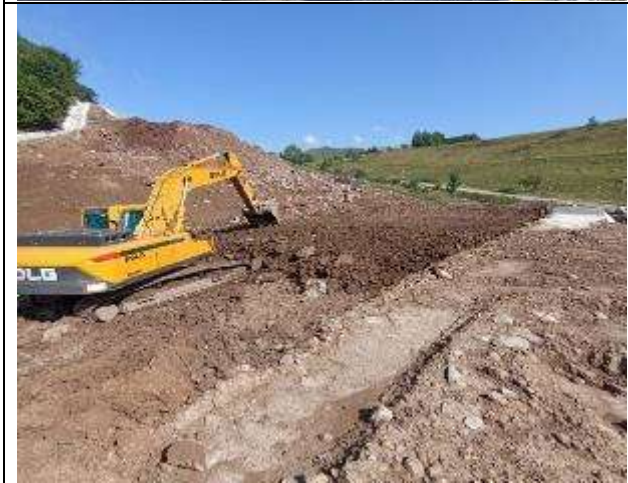
Ongoing Construction activities at Gudauri Access road project September 2024

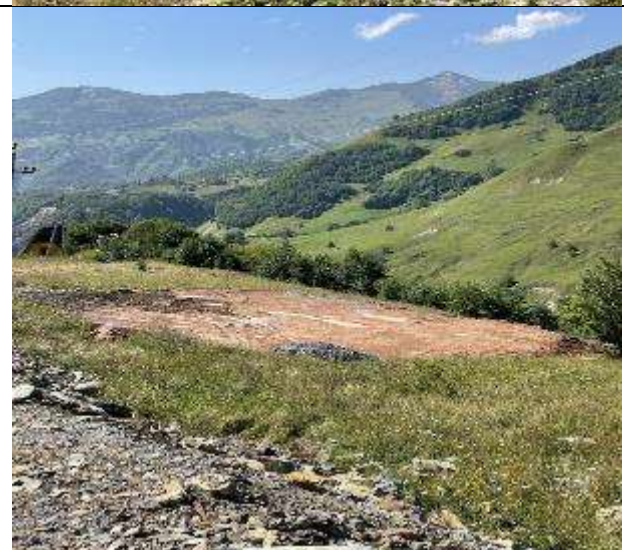
A photograph of a dirt area on a hillside, likely a construction site, with a view of distant mountains.	<p>Place for shifting of CH in Benian Begoni September 2024</p>

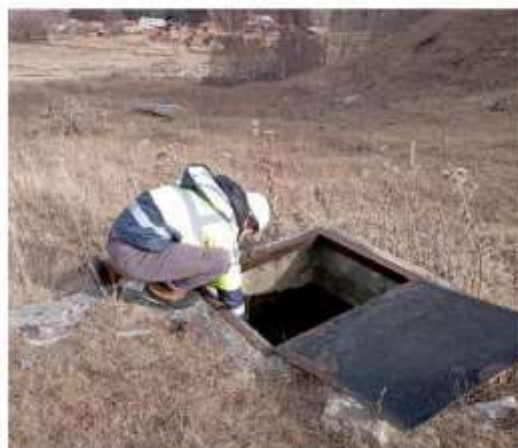
Figure 3.1.1 Ground Water Quality Monitoring (GWS - #1)

Water sample was taken from the well. The well is located above the construction camp. Gergili team used sterile bottles for sampling. The volume of the water was – 5 liters. The samples were not examined/analyzed at the location. Instead, they were sent to the lab considering all the safety rules.

Parameter	Measurement Unit	Method used	Results	Maximum permissible limit according to ordinance #425
Organoleptic Parameters				
Color	degrees	Gost 3351-74	0	not be observed in the water column
Physical-chemical Parameters				
pH	-	SST ISO 10523:2008/2010	7.95	6.5-8.5
Turbidity	NTU	ISO 7027-1:2016	1.24	N/A
TPH	mg/L	Validated method GL-SOP Wch-73-G-19	<0.05	0.3
Total Mineralization (TDS)	mg/L	SST ISO 7888-2007	136.1	<1000
Microbiological Parameters				
Total Coliforms	cfu/1 L	ISO9308-1:2014	Didn't show	≤10 000/1L

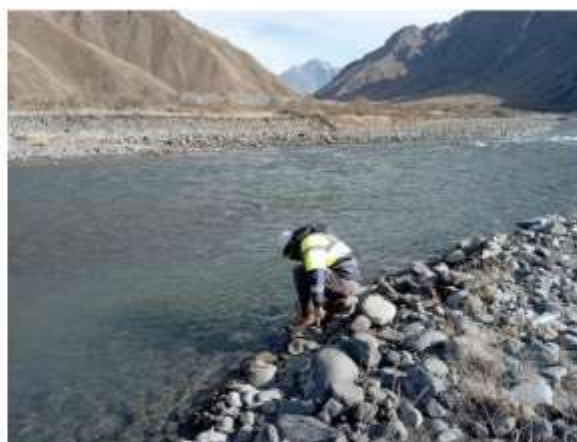
Figure 3.2.1 Upstream Water Quality Monitoring (SWS - #1)

Parameter	Measurement unit	Method used	Results	Maximum permissible limit according to ordinance #425
Physical-chemical Parameters				
pH	-	SST ISO 10523:2008/2010	7.78	6.5-8.5
Conductivity	mS/cm	SST ISO 7888:1985	0.635	≤0.3
Turbidity	NTU	ISO 7027-1:2016	9.68	N/A
TPH	mg/L	Validated method GL-SOP Wch-73-G-19	<0.05	≤0.3
Chemical Oxygen Demand (COD)	MgO/L	HACH Method LCK 214	4.60	≤30
Microbiological Parameters				
Total Coliforms	cfu/1 L	ISO9308-1:2014	40	≤10 000/ 1 L

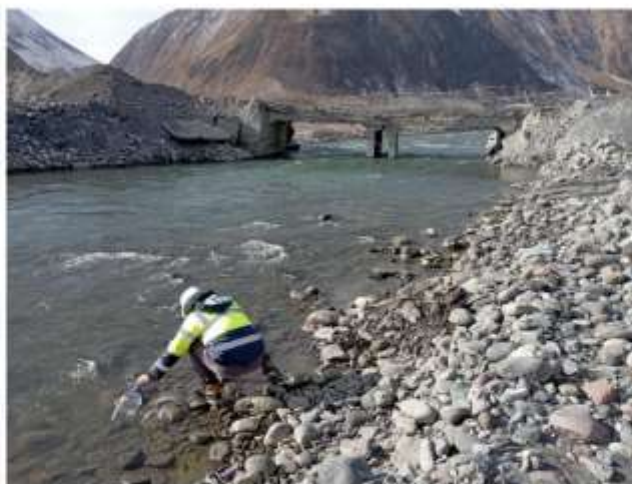
Figure 3.3.1 Down Stream Water Quality Monitoring (SWS - #2)

Parameter	Measurement unit	Method used	Result	Maximum permissible limit according to ordinance #425
Physical-chemical Parameters				
pH	-	SST ISO 10523:2008/2010	7.81	6.5-8.5
Conductivity	mg/L	SST ISO 7888:1985	0.674	≤0.3
Turbidity	NTU	ISO 7027-1:2016	12.40	N/A
TPH	mg/L	Validated method GL-SOP Wch-73-G-19	<0.05	≤0.3
Chemical Oxygen Demand (COD)	Mg0/L	HACH Method LCK 214	7.49	≤30
Microbiological Parameters				
Total Coliforms	cfu/1 L	ISO9308-1:2014	60	≤10 000/ 1 L

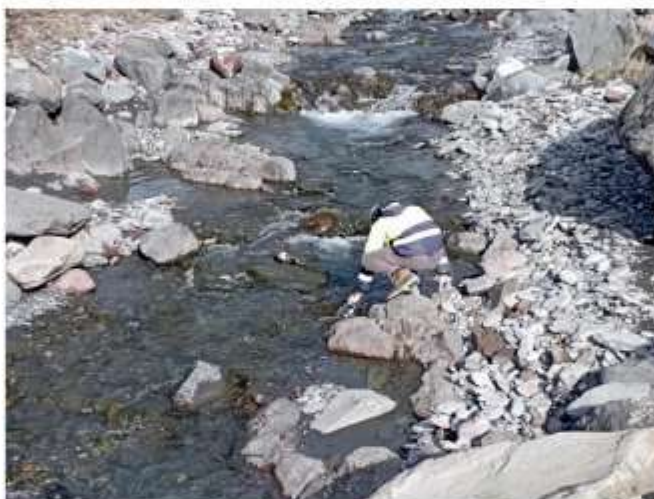
Figure 3.4.1 Up Stream Water Quality Monitoring (SWS - #3)

Parameter	Measurement unit	Method used	Result	Maximum permissible limit according to ordinance #425
Physical-chemical Parameters				
pH	-	SST ISO 10523:2008/2010	7.6	6.5-8.5
Conductivity	mg/L	SST ISO 7888:1985	0.276	≤0.3
Turbidity	NTU	ISO 7027-1:2016	0.40	N/A
TPH	mg/L	Validated method GL-SOP Wch-73-G-19	<0.05	≤0.3
Chemical Oxygen Demand (COD)	Mg0/L	HACH Method LCK 214	0.00	≤30
Microbiological Parameters				
Total Coliforms	cfu/1 L	ISO9308-1:2014	20	≤10 000/ 1 L

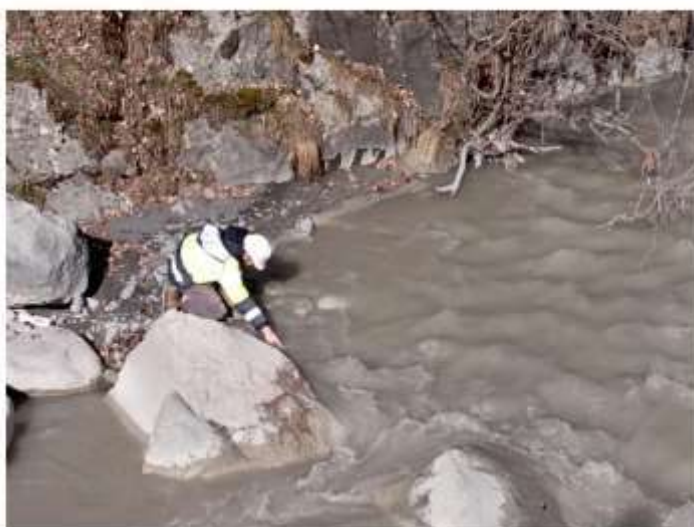
Figure 3.5.1 Down Stream Water Quality Monitoring (SWS - #4)

Parameter	Measurement unit	Method used	Result	Maximum permissible limit according to ordinance #425
Physical-chemical Parameters				
pH	-	SST ISO 10523:2008/2010	8.09	6.5-8.5
Conductivity	mg/L	SST ISO 7888:1985	0.194	≤0.3
Turbidity	NTU	ISO 7027-1:2016	130	N/A
TPH	mg/L	Validated method GL-SOP Wch-73-G-19	<0.05	≤0.3
Chemical Oxygen Demand (COD)	Mg0/L	HACH Method LCK 214	1.28	≤30
Microbiological Parameters				
Total Coliforms	cfu/1 L	ISO9308-1:2014	3200	≤10 000/ 1 L

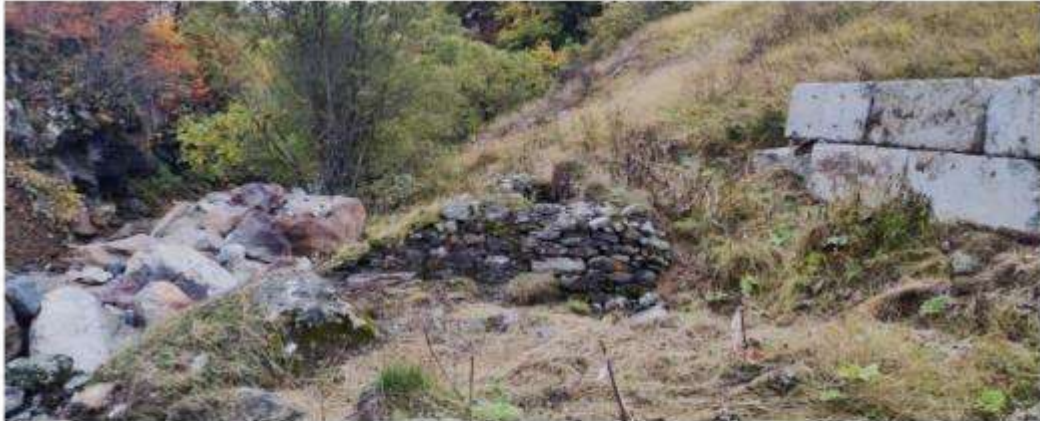
Figure 6: Measurement Point – VM#1 – #10 Tower

1. VM#1 - #10 Tower - Svianaant Tower - located near the Khadiskali gorge, 124 meters from the portal of the third tunnel and near the fourth access road, due to the proximity to the construction area, heavy equipment traffic is frequent on this section. The tower is heavily damaged, one side of it has completely collapsed.

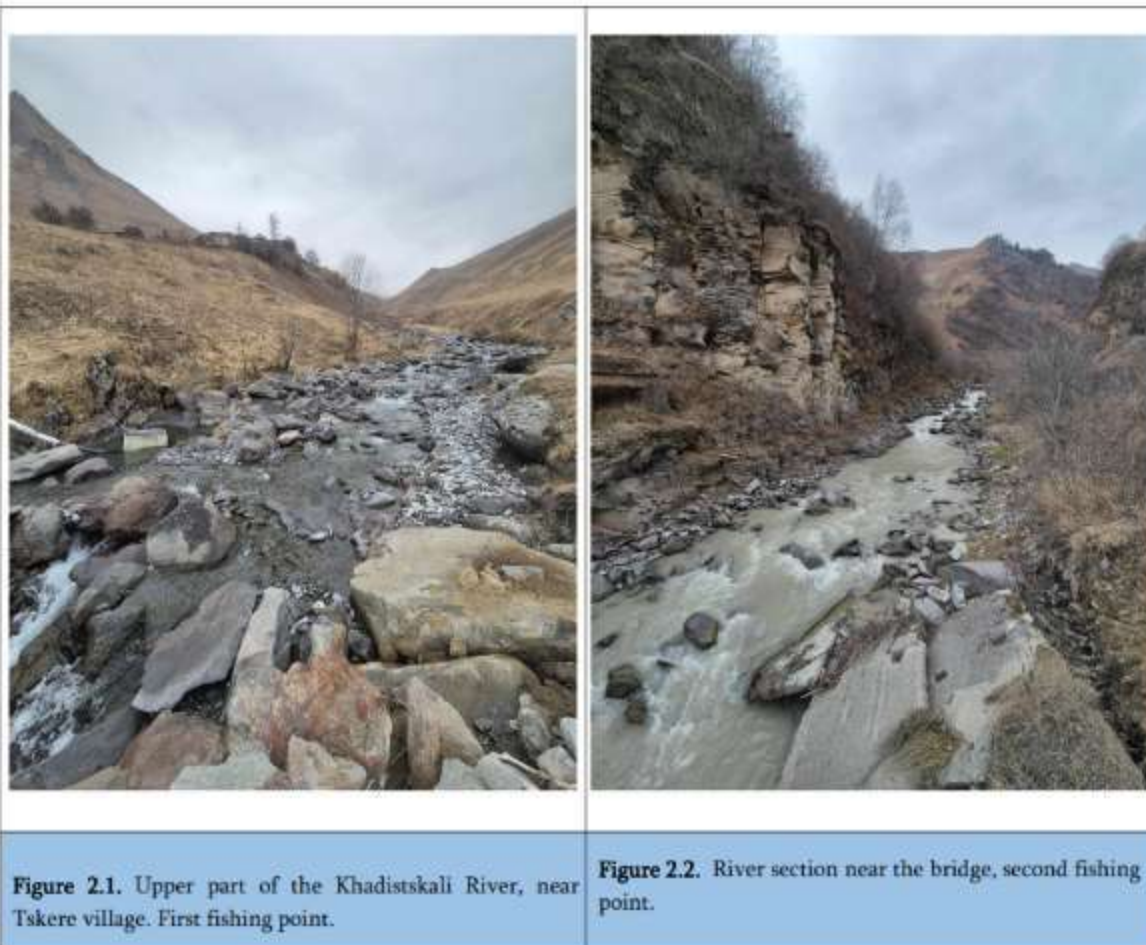
Second fishing attempt carried out near the bridge (Fig. 2.2). On this section, small unnamed stream joins Khadistskali River from the left side, which has waterfall (Fig. 2.3) (coordinate: X – 461260.92 – Y - 4700330.79). For the reason mentioned above, the river in this section was muddy. Neither fish nor macroinvertebrate organisms were observed in this location.

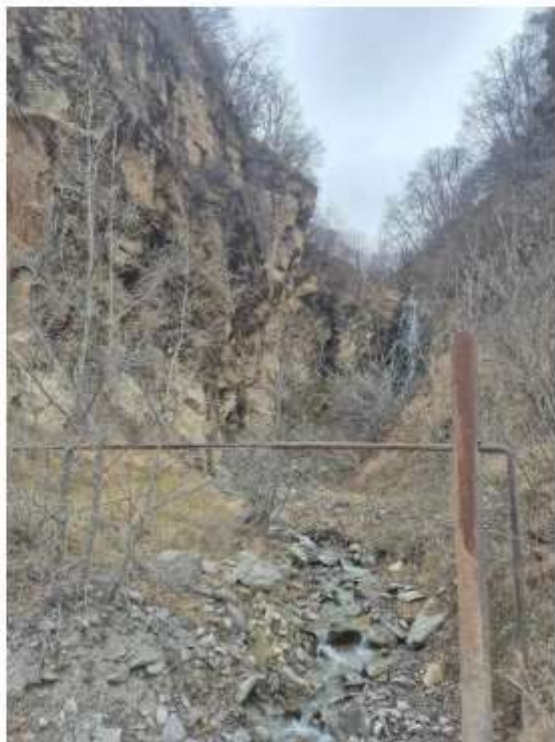
Figure 2.3. Left unnamed tributary of the Khadistskali River with waterfall, second fishing point.

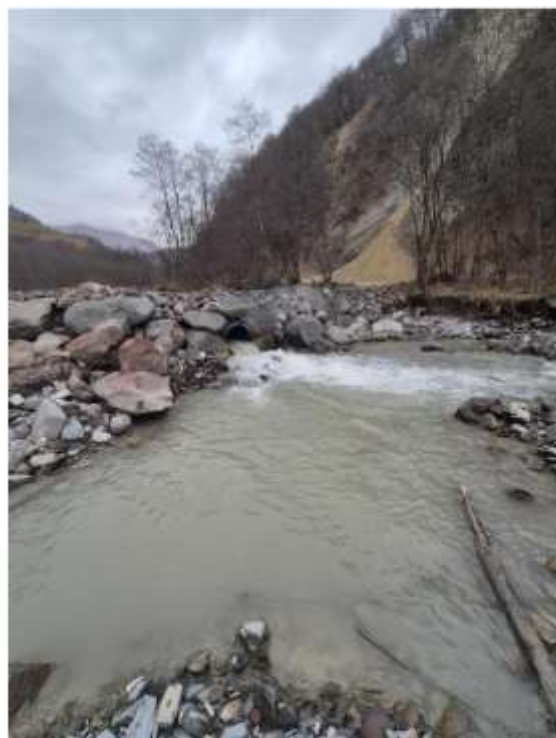
Figure 2.4. Placement area of bridge (N 3), third fishing point.

A third fishing attempt was carried out in the area of the project bridge (N 3) where a temporary passage is arranged over the river for construction works (Fig. 2.4) (coordinate: X - 461150.24 - Y - 4699365.16). No fish were observed in this section.

Construction works of mentioned road are in active phase. Periodically, there is muddy water in the river bed, which was also observed during the survey. Consequently, the anthropogenic pressure on the Khadistskali River and its ichthyofauna is still high. Field monitoring has shown that during the late autumn, trout are found in the middle and lower sections of the river. At the headwaters, near the Tskere, where the water is the cleanest, the trout has not been observed. The reason for this may be that the river below the Tskere is mostly muddy and also, temporary water-conducting pipes (Fig. 2.4) hinder the movement of trout in the river.

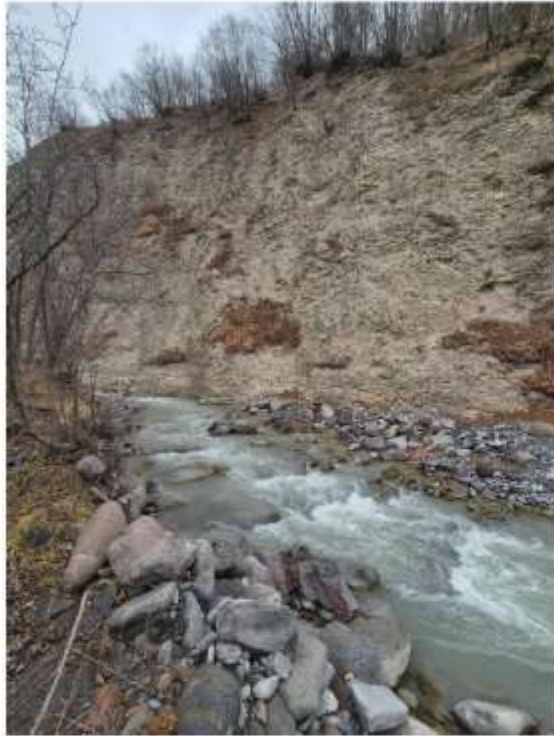
Figure 2.5. River at the fourth survey point by 11 A.M.

At the fourth fishing point (Fig. 2.5 & 2.6) (coordinate: X – 462419.61 – Y - 4698202.97), 3 adult individuals of Caspian trout – *Salmo caspius* were seen (Fig. 2.7). After morphological research, all of them were returned to the river (Fig. 2.8). It is noteworthy that at the time of the survey, the river was clean by 11 a.m. (Fig. 2.5). However, in about 1 hour, its condition deteriorated sharply and became muddy (Fig. 2.6), which is likely caused by ongoing construction works.

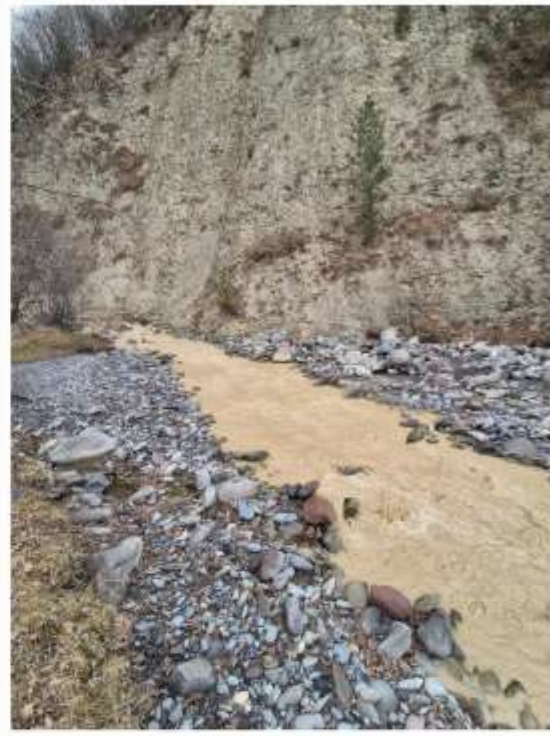
Figure 2.6. River at the fourth survey point by 12 A.M.

- In the process of construction works in the river bed, appropriate measures should be taken to prevent significant damage to the river bed, which will worsen the existing ecological conditions and fish habitats;

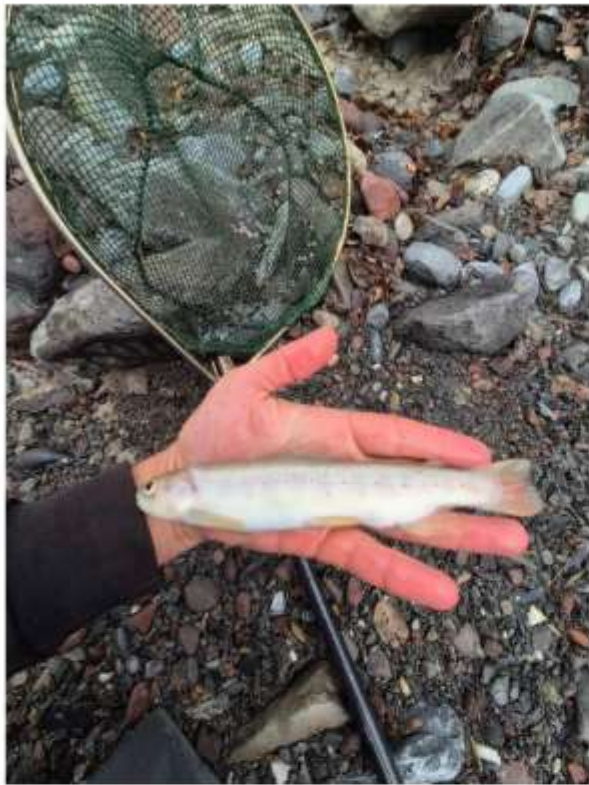
Figure 2.7. Caspian trout – *Salmo caspius*, fourth fishing point.

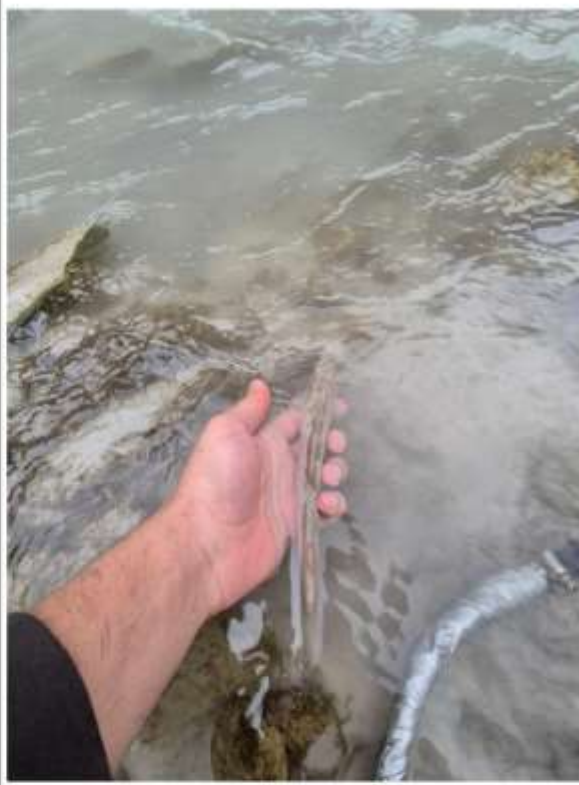
Figure 2.8. Releasing trout into the river.

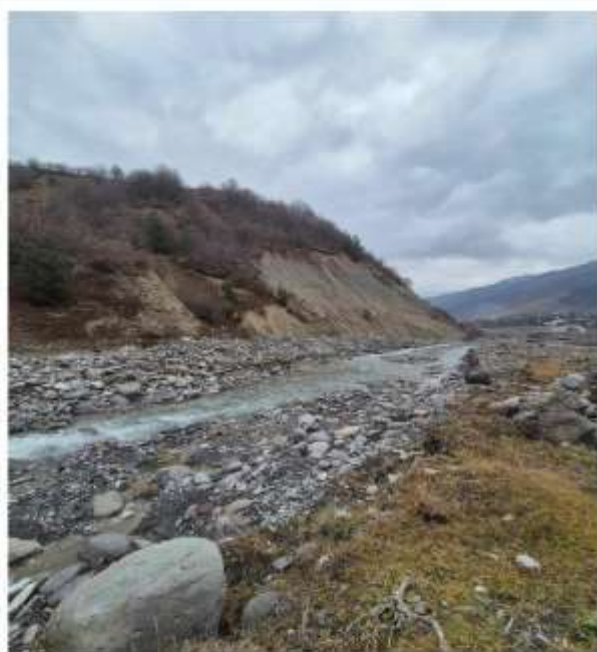
Fifth fishing point is located near the village Bedoni (Fig. 2.9.) where two juvenile trout were seen during the survey (Fig. 2.10).

Figure 2.9. The Khadistskali River near village Bedoni, fifth fishing point.

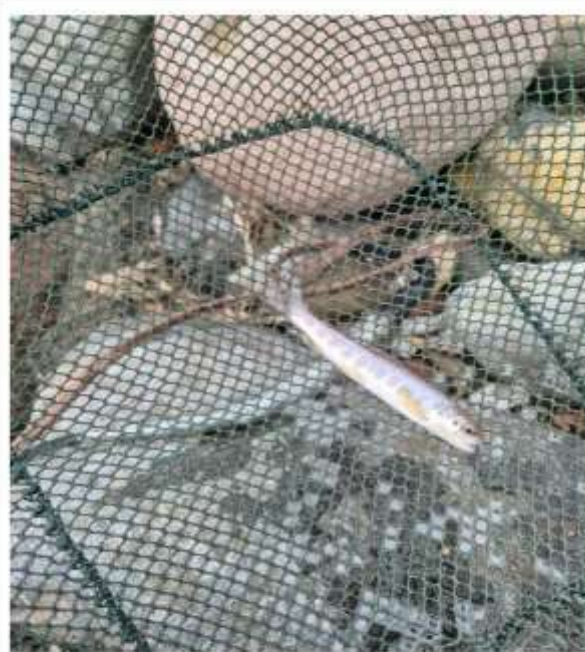
Figure 2.10. Juvenile trout from the fifth fishing point.

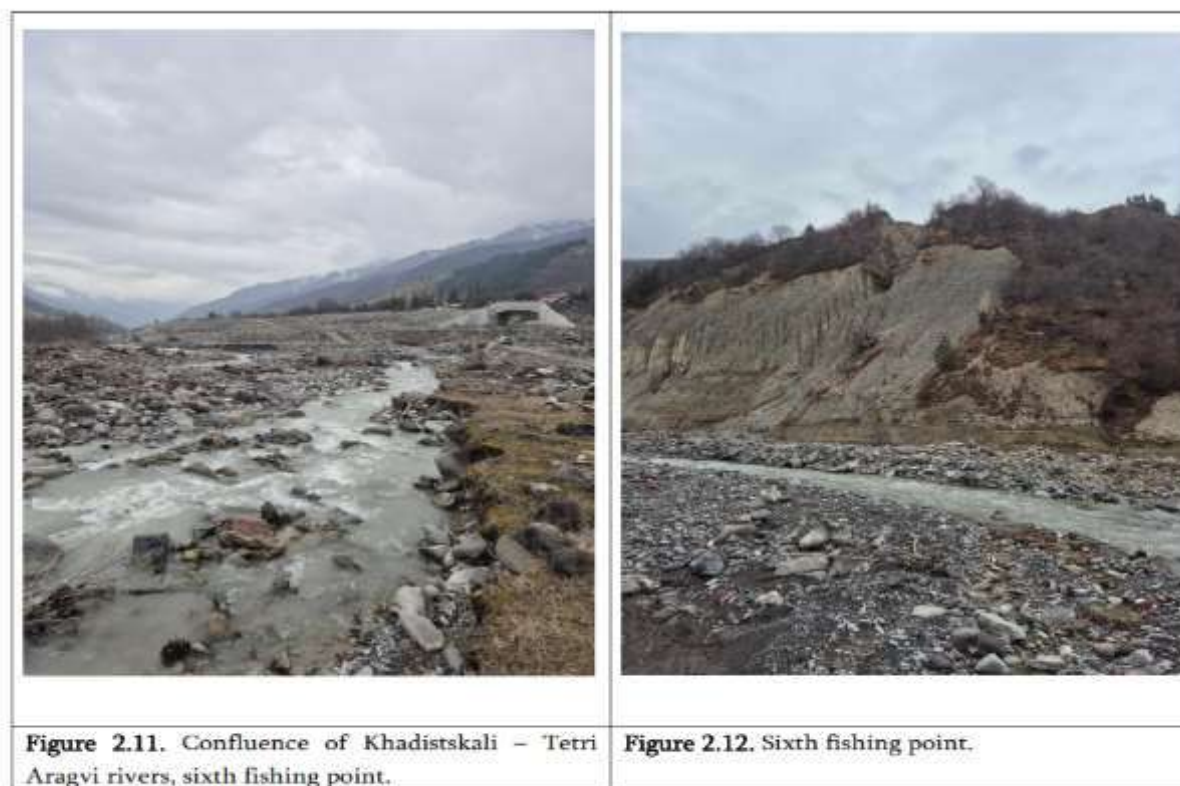
Sixth fishing point is located near the confluence of the Khadistskali – Tetri Aragvi rivers (Fig. 2.11 & 2.12). No fish were observed at this point.
