# Semi-annual Environmental Monitoring Report

Reporting period: July – December 2025

## **Georgia: North-South Corridors (Kvesheti – Kobi) Road Project**

Loan No GEO 3803

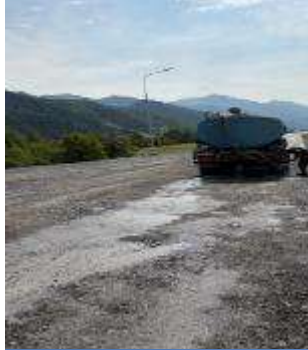
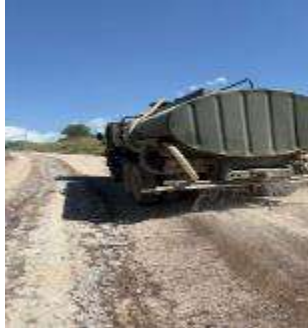
| # | Locations | Date | Issue | Priority | Mitigation Measures | Target Date | Action Taken |
|---|---|---|---|---|---|---|---|
| 1 | Lot 2 Access roads | July 2025 | Fugitive dust emissions at access roads | Medium | Contractor to carry out regular water sprinkling at all the access roads. | July 2025 | <p>The contractor carrying out regular water sprinkling at the access roads.</p> |

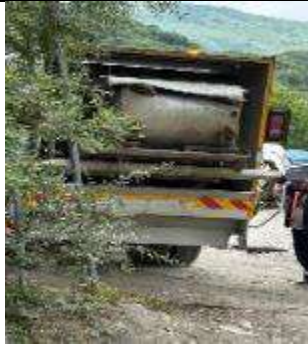
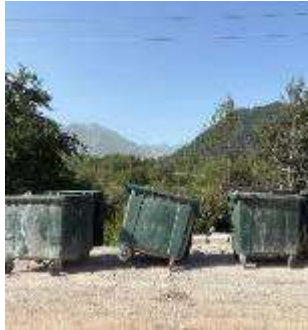
| # | Locations | Date | Issue | Priority | Mitigation Measures | Target Date | Action Taken |
|---|---|---|---|---|---|---|---|
| 2 | Campsites Lot 2 | July 2025 | Waste management at the campsites. Waste overflowing from containers. | Medium | The contractor to collect the waste from the campsites before filling of municipality containers. | July 2025 | <p>The contractor collected the waste from the campsites and delivered it to the municipality containers.</p> |

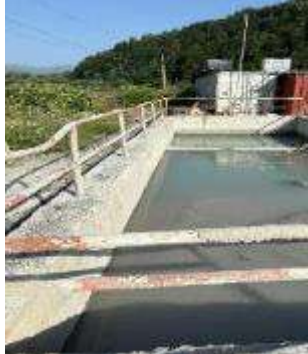
| 4 | Batching Plant 3 Lot 2 | July 2025 | Cleaning of pit in batching plant | Low | Contractor to clean the pit of the batching plant to recycle the waste water. | July 2025 | <p>The contractor cleaned sediment pit at batching p</p> |

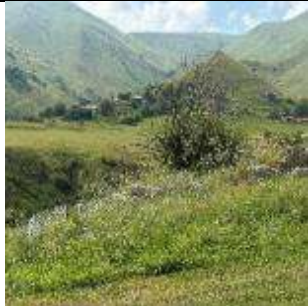
| 5 | Lot 2 Khada Valley CH 27 | July 2025 | Installation of fence around the CH27 | July 2025 | The contractor to fence the CH site | July 2025 | <p>The contractor fenced the</p> |

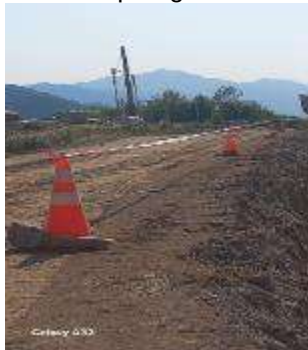
| 7 | Lot 2<br>Gudauri<br>Access<br>road | July 2025 | Installation of<br>temporary<br>barriers to<br>guide road<br>users | July<br>2025 | The contractor<br>to install soft<br>barriers to<br>guide road<br>users. | July 2025 | <p>The contractor placed<br/>cones and demarkated the<br/>the red tap to guide road u</p> |

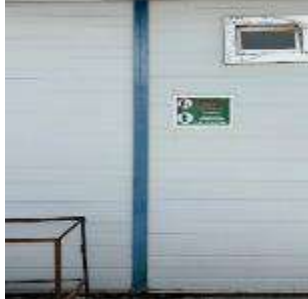
| 10 | Lot 2 Constructi on site | July 2025 | Posting of appropriate signs | July 2025 | The contractor to post appropriate signs at the site | July 2025 | <p>The contractor posted the environment signs at the s</p> |

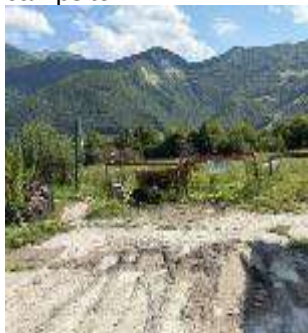
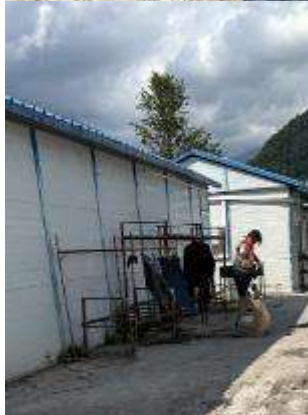
| 11 | Camp 2<br>Lot 2 | July 2025 | Cleaning of<br>the camp 2 | July<br>2025 | The contractor<br>to clean out the<br>whole camp. | July 2025 | <p>The contractor cleaned<br/>campsite.</p> |

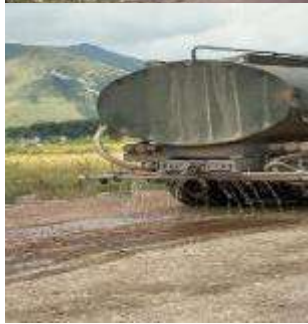
| 12 | Lot 2 Access roads | August 2025 | Fugitive dust emissions at access roads | Medium | Contractor to carry out regular water sprinkling at all the access roads. | August 2025 | <p>The contractor carrying out regular water sprinkling at the access roads.</p> |

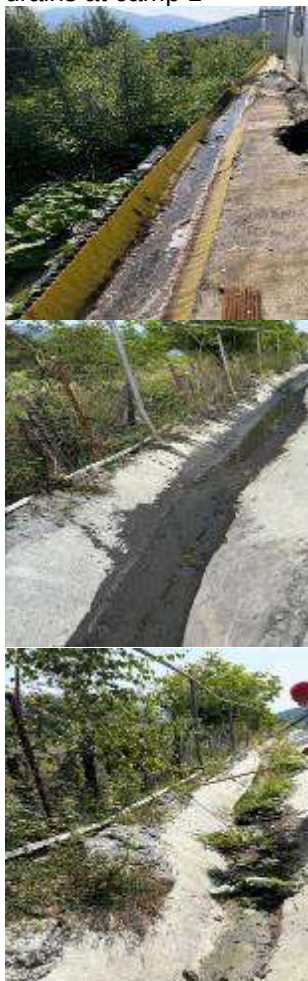
| 14 | Camp Lot 2 | August 2025 | Cleaning of the drains | August 2025 | Contractor to clean the drains of the campsite. | August 2025 | <p>The contractor cleaned drains at camp 1</p> |

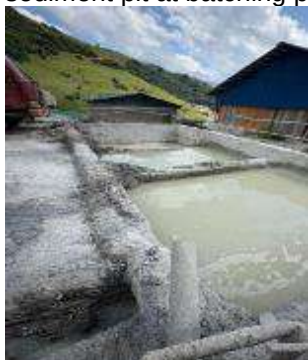
| 15 | Batching Plant 2 & 3 Lot 2 | August 2025 | Cleaning of pit in batching plant | Low | Contractor to clean the pit of the batching plant to recycle the wastewater. | August 2025 | <p>The contractor cleaned sediment pit at batching p</p> |

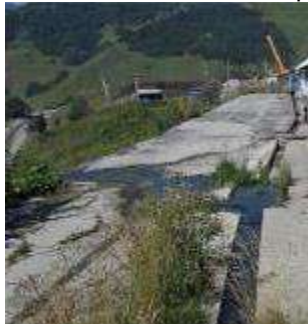
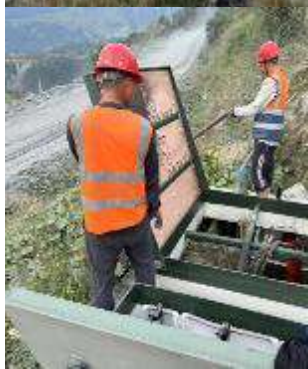
| 16 | Lot 2<br>Camp 3 | August<br>2025 | Maintenance<br>of the Camp 3<br>STP | August<br>2025 | The contractor<br>to carry ou the<br>maintenace of<br>the STP 3 and<br>clean out the<br>drains. | August<br>2025 | <p>The contractor condu</p> <p>maintenance of the Camp</p> |

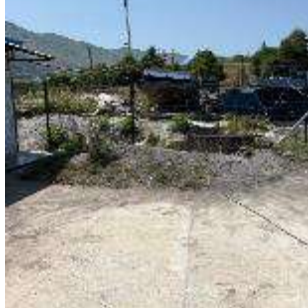
| 20 | Camp 2 Lot 2 | August 2025 | Cleaning of the camp 2 | August 2025 | The contractor to clean out the whole camp. | August 2025 | <p>The contractor cleaned campsite.</p> |

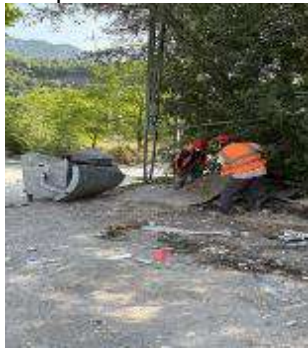
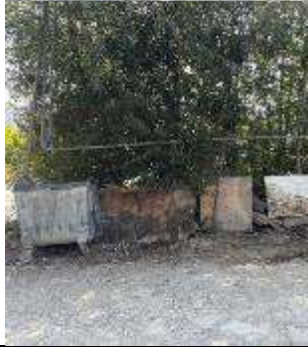
| 21 | Camp 1<br>Lot 2 | August<br>2025 | Cleaning of<br>the camp 1 | August<br>2025 | The contractor<br>to clean out the<br>whole camp. | August<br>2025 | <p>The contractor cleaned campsite.</p> |

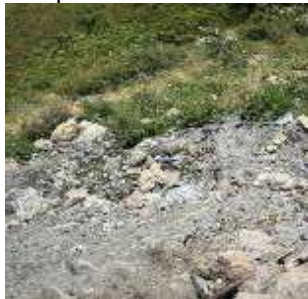
| 22 | Camp 3<br>Lot 2 | August<br>2025 | Cleaning of<br>the camp 3 | August<br>2025 | The contractor<br>to clean out the<br>whole camp. | August<br>2025 | <p>The contractor cleaned campsite.</p> |

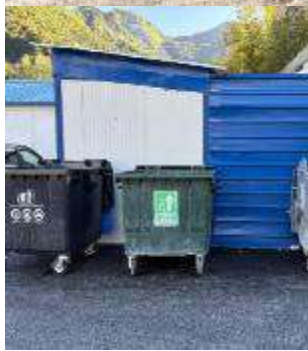
| 24 | Campsites Lot 2 | Sept. 2025 | Waste management at the campsites. Waste overflowing from containers. | Medium | The contractor to collect the waste the campsites before filling of municipality containers. | Sept 2025 | <p>The contractor collected and delivered to municipality containers.</p> |

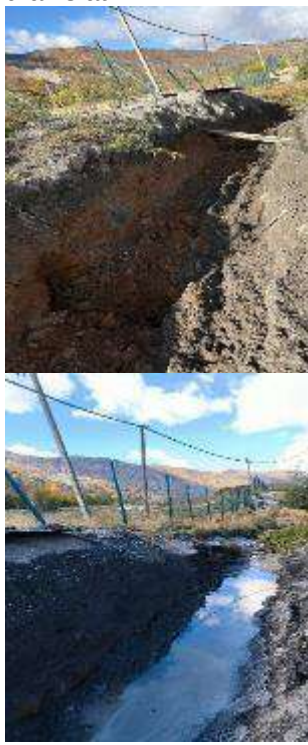
| 26 | BP 2<br>Lot 2 | Sept.<br>2025 | Cleaning of<br>the drains | Sept<br>2025 | Contractor to<br>clean the drains<br>of the batching<br>plant | Sept<br>2025 | <p>The contractor cleaned drains at BP 2</p> |

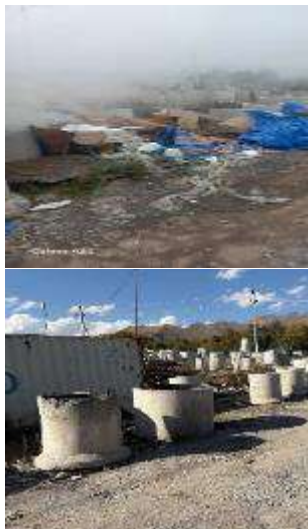
| 27 | Camp Lot 2 | Sept 2024 | Cleaning of the access road | Loe | Contractor to clean out the road. | Sept 2025 | Contractor cleaned out the<br> |

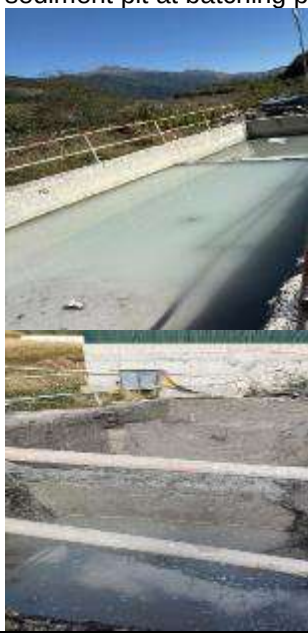
| 28 | Batching Plant 2 & 3 Lot 2 | Sept 2025 | Cleaning of pit in batching plant | Low | Contractor to clean the pit of the batching plant to recycle the wastewater. | Sept 2025 | The contractor cleaned sediment pit at batching p<br> |

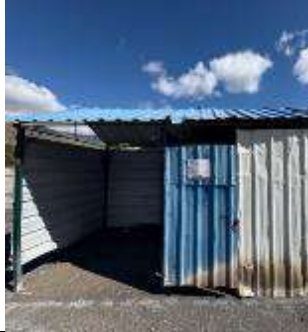
| 30 | Lot 2 | Sept 2025 | Posting of the signs | Sept 2025 | The contractor posted the | Sept 2025 | The contractor posted the |

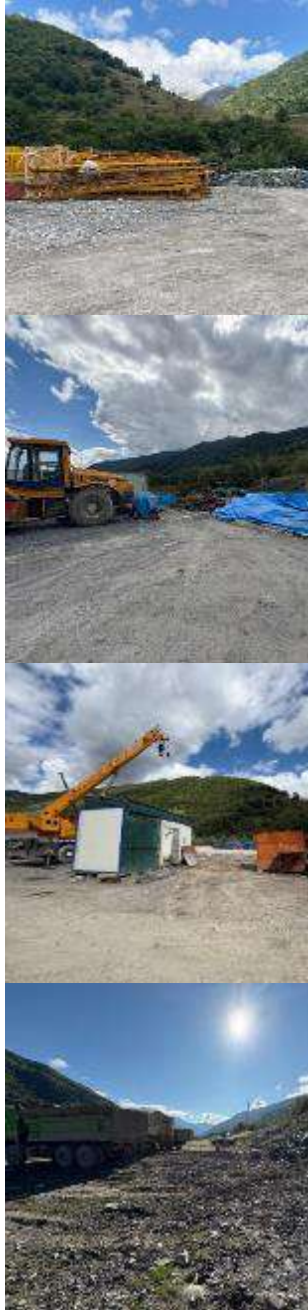
| 33 | Parking Area Lot 2 | Sept 2025 | Cleaning of the parking area | Sept 2025 | The contractor to clean out the whole area | Sept 2025 | <p>The contractor cleaned the area.</p> |

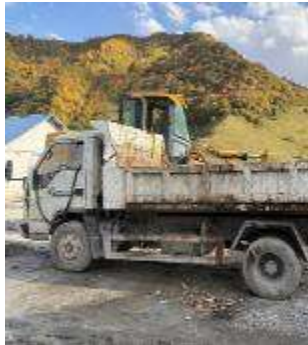
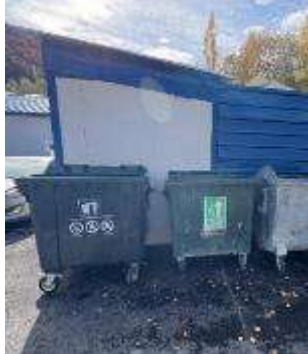
| 35 | Campsites Lot 2 | Oct 2025 | Waste management at the campsites. | Medium | The contractor to collect the waste the campsites before filling of municipality containers. | Oct 2025 | <p>The contractor collected and delivered to municipalities containers.</p> |

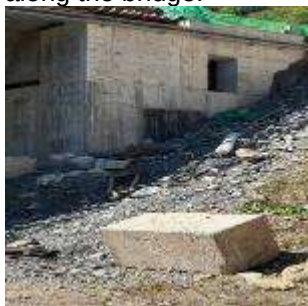
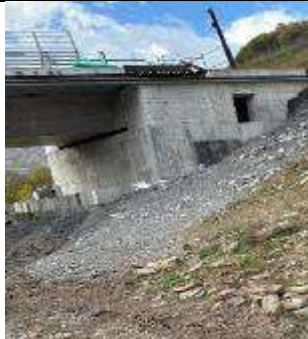
| 36 | Bridge 2 | Oct 2025 | Cleaning of the bridge 2 | Oct 2025 | Contractor to clean out the slopes and surroundings of the Bridge 2. | Oct 2025 | <p>The contractor cleaned along the bridge.</p> |

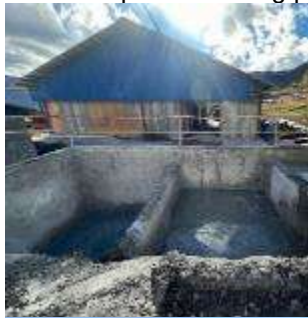
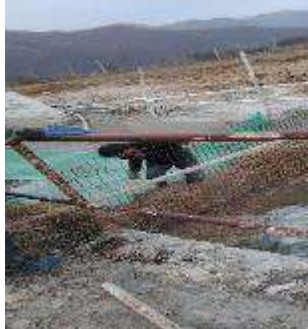
| 37 | Batching Plant 2 & 3 Lot 2 | Oct 2025 | Cleaning of pit in batching plant | Low | Contractor to clean the pit of the batching plant to recycle the wastewater. | Oct 2025 | <p>The contractor cleaned sediment pit at batching p</p> |

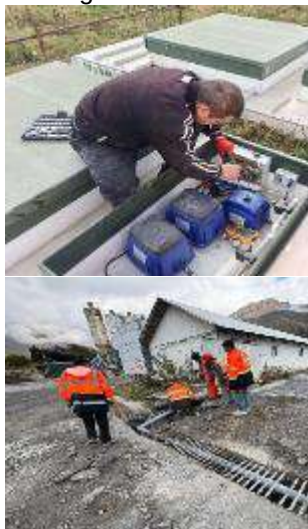
| 38 | Camp 3 STP and drainage line | Oct 2025 | Maintenance of STP 3 by calling the maintenance company | Oct 2025 | The contractor to call the company for the maintenance of STP 3 | Oct 2025 | <p>The contractor called the for the maintenance of Additionally the maintenance drainage line was carried</p> |

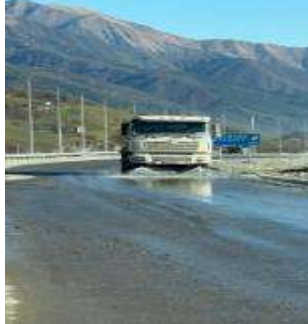
| 39 | Lot 2 Access roads | Nov 2025 | Fugitive dust emissions at access roads | Medium | Contractor to carry out regular water sprinkling at all the access roads. | Nov 2025 | <p>The contractor carrying out sprinkling at the access</p> |

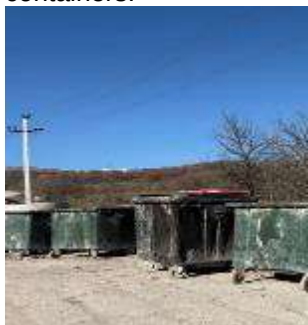
| 40 | Campsites Lot 2 | Nov 2025 | Waste management at the campsites. | Medium | The contractor to collect the waste the campsites before filling of municipality containers. | Oct 2025 | <p>The contractor collected and delivered to municipality containers.</p> |

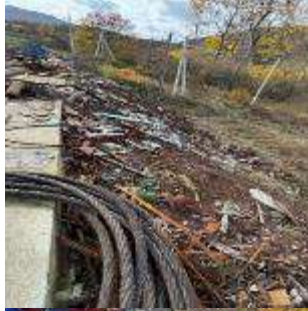
| 41 | Bridge 3 | Oct 2025 | Cleaning of the bridge 3 | Nov 2025 | Contractor to clean the surrounding area of the bridge 3. | Nov 2025 | <p>The contractor cleaned around the bridge construction area.</p> |

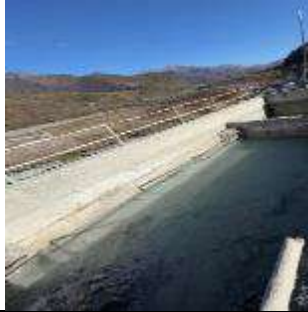
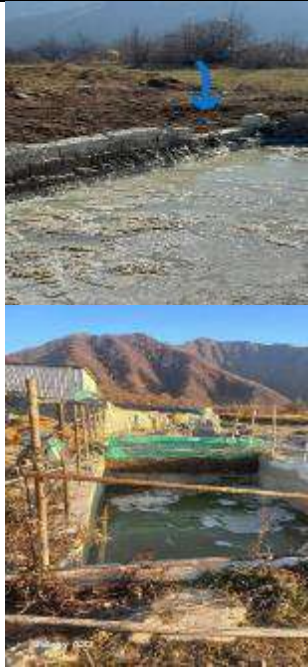
| 42 | Batching Plant 2 & 3 Lot 2 | Nov 2025 | Cleaning of pit in batching plant | Low | Contractor to clean the pit of the batching plant to recycle the wastewater. | Nov 2025 | <p>The contractor repaired the concrete pit for batching plant 2 &amp; 3, cleaned out the sediment, and installed a new concrete pit for batching plant 2 &amp; 3.</p> |

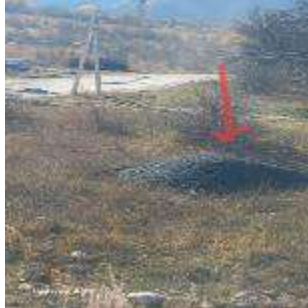
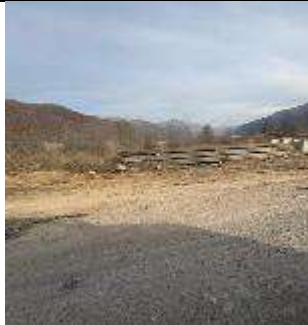
| 44 | Didveli Plateau Lot 2 | Nov 2025 | Asphalt waste management | Medium | The contractor to collect the asphalt waste. | Nov. 2025 | <p>The contractor collected the asphalt waste and cleaned out the</p> |

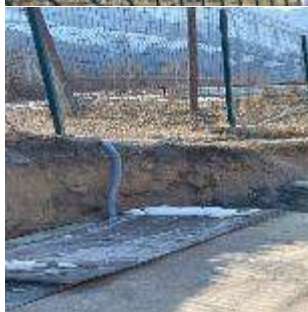
| 48 | Drainage of the BP 2 and Camp 2 | Oct 2025 | Maintenance of the STP 2 and pipe works for the drainage | Medium | The contractor to call the maintenance team for the repair of the STP and complete the installation of drainage pipes. | Nov 2025 | The contractor completed the STP and pumps networks and the maintenance of the drainage pipes. calling the team.<br><br> |

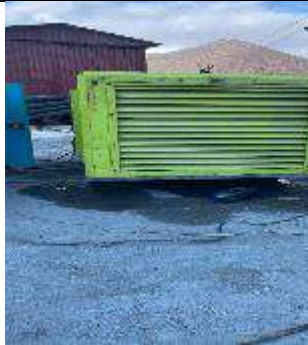
| 50 | BP 1 Lot 2 | Dec 2025 | Oils spills | Medium | The contractor collects oil spills and treat them as hazardous waste and place in the hazardous waste disposal site. | | Oil spill collection is required<br> |

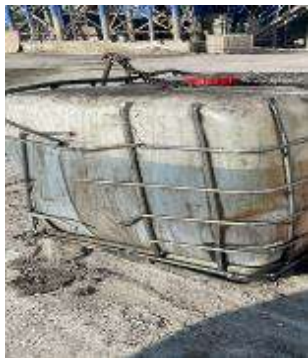
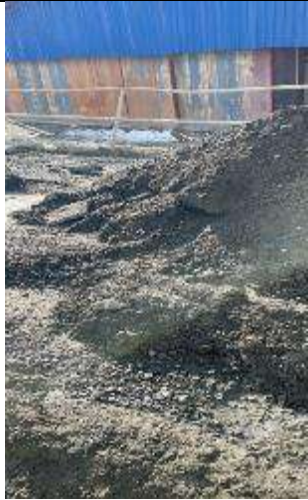
| 52 | BP 3 & Camp 3 | Dec 2025 | Concrete washout filled with sand<br><br>Diesel container placed on the floor posing the risk of fire<br><br>Used drums on the floor | Medium | The contractor to restore the washout facility, collect the diesel container and used drums and place it on designated area | Immediately | The contractor to remove container immediately and area.<br><br> |

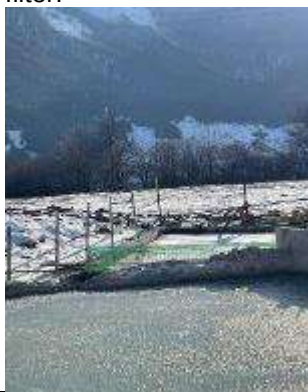
| 53 | Concrete washout pit BP 2 | Dec 2025 | Maintenance of the pit | Low | The contractor to change the grass filter for the effective operation of the pit | | <p>The contractor changed filter.</p> |

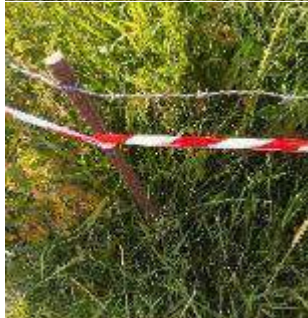
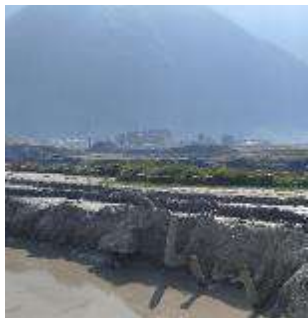
| 1 | Kobi Crushing Plant | July 2025 | Fencing the ponds of crushing plant. | Low | The contractor required to fence the ponds of crushing plant to restrict the entry of the animals in that zone. | July 2025 | <p>The contractor fenced the crushing plant.</p> |

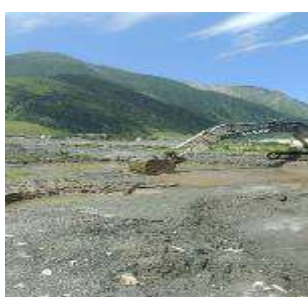
| 2 | Kobi Crushing plant | July 2025 | Cleaning of sedimentation Ponds in Crushing Plant | Low | Clean the sedimentation ponds for effective treatment of crushing plant | July 2025 | <p>The contractor cleaned crushing plant sedimentat</p> |

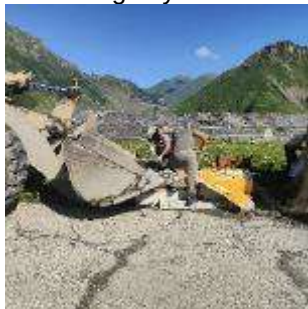
| 6 | Septic tank near Engineer office | July 2025 | Sewage system choked and need to be repaired. | Low | The contractor to repair the sewage system from engineer camp | July 2025 | The contractor repaired the sewage system<br> |

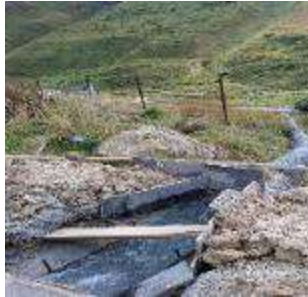
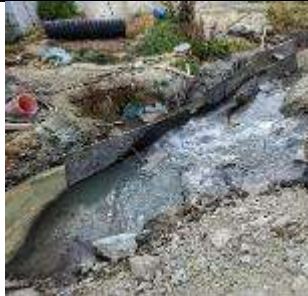
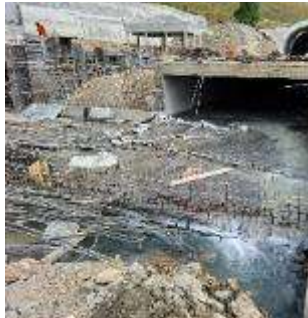
| 12 | Tskere | August 2025 | Modification of the tunnel water system. | Low | The contractor to extend the pipe up to sedimentation ponds for pretreatment of the tunnel water. | August 2025 | <p>The contractor extended t</p> |

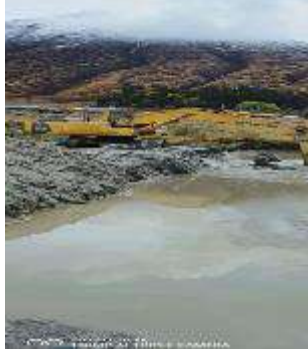
| 13 | Kobi Crushing plant | Sept 2025 | Cleaning of sedimentation Ponds in Crushing Plant | Low | Clean the sedimentation ponds for effective treatment of crushing plant | Sept 2025 | <p>The contractor cleaned crushing plant sedimentation ponds</p> |

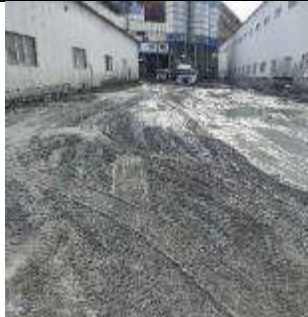
| 14 | Kobi Batching Plant | Sept 2025 | Cleaning of the sedimentation ponds | Low | Clean the sedimentation pits and ponds for the effective | Sept 2025 | <p>The contractor cleaned sedimentation pond</p> |

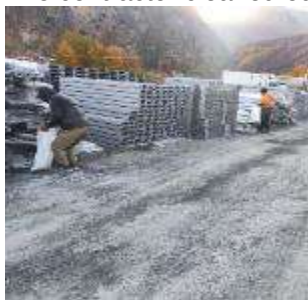
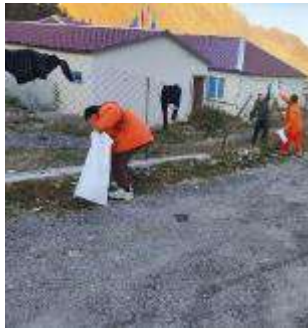
| 15 | Kobi Campsite | Sept 2025 | Housekeeping | Medium | The contractor to clean the camp | Sept 2025 | <p>The contractor cleaned out</p> |

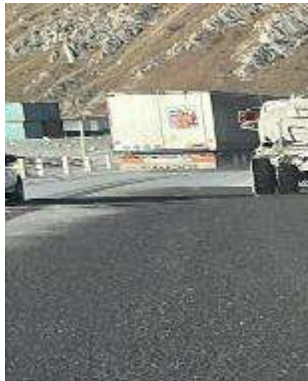
| 16 | E-117 Kobi | Sept 2025 | Dust on the road | Low | The contractor to spray water on E-117 to suppress the dust | Sept 2025 | <p>The contractor sprinkled the road.</p> |

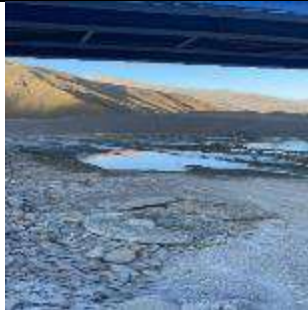
| 17 | Kobi | Sept 2025 | Modification of the tunnel water system. | Low | The contractor to extend the pipe up to sedimentation ponds for pretreatment of | Sept 2025 | <p>The contractor cleaned the extended the pipe.</p> |

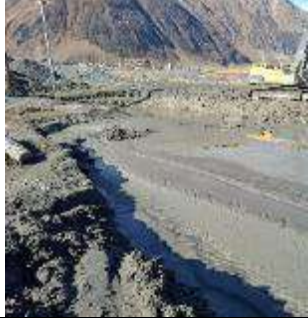
| 18 | Kobi Crushing plant | Oct 2025 | Cleaning of sedimentation Ponds in Crushing Plant | Low | Clean the sedimentation ponds for effective treatment of crushing plant | Oct 2025 | <p>The contractor cleaned crushing plant sedimentation</p> |

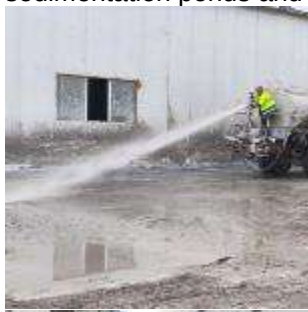
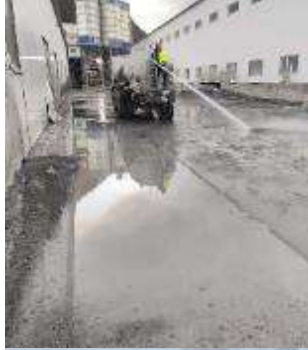
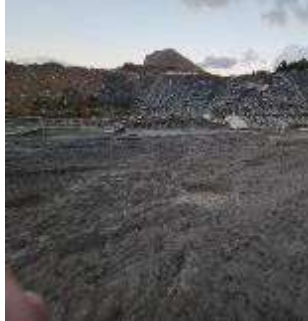
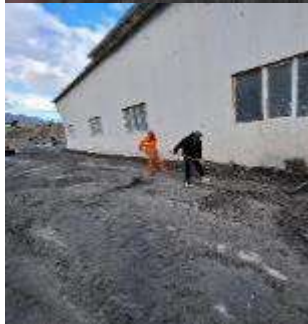
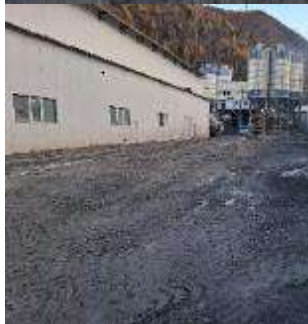
| 20 | Kobi Batching Plant | Oct 2025 | Cleaning of the sedimentation ponds and the area. | Low | Clean the sedimentation pits and ponds for the effective treatment of tunnel water and the area along the batching plant. | Oct 2025 | <p>The contractor clean sedimentation ponds and</p> |

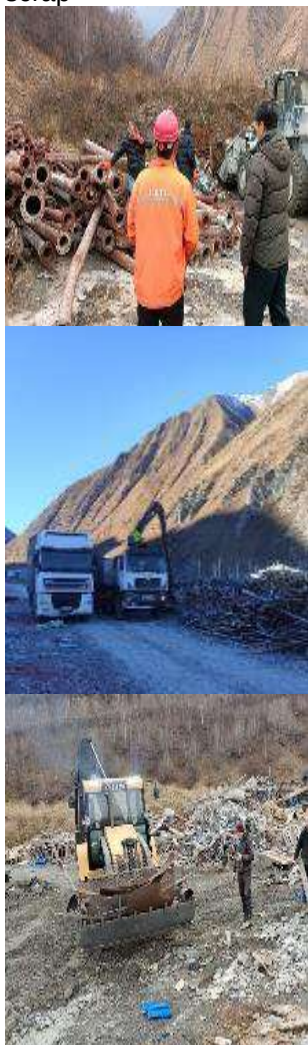
| 21 | Kobi Scrap yard | Oct 2025 | Removing the scrap | Medium | The contractor to handover the scrap to third party and clean the site | Oct 2025 | <p>The contractor started removing scrap</p> |

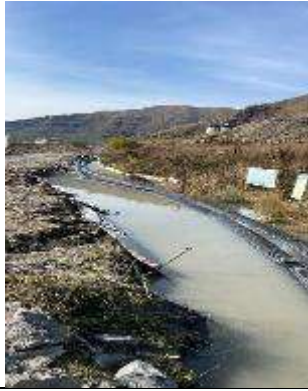
| 22 | Tskere Tunnel water | Oct 2025 | Tunnel water treatment | Medium | The contractor to divert tunnel water to sedimentation ponds | Oct 2025 | <p>The contractor diverted water to the sedimentation ponds</p> |

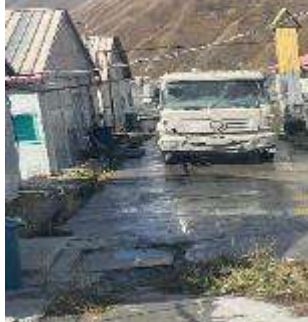
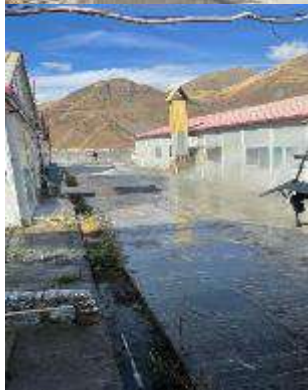
| 24 | Kobi Campsite | Oct 2025 | Housekeeping | Medium | The contractor to clean the camp | Oct 2025 | The contractor cleaned the camp<br><br> |

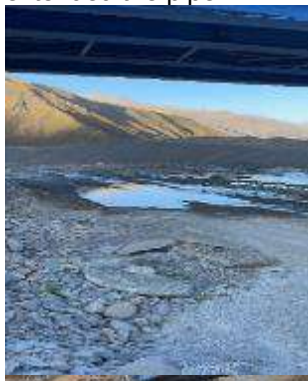
| 26 | Kobi | Oct 2025 | Modification of the tunnel water system. | Low | The contractor to extend the pipe up to sedimentation ponds for pretreatment of the tunnel water. | Oct 2025 | <p>The contractor cleaned the extended the pipe.</p> |

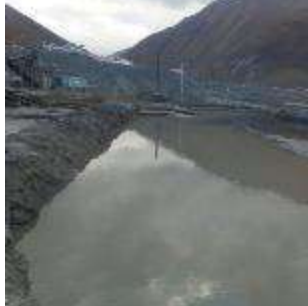
| 28 | Kobi Crushing plant | Nov 2025 | Cleaning of sedimentation Ponds in Crushing Plant | Low | Clean the sedimentation ponds for effective treatment of crushing plant | Nov. 2025 | <p>The contractor cleaned crushing plant sedimentation</p> |

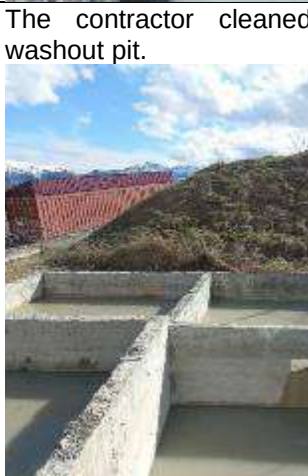
| 29 | Tskere Batching plant Pit | Nov 2025 | Cleaning of sedimentation Ponds in batching Plant | Low | Clean the sedimentation ponds for effective treatment of washout pit. | Nov 2025 | <p>The contractor cleaned washout pit.</p> |

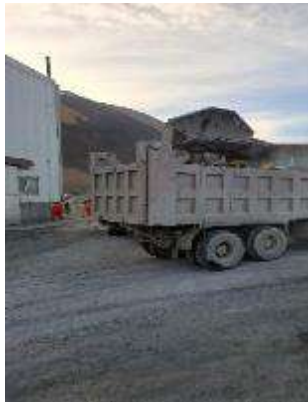
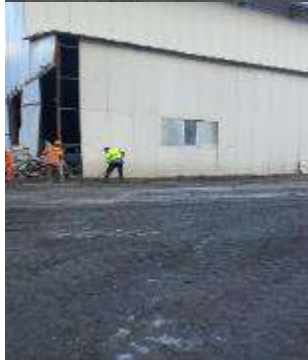
| 30 | Kobi Segment Plant | Nov 2025 | Cleaning of the sedimentation ponds and the area. | Low | Clean the sedimentation pits and ponds for the effective treatment of tunnel water and the area along the batching plant. | Nov 2025 | <p>The contractor cleaned sedimentation ponds and</p> |

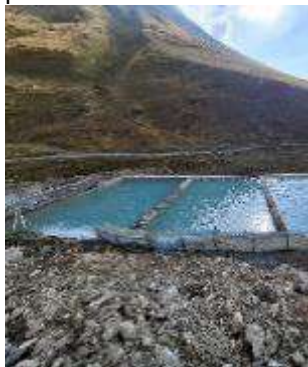
| 31 | Tskere Tunnel water | Nov 2025 | Tunnel water treatment | Medium | The contractor to clean the sedimentation ponds | Nov 2025 | <p>The contractor diverted water to the sedimentation and cleaning the sedimentation ponds.</p> |

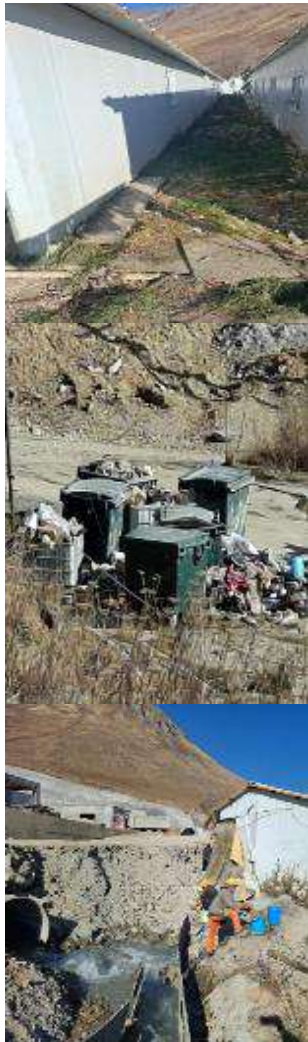
| 32 | Tskere Campsite | Nov 2025 | Housekeeping | Medium | The contractor to clean the camp | Nov 2025 | <p>The contractor cleaned out the camp area.</p> |

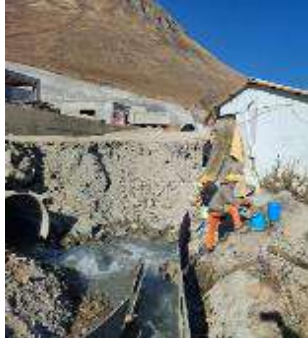
| 33 | Kobi Campsite | Nov 2025 | Housekeeping | Medium | The contractor to clean the camp | Nov 2025 | <p>The contractor cleaned the campsite area.</p> |

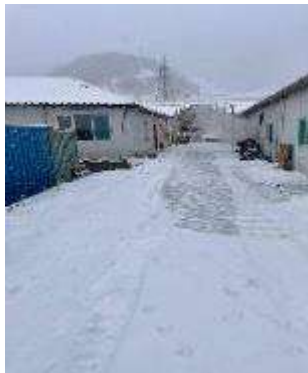
| 43 | Kobi Campsite | Dec 2025 | Snow fall causing the risk of slipping | Medium | Contractor to remove snow on regular basis | Dec 2025 | <p>The contractor started removing snow from the corridors.</p> |

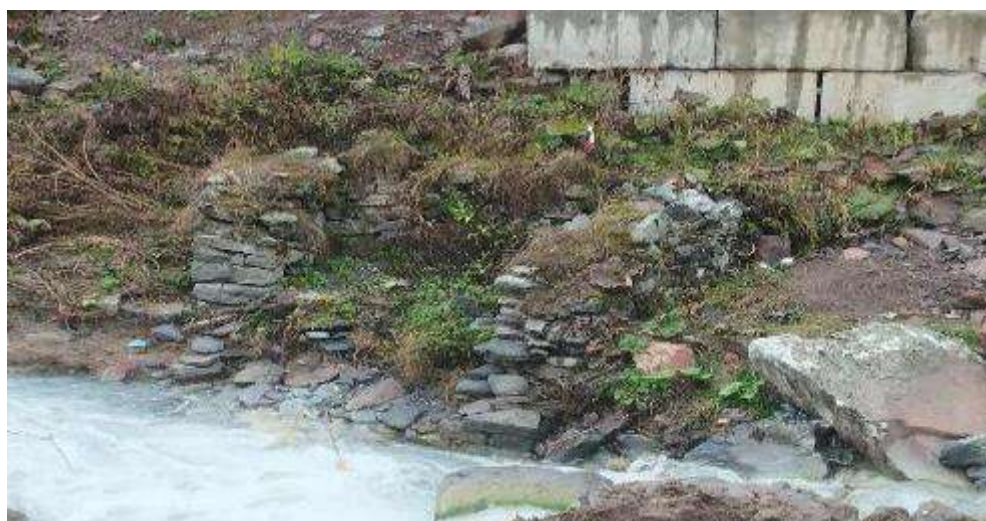
**Figure 24: CH 28 being affected by the river diversion**

156. During the reporting period, it has been observed that Cultural Heritage Site #28 (Remains of a Water Mill), located near Bridge 6, was being negatively impacted by construction activities. Specifically, the diversion of the Khadistskhali River during these works has led to erosion and the partial washing away of the cultural heritage site. Additionally, the operation of heavy construction equipment in close proximity poses a further threat to the site's physical preservation. In accordance with cultural heritage protection regulations and project requirements, we request that the Contractor immediately implement necessary measures to prevent further damage.

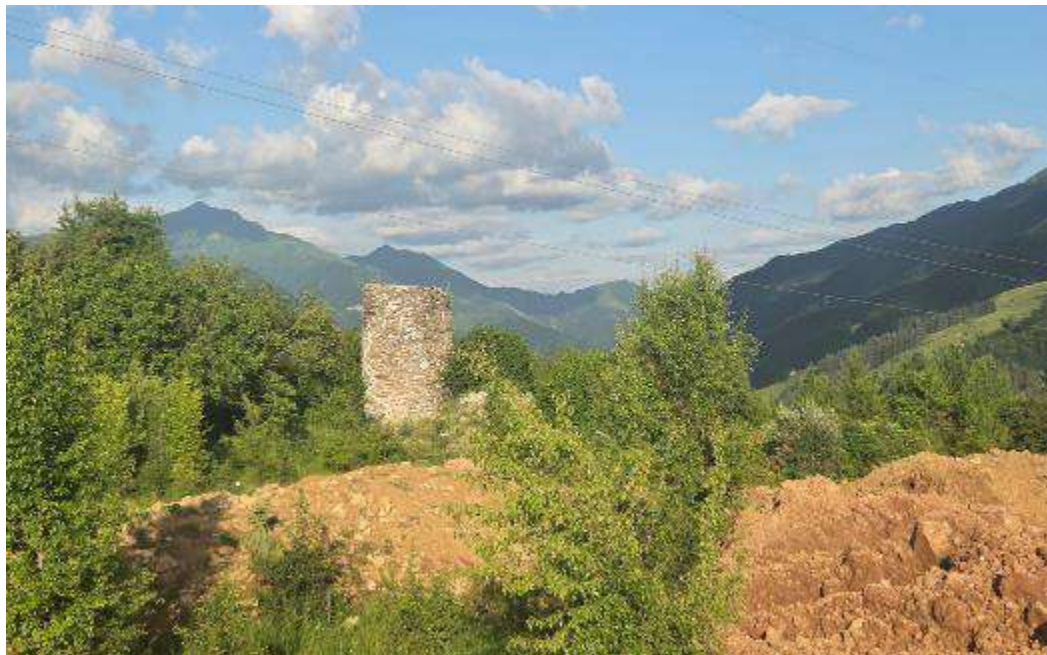
**Figure 25: Gas Pipeline Relocation Works near Didveli Backed Tower (CH Site #10)**

157. The contractor has been working on the relocation of gas pipes along the Gudauri road. This relocation has become necessary in several sections due to the project, including the area near CH 10 – Didveli Backed Tower. The process has not yet been fully completed. CH specialists were monitoring the process. No issues of concern were identified.

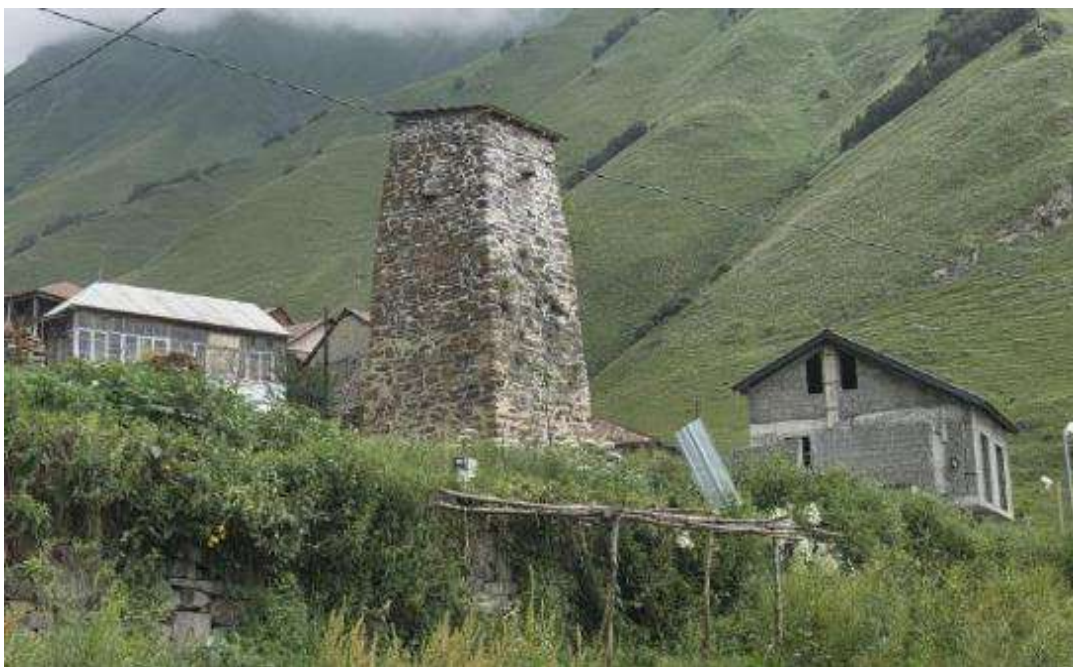
**Figure 26: Naraidze's Tower, Tskere village**

158. During this reporting period, the PMCSC CH Specialists consistently monitored the identified CH sites. Construction activities did not impact any of the identified sites. Additionally, the contractor for Lot 2 upgraded and reinforced the damaged fences surrounding the necessary CH sites as shown in the figures below.

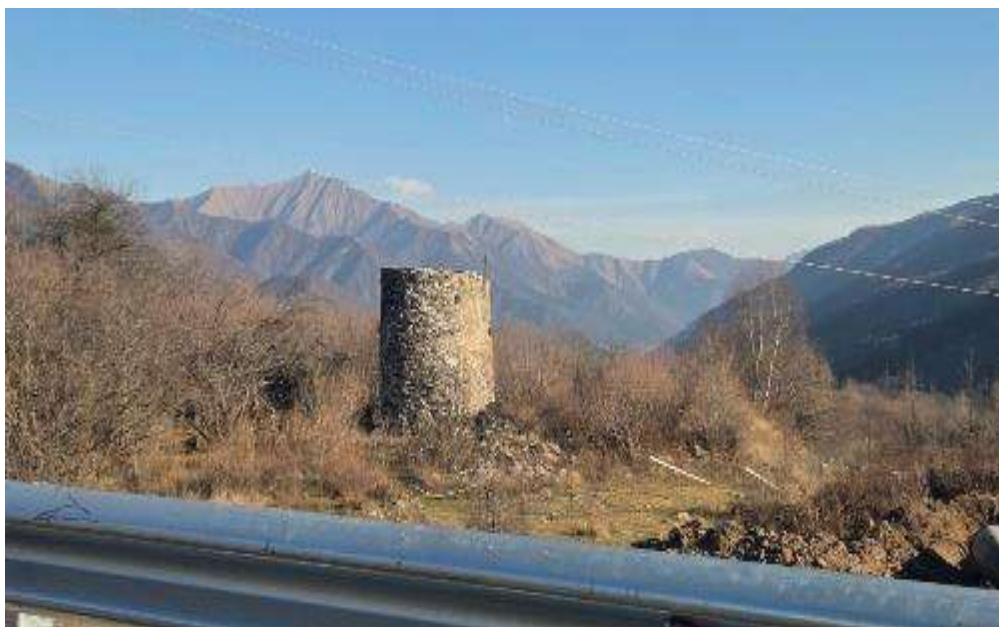
**Figure 28: CH 10, conservation work completed.**

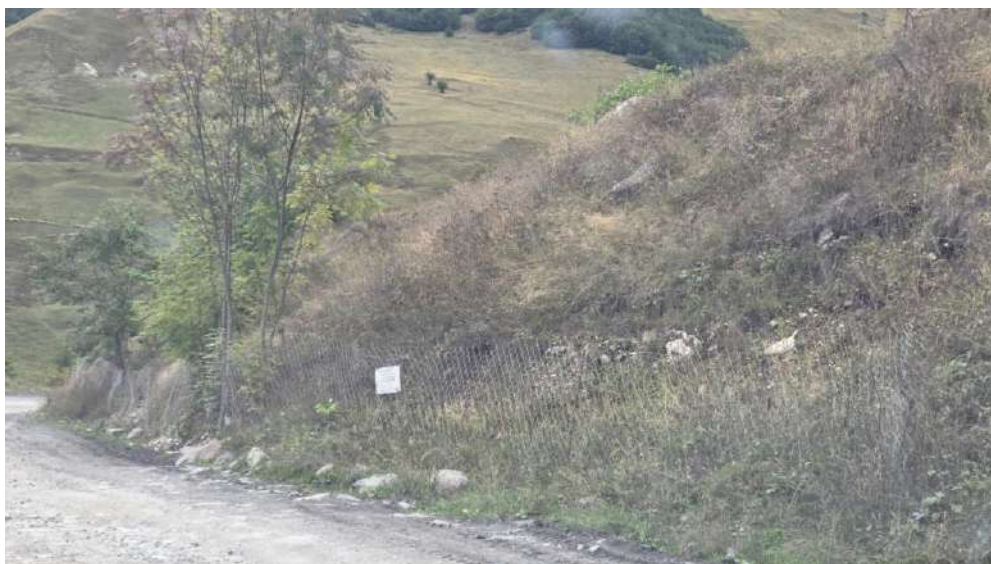
**Figure 29 A: CH 23, wire mesh fence**

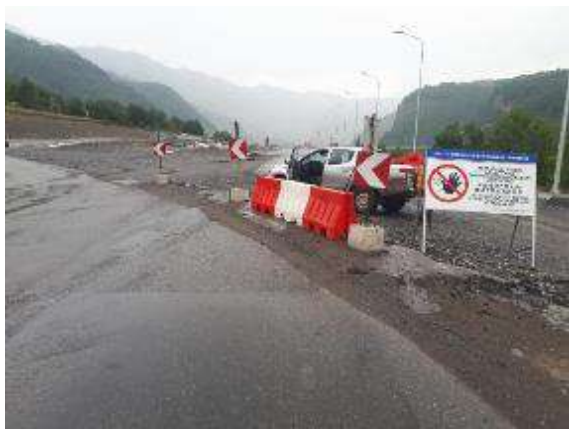
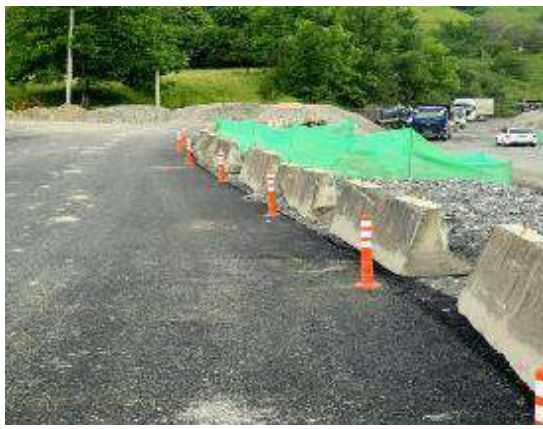
165. During the reporting period:
  - Lot 2 Contractor continued the road works at Kvesheti - Arakhveti section up to Bridge 2, close to the active road. These road works still required a frequent diversion of traffic flow and narrowing of a road section which was very challenging for the whole process. Effective controls were extremely necessary for the safety of working personnel as well as for the safety of road users and locals. Proceeding from it, H&S specialists were actively involved in this process. This included installation and maintenance of informational and safety signs with traffic cones, effective control of narrowed or diverted sections by having flagmen in place and supervision of the whole process in general, etc. The whole management process of traffic was done in accordance with the Road Safety specialist's recommendations and approved traffic management schemes (Pic 1, Pic 2)

| Pic 1 Traffic control measures | Pic 2 Traffic controls / shoulder protection |

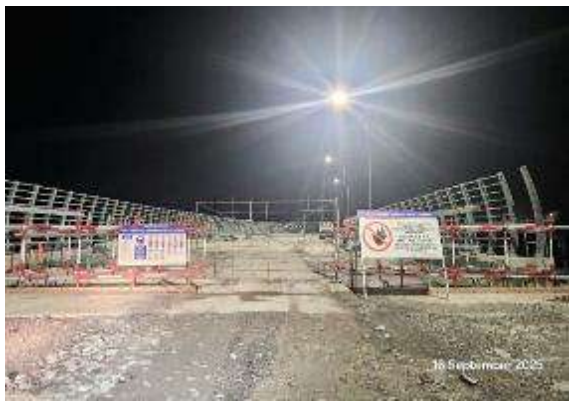
- At the beginning of the reporting period, locals were observed using Tunnel No. 1 and Bridge No.2 as a shortcut between Plateau to Arakhveti. Through the active involvement of the Engineer, this issue was addressed and the Contractor installed metal gates at both ends of this section: Bridge 2 entrance – Tunnel 1 exit (Pic 3). These metal gates were kept open during the working hours as project equipment used this road section, but entrance was controlled by a flagman. After working hours gates were kept closed preventing locals from driving through. The Contractor was reminded to enhance the entry control over this section during the winter period when active highways might be temporarily closed due to snow and the need to use this section as a bypass might increase among the locals.

| Pic 3 Access control at Bridge 2 | Pic 4 Community safety / guardrails |

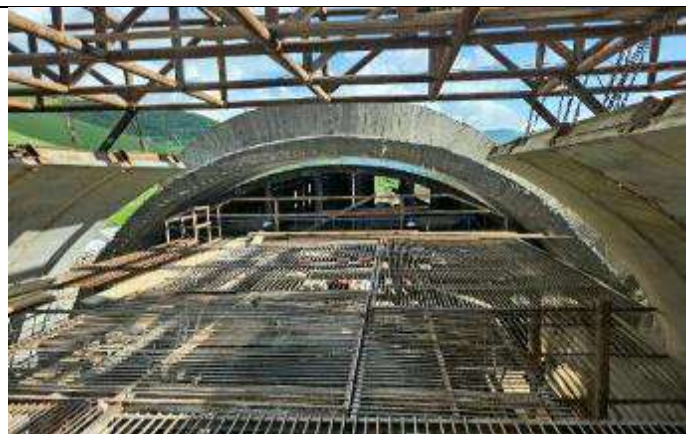
170. During the reporting period, Lot 1 Contractor completed the construction of C&C sections at South portal in Tskere for both tunnels: main and Emergency Gallery. Mostly, this activity included work at height. Multiple working platforms and stairs for access to height made this work difficult and complex as many workers were involved simultaneously and it was necessary to inspect the condition of all platforms daily. Personnel involved in this activity received mandatory training targeting work at height as well as regular toolbox talk. The requirements of national legislation

171. Violations of work at height were identified during the construction of C&C by the Engineer but they were not critical. In particular, workers were observed not to report timely the damages of the working platforms, and the Contractor was not always able to timely correct the shortcomings such as unsafe access, damaged guard rails, etc. Proceeding from it, the involvement of the Engineer's H&S specialist was extremely important to ensure that workers are not exposed to uncontrolled hazards, and all working platforms are in safe condition

Pic 5 Construction of C&C section for main tunnel at Tskere / South portal, LOT 1

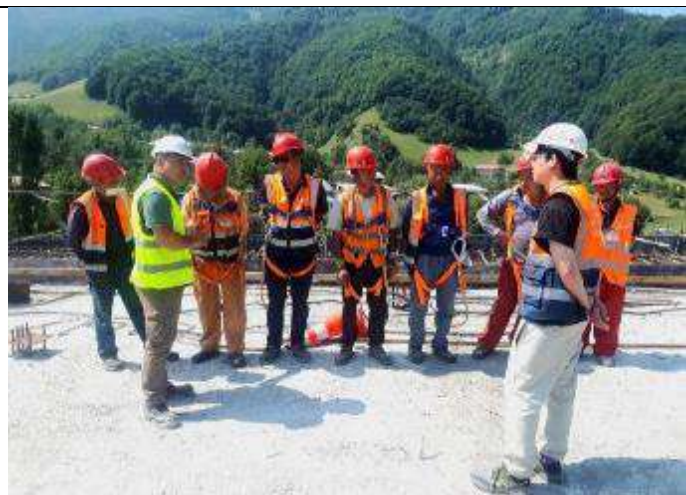
178. Lot 2 Contractor successfully completed the construction of pedestrian sidewalks at Bridge No. 2 which was high-risk activity. This task included the preparation of reinforcements and installation of formworks right at the edge of the bridge deck working too close to the edge of the bridge. It was mandatory for all workers to use fall arrest equipment during the preparation of rebar cages and installation of formworks for bridge sidewalks as it was within the 2 meters distance from the edge. At the same time, temporary guardrail systems were installed along the edge of Bridge No. 2 as an additional control measure. On a few occasions it was observed that temporary guardrail systems were damaged and workers were protected only by the use of PPE (fall arrest equipment). These issues were identified by the Engineer and timely communicated with the Contractor. No major violations of PPE requirements were identified during this activity and only a few times workers were found not wearing PPE while working at the edge. Permanent supervision and toolbox talks were used to address this issue. Construction of pedestrian sidewalks at Bridge 2 was under permanent monitor of the Engineer (Pic 7).

Pic 7 Toolbox talk with Bridge 2 working personnel, LOT 2

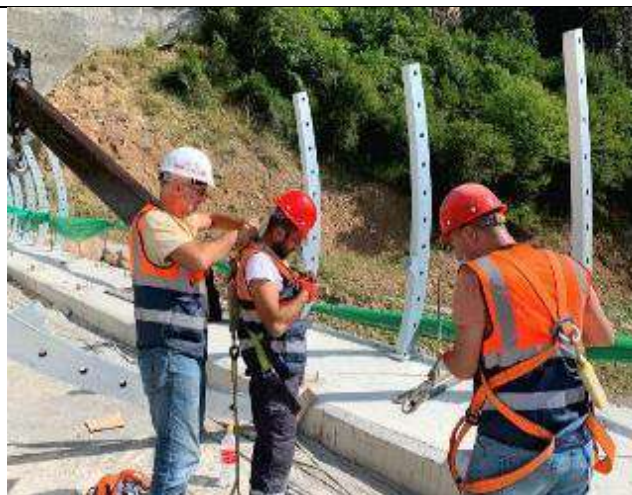
179. The Contractor periodically inspected fall arrest equipment at the Bridge 2 and Bridge 3 worksites. Few pieces of equipment were found to be damaged and were immediately removed from the use (Pic 8).

Pic 8 Inspection of fall arrest equipment at Bridge 2, LOT 2.

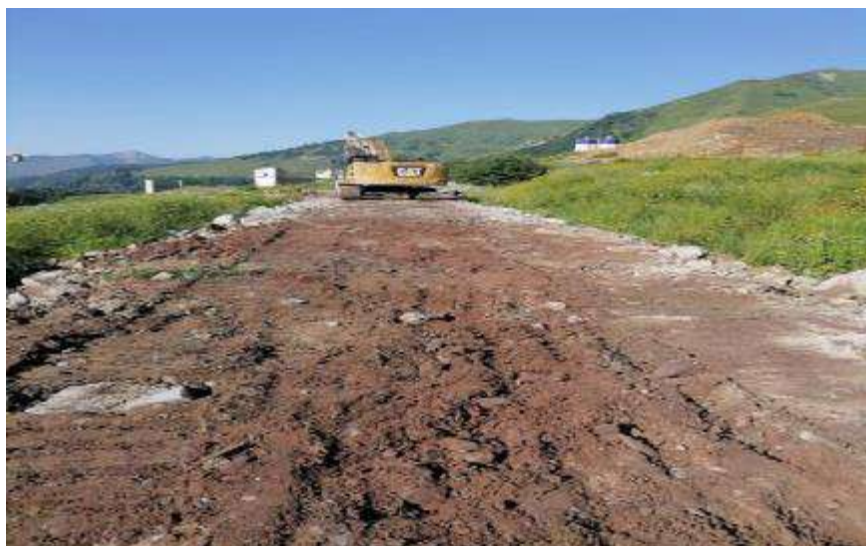
**Figure 34: Improving the access road to Village Mughure**

- The contractor improved the access road to Mughure village by using the spoil material and providing the safe access.

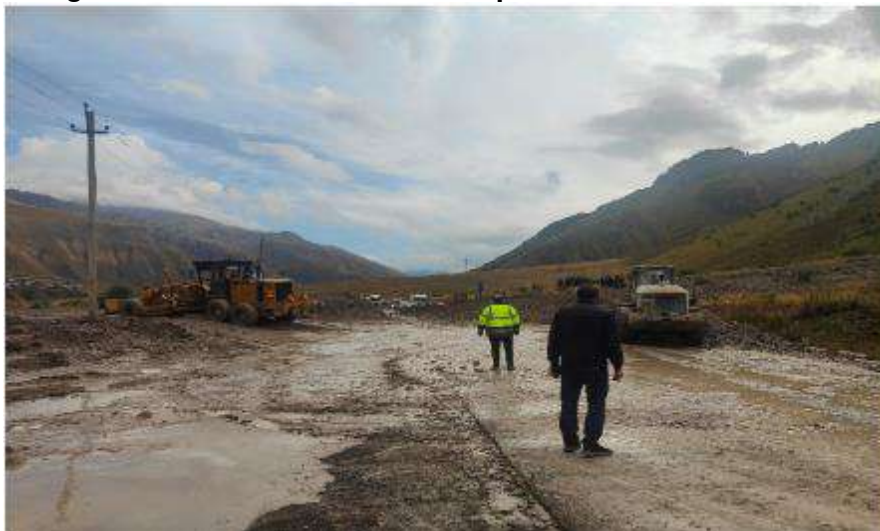
**Figure 35: CRTG and PMCSC helped to remove land silide from E-117**

- The contractor helped to open the E-117 road closed due to land sliding in Kobi

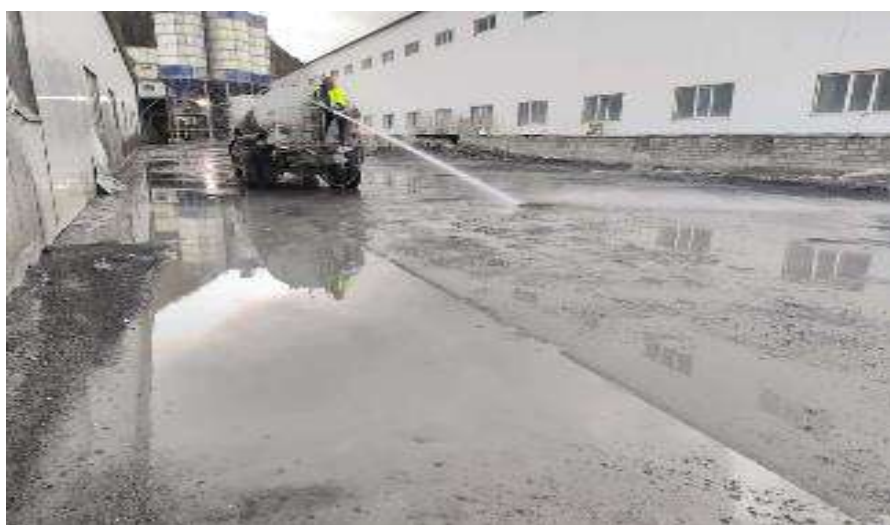
**Figure 36: Washing of the Batching Plant- Kobi**

- The contractor washed and cleaned the batching plant and campsite with water truck and cleaned the site by taking concrete waste from the washout pit in October 2025.

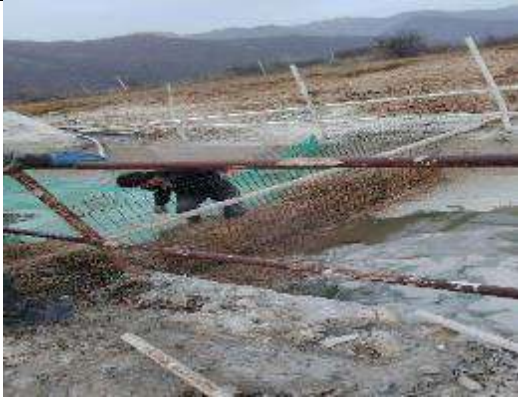
- 
- The contractor repaired the concrete washout pit at batching plant 2 and installed new grass filter.
- CC provided the guard rail along the highway E-117 in Kvesheti to avoid accidents.
- 
- CC carried out the seasonal fish monitoring
- CC controlled the access to the bridge 2 for the unauthorized vehicles by installing the temporary gates at bridge 2 and Tunnel 1.
- The contractor has installed the necessary signs and safety barriers at the site.
- CC provided additional sedimentation tank to treat wastewater at batching plant 2

| Maintenance of Washout pit | Site cleaning |

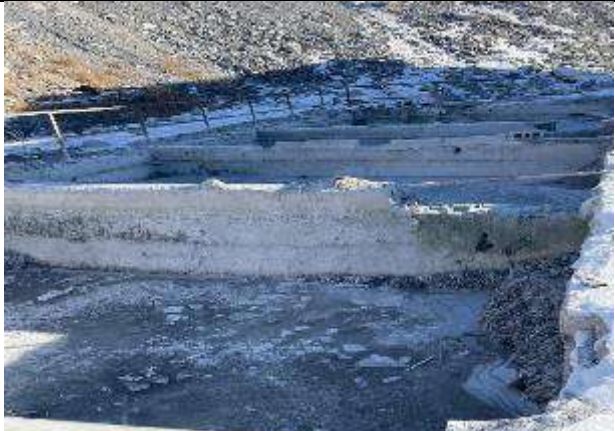
| Pictures | Description |
|---|---|
| | <p>Abandoned sedimentation ponds in Kobi, Tunnel water diverted to Baidara river as per design.</p> <p>December 2025</p> |

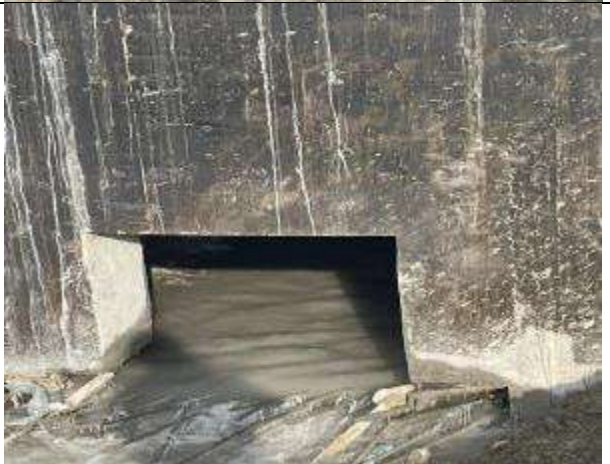
| | <p>Turbed water coming out of the tunnel south portal<br/><br/>December 2025</p> |

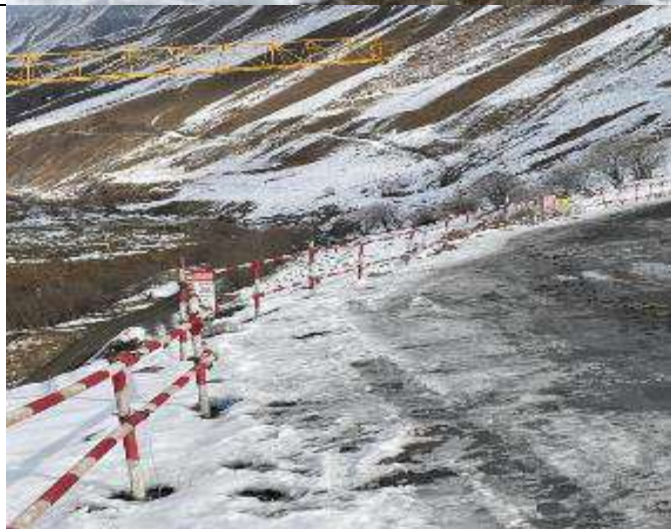
| A photograph of a snowy, icy access road. A temporary fence made of red and white striped poles and red plastic tape is installed along the edge of the road. In the background, a yellow crane or similar construction equipment is visible on a higher level of the road or embankment. | <p>Temporary fence installed on access road near bridge 6<br/>December 2025</p> |
