# Semi-annual Environmental Monitoring Report

Reporting period: July – December 2025

## **Georgia: North-South Corridors (Kvesheti – Kobi) Road Project**

Loan No GEO 3803

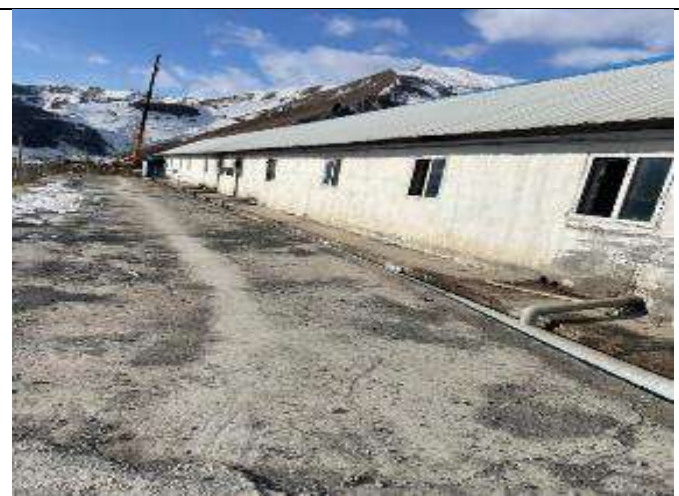
| A photograph showing a long, low, light-colored building with a corrugated metal roof. A dirt road runs alongside the building, and a drainage pipe is visible in the foreground. Snow-capped mountains are in the background under a blue sky. | <p>Camp 3 Lot 2 drainage system<br/>maintained after ground failure<br/>November 2025</p> |

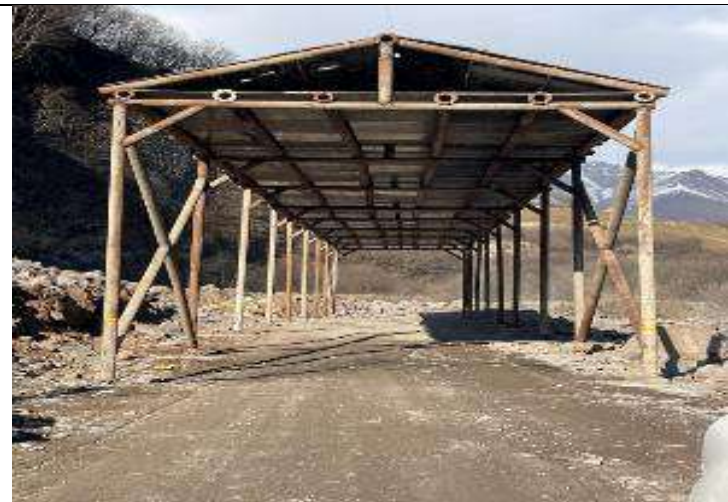
| | <p>Vehicle protection from falling object<br/>under bridge 3<br/>December 2025</p> |

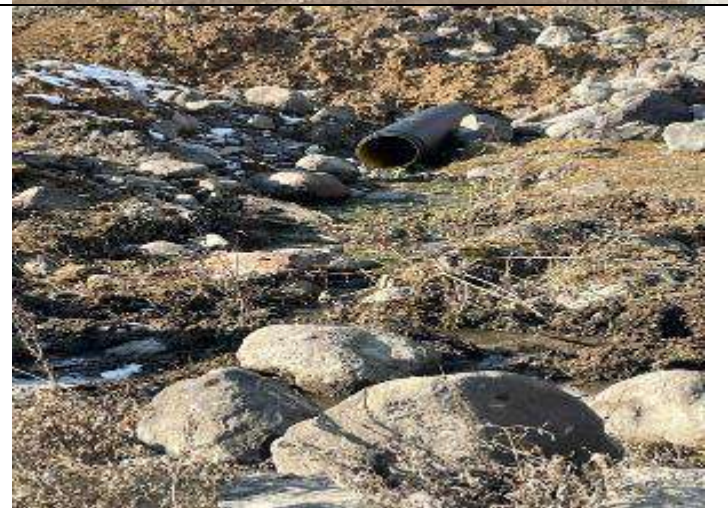
| | <p>Pipe to drain the water across<br/>village Bedoni<br/><br/>December 2025</p> |

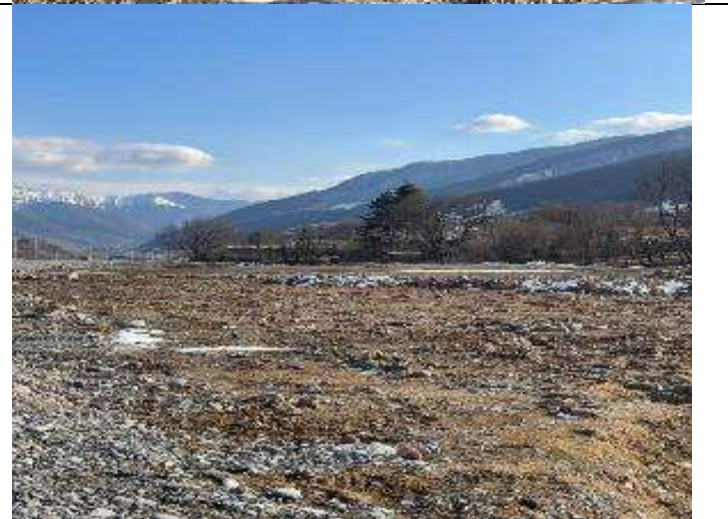
| | <p>Bedoni filling area<br/>December 2025</p> |

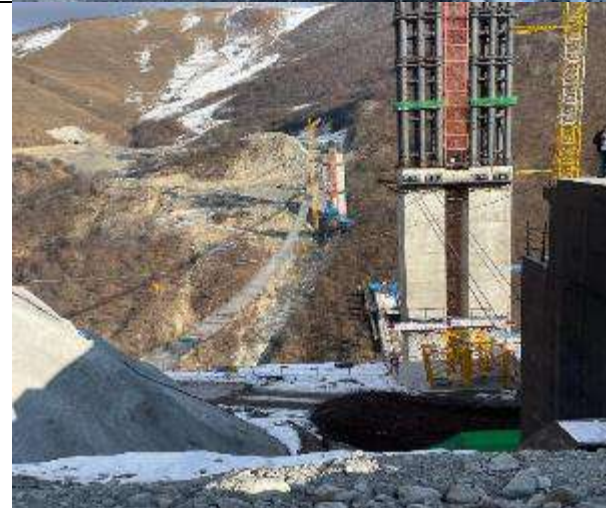
| | <p>Bridge 3 ongoing construction<br/>December 2025</p> |

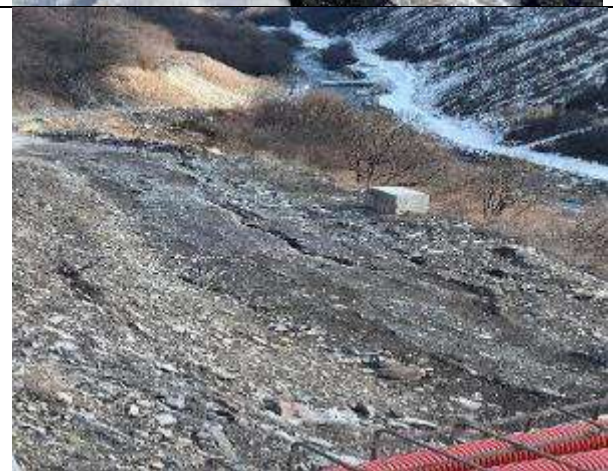
| | | <p>Slope to be stabilized near bridge 2<br/>December 2025</p> |

| At Bridge 2, UBM is recommended to conduct a structural inspection of the bridge and ensure that the Lot 2 Contractor immediately undertakes stabilization or reconstruction of the damaged span. | CC for Lot# 2 to implement and PMCSC to monitor |

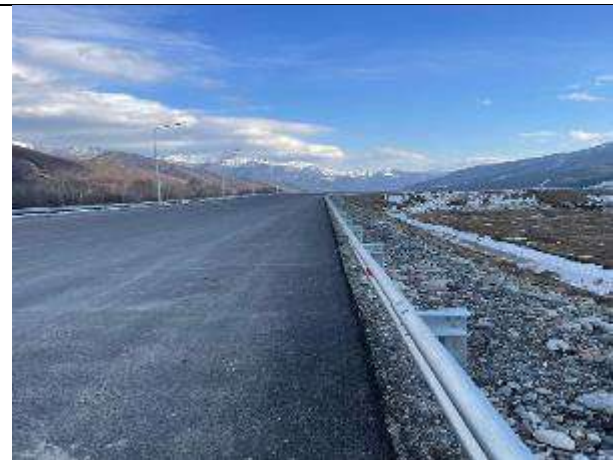
| | | <p>Drainage channel to be cleaned out from the rock pieces<br/>December 2025</p> |

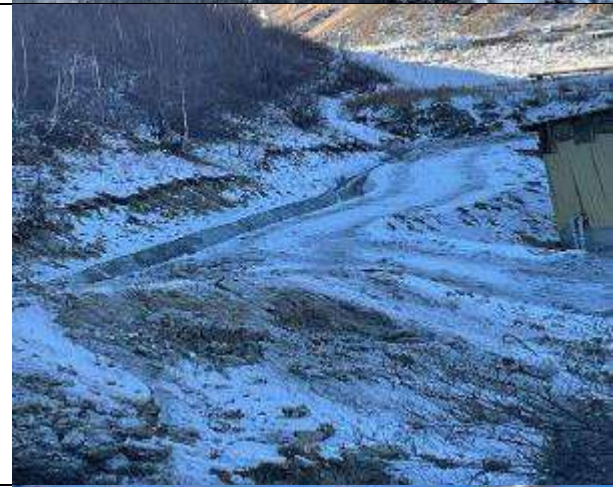
| | | <p>New drainage channel as per design to drain Kobi Tunnel water<br/><br/>December 2025</p> |

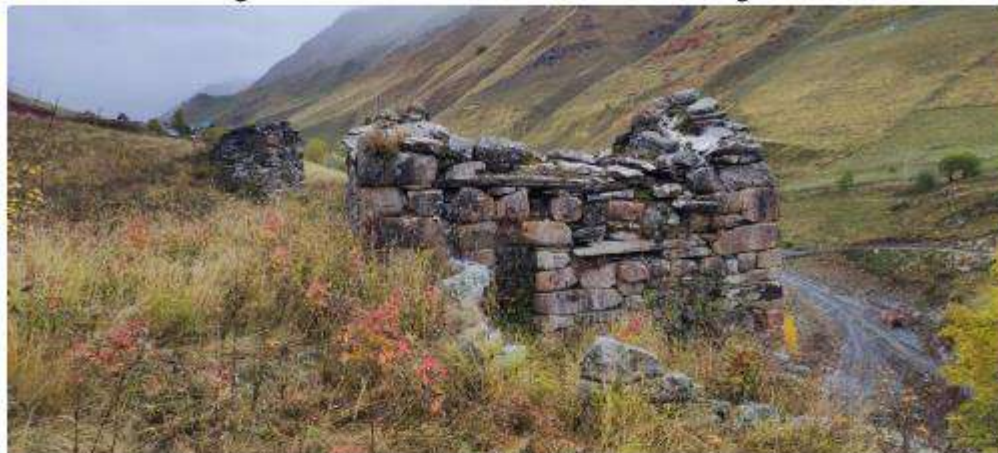
**Figure 6: Measurement Point – VM#5 – Cultural Heritage #29**

Construction vibration does not affect the overall condition

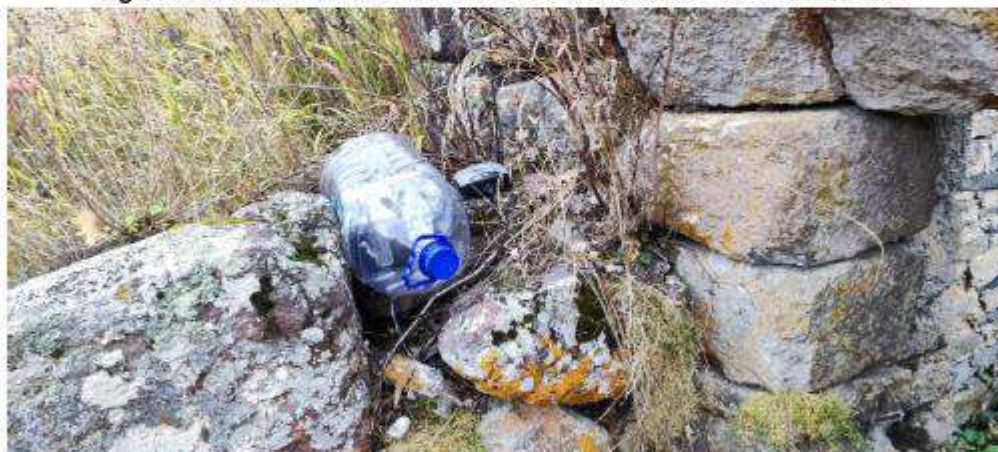
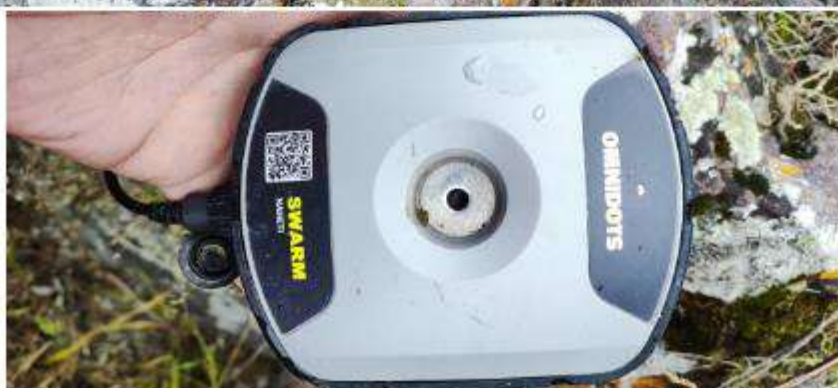
**Figure 6.1: Vibration monitor SWARM was installed outside on the wall of the Tower**

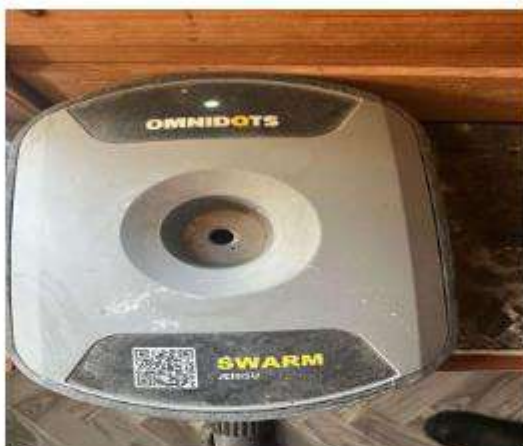
**Figure 7: Measurement Point – VM#6 – Kakha Burduli**

| <p>9. Evaluation</p> | <p>Construction vibration does not affect the overall condition</p> |

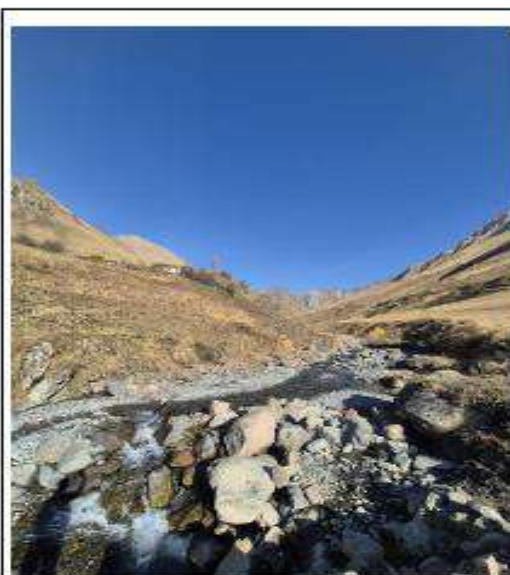
The first fishing attempt was carried out near the Tskere village (Fig. 2.1) (coordinates: X 461880.82 – Y 4702954.24). No trout were found in this location. The situation was similar during the previous monitoring. It seems that trout rarely reach this point because there are natural barriers (waterfalls) in the river. Below this point, a bridge (N6) is under construction. Also, down from the temporary bridge, ground water from the main tunnel enters the river. It is worth noting that at the time of monitoring, this water was almost dry, however the river was still turbid in this section (Fig. 2.2).

**Figure 2.1.** The Khadistskali River, near the Tskere village. First fishing point (coordinates: X 461698.23 – Y 4702639.57).

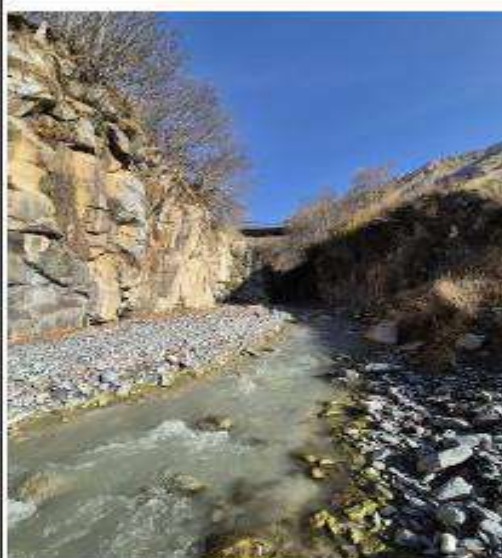
**Figure 2.2.** Riverbed near the bridge N6. First fishing point.

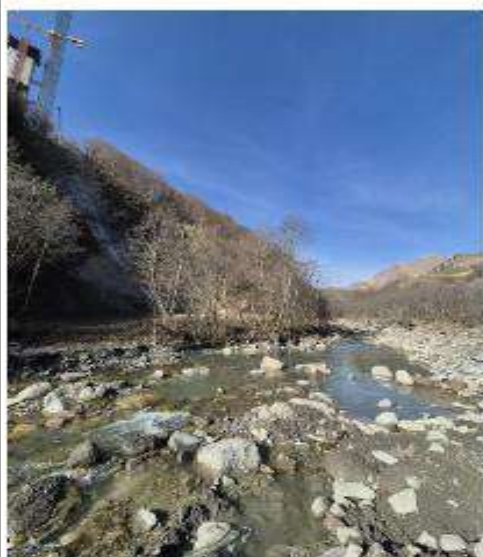
A third fishing attempt was carried out in the area of the project bridge (N3) (Fig. 2.5 & 2.6) (coordinates: X 461150,24 – Y 4699365,16). No fish were recorded in this section either.

**Figure 2.5.** Placement area of bridge (N3), third fishing point (coordinates: X 461150,24 – Y 4699365,16).

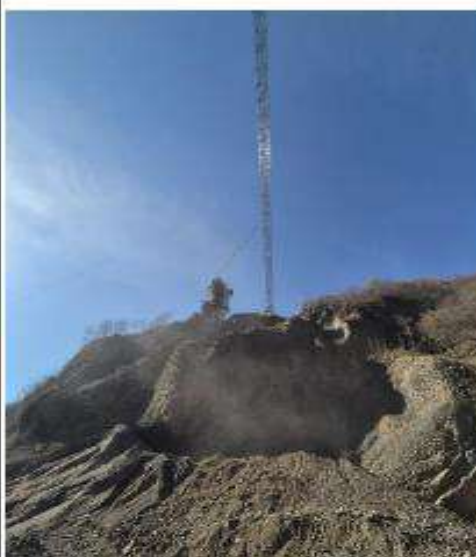
**Figure 2.6.** Construction works of bridge (N3).

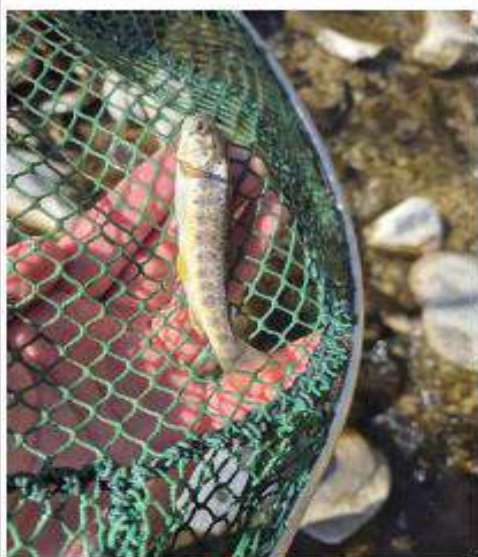
**Figure 2.9.** Juvenile Caspian trout – *Salmo caspius*, fourth fishing point.

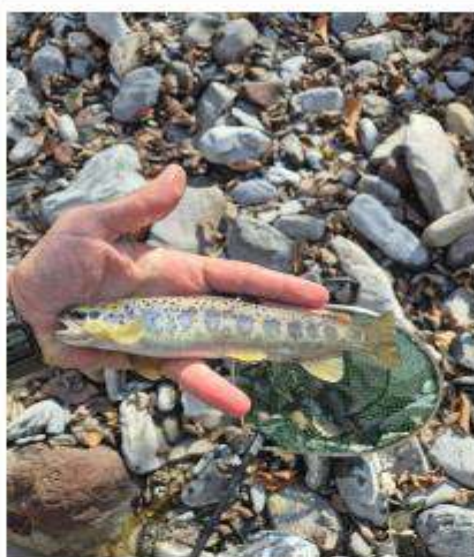
**Figure 2.10.** Adult trout, fourth fishing point.

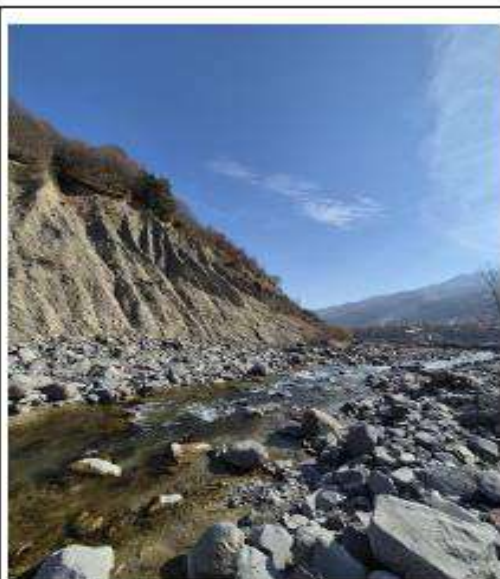
At the sixth research point which is located near the confluence of the Khadistskali – Tetri Aragvi rivers (Fig. 2.13) (coordinates: X 463195.62 – Y 4697578.80), three adult trout individuals were observed (Fig. 2.14).

**Figure 2.13.** The sixth fishing point at the confluence of the Khadistskali-Tetri Aragvi rivers (coordinates: X 463195.62 – Y 4697578.80).

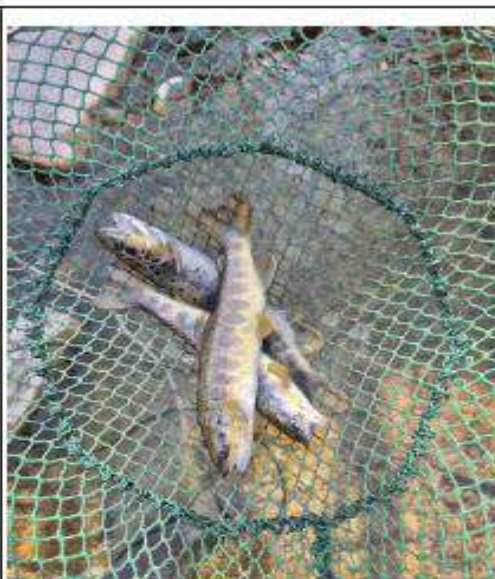
**Figure 2.14.** Adult trout individuals from the confluence of the Khadistskali-Tetri Aragvi rivers, sixth fishing point.
