# Semi-annual Environmental Monitoring Report

Reporting period: January – June 2024

## **Georgia: North-South Corridors (Kvesheti – Kobi) Road Project**

Loan No GEO 3803

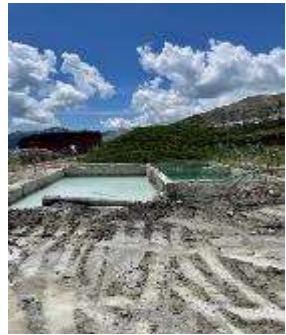
| # | Locations | Date | Issue | Priority | Mitigation | Target Date | Action Taken | Status |
|---|---|---|---|---|---|---|---|---|
| 1 | Lot-1<br>Tskere | Jan 2024 | Concrete washout pit filled with frozen water and concrete | Low | Cc to clean washout pit, otherwise concrete would be consolidated with concrete. | Feb 2024 | Pit cleaned out<br> | Closed<br>May 2024 |

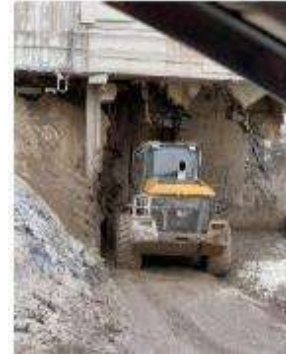
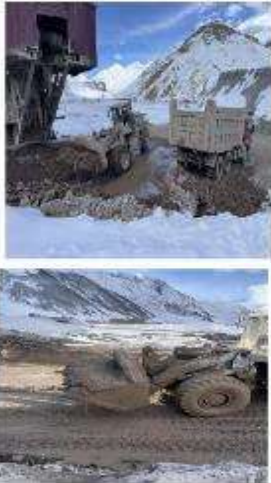
| # | Locations | Date | Issue | Priority | Mitigation | Target Date | Action Taken | Status |
|---|---|---|---|---|---|---|---|---|
| 2 | Lot-1 | Feb 2024 | Cleaning of conveyer belts required | Low | Clean the conveyer belt of TBM | Feb 2024 | CC cleaned the conveyer belt<br> | Closed<br>Feb 2024 |

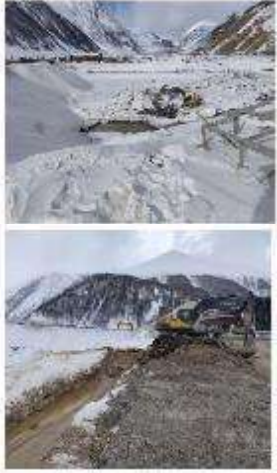
| 3 | Lot-1<br>Kobi | Feb 2024 | Cleaning of sedimentation ponds for treatment of tunnel water | High | CC to clean all the tunnel water treatment ponds on regular basis for efficient treatment | February 2024 | <p>CC cleaned all the ponds in Feb 2024 in regular basis.</p> | <p>Closed</p> <p>Feb 2024<br/>Being repeated and closely monitored by engineer</p> |

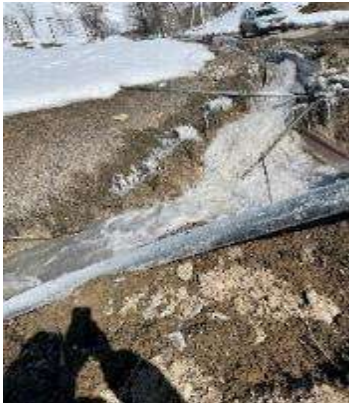
| 12 | Lot-1<br>Tskere | Feb/ Mar<br>2024 | <p>High flow of turbid water from the tunnel directly flowing in the River</p> | High | Divert the flow with high-capacity pipe to sedimentation ponds and clean the ponds on daily basis | March 2024 | <p>CC diverted the water but more than half of the water coming from tunnel flowing directly in to the river</p> | <p>Pending<br/>However<br/>turbidity<br/>level<br/>decreased<br/>due to<br/>break in<br/>TBM<br/>excavation</p> |

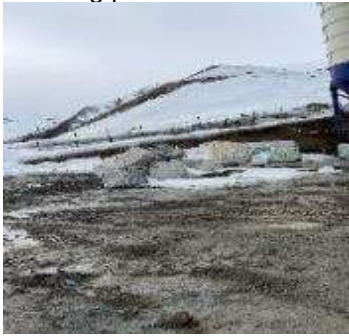
| 15 | Lot-1<br>Tskere<br>Batching<br>Plant | March<br>2024 | Waste containers thrown in<br>batching plant area<br> | Low | CC to remove the used<br>containers from the site<br>and store at appropriate<br>manner | March 2024 | Contractor cleaned out<br>the area and removed<br>use containers.<br> | Closed |

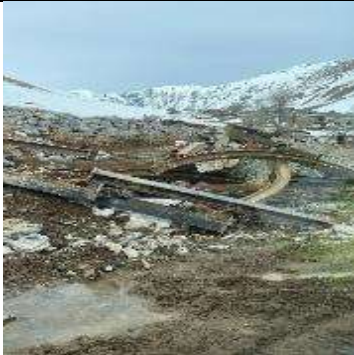
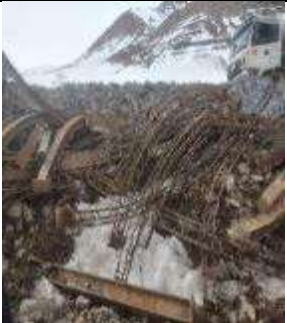
| 16 | Lot-1<br>Tskere | Feb 2024 | Used iron support placed on<br>the slopes | Med | Material should be<br>placed in the designated<br>area | March 2024 | Contractor removed the<br>scarp and stored it in<br>scrap yard. | Closed |

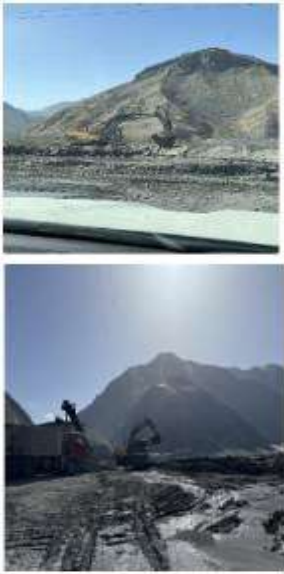
| 18 | Lot-1<br>batching<br>plant Kobi | April 2024 | Cleaning of sedimentation pit<br>and batching plant area | Low | Clean the pit and<br>batching plat in Kobi | ASAP | CC cleaned the pit and<br>floor of batching plant<br> | Closed<br>April 2024 |

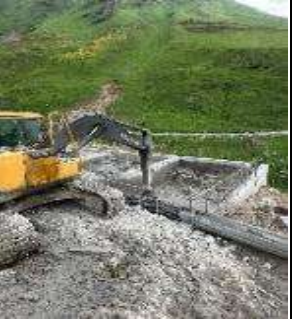
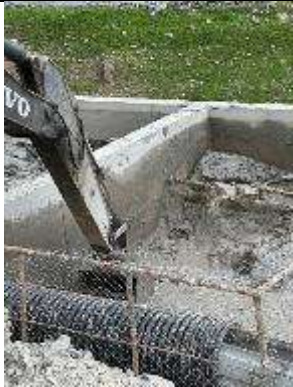
| 21 | Lot-1 Tskere Sedimentation ponds | May 2024 | Sedimentations Pit need to be cleaned out | Low | Cc to clean out sedimentation ponds | May 2024 | Sedimentation Pits cleaned out by diverting water and the pit was washed out completely.<br> | Closed May 2024 |

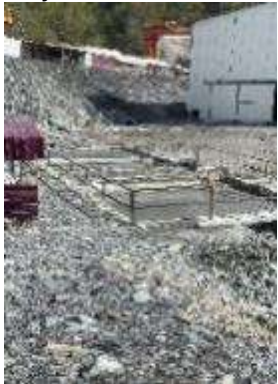
| 22 | Lot-1<br>batching<br>plant Kobi | May 2024 | Cleaning of sedimentation pit<br>and batching plant area | Low | Clean the pit and<br>batching plat in Kobi | ASAP | CC cleaned the pit and<br>floor of batching plant in<br>May 2024<br> | Closed<br>May 2024 |

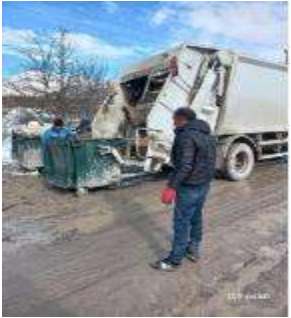
| 38 | Camp 2<br>and Camp 3 | February 2024 | Waste collection from Camp 3 and Camp 2 is required. | High | CC to regularize the waste collection especially from camp 3 as the municipality truck cannot reach there and | February 2024 | CC collecting waste by his own vehicle from camp 3 but need to regularize. Waste from camp 2 is being | Closed<br>February 2024 |

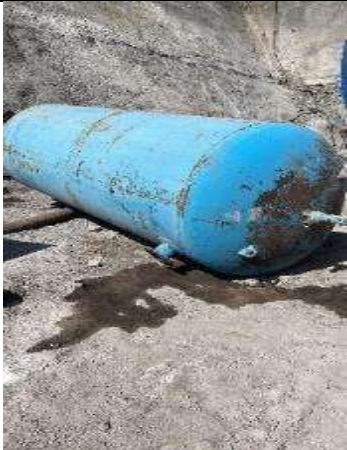
| 46 | Lot-2 Tun1 Exit | Mar 2024 | Oil spill and oil/ chemical container on the ground | Med | Contractor to collect the contaminate soil and remove the container | Mar 2024 | CC removed the container and clean out the area.<br> | Closed<br>May 2024 |

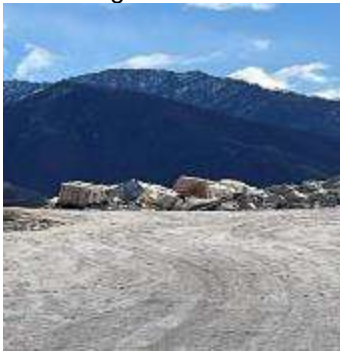
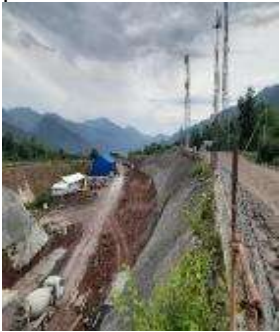
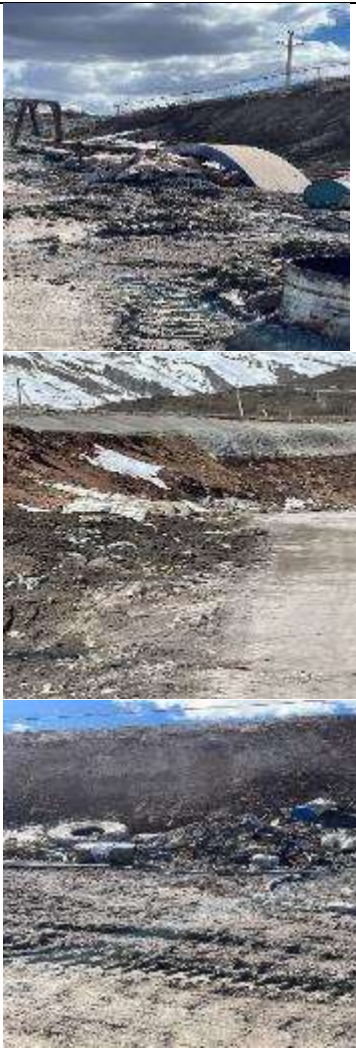
| 47 | Lot-2<br>Tun 1Exit | Mar 2024 | <p>Poor housekeeping, containers , waste of different kinds on ground</p> | Med | Contractor to clean out the area | Mar 2024 | <p>CC cleaned out al the area at the tunnel 1 exit and started slope protection works.</p> | Closed<br>June 2024 |

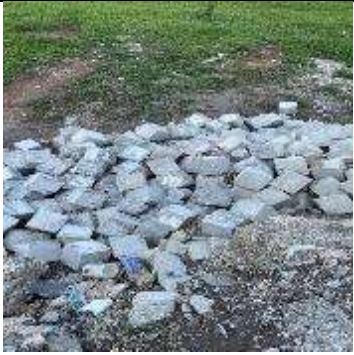
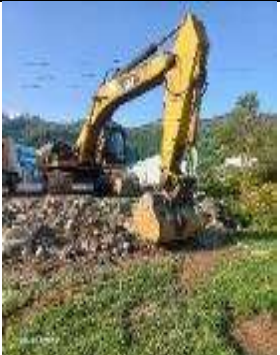
| 59 | Lot-2 camp 2 | May 2024 | Concrete blocks and waste on the private land | Low | Contractor to remove the blocks and waste from private land | May 2024 | Cc removed the concrete blocks and cleaned the area | Closed June 2024 |

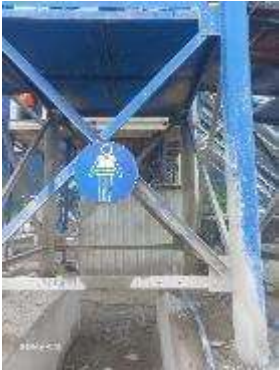
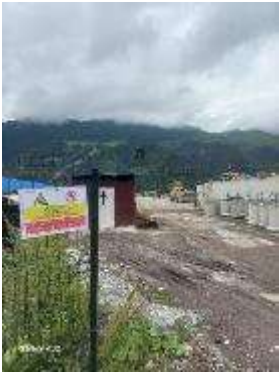
| 61 | Lot-2 Construction site | June 2024 | Lack of safety signs on the site | medium | CC to install the warning signs at the missing places pointed out by the PMCSC | June 2024 | CC installed the safety signs at the required places. | Closed June 2024 |

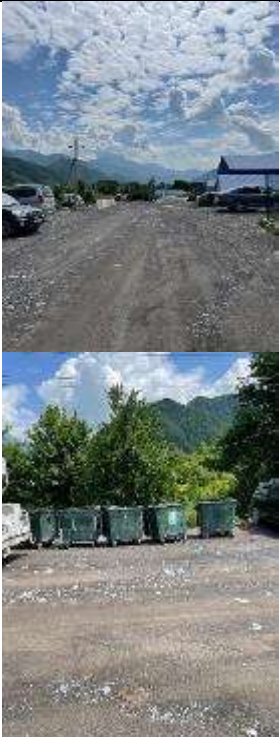
| 63 | Lot-2<br>Camp 2 | June 2024 | Poor housekeeping at Camp 2, containers filled with the waste. | Low | Contractor to call municipality to collect the waste from the containers. | ASAP | Waste collected by the municipality. | Closed<br>June 2024 |

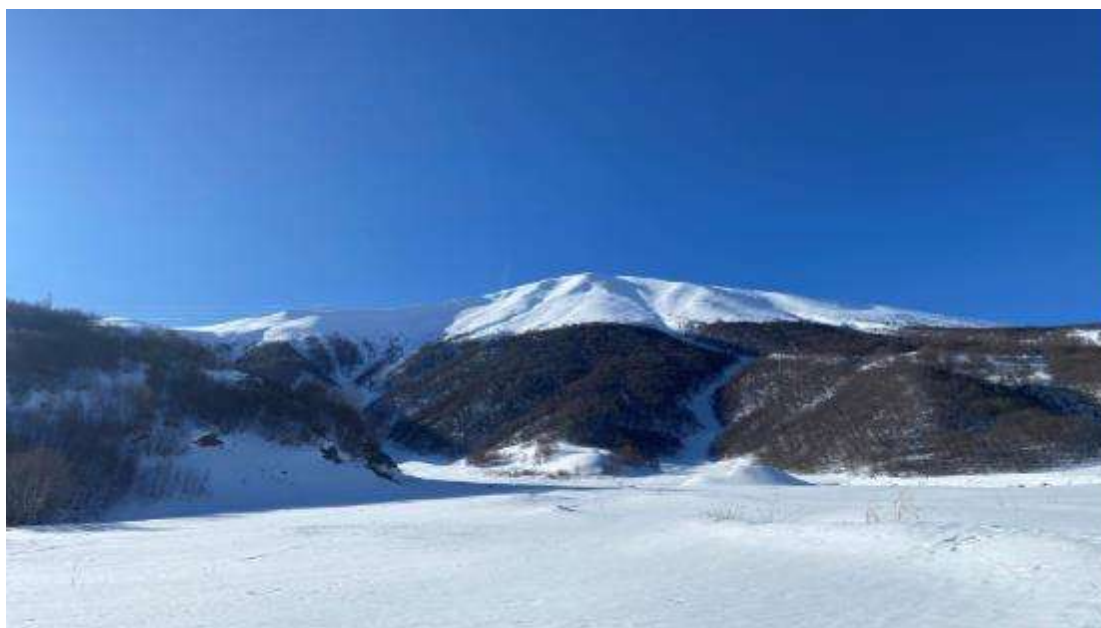
89. For Lot 1 ground water quality testing was not carried out from January to May 2024 as it was not possible to collect the sample from the spring due to heavy snow as shown in Figure 7 D.

91. During reporting periods contractor did not take any action to eliminate the Total Coliform in the water. PMCSC has advised several times in meetings to start chlorine dosing to eliminate the coliform bacteria. As it is quite probable that the presence of coliforms is due to degradation of leaf/ grass and due to animal dung (grazing in that area during summer) entering in spring with rain water.

**Figure 7 D: Heavy snow during March 2024 restricted ground water sampling from spring in Kobi**

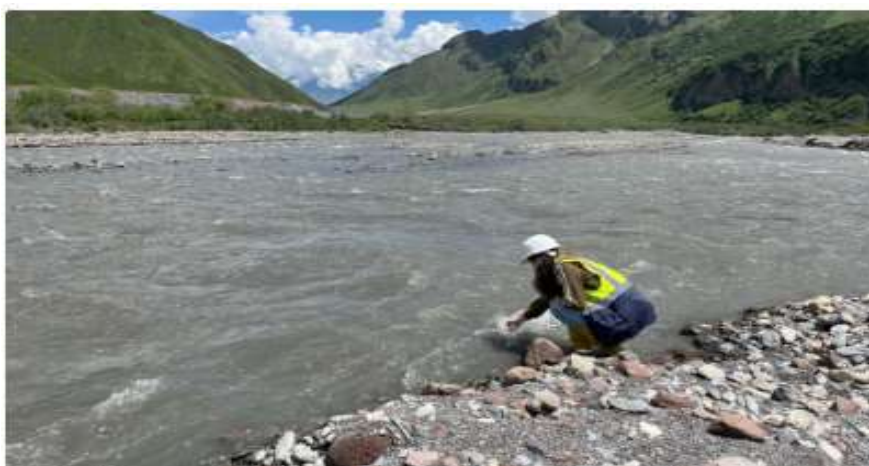
**Figure 8: Downstream Surface Water Sampling in Tergi River, June 2024**

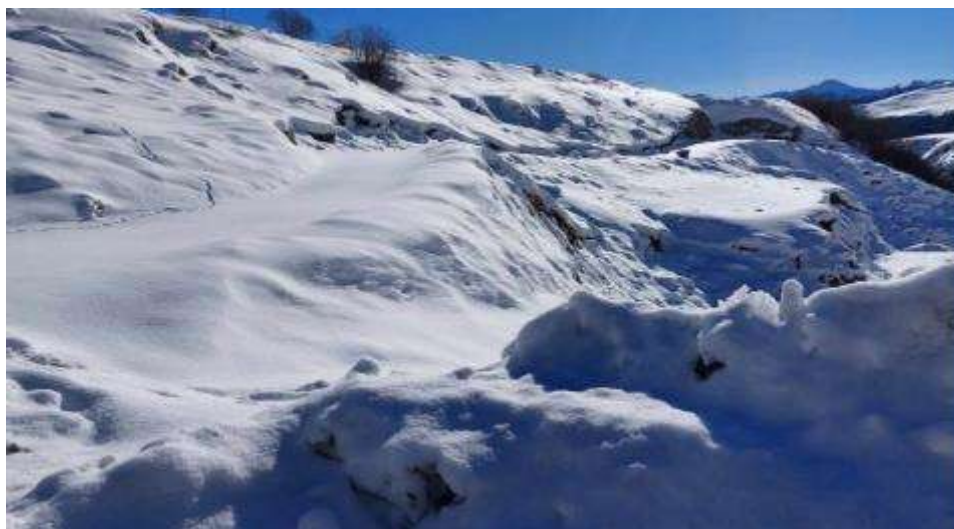
98. Due to heavy snow in Tskere during the months of January to March 2024 there was no access to River Khadistskali, therefore it was not possible to take water sample upstream and downstream of the river.

**Figure 9: Heavy snow during January 2024 restricted water sampling from River Khadistskali**

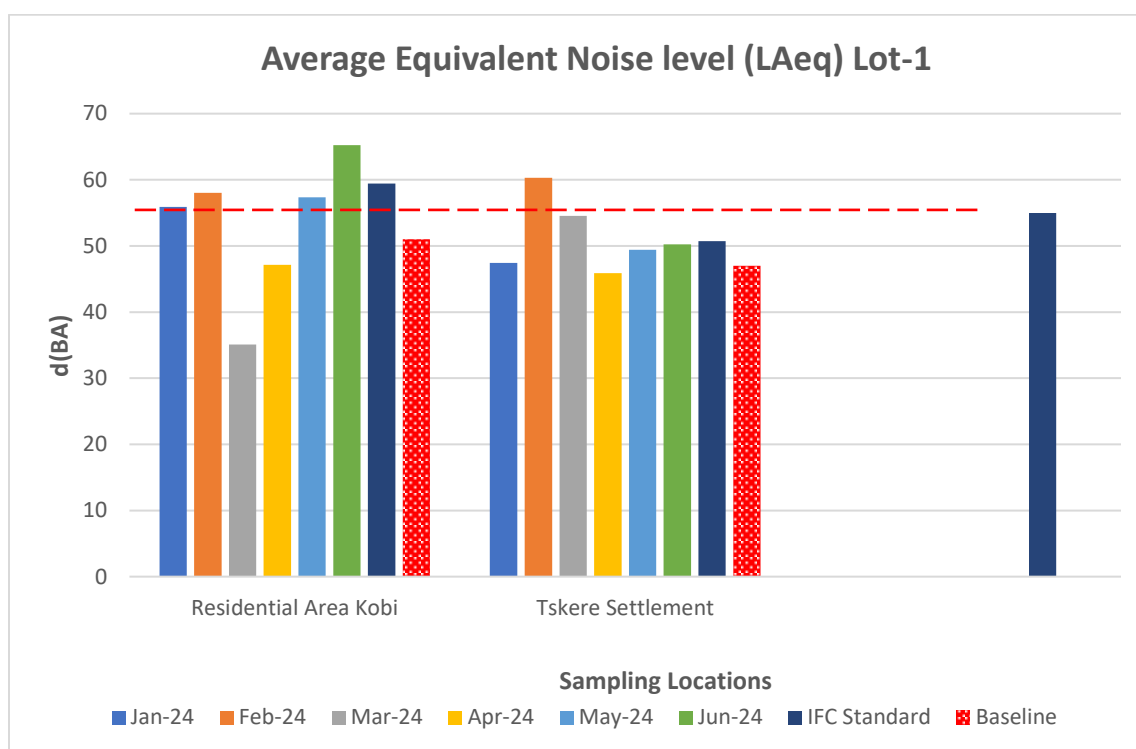
108. For Lot 1 overall, the LAeq results vary between 35 dBA to 65 dBA. The increased levels observed in June 2024 in Kobi from the range of IFC standard 55 d(BA) for residential areas during the day time. The increased high levels in Tskere in February 2024 are anticipated to be due noise of water flowing from the tunnel to sedimentation ponds in Tskere. In Kobi the increased noise levels are due to cumulative effect of traffic on E-117 and construction activities in Kobi. Graphical presentation of the day time levels at Lot 1 is shown in the Figure 10. The difference of 3dB(A) is hardly to be detected by the human ear.

**Figure 10: Average Equivalent Day Time Noise levels (LAeq) Lot-1**

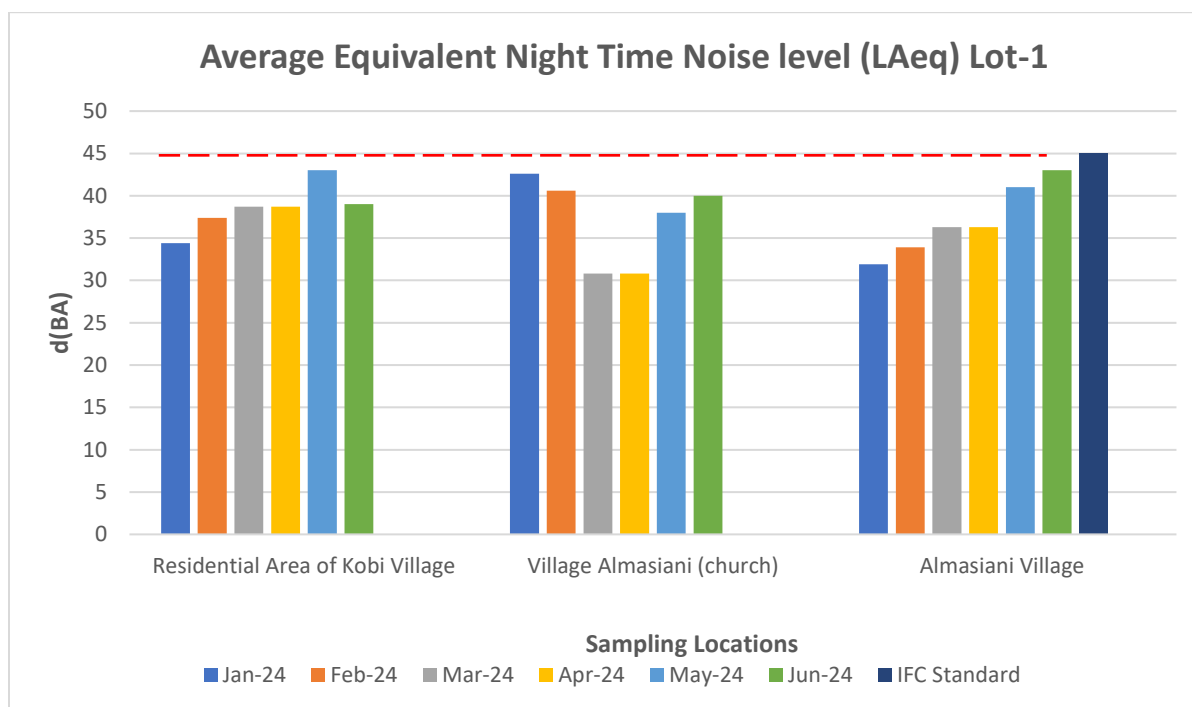
109. The night time noise levels in village Kobi and Almasiani were within the limits of the standard which is (45 dBA). In Kobi, crushing plant has been surrounded by SDA 1 and stockpile height has been increased enough and that is acting as a noise barrier especially for the village Almasiani. Night time noise levels were not conducted in Tskere as there was no construction activity in Tskere in the night time. Graphical presentation of the night time levels at Lotv1 is shown in the Figure 11.

**Figure 11: Average Equivalent Night Time Noise levels (LAeq) Lot-1**

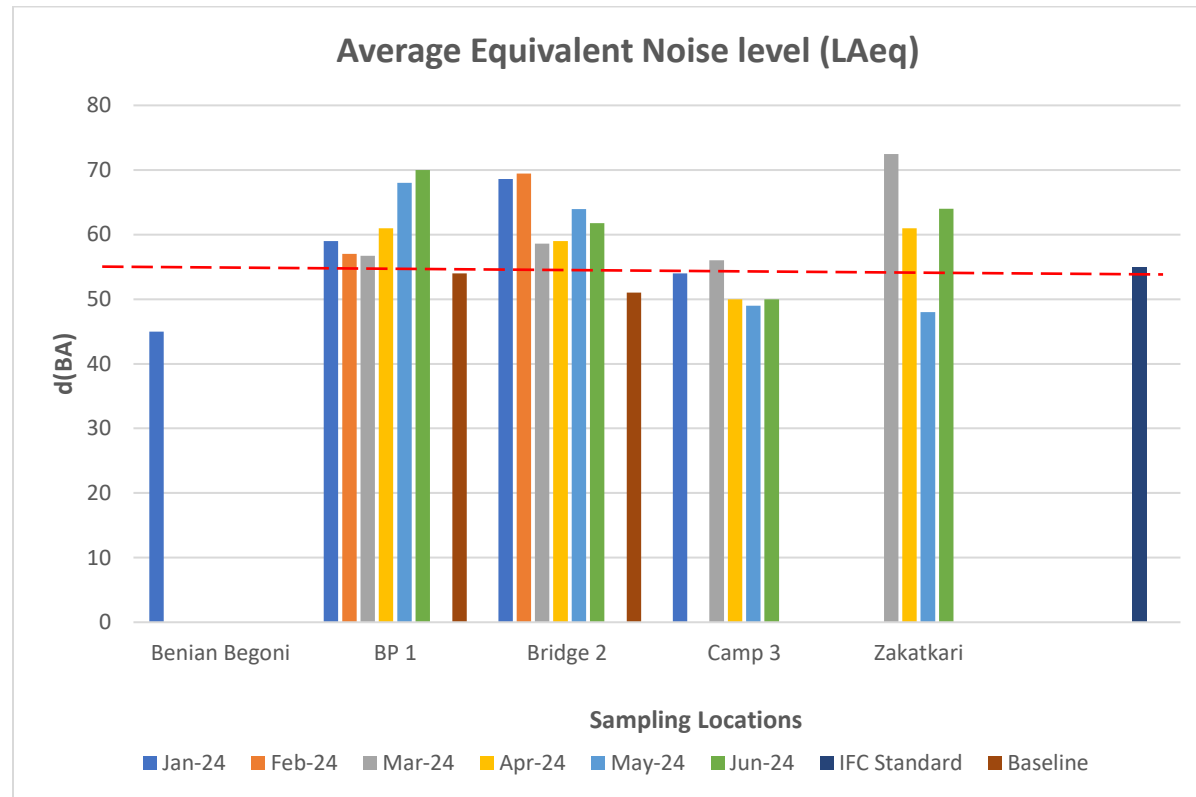
110. Noise monitoring results detail for Lot 2 is given in Table 12C. As indicated in the Table 12C and shown in Figure 12, along the E-117 noise levels are exceeding the day time IFC limits for residential area due to heavy traffic movements on the highway and construction activities; however, these are below the IFC limits of commercial noise levels 70 dB(A). Lot 2
111. High noise levels observed in village Zakatkari are due to construction activities. Contractor does not conduct any construction activities at night time and there is no need for night time noise monitoring for Lot 2.

**Figure 12: Average Equivalent Day Time Noise levels (LAeq) Lot-2**

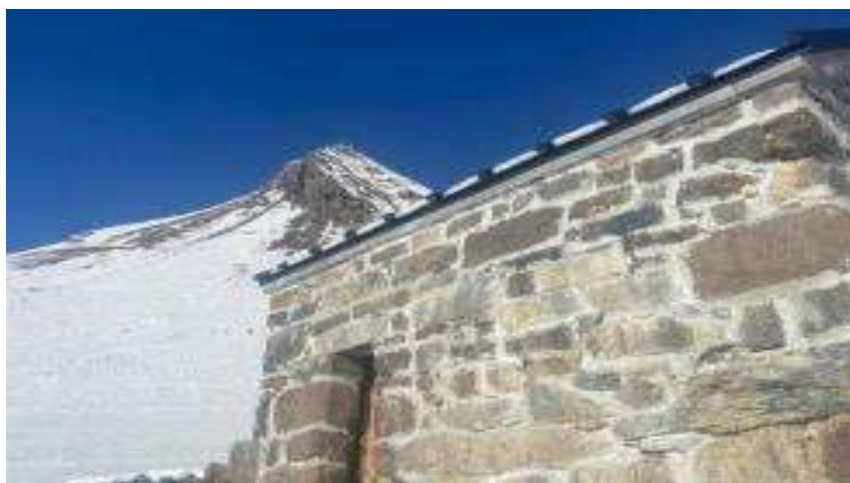
112. During the reporting period, Lot 1 conducted continuous vibration monitoring at one sampling point: Kvelatsminda Church building in Tskere Village. The device also covers Naraidze Tower, Zakaidze Tower and the old graves in Tskere. No exceedance of the reference value of DIN 4150-3 standard was observed due to construction activities in Tskere. Exceedance observed are due to change in battery, physical contact by locals.

**Figure 14: Vibration monitoring in Tskere Kvelatsminda Church**

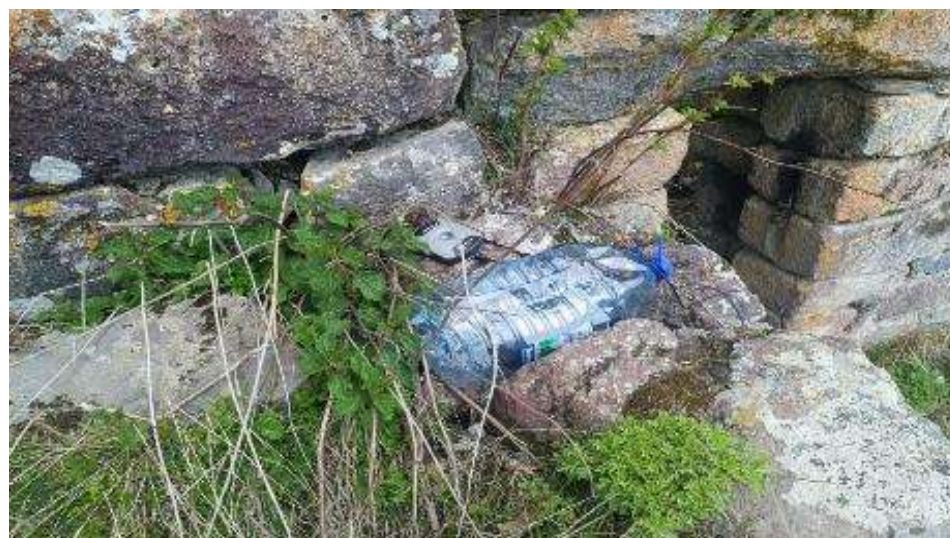
**Figure 16: Continuous Vibrational Monitoring at CH Site 29, Mughure, Lot 2**

118. No significant Exceedance was observed due to construction activities at the locations mentioned in Table 13C. The exceedances observed in March 2024 & June 2024 were due to contact with animals or due to change of batteries or shifting of devices.

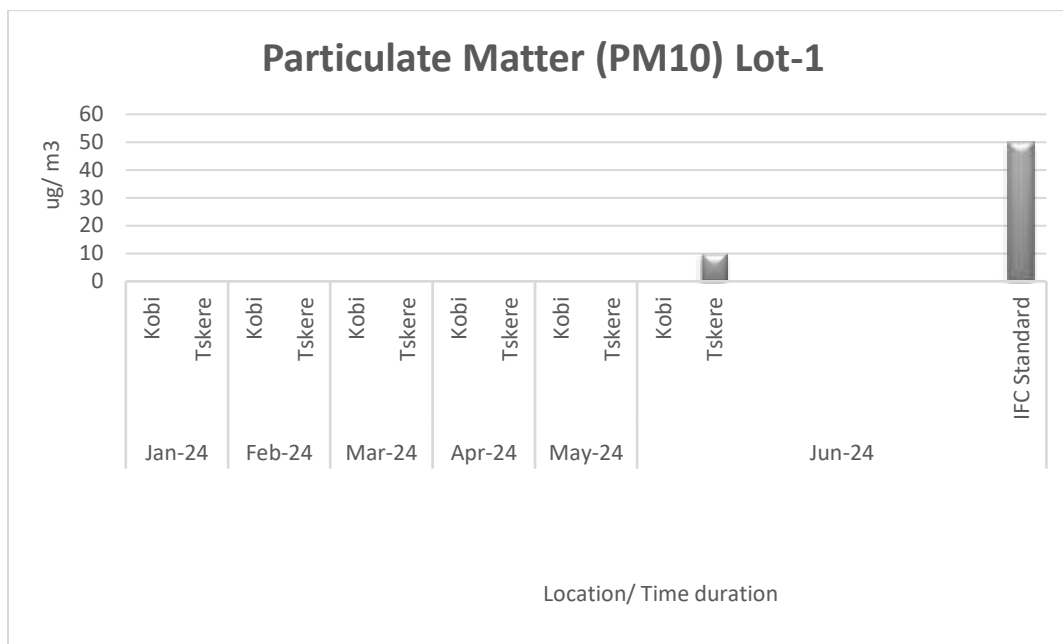
121. PM10 levels including the concentration levels of NO<sub>2</sub>, SO<sub>2</sub>, CO and dust levels as indicated in Table 14A are within the national limits for air quality in Georgia and IFC guidelines (for trend of PM 10 Levels during reporting period (see figure 17). CC for Lot 1 was carrying out regular water sprinkling at Kobi; however, CC for Lot-1 is not using the access road 1 as they have access for Tskere through tunnel 5.

**Figure 17: Dust Levels (PM10) at Lot 1 (January – June 2024)**

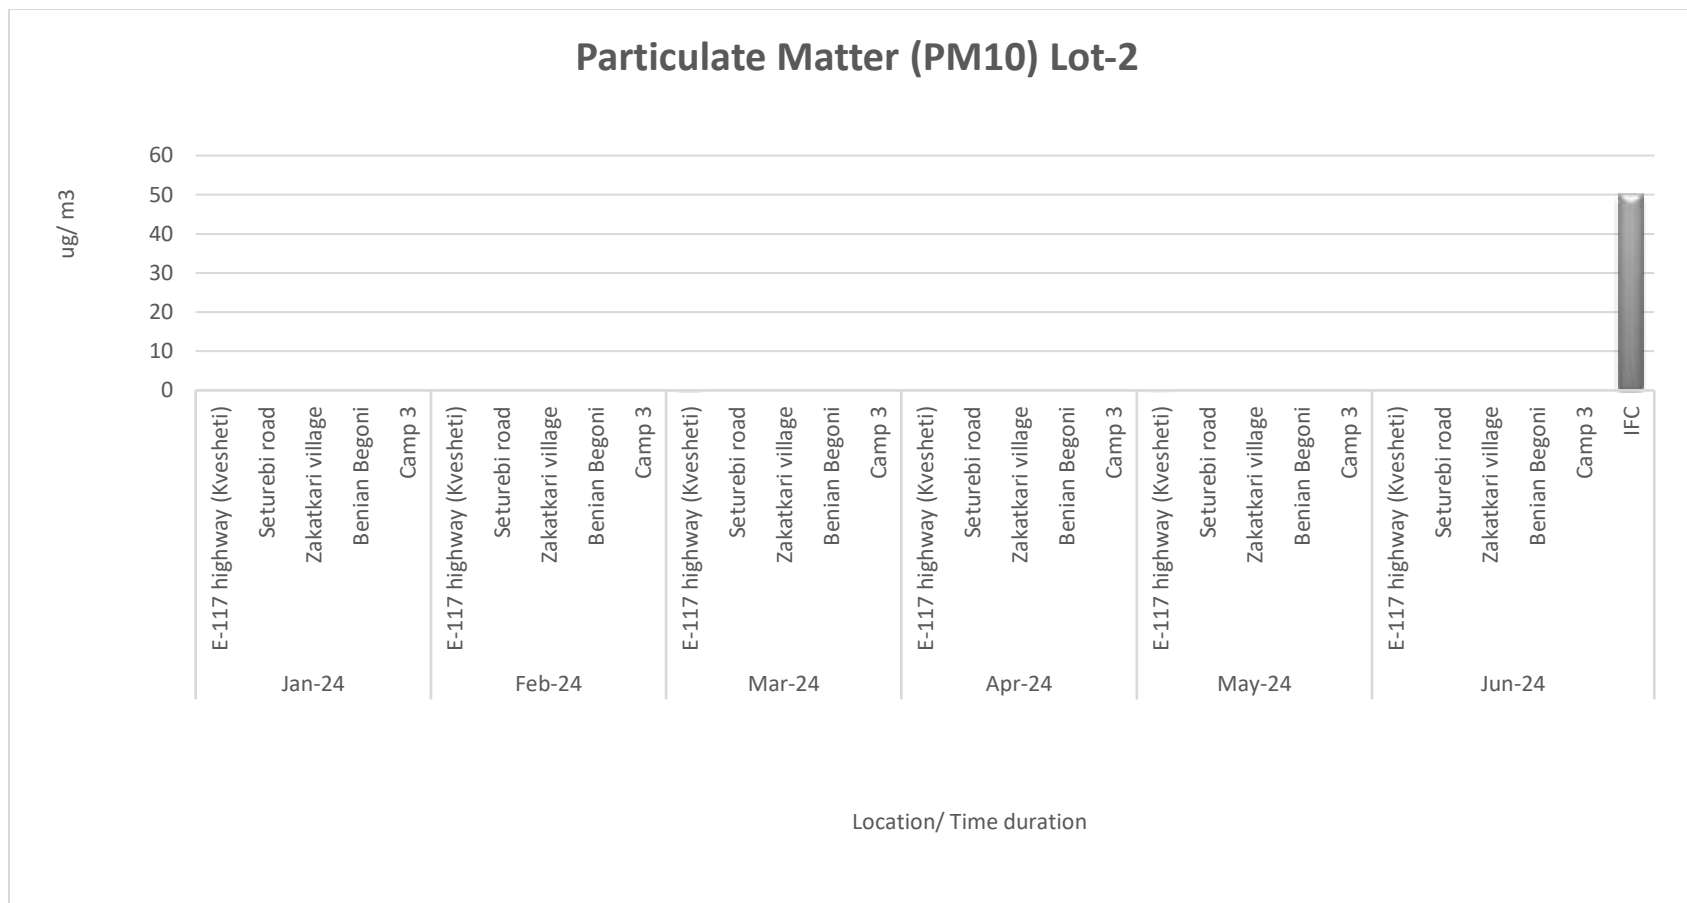
122. CC for Lot 2 monitored air quality from January to June 2024. The details of locations and results are provided in the Table 14B. All the parameters measured are within the permissible limits of IFC guidelines. Graphical presentation is shown in the Figure 18 to see the trends during the reporting period and ambient air is very clean. Fugitive dust emissions are being observed at the access road when heavy vehicles moving on the access roads during dry and windy days. Contractor is required to regularize the water sprinkling in Khada Valley and Didveli plateau to suppress the fugitive dust. Fugitive dust levels are the major issue in Khada Valley and Plateau at access road while vehicles travelling on access road during dry and windy season. Lot 2 has prepared dust management plan consisting of Action Plan to combat the dust and need to be properly implemented and UBM field officers should monitor on daily basis.

**Figure 18: Dust Levels (PM<sub>10</sub>) for Lot 2 (January – June 2024)**

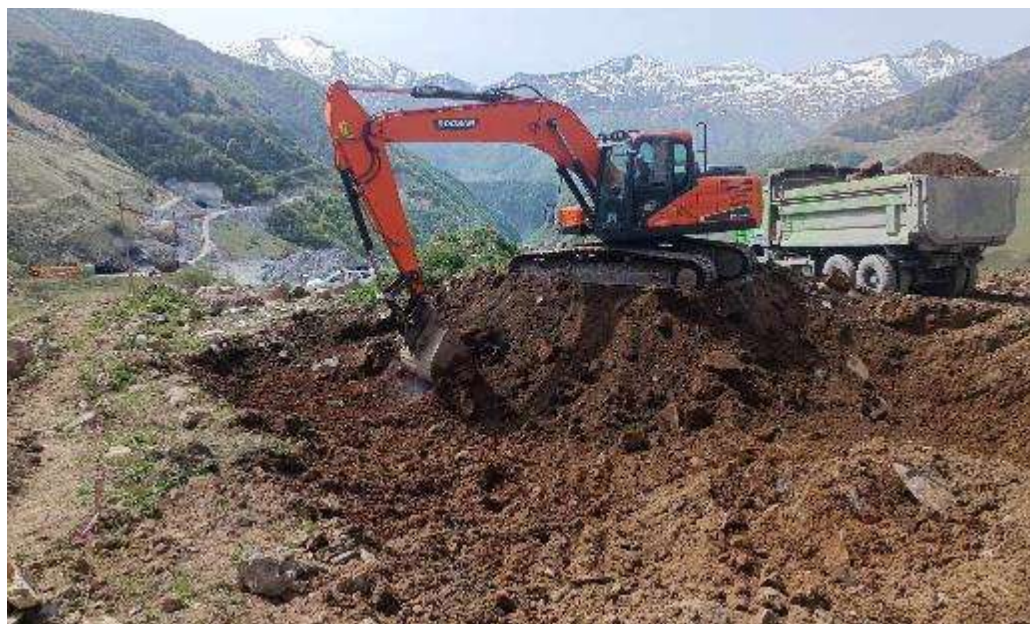
**Figure 21: Earthworks near CH 26**

127. In the monitoring period the contractor for LOT 2 (CRCC) has embarked on earthworks along the Gudauri access road. This phase of the project involved the removal of topsoil, a process closely scrutinized by the Engineers' Cultural Heritage team. Diligent observation during the earthworks revealed no evidence of cultural heritage remains.
128. The Lot 2 Contractor started topsoil stripping at 3+200 Km. the Engineers CH specialists closely monitored the process. The chance find was not detected.
129. In the monitoring period the Contractor commenced earthworks at 10+600 Km, near the CH 26. The Engineers and The Contractors' CH specialists monitored the process. The chance find was not detected.

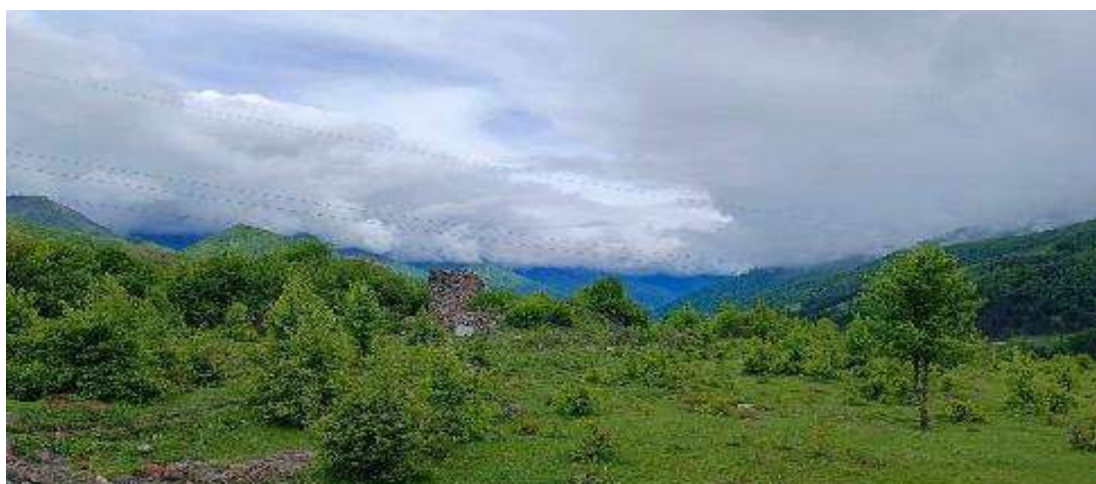
**Figure 22: Conservation Works of Didveli Backed Tower (CH Site #10)**

130. In December 2023, the Contractor initiated conservation efforts targeting the CH 10 tower. Originally slated for completion by December 8, 2023, the project encountered delays due to adverse weather conditions, stalling the subcontractor's progress. Consequently, the National Agency for Cultural Heritage Preservation (NACHP) revised the project's deadline to May 2024 to accommodate these setbacks. However, the contractor could not complete the work even in May. Accordingly, he applied to NACHP for a new permit. The subcontractor received a new permit deadline of August 26, 2024

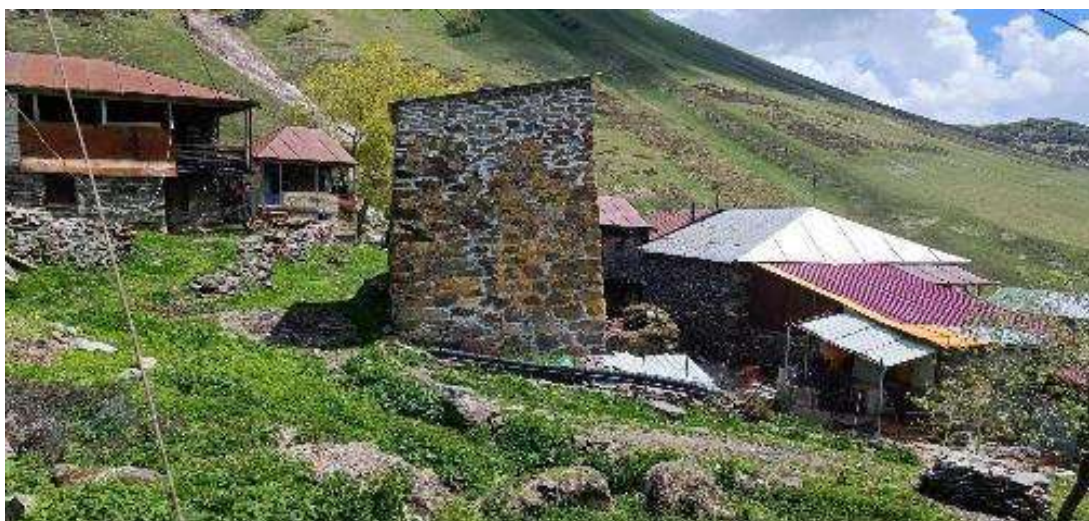
**Figure 23: Tskere, Zakaidze tower**

135. In the reporting period, PMCSC CH Specialists constantly monitored the identified CH Sites. Construction didn’t affect any identified CH Sites.
136. The Contractor for Lot 2 upgraded and reinforced the damaged fences around the required CH sites. The contractor for Lot 2 fenced Svianaant Old Village with wire mesh to avoid physical damage during construction works.

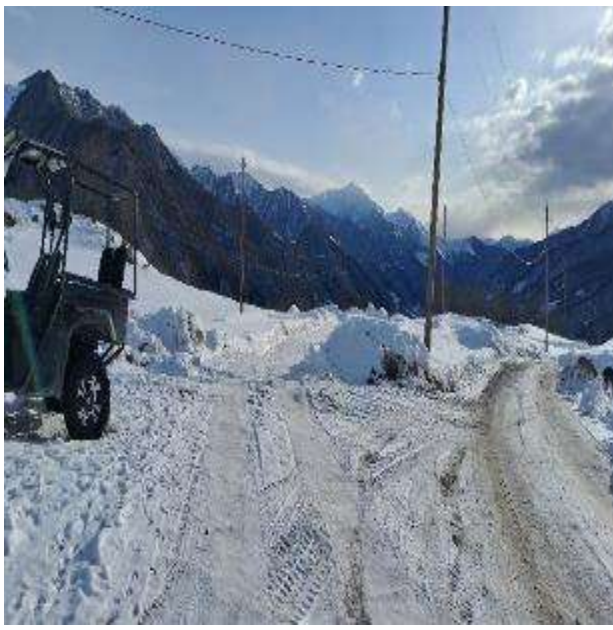
142. To ensure community health and safety, both Contractors carried out different activities during the reporting period:
- Cleaning of the local roads to villages Seturebi, Zakatkari and Jaghmiani from snow at Didveli Plateau (Pic 1)

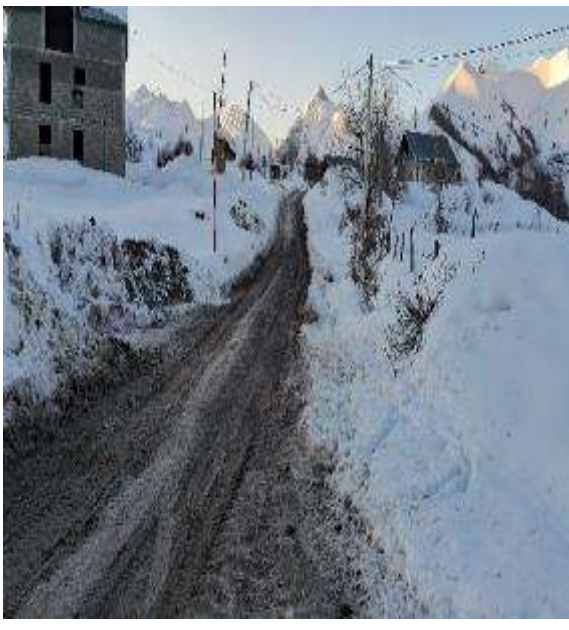
- Regular clearing of Khada Valley main road and access roads from snow by both LOTs (Pic 2)
  - LOT 1 Contractor was conducting noise monitoring during nighttime at a different period of time in Tskere in order to ensure that TBM which was at that time approaching South portal, did not generate any noise which could exceed the permissible limits and bother local community. As a result, no exceedances were detected, and the monitoring results were communicated with the locals.

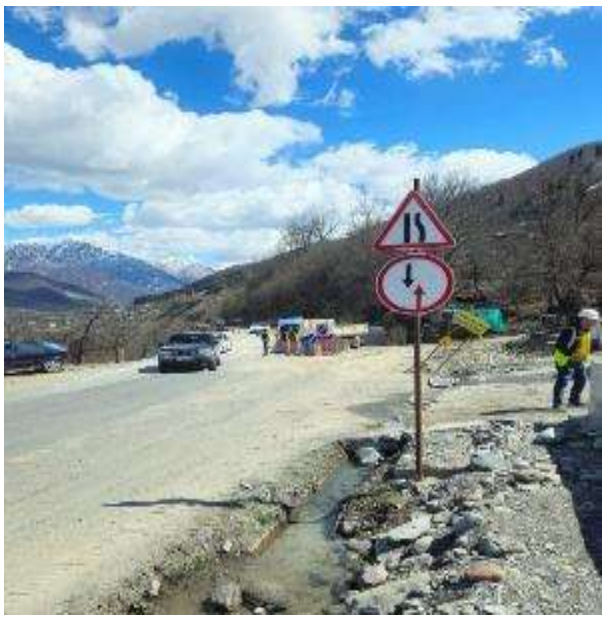
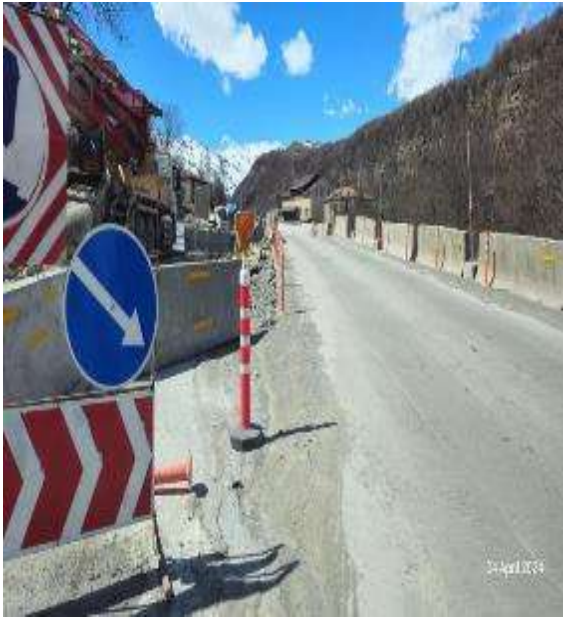
- Road works in Arakhveti resulted in the temporary narrowing of the roadway and hence, the movement of traffic became difficult which required mitigation measures to ensure smooth traffic movement. For this purpose, the LOT 2 Contractor, according to the recommendations provided by the Engineer's Road Safety specialist, installed additional traffic signs from both directions of the narrowed section. Also, flashing cone lights were installed to increase the awareness of road

users during the nighttime. In addition, two flagmen were mobilized from both directions to facilitate the traffic control at that section. (Pic 3,4 )

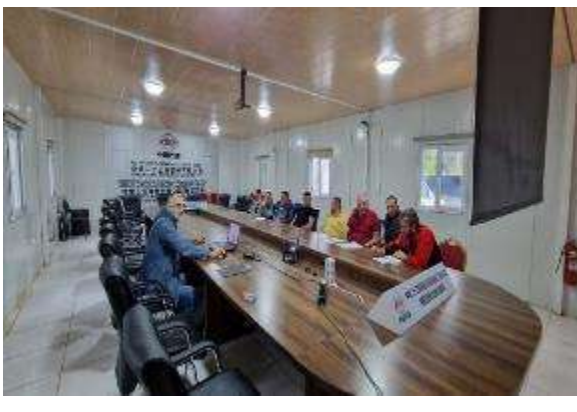
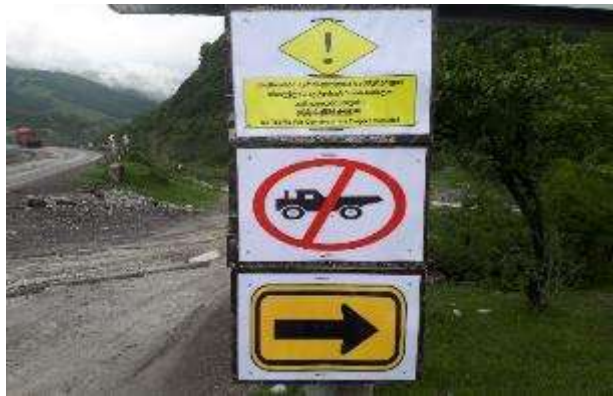
- Fencing of the excavations at different locations along the Arakhveti village, adjacent to the highway and residential areas
143. The residents of the village Bedoni expressed their concern regarding LOT2 Contractor's dump trucks driving on the road section which connects highway to this village. According to the local's explanation, it was disturbing and unsafe to drive on that road together with the dump trucks and it was creating a risk to their safety. Also, dump trucks were damaging this road. As a follow up on, the Contractor has diverted all dump trucks to the ROW section, avoiding driving on that local road. In addition, necessary signs were installed from both directions of this road's section, forbidding the dump trucks entering that section. Necessary instructions were also delivered to the dump truck drivers through the training session regarding this issue. (Pic 6,7)

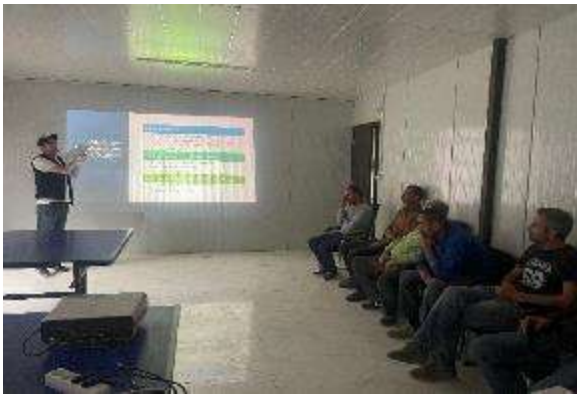
145. During this meeting, locals stated that night shift activities at the tunnel portal (excavation of C&C section) might create noise which can disturb children at night. It was agreed with the Contractor that night activities will take a place at the different location, distant from the village and hence, no disturbing noise at nighttime can be expected. (Pic 8)

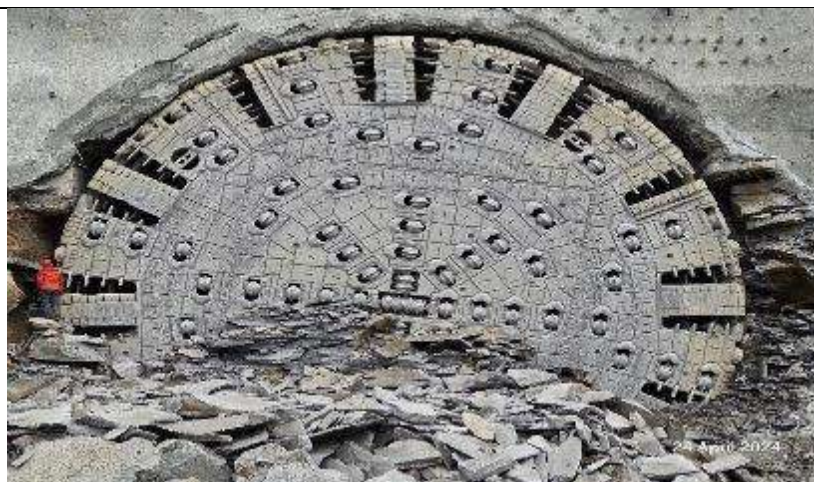
Pic 1

supervision ensured the safe completion of Tunnel 1 excavation without major incident or any other unwanted event. Safety procedures and mechanisms which were developed for the safe operation of TBM were strictly followed by the Contractor until completion of tunnel excavation which ensured safe working environment during the whole construction phase. The completion of this work significantly reduced the safety risks in the Tunnel No. 1 as TBM operation was extremely complex and challenging activity. The Engineer continues to closely monitor the remaining activities in Tunnel No.1 which are mostly the construction of driveway shoulders and arrangement of substructure basement (Pic 1)

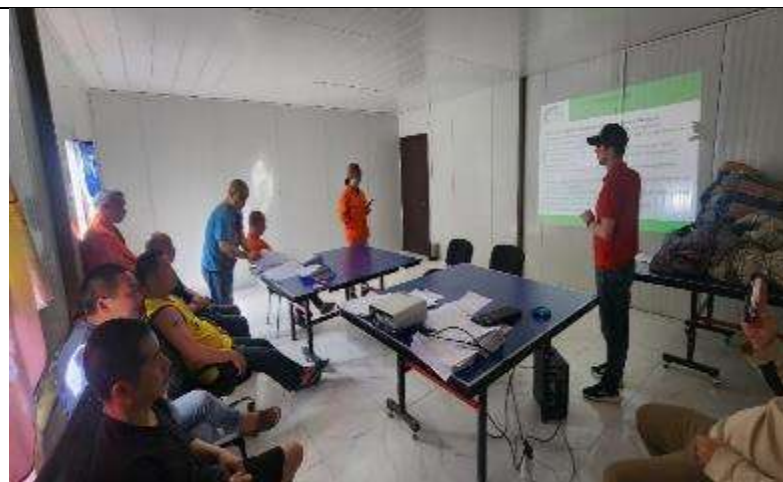
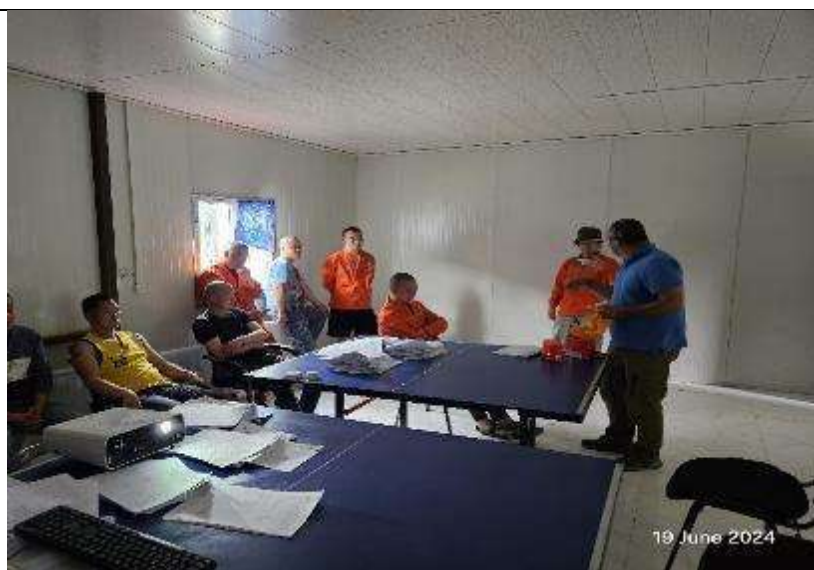
151. The Engineer together with both Contractors continues to deliver trainings during the reporting period to the tunnel personnel targeting safety requirements for the tunnel construction. During these trainings, not only theoretical materials are delivered to workers, but practical application takes a place targeting proper use of self-rescue equipment etc. (Pic 2, Pic 3)

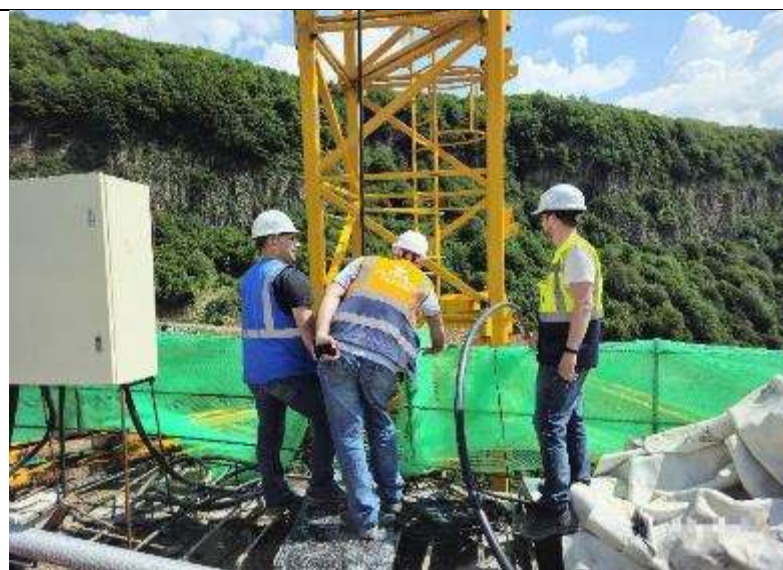
Pic 4

- Limited visibility
  - Emergency
  - Blasting
153. The biggest challenge for health and safety at Lot 2 section during the reporting period remained the construction of P3 and P4 at Bridge No.2. The stair towers, scaffolding and guardrail systems are a subject of permanent inspection carried out by a certified scaffolder, who is mobilized by the Contractor on a full-time basis. In addition to it, the Contractor's and the Engineer's HS specialists carry out permanent joint inspections of P3 and P4, when the results are documented in the HS reports and check lists. The Engineer also uses a drone system to inspect P3 and P4 worksites, when the inspection is required immediately. Drone system allows the Engineer to promptly and remotely check the situation at worksite which significantly facilitates this process and makes it much more effective (Pic 4).

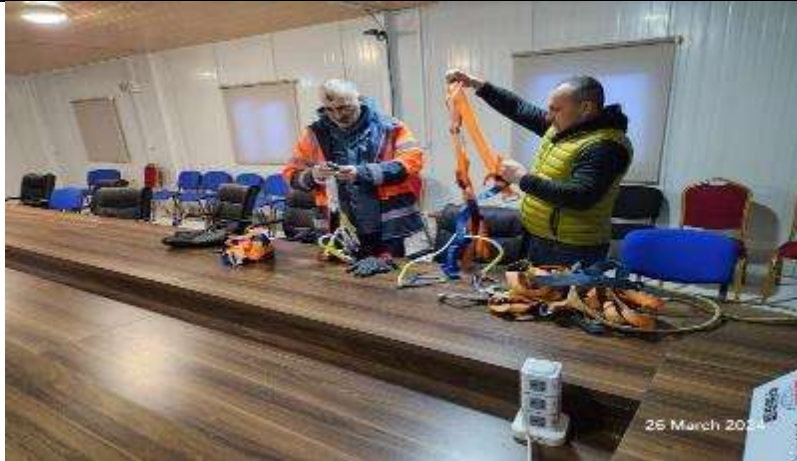
Pic 5

157. Inspection of fall arrest equipment is done regularly by the workers prior to every use and regularly by HS specialists when results are documented. This ensures that fall arrest system is in good working condition and is of a proper type for the task being performed (Pic 5)

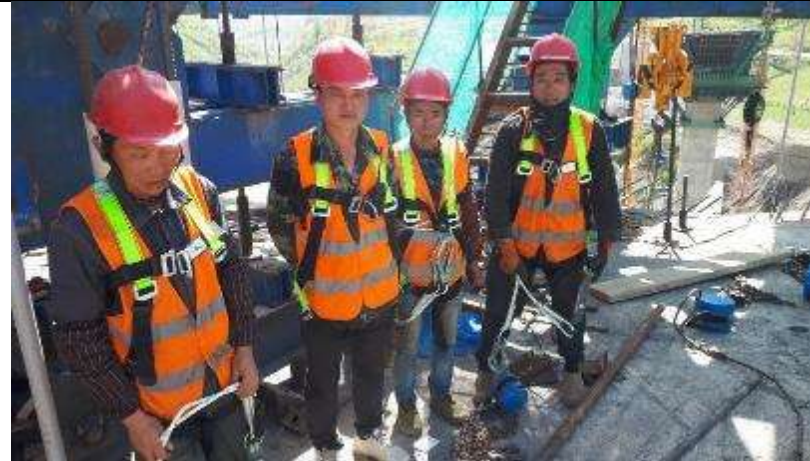
Pic 6

158. The Contractor has resupplied the personnel with the new fall arrest systems during the reporting period, which is a proactive and good practice, when the old PPEs are timely taken out of the use (Pic 6).

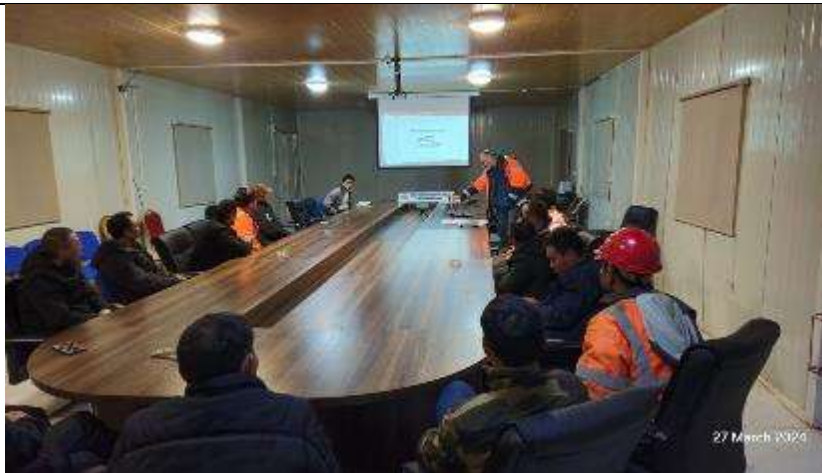
Pic 7

159. The Engineer together with both Contractors continued to deliver trainings during the reporting period for the personnel working at Bridge No. 2 targeting safety requirements for work at height. Work at height training is mandatory for every employee who is involved in this activity and is delivered prior to the start of work as well as at a regular interval. (Pic 7, Pic 8).

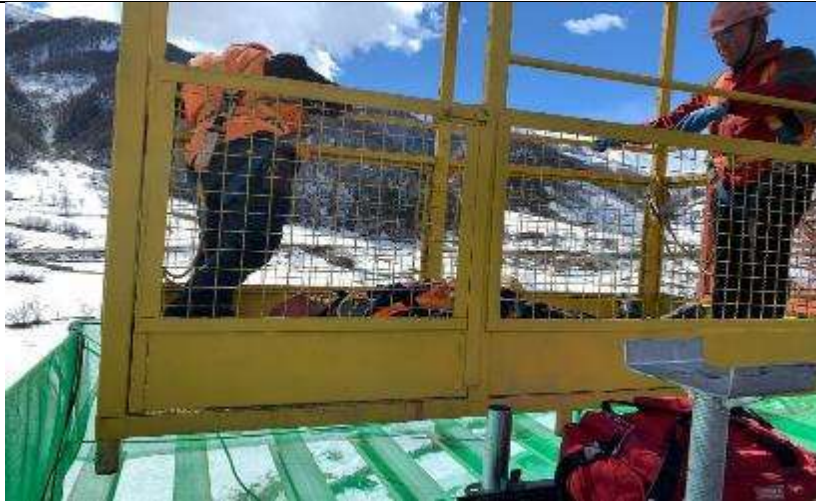
Pic 9

163. This drill will help the Contractor in the future to respond to this type of emergencies, as a lot of activities are currently carried out at that height and even suspended trauma (if fall from height occurs) will require the Contractor to initiate rescue from height operation (Pic 9, Pic 10, Pic11)

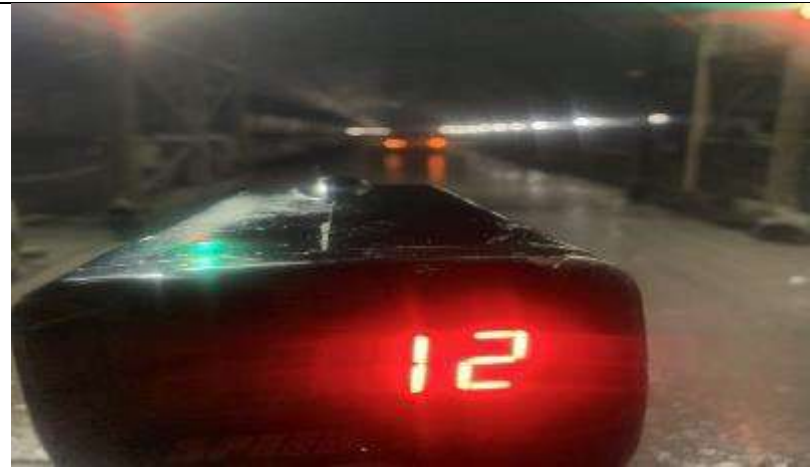
Pic 12

169. LOT 1 Contractor demonstrated good practice for the management of mobile equipment. The Contractor delivered toolbox talks to the drivers and operators permanently during the whole reporting period. All shortcomings related to the transport and mobile equipment were immediately followed up and improved. In addition, to control the speed limits in the tunnels, the Contractor started to use a speed gun which allows to effectively identify speeding from the distance (Pic 12)
