# Semi-annual Environmental Monitoring Report

Reporting period: January – June 2024

## **Georgia: North-South Corridors (Kvesheti – Kobi) Road Project**

Loan No GEO 3803

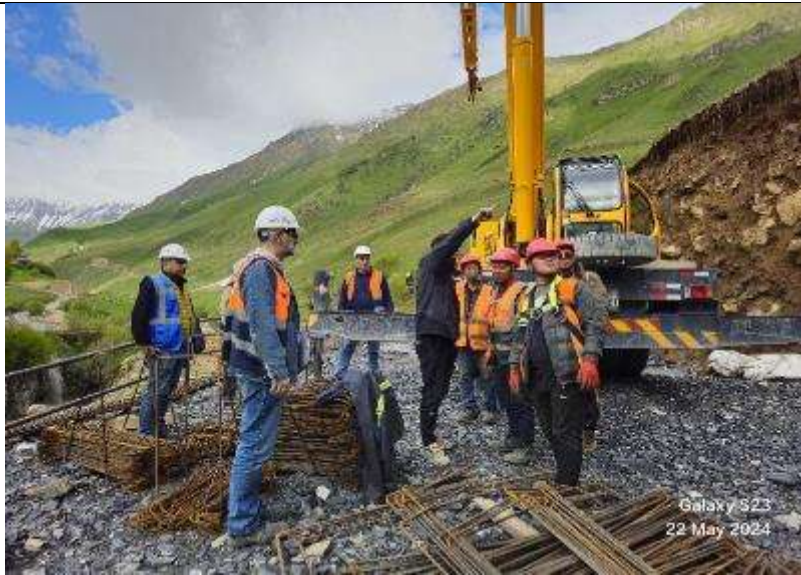
Pic 13

175. Both Contractors continued to deliver Toolbox Talks on a regular basis. Toolbox talks are targeting general safety requirements as well as specific topics for different work activities. Despite the fact that comparing to previous reporting period Lot 2 Contractor increased the number of TBT, it is still required to improve the frequency. As for LOT 1 Contractor, the frequency and the quality of TBT is of a good standard (Pic 13).

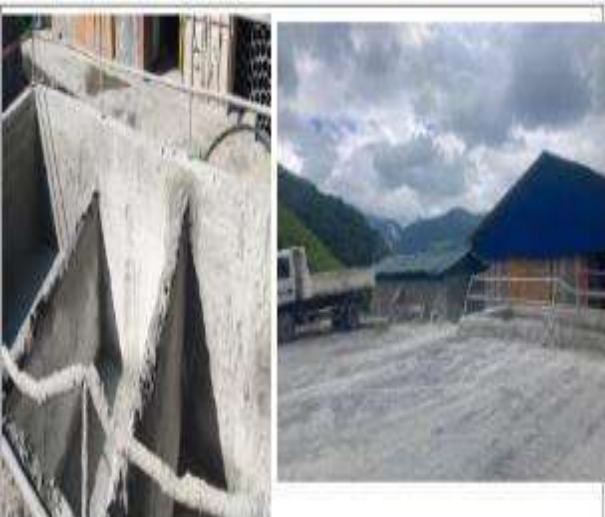
| | <p>Cleaning of washout pit at BP 3 Lot- 2 May 2024</p> |

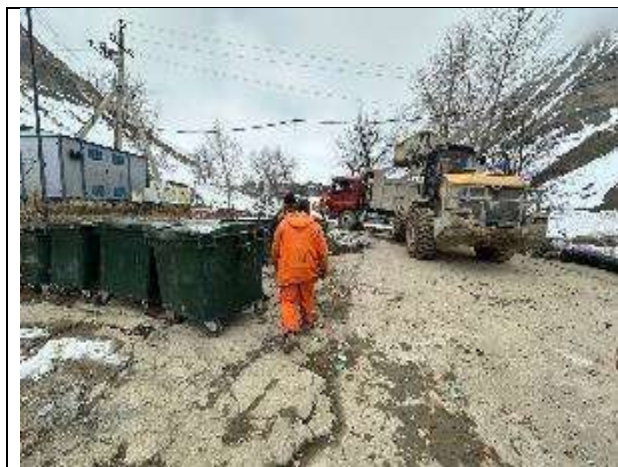
Housekeeping at Tskere camp and Kobi  
cansite Feb 2024

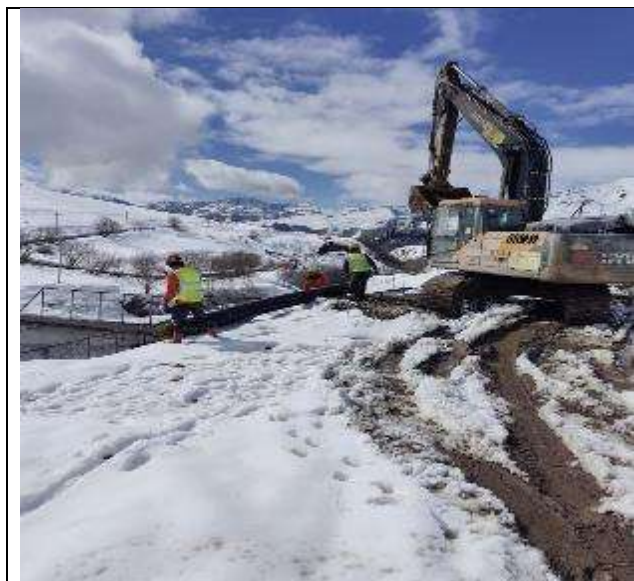
Sedimentation ponds cleaning in Tskere  
February 2024

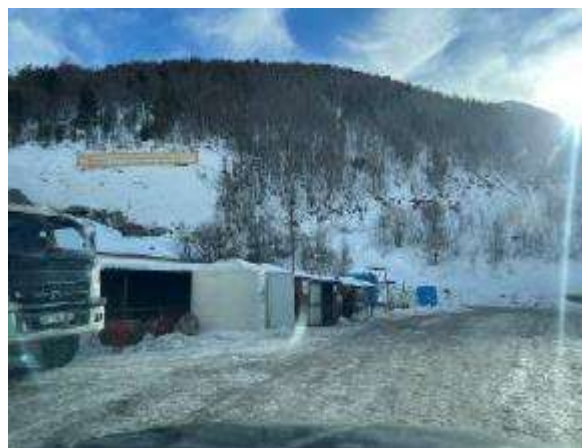
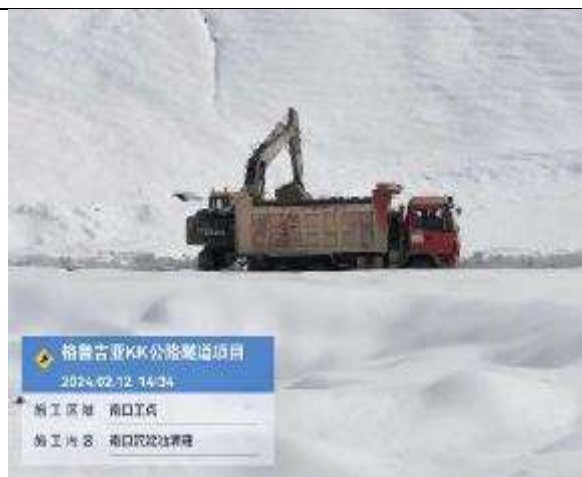
Site cleaning in Kobi batching plant and diesel facility March 2024

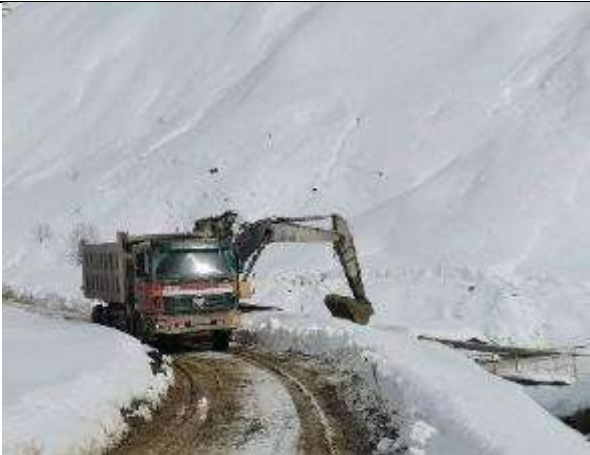
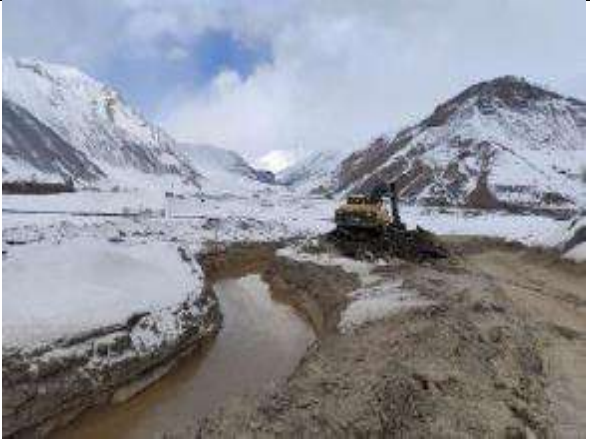
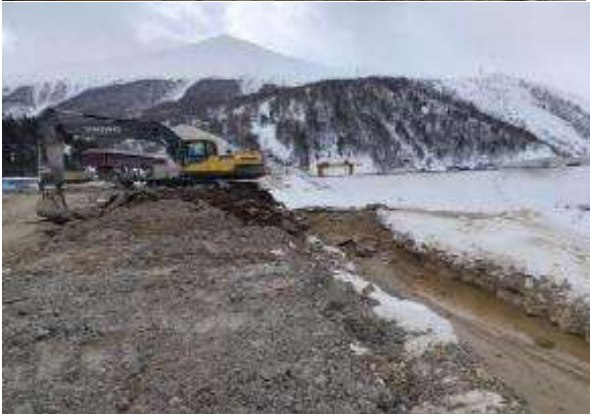
| | <p>Sedimentation ponds cleaning in Kobi March 2024</p> |

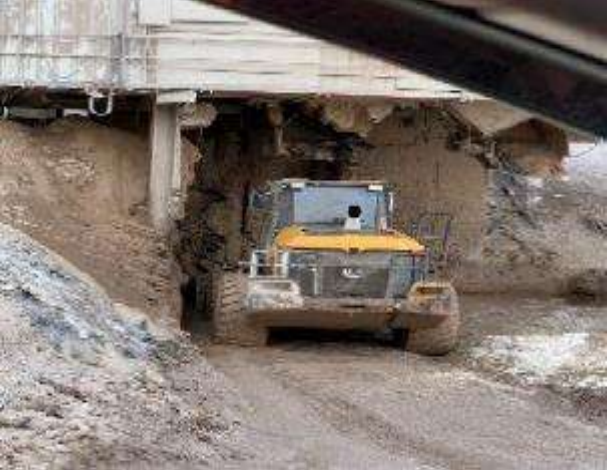
| | Conveyer belt cleaning Feb 2024 Lot-1 |

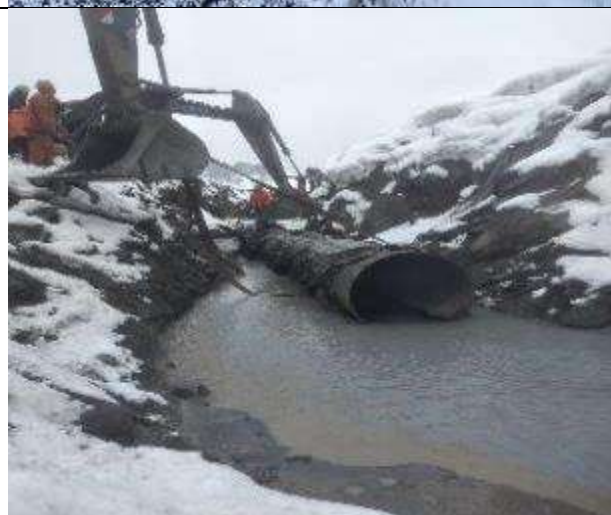
Washout pit cleaning Kobi BP Feb 2024

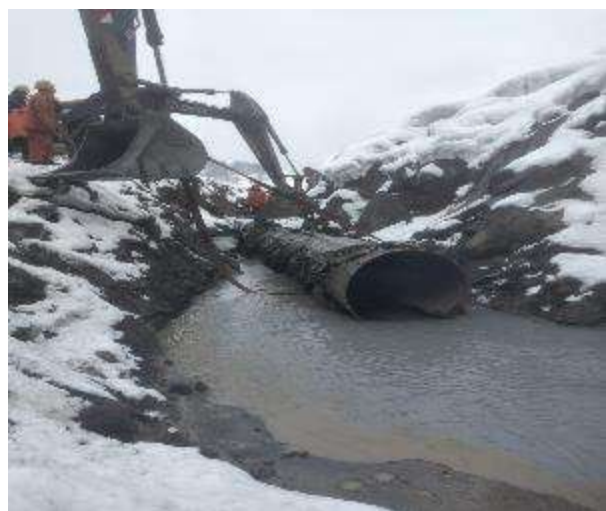
Tunnel water pipe underground being arranged by LOT-1 CC Tskere. March 2024

| The Lot 1 Contractor is recommended to replace the tunnel water discharge channel, made of metal sheets, with the plastic pipes to avoid leakage of discharge water and subsequent damage to the land. | CC for Lot# 1 to implement and PMCSC to monitor |

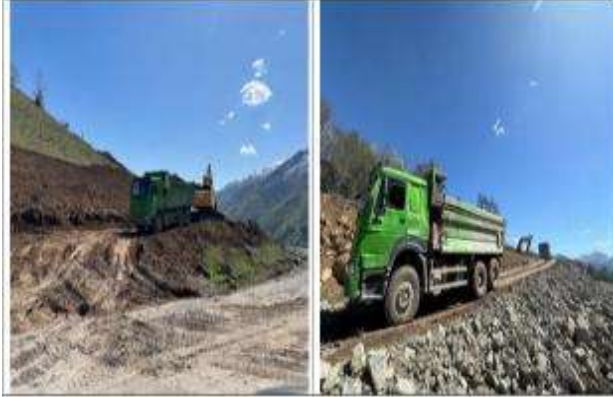
| | Topsoil stripping at GARP lot-2 April 2024 |

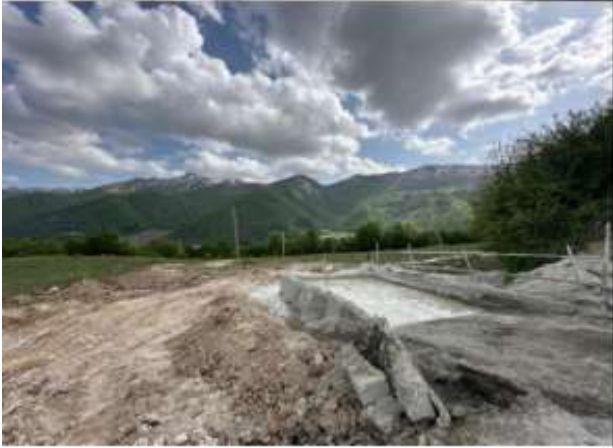
| | Cleaning and changing grass filters for sedimentation ponds at BP 2 lot-2 April 2024 |

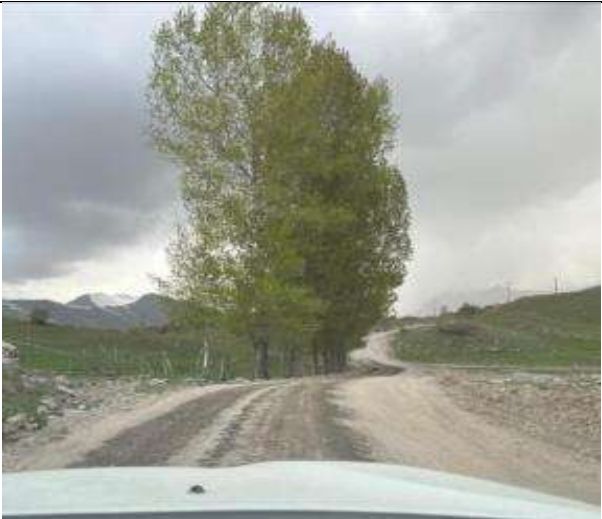
| | <p>Water sprinkling at acces road plateau Lot-2<br/>2April 2024</p> |

| Add one water sprinkling truck for Khada valley road water and should spray water at least three times a day during windy and dry days. Repair the damaged water truck and follow the dust management plan. | CC for Lot# 2 to implement and PMCSC to monitor |

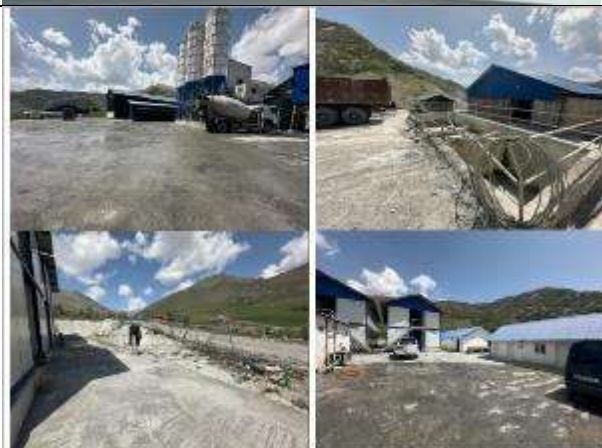
| | <p>Campsite 3 cleaning works<br/>April 2024</p> |

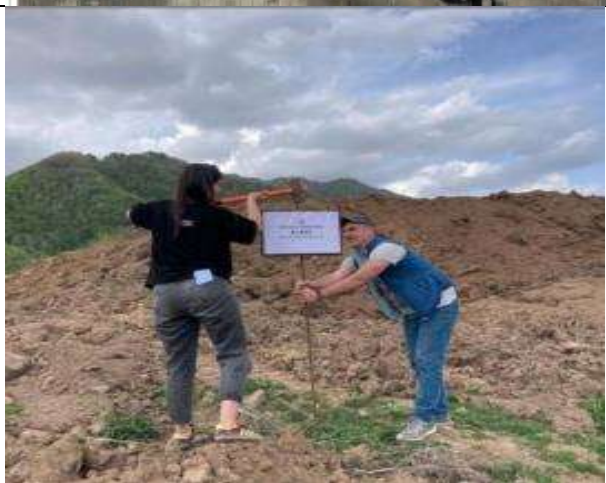
Installation of signs at topsoil storage area  
April 2024

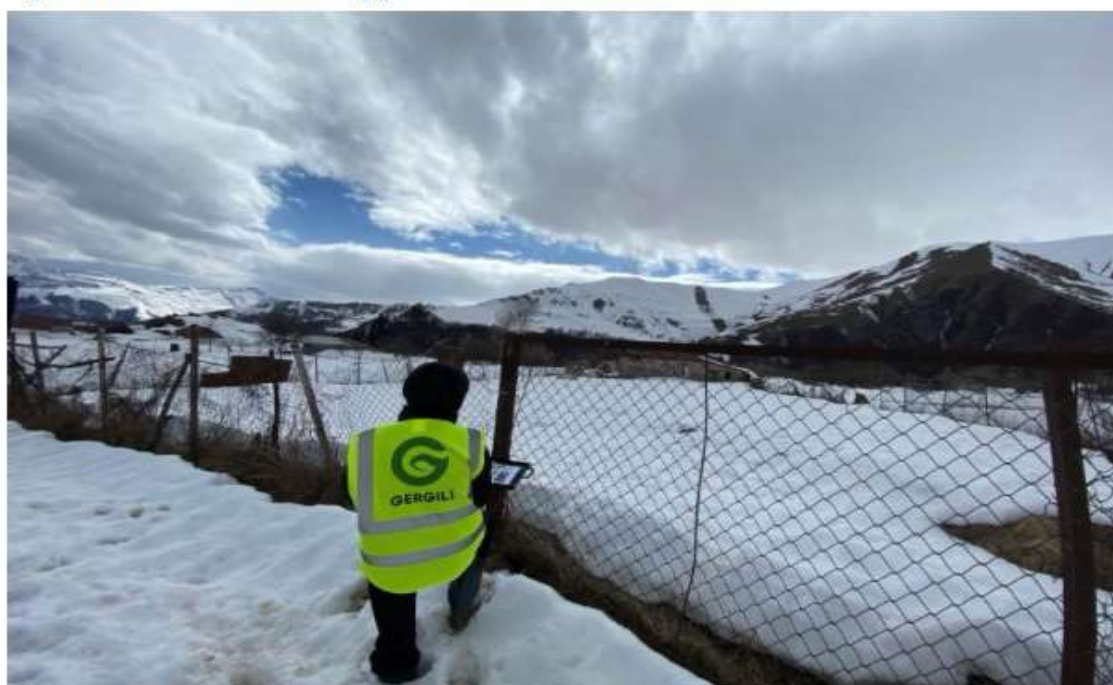
Figure 6.1.1 Vibration Monitoring point is located in Beniani settlement

At the time of the monitoring point, no works were carried out in the village of Beniani, the construction site of Tskere is located about 3.5 kilometers from this point

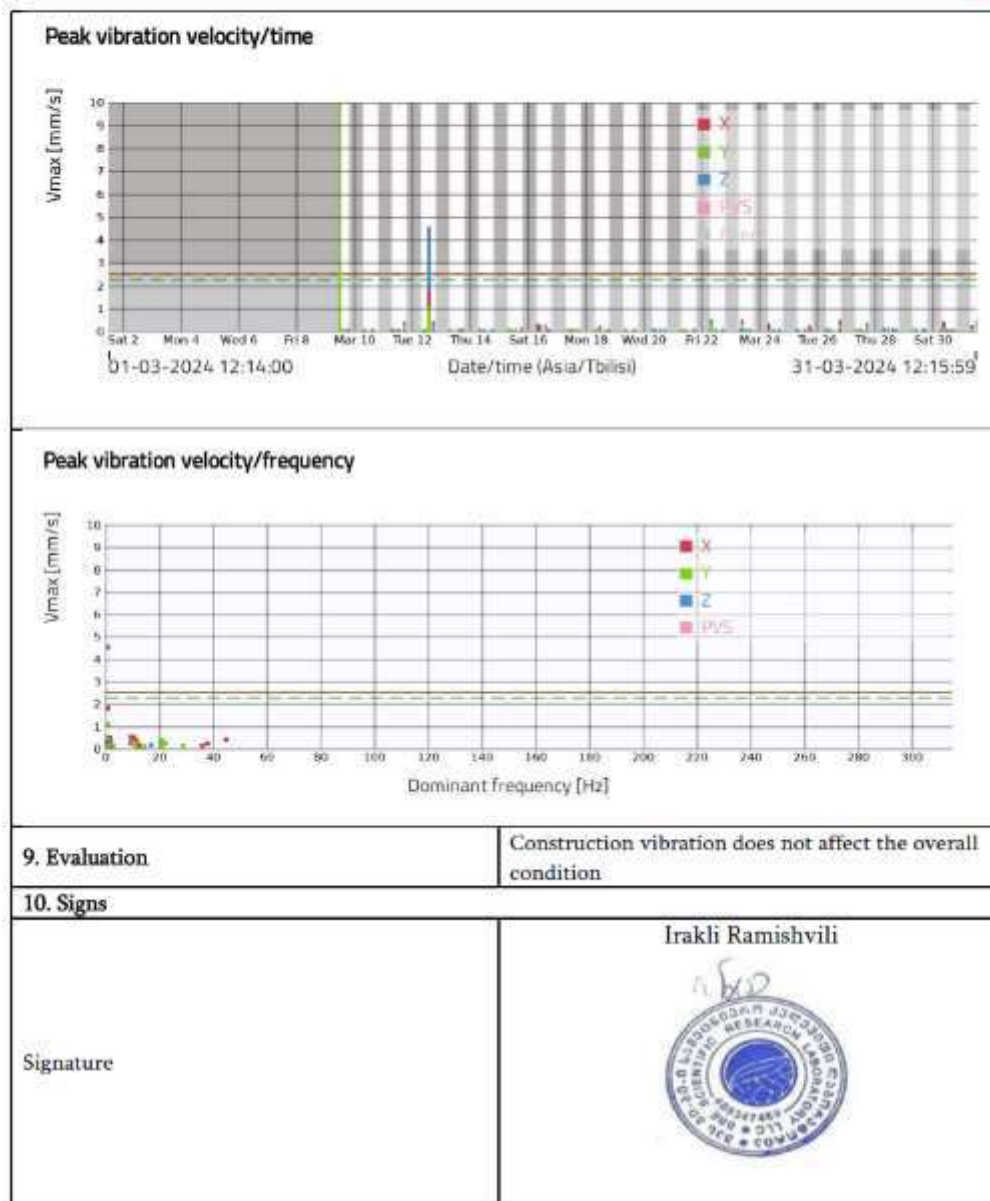
As can be seen from the data from the protocol, the level of vibration exposure generated by the construction at the control points are much lower than the reference values specified in DIN 4150-3.

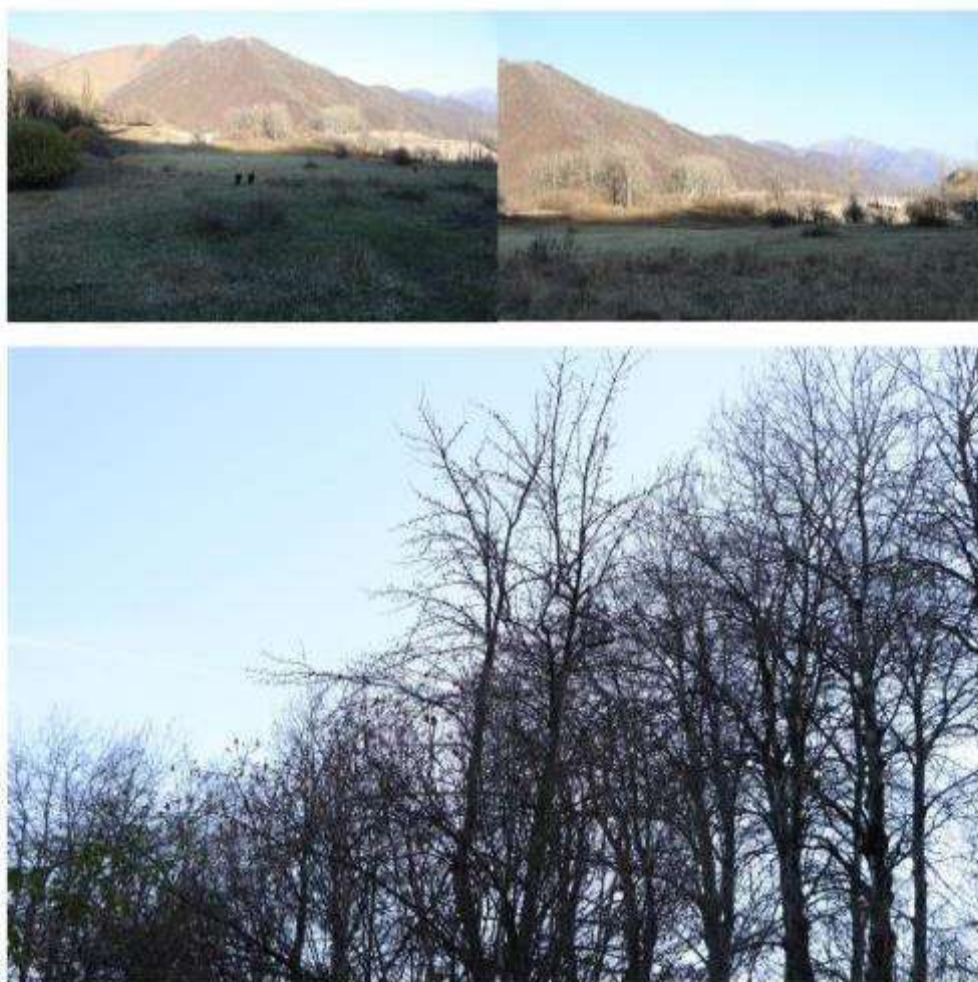
Figure N 3.1.1

The initial approximately 800 m section of the project road coincides with the meadow-type pasture area, sparsely forested areas, windbreaks and arable land plots. (See Figure N3.1.1) It should be noted that the design road buffer mainly coincides with the existing track/road used for cattle movement and agricultural plots, as well as internal rural roads.

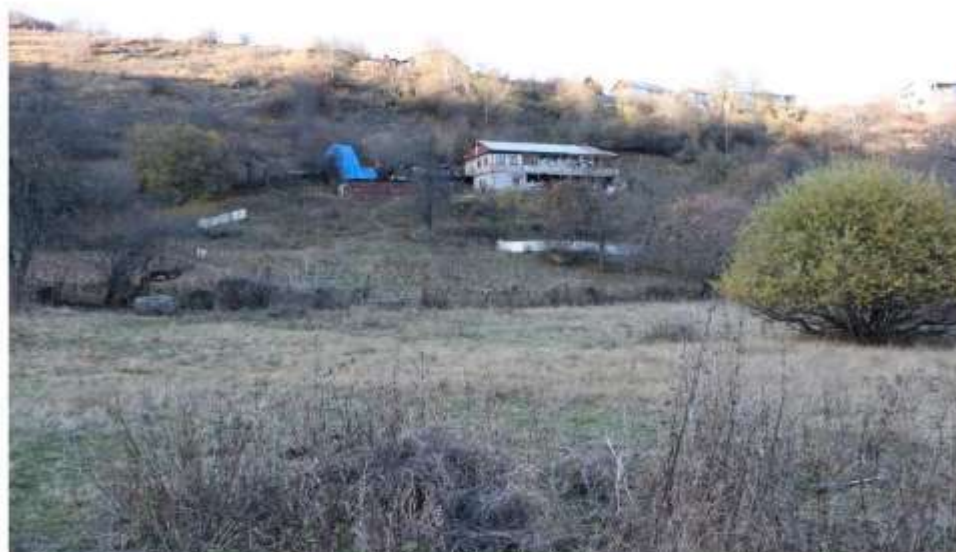
The second section of the project road, conditionally divided, is part of a road of about 1000 m, the beginning of which crosses the existing secondary road and goes around the small hill there from the south to the west, where the nearest residential house is located, and follows the right and left sides of the existing road, the area also includes part of the existing road. The area is quite inclined to the south and east. See Figure N3.1.2

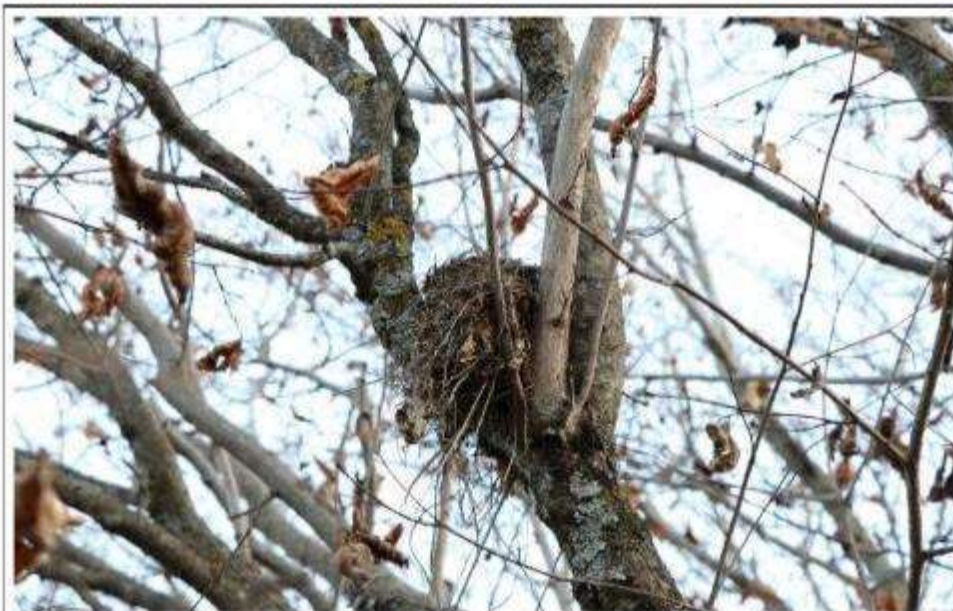
Figure N3.1.3

The territory consists mainly of pastures and herbaceous vegetation, sparsely forested areas, which serve as windbreaks. During the field survey here, approximate coordinates X460020 Y4698425, a swallow's nest was observed (See Figure N3.1.3)

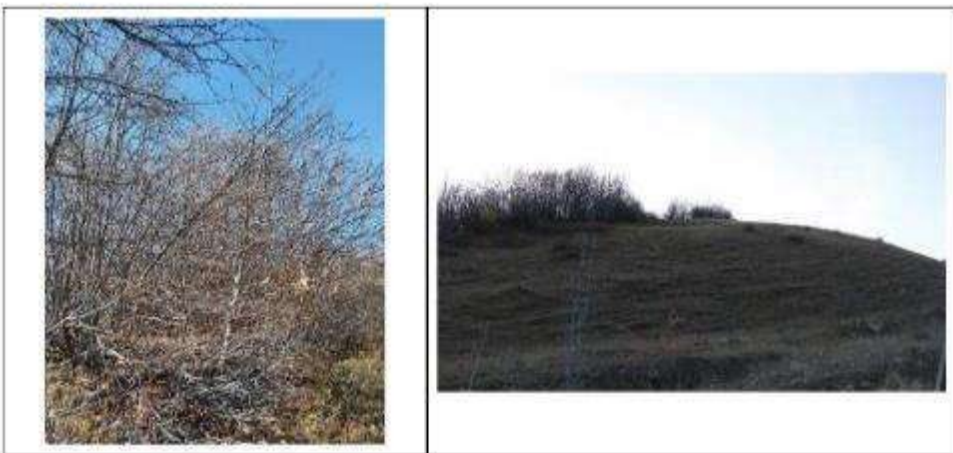
Figure N3.1.4

At the same section, it is worth noting that the project road crosses the lands of the Forestry Fund. The project road with an area of about 80 m<sup>2</sup> crosses the lands of the Forest Fund, the approximate coordinates are (X459985 Y4697997 H1690). (See Figure N3.1.4) Within the framework of the project road, the mentioned forestry fund crossing is the only one and it does not happen anywhere else.

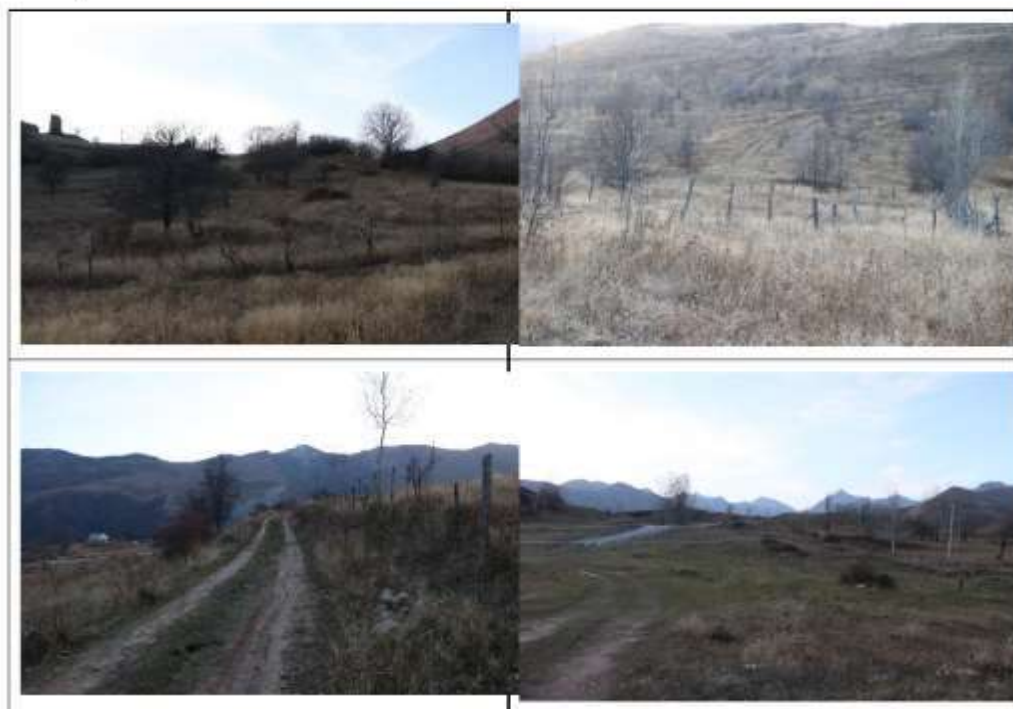
Figure N3.1.5

Within the mentioned section, there is a grazed area on the slopes of the hill, which then turns into arable land plots and a part of the narrow dirt road near the village of Kaishaurni. (See Figure N3.1.5)

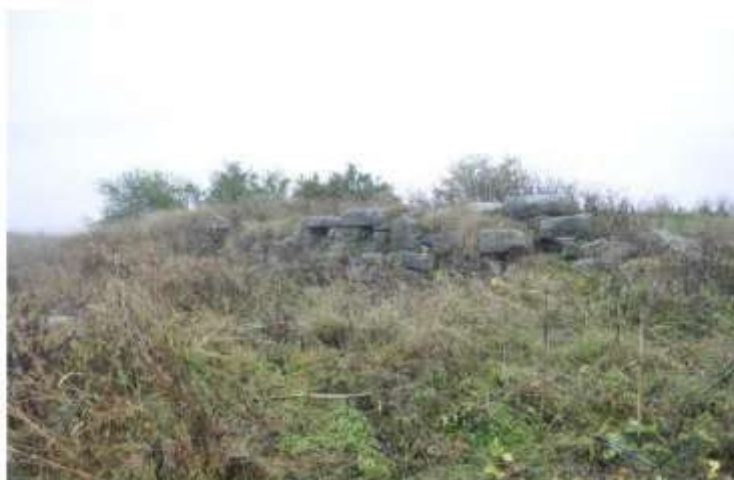
2. Ruins of backed tower-11557 - "X: 460150.20; Y: 4698007.86"

The ruins of the tower and the settlement are located on the Didveli plateau, in the territory of today's Kaishaurni village, in the place "Suntidzebi", to the southwest of the Suntni (Sunti) tower. The building is a dry piled tower of well-lit basalt stones. The tower is preserved as ruins. Only its first, deaf floor has survived. The maximum height of the best preserved wall of the tower is about 1.20-1.50 meters.

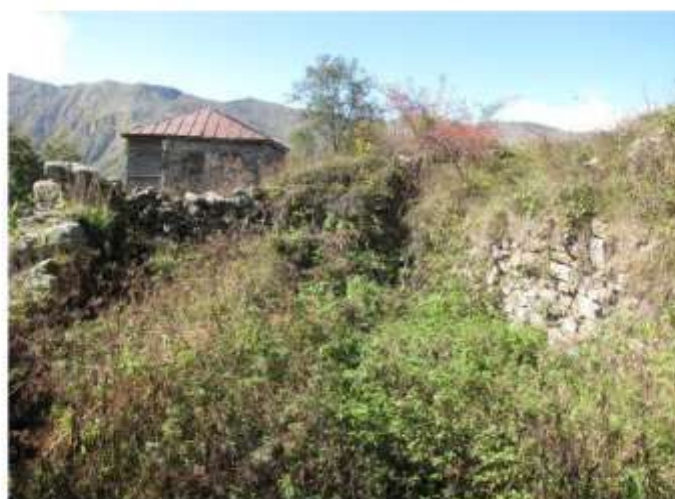
3. Settlement-site in Murghulebi district-35073 - "X: 460048.71; Y: 4698599.73"

The remains of the buildings are located in the southeast of Kaishaurni, 20-30 meters to the northeast of the Murghuls' house. Stacks of large stones are fixed on a slightly elevated hill. To the

south and east of it, the remains of the building wall have been preserved. Flat stones of various sizes of raw rock and in some places large stone boulders were used in the construction. The pile is dry.

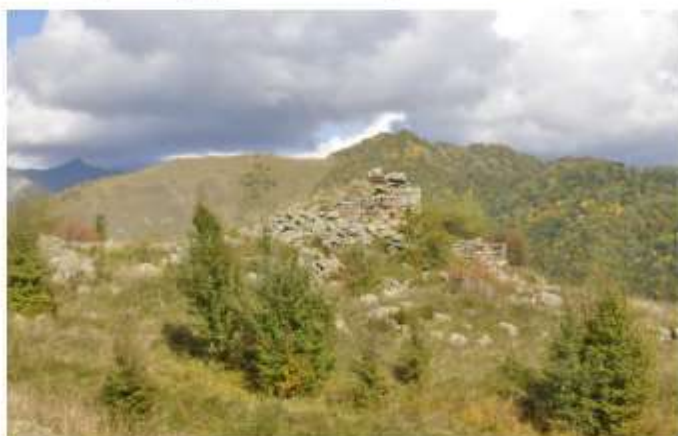
4. Sameba tower-11655\_Field ID (19) - "X: 460205.31; Y: 4698844.57"

The Tower of the Trinity is located 300 meters east of Kaishaurni Castle, overlooking Zakatkar village and Didveli plateau. The surviving dimensions of the tower of the Trinity are 7.2x4.2 m. It is built with crushed stone, roughly worked basalt, megalithic stones are used for flat walls and corners. The tower is destroyed - only the first floor level remains. The tower is surrounded by settlements on three sides - one terrace on the north and south sides, and three terraces on the east side. The tower must be an early medieval building, which was repaired in later centuries.

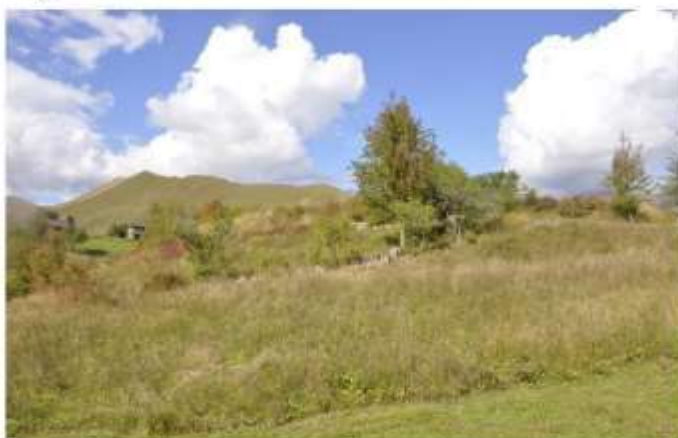
5. Niche of the Virgin and site of former church-35074 - "X: 459984.10; Y: 4698649.41"

The building is located 70 meters northwest of the Murghuli house, in the territory of the old Murghuli cemetery. An iron cross with a broken arm is erected in the central part of the cemetery.

A small niche is arranged with it, the locals refer to it as the niche of the Virgin Mariam. To the north of it, the remains of a rectangular building have been preserved. The walls are built of large, rough-hewn stone boulders, dry piled. The wall thickness is about 0.90 centimeters.

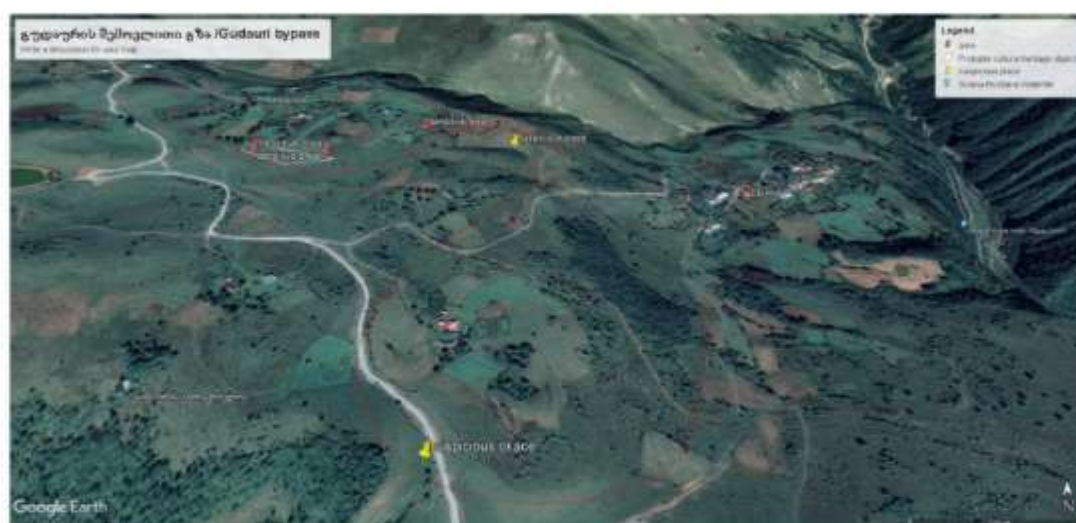
1

In addition to the cultural heritage objects mentioned above, the survey revealed several suspicious and sensitive places that require special attention during earthworks (photo: 1). During surface survey, ceramic fragments were collected in suspicious places (GPS coordinates: 1- X - 460114; Y- 4698767; 2- X-460037; Y-4697981.) (photo: 2-4), as for the sensitive area (GPS coordinates: 1. X-459683; Y-4698654; 2. X-459802; Y-4698654; 3. X-459953; Y-4698792.). It is notable for its location and terrain, which includes an elevated and specially groomed area. (Photo: 5-7)

Due to the abundance of cultural heritage objects in the construction area of the said bypass road, it is necessary to be supervised by a cultural heritage expert during earthworks, in case of the appearance of a cultural layer immediately stop the works and start the procedures stipulated by the law. In addition, when using heavy machinery during soil removal, it is necessary to use a toothless, bladed basket in the excavator, so as not to damage the cultural layers during soil removal, and for the supervisor to easily distinguish the normal layer from the cultural one.
