# Semi-Annual Environmental Monitoring Report

Semestral Report (January – June 2024)

## Georgia: East-West Highway (Shorapani – Argveta Section) Improvement Project

Prepared by the Roads Department of the Ministry of Regional Development and Infrastructure of Georgia for the Asian Development Bank.

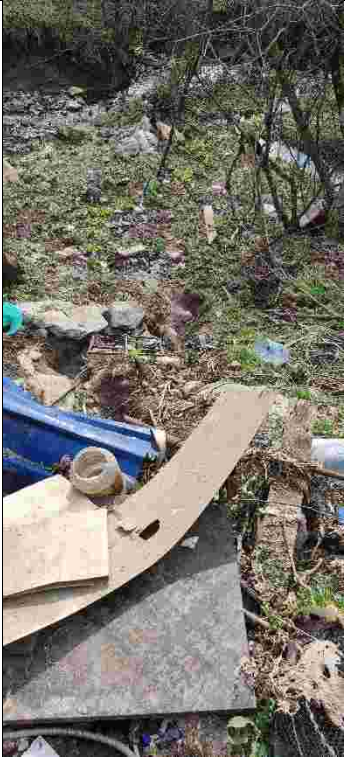
| Poor Waste Management (Worker’s Camp No 2, February 2024) | Poor Management of Discharge Water (Batching Plant No: 1 February 2024) |

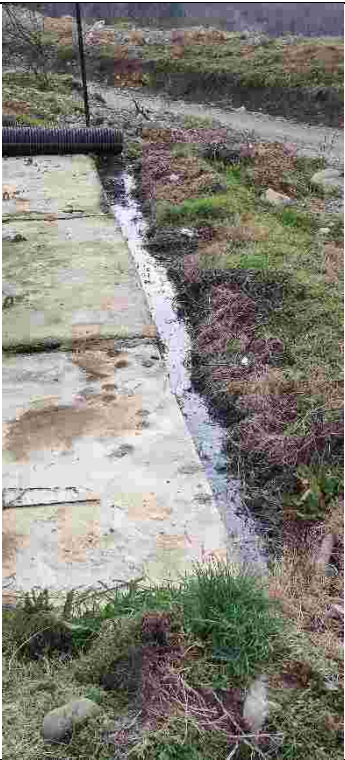
| <p>Leaking Sewage Tank (Worker's Camp No 6, February 2024)</p> | <p>Poor Housekeeping (Worker's Camp No 6, February 2024)</p> |

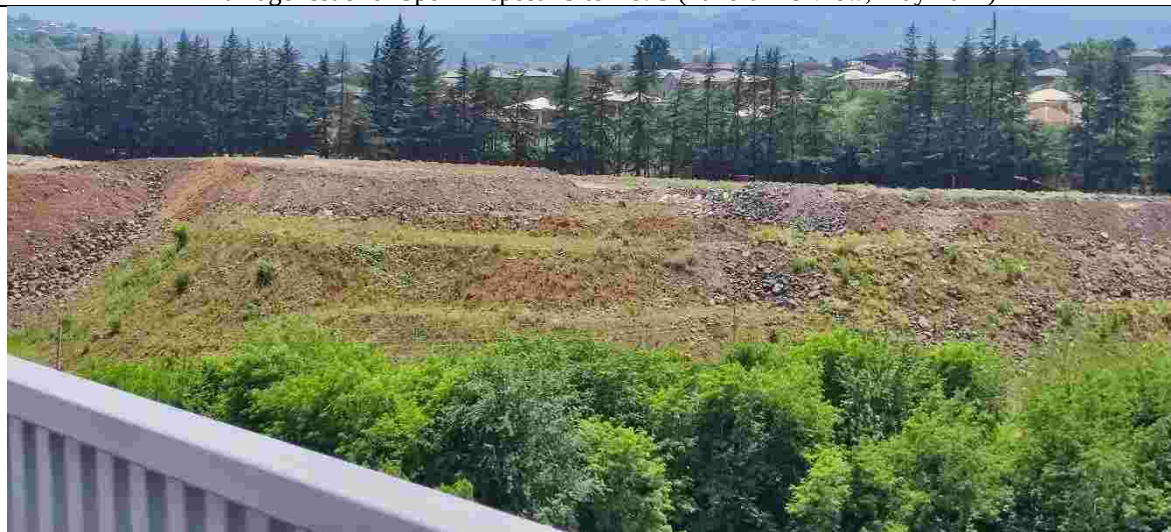
Drainage Issue for Spoil Disposal Site No: 3 (Panoramic View, May 2024)

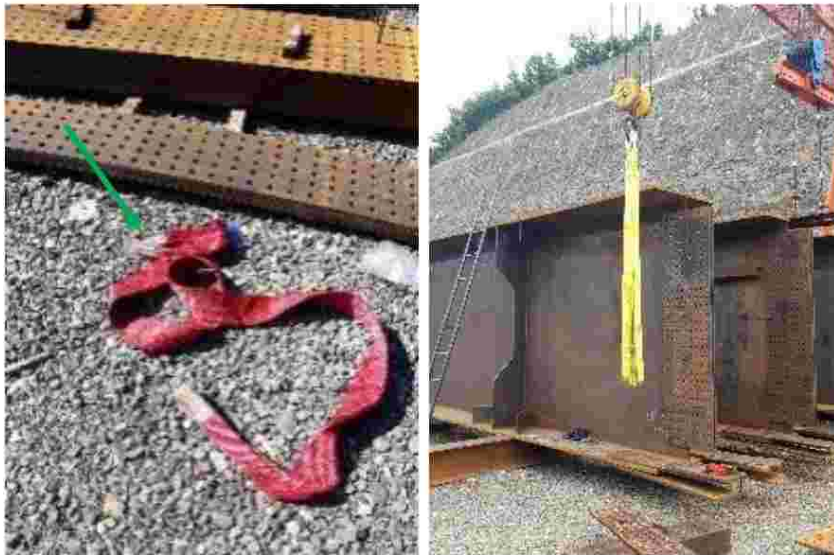
**Bridge N2 (Workshop)** – *It has been observed that the crew was using correct and good quality lifting equipment.*

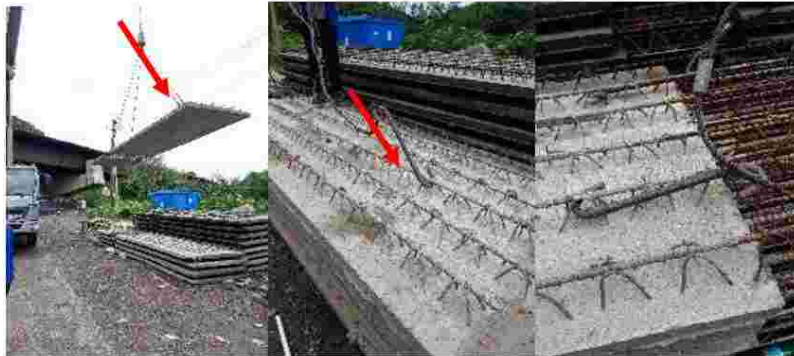
**Picture 3: Positive and Negative observation – Lifting safety (All tunnel and bridges)** – Good and bad (Including handmade) quality lifting equipment has been observed during site inspection. The Engineer has asked the Contractor's site responsible persons to take care of this issue and pay additional attention at to avoid the possible incidents and injury of working personnel. Issue isn't solved yet.

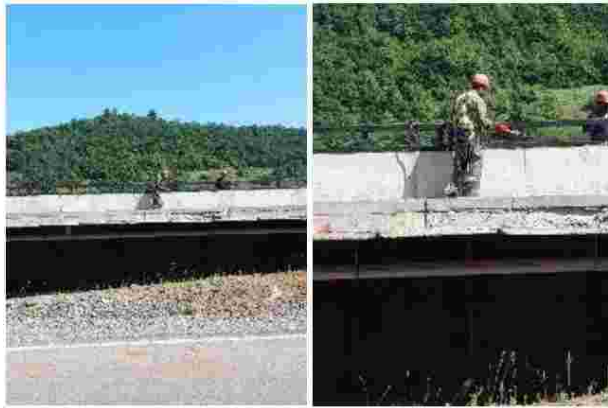
**Bridge N2 AT –** Safe work process has been observed during site inspection. The worker was equipped with the proper PPE (Fall arrest equipment) while performing the task at the elevated height.

**Picture 4: Negative and positive observations – Working at height Safety - (Bridges) –** The persons in safe and an unsafe position have been observed during site inspection. It is forbidden to perform the task at height without proper PPE, because it may cause the possible incident, fall and injury of the working personnel. Correct PPE, technique and equipment must be used to avoid the incident and personal injury. Non-compliance isn't solved.

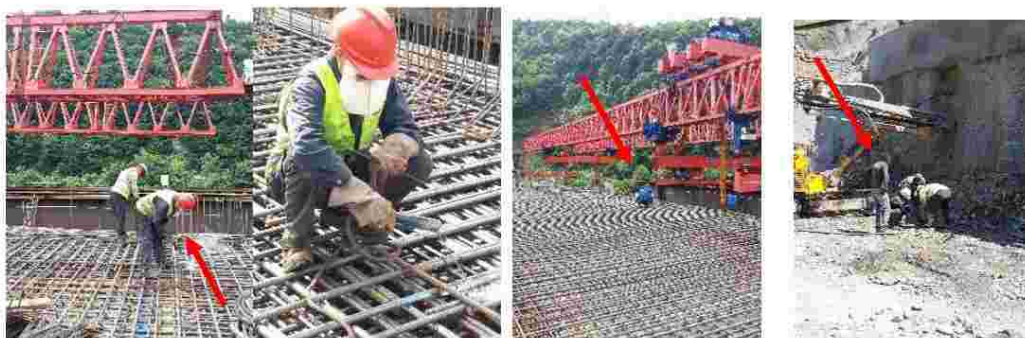
**Bridge N1 TA**

The workers aren't equipped with proper PPE (Safety helmet, safety shoes, reflective jackets, welding face shield, leather jacket and handgloves) when performing the task.

**Picture 7: Negative and Positive observations – PPE (Tunnels and Bridges)** – Violation of safety rules and requirements have been observed. It has been observed that the workers weren't equipped with proper PPE when performing the task. The Contractor has to pay attention to this issue in order to avoid the possible incident at the workplace and injury of the working personnel. Non-compliance isn't solved.

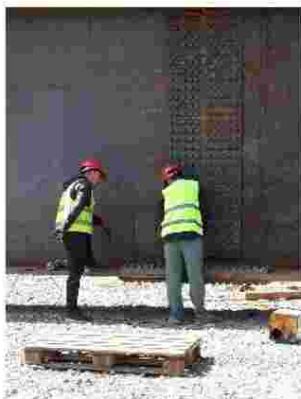
**Workshop (Bridge №2)**

The workers are equipped with the proper PPE when performing the task.

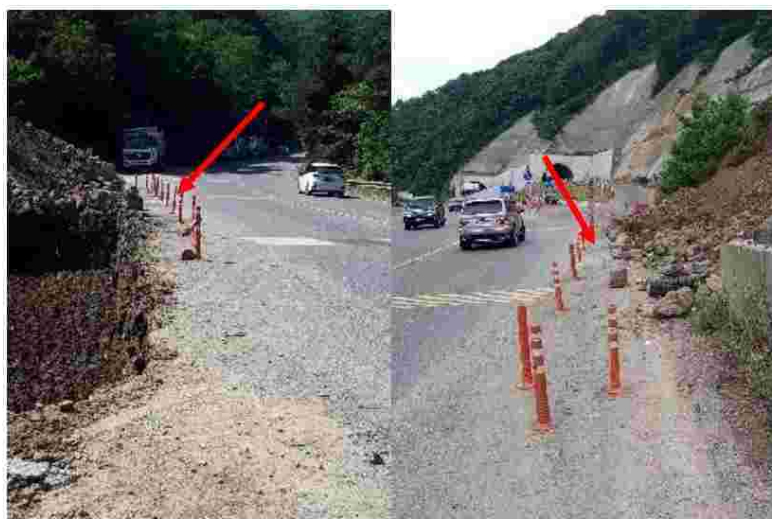
Before

**Access to the Tunnel N2 TA-A** – After a verbal warning given to the Contractor, the safety flash cones have been placed all along the access road. It isn't enough to close the issue, the hard barriers and warning signs must be installed to ensure that the access to the workplace is safe.

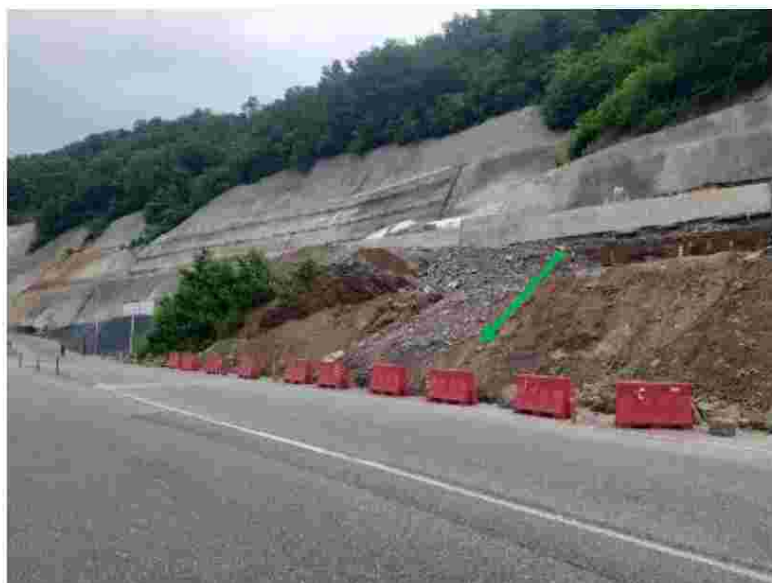
**Main road (E60) (Near the Tunnel N1 TA-Tbilisi side)** – After a verbal warning, given to the Contractor, the jersey barriers have been placed.

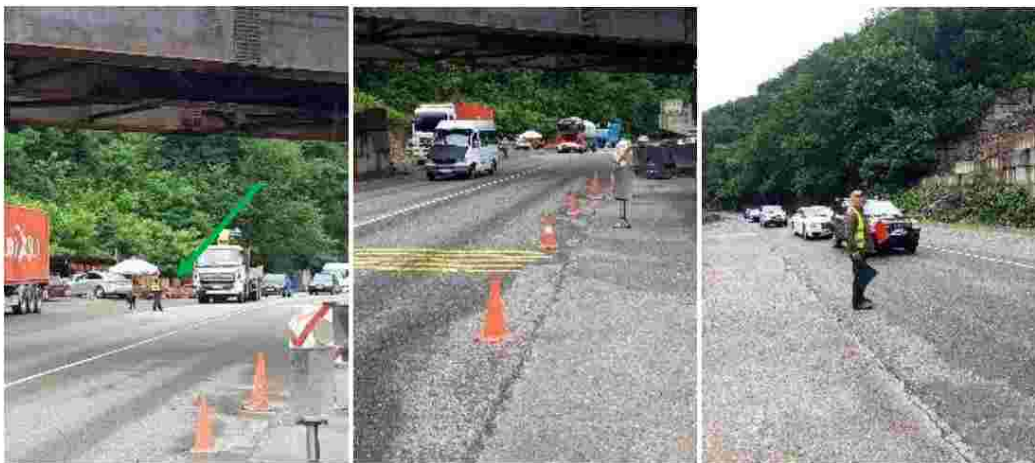
**Picture 13: Positive Observation – Lifting safety (Main road (E60))** – Safe lifting process has been observed during site inspection. It has been observed that the working area was protected by using traffic flash cones and plus, the flagmen were appointed to control the movement of the vehicles crossing the workplace.
