# BI-ANNUAL ENVIRONMENTAL MONITORING REPORT

Loan No. 2560 – GEO  
JULY – DECEMBER 2017

REPUBLIC of GEORGIA: ROAD CORRIDOR INVESTMENT  
PROGRAM – PROJECT 1, CONSTRUCTION SUPERVISION OF  
KOBULETI BYPASS ROAD

**Prepared by:** DOHWA Engineering Co., Ltd. Korea  
**For:** Roads Department of the Ministry of Regional Development and  
Infrastructure of Georgia  
**Endorsed by:** Mr. Nugzar Gasviani (Deputy Chairman)

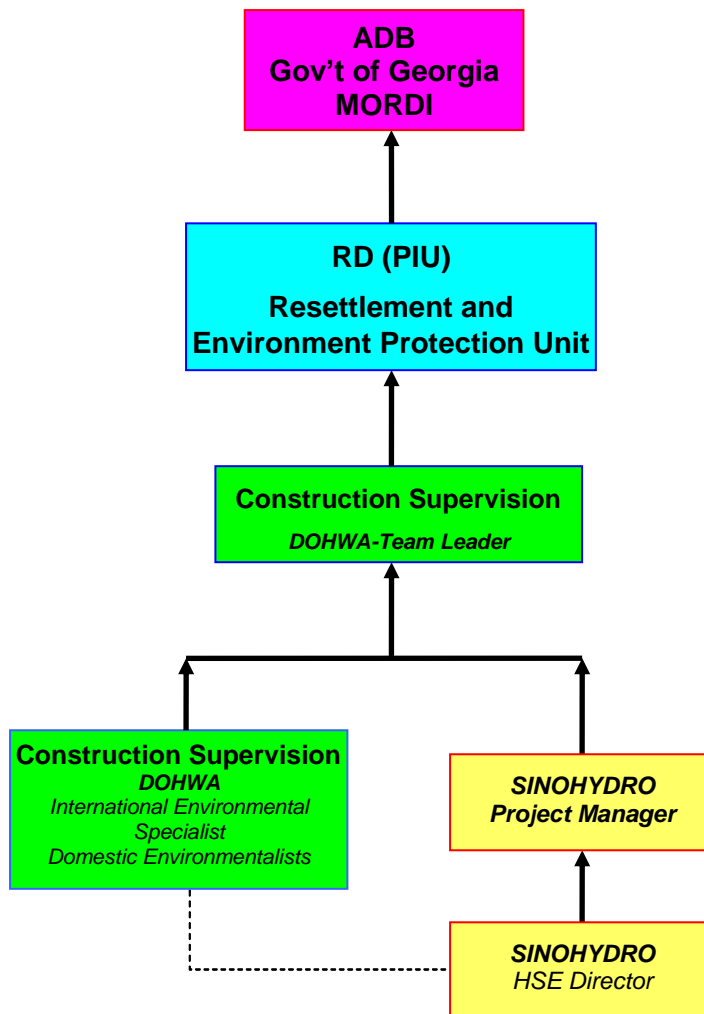
Figure 2: Environmental Monitoring Work Coordination Set-Up

22. Environmental issues arising from the construction activities should immediately be brought to the attention of the construction supervision team to coordinate efforts in order to immediately mitigate impacts, protect the environment, and safeguard the health and welfare of the local communities. All these are to be conducted within the framework of the overall construction management and supervision. Aspects in the environmental monitoring are reported in a monthly, quarterly and bi-annual basis to the RD (PIU) and ADB. The applied environmental monitoring work coordination set-up for the Project road is represented in Figure 2 below.

<b>Figure 1: Location Map of the Project</b> .....	6
<b>Figure 2: Environmental Monitoring Work Coordination Set-Up</b> .....	12
